Municipal Waterways Maintenance Plan Annual Report Fiscal Year 2022

THINK BLUE®
City of San Diego
Stormwater Department

October 2022

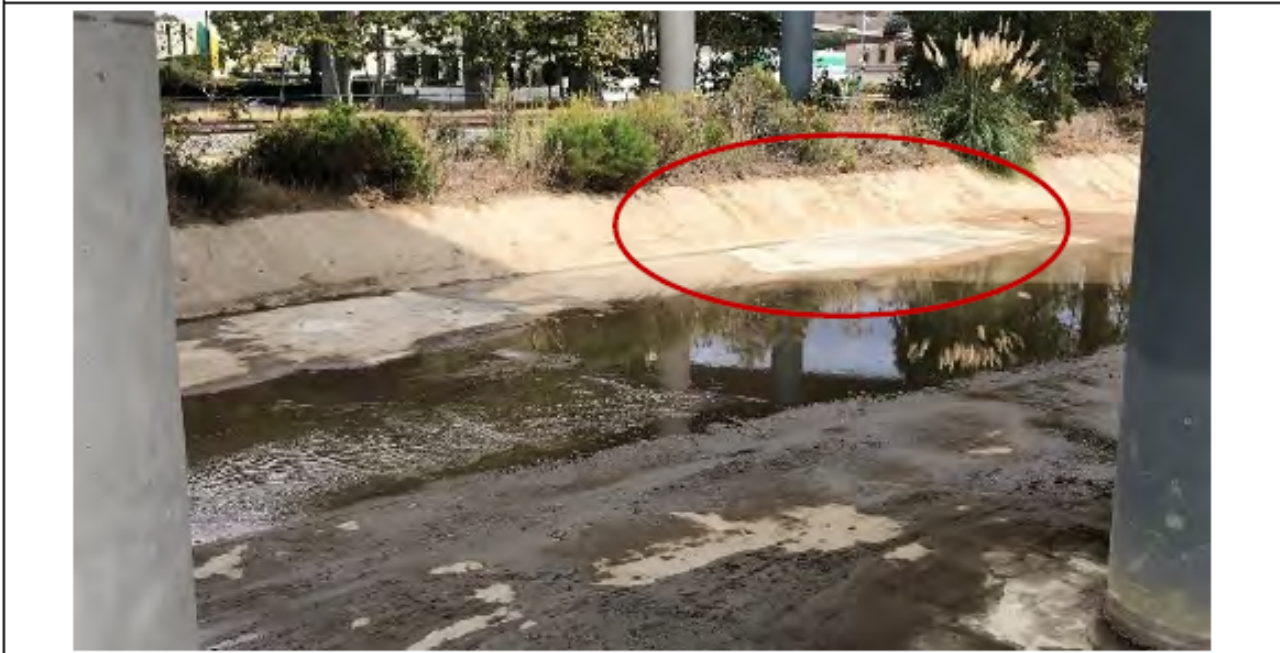
Roselle Concrete Repair- Photo 9: View of minor concrete repair area (circled in red) completed within concrete-lined channel at Roselle 2, looking southeast.

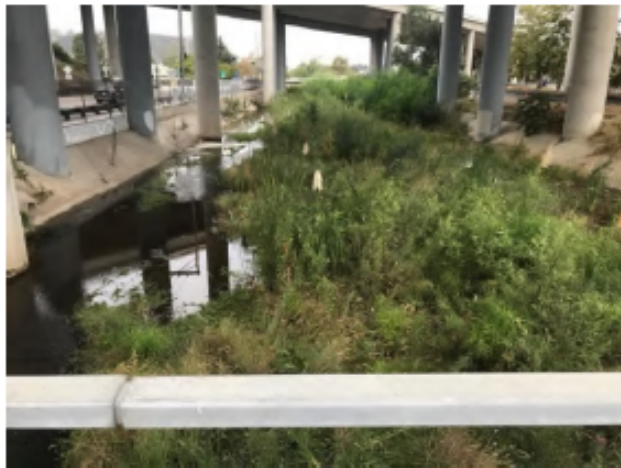
Roselle Pre-Maintenance - Photo 10: view of Roselle 2 taken from sidewalk that runs parallel to Sorrento Valley Blvd, near the intersection with Roselle Street. Thick vegetation shown to be present in channel.

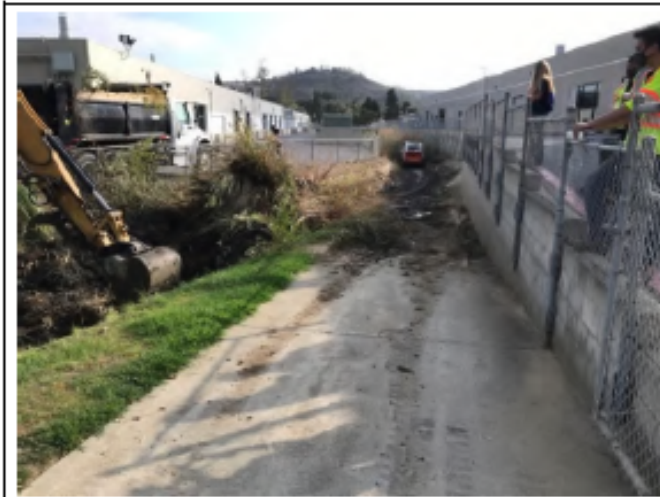
Flintkote Pre-Maintenance - Photo 1: view of Flintkote 1 looking northeast. Taken from western edge of project site. Thick vegetation shown in bed of channel.
(September 16, 2021)

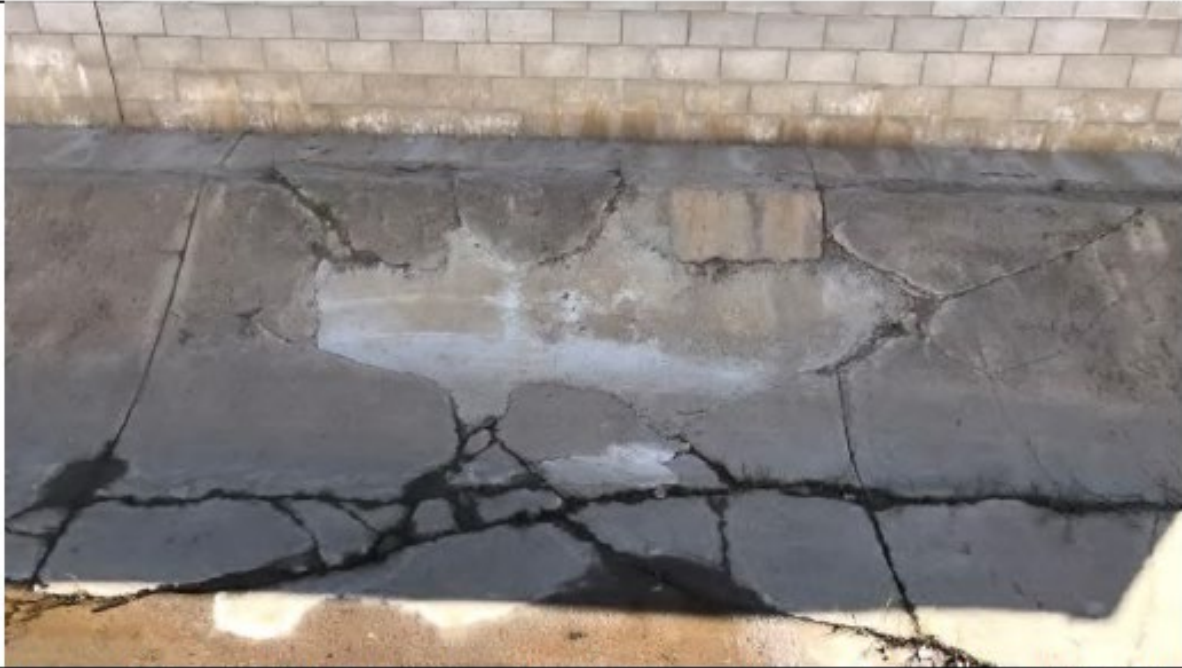
Flintkote Concrete Repair - Photo 3: View of concrete patching done within concrete-lined channel at Flintkote 1, looking south.

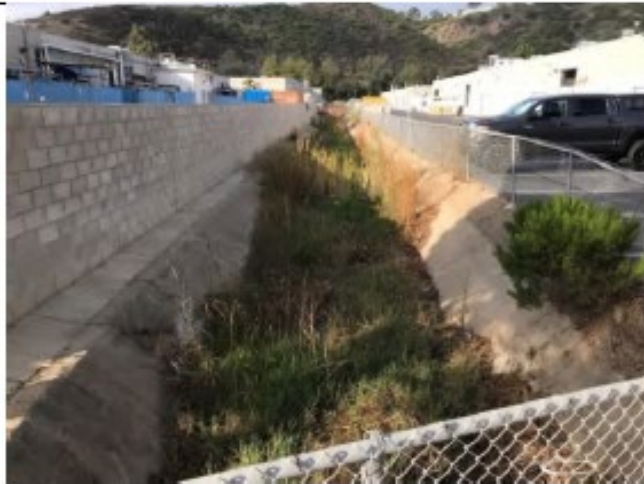
Flintkote Pre-Maintenance - Photo 4: View of Flintkote 1 looking south from Roselle Street crossing. Access area shown next to vegetated channel.

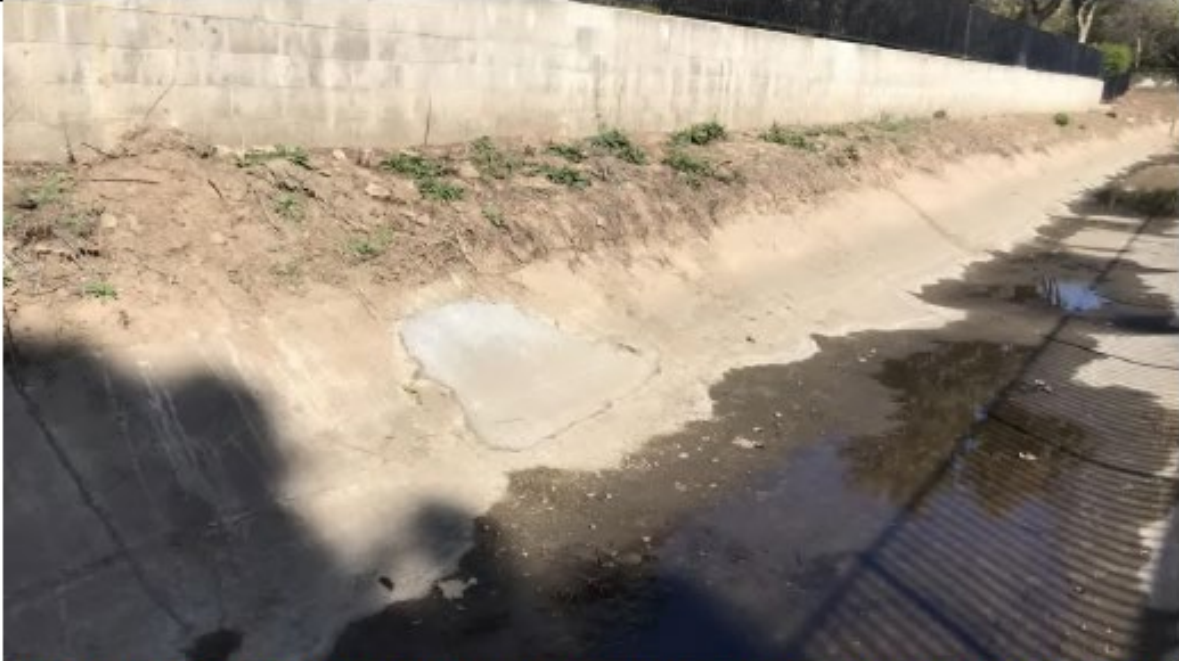
Flintkote Concrete Repair- Photo 5: View of concrete patching done within concrete-lined channel at Flintkote 1, looking northeast.
(November 4, 2021)

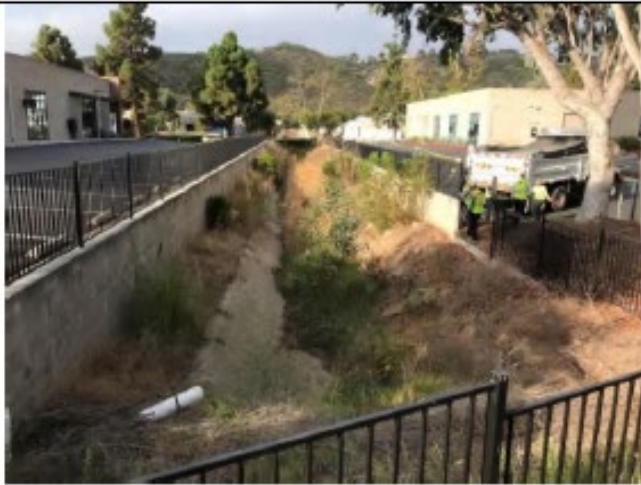
Flintkote Pre-Maintenance - Photo 6: View of Flintkote 1 looking southwest from eastern edge of the project. Access area shown next to vegetated channel.
(September 16, 2021)

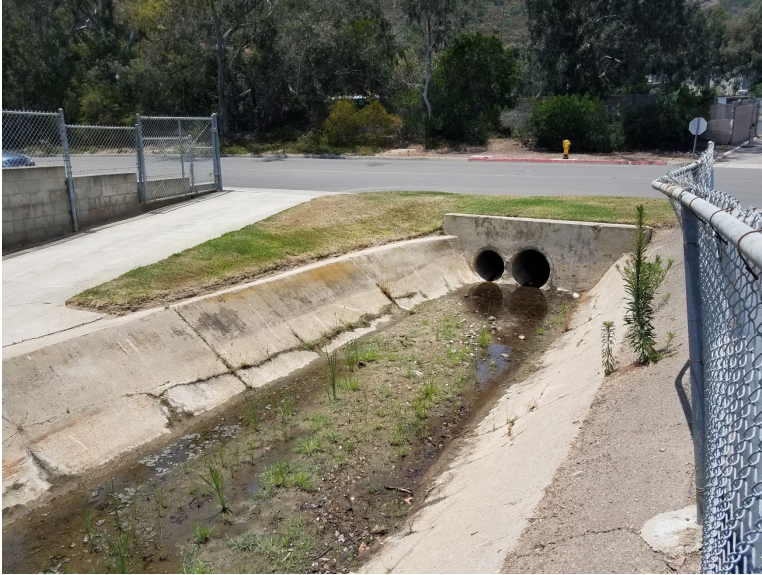
Flintkote premaintenance photo western terminus looking towards culverts and Flintkote Avenue
(June 25, 2022)

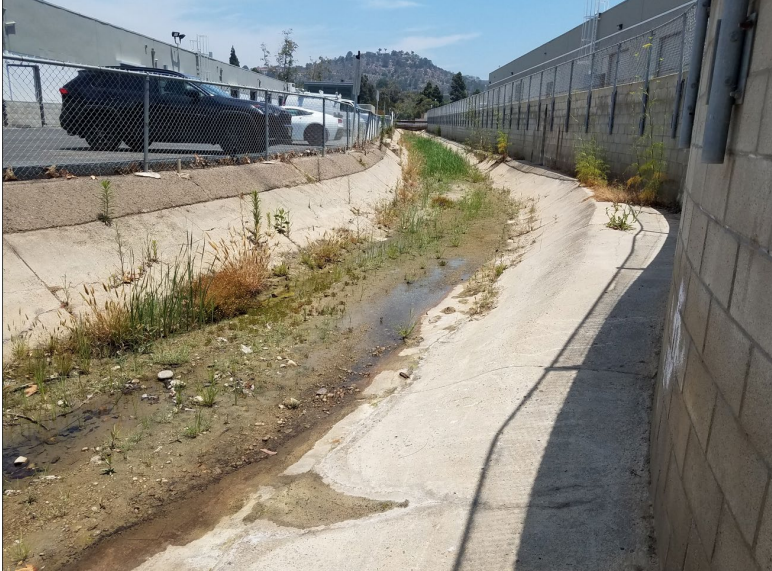
Flintkote pre-maintenance photo looking from the equipment access ramp on the western terminus east towards a mid-channel bridge crossing, illustrating silt, sparse and low growth vegetation (June 25, 2022)

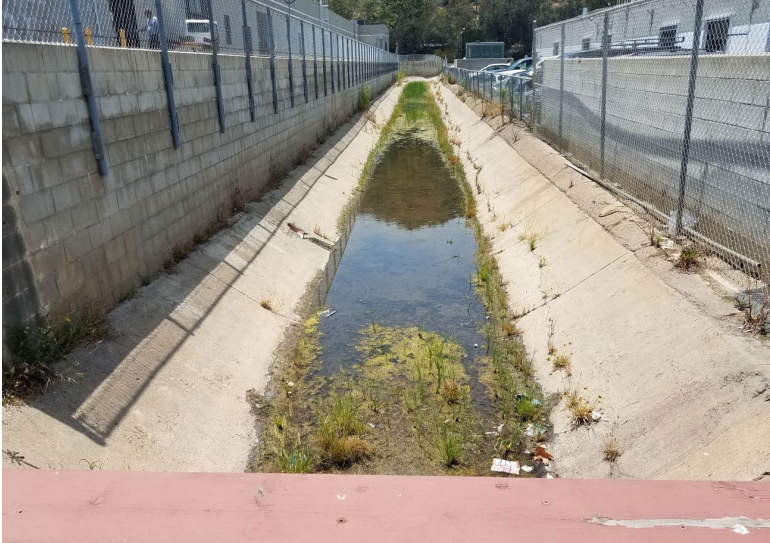
Flintkote pre-maintenance photo looking from mid-channel bridge crossing west towards Flintkote Avenue, illustrating standing water, silt, sparse and low growth vegetation (June 25, 2022)

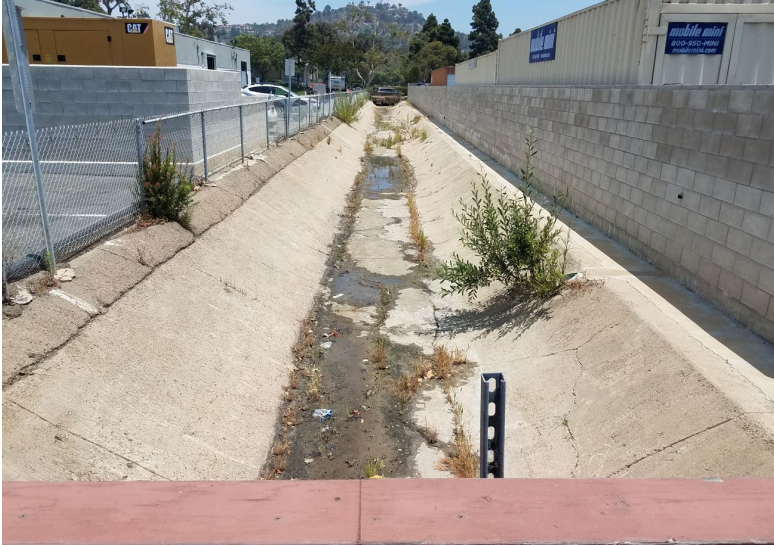
Flintkote premaintenance photo looking from mid-channel bridge crossing east towards Roselle Street, illustrating minor silt, standing water, and sparse vegetation growth (June 25, 2022)

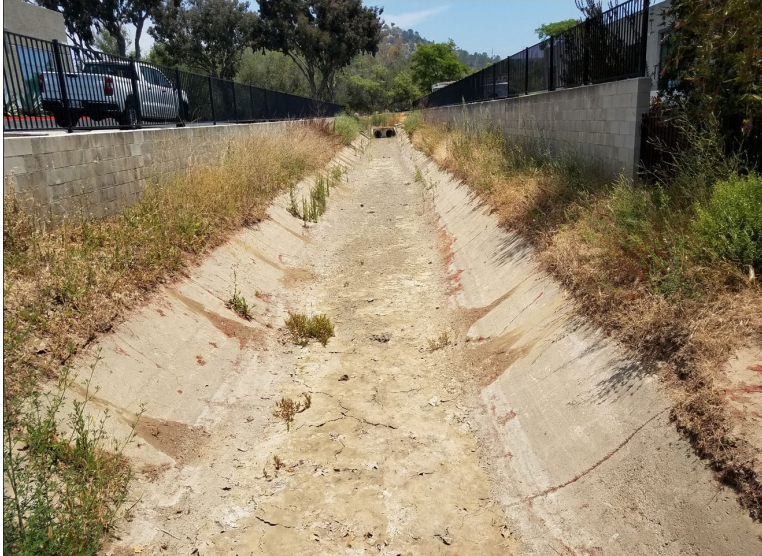
Flintkote pre-maintenance photo looking near Roselle Street east towards culverts that enter the Roselle channel, illustrating primarily silt and vegetation growth along the upper bank (June 25, 2022)

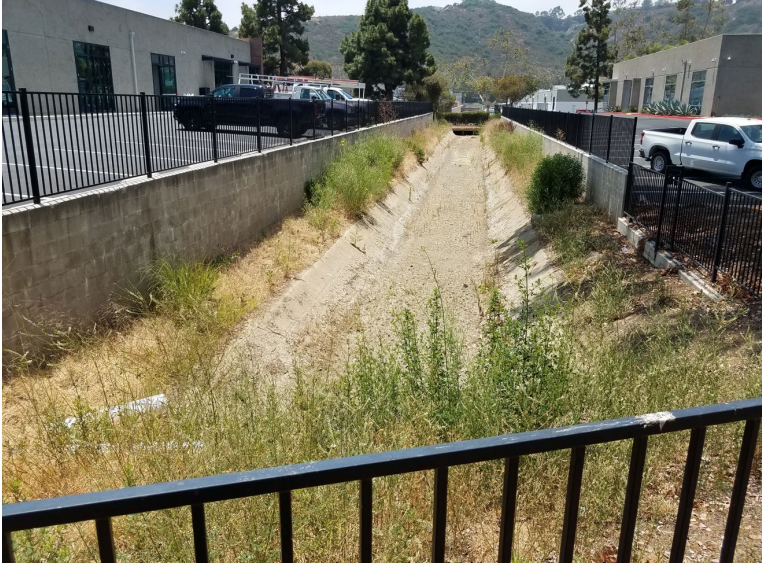
Flintkote pre-maintenance photo at the eastern terminus looking towards Roselle Street, illustrating primarily silt and vegetation growth along the upper bank (June 25, 2022)

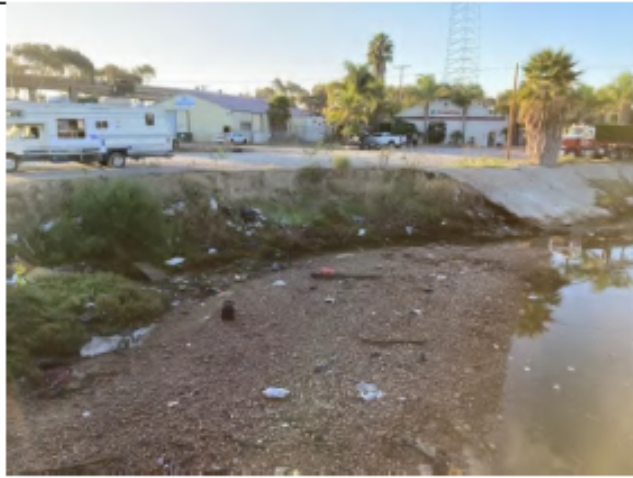
Photo Point 1 – Pre-Maintenance: Looking south within National 1 from the National Ave. bridge at material and trash accumulated within the channel (October 21, 2021).

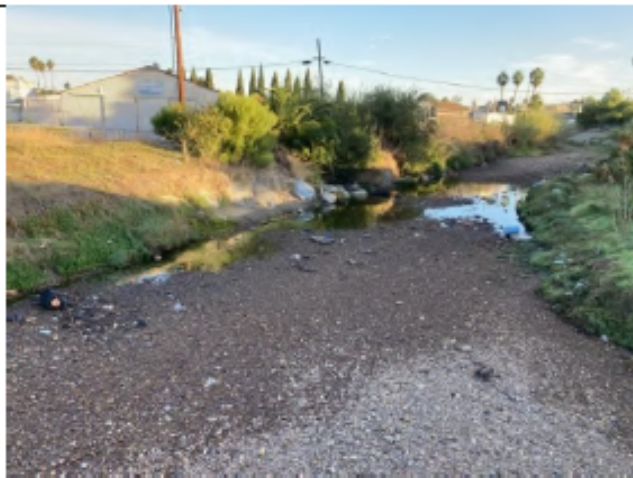
Photo Point 2 – Pre-maintenance: Looking north above National 1 from National Ave. bridge at vegetation and sediment/cobble accumulation within the channel (October 21, 2021).

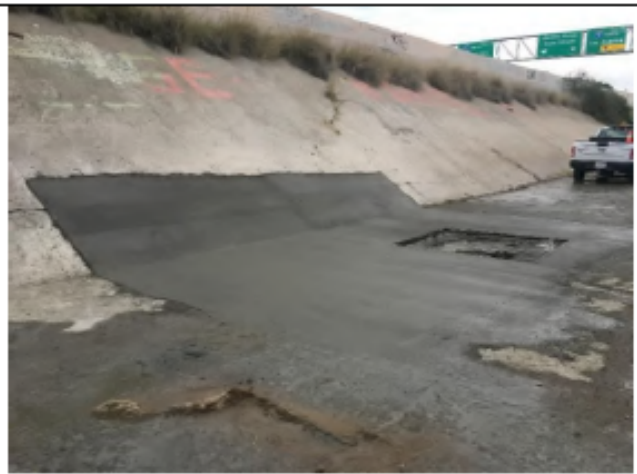
Photo - During-maintenance: Looking southeast within National 2 at the concrete repair location following concrete pour (January 13, 2022).

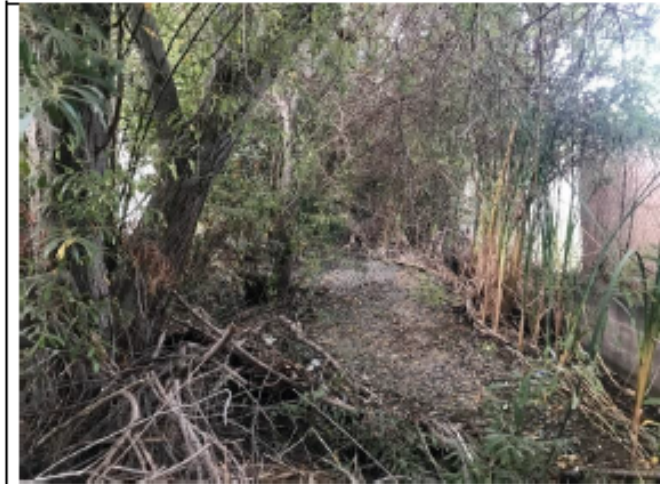
Pre-Maintenance - Photo 3: Pre-maintenance photo facing southwest from within the developed concrete lined channel looking at vegetation accumulated in the the Industrial 2 channel.

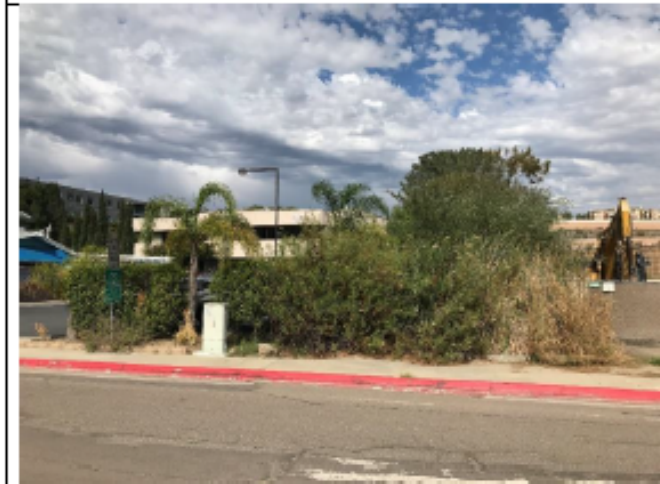
Pre-Maintenance - Photo Point 4: Pre-maintenance photo facing northeast from Sorrento Valley Road looking at vegetation accumulated in the downstream end of the Industrial 2 channel

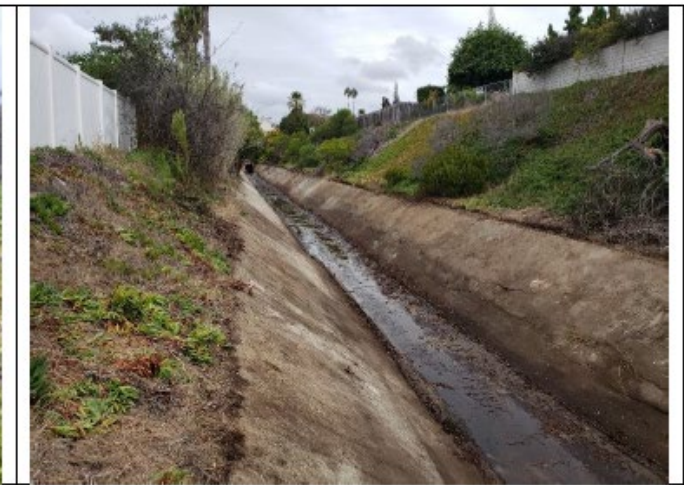
<p>Pre-Maintenance (PP-5)</p>	<p>Post-Maintenance (PP-5)</p>
<p>Looking northwest at palm trees established in the channel (10/7/2021).</p>	<p>Looking northwest in channel, vegetation removal shown to be complete (12/6/2021).</p>

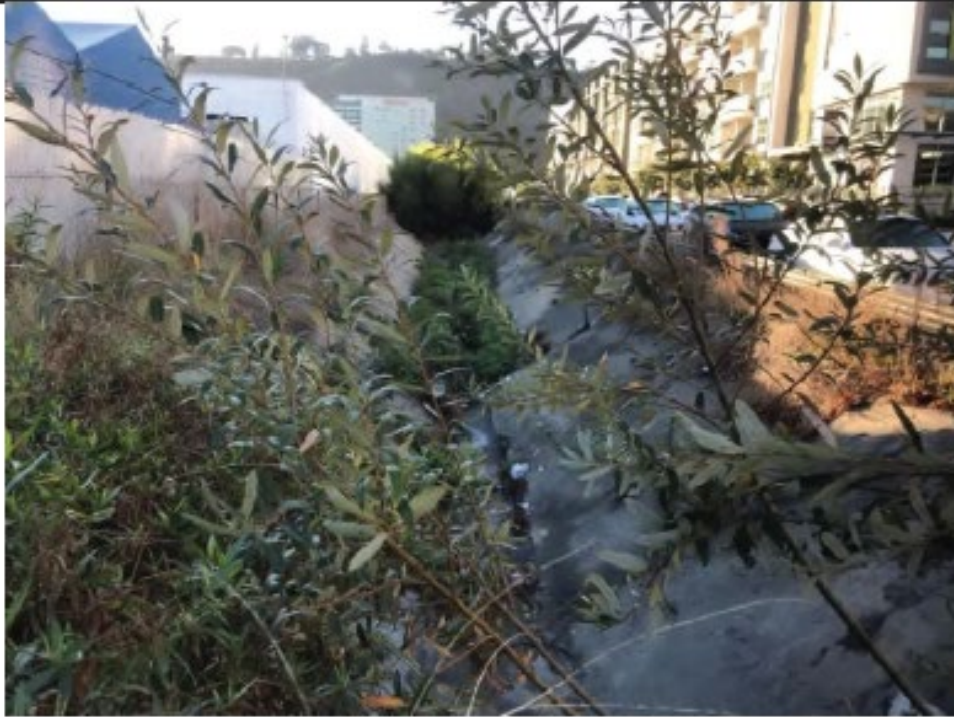
Pre-Maintenance Photo Point 1: Looking south from the northern, downstream end of Camino del Arroyo-vegetation and willow scrub/trees visible within the channel (12/11/21).

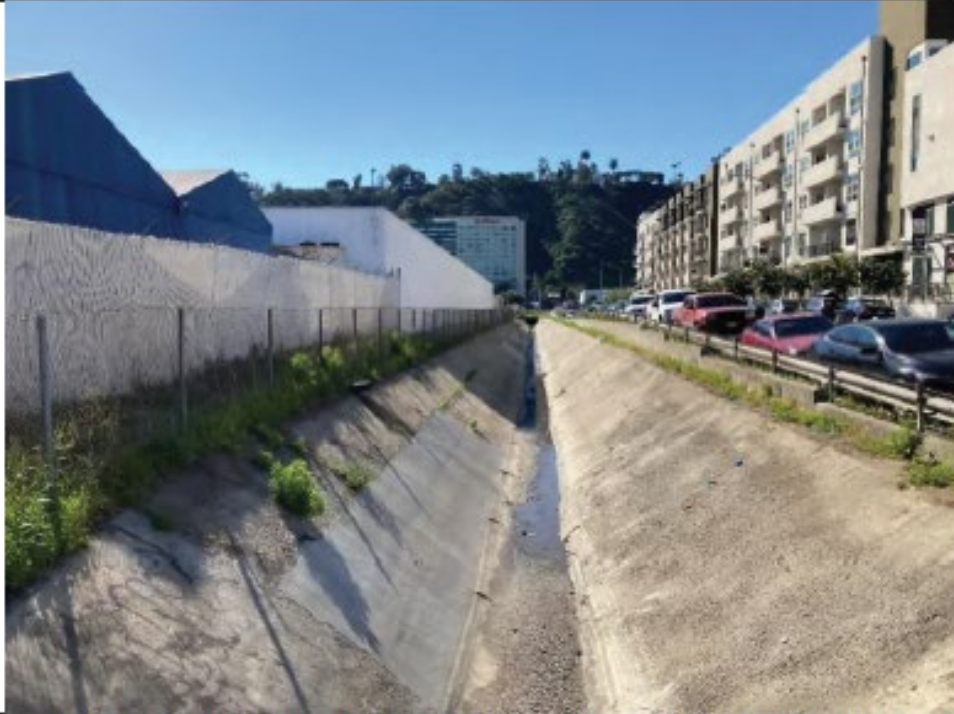
Post-Maintenance Photo Point 1: Looking south from the northern, downstream end of Camino del Arroyo-maintenance shown to be complete, concrete repair shown on left (3/2/22).

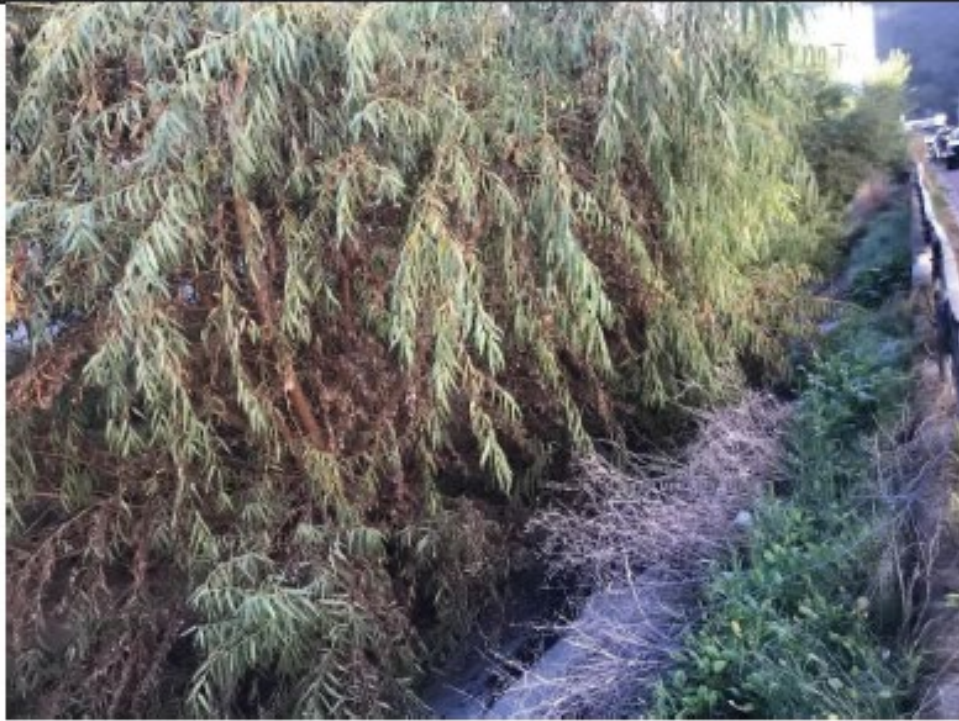
Pre-Maintenance Photo Point 2: Looking southeast from the western edge of Camino del Arroyo 1 – willow scrub/trees and vegetation shown within the channel (12/11/2021).

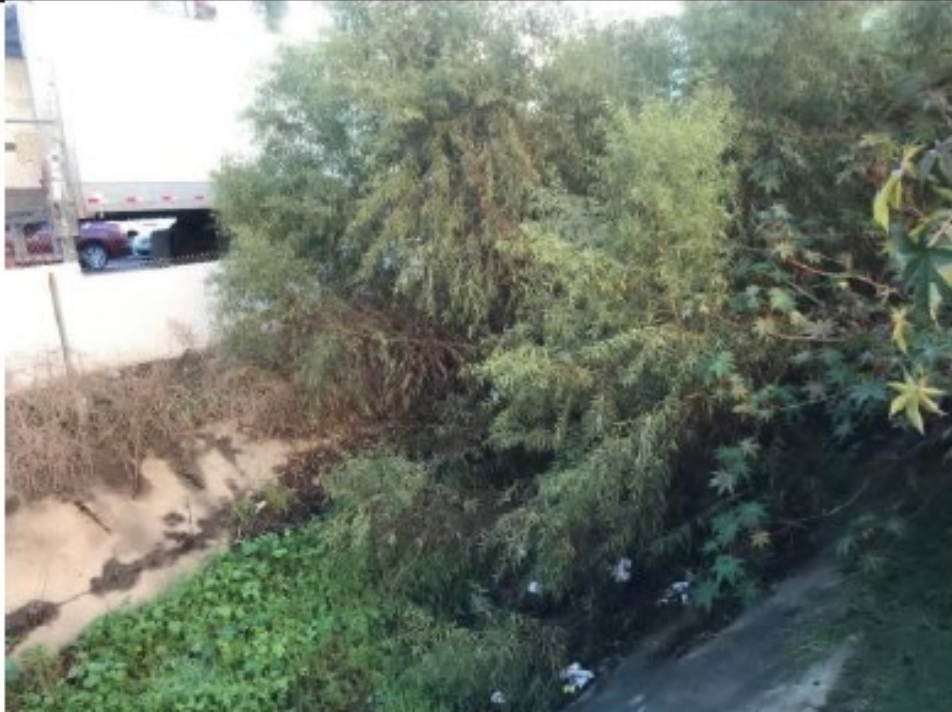
Pre-Maintenance Photo Point 3: Looking southeast from the southern end of Camino del Arroyo 1 – willow scrub/trees and vegetation shown within the channel at the start on maintenance (12/11/2021).

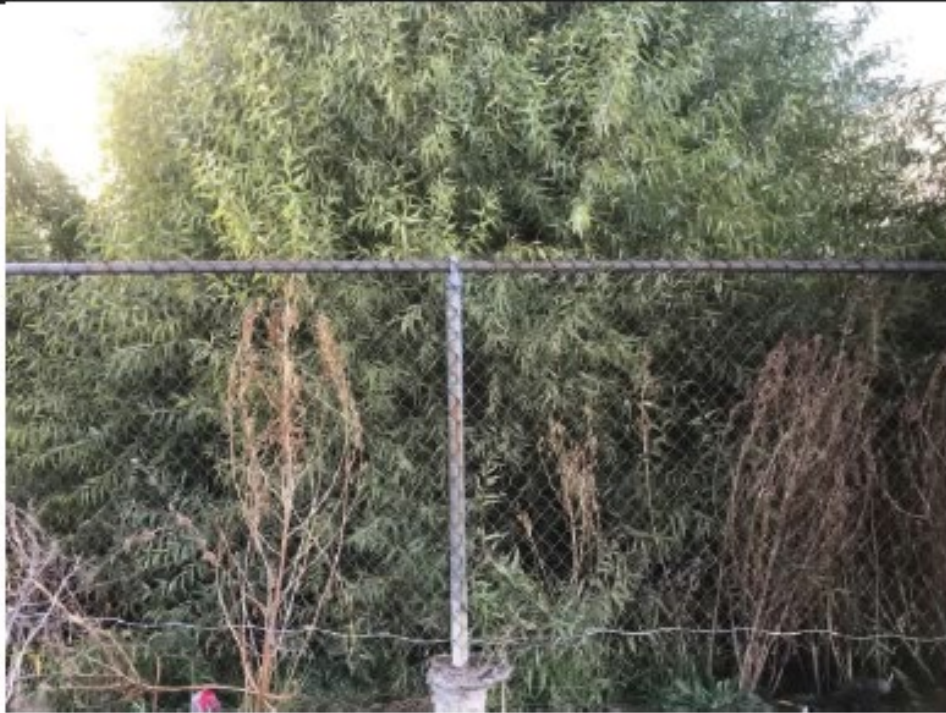
Pre-Maintenance Photo Point 4: Looking north from the southern end of Camino del Arroyo 1 – thick willow scrub/trees and vegetation shown within the channel (12/09/2021).

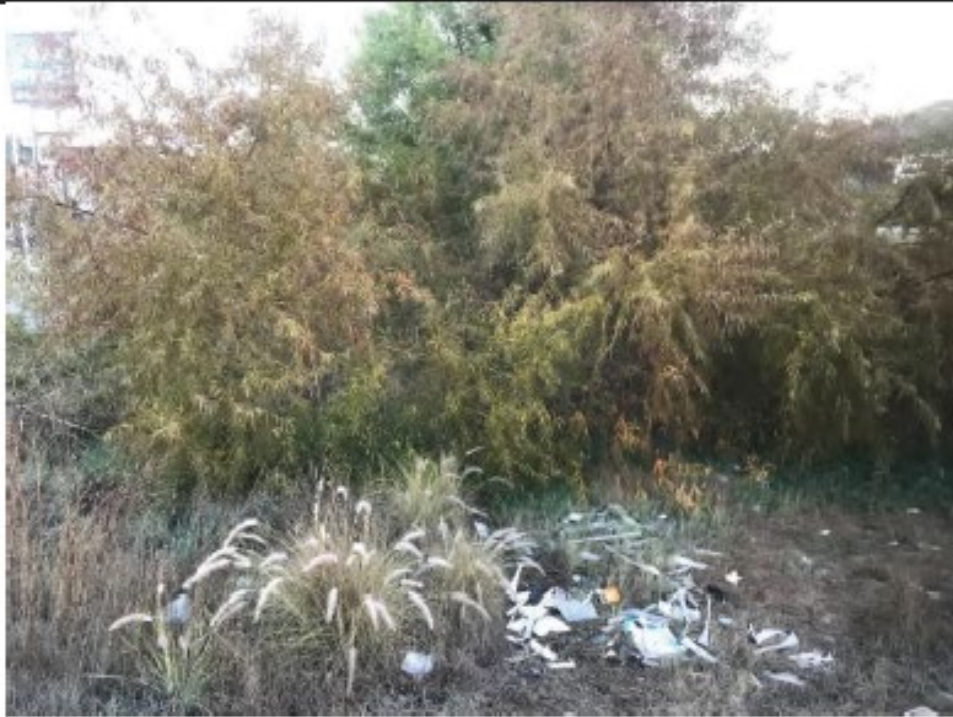
Pre-Maintenance Photo Point 5: Looking east from western end of Camino del Rio 1 at vegetation and other materials accumulated in channel (12/11/2021).

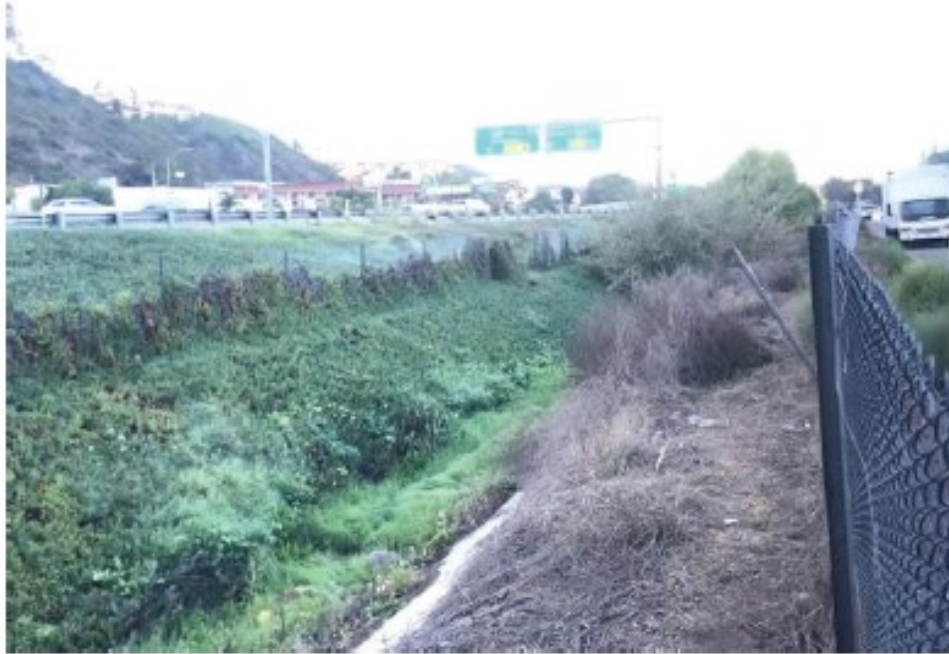
Pre-Maintenance Photo Point 6: Looking southwest from north bank of Camino del Rio 1 at vegetation and other materials accumulated in the downstream section of the channel (12/11/2021).

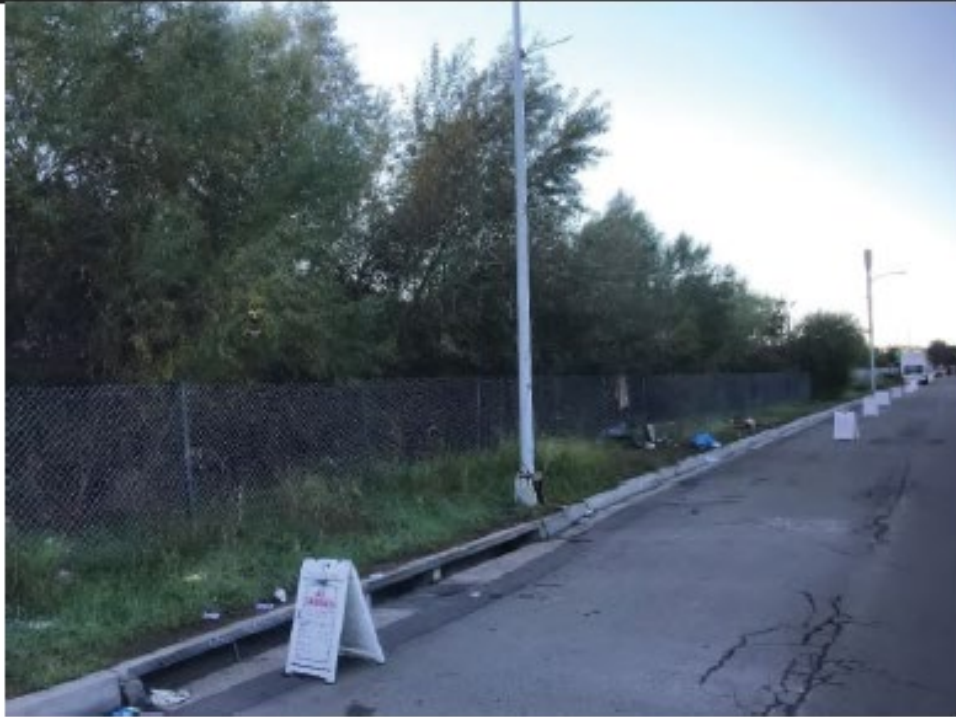
Pre-Maintenance Photo Point 7: Looking southwest from the northern side of Camino del Rio 1 at vegetation accumulated in the channel (12/11/2021).

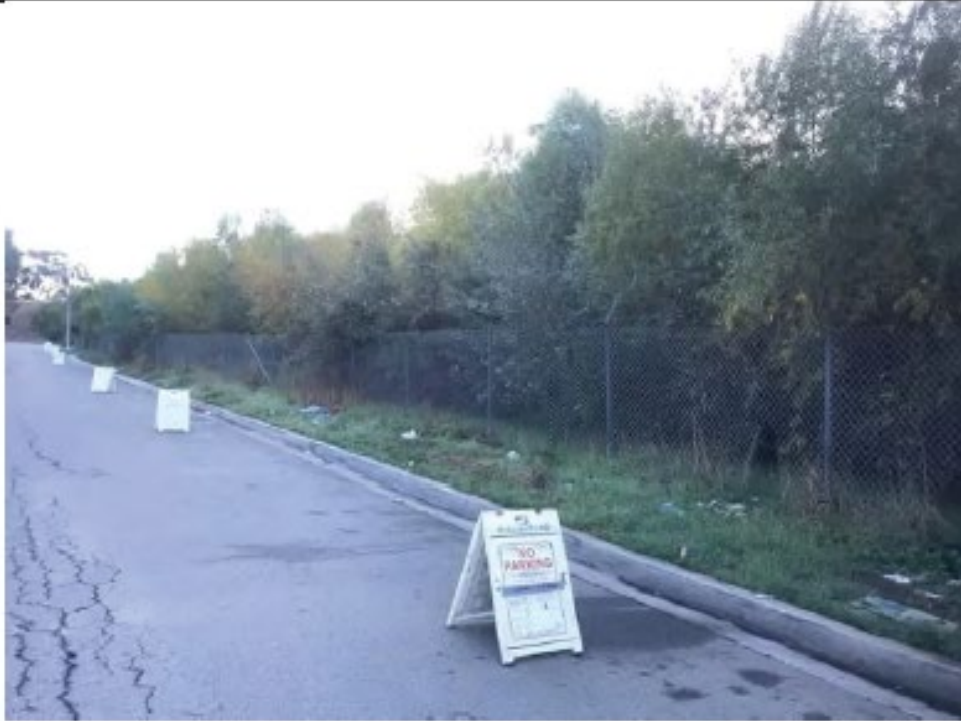
Pre-Maintenance Photo Point 8: Looking east from the northern side of Camino del Rio 1 at vegetation accumulated within the channel (12/11/2021).

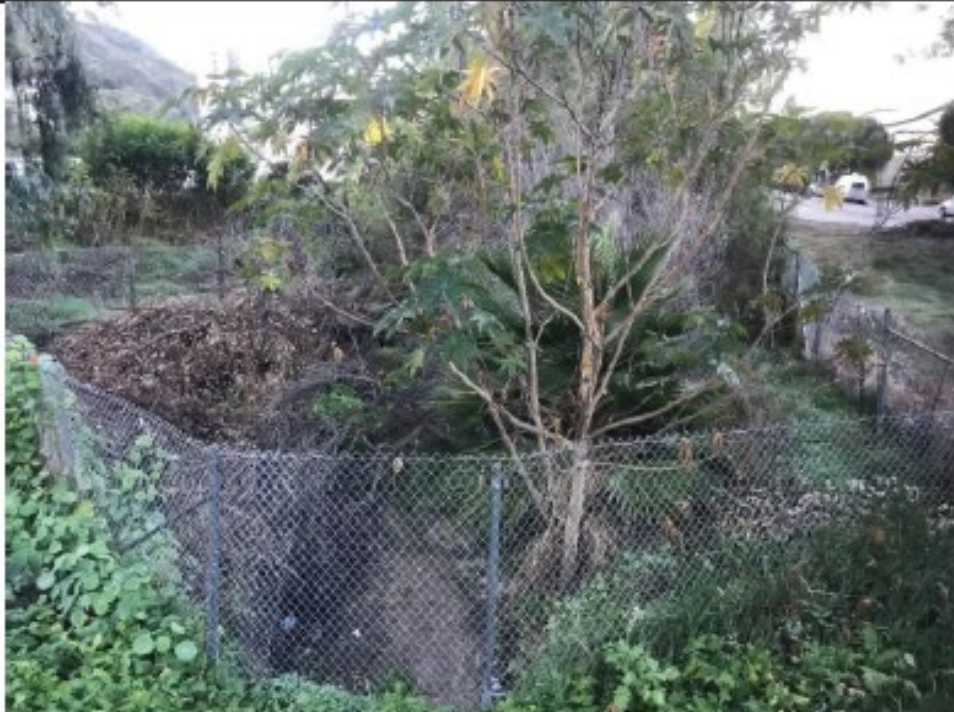
Pre-Maintenance Photo Point 9: Looking southwest from the eastern, upstream end of Camino del Rio 1 at thick vegetation growth in channel (12/11/2021).

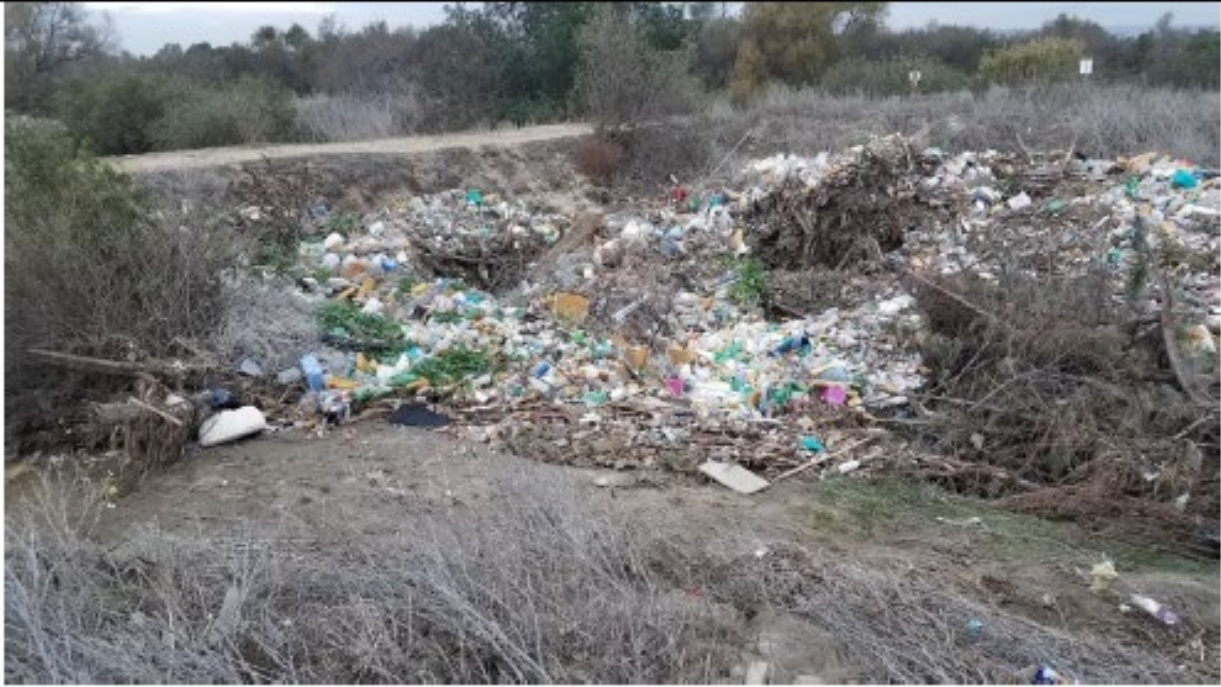
Photo 1: Pre-construction photo showing trash accumulation within the channel and blocking south side of Disney Bridge culverts (12/22/2021).

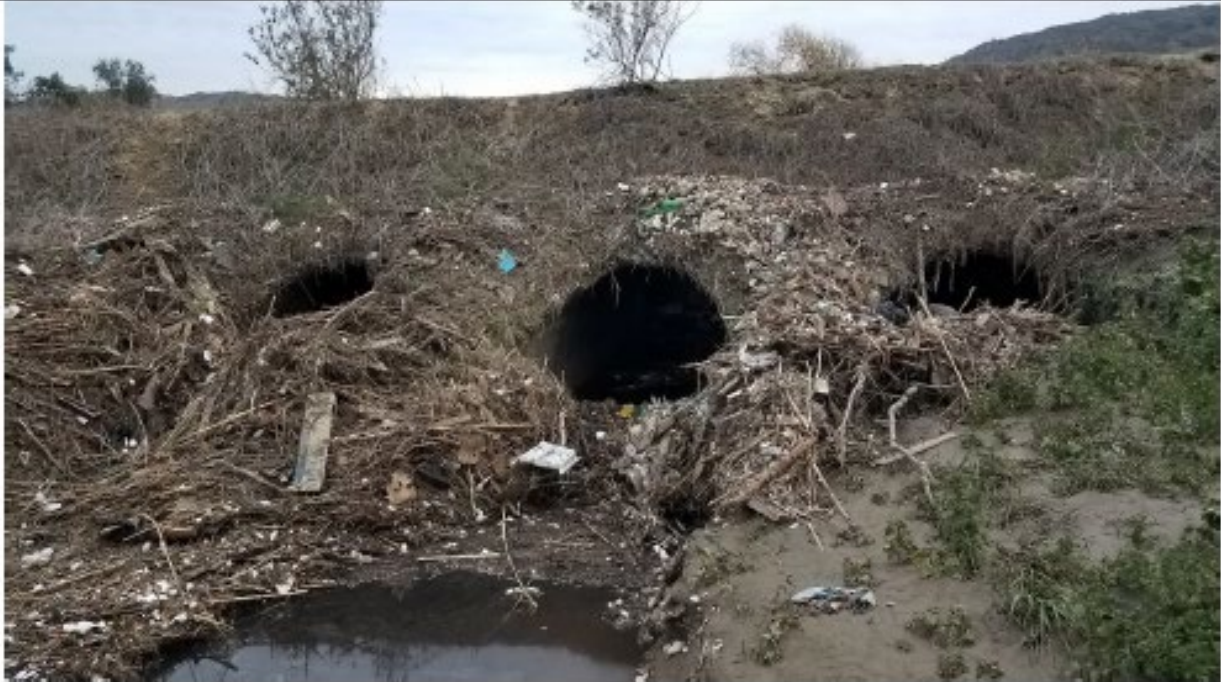
Photo 2: Pre-construction photo showing trash and debris blocking Disney Bridge culverts on north side (12/22/2021).

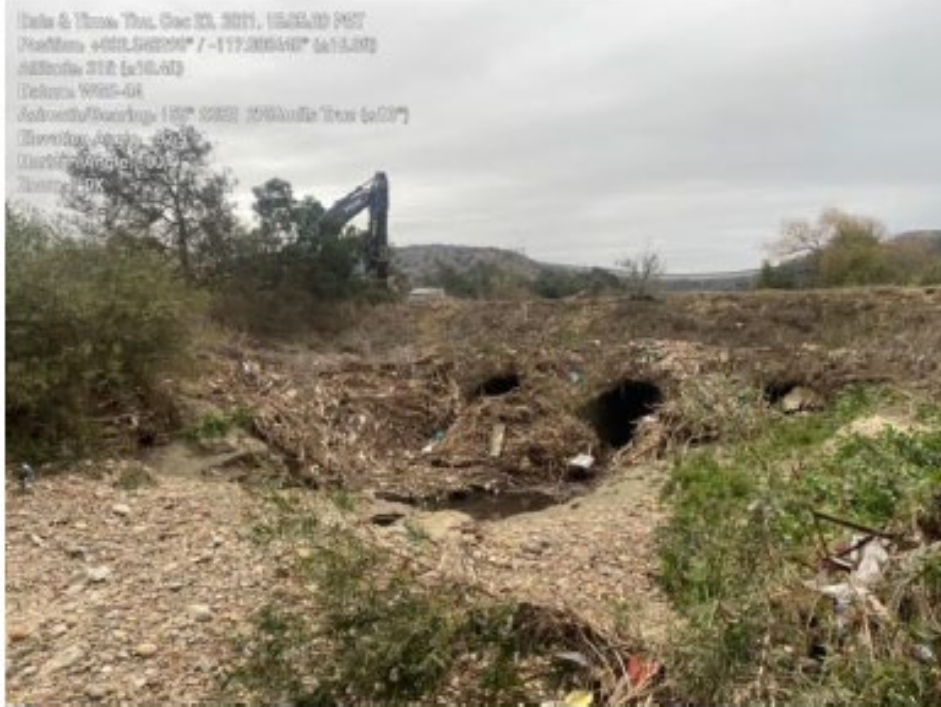
Photo 3: Pre-construction photo showing trash and debris blocking Disney Bridge culverts on the north side (12/23/2021).

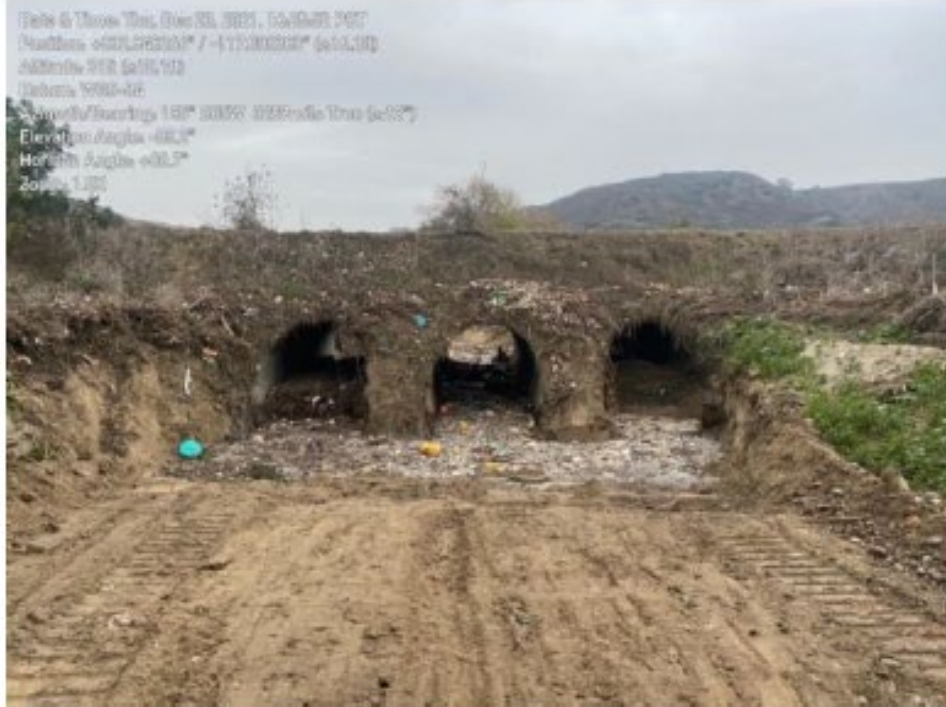
Photo 7: Looking south at Disney bridge culverts nearly cleared from trash and debris (12/23/2021).
