STUDY OF KENSINGTON CIRCUIT 3 STREET LIGHTS

CITY OF SAN DIEGO

EXISTING CONDITIONS AND RESTORATION ASSESSMENT

MAY 10, 2024

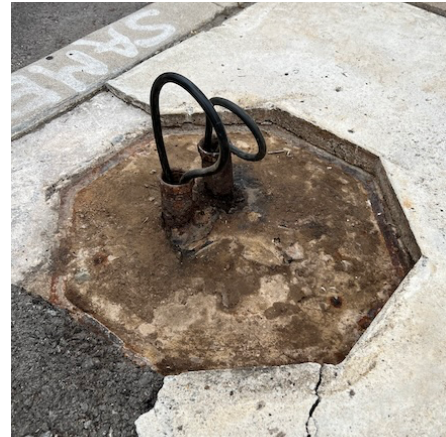
In one existing light location in Circuit 2, the moisture inside the light base had caused the anchor rods to corrode completely through. The light only remained in place due to gravity and internal wiring. The contractor who removed this light noted that the bottom of the cast iron light base disintegrated once removed from the concrete.

Circuit 2 anchor bolts disintegrated by corrosion over time

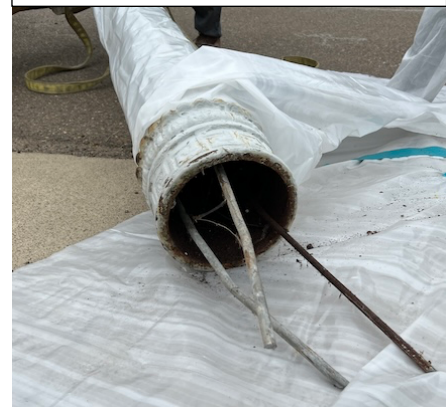
Top of anchor rods and internal assembly rods not accessible due to soldered connection at collar.

The top of the anchor rods and fastening nuts are located above the top collar of the cast-iron base which is soldered to the sheet steel pole. There is no opening to access the

fastening nuts to remove the rods without disassembly of the collar from the pole.

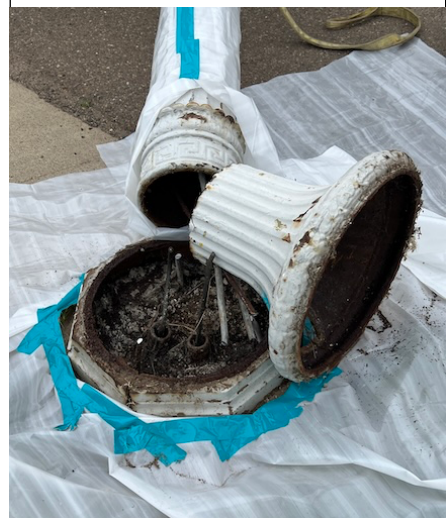
Three sections of the cast iron base.

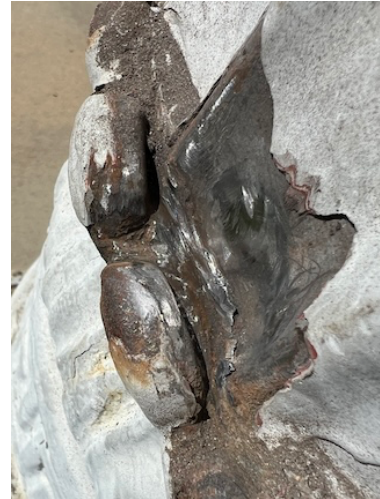
It was noted that a bead of lead solder was applied to the joint where the sheet steel pole is press fit into the cast iron light base. This appears to be to prevent water ingress at the joint and possibly to add strength to the connection.

Soldered pole to base joint.

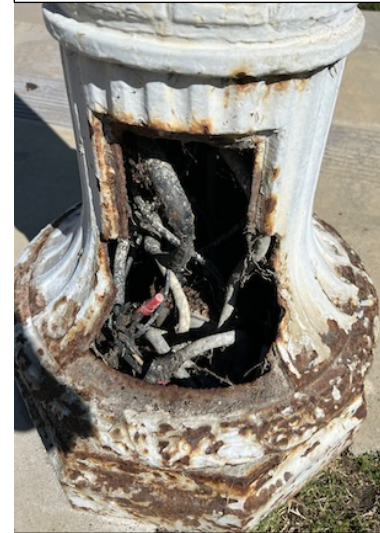
The cast iron light base has a hand hole access to examine internal components and wiring. Portions of the cast iron around the hand hole were often missing from each light base from what appeared to be attempts to pry off the hand hold cover in past years.

Cast iron base and hand hole.

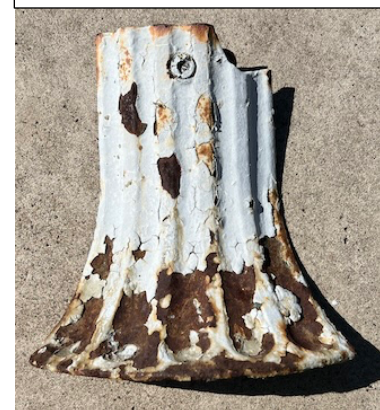
A measurement of the hand hole cover indicates the cast iron used in the light base varies in thickness from 0.24” to 0.40” (varies due to corrugations) which is approximately half the thickness of castings used in modern decorative lighting.

Broken hand hole cover.

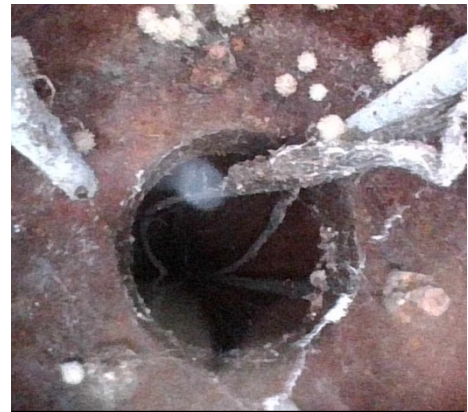
Corrosion of internal assembly rods

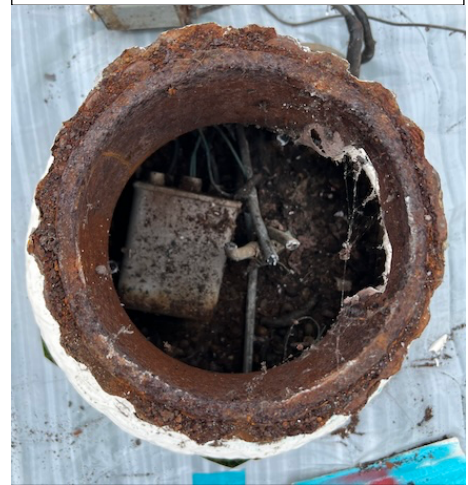
Internal corrosion of cast iron base.

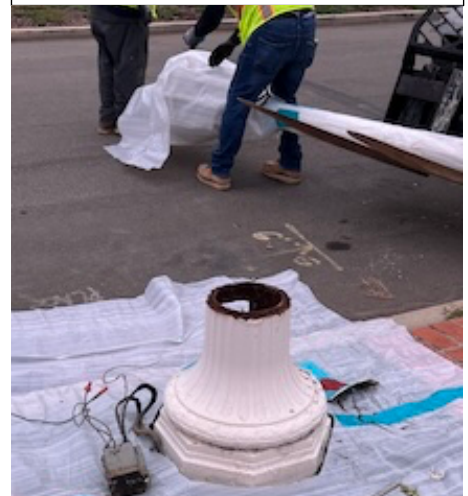
Lead paint wrapping.

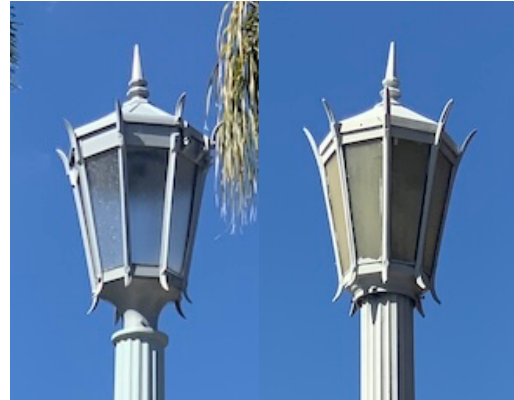
The Interior of the fixtures had no paint present and showed surface corrosion of the steel frame. Glass panels of the fixtures had yellowed and turned opaque.

New LED Empire fixture vs yellowed opaque glass of existing light

If the modifications to the existing fixtures to adapt a LED emitter are not possible then the City may consider replacing the entire fixture with the type used for the new lights in Circuit 2. This may require an adapter collar to mount the fixture to the top of the light standard.

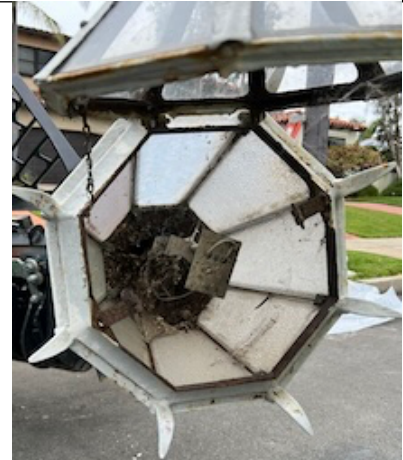
Bulb socket requires replacement. Frame corrosion.

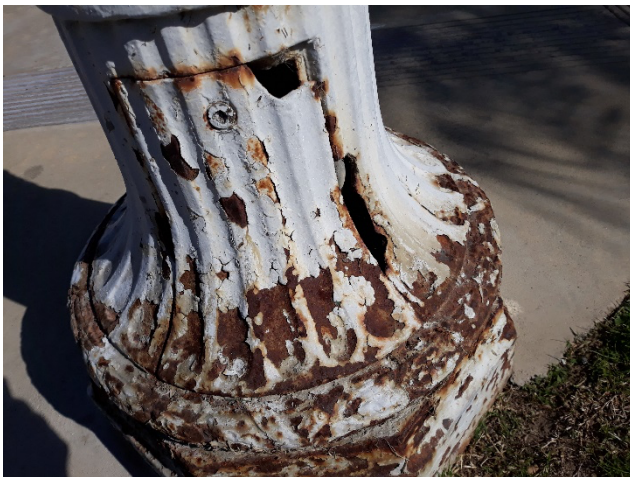
- A. Base.** The base of the lamp post is cast iron. The surface has been painted numerous times. From observation the paint application has multiple layers and has a thickness of approximately 26 -27 mils. This may indicate that the posts were painted 8 or more times over the years with an average mil thickness of 3 mils per coat as an estimate. The paint was tested for lead and the result was positive. The paint exhibited clear signs of an aged paint application i.e. cracking chipping, flaking, chalking, etc.

The rust condition of the cast base appears to be substantially below worse than rust Grade D identified in the SSPC-VIS 1 Guide – indicating heavy pitting and lose of metal with layers of oxidation. So if grit blasting is employed for surface preparation the result would be a surface of heavy pitting and the creation of multiple penetrations(holes) in the bases that would need repair if salvage is intended. In addition, due to the age and brittleness of cast and the potential progression path of crevice corrosion or fretting that maybe present even larger sections of the base maybe destroyed under grit blasting.

Graphitization was not observed but maybe present under the corrosion or remaining paint. Pockets of moisture were still present in the cast iron bases from the past week rain indicating deep pockets of corrosion in areas of the bases.

Certain sections of the base around the cover have broken off. This is most likely due to attempts to pry off the cover either because of the layers of paint or of it being rusted to the base. Any rehabilitation of the bases would require welding on cast which would be difficult on these bases since the cast is thin and it would still remain a weak point for future damage. Epoxy repair would be possible for aesthetics

reasons but would be subject to easy future damage. It is unknown as to the condition of the bases after blasting and the amount of repair would vary from one piece to another for pitting, design rebuild and hole repair.

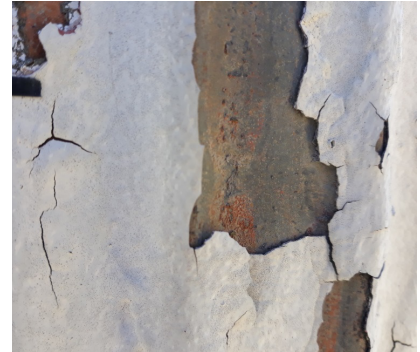
B. Stem of Lamp Post. The stem of the lamp post is constructed of sheet metal. Other than the condition of the paint and the presence of lead, the substrate metal appears to be in good shape. From the metals appearance in areas where the paint has fallen off, it appears the stem was either hot dipped for corrosion protection or there is a layer of manufacture mill scale present which can provide a level of corrosion protection. Delamination of the paint due to age(as paints age they lose flexibility and disbond as they are unable to expand and contract with a substrate), and additionally poor adhesion to the substrate because of no surface preparation.

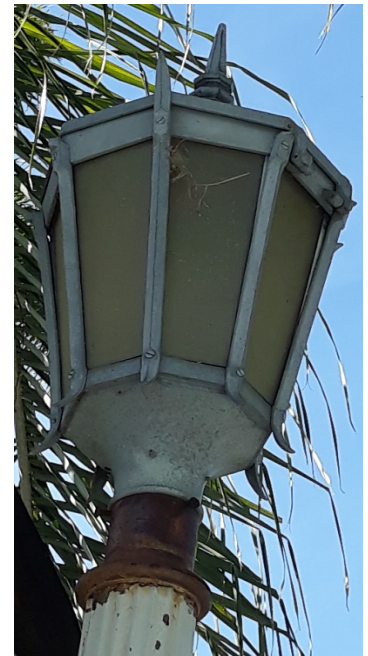
C. Street Light Fixture. Some of the lamp tops have been work on in the past exhibiting different substitute metal fittings screws, caulking etc. To rehabilitate the fixtures, it is recommended to disassemble and soak in paint/lacquer remover as this is a common practice for removal of paint rather than blasting that may damage the pieces. Lead containment for this process would also be required.

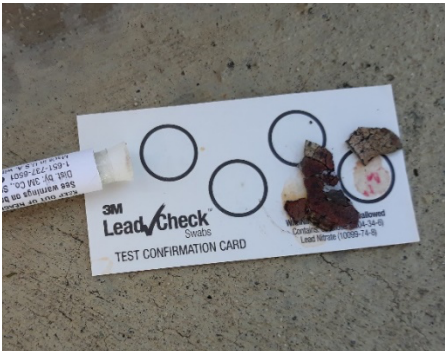
Lead Testing: The photo below is the result of the field lead test. The red/pink spot on the test card shows the test application will detect the presence of lead. The paint chips shown are the back side of paint chips from the posts. They also showed the presence of lead. The top coat of the painted lamp posts were tested and a very light tinge of pink appeared around the perimeter of the test. This maybe from the lead leaching directly through to the higher layers of paint or through the abundant complex cracking and chipping of the paint. The cracking and chipping encompasses and is visible in the whole paint system layers on the lamp posts inspected.
