**Letter Report**

Subject: 2019 Sewer Capacity Study Update

At your request, Brown and Caldwell (BC) has performed an update to the 2014 Sewer Capacity Study conducted at the SeaWorld Parks and Entertainment (SeaWorld) theme park in San Diego, California.

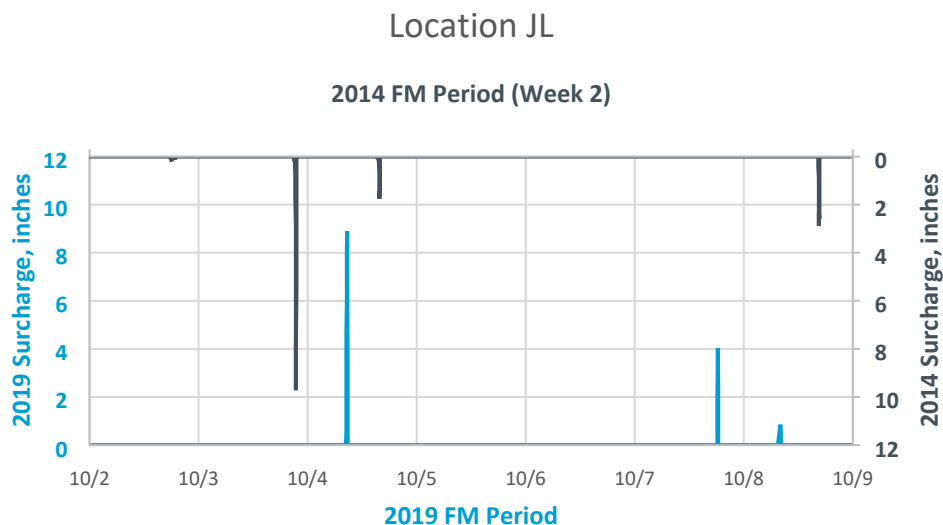
**Figure 1. Comparison of Surcharges at Location JL**

**Location JL.** Location JL is the furthest upstream of the monitoring locations. The 10-inch-diameter mainline enters from the west and exits to the east at roughly the same invert elevation. A third pipe enters at the north from the Shark and Otter area. ADS installed the flow meter in the incoming 10-inch main. Per the 2014 study, surcharging at this location is due to backwatering, not to the capacity of the pipe at this location.

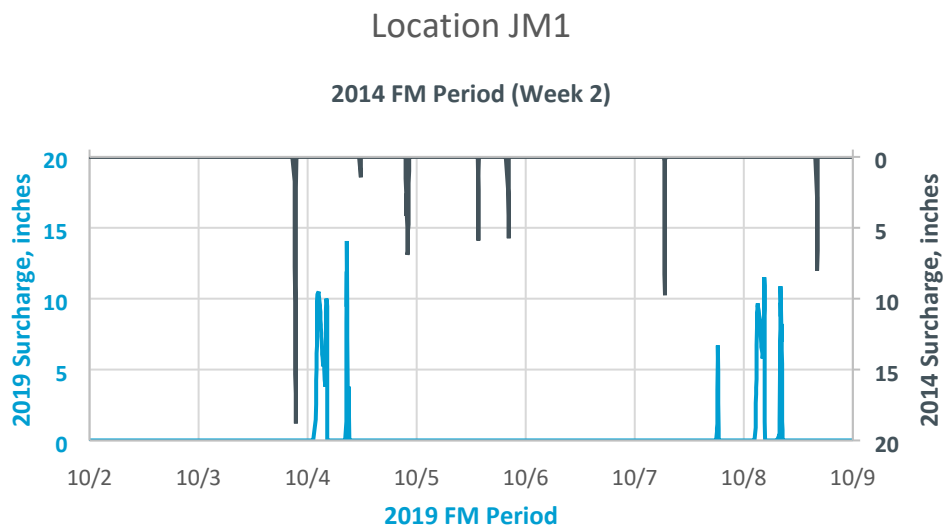
Figure 2 . Comparison of Surchages at Location JM1

**Location JM1.** Location JM1 is the next downstream location from JL. The 10-inch-diameter mainline enters from the west and exits to the south at roughly the same invert elevation. A third pipe enters at the north from the Cascades area. ADS installed the flow meter in the incoming 10-inch main.

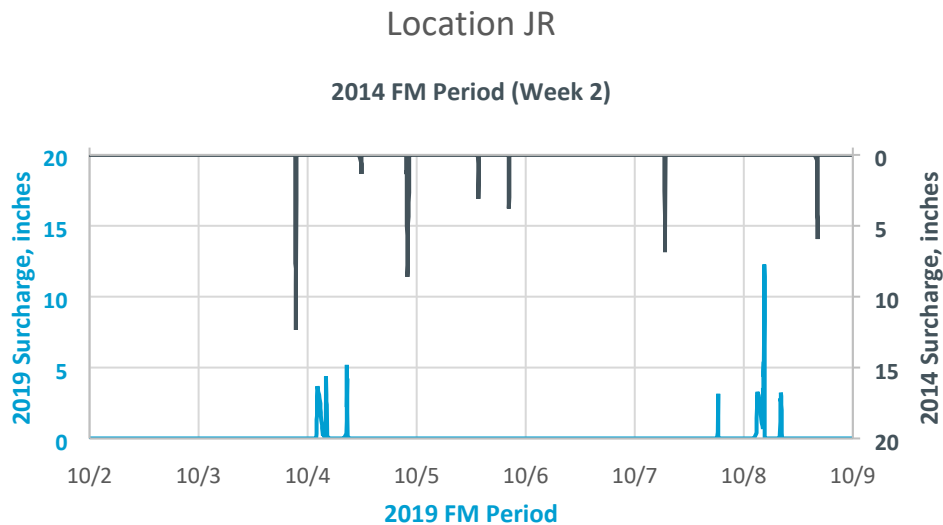
Figure 3. Comparison of Surchages at Location JR

**Location JR.** Location JR is the next downstream location from JM1. The 10-inch-diameter mainline enters from the north and exits to the south at roughly the same invert elevation. The flow meter was installed in the 8-inch-diameter pipe that enters from the Shipwreck Rapids area to the east. That pipe drops into the manhole approximately 4 to 6 inches above the manhole invert, so the surcharging above the top of the 10-inch-diameter mainline is actually a few inches higher than the value reported for JR.

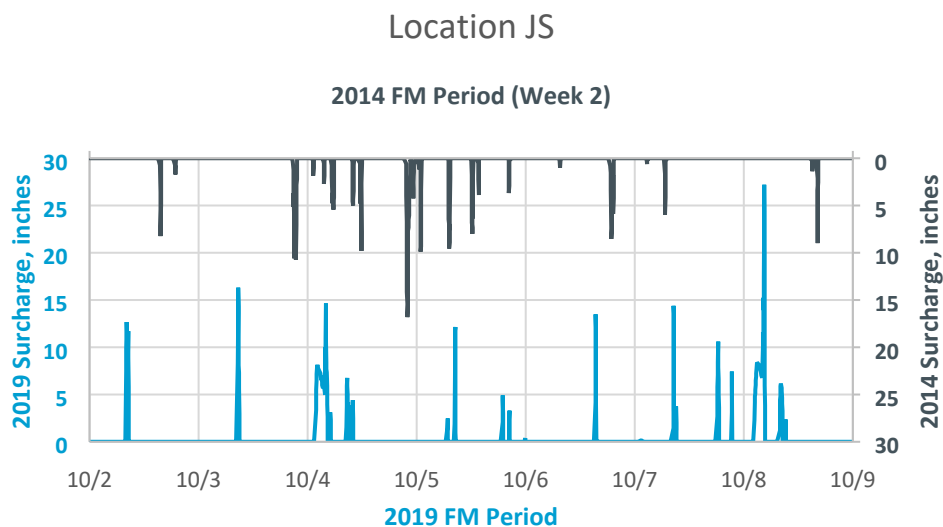
Figure 4. Comparison of Surcharges at Location JS

**Location JS.** Location JS is the furthest downstream location. The 10-inch-diameter mainline enters from the north and exits to the south at roughly the same invert elevation. The flow meter was installed in the 6-inch-diameter pipe that enters from the Main Plant area to the west. The top of the 6-inch-diameter pipe is roughly equal to the top of the 10-inch-diameter mainline, so surcharging above the top of the 10-inch main is roughly the same as the reported value.

- **Location JS.** JS was impacted by the reduction in backwash flow rate and duration in backwash operations at the Main Recovery Plant. Although the frequency of surcharging was reduced in comparison to the 2014 study, the typical height of the surcharge at JS was greater in 2019. Reductions in surcharge frequency at this downstream location likely contributed to lower surcharge frequencies observed at upstream manholes. However, this location experiences peak flows from all of the upstream activities, and the 10-inch-diameter main between JX and JS is still a bottleneck in the system. This capacity restriction continues to cause propagation of surcharge upstream, although the impact appears to be somewhat less than it was in 2014.

- Install a SmartCover at Manhole JS. SmartCovers measure remote site water levels in real-time and can give instant feedback about water levels or provide means for automation control to sequence operations, thereby allowing SeaWorld staff to implement measures to prevent SSOs caused by surcharge from maintenance activities on top of storm-induced flows. Consider installing SmartCovers on other manholes as well.
- Notify the City of required repairs to the liner in manhole JZ and to cap the sewer line north of Shark, as noted in the 2014 report.

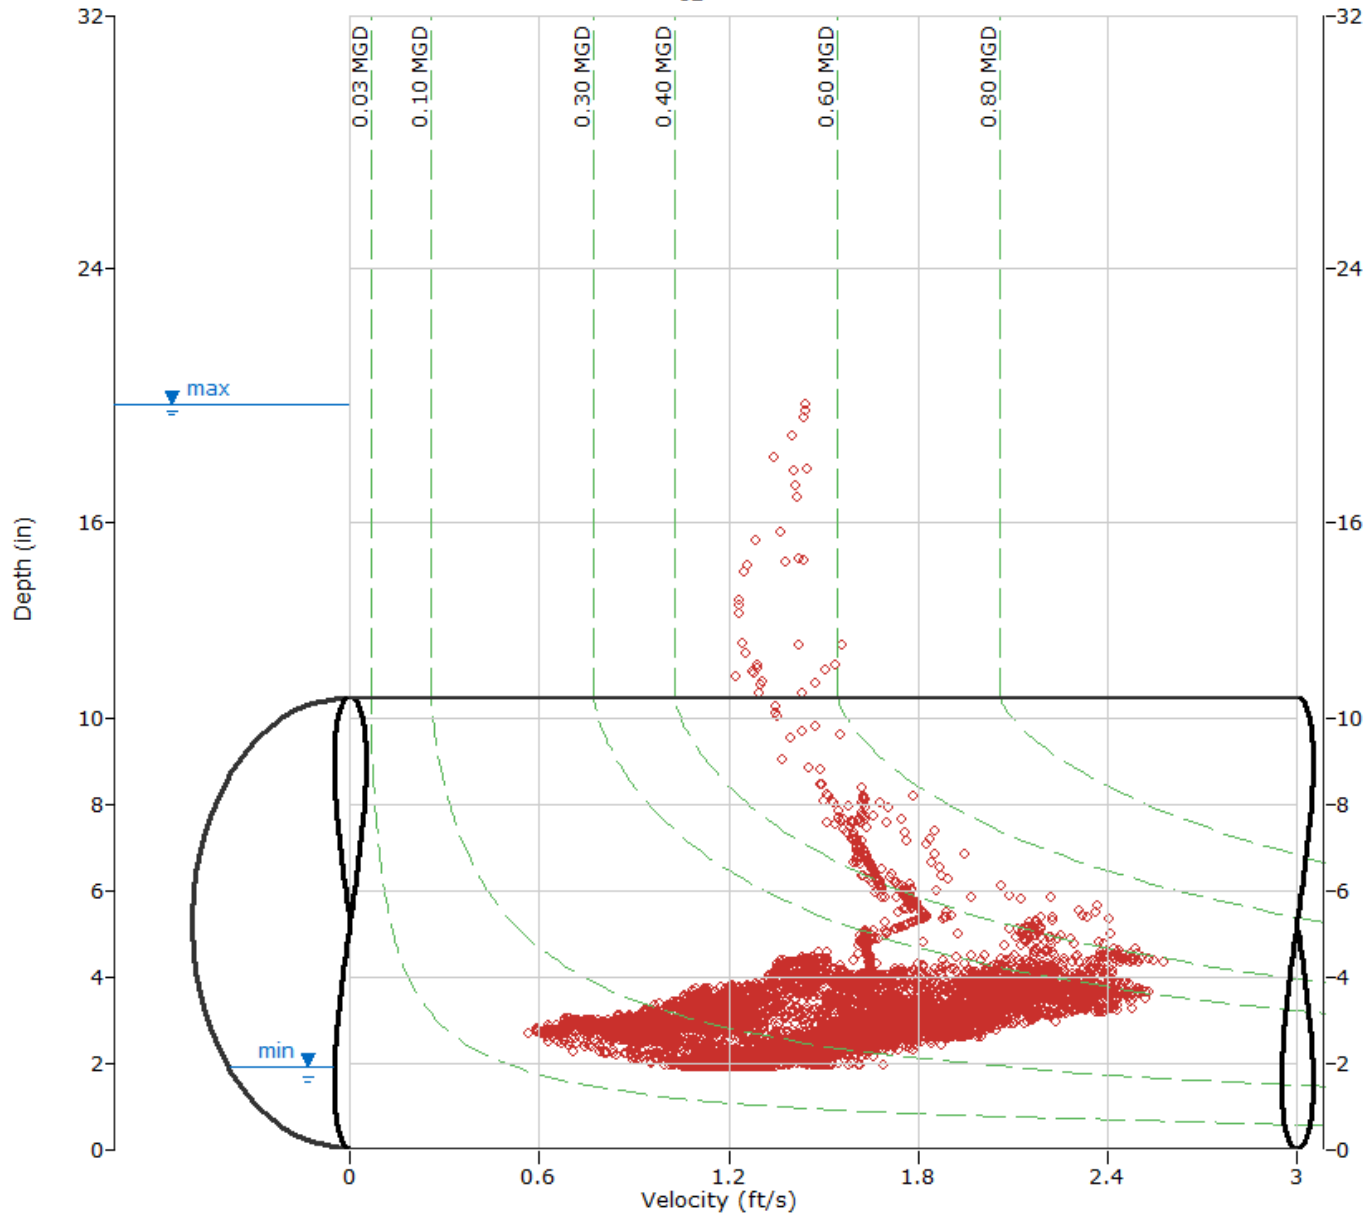
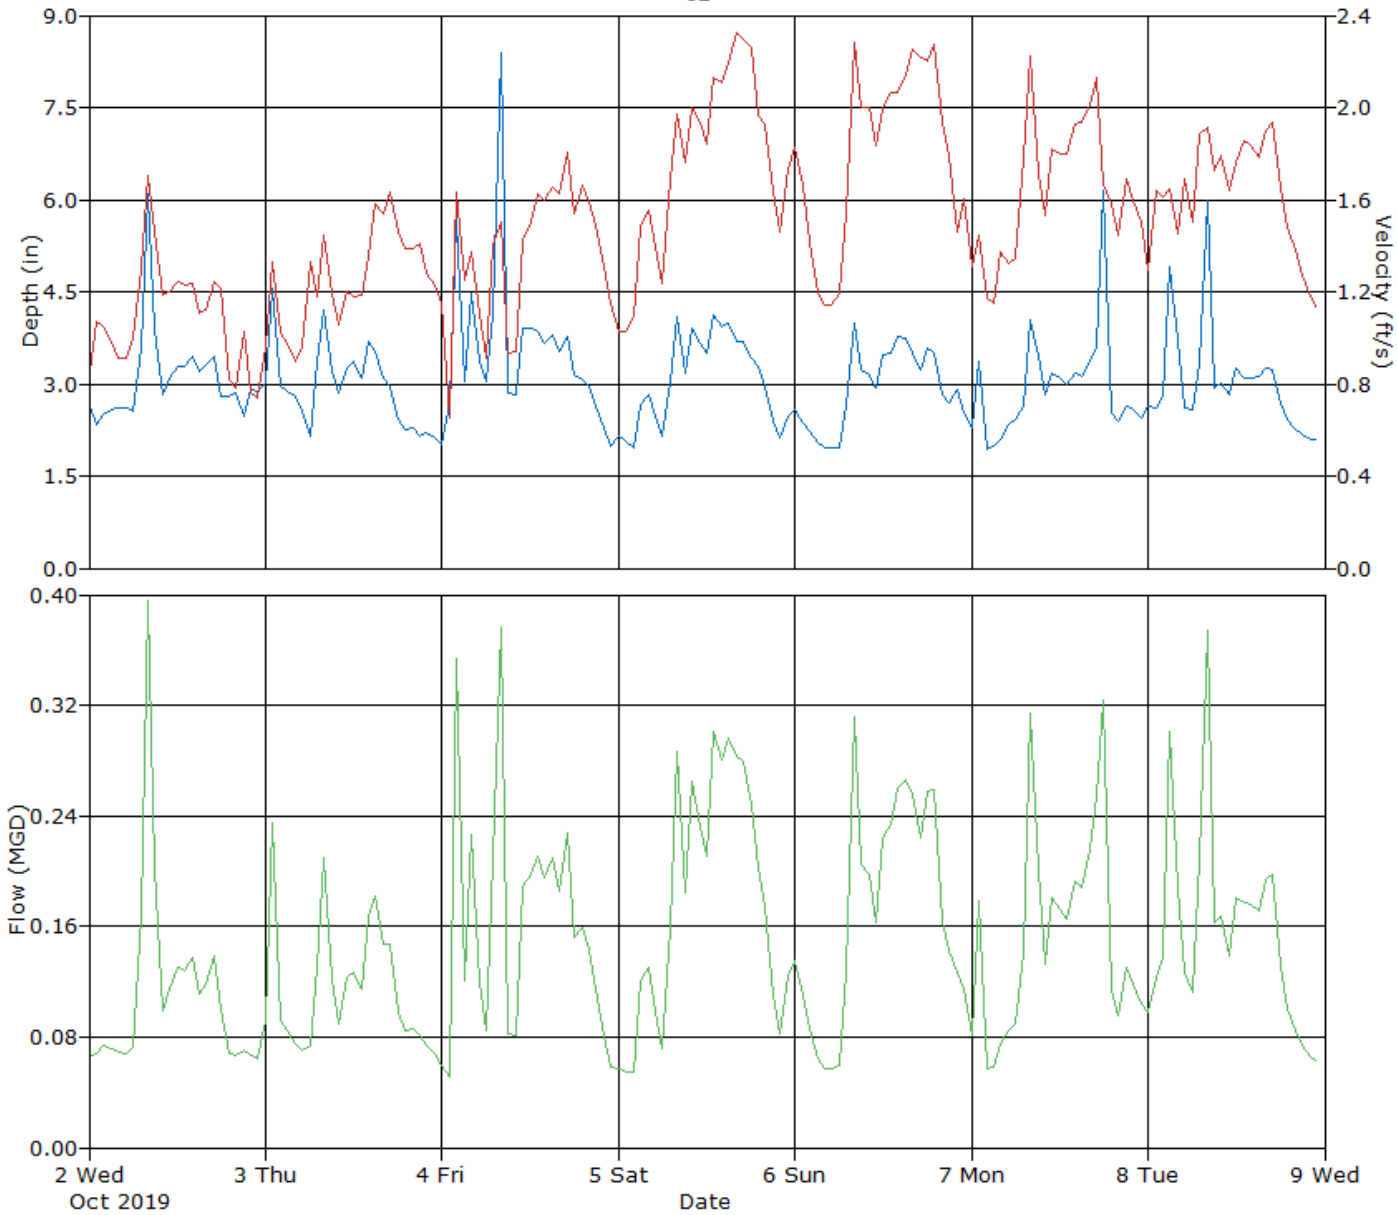
Site JL functioned under normal conditions during the period Wednesday, October 2, 2019 to Tuesday, October 8, 2019. Surge conditions were experienced at this location. Review of the Scattergraph shows that both free flow and backwater conditions were recorded during the study period.

Average flow depth, velocity, and quantity data observed during Wednesday, October 2, 2019 to Tuesday, October 8, 2019, along with observed minimum and maximum data, are provided in the following table. The values presented herein are based on 2-minute data. In regards to depth, this site flows at approximately 188% full at its recorded 2 minute peak of 19.70 inches and approximately 29% full during the typical average depth of 3.08 inches.

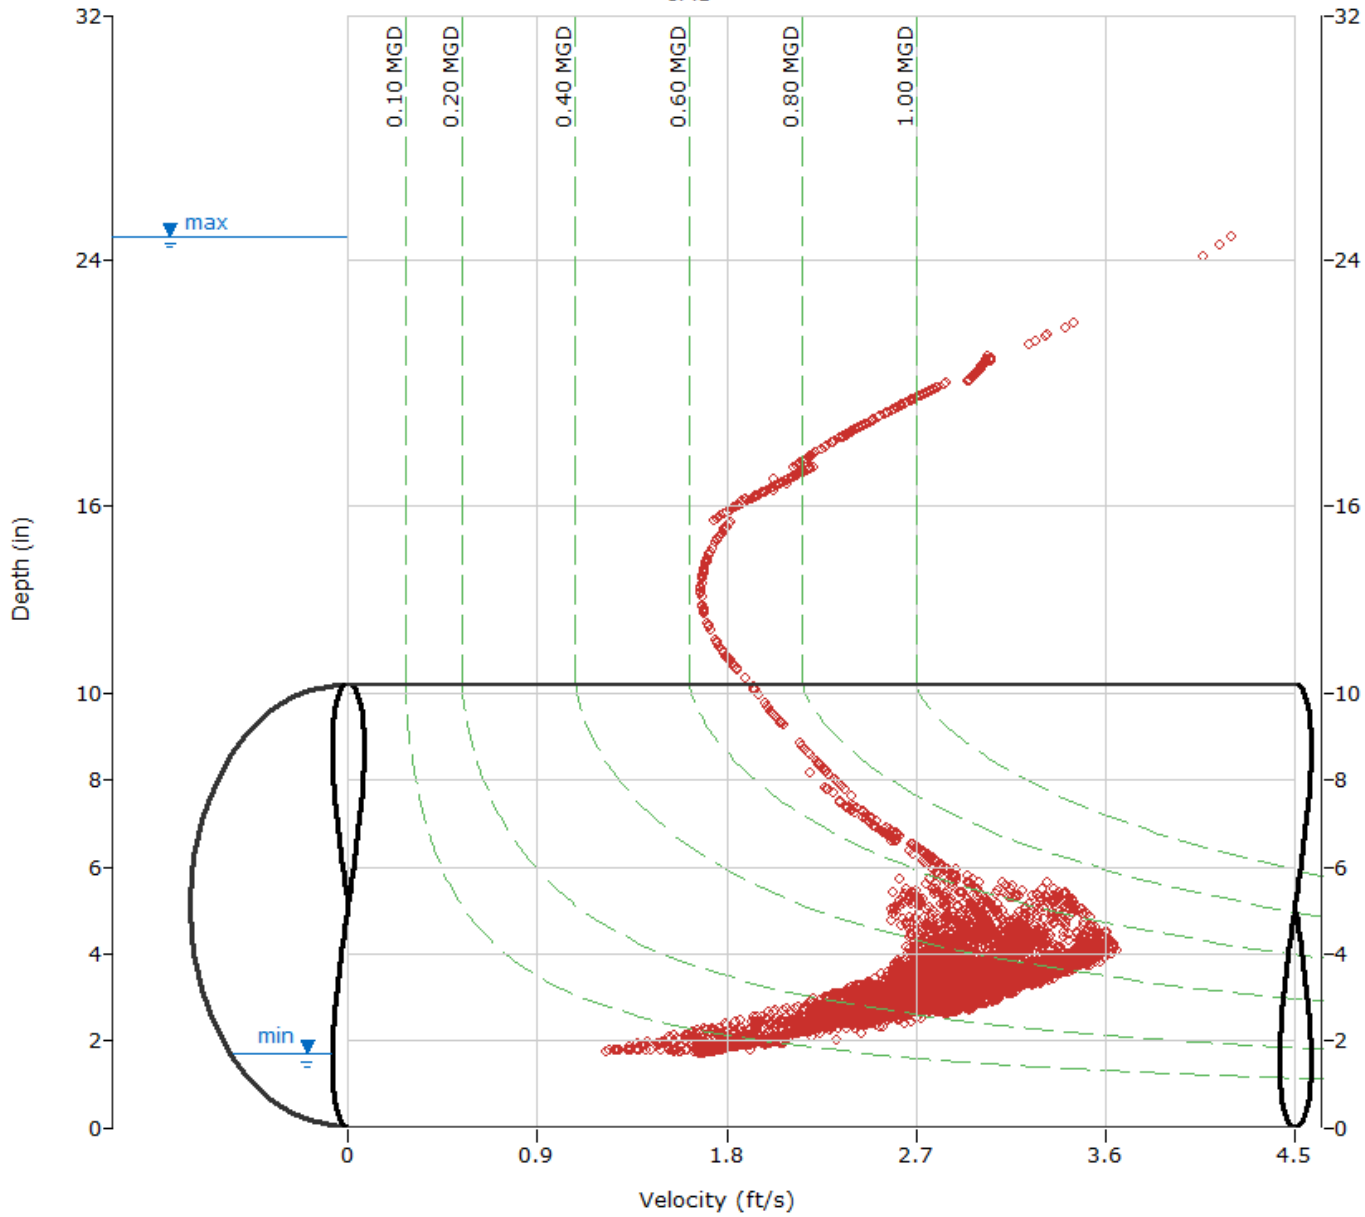
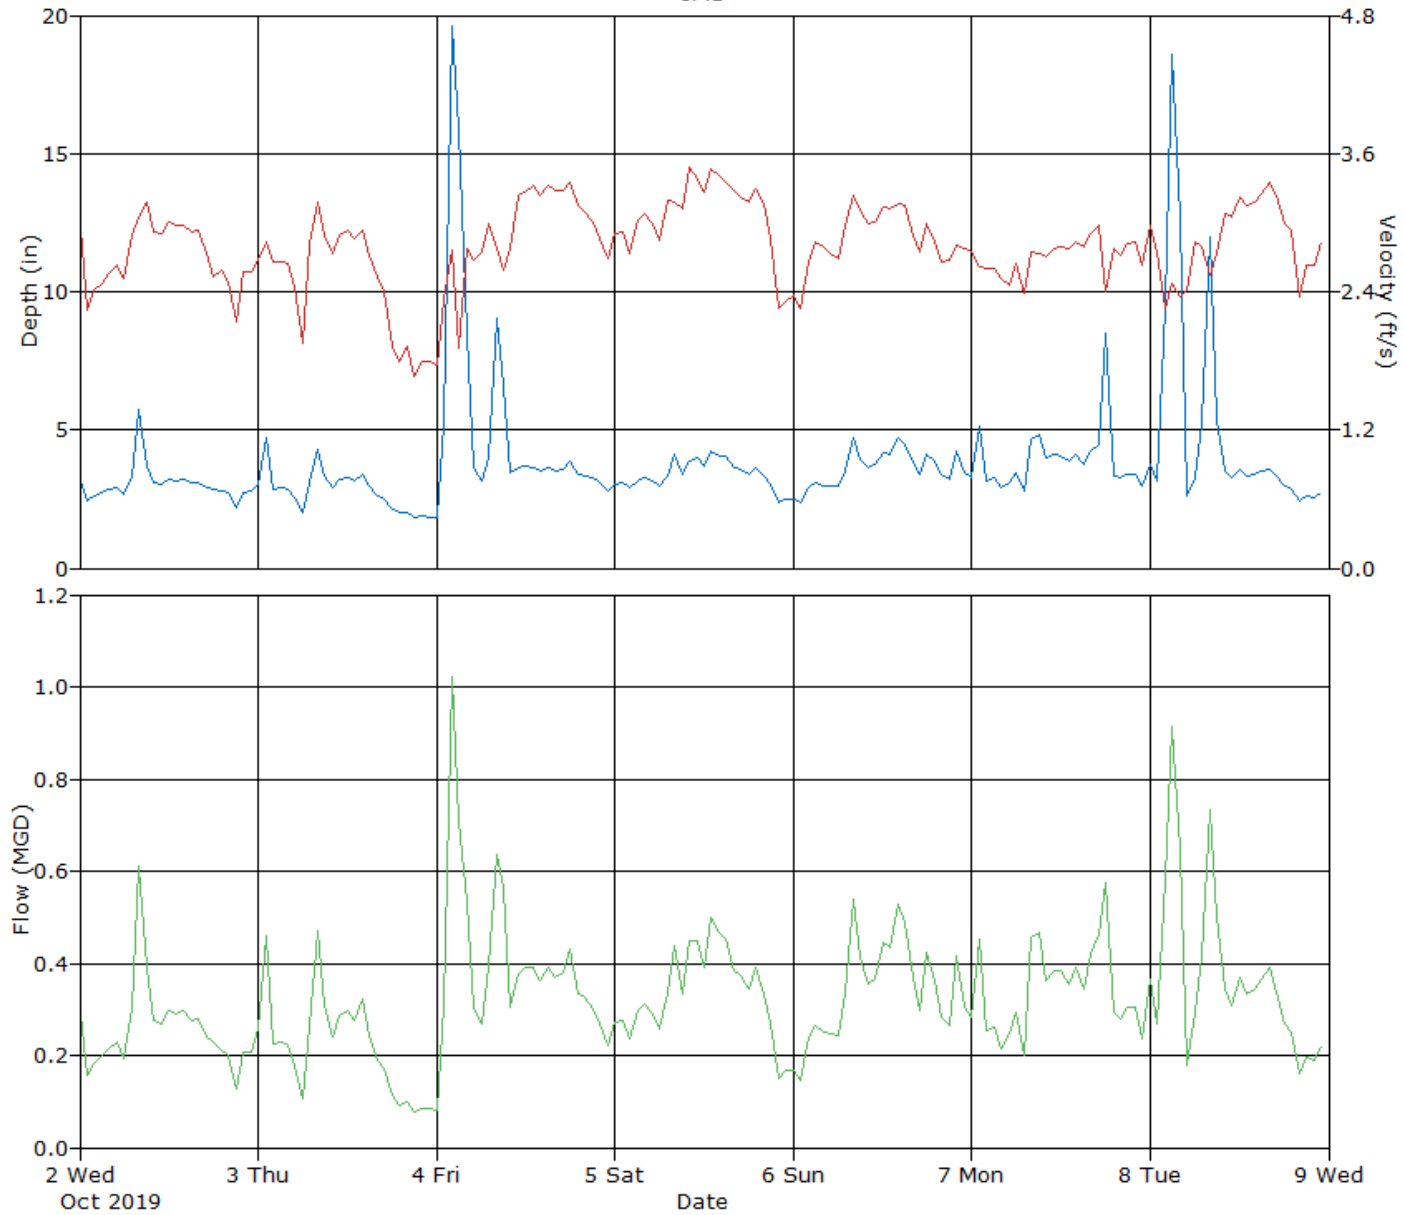
Site JM1 functioned under normal conditions during the period Wednesday, October 2, 2019 to Tuesday, October 8, 2019. Surcharge conditions were experienced at this location. Review of the Scattergraph shows that both free flow and backwater conditions were recorded during the study period.

Average flow depth, velocity, and quantity data observed during Wednesday, October 2, 2019 to Tuesday, October 8, 2019, along with observed minimum and maximum data, are provided in the following table. The values presented herein are based on 2-minute data. In regards to depth, this site flows at approximately 241% full at its recorded 2 minute peak of 24.75 inches and approximately 38% full during the typical average depth of 3.86 inches.

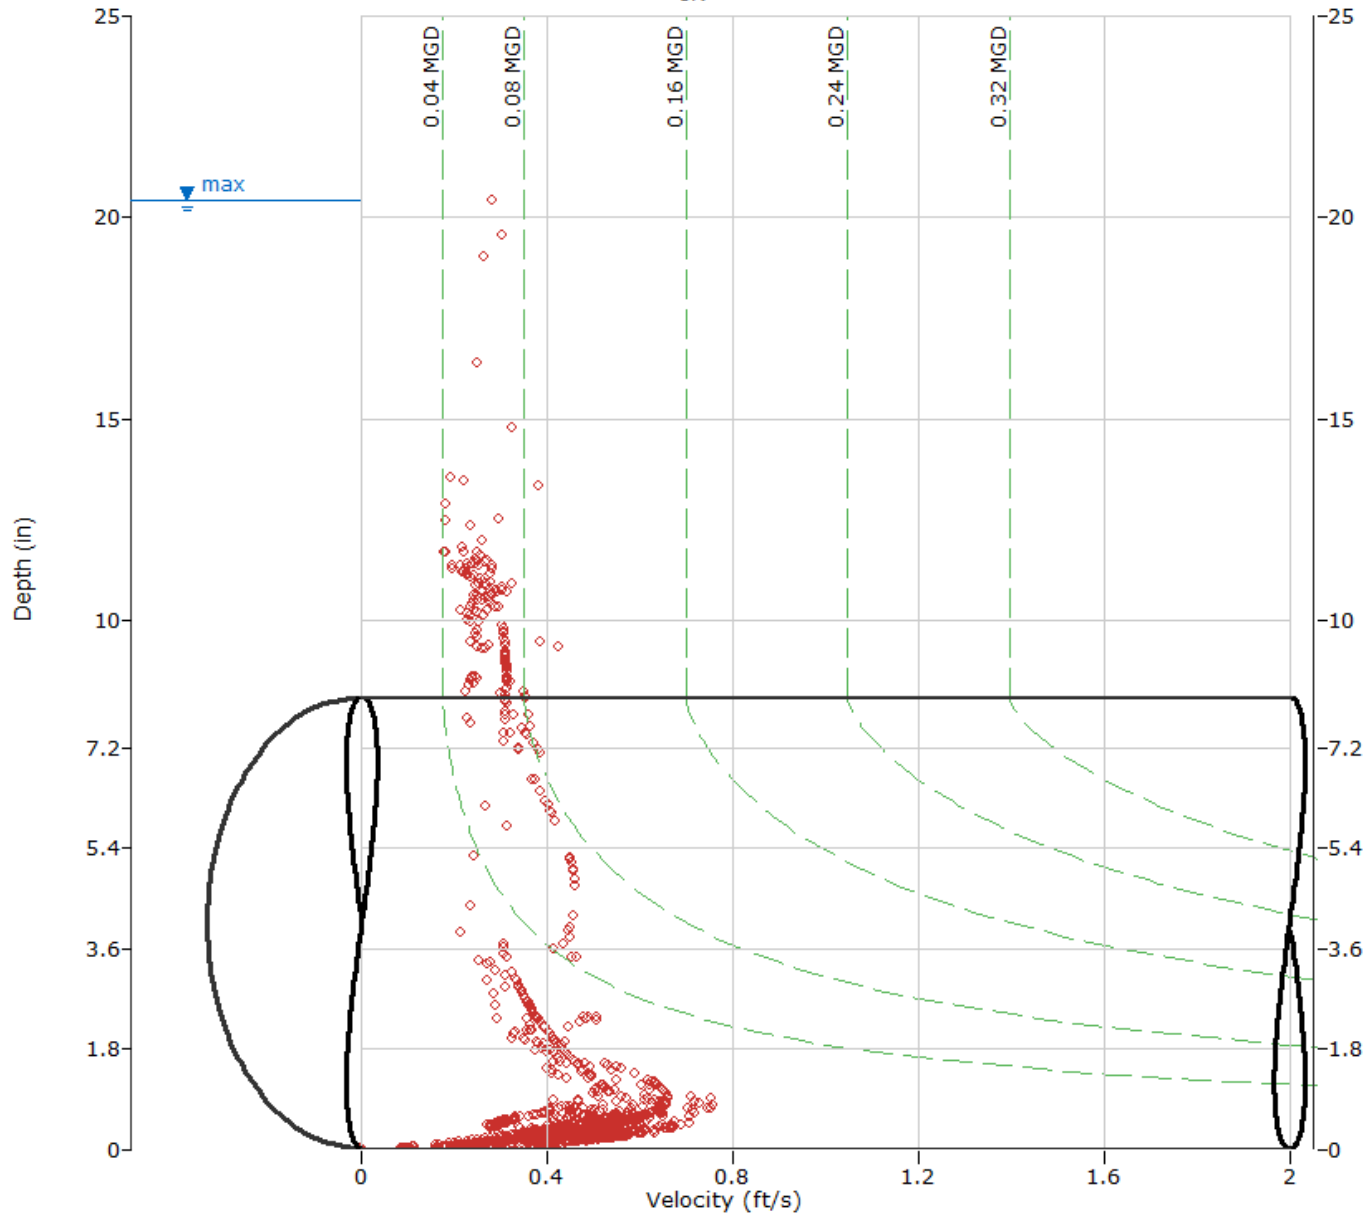
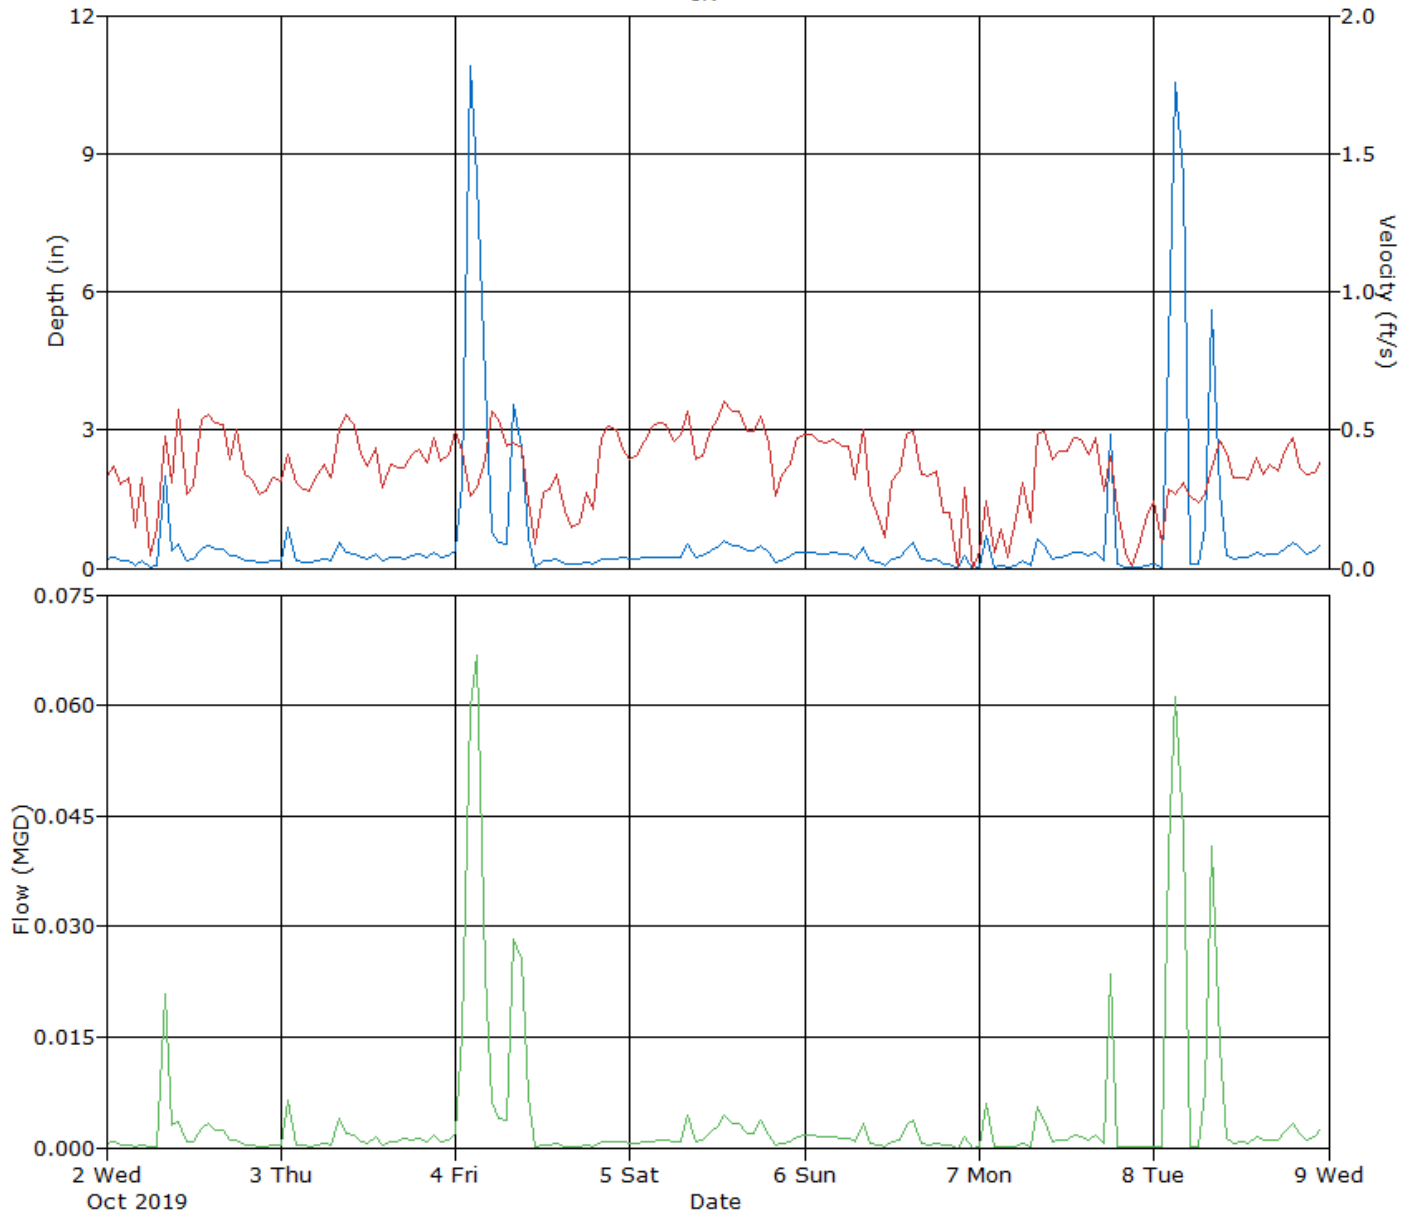
Site JR functioned under normal conditions during the period Wednesday, October 2, 2019 to Tuesday, October 8, 2019. Surcharge conditions were experienced at this location. Review of the Scattergraph shows that both free flow and backwater conditions were recorded during the study period.

Average flow depth, velocity, and quantity data observed during Wednesday, October 2, 2019 to Tuesday, October 8, 2019, along with observed minimum and maximum data, are provided in the following table. The values presented herein are based on 2-minute data. In regards to depth, this site flows at approximately 251% full at its recorded 2 minute peak of 20.40 inches and approximately 8% full during the typical average depth of 0.64 inches.

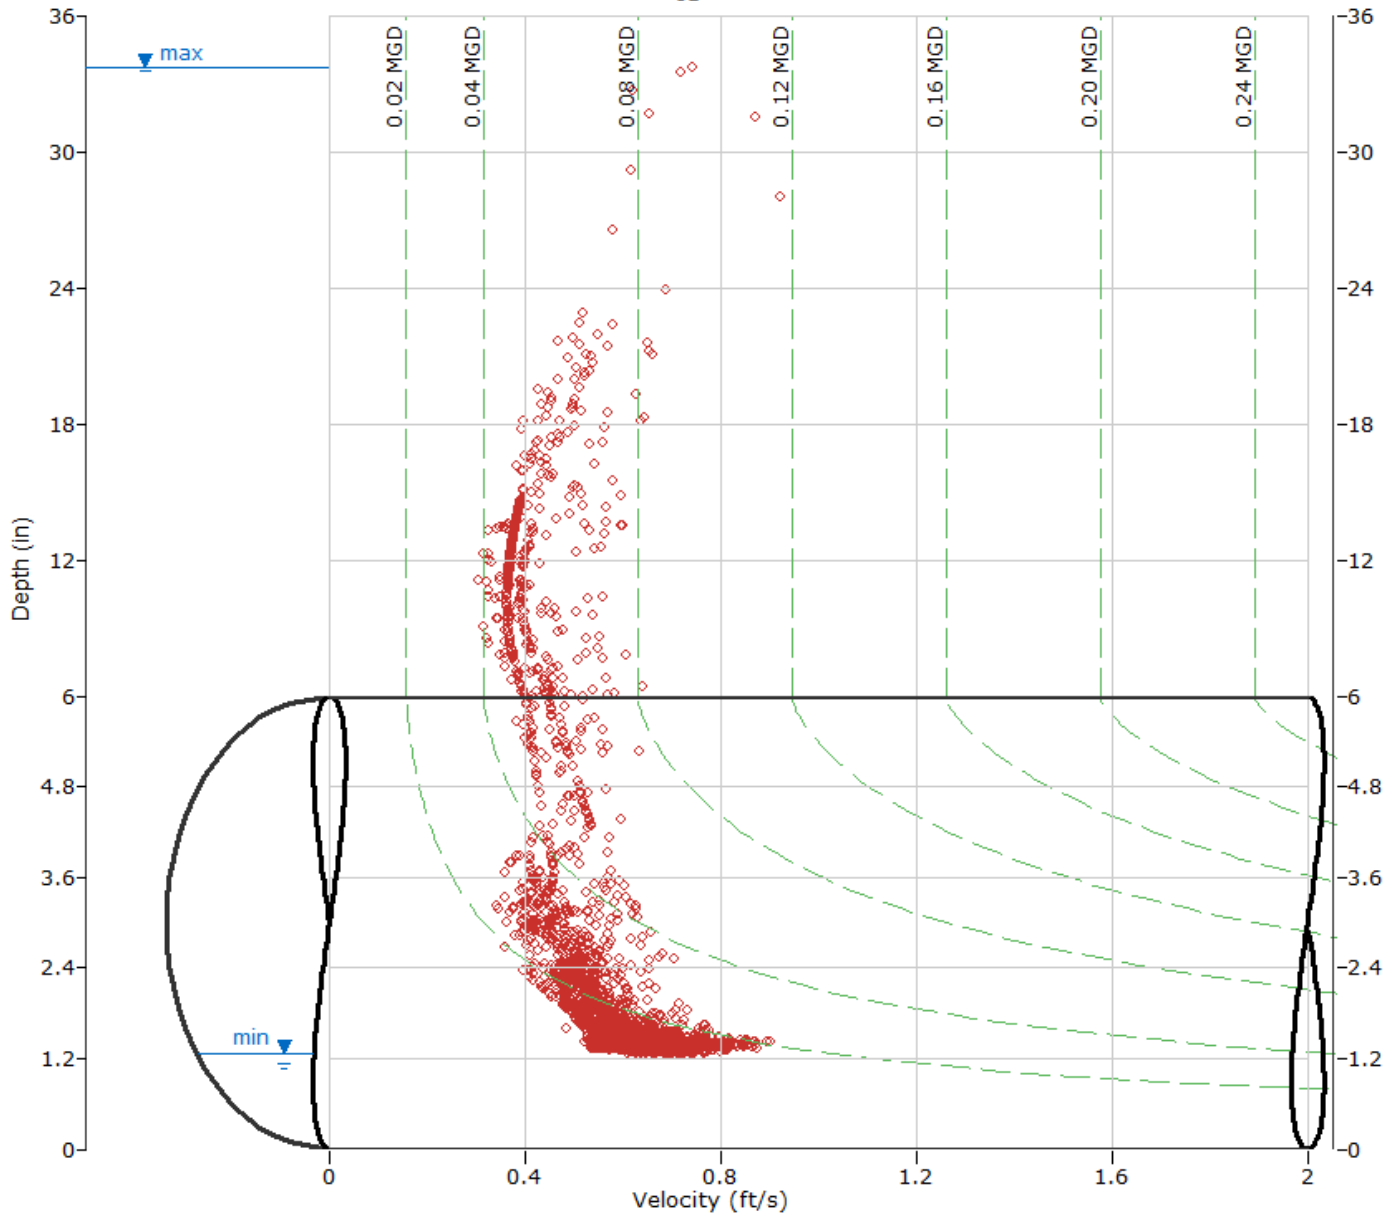
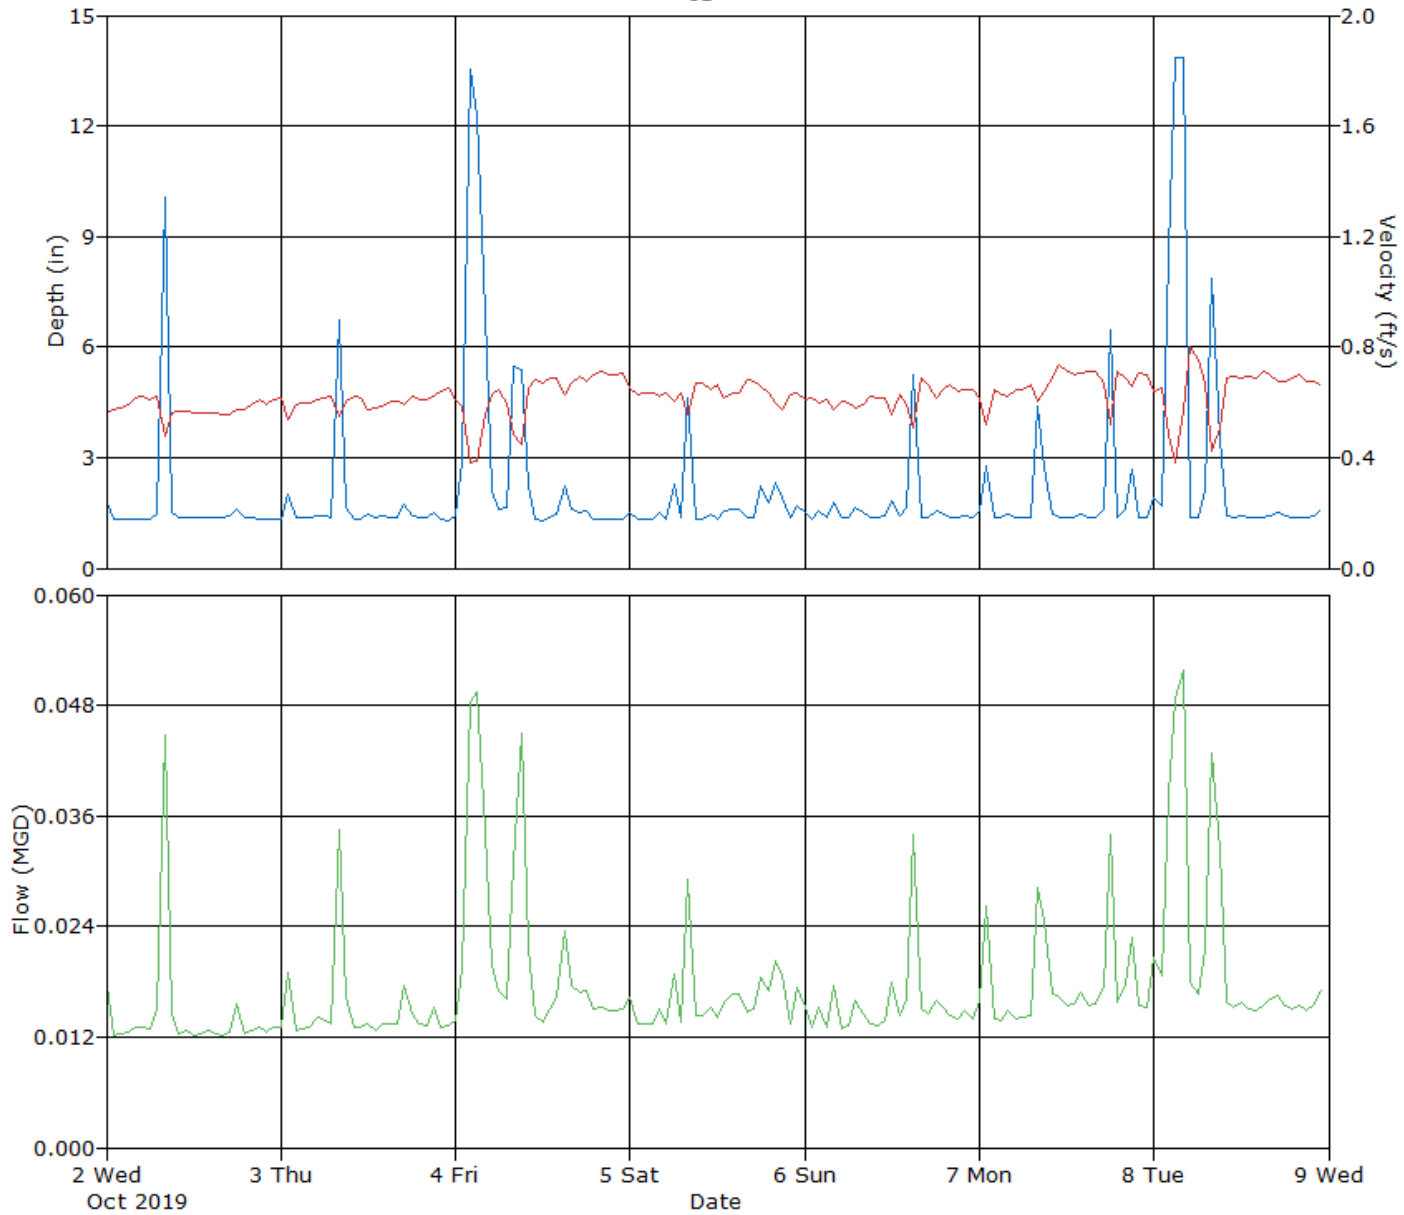
Site JS functioned under normal conditions during the period Wednesday, October 2, 2019 to Tuesday, October 8, 2019. Surcharge conditions were experienced at this location. Review of the Scattergraph shows that both free flow and backwater conditions were recorded during the study period.

Average flow depth, velocity, and quantity data observed during Wednesday, October 2, 2019 to Tuesday, October 8, 2019, along with observed minimum and maximum data, are provided in the following table. The values presented herein are based on 2-minute data. In regards to depth, this site flows at approximately 562% full at its recorded 2 minute peak of 33.70 inches and approximately 36% full during the typical average depth of 2.13 inches.
