**FAULT RUPTURE
HAZARD INVESTIGATION**

**CLAIREMONT VILLAGE
SAN DIEGO, CALIFORNIA**

**CLAIREMONT VILLAGE QUAD, LLC
SAN DIEGO, CALIFORNIA**

**NOVEMBER 12, 2021
PROJECT NO. G1992-52-03**

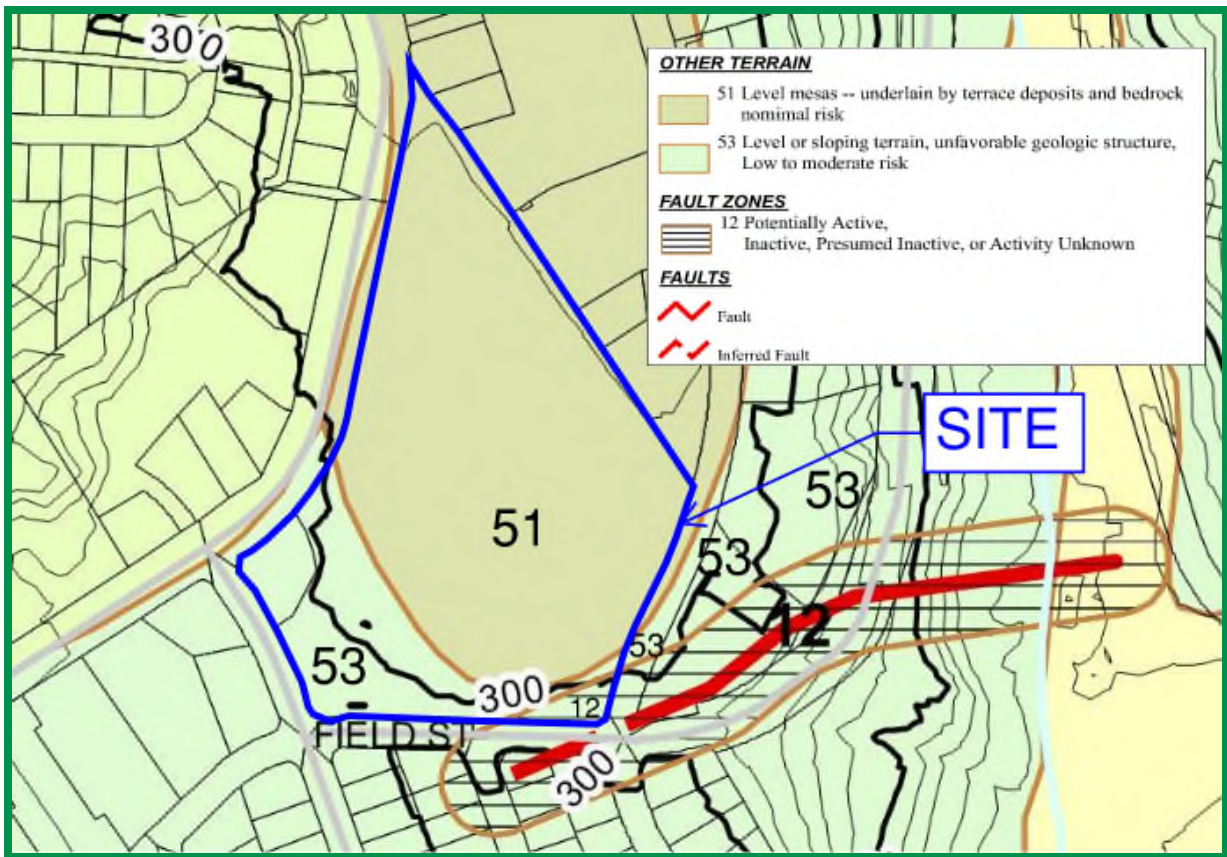
Hazard Category Map

The City of San Diego Seismic Safety Study, Geologic Hazards and Faults, Sheet 25 defines the northern portion of the site with *Hazard Category 51: Level mesas, underlain by terrace deposits and bedrock, nominal risk*. The southern portion of the site is defined as *Hazard Category 53: Level or sloping terrain, unfavorable geologic structure, low to moderate risk*. A fault is mapped southeast of

the site and is labeled as *Hazard Category 12: potentially active, inactive, presumed inactive, or activity unknown* (see Hazard Category Map).

By definition of the California Geological Survey (CGS, 2018), an active fault is a fault that has had surface displacement within Holocene time (the last 11,700 years). A pre-Holocene fault is a fault whose recency of past movement is older than 11,700 years. According to these definitions, Earthquake Fault Zones mandated by the State of California (Alquist-Priolo) Geologic Hazards Zones Act were adopted. The purpose of this act is to assure that structures for human occupancy are not constructed across traces of active faults. The City of San Diego has a further designation of “potentially active” for faults with Quaternary displacement, but the most-recent activity is older than 11,700 years ago. The Regional Geologic Map shows the same fault southeast of the property boundary. This fault is mapped as Tertiary-age (CDMG, 1975), indicating it does not offset the Quaternary-age Qvop.

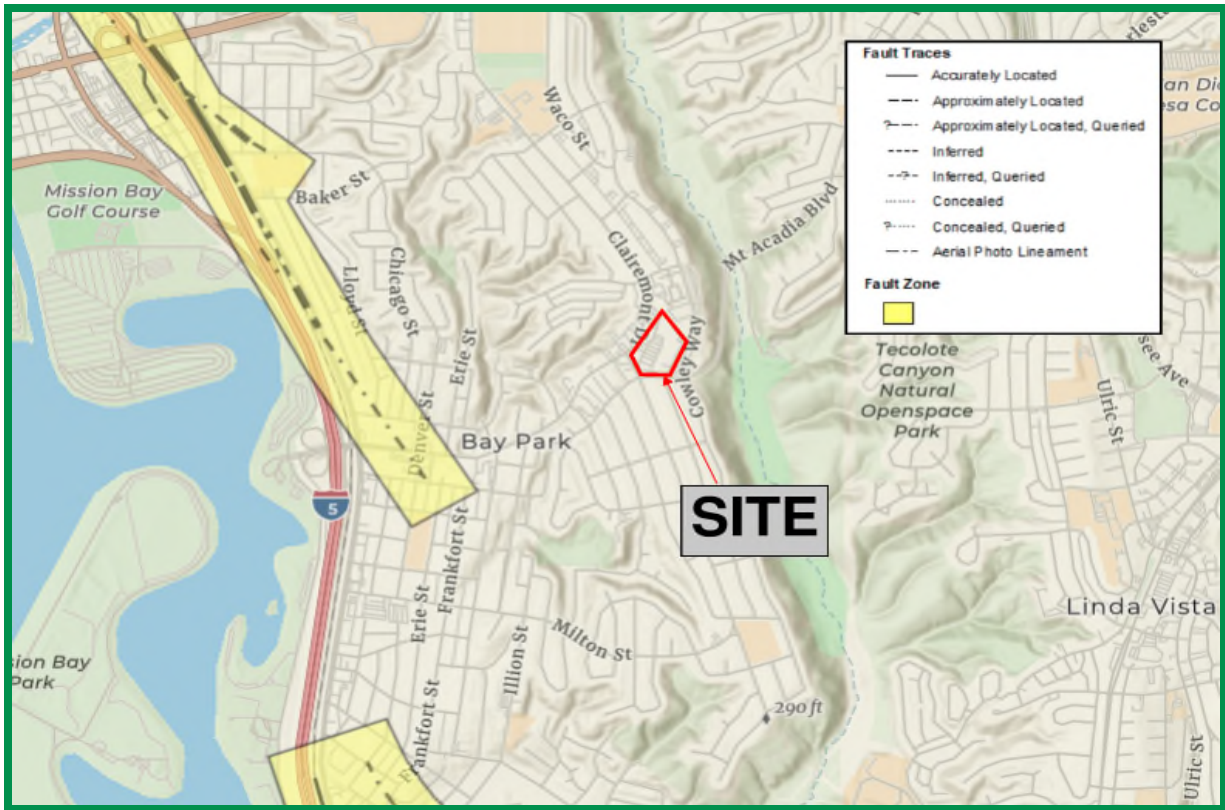
The CGS Earthquake Fault Zone Map (CGS, 2021) indicates Holocene-active faulting is not present in the immediate vicinity, projecting toward, or traversing, the subject property.

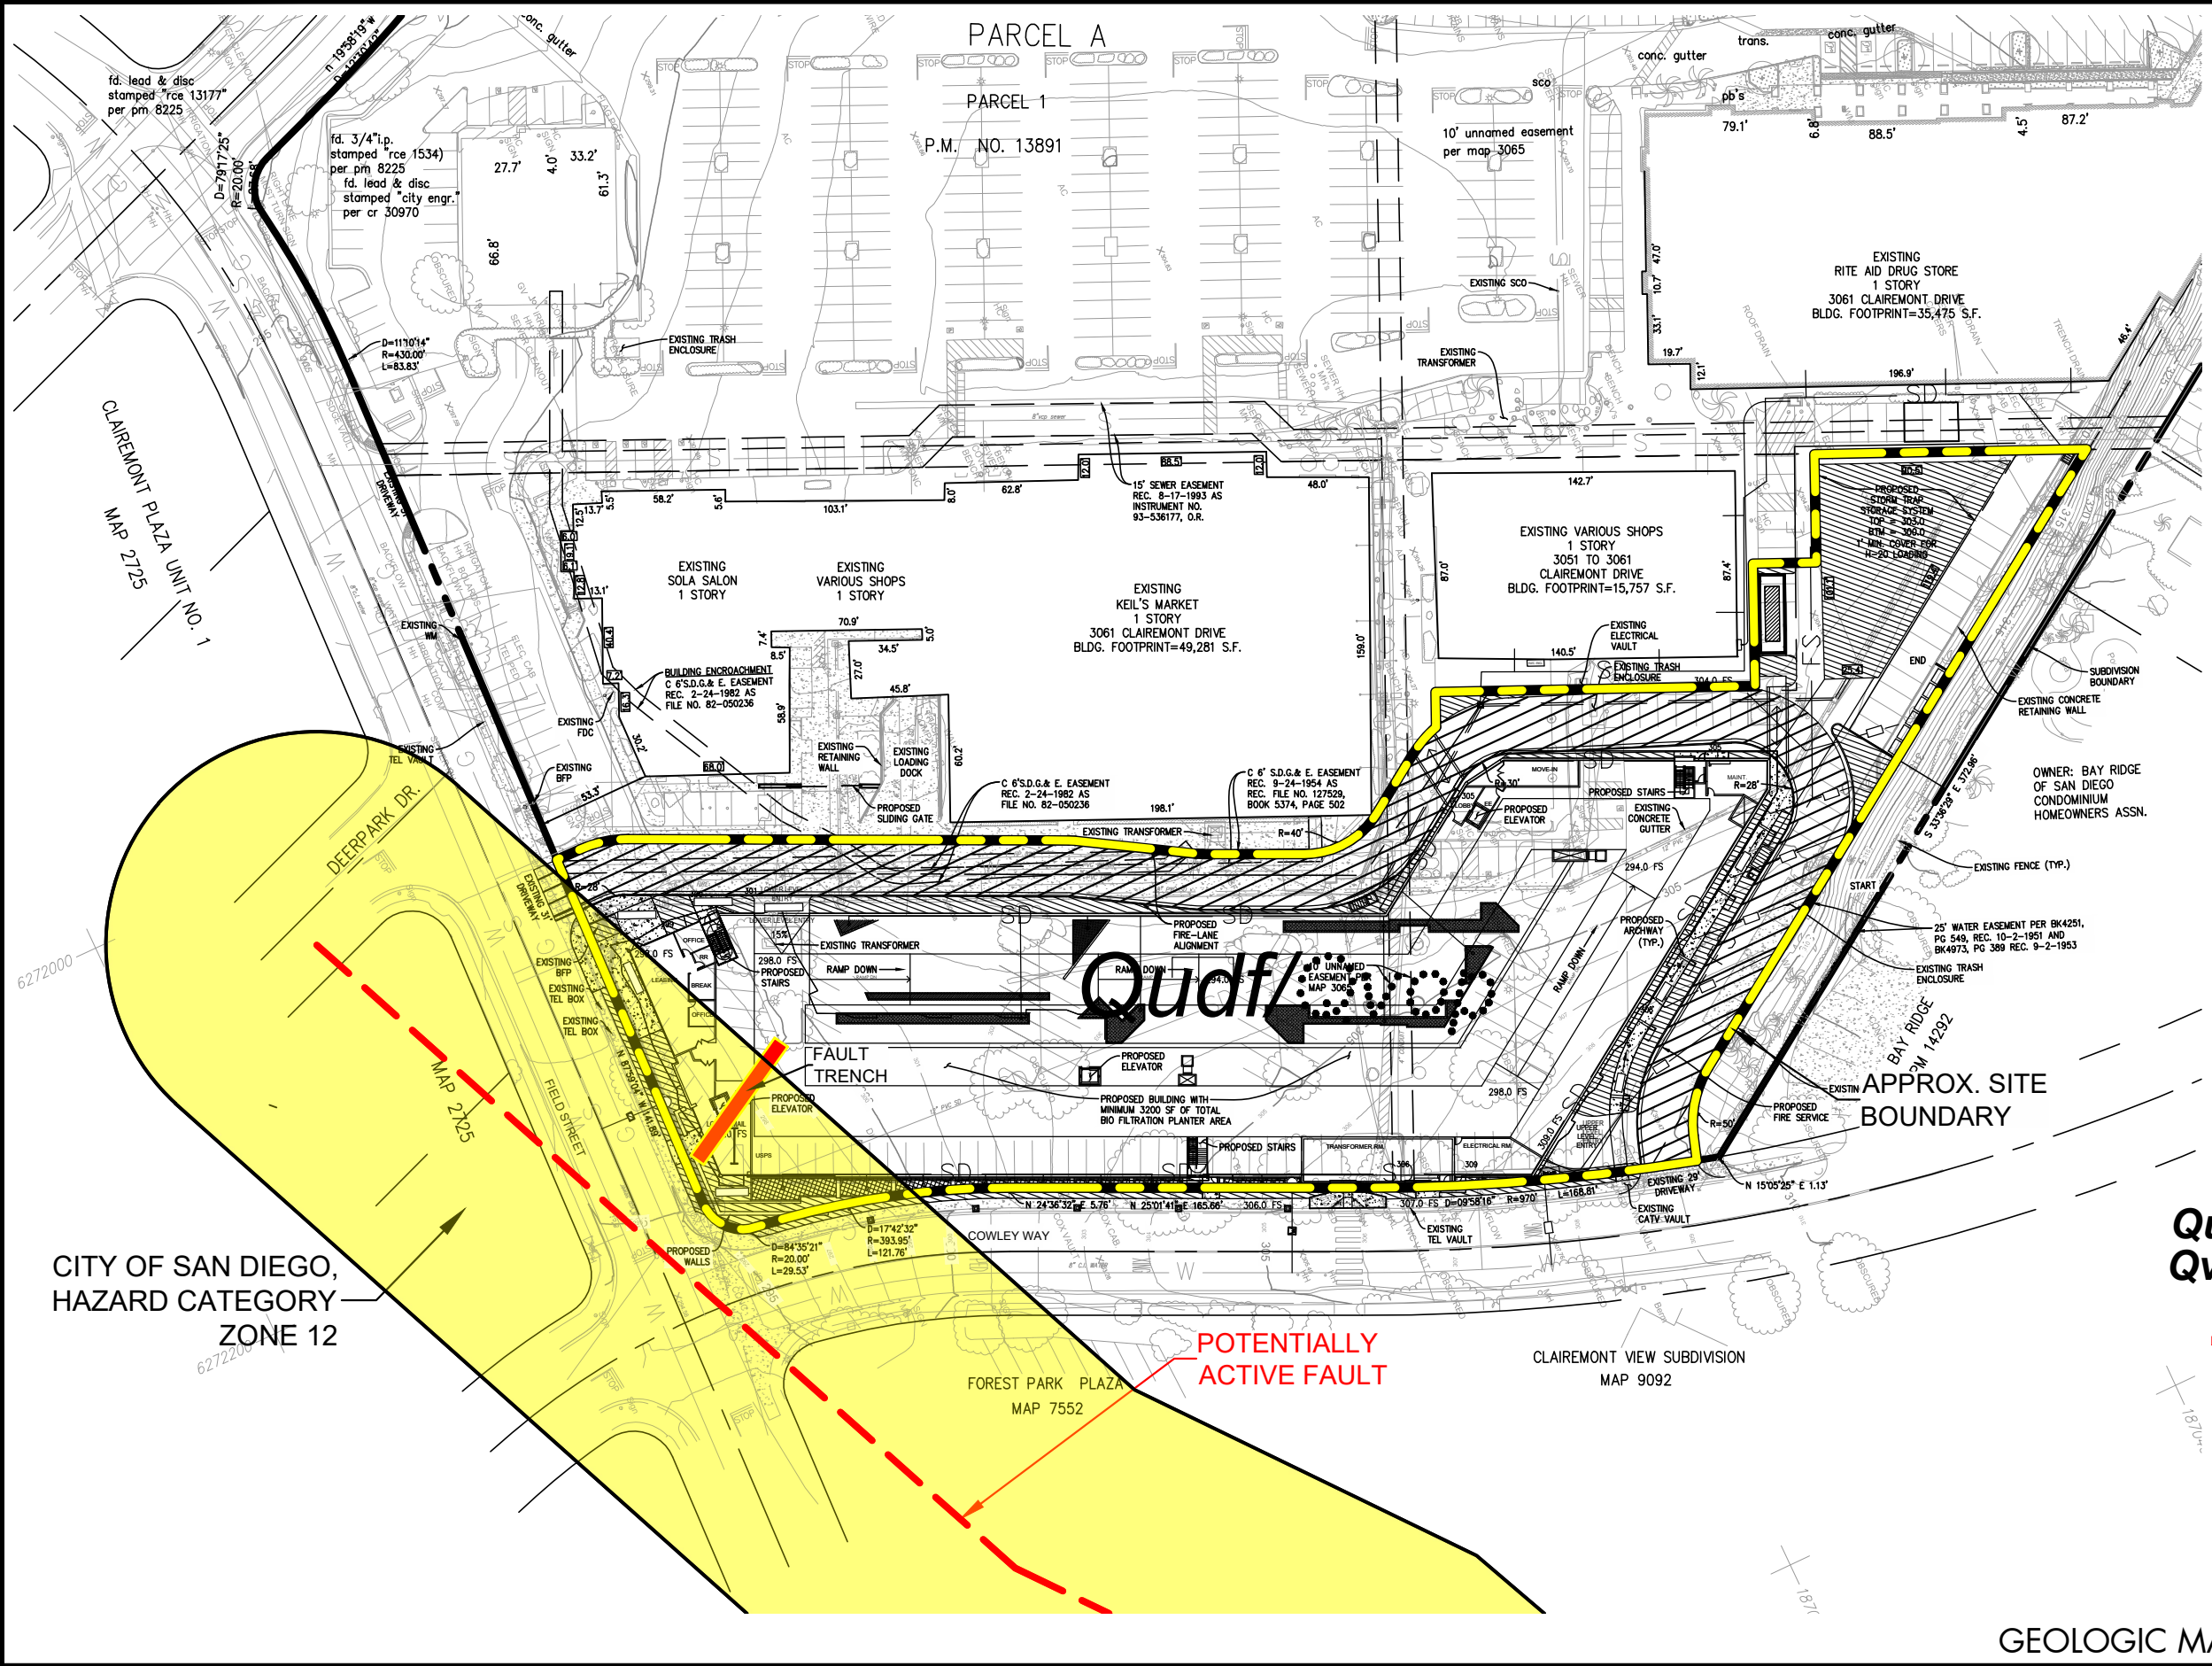
GEOLOGIC MAP
FIGURE 1
DATE 11 - 12 - 2021

increasing age. The approximate lateral extent of the geologic conditions is presented on the Geologic Map.

CITY OF SAN DIEGO,
HAZARD CATEGORY
ZONE 12

POTENTIALLY
ACTIVE FAULT

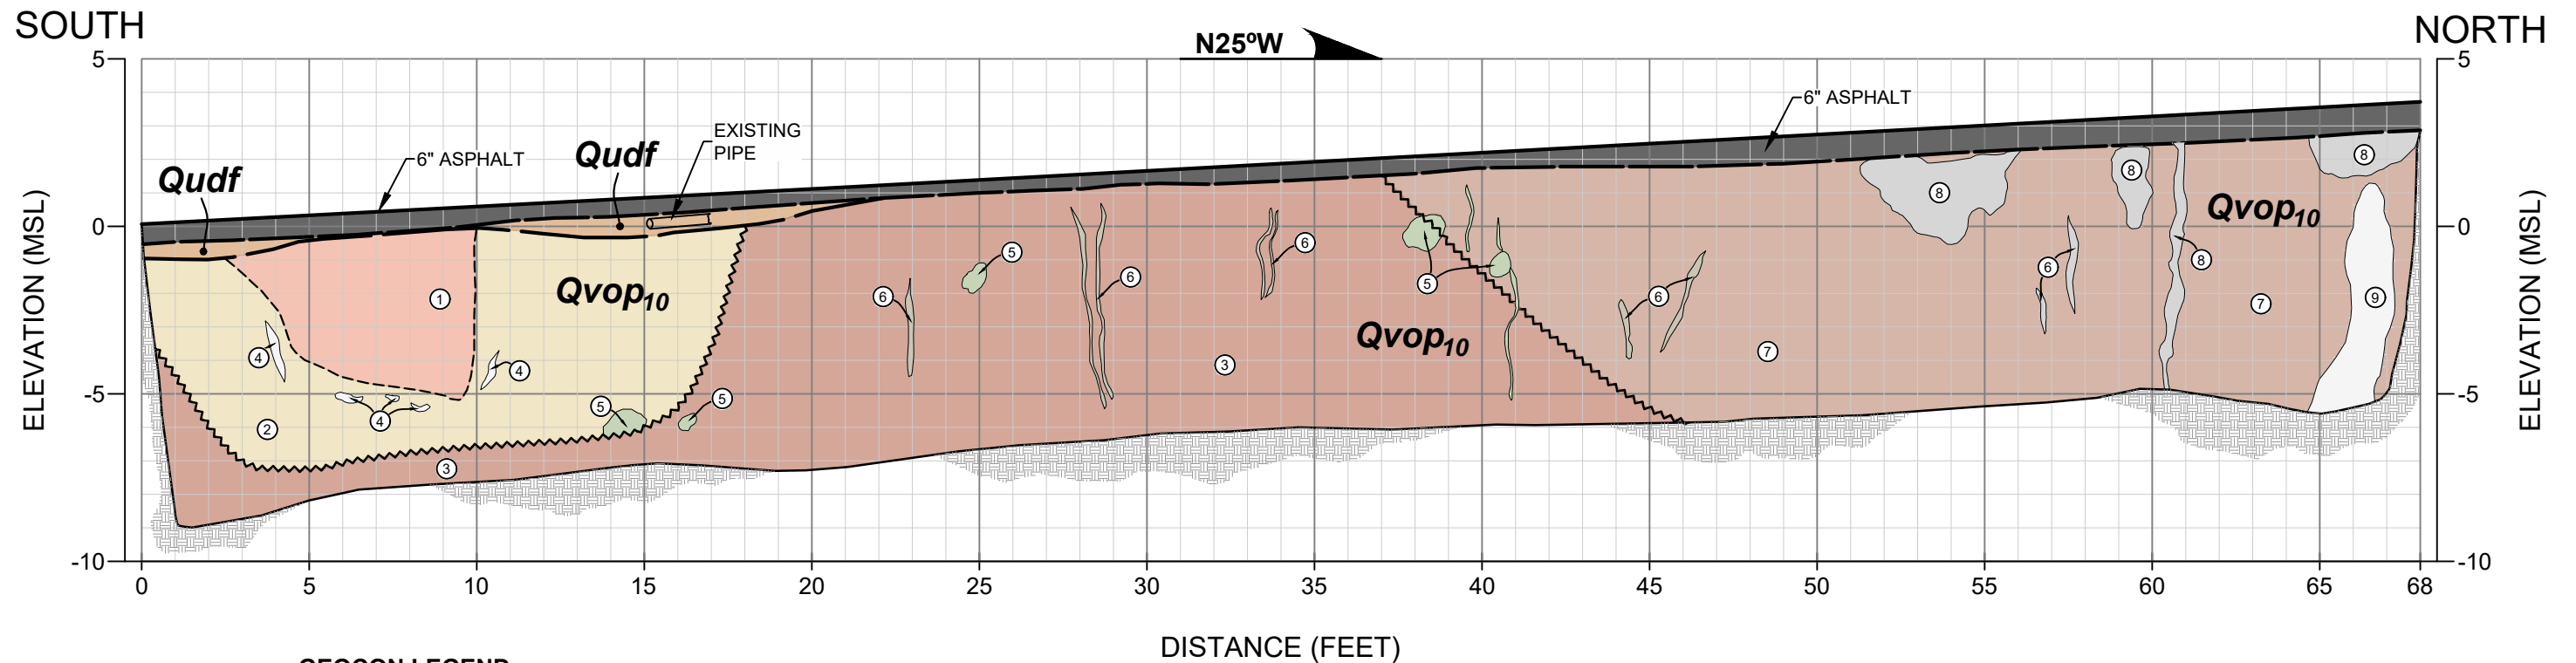
FIGURE 2
DATE 11 - 12 - 2021

The geologic unit exposed in the trench consisted of Very Old Paralic Deposits (Qvop) with minor undocumented fill mantling the native soils. For logging purposes, the sediments were divided into four separate zones based upon variable weathering profiles. Detailed descriptions of the zones are presented in the Trench Log, Figure 2.

We observed a possible channel deposit near the south end of the trench, consisting of a very coarse sandstone, generally massive, but weakly laminated at the base of the deposit. Below this is a zone of distinct weathering where a medium-grained sandstone is colored light yellowish brown and contains abundant grayish brown mottles.

The remainder of the trench is comprised of a silty sandstone, with a distinct weathering profile change from the south end of the trench to the north. The northern portion of the trench has a higher degree of cementation and also proved more difficult to excavate. The zone indicated on the trench log at Station 0+35 to 0+45, represents approximately where the change in weathering is located.

Numerous vertical to sub-vertical, zones of preferential weathering were observed. In addition, two vertical sand features, one well cemented the other friable, were observed at Station 0+61 and 0+66, respectively. These features were not observed across to the opposite trench wall. They are discontinuous and are not fault related.

As previously indicated, the entire trench exposure was scraped and picked with hand tools and closely examined for potential lateral and vertical lithologic discontinuities, offsets, shear zones, gouge zones, clay-filled fractures or fissures, or any other fault-related features in the generally massive stratigraphic unit. The Qvop deposits were observed to be laterally and vertically continuous, undeformed and intact. These observations also apply to those portions of the excavations that only contain one mappable unit. Despite not having mappable lithologic units in this area, fault-related features were not observed upon close inspection.

1. No topographic or geomorphic lineaments were observed on historic topographic maps to traverse or project toward the site.
2. No faults have been documented in the surrounding blocks by other consultants to project toward the site.
3. The pre-Holocene (middle Pleistocene) Very Old Paralic Deposits (Qvop) were observed to be laterally continuous in our exploratory trench at the site and no faults or fault-related features were observed. There is no evidence of fracturing, shearing, or offset of soil features.

The age, lateral continuity, and lack of deformation of the distinct geologic unit provides clear evidence for continuous, un-faulted, pre-Holocene age sediments across the site and rules out active faulting.

Based on our observations and research, we opine active, potentially active or inactive faults are not present at the subject site. Therefore, we opine building restrictions (i.e. structural setbacks) on future development of the site are not necessary with respect to the hazard of surface fault rupture, beyond the standard seismic engineering requirements for buildings in California. Our conclusions regarding the absence of active faulting and the suitability of the site for the proposed development cannot be confirmed until our fault investigation report is reviewed by the Development Services Department Geology Division and an approval letter is issued by the city geologist.
