APPENDIX E

Public Outreach: “Walk ‘n Roll” Audit

Table E-1: Pedestrian Field Review

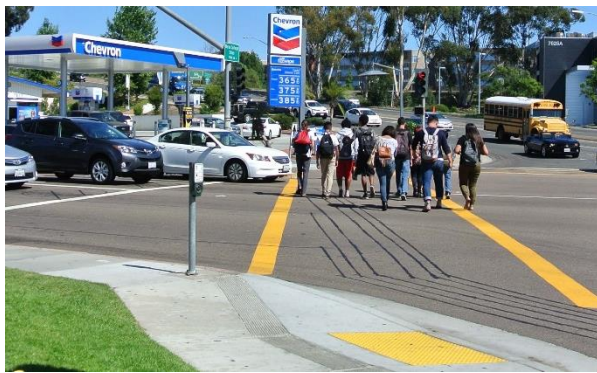
Map ID	Description	Image
1	<p>Linda Vista Road and Mesa College Road</p> <ul style="list-style-type: none"> • High pedestrian activity intersection • Observed crossing phase short for crossing time (east-west on north leg)

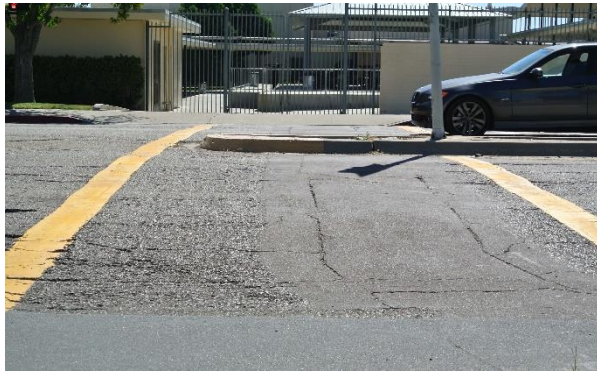
2	<p>Ashford Street and Mesa College Drive</p> <ul style="list-style-type: none"> • Median is an ADA-obstruction in the north-south crosswalk

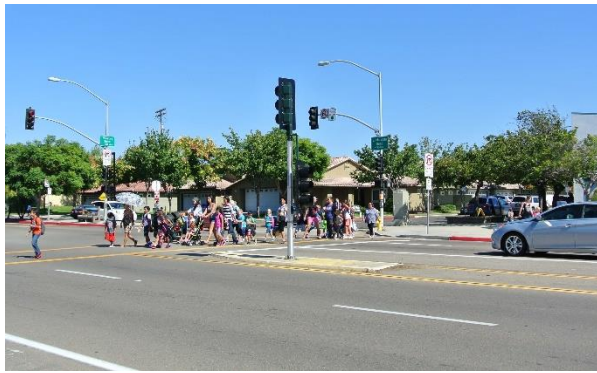
3	<p>Linda Vista Road and Wheatley Street</p> <ul style="list-style-type: none"> • High pedestrian activity intersection • Non-ADA curb ramps (all corners) • “Cars speed and blow through the light [when red].” – Chesterton Elementary School crossing guard • Observed vehicle speeds appear to exceed posted speed (35 mph, 25 mph when children are present)

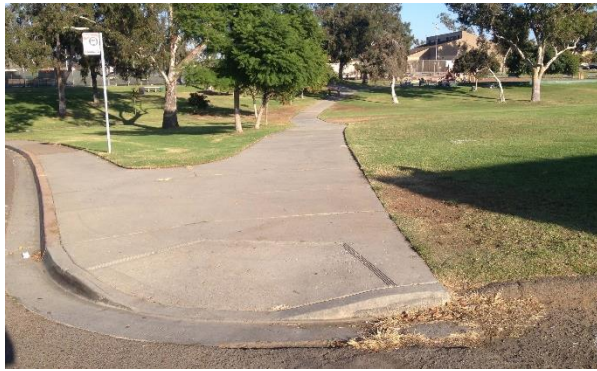
4	<p>Osler Street (west side of Linda Vista Community Park)</p> <ul style="list-style-type: none"> • Non-ADA curb ramp on south side of Osler Street entering the park • Sidewalk section on south side of Osler Street at bus stop is asphalt

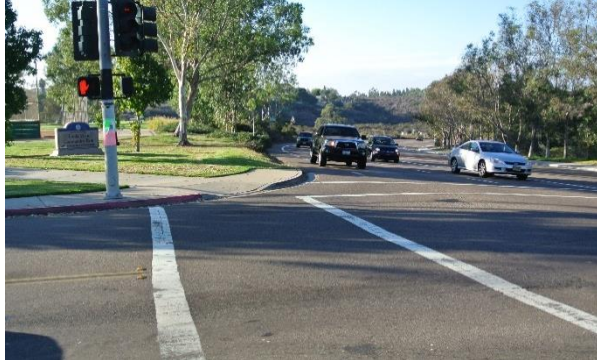
Map ID	Description	Image
5	<p>Osler Street and Genesee Avenue</p> <ul style="list-style-type: none"> • Non-ADA curb ramps (all corners) • No sidewalk on Genesee Avenue, west of Osler Street (south side)

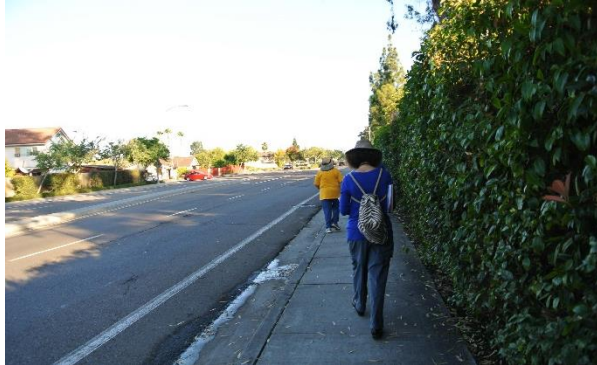
6	<p>Genesee Avenue between Osler Street and Linda Vista Road</p> <ul style="list-style-type: none"> • Landscaping on south side of Genesee Avenue extends over sidewalk, reducing effective sidewalk width

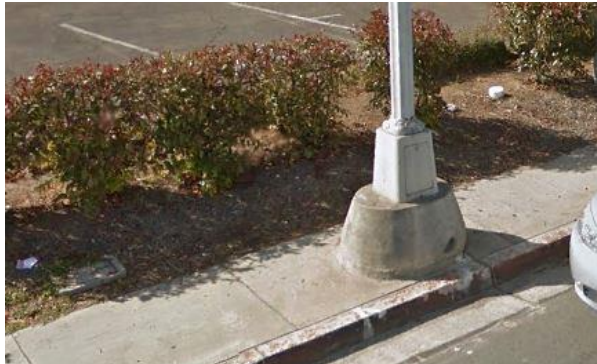
7	<p>Linda Vista Road and Genesee Avenue</p> <ul style="list-style-type: none"> • Non-ADA curb ramps (all corners) • Sidewalk obstructions: south leg heading northbound (pictured) and northeast corner of intersection

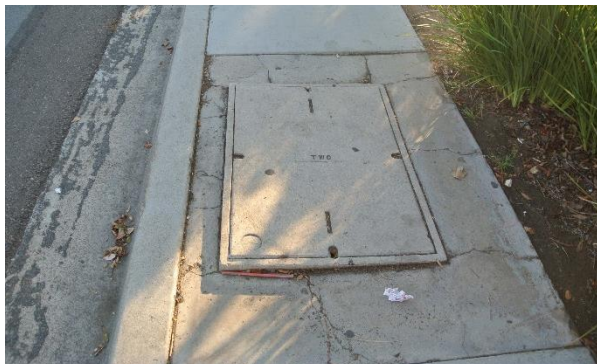
8	<p>Linda Vista Road (from Genesee Avenue to Levant Street)</p> <ul style="list-style-type: none"> • Multiple damaged/hazardous sidewalk sections on west side of Linda Vista Road

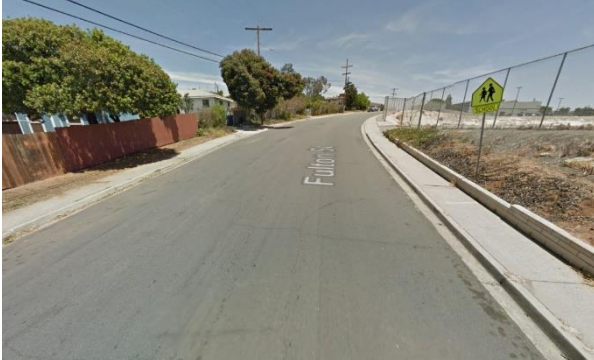
Map ID	Description	Image
9	<p>Fulton Street (from Comstock Street to Ulric Street)</p> <ul style="list-style-type: none"> • “Few working street lights” (resident)

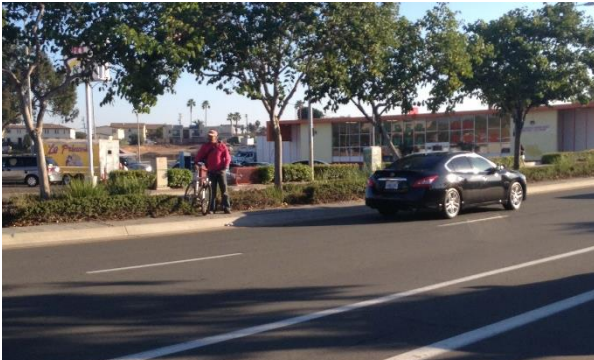
10	<p>Mid-Block Crossing on Linda Vista Road between Ulric Street and Fulton Street</p> <ul style="list-style-type: none"> • Long wait for pedestrian signal may increase the volume of prohibited crossings

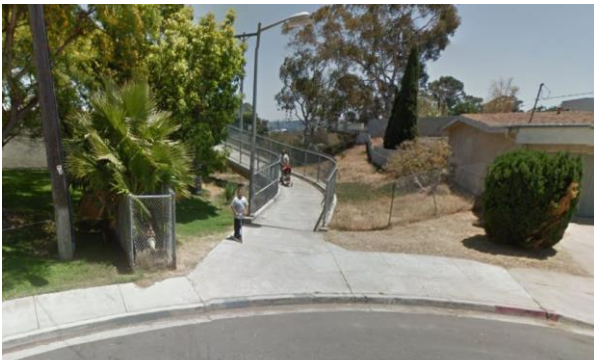
11	<p>Pedestrian Bridge over SR-163 at Fulton Street eastern terminus</p> <ul style="list-style-type: none"> • Pedestrian bridge provides only crossing additional to Mesa College Road over SR-163, however, bridge is at the end of a street indicating “NO OUTLET” with no signs for additional pedestrian connections • Bridge might see more use if wayfinding signage is provided

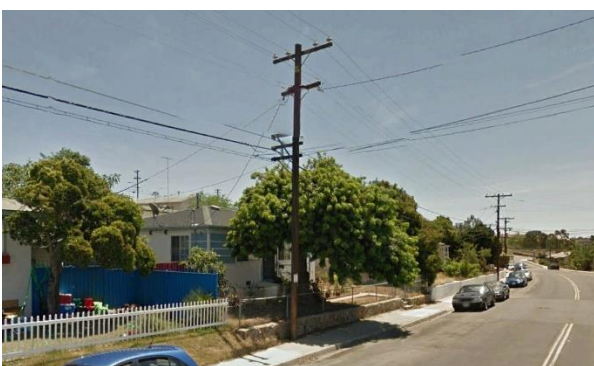
12	<p>Comstock Street (from Morley Street to Fulton Street)</p> <ul style="list-style-type: none"> • “Few working street lights” (resident)

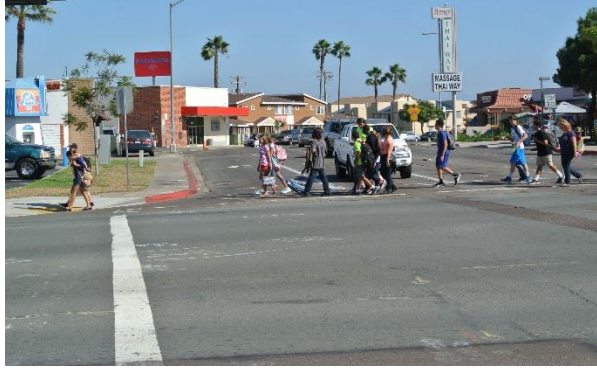
Map ID	Description	Image
13	<p>Linda Vista Road and Ulric Street</p> <ul style="list-style-type: none"> • High pedestrian activity intersection • Poorly marked crosswalks • Observed crossing phase short for crossing time (east-west on north leg)

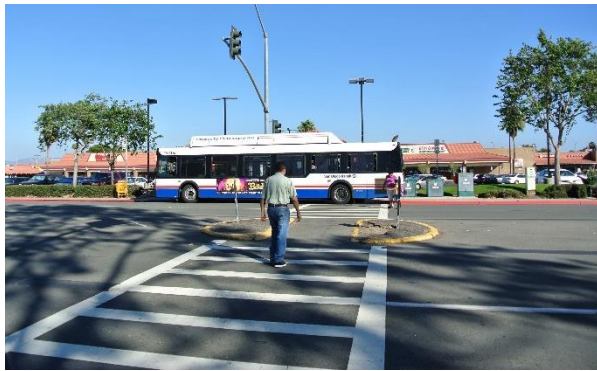
14	<p>Linda Vista Road Mid-Block Crossing (btwn Comstock Street and Ulric Street)</p> <ul style="list-style-type: none"> • When the bus is at northbound bus stop it blocks pedestrian vision of the pedestrian signal head (shown)

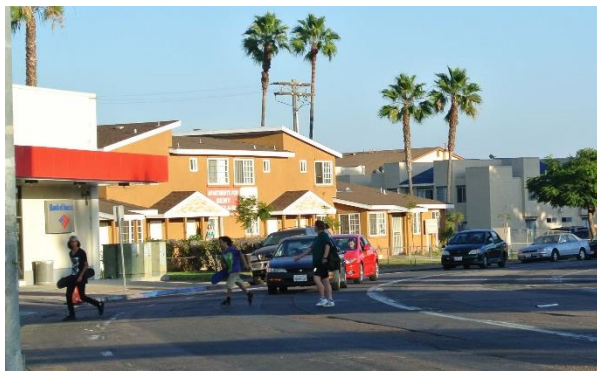
15	<p>Ulric Street (from Linda Vista Road to Comstock Street)</p> <ul style="list-style-type: none"> • High pedestrian activity corridor • Many different groups of pedestrians observed not using designated crossings • Existing roadway width potentially has room for continuous refuge

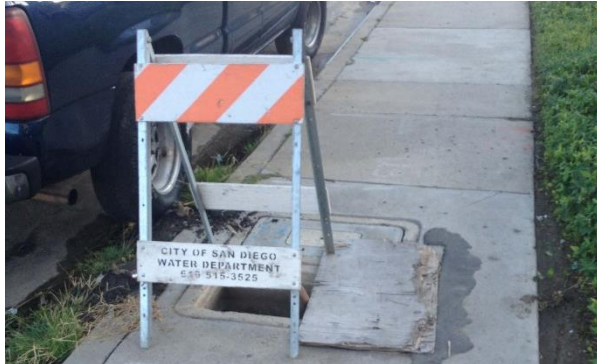
16	<p>Ulric Street (from Linda Vista Road to Comstock Street)</p> <ul style="list-style-type: none"> • West side of Ulric Street sidewalk is in very bad shape: damaged, obstructions, temporary asphalt patches on concrete • “Open utilities and hoses have been ignored for years” (resident)

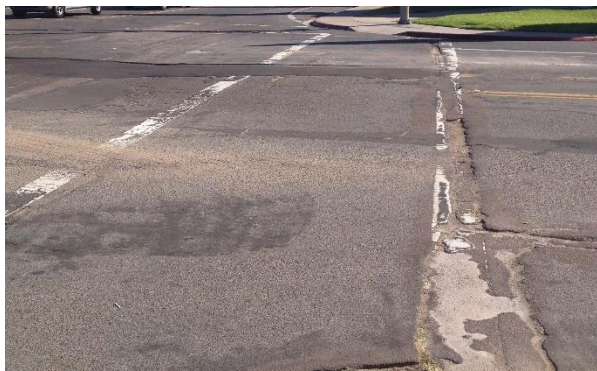
Map ID	Description	Image
17	<p>Ulric Street and Comstock Street</p> <ul style="list-style-type: none"> • Non-ADA ramps (all corners) • Poor crosswalk condition • Poor road condition

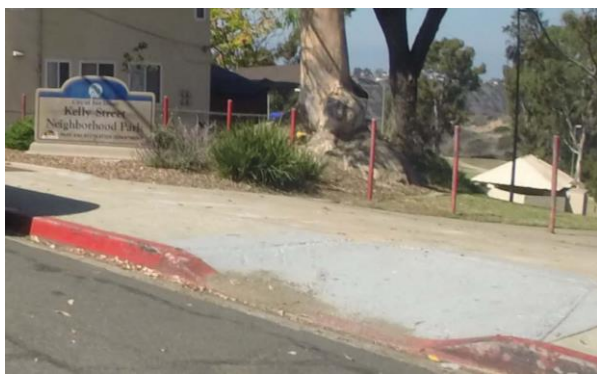
18	<p>Kelley Street by Kelley Street Park</p> <ul style="list-style-type: none"> • Non-ADA curb ramp on north side of Kelley Street, leading to Kelley Street Neighborhood Park • Damaged, cracked sidewalk and temporary asphalt patches on Kelley Street just east of the Park

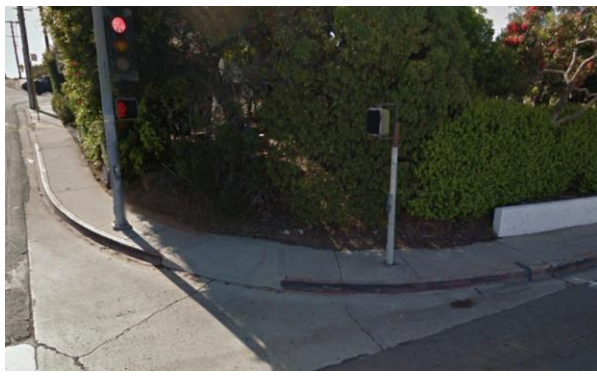
19	<p>Linda Vista Road and Tait Street</p> <ul style="list-style-type: none"> • Unmarked sidewalks • Non-ADA curb ramps (all corners) • Sidewalk obstructions (all corners)

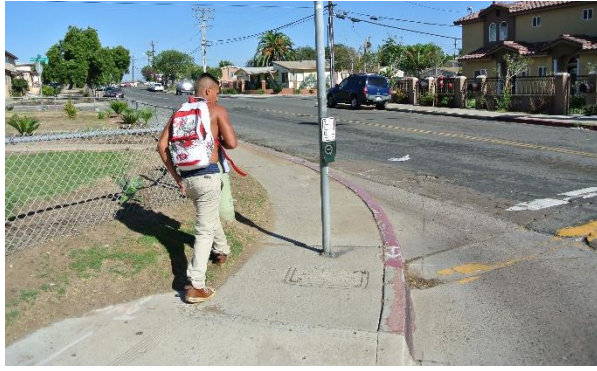
20	<p>Ulric Street and Tait Street</p> <ul style="list-style-type: none"> • Non-ADA curb ramps (all corners) • Sidewalk obstructions (all corners) • Poor crosswalk condition • Poor road condition

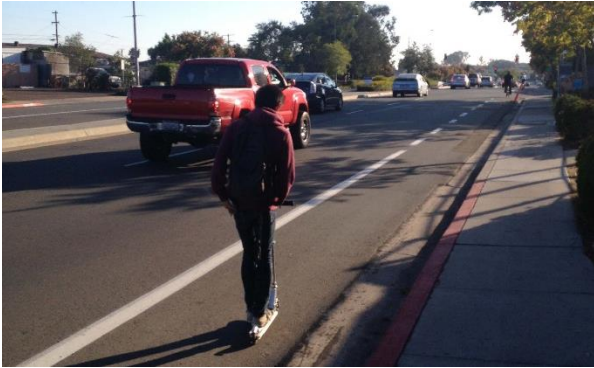
Map ID	Description	Image
1	<p>Linda Vista Road from Mesa College Drive to Alcala Knolls Drive</p> <ul style="list-style-type: none"> • Bike lane is adjacent to fast moving traffic (observed speeds seem higher than posted) • Increased separation (buffer or physical barrier) would improve cycling environment

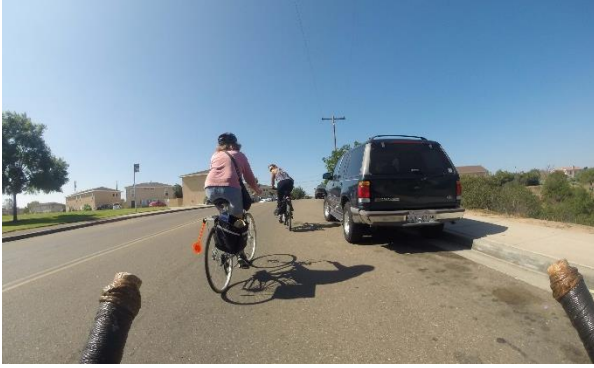
2	<p>Osler Street from Ulric Street to Genesee Avenue</p> <ul style="list-style-type: none"> • Parked cars, horizontal and vertical curves reduce cyclist visibility in eastbound direction • Additionally, observed speeding cars combined with slower, uphill climb create uncomfortable cycling environment

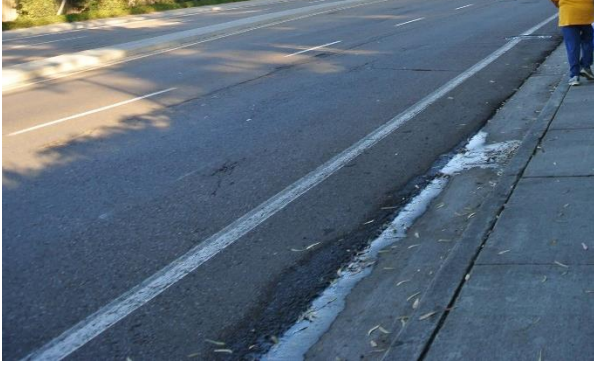
3	<p>Genesee Avenue from Osler Street to West of SR-163 Southbound On-Ramp</p> <ul style="list-style-type: none"> • Effective width of bike lane is very narrow (approximately 3.5 feet) due to the gutter pan • Cyclists would benefit from increased separation due to high speed vehicles

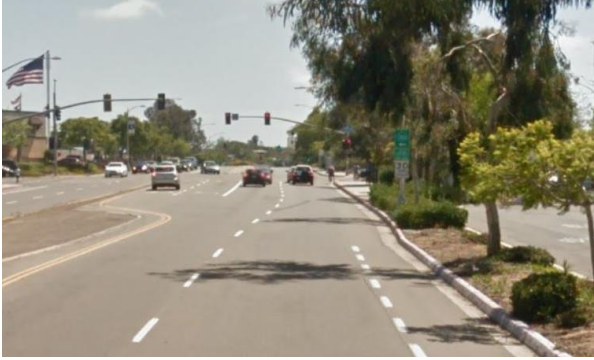
4	<p>Linda Vista Road between Korink Avenue / Daniel Avenue and Genesee Avenue</p> <ul style="list-style-type: none"> • Bike lane drops in southbound direction approximately 300 feet before Genesee Avenue intersection

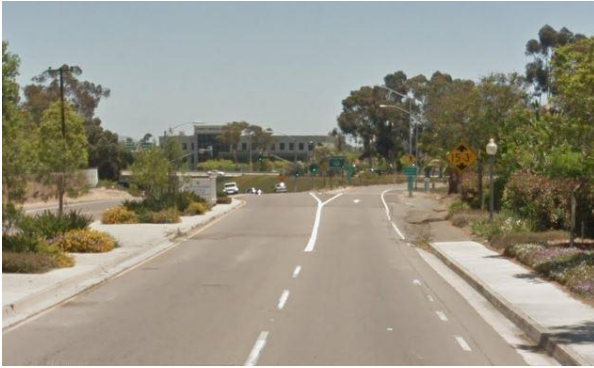
Map ID	Description	Image
5	<p>Genesee Avenue and SR-163 Southbound On-Ramp</p> <ul style="list-style-type: none"> • Eastbound bike lane ends abruptly at SR-163 southbound on-ramp

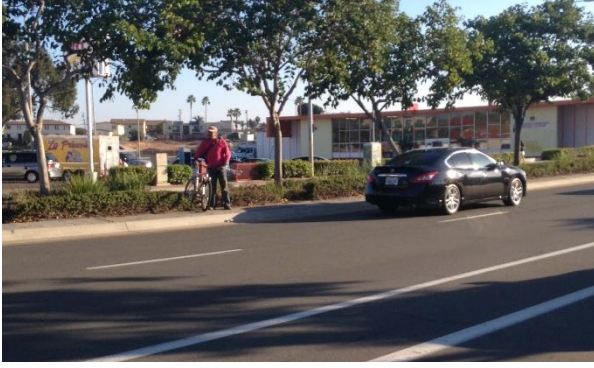
6	<p>Mid-Block Crossing on Linda Vista Road between Ulric Street and Fulton Street</p> <ul style="list-style-type: none"> • Long wait for mid-block signal may increase the volume of prohibited bicycle and pedestrian crossings

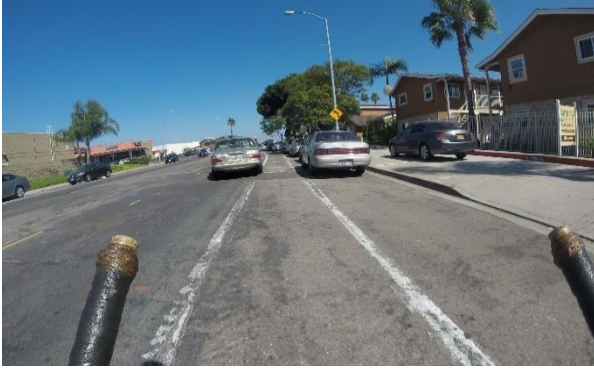
7	<p>Ulric Street between Linda Vista Road and Dunlop Street</p> <ul style="list-style-type: none"> • Bike lane paint is very faded throughout this segment • Bike lane drops in northbound direction approximately 200 feet before Linda Vista Road intersection • Horizontal curve reduces driver's visibility of cyclists

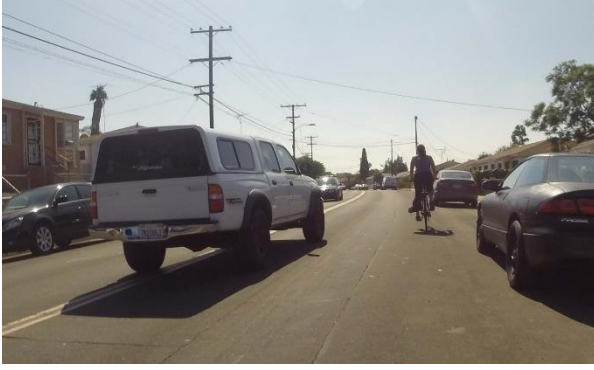
8	<p>Comstock Street from Osler Street to Linda Vista Road</p> <ul style="list-style-type: none"> • High-speed residential roadway with parking on both sides. Very limited space for cyclists • Cyclists must ride within full travel lane • Traffic calming would benefit cyclist and pedestrian safety

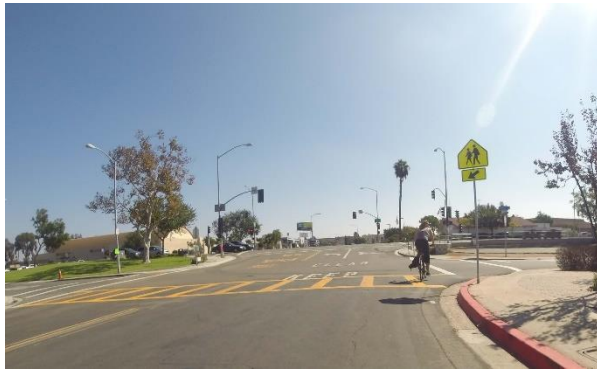
Map ID	Description	Image
9	<p>Linda Vista Road and Comstock Street</p> <ul style="list-style-type: none"> • Closely spaced intersections and vertical/horizontal curves impede driver’s visibility of cyclists

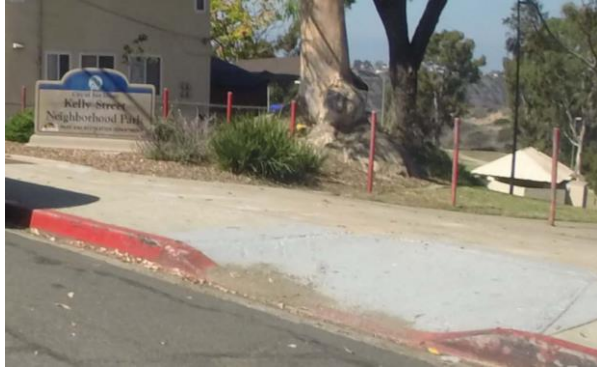
10	<p>Kelley Street by Kelley Street Park</p> <ul style="list-style-type: none"> • No bike parking at park

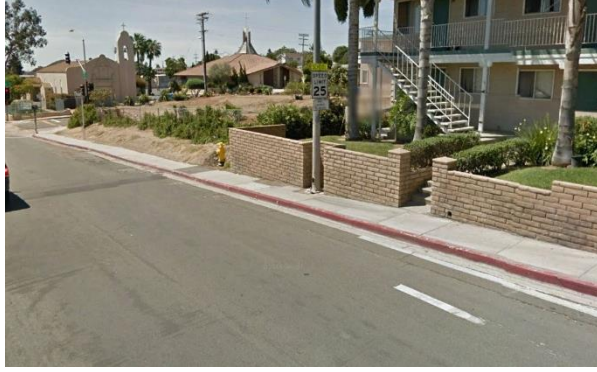
11	<p>Ulric Street and Tait Street</p> <ul style="list-style-type: none"> • Bike lane on Ulric Street drops in southbound direction approximately 180 feet before the intersection • Bike lane on Ulric Street in northbound direction does not begin until approximately 110 feet after the intersection

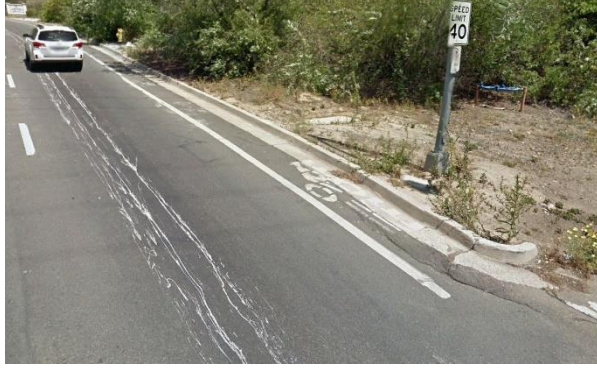
12	<p>Ulric Street from Tait Street to southern community boundary</p> <ul style="list-style-type: none"> • Effective width of bike lane is very narrow (approximately 3.5 feet) due to the gutter pan • Narrow bike lane heading uphill (northbound direction) is dangerous for cyclists • Cyclists would benefit from increased separation due to high speed vehicles

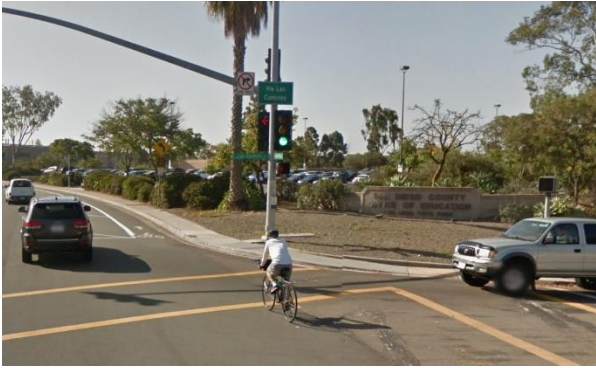
Map ID	Description	Image
13	<p>Linda Vista Road at Via Las Cumbres</p> <ul style="list-style-type: none"> • Vertical and horizontal curves combined with width of roadway and high vehicle speeds make this intersection and approach segments dangerous for cyclists • Increased warning signage, traffic calming measures, and separation for cyclists would be beneficial

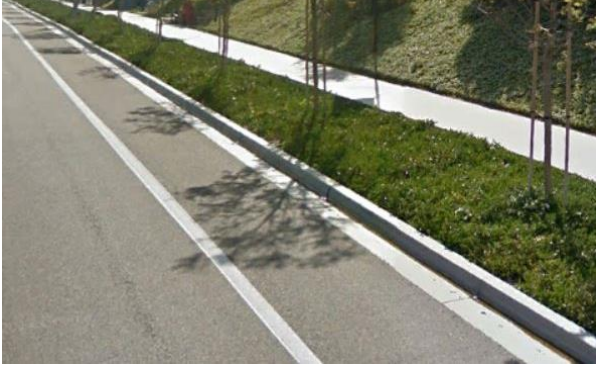
14	<p>Linda Vista Road from Goshen Street to Edward Tyler Cramer Park</p> <ul style="list-style-type: none"> • Buffered bike lane is present in downhill (southbound) direction, and bike lane without buffer in uphill (northbound) direction • Buffer is more necessary in uphill direction where cyclists' speed is much slower

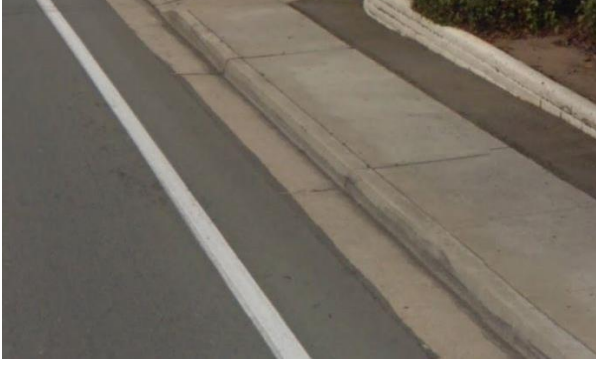
15	<p>Linda Vista Road from Mildred Street to Napa Street</p> <ul style="list-style-type: none"> • Fast moving traffic with little separation from bike lane creates an uncomfortable cycling environment • Effective width of bike lane is very narrow (approximately 3 – 3.5 feet) due to the gutter pan
