POINT LOMA OCEAN OUTFALL ANNUAL INSPECTION REPORT

2023

POINT LOMA WASTEWATER TREATMENT PLANT

SUBJECT: Point Loma Ocean Outfall 2023 Annual Inspection Report

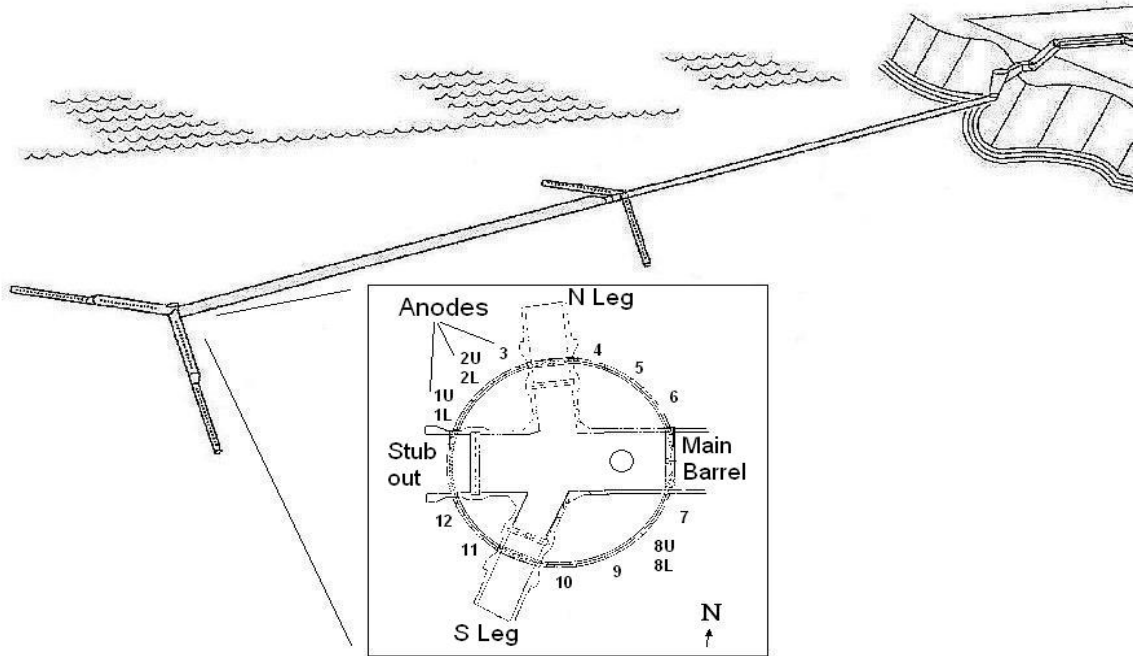
Appendix B.3

The structure continues to be in overall good condition. A schematic of the twelve pairs of anodes on the New Diffuser Wye is shown in Appendix B.3. Lower anodes 1, 2, and 8, along with its mounting bracket are missing or consumed. The remaining eight lower anodes were thought to have been buried with armor rock during construction, thus no conclusion can be drawn regarding their condition. The protective wrappings on the remaining anodes of the upper ring have loosened

over time to varying degrees, which has caused them to become partially active. These eight anodes, however, have continued to retain much of their original mass. No corrosion of the metal crib structure was noted and it is assumed, therefore, that the remaining anodes continue to provide adequate cathodic protection. Localized areas of leaking were observed emanating from the seams of the North and South Leg Gate Cover as well as, the Stubout Gate Cover. This observation is not new and is likely a function of the time of day the survey is being performed and, thus, the accompanying pressure inside the pipe. Effluent continues to leak from different locations on the perimeter of Stubout Gate. However, these leaks are of little consequence, in regard to water quality, as the initial dilution of this low flow effluent escaping is much higher than that of effluent being discharged from the nearby Diffuser Ports.

Anode Schematic of PLOO extension.
