SOUTH BAY OCEAN OUTFALL ANNUAL INSPECTION REPORT

South Bay Water Reclamation Plant

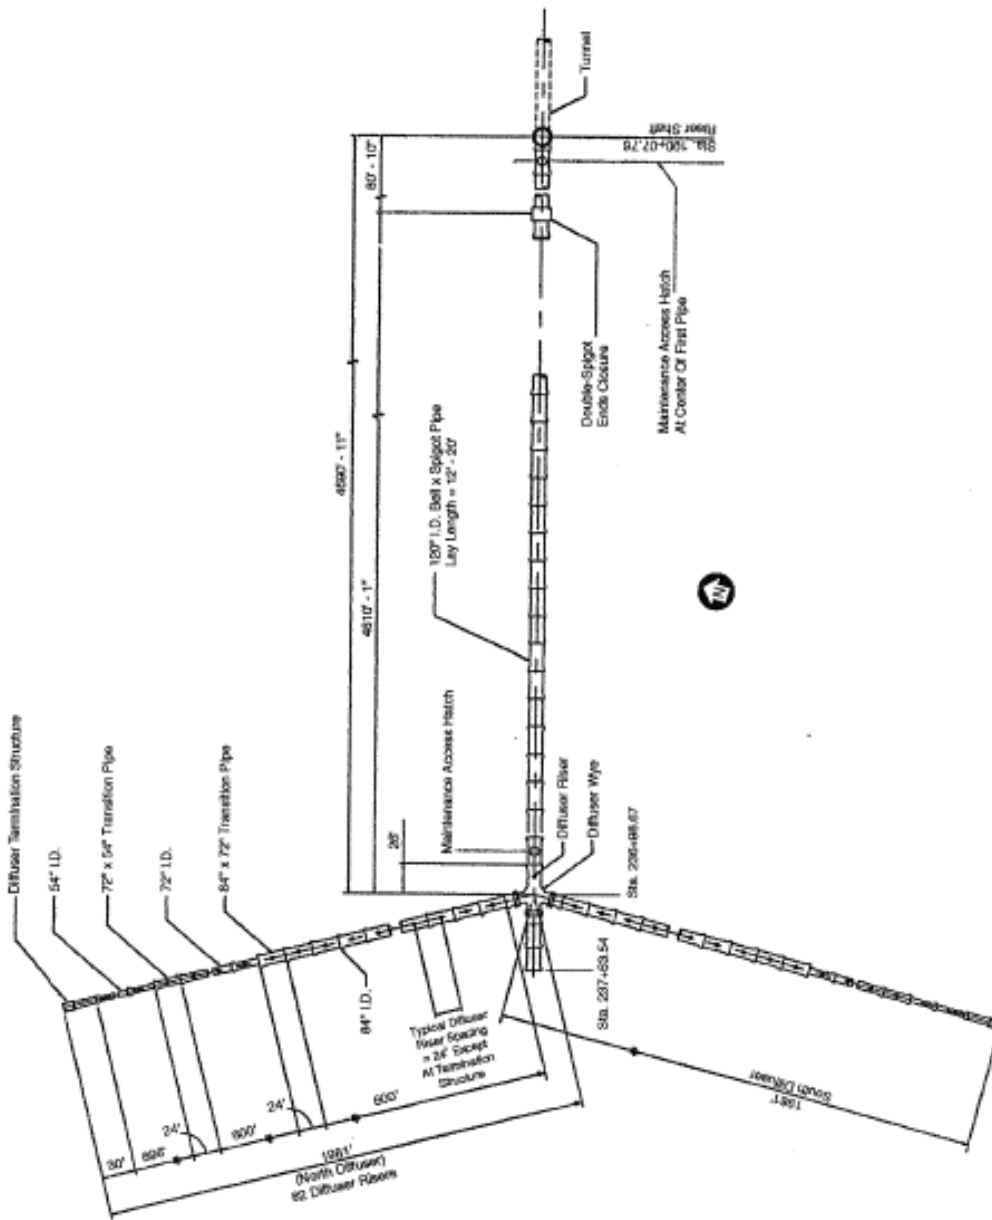
- 6 The upgrade to secondary treatment at the SBIWTP in January 2011 has continued to markedly improve the visible quality of discharged effluent and may have also been responsible for the virtual elimination of the bacterial mats seen near all points of discharge in the years predating the current review period. The change in effluent color observed in the 2022 survey was not observed in 2023. The effluent color appears to have returned to the quality observed from 2011 to 2021 surveys.

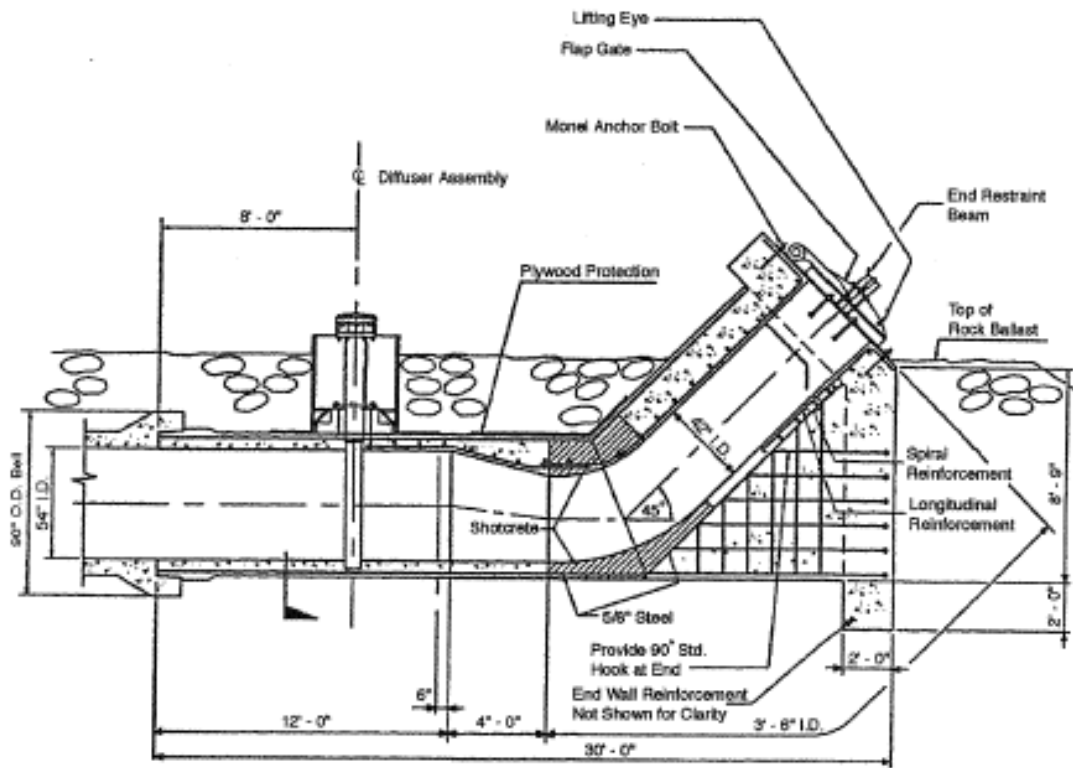
The Diffuser Wye structure for the SBOO.

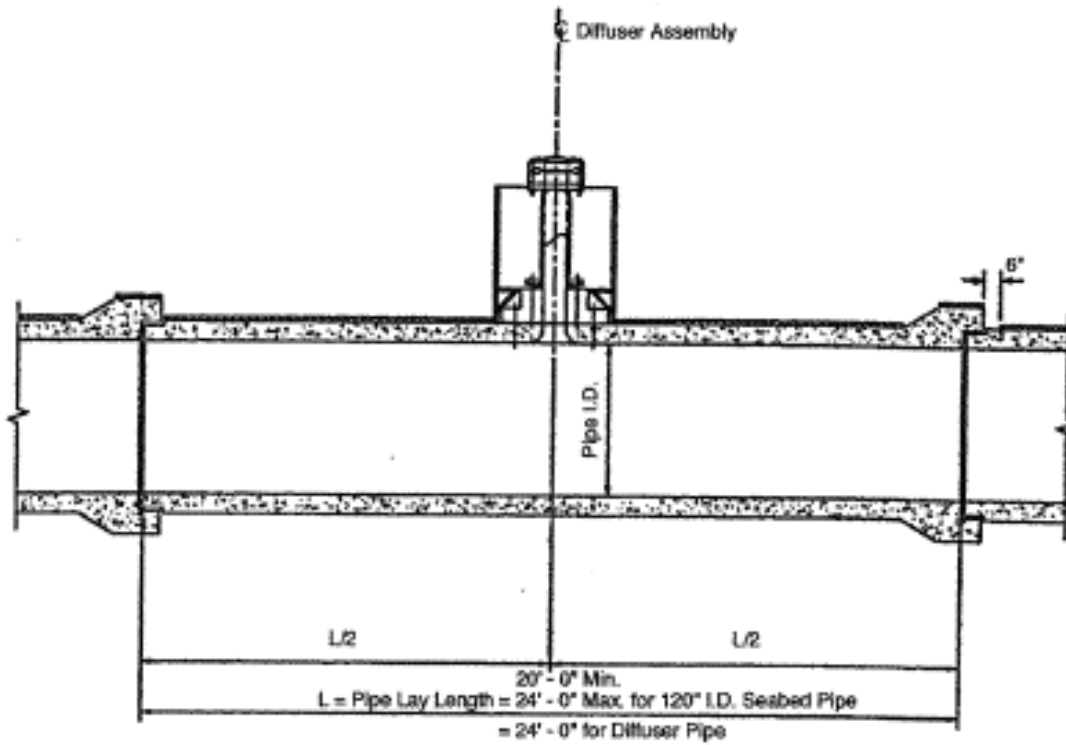
Termination structure found at the end of the SBOO Diffuser Legs.

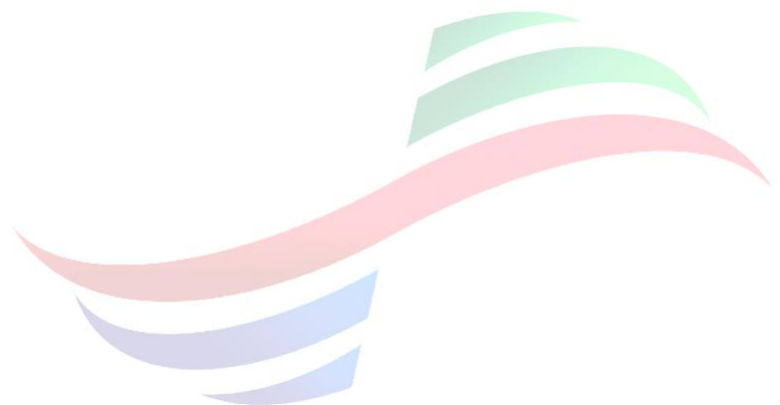
1. EXECUTIVE SUMMARY	4
2. INTRODUCTION/BACKGROUND	4
3. SCOPE OF WORK.....	5
4. METHOD OF INVESTIGATION	5
5. INSPECTING FINDINGS	6
6. RECOMMENDATIONS	12
7. ROUTINE UNDERWATER CONDITION ASSESSMENT RATING DESCRIPTIONS.....	13
8. APPENDIX A – PROJECT PHOTOGRAPHS	14

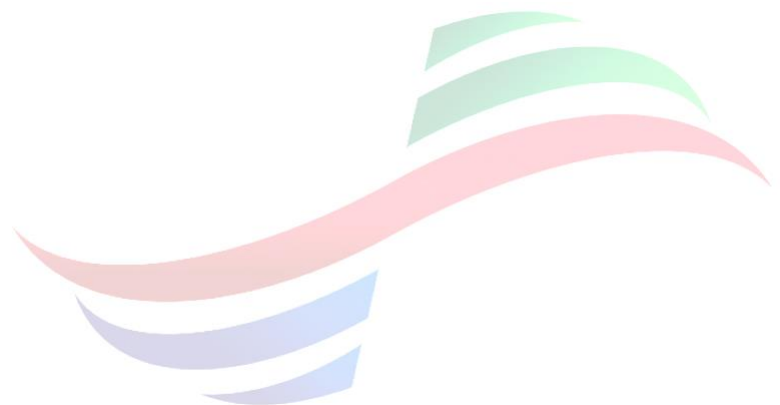
An immediate post-event inspection should be conducted on the structures after any significant or unusual event, including but not limited to flood or earthquake or other event that has potential to cause damage to the structure.

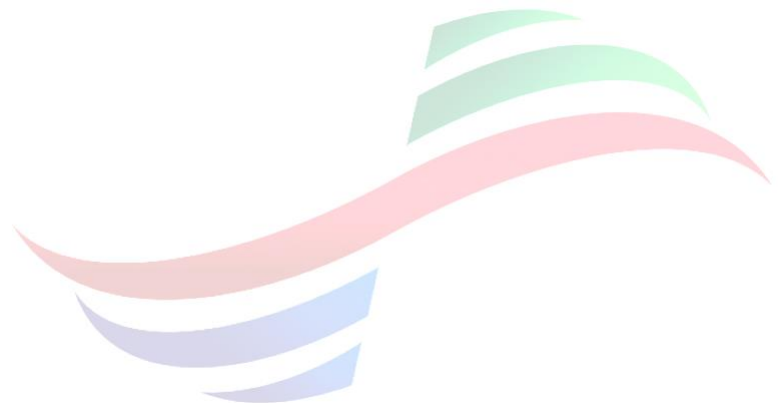
Critical: Very advanced deterioration, overstressing or breakage has resulted in localized failure(s) of primary structure components. More widespread failures are possible or likely to occur, and load restriction should be implemented as necessary. Repairs may need to be carried out on a very high priority basis with strong urgency.

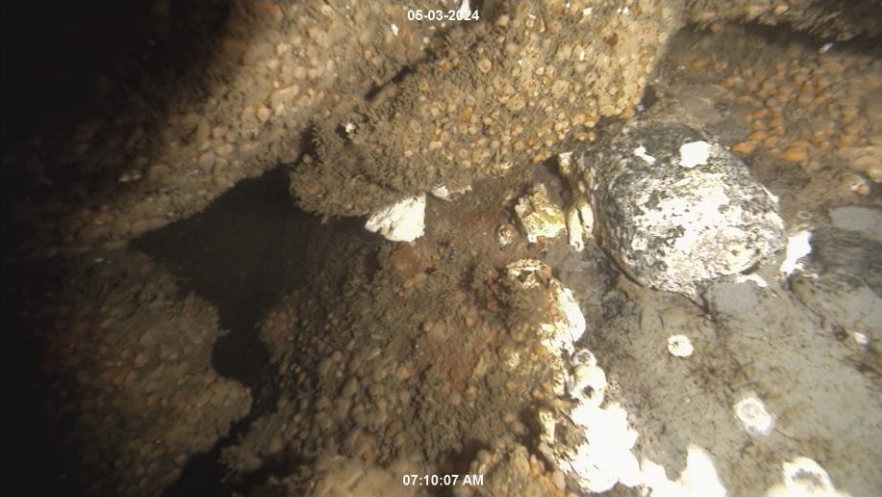
Client: City of San Diego	
Description: Typical Sacrificial Anode Condition at 90% Remaining
