APPENDIX F
Structural Review of Field Conditions

DATE: April 18, 2023 JOB #:
PROJECT: 6110 Camino De La Costa WEATHER: Overcast
LOCATION: La Jolla, CA
PRESENT: Matthew Segal (on site videos and photos);
Jonathan Deck (review of videos and photos)

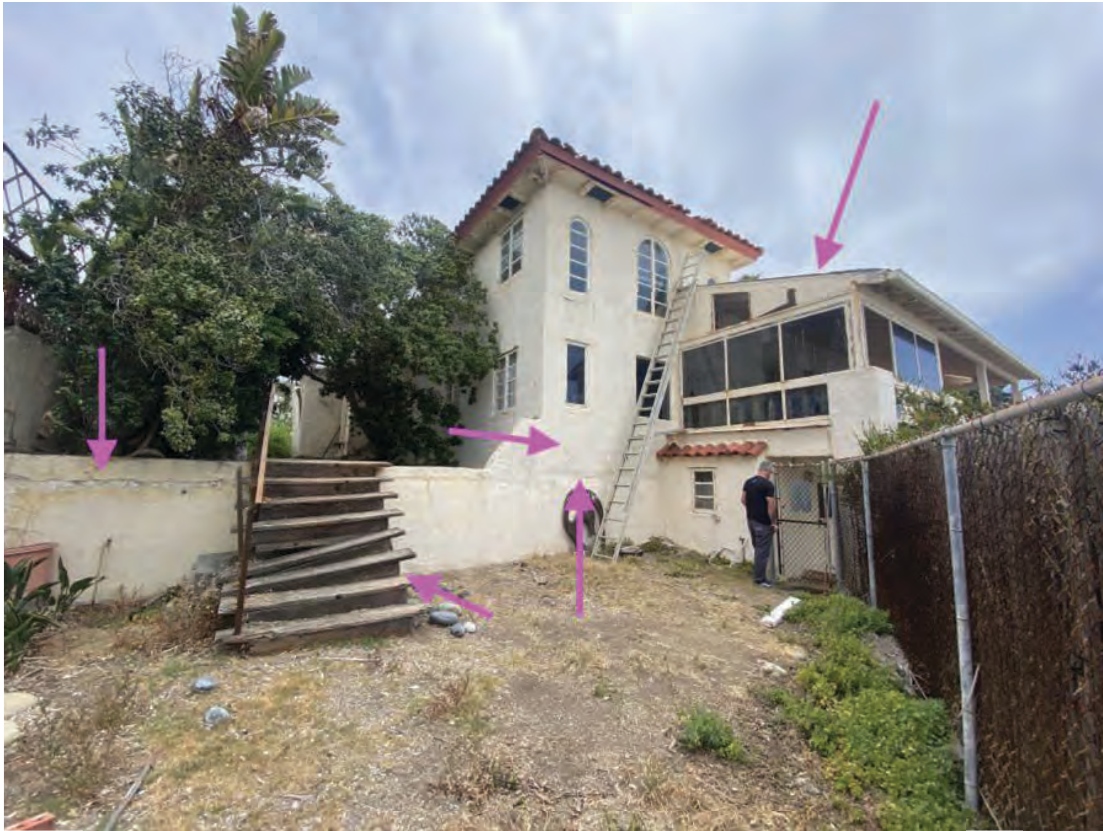
Figure A - Stairs Failing, Offset in Building Walls, Cracking in Multiple Site Walls

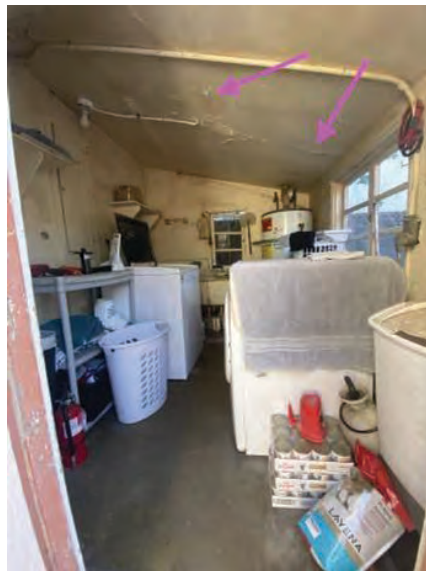
Figure B - Cracking in Garage Ceiling, Doors Racking

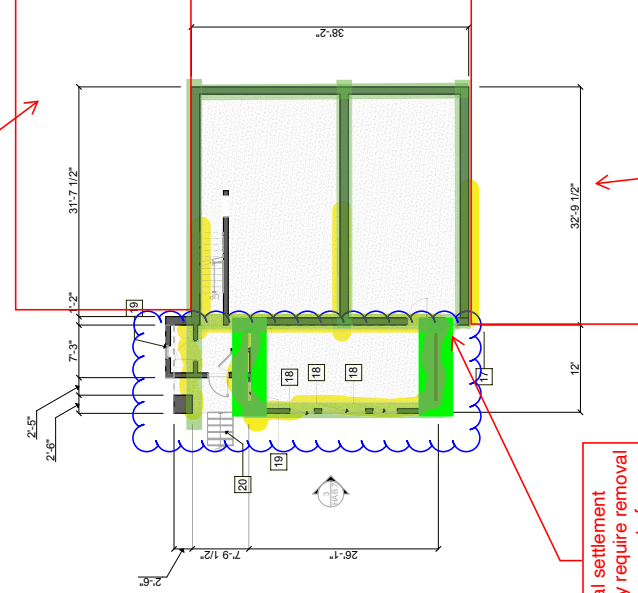
1 -1. Basement SCALE: 1/8" = 1'-0"
 2
 3 DECORATIVE MEDALIONS SCALE: 3" = 1'-0"
 4 CEMENT RAILING SCALE: 1 1/2" = 1'-0"

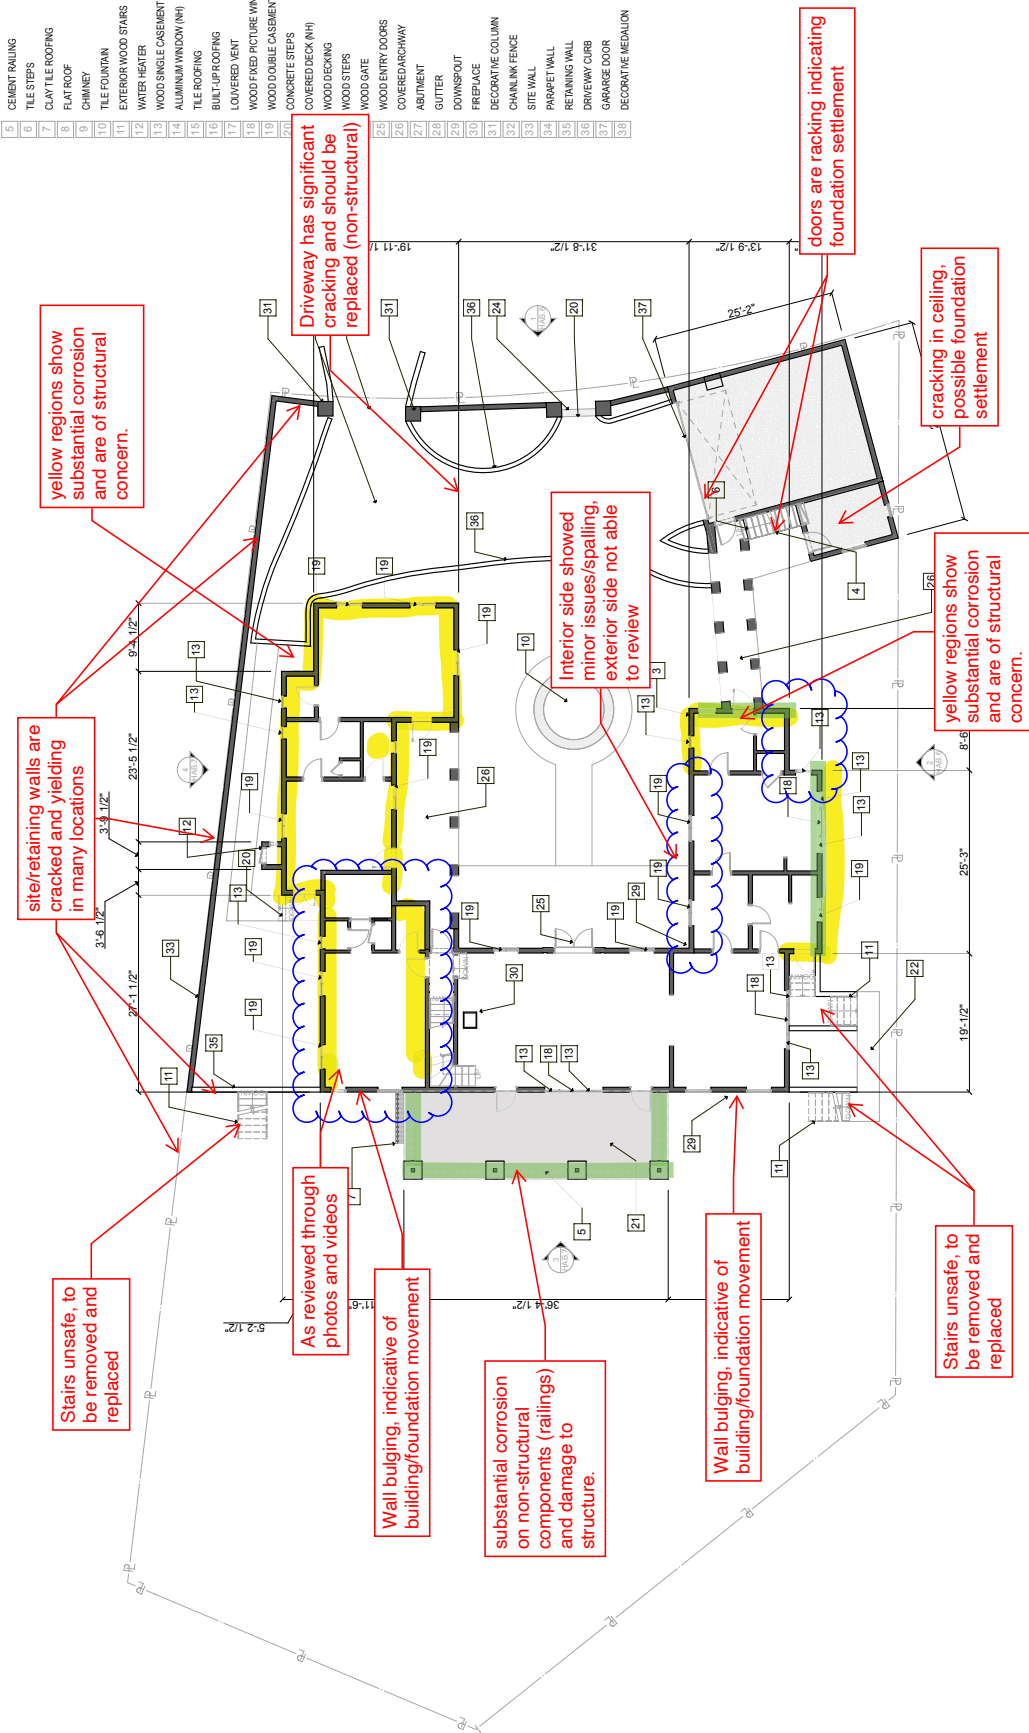
Yellow regions show substantial corrosion and are of structural concern.

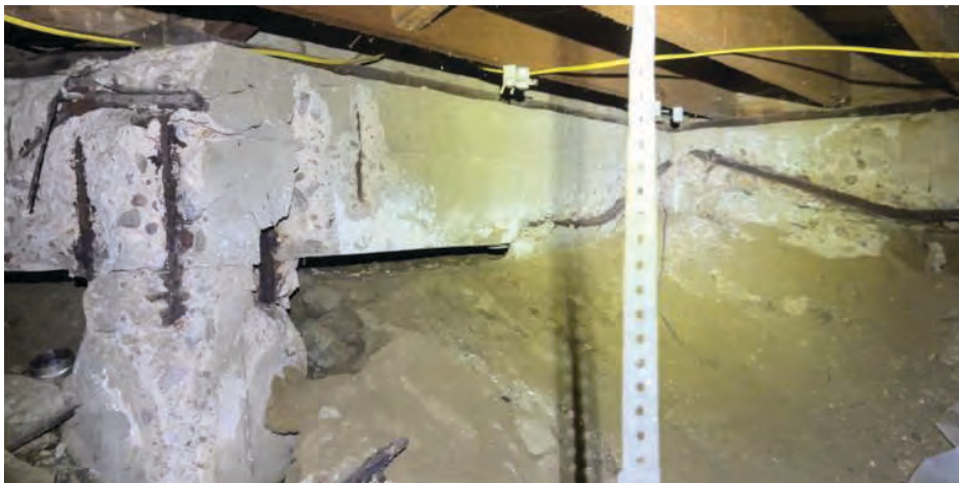
Figure A - Rebar Corrosion, Cracking and Spalling in Concrete Grade Beams at Western Portion of Building

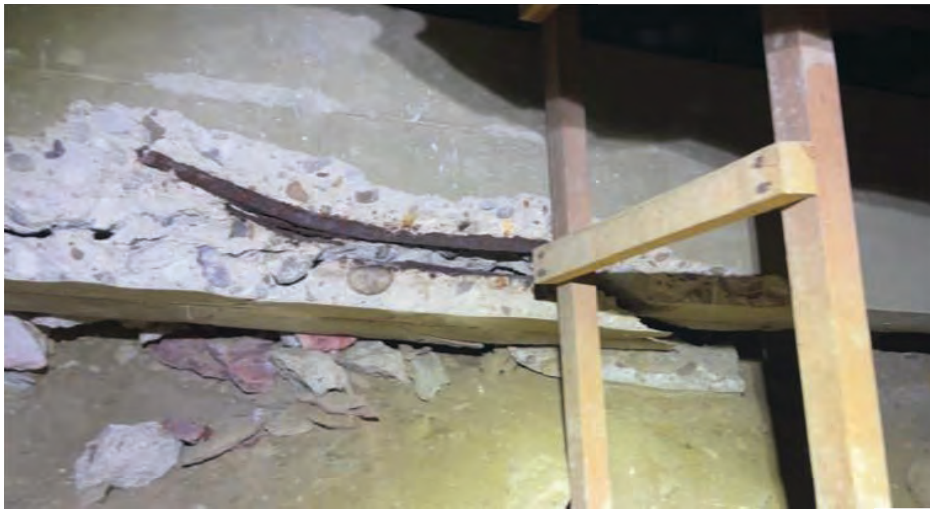
Figure B - Spalling, corrosion, delamination and displacement in a foundation beam.

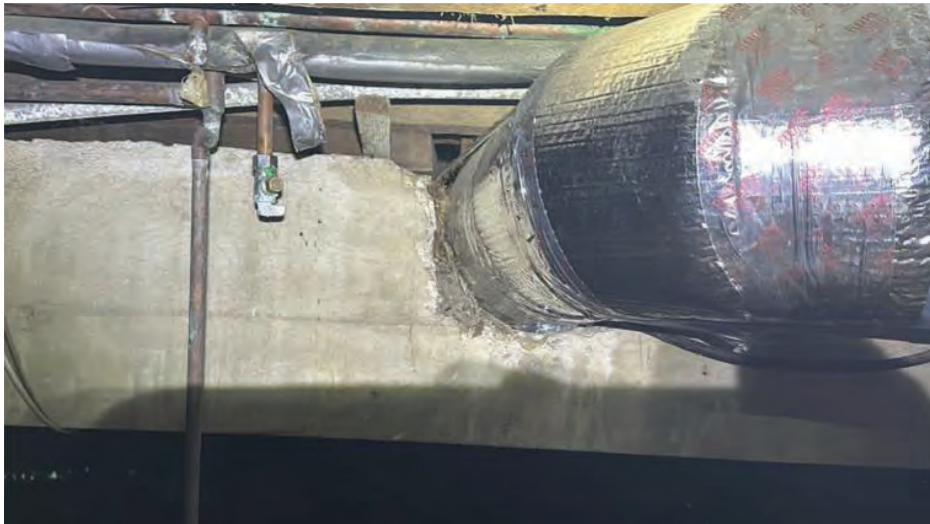
Figure C - Notch in foundation beam to accommodate ductwork.

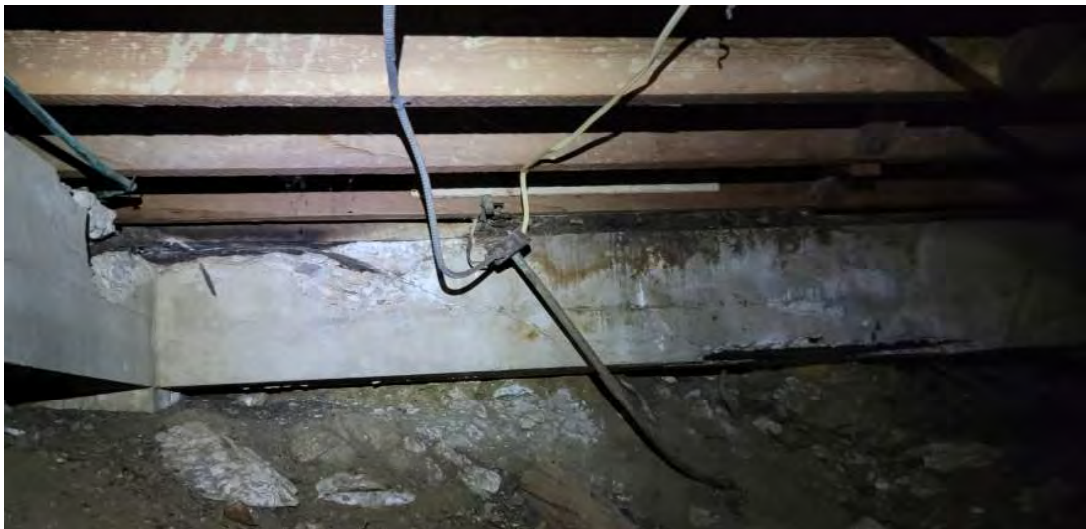
Figure 1 – Rebar Corrosion, Cracking and Spalling in Concrete Grade Beams at South Wing

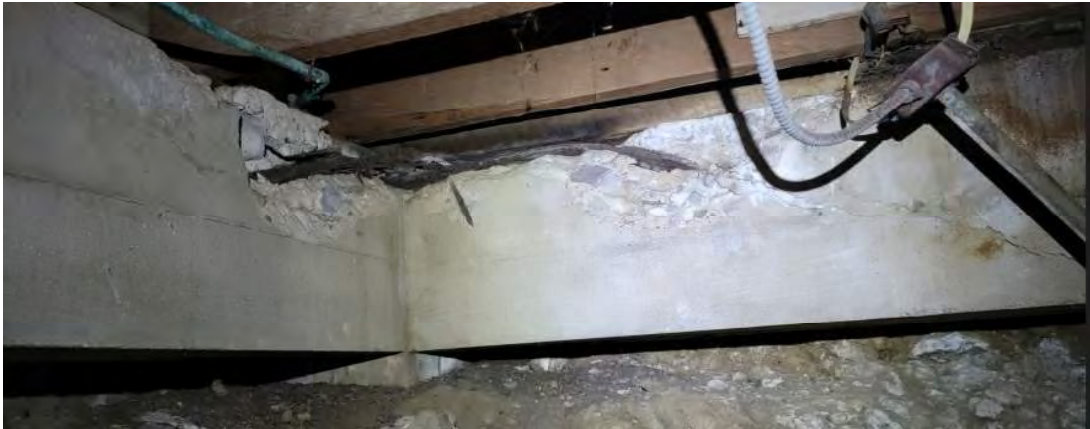
Figure 2 - Reinforcing shows substantial loss of area, Grade beams in South Wing

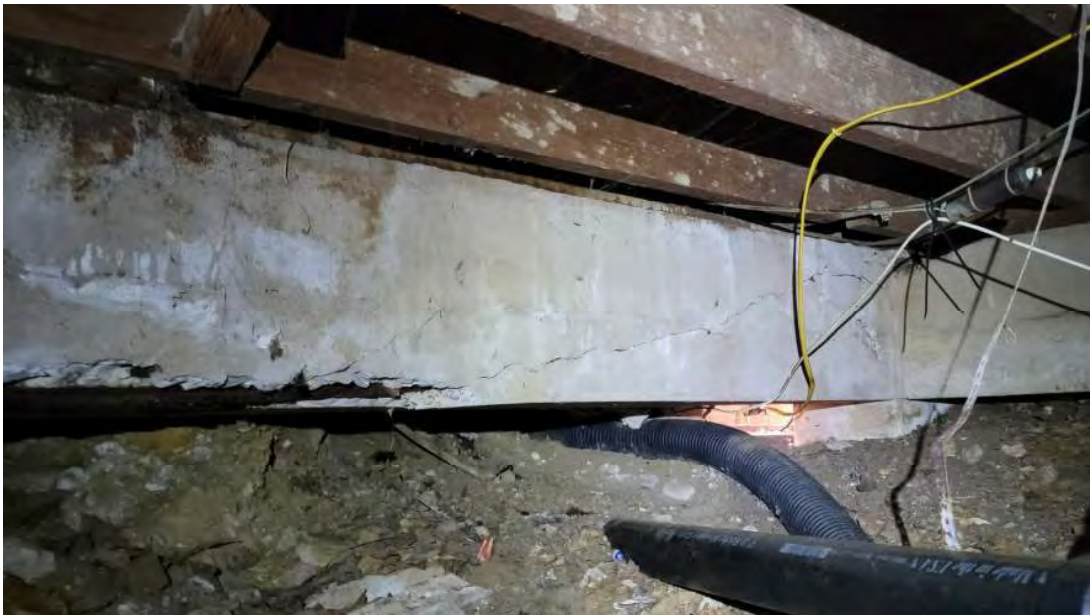
Figure 3 - Substantial Diagonal Crack (Shear), Spalling of Concrete, Corrosion of Rebar in South Wing Grade Beams.

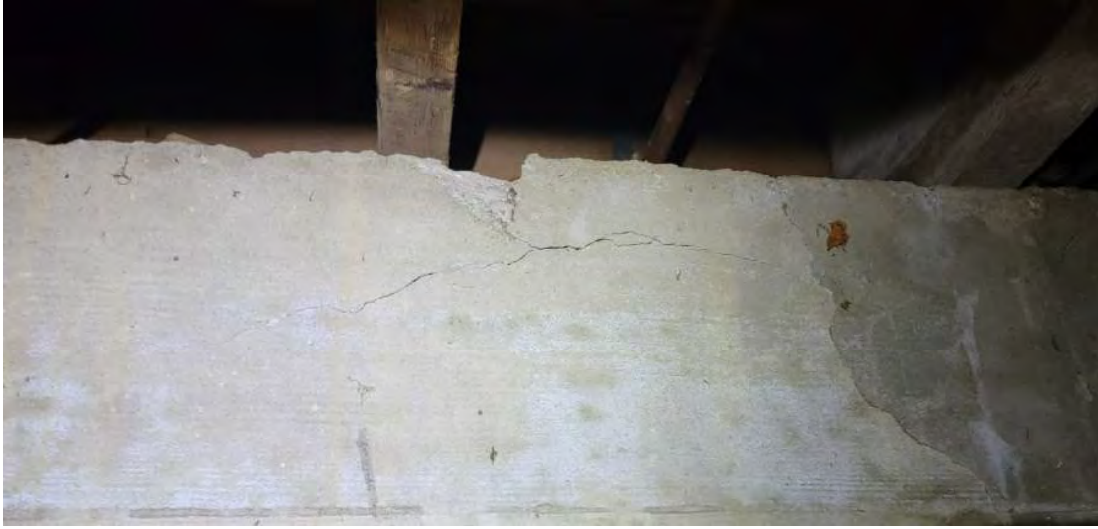
Figure 4 – Smaller Cracks in Grade Beam on Southwest side.

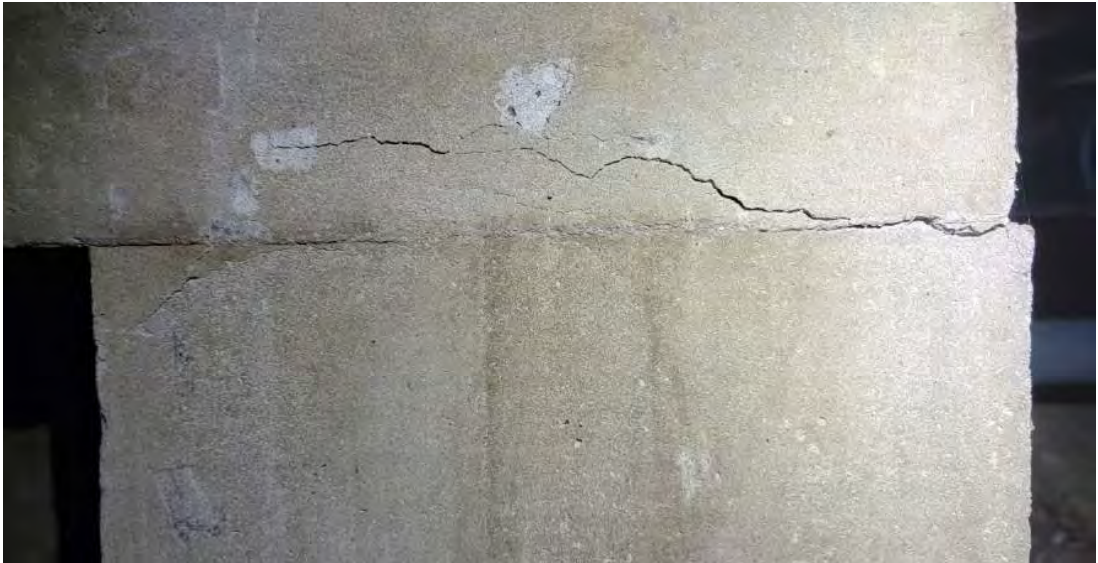
Figure 5 – Smaller Crack in Grade Beam/Column interface on Southwest Side

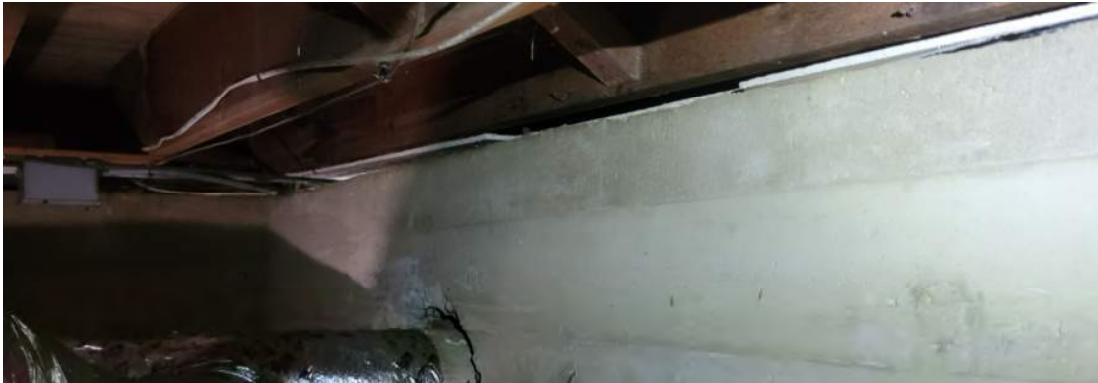
Figure 6 – West wall of South Wing, Wall on right slopes down towards the west with gap size increasing to the west. West portion of building appears to have settled and been shimmed to re-level structure above.

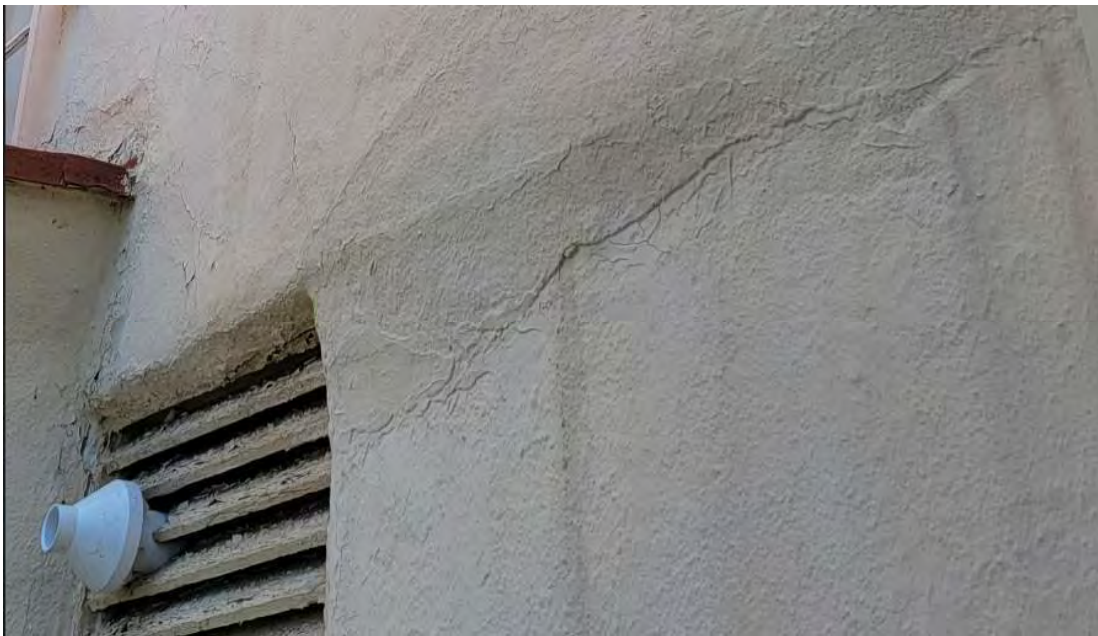
Figure 7 – Southwest Corner, Exterior, Appears to show patching of finish with movement of structure above relative to concrete walls/beams below.

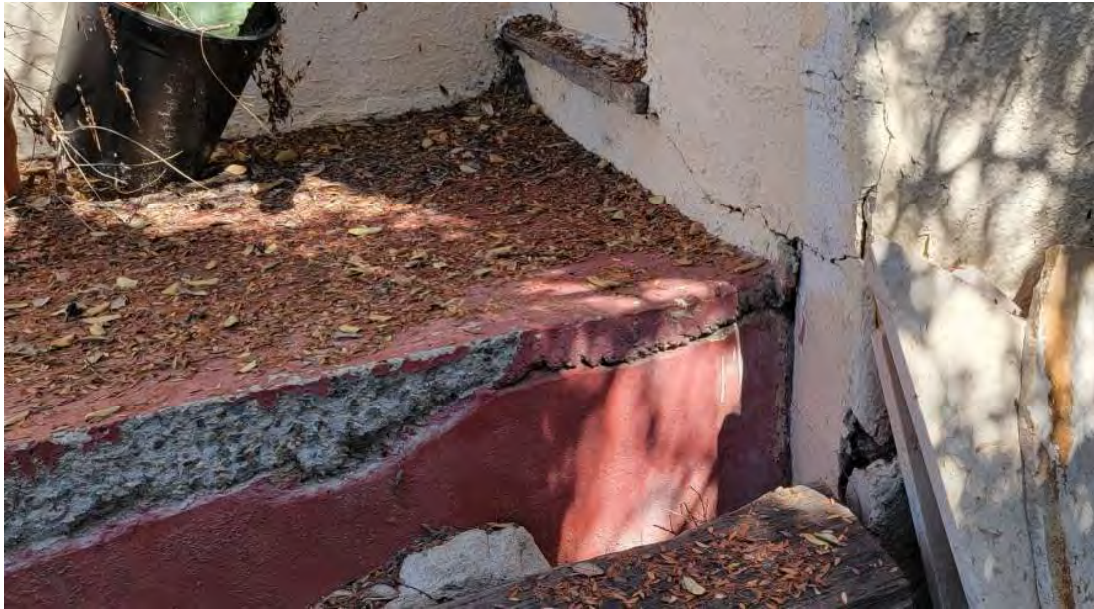
Figure 8 – Exterior Patio Area and Surrounding Walls Cracking and showing signs of settlement/distress.

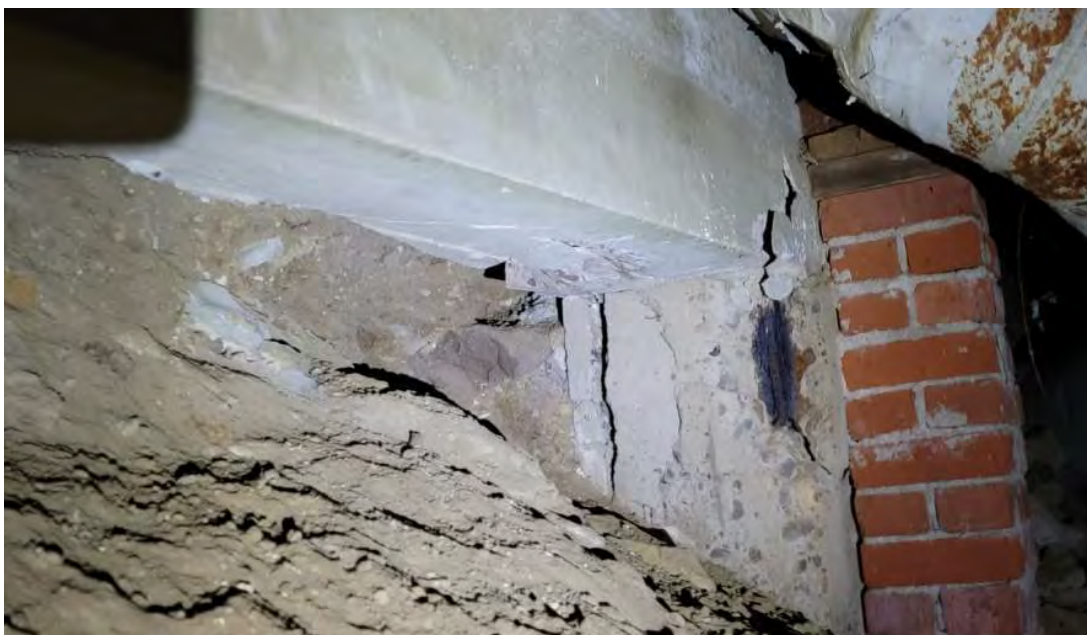
Figure 9 – Rebar Corrosion, Cracking and Spalling in Concrete Column and grade beam at North Wing. Note that both corners are spalling substantially as is blind side of beam.

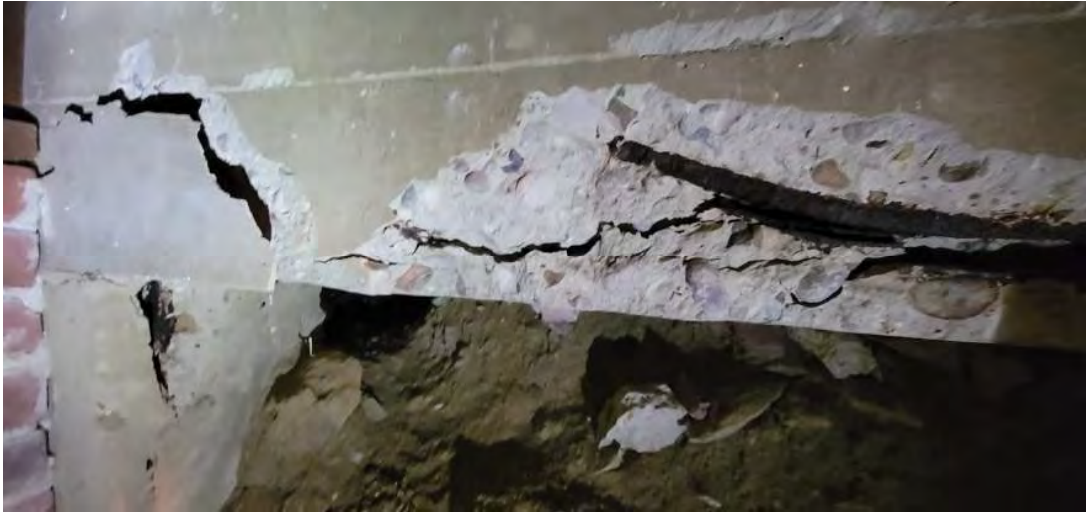
Figure 10 - Opposite End of Grade Beam shown in Figure 9 showing substantial spalling and corrosion

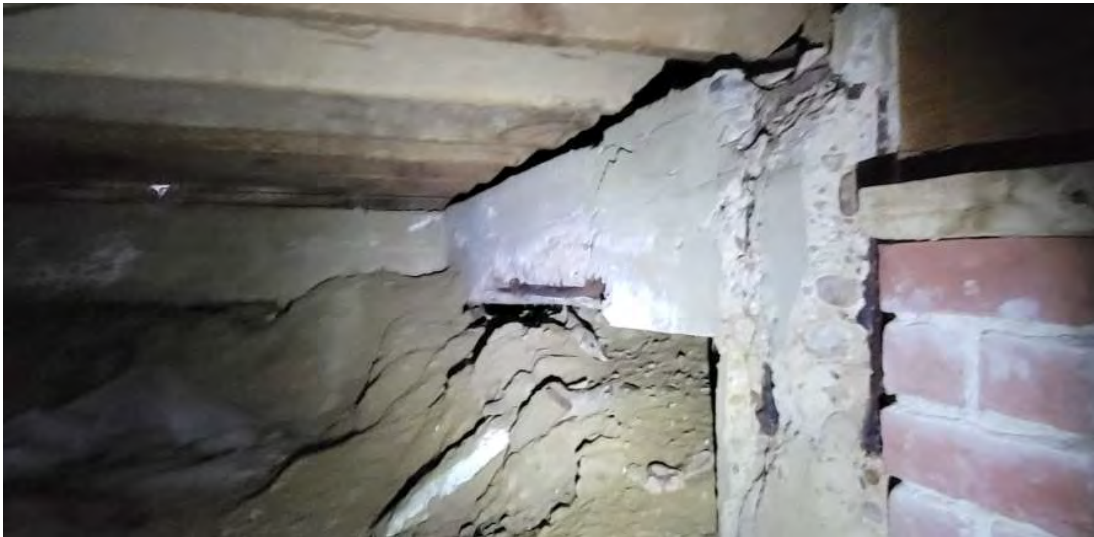
Figure 11 - Opposite Side of Column shown in Figure 10 showing substantial deterioration.

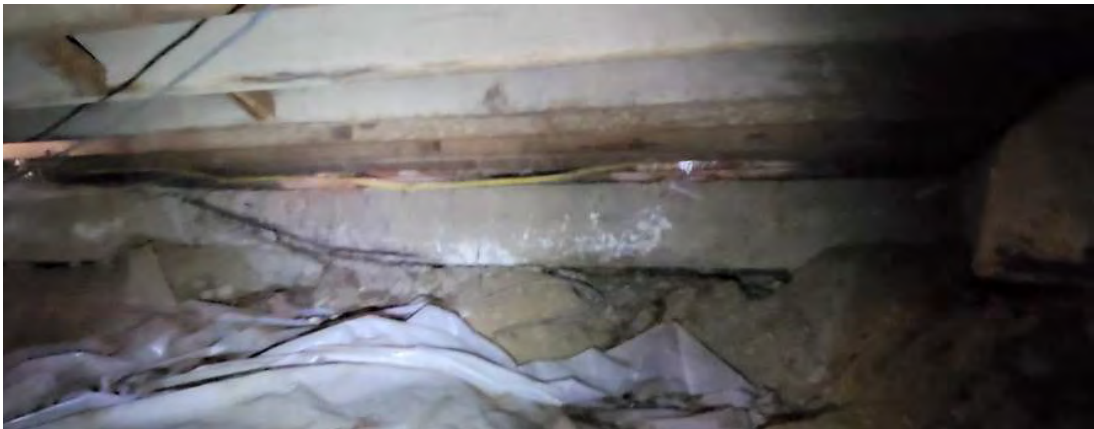
Figure 12 - Grade Beam showing deterioration and flexural failure and deflection.

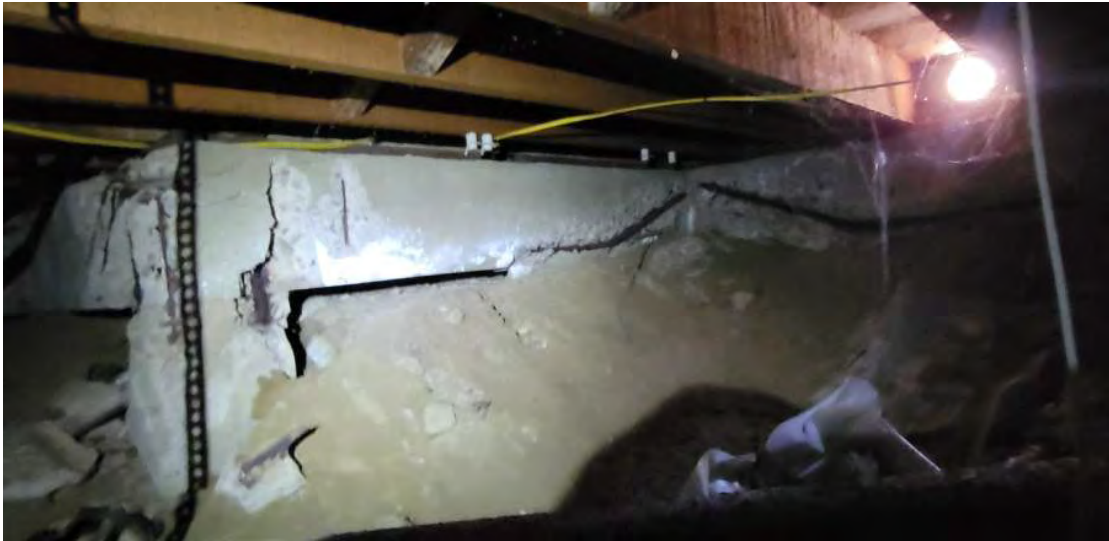
Figure 13 – Grade Beam and column showing significant deterioration. Reinforcement in corner has corroded and is completely broken.

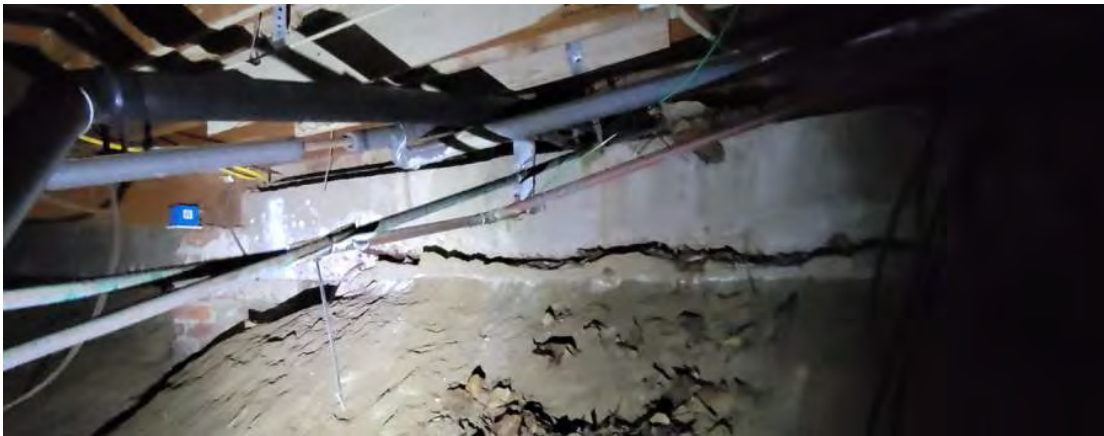
Figure 14 – Grade Beam showing significant spalling and corrosion. Reinforcement in bottom of beam is significantly corroded and exposed to soil. Beam is noticeable sagging.

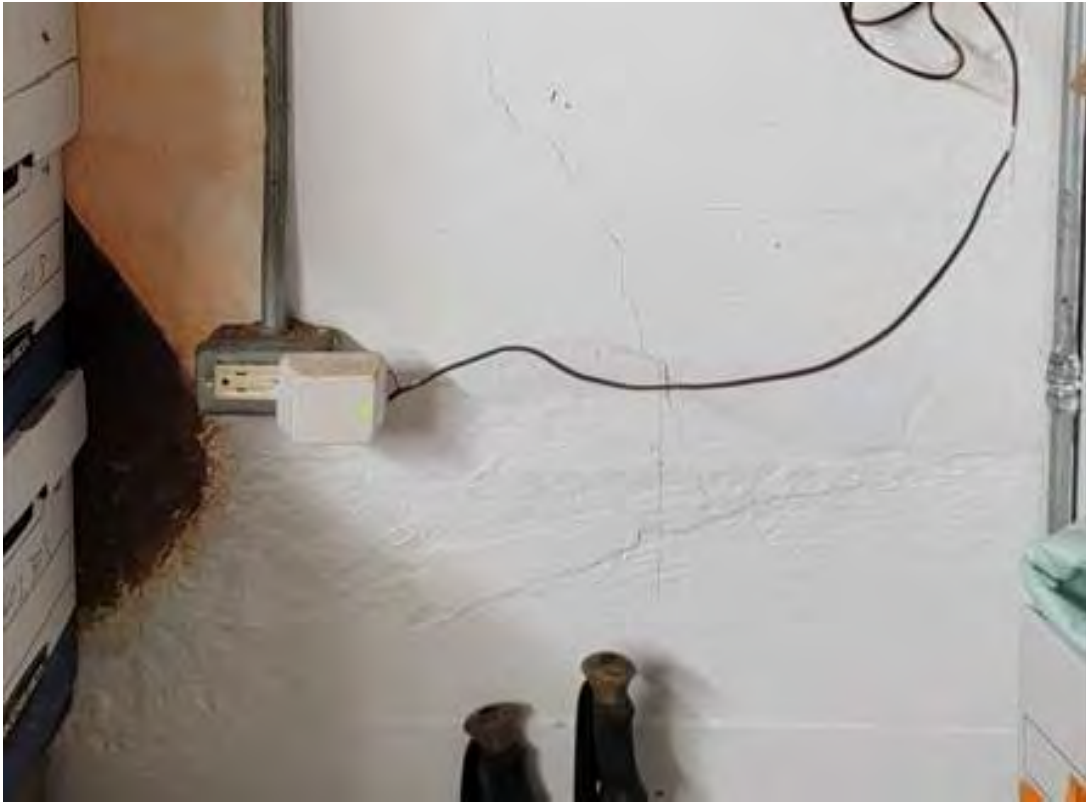
Figure 14 – Cracking of concrete basement walls in central lower level.

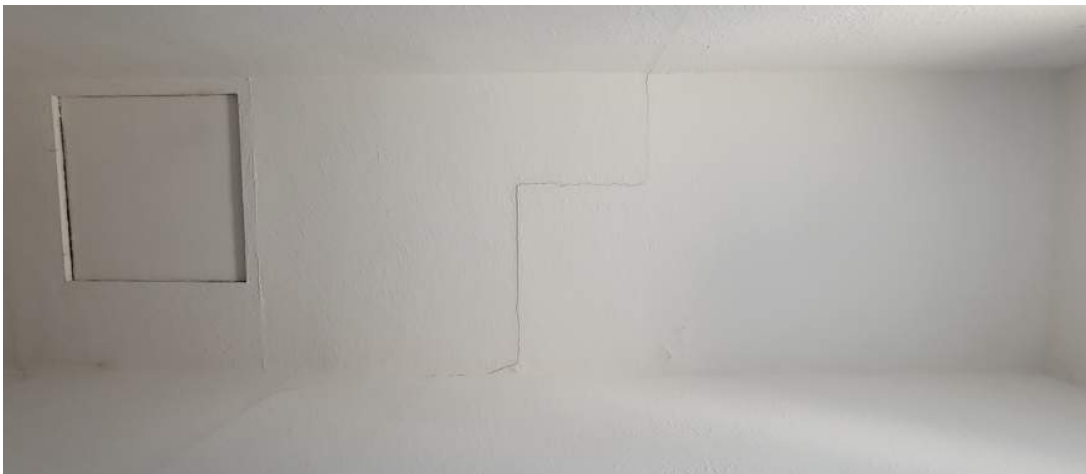
Figure 15 – Cracking of stair ceiling between main level and upper level. Cracking is indicative of building movement/settlement.
