MEMORANDUM

To: Delfa Genova, P.E.

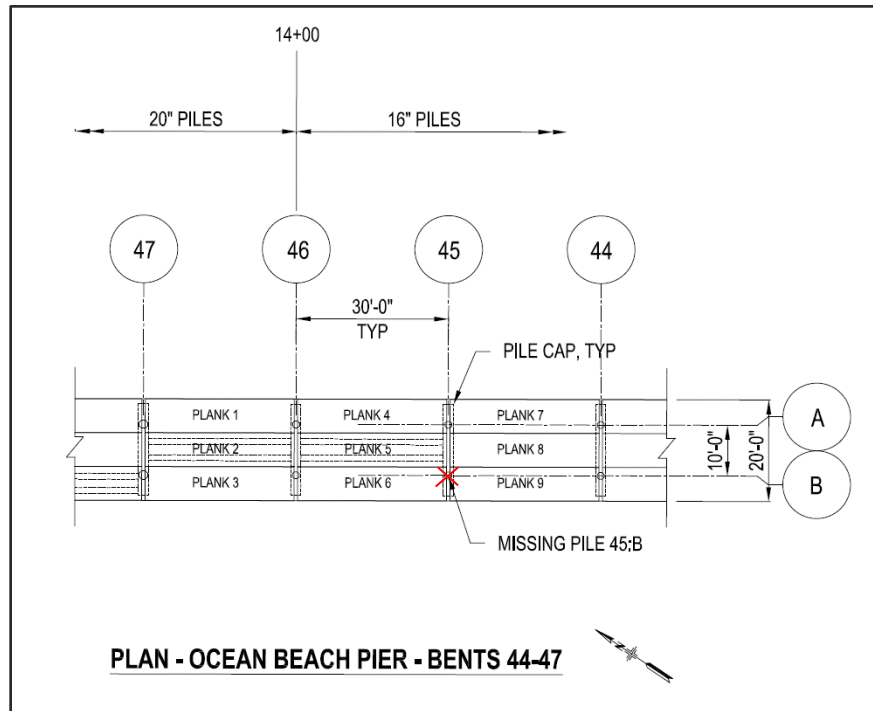
Figure 1: Plan View - Bents 44-47.

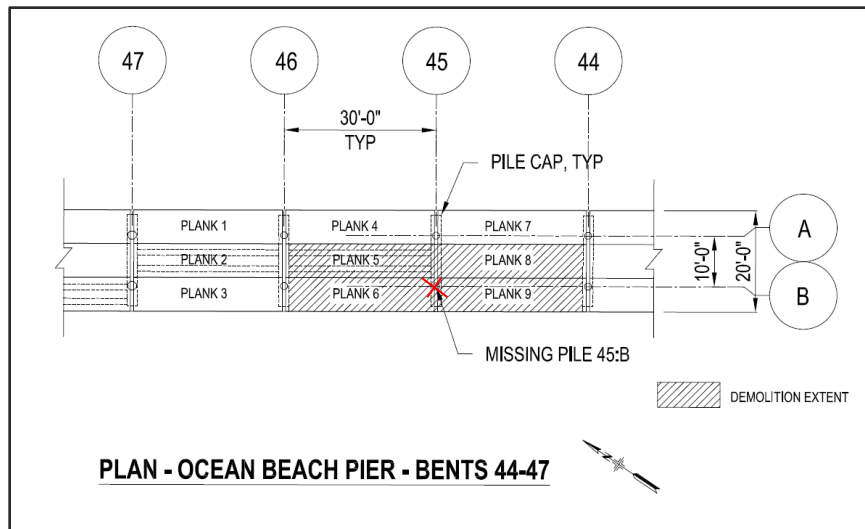
Figure 2: Plan View- Bent 44 to 47 proposed demolition extents.

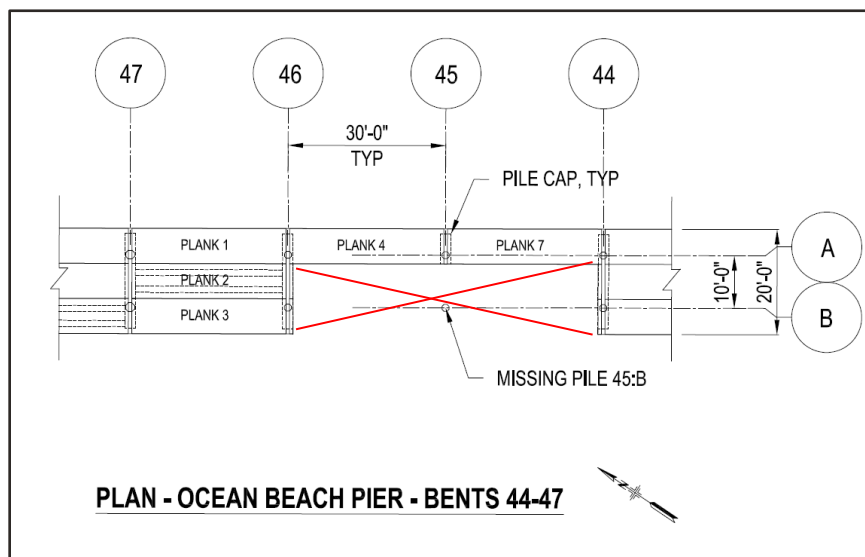
Figure 3: Plan view - Bents 44 to 47 after deck removal.

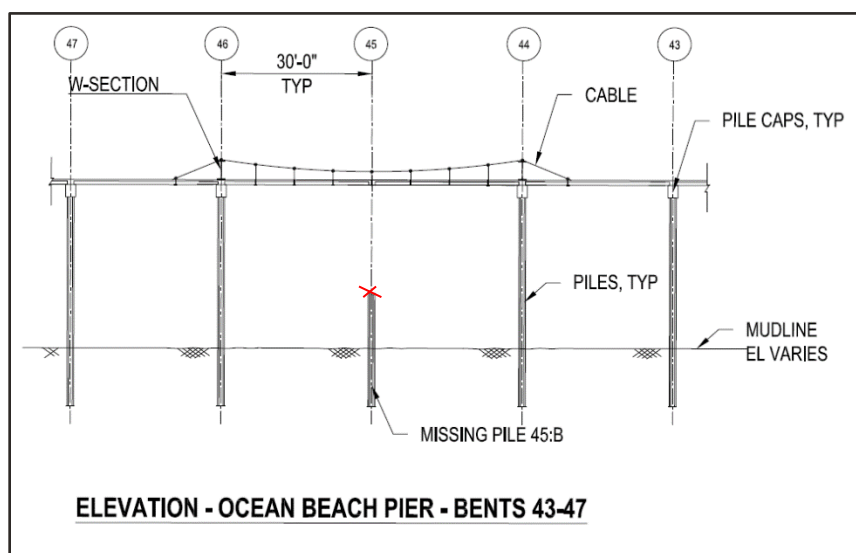
Figure 4: Elevation - Bent 43-47- Cable Support

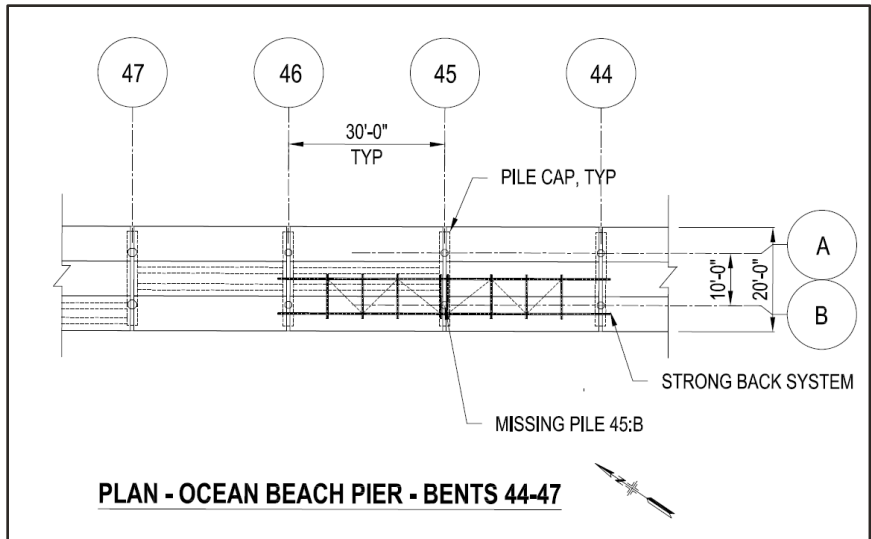
Figure 5: Plan view - Bents 44 to 47 with strong back system.

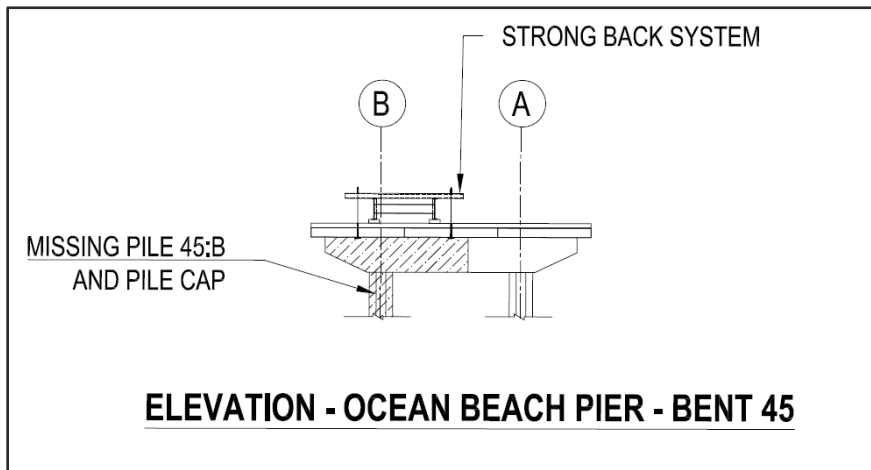
Figure 6: Elevation - Bent 45 with strong back system.

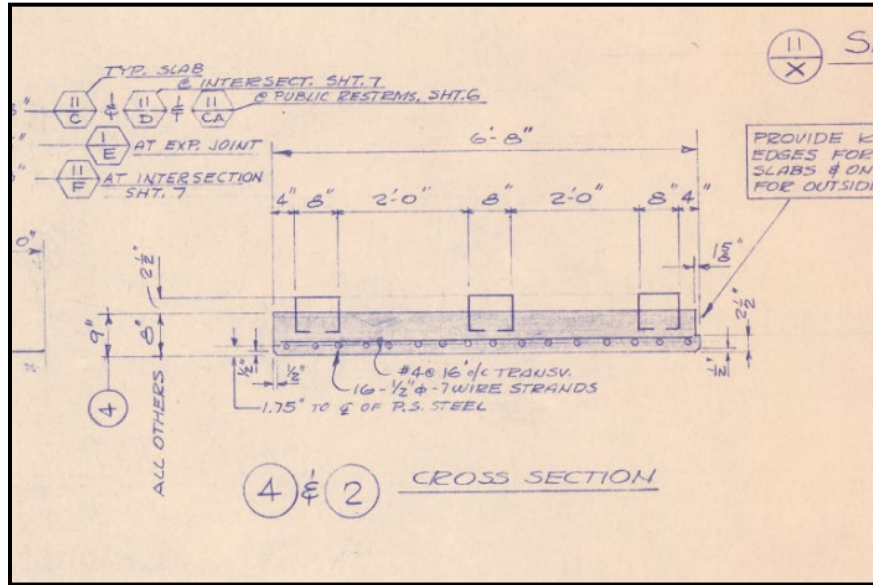
Figure 3: 1966 Record Drawing: Precast plank typical cross-section at 30ft spans.

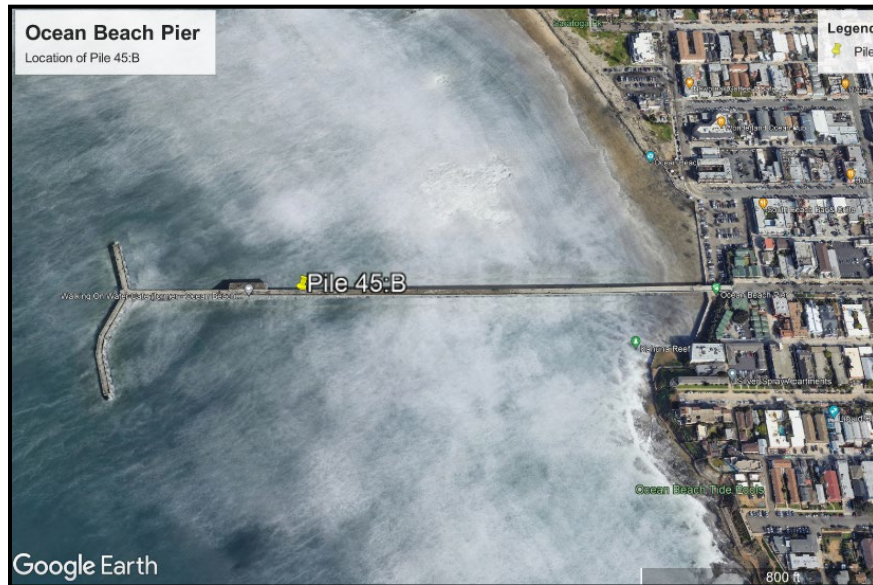
Figure 4: OB Pier Aerial Image showing the missing Pile 45:B.

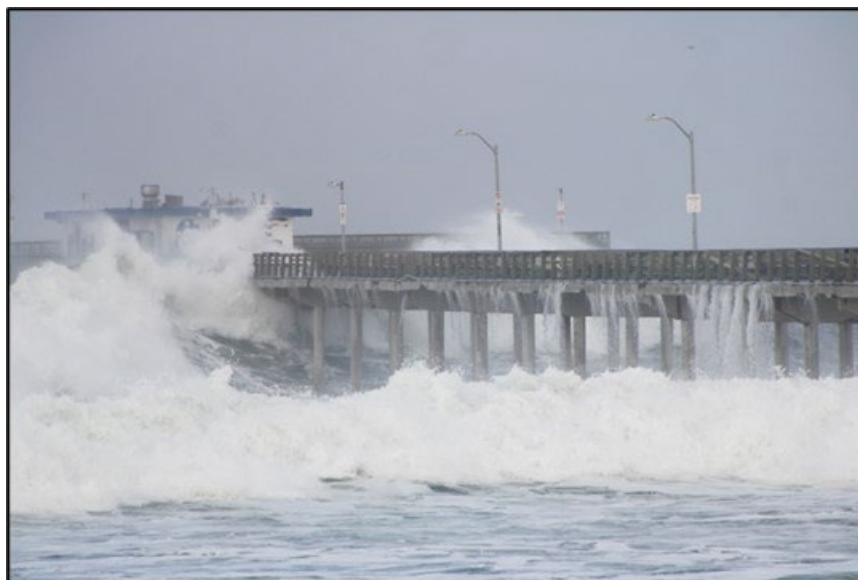
Photo 2: December 28th-29th, 2023, storm event impacting the OB Pier. Note that the broken wave overtops the pier and completely engages the underside of the deck and pile cap.

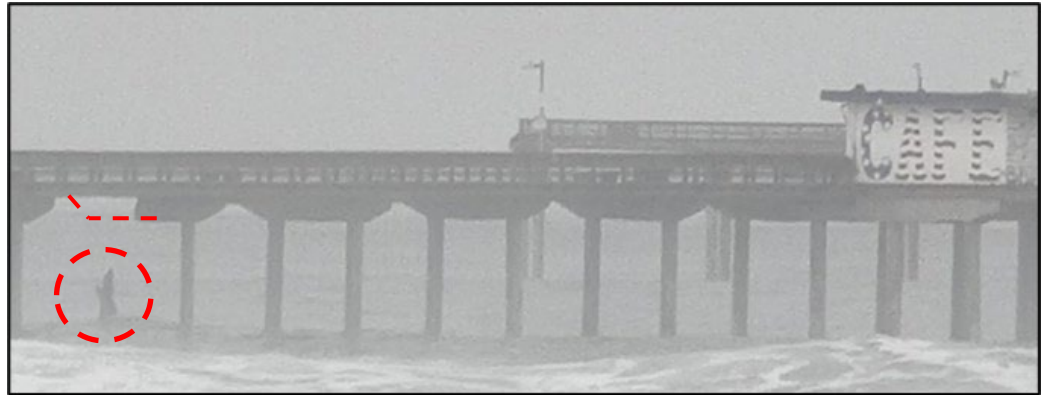
Photo 3: December 28th-29th, 2023 storm event. Pile 45:B broke (red circle) above the waterline pile cap broken shown in dashed red lines.

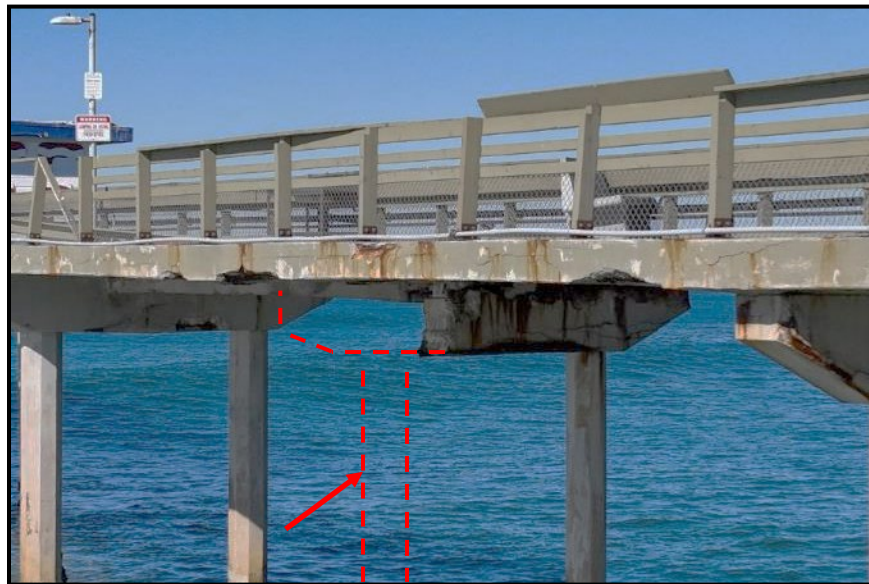
Photo 4: Bent 45 looking north. The dashed lines show the missing pile and pile cap at Pile 45:B.

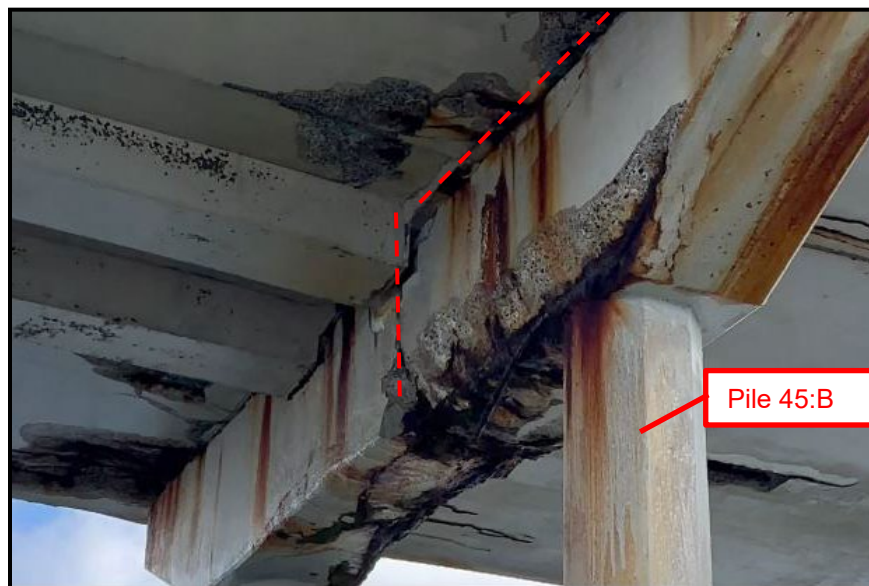
Photo 5: Bent 45 May 2023 visual inspection Dashed lines show assumed pile cap "break-away" location from pier deck.

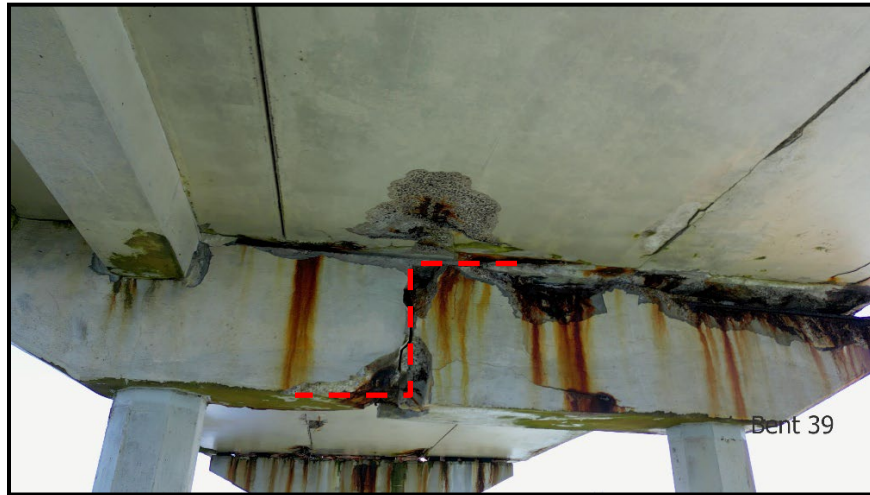
Photo 6: Bent 39 looking east. In the photo, spalled concrete is noticeable at the pile cap with exposed reinforcement at the top of the pile cap. The red segmented line shows the vertical crack at the cold joint.

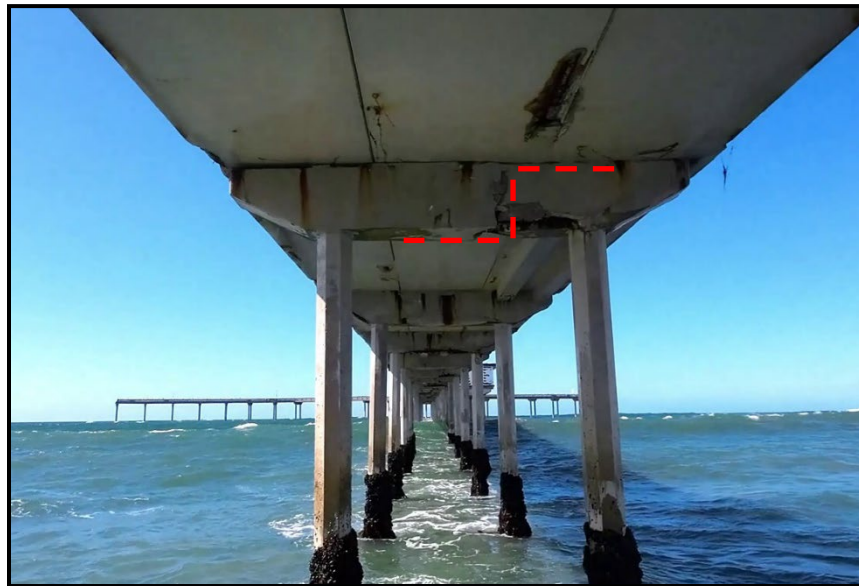
Photo 7: Bent 39 looking west. The red segmented line shows the vertical crack at the cold joint.

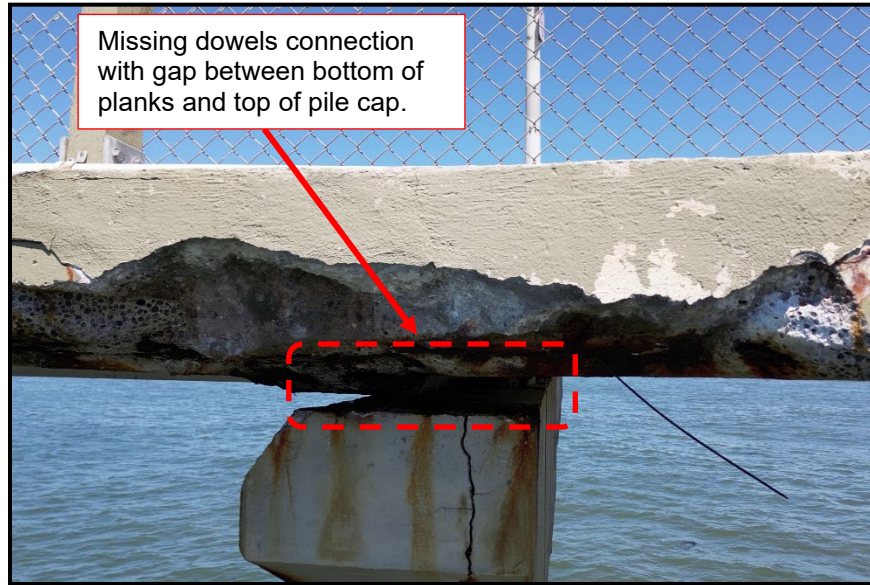
Photo 8: Bent 39 south face of pile cap. The red arrow points to the loss dowel connection between the pile cap and the precast planks.

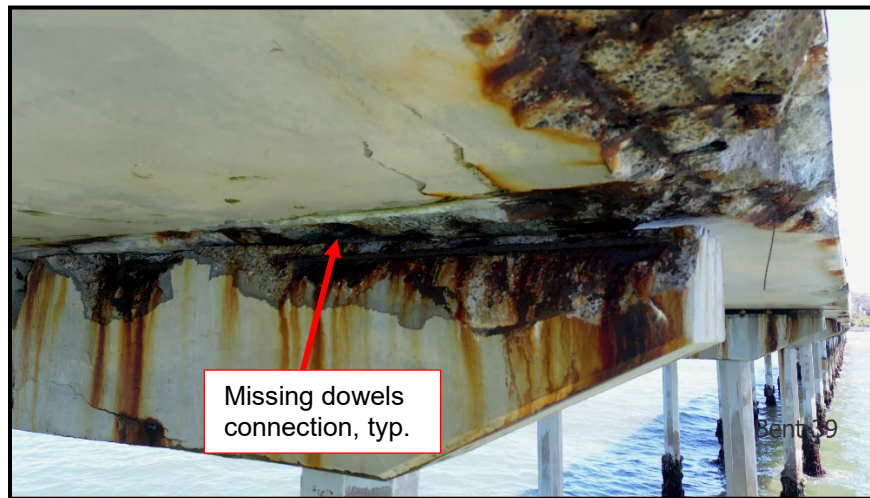
Photo 9: Bent 39 looking east. Close up of spalled concrete and missing dowel connection.

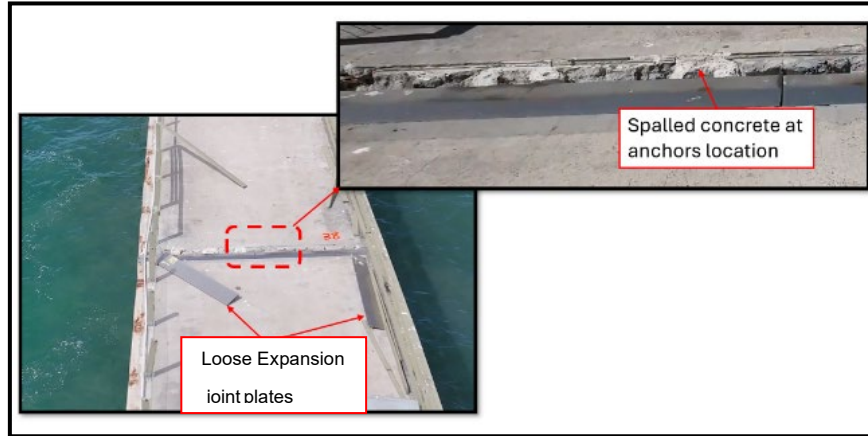
Photo 10: Displaced steel expansion joint plate lost during the storm event.

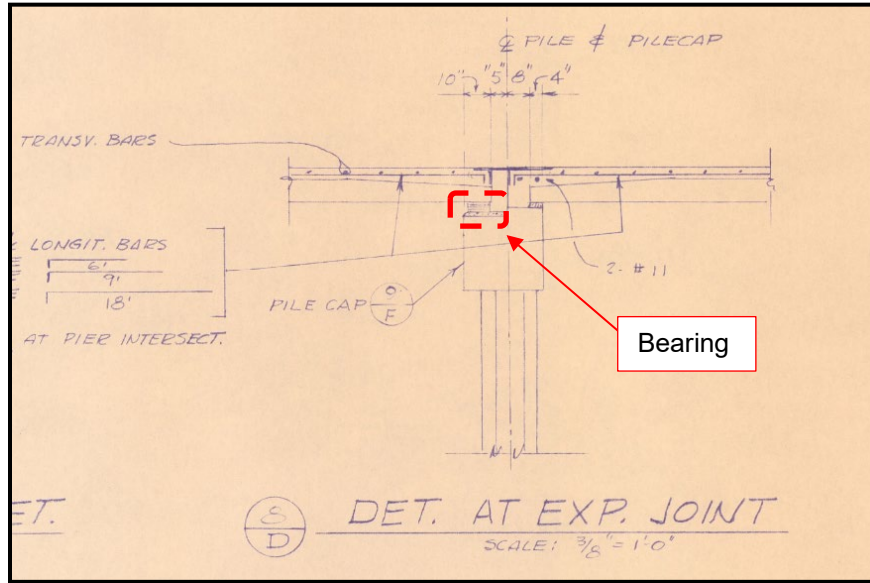
Figure 5: Record Drawing: The arrows point to the bearings shown in the 1966 record drawings.

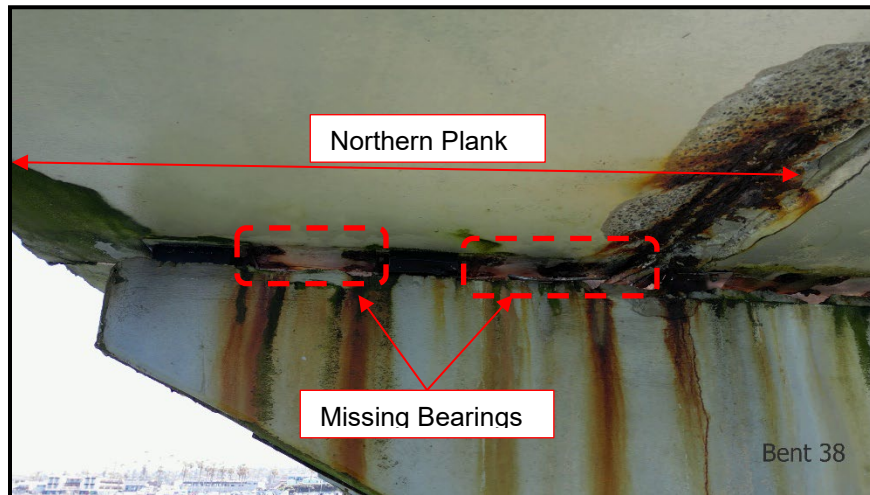
Photo 11: Bent 38 (looking east): northern PC plank, red dashed rectangles point to missing bearing pads.

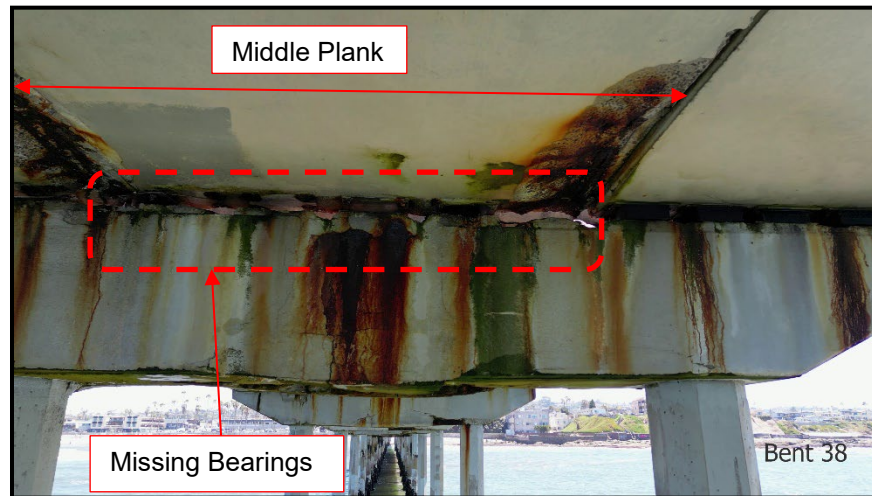
Photo 12: Bent 38 (looking east): middle PC plank, red dashed rectangles point to missing bearing pads.

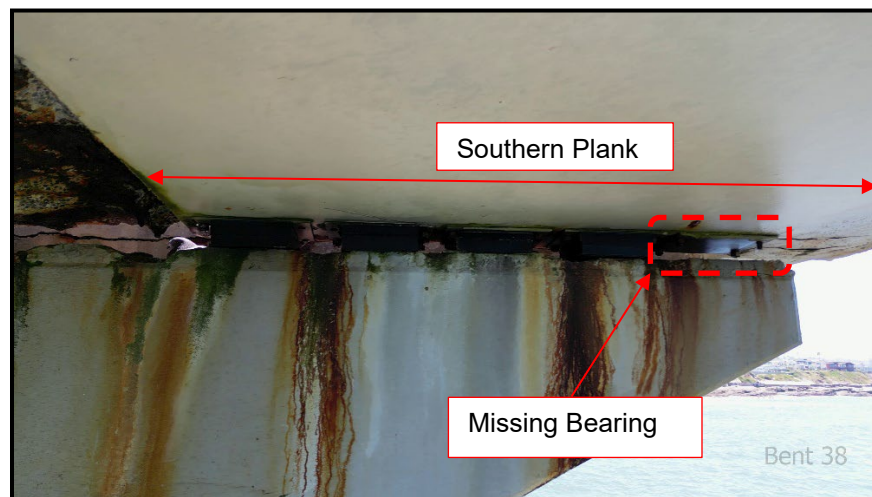
Photo 13: Bent 38 (looking east): southern PC plank, red dashed rectangles point to missing bearing pads.

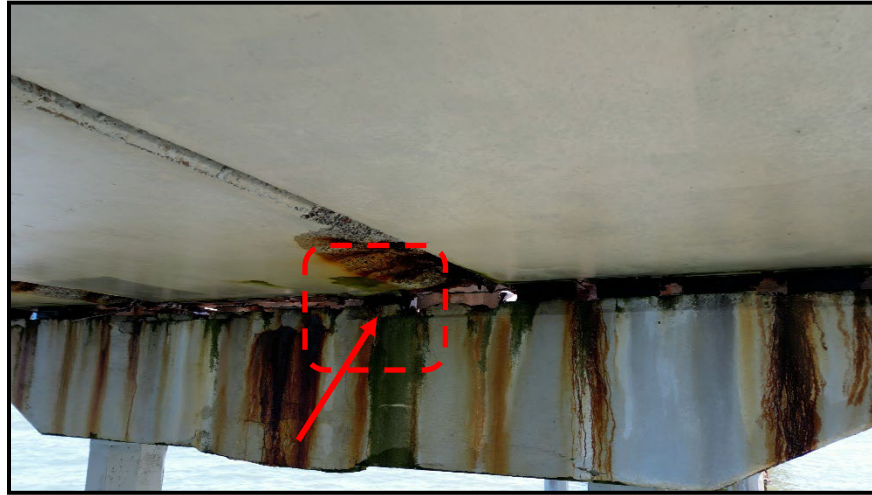
Photo 14: Bent 38 (looking east): Red arrow point to a displaced bearing at the middle plank that provides partial support.

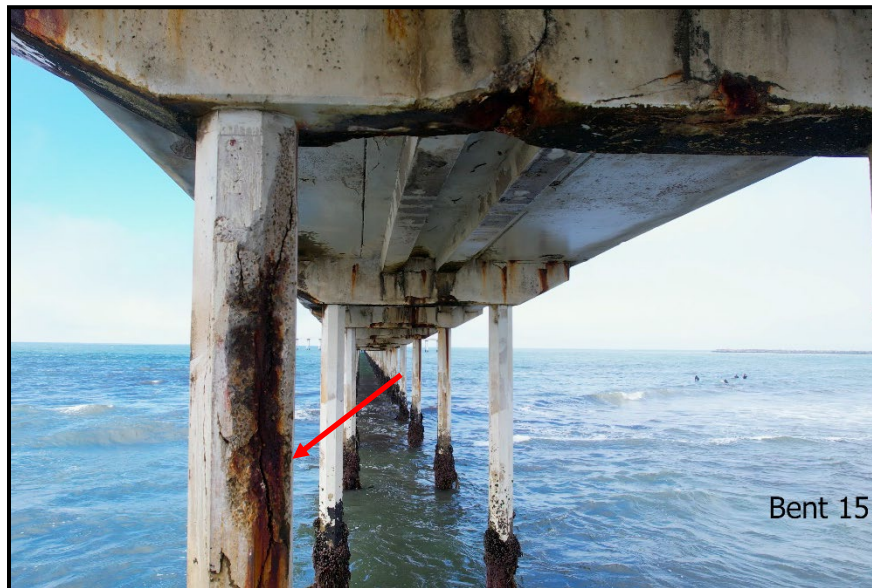
Photo 15: Bent 15 looking west. The arrow points to an open corrosion spall OCS on Pile 15:B.

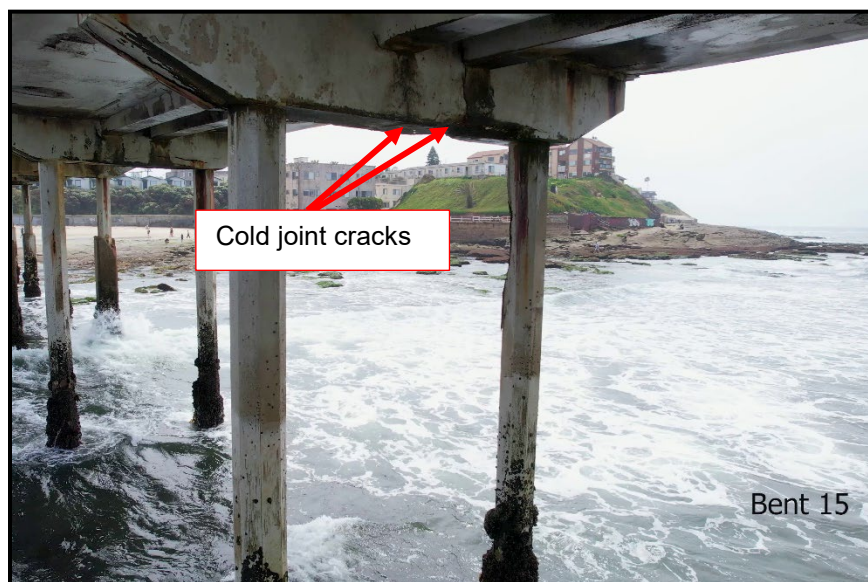
Photo 16: Bent 15 looking east. The red arrow points to initiation of cracking at cold joint.

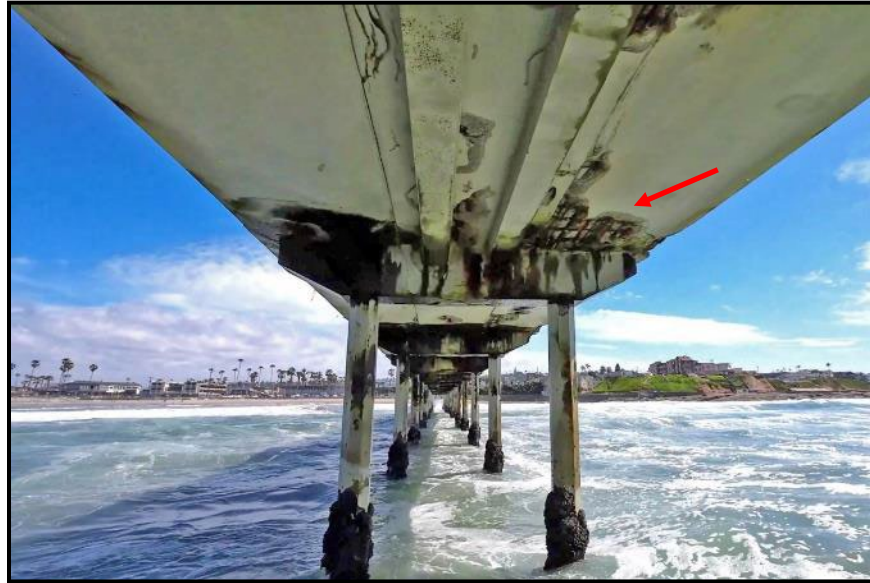
Photo 17: Bent 31 An elevation of pile cap at Bent 31 looking east (March 2024). The arrow points to the open spall corrosion with exposed strands at the southern plank.

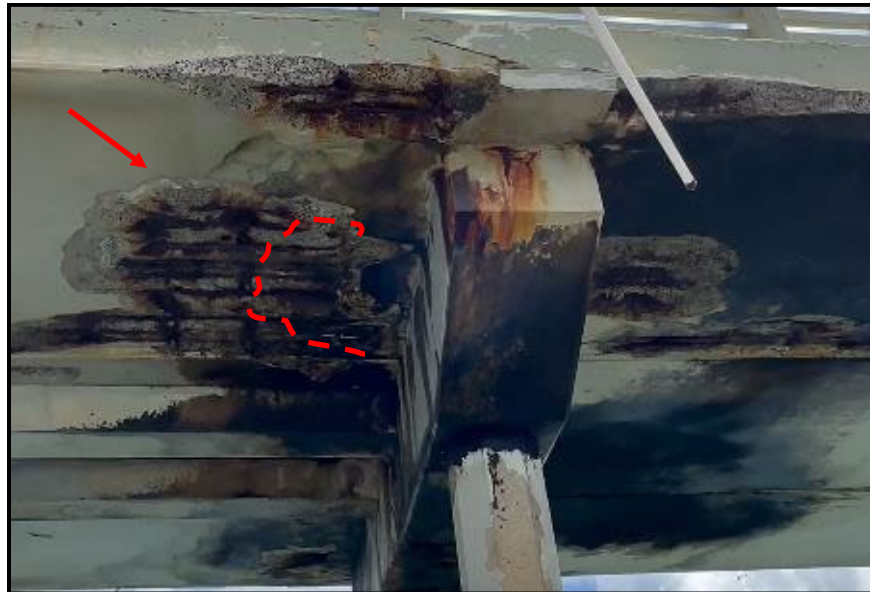
Photo 18: Bent 31 From May 2023 visual inspection looking north. The dashed line shows the approximate boundary of concrete damage when surveyed in 2016. The arrow points to the open spall corrosion with exposed strands at the southern plank during the 2023 survey.

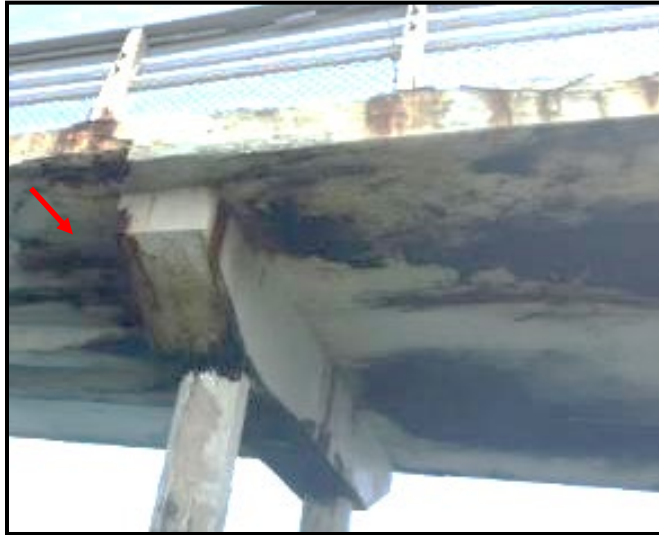
Photo 19: Bent 31 From July 2016 visual inspection looking north (underdeck spall partially hidden by pile cap).

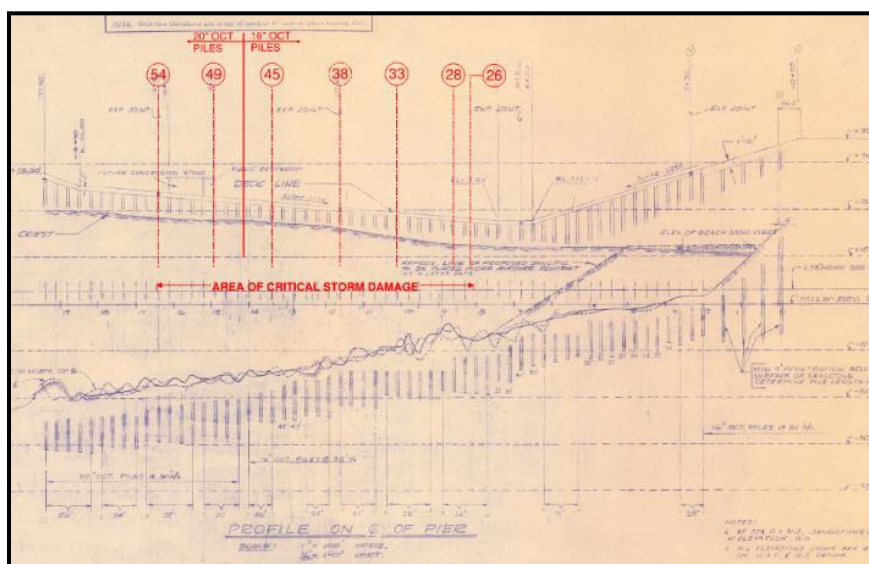
Figure 6: Critical area for storm damage.

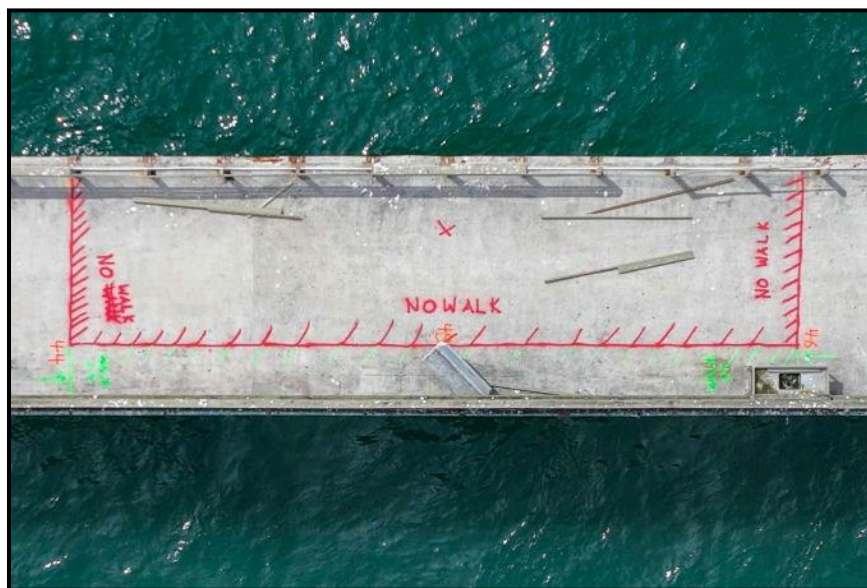
Photo 20: Walk/No walk demarcation around missing Pile 45:B

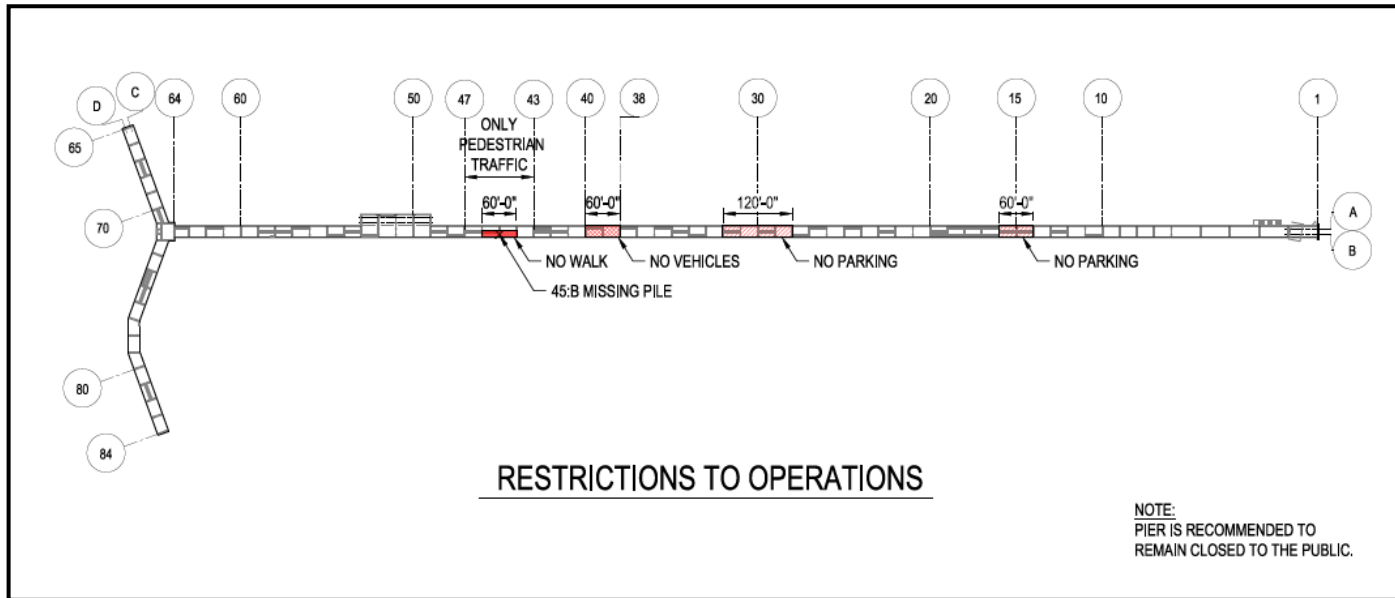
Figure 7: Restrictions on the pier.

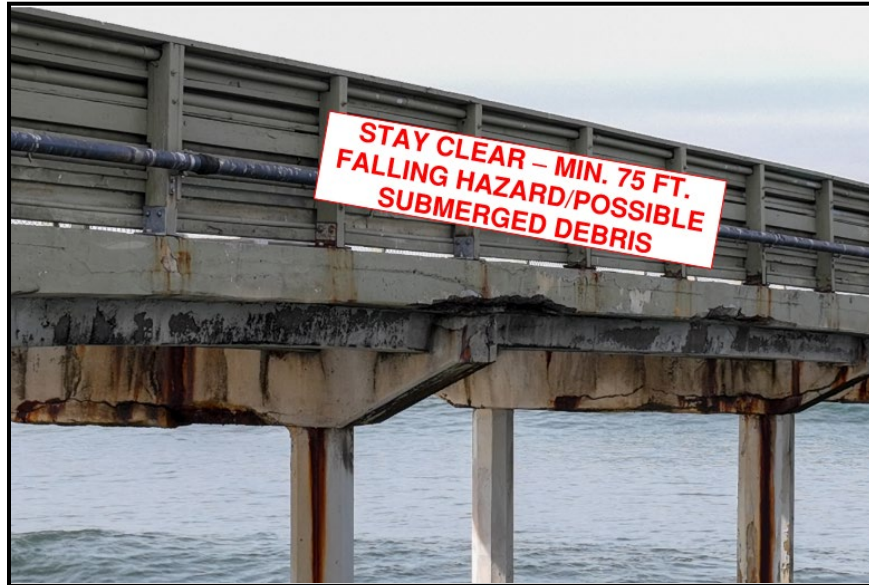
Figure 8: Proposed sign near missing Pile 45:B.

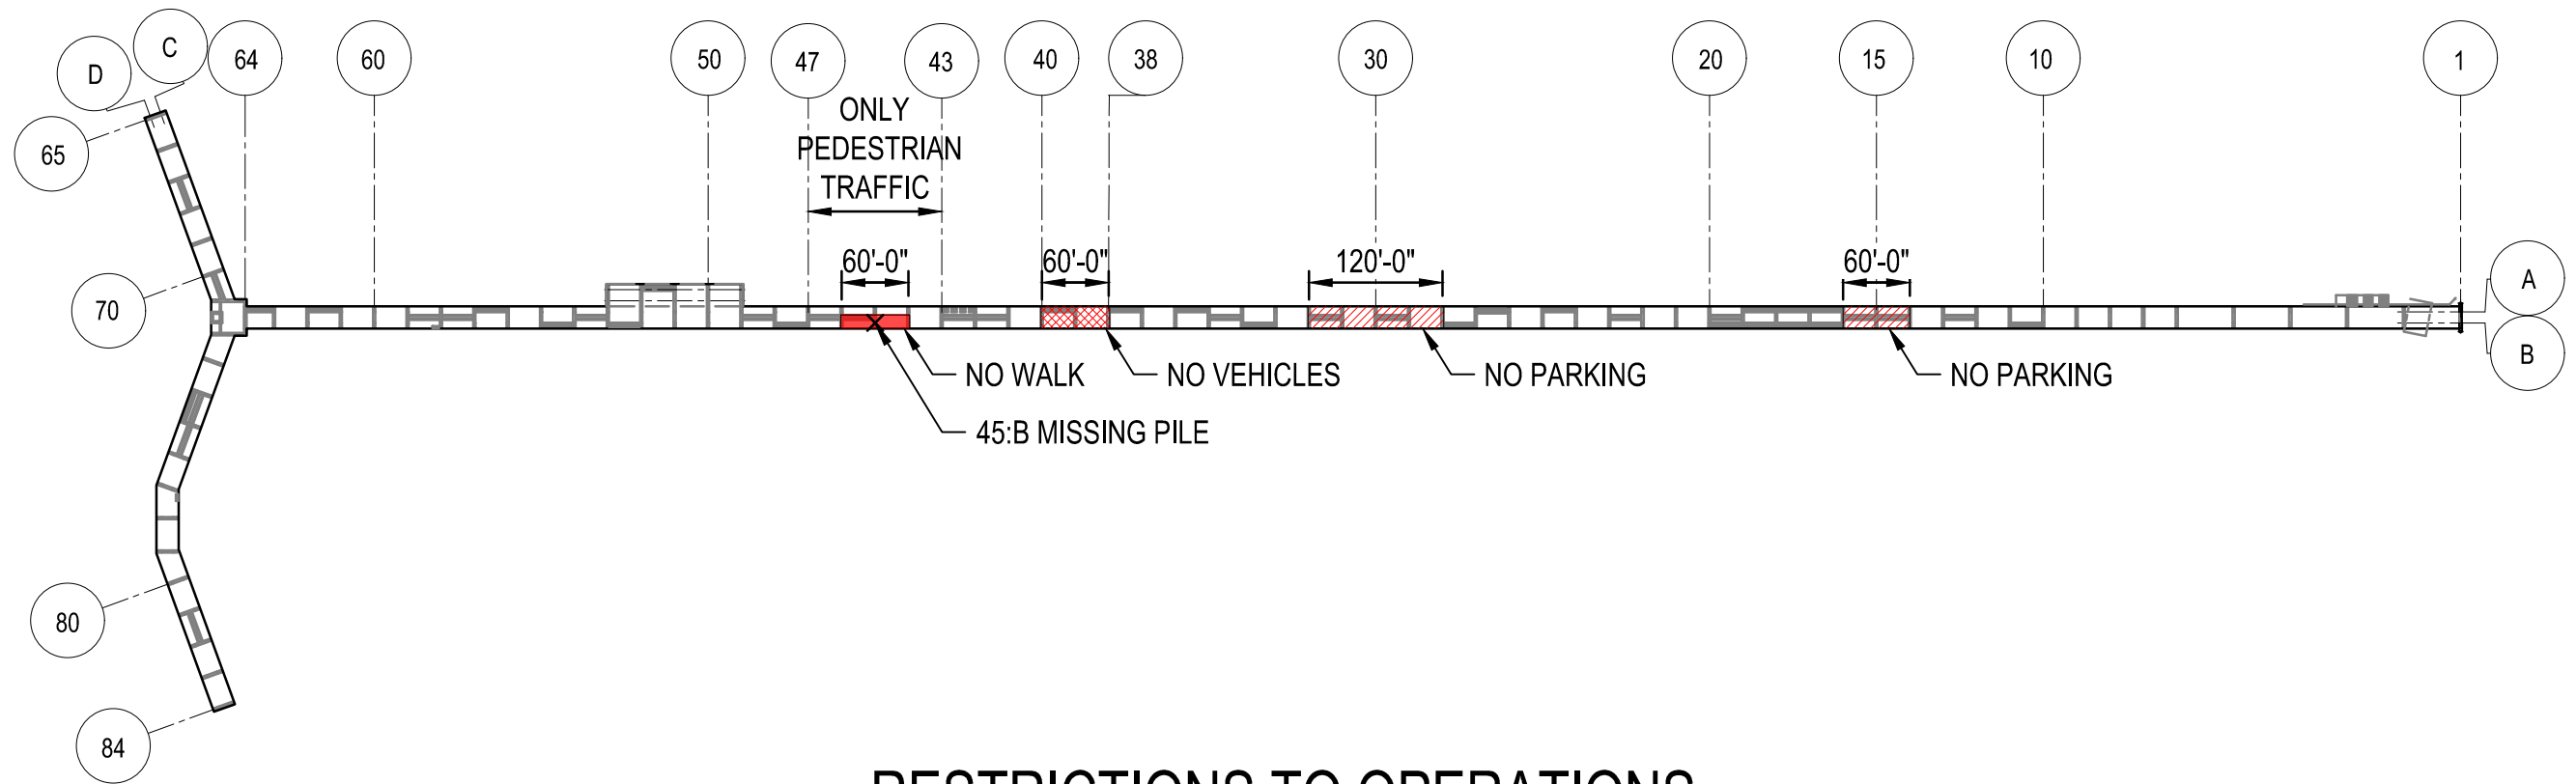
RESTRICTIONS TO OPERATIONS

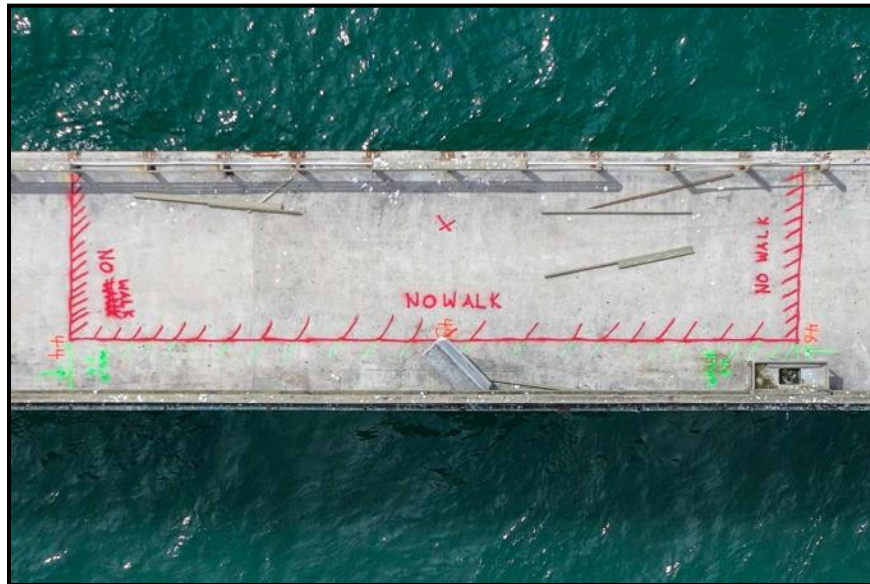
Photo 1: Walk/No walk demarcation around missing Pile 45:B.

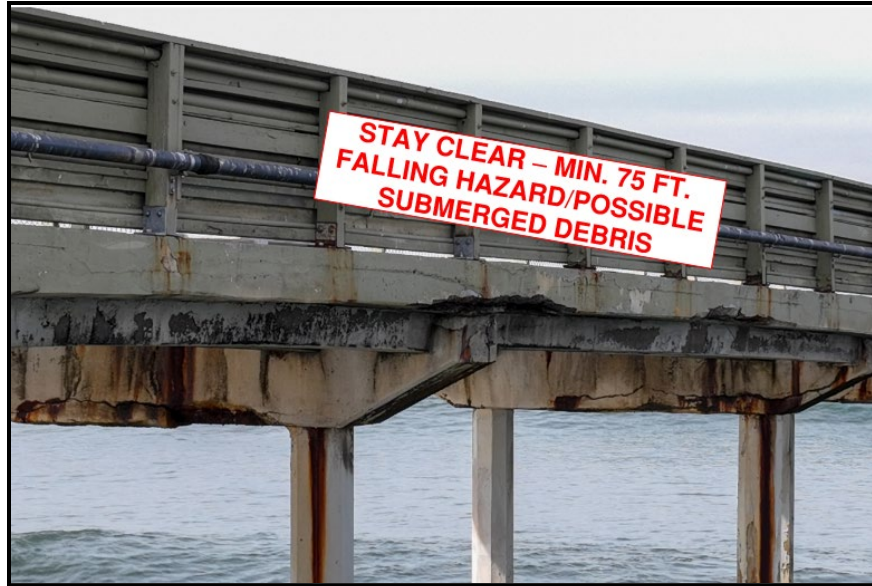
Figure 1: Proposed sign near missing Pile 45:B.

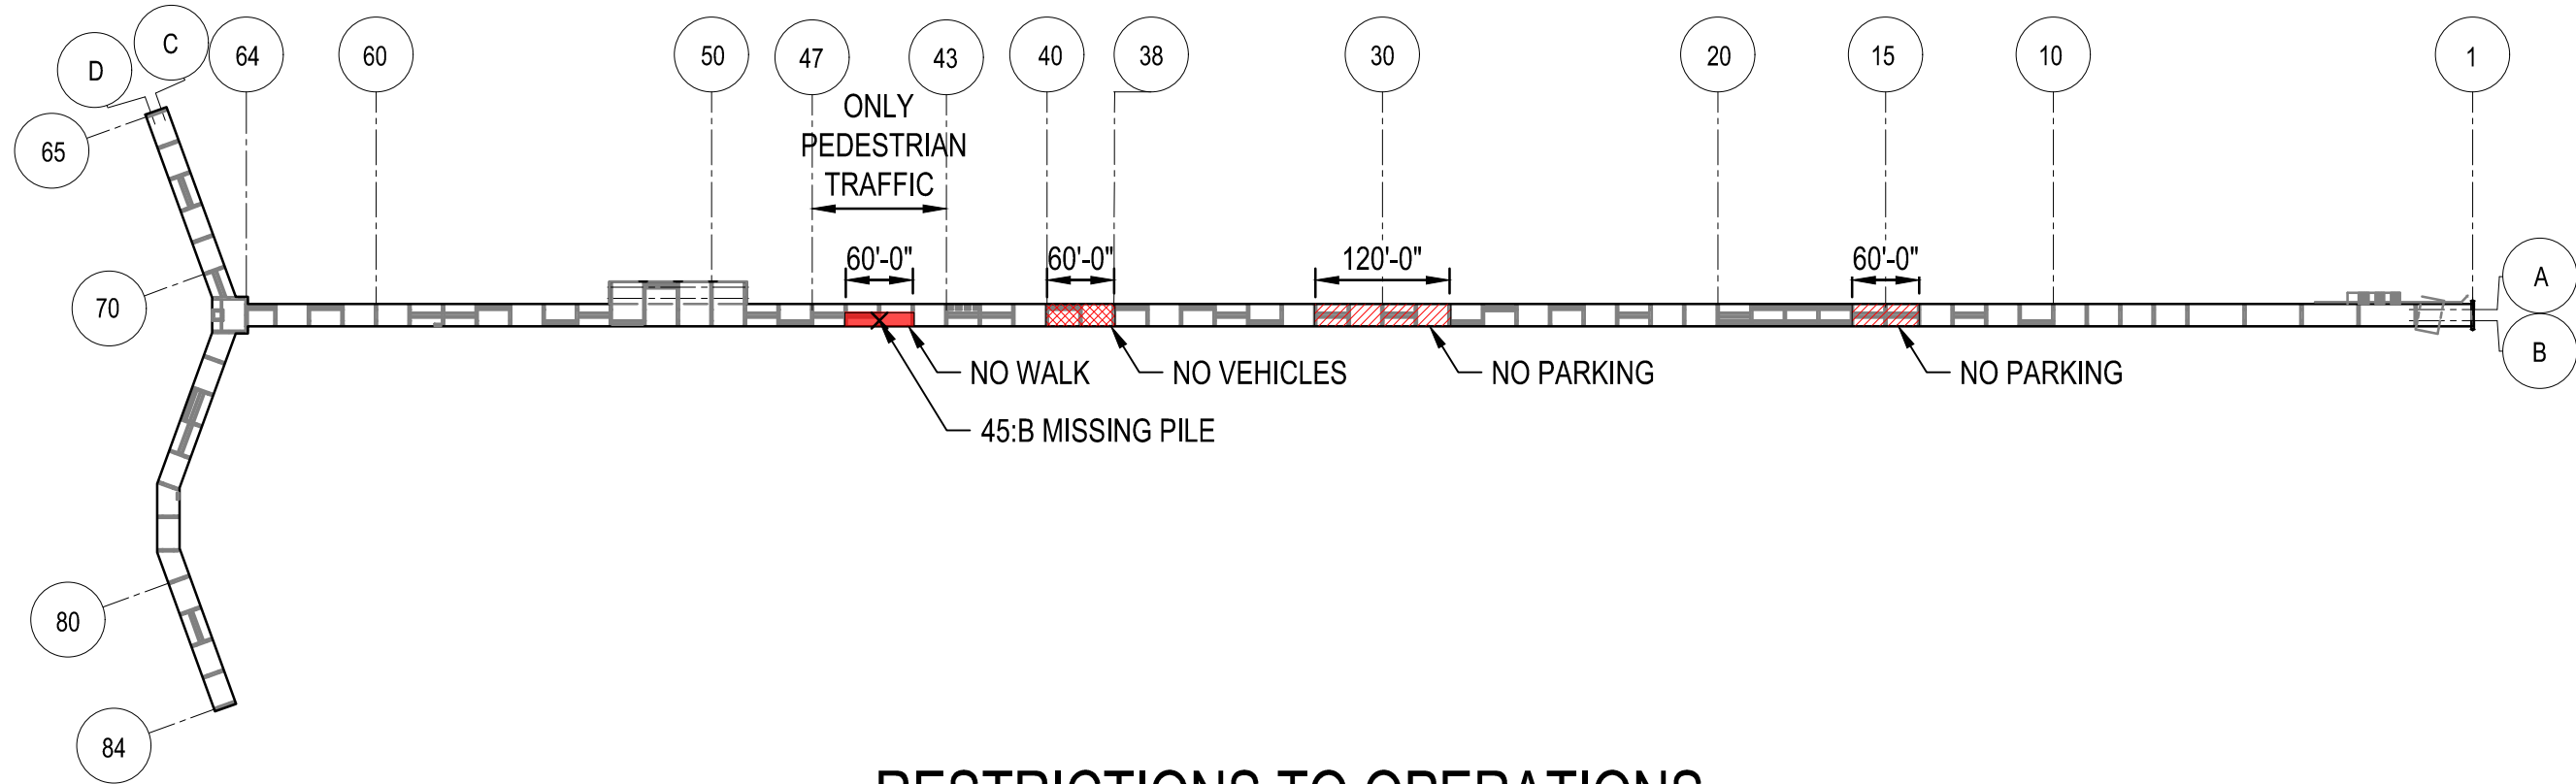
RESTRICTIONS TO OPERATIONS
