CERTIFIED ARBORIST REPORT

Date: August 1 , 2022

Tree Inspection at Clairemont Village Shopping Center
3089 Clairemont Drive
San Diego, CA 92117

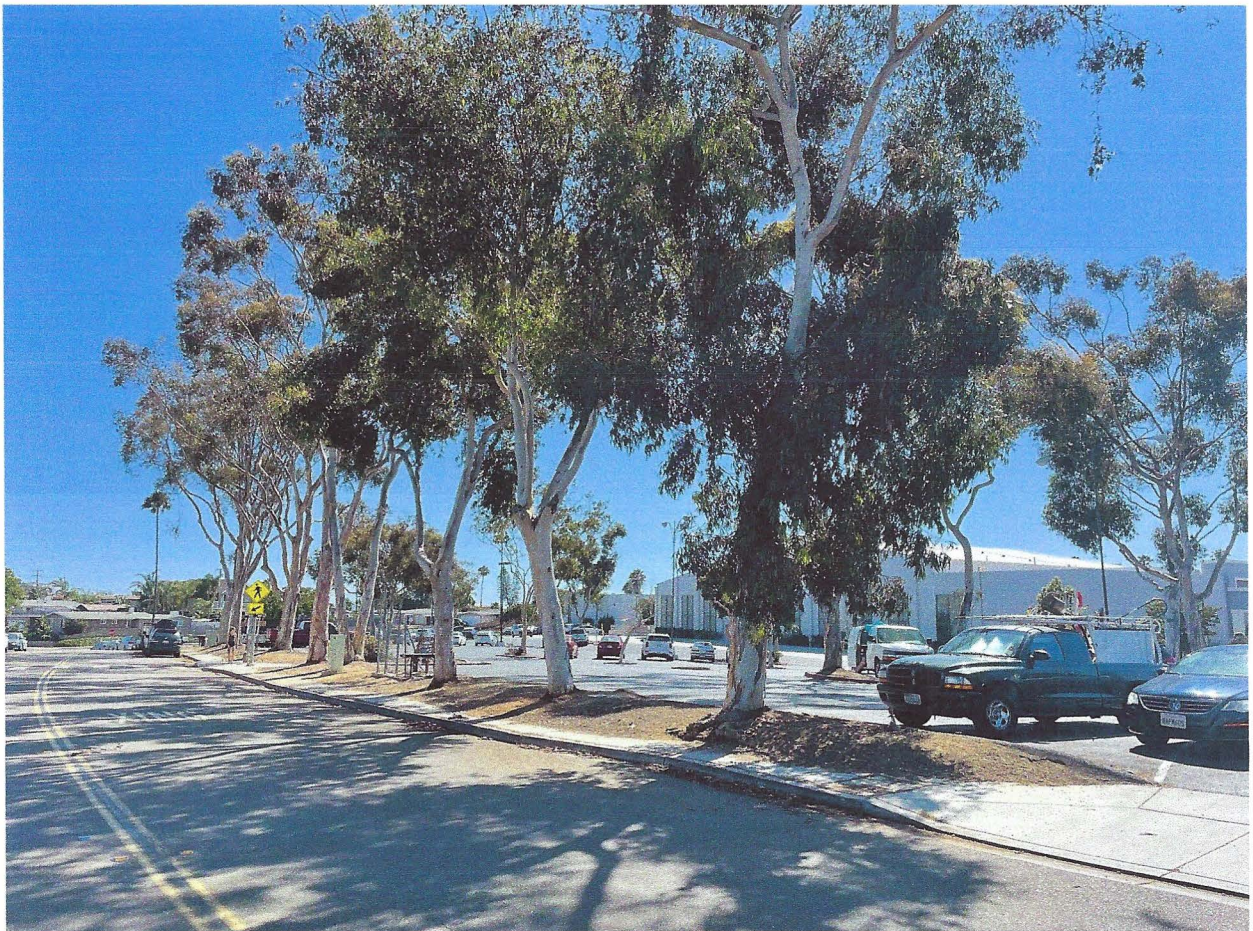
Most of the eucalyptus trees in this lineup are healthy and in decent shape—however, one appears to be in a stress response. It possesses dead limbs and overall, does not look as healthy as the rest of the trees.

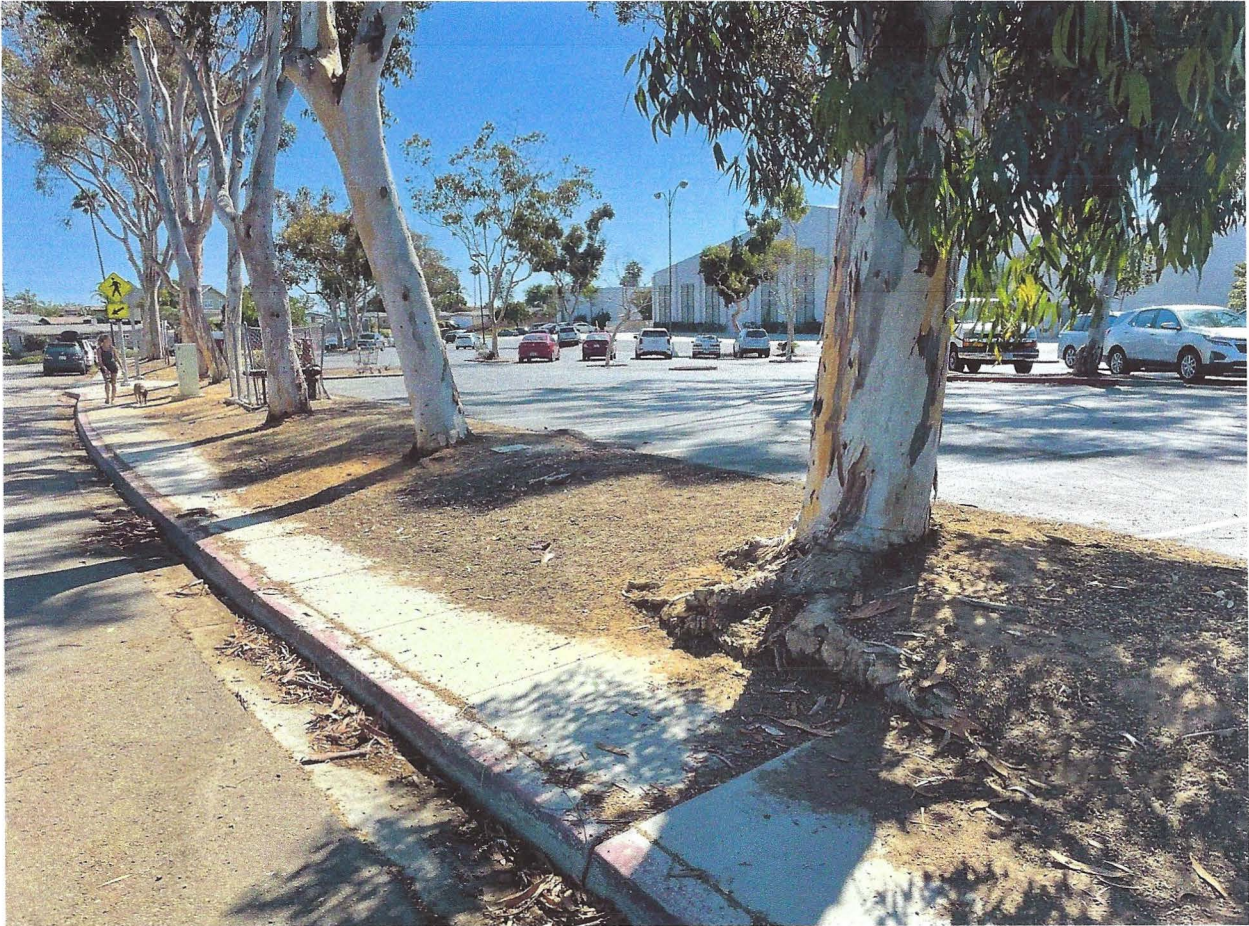
These eight eucalyptus trees are positioned within five feet of the sidewalk. In the past, the sidewalk was replaced due to damage that was incurred from tree roots. To protect the new sidewalk, several of the trees had their roots pruned back. But despite the

efforts, multiple sections of the sidewalk have begun to lift again due to the trees' root vigorous root systems.

It is my understanding that the sidewalk will be replaced, with the new sidewalk being installed closer to the trees in order to make room for a landscape pathway between the sidewalk and street. The problem with this plan is that the new hardscape development will encroach too close to the base of the trees—resting directly above the root collar of a tree or at the center of the tree itself. Although these trees are accustomed to tight living spaces, they are likely to suffer if their already compact area is downsized even more.

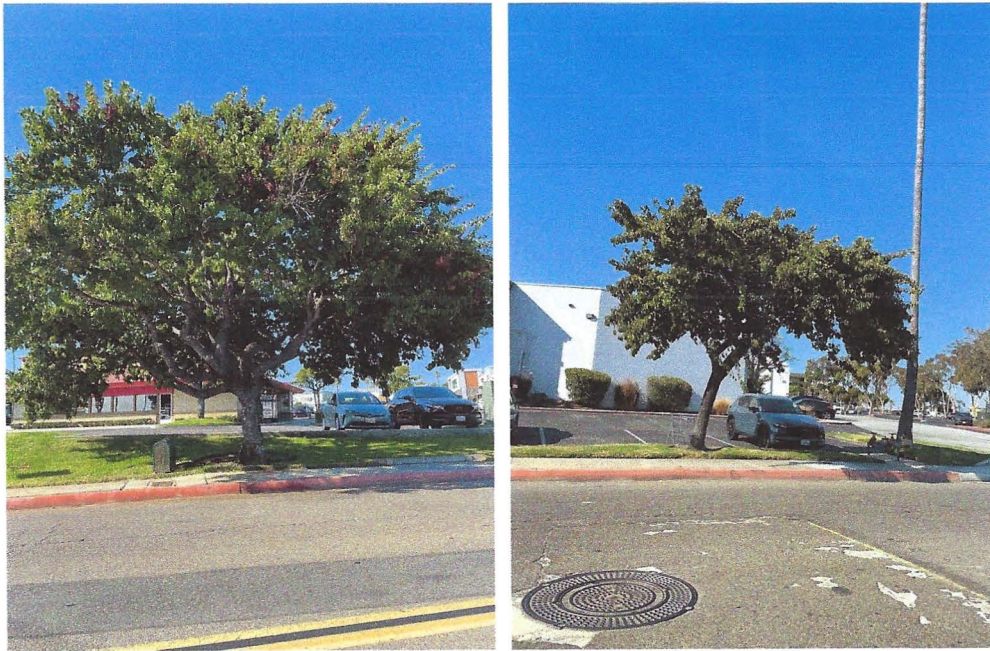
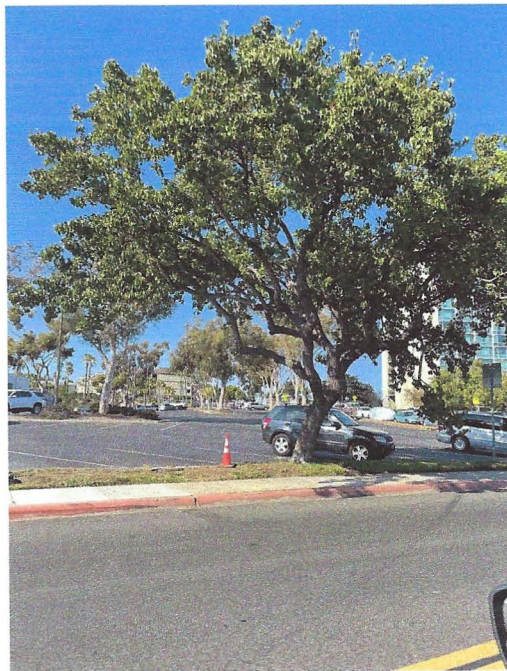
There are 4 Ornamental Pear trees and 2 Mexican Fan Palms along Field St. All appear in great condition and are extremely healthy. They are positioned within 3 feet of the sidewalk. If the sidewalk needs to be altered the trees will need to be removed. They are all too large to be transplanted and aside from the Mexican Fan Palms, would not handle the move well.

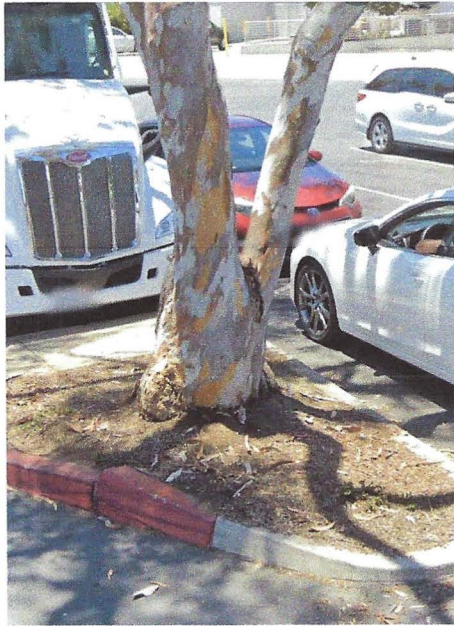
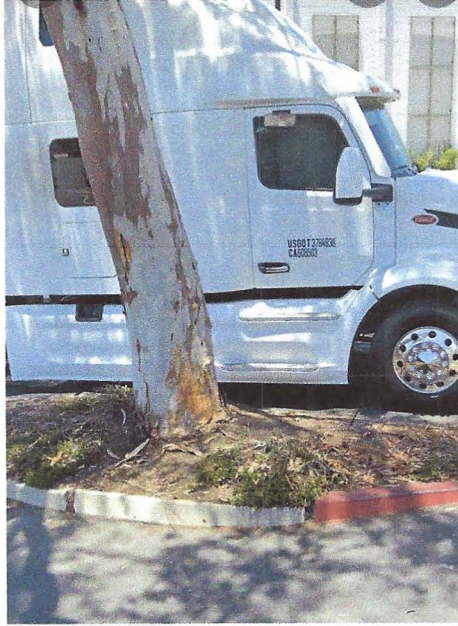
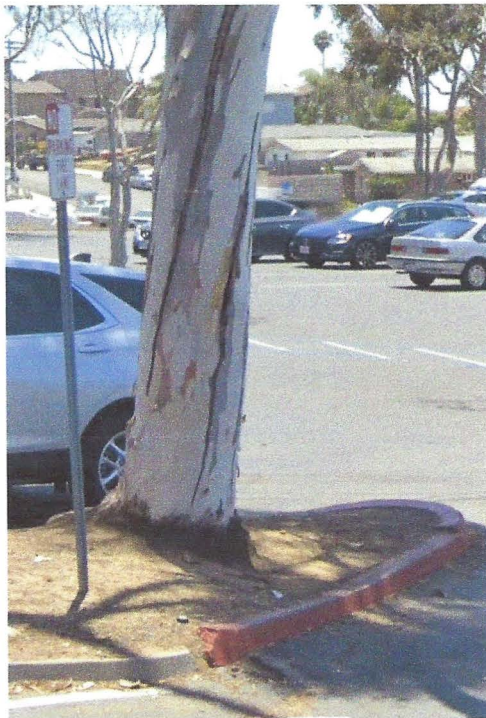
Inside the parking lot slated for renovation, there are sixteen Eucalyptus trees growing in planters. Aside from a few dead trees, most are in decent to good health. The majority of these trees have trunk injuries from vehicles running into them, which is common for parking lots. Roots from these trees have severely damaged the parking lot and in my opinion have out grown the planters. Below are a few pictures depicting the condition and damage caused by the trees.
