ASBESTOS AND LEAD-BASED PAINT SURVEY

Midway Rising
Portions of Assessor's Parcel Number (APN) 441-590-04
3220, 3240, 3250, 3350, and 3500 Sports Arena Boulevard
San Diego, CA 92110

SCS ENGINEERS

Project No. 01213320.07 | August 17, 2023

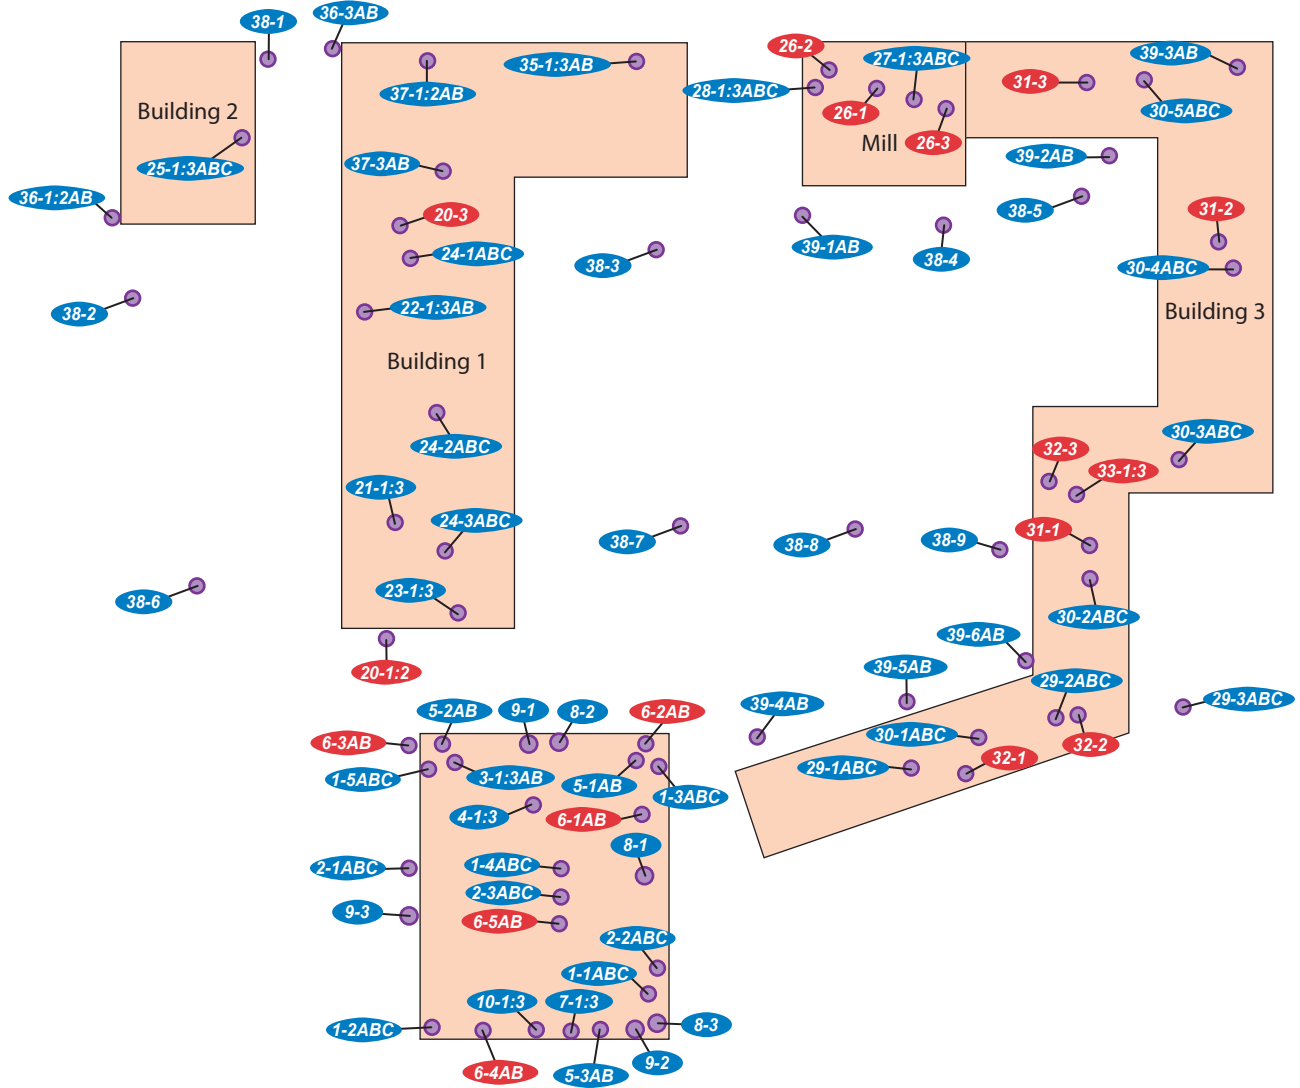
**Dixieline Lumber
3250 Sports Arena Boulevard**

- 9-2 Non-asbestos-containing sample location
- 6-4AB Asbestos-containing sample location

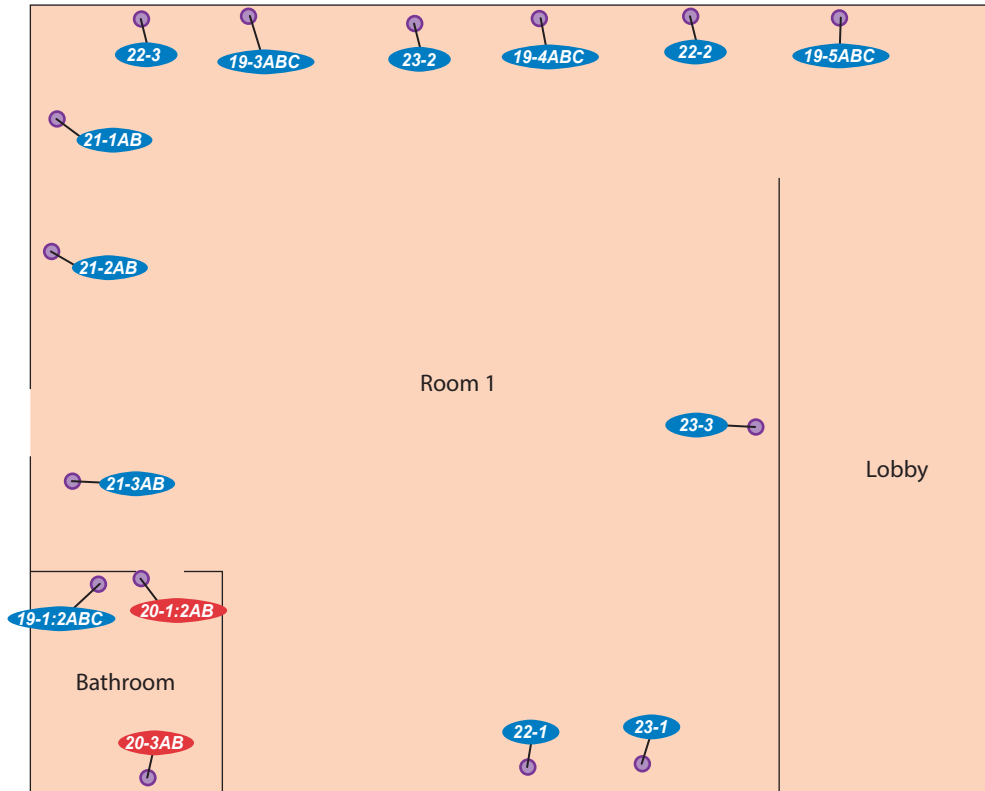
**3350 Sports Arena Boulevard
Crack in the Wall, Suite G**

- 22-2 Non-asbestos-containing sample location
- 20-3AB Asbestos-containing sample location

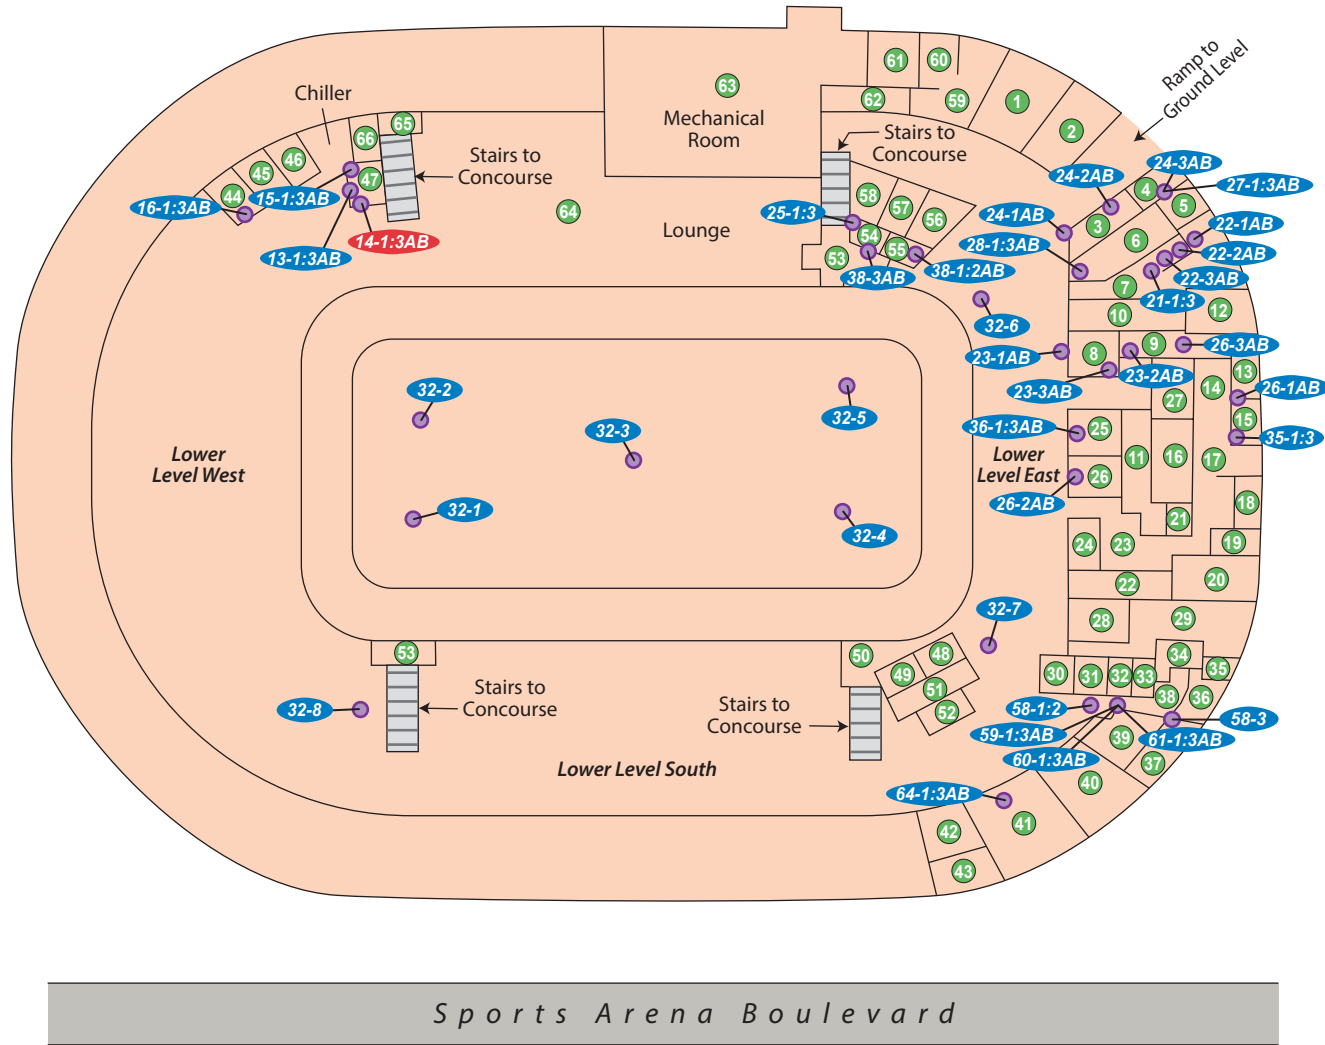
**3500 Sports Arena Boulevard
Pechanga Arena - Floor**

- 29-4 Non-asbestos-containing sample location
- 14-1:3AB Asbestos-containing sample location
- 13 Section numbers

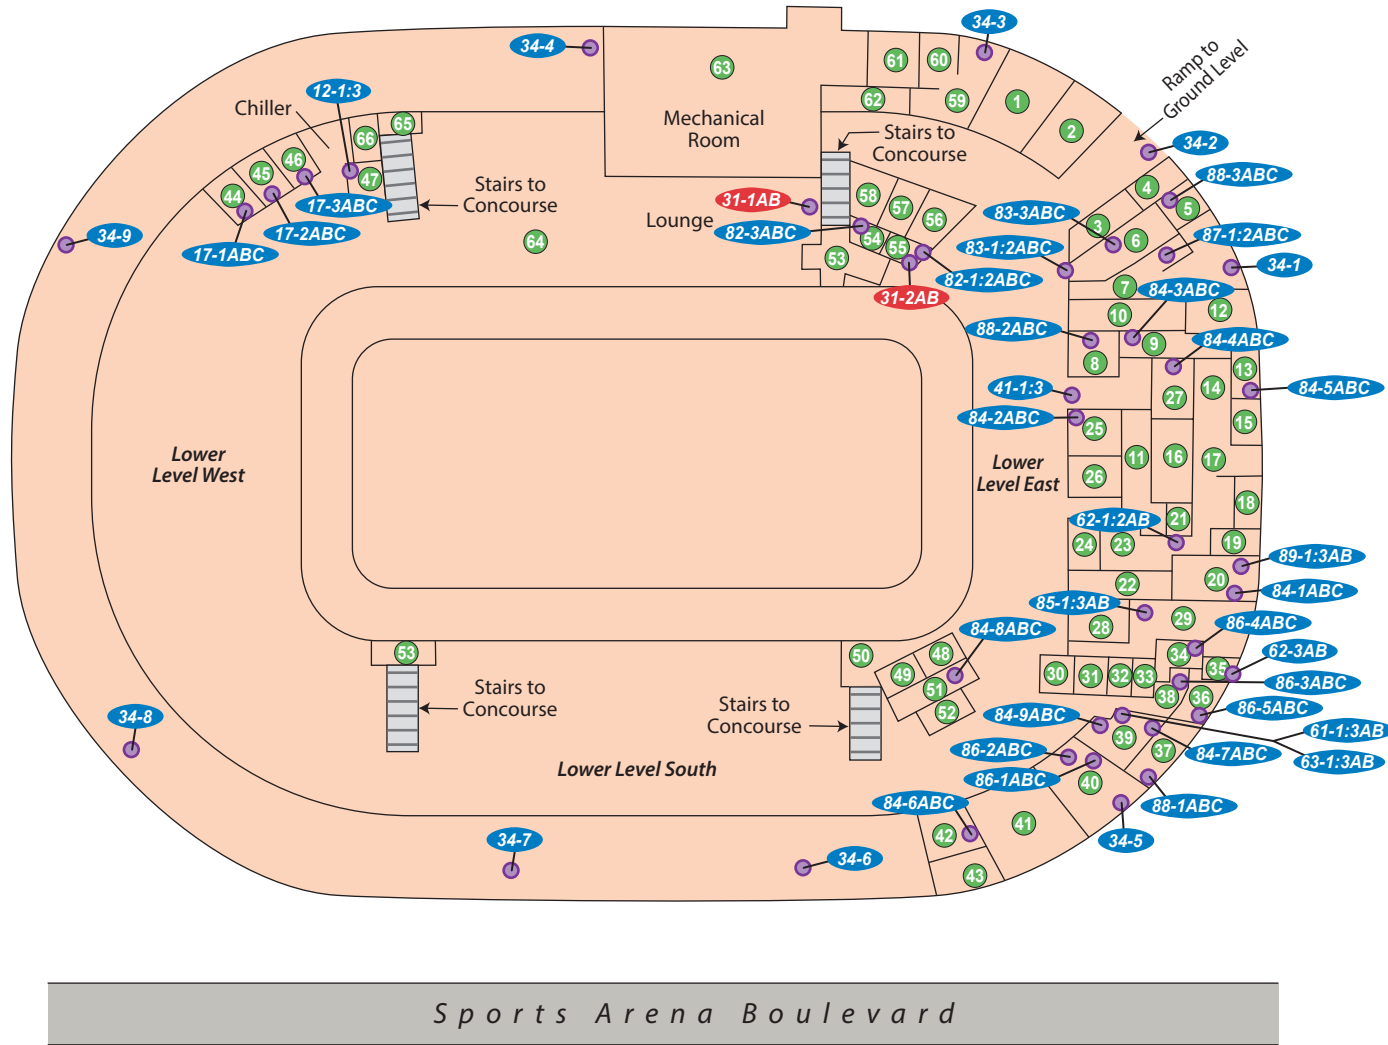
**3500 Sports Arena Boulevard
Pechanga Arena - LL Walls (1 of 2)**

- 34-8 Non-asbestos-containing sample location
- 31-1AB Asbestos-containing sample location
- 13 Section numbers

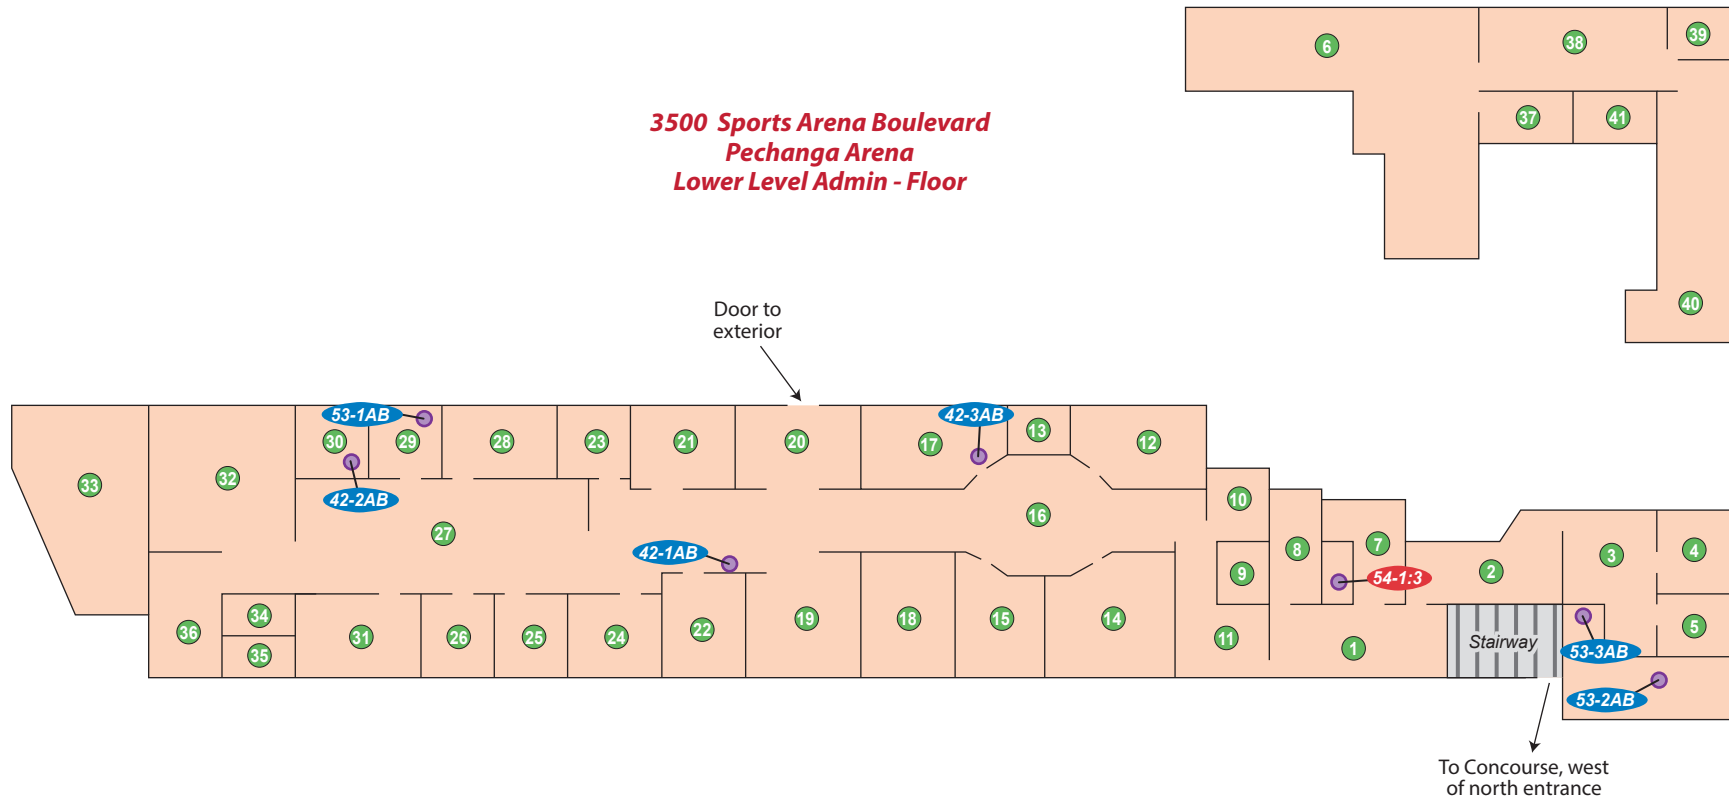
**3500 Sports Arena Boulevard
Pechanga Arena
Lower Level Admin - Floor**

- 42-2AB Non-asbestos-containing sample location
- 54-1:3 Asbestos-containing sample location
- 13 Section numbers

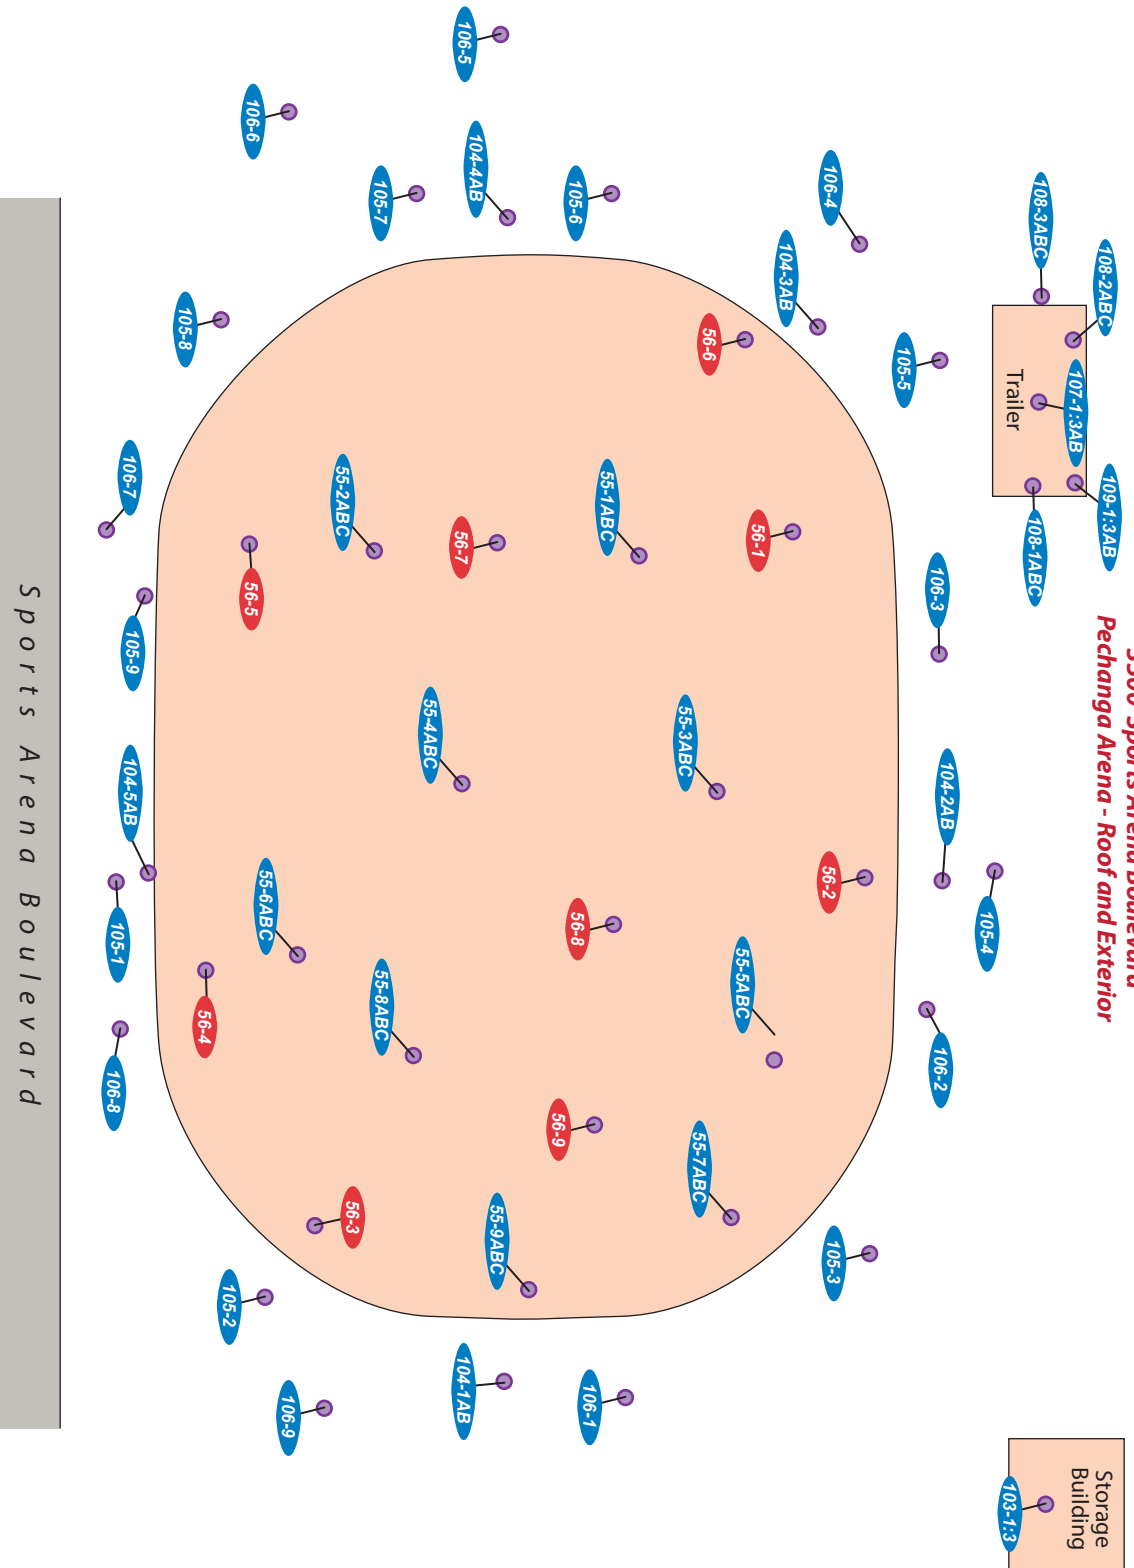
3500 Sports Arena Boulevard Pechanga Arena - Roof and Exterior

- 105-5 Non-asbestos-containing sample location
- 56-4 Asbestos-containing sample location
