2185 Station Village Way
San Diego, CA 92108

SITE PHOTOGRAPHS

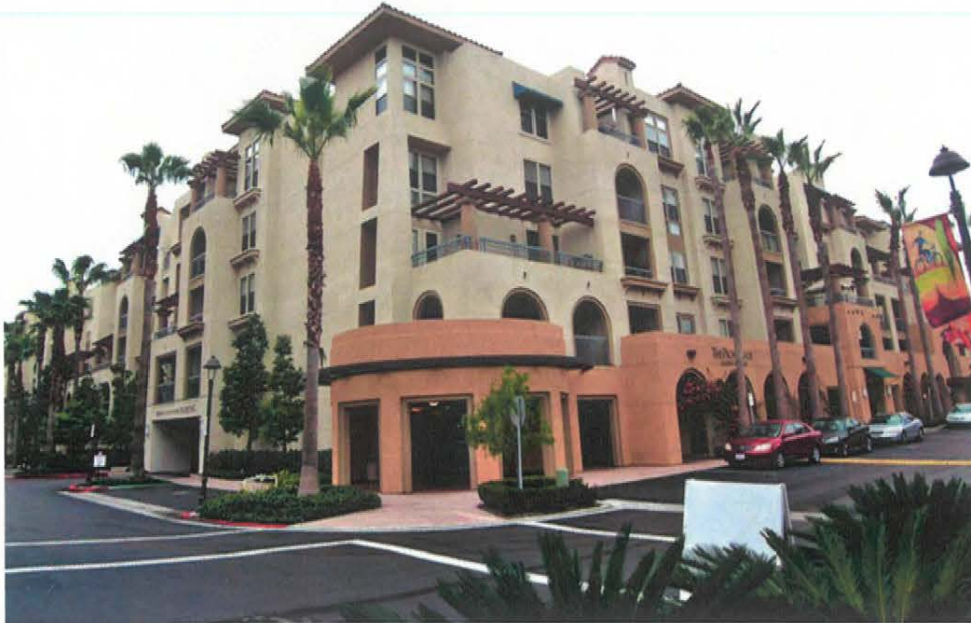
1) Typical of exterior finishes at Building 4.

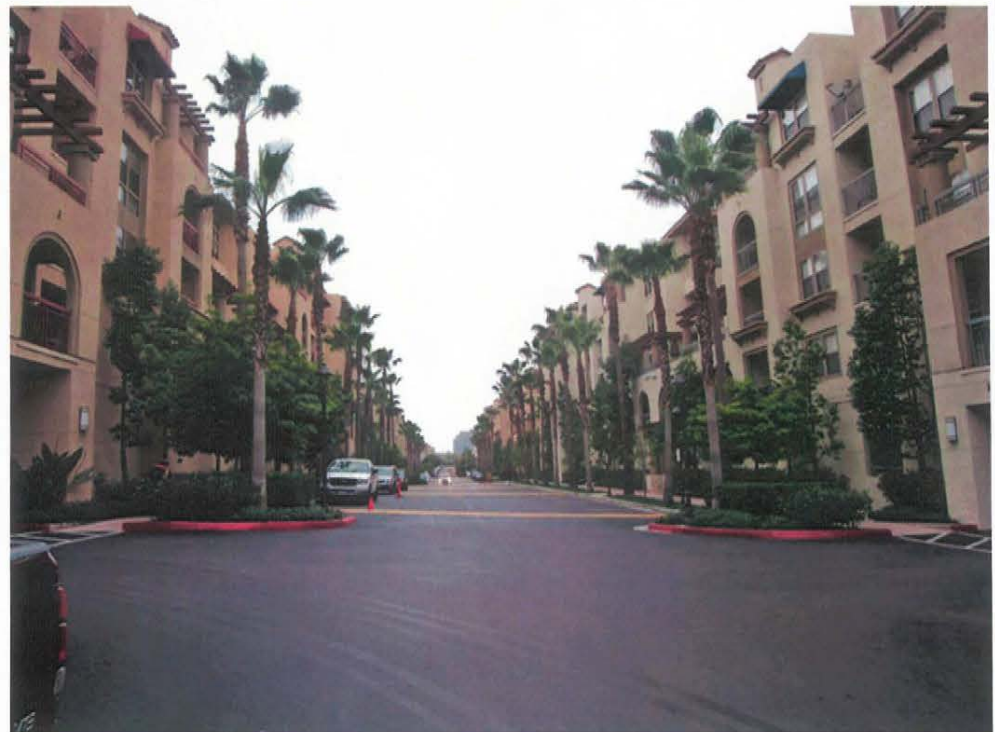
2) Looking west between Buildings 3, 4, 5 and 6.

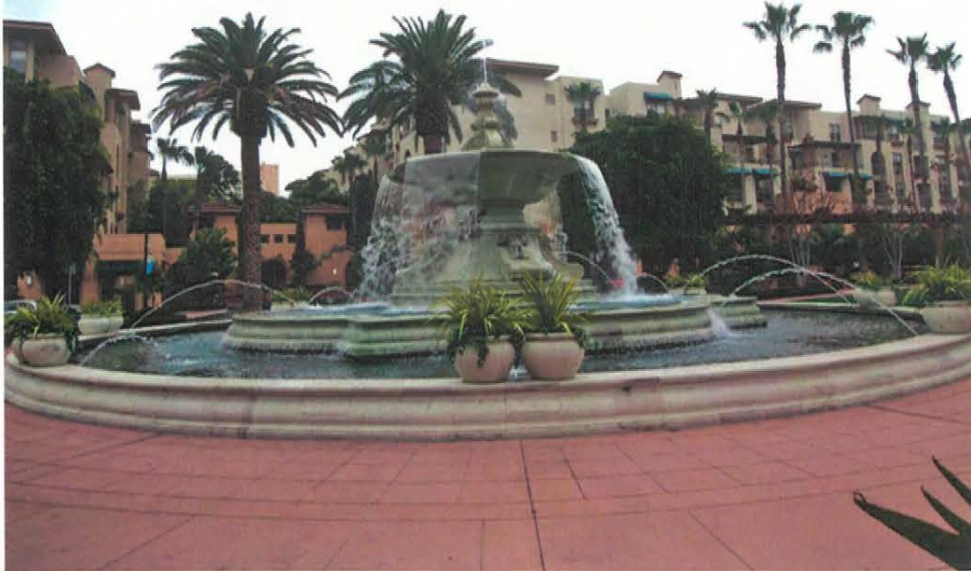
3) View of fountain at main entry drive on site.

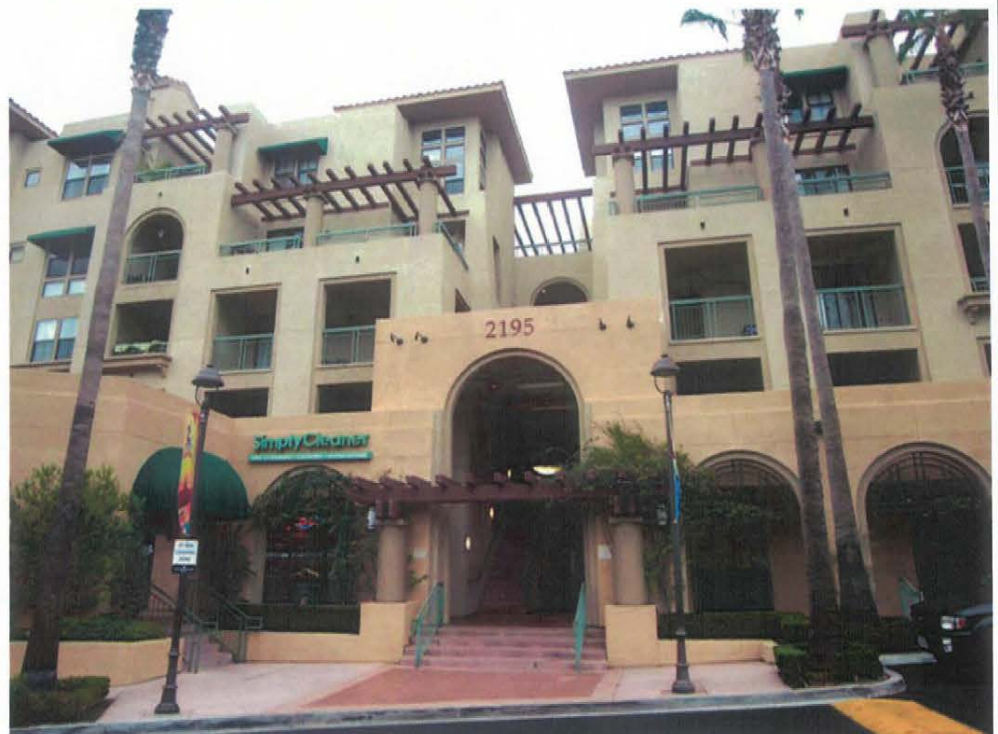
4) Typical of exterior finishes at commercial portions of buildings.

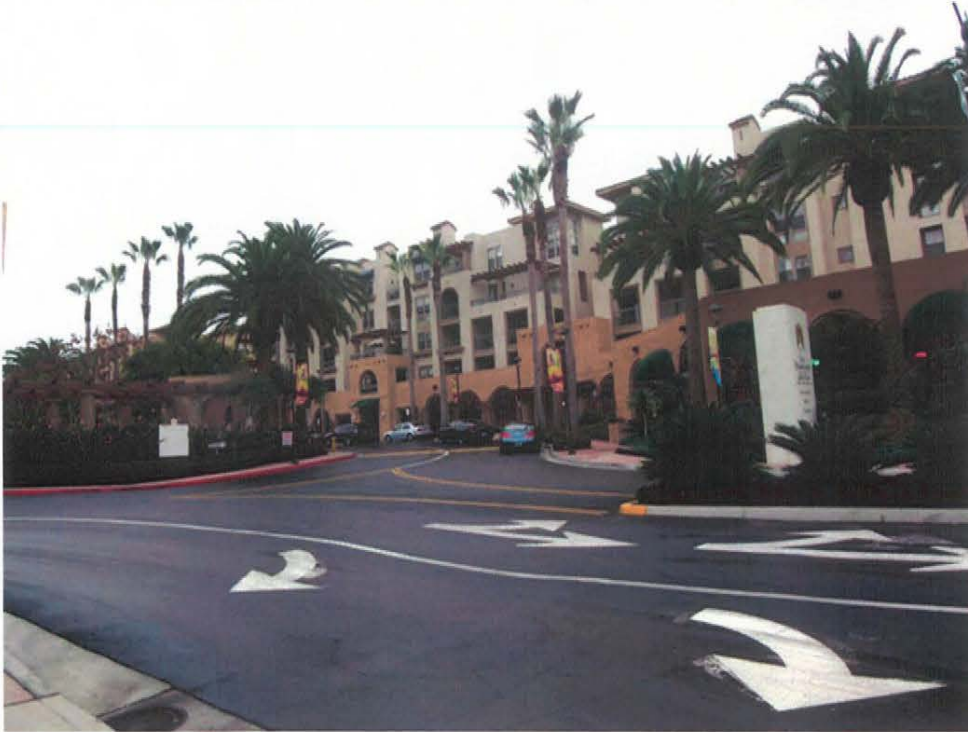
5) View of buildings from main entrance drive.

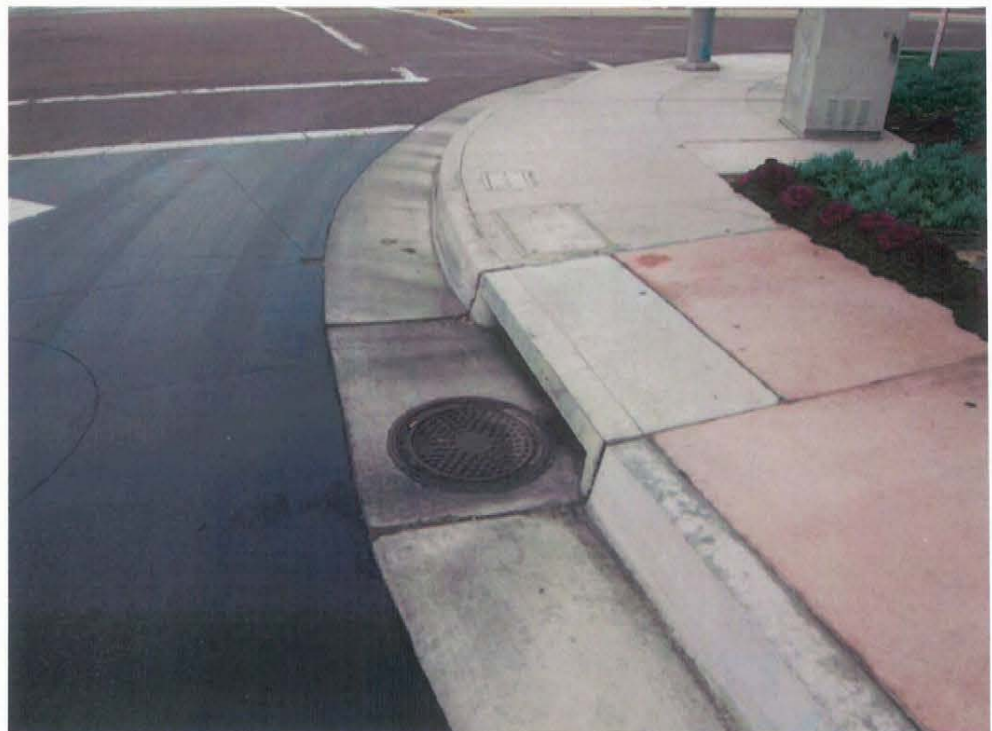
6) View of storm drain inlet.

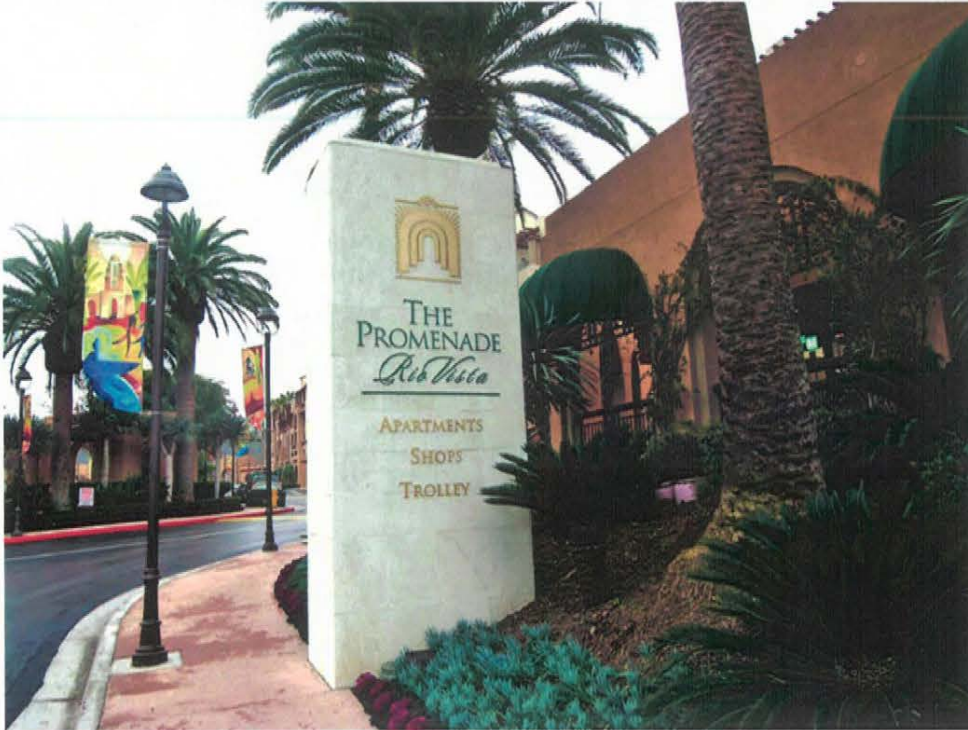
7) View of signage at entry to site.

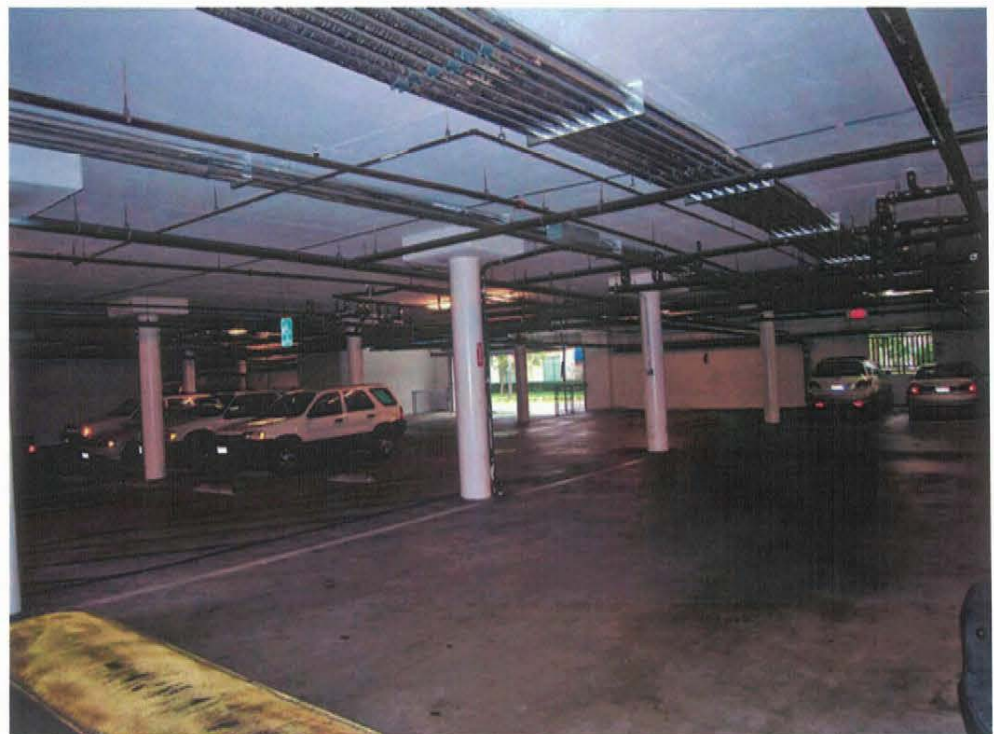
8) Typical of parking garage finishes.

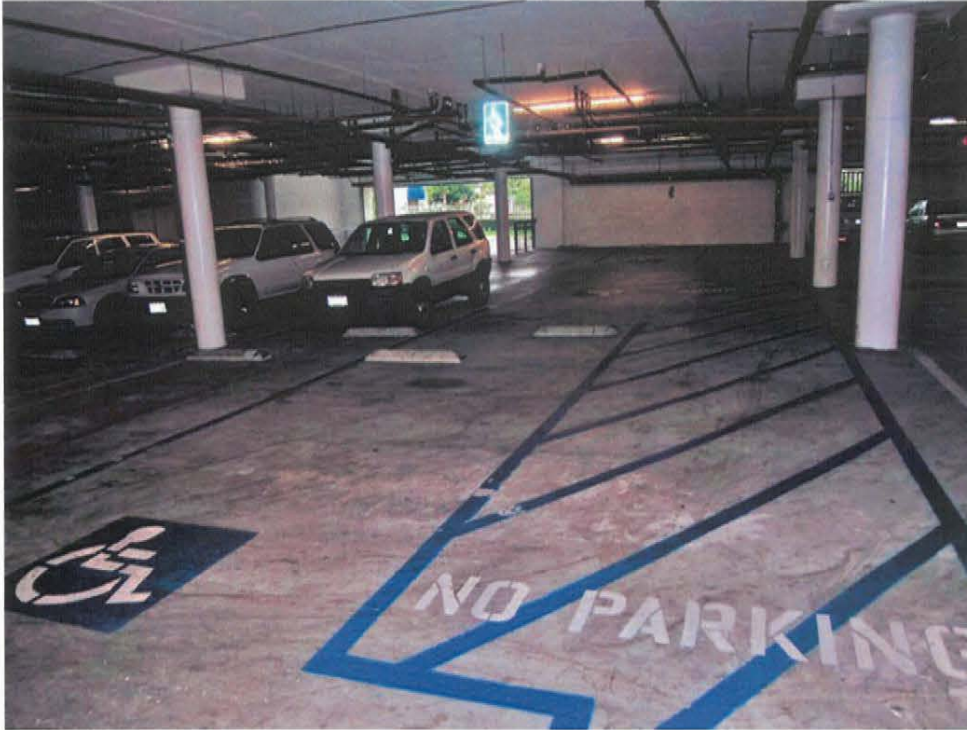
9) Typical of disabled accessible parking spaces.

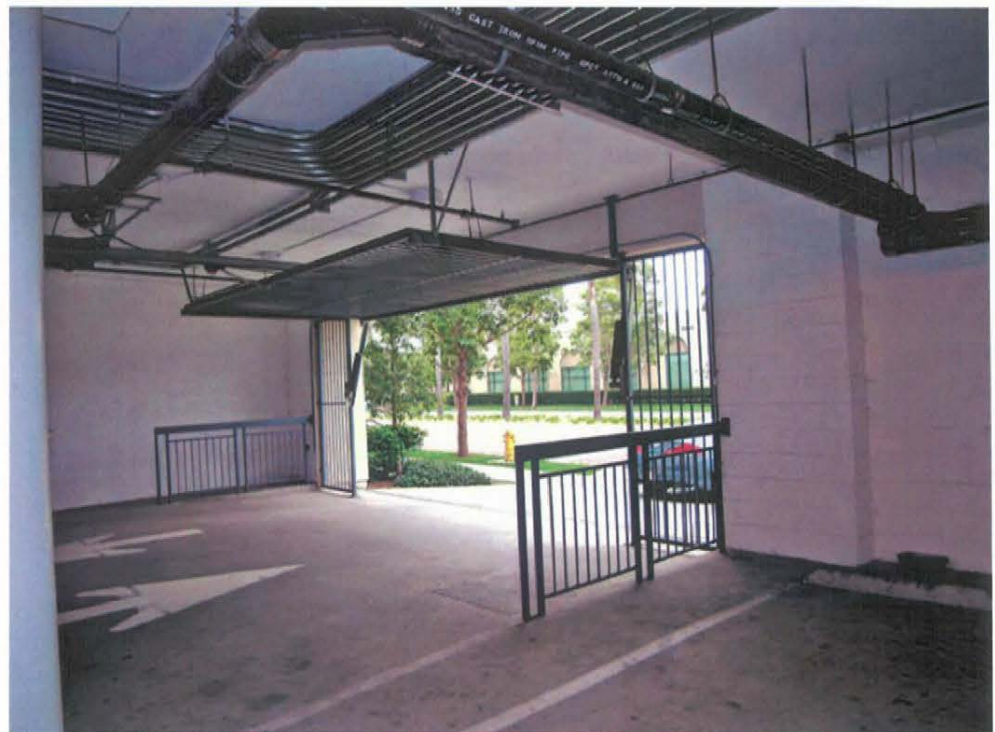
10) Typical of parking garage exits

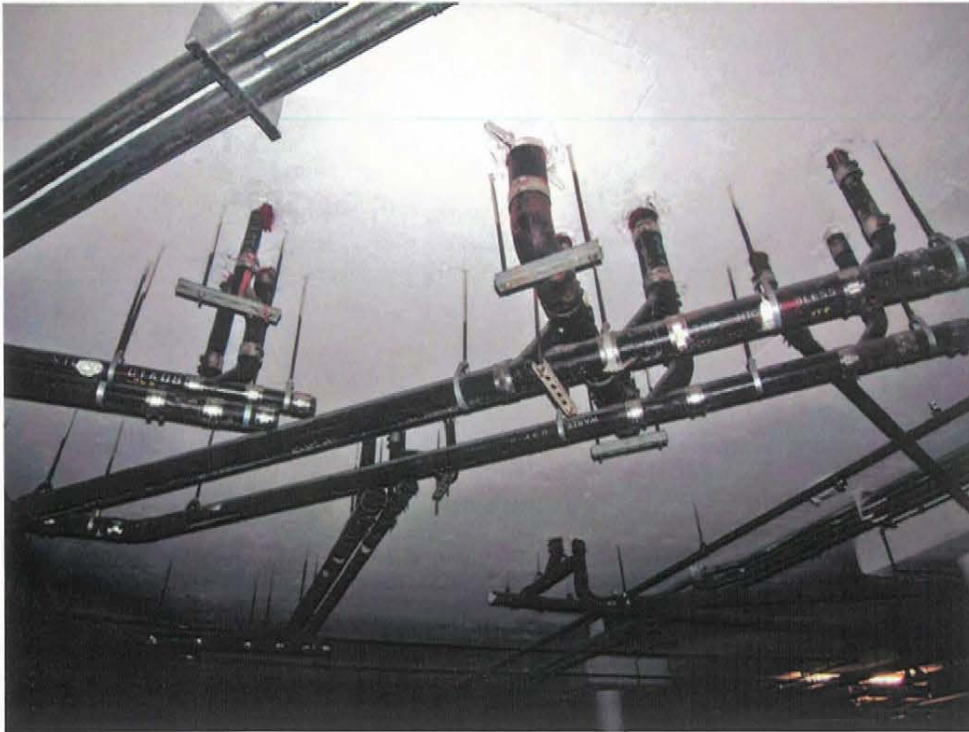
11) Typical of cast iron sewer waste piping visible in parking garage.

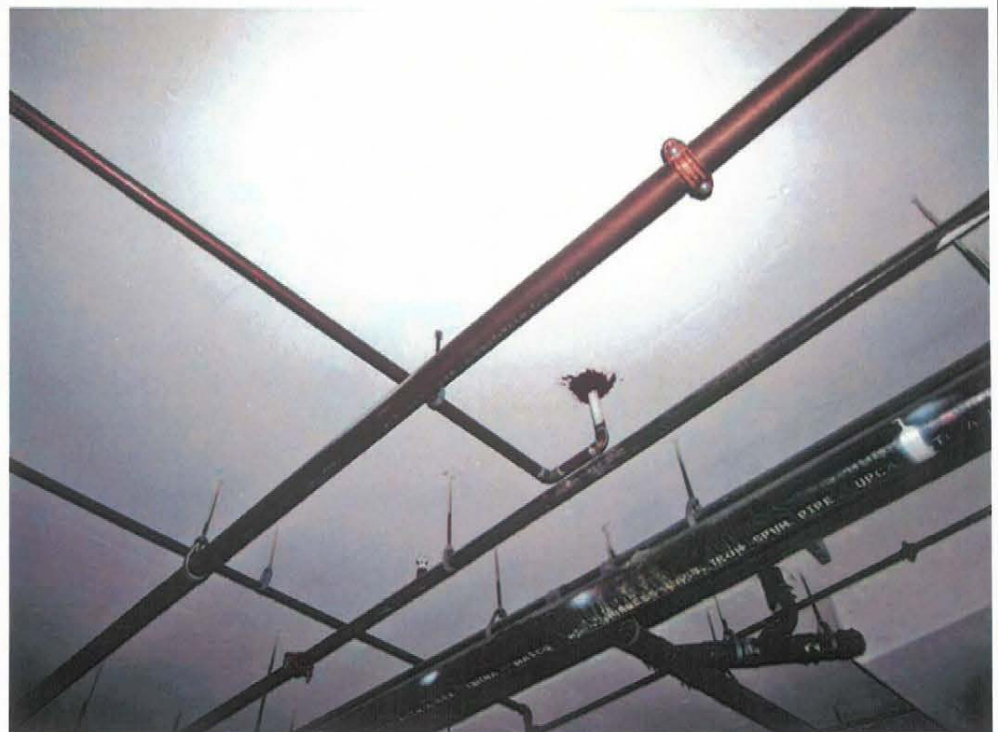
12) Typical of copper water piping visible in parking garage.
