Facility Maintenance Plan

Washington Canyon Creek - Washington Facility Group

Washington Canyon Creek - Washington Facility Group Facility Maintenance Plan

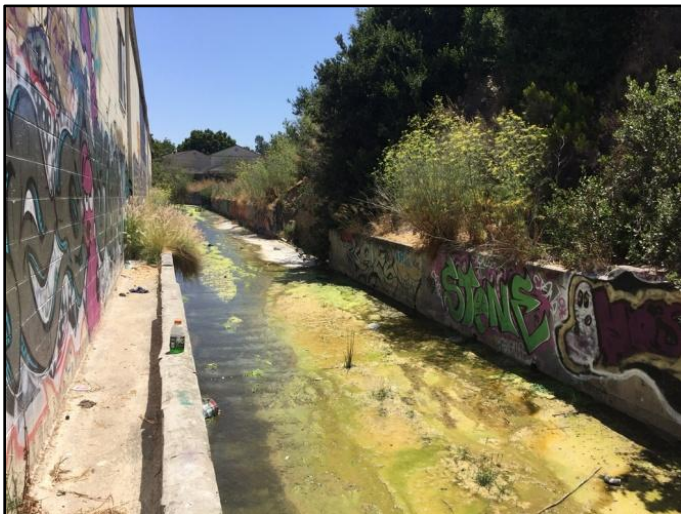
Figure 1: July 2017, looking upstream; missing sidewalk and eroded bank at center

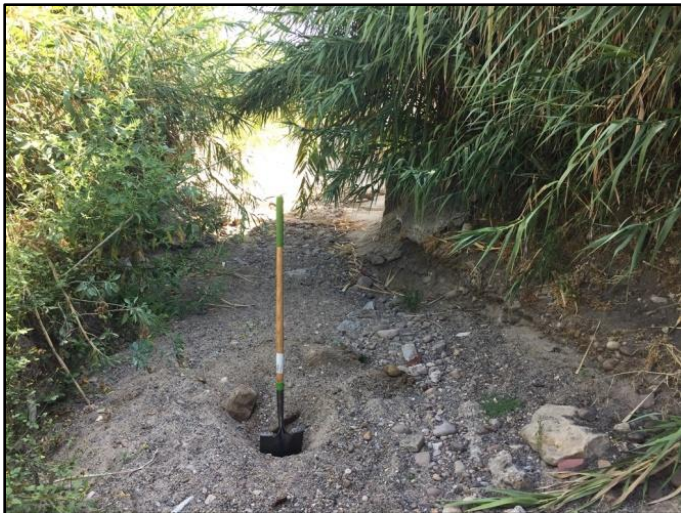
Figure 1: August 2017, looking upstream just after transition from concrete to earthen lining; deep sediment observed

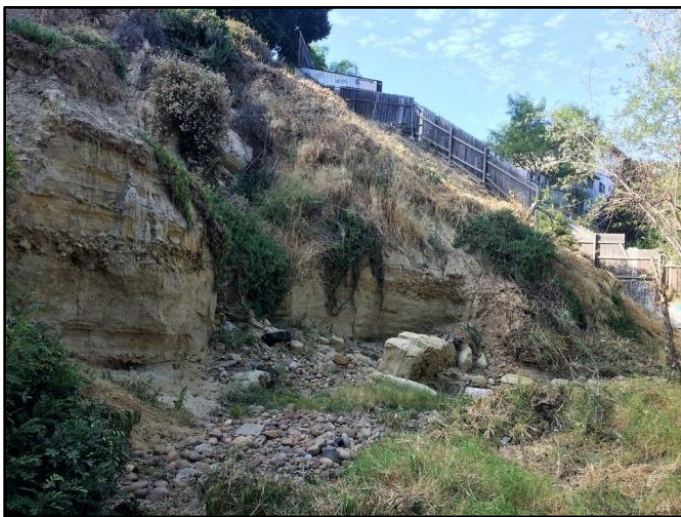
Figure 1: August 2017, looking downstream toward channel bank failure/erosion

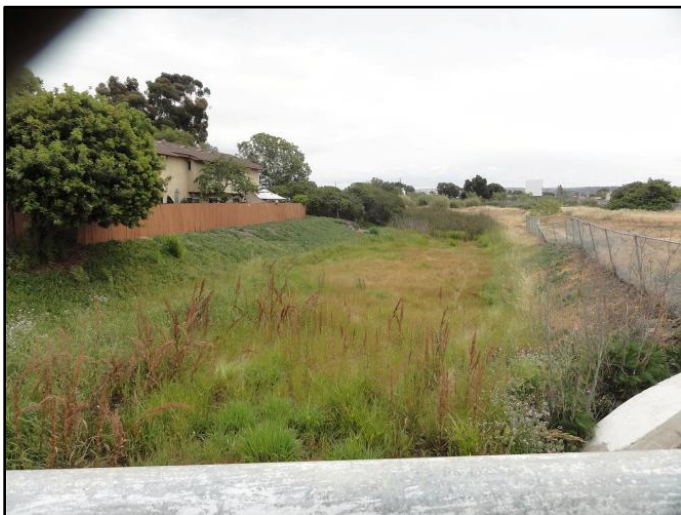
Figure 1: April 2015, looking upstream at the downstream end of the segment

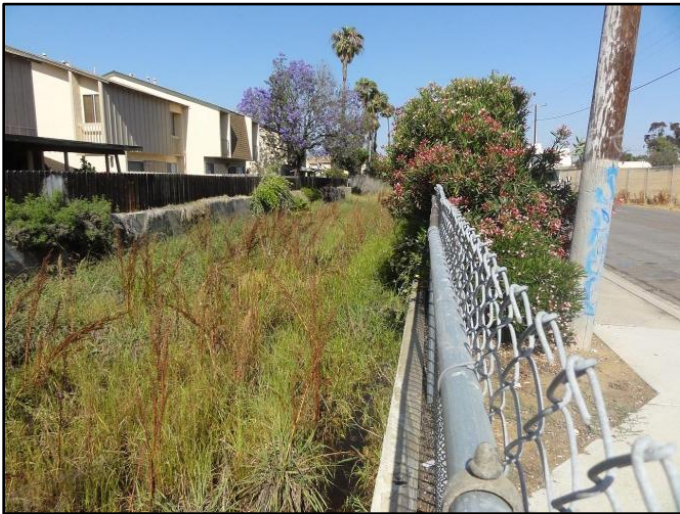
Figure 1: May 2015, looking upstream at the downstream portion of the segment
