Municipal Waterways Maintenance Plan Annual Report Fiscal Year 2023

THINK BLUE[®]
City of San Diego
Stormwater Department

October 2023

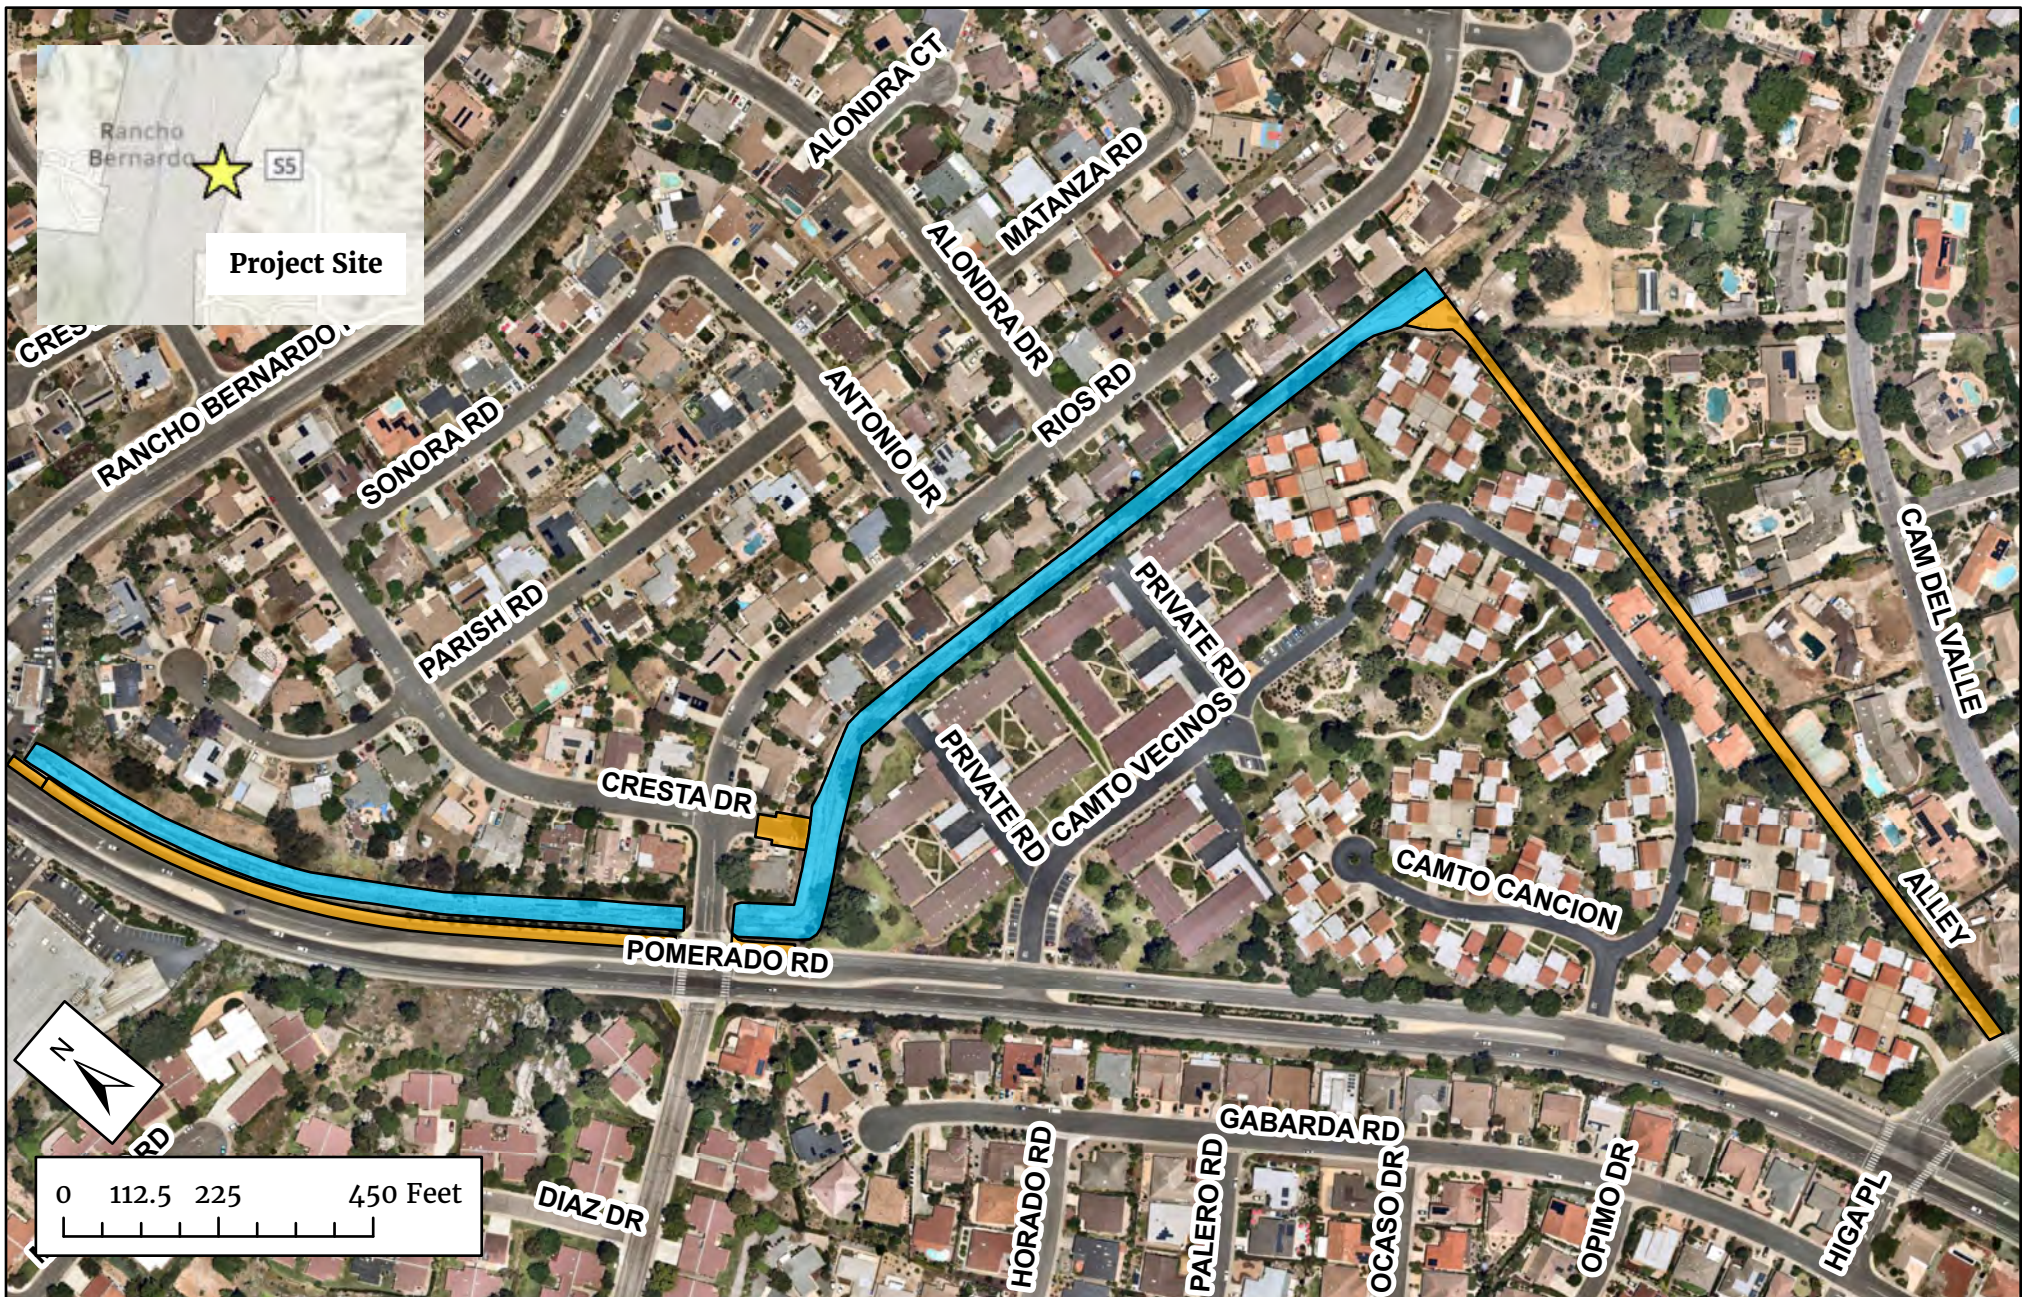
Pomerado 2 (1-04-033)
 FY 23 Routine Channel Maintenance
 Municipal Waterways Maintenance Plan Annual Report
 October 2023

Access, Staging, and Stockpiling Area

Maintenance Area

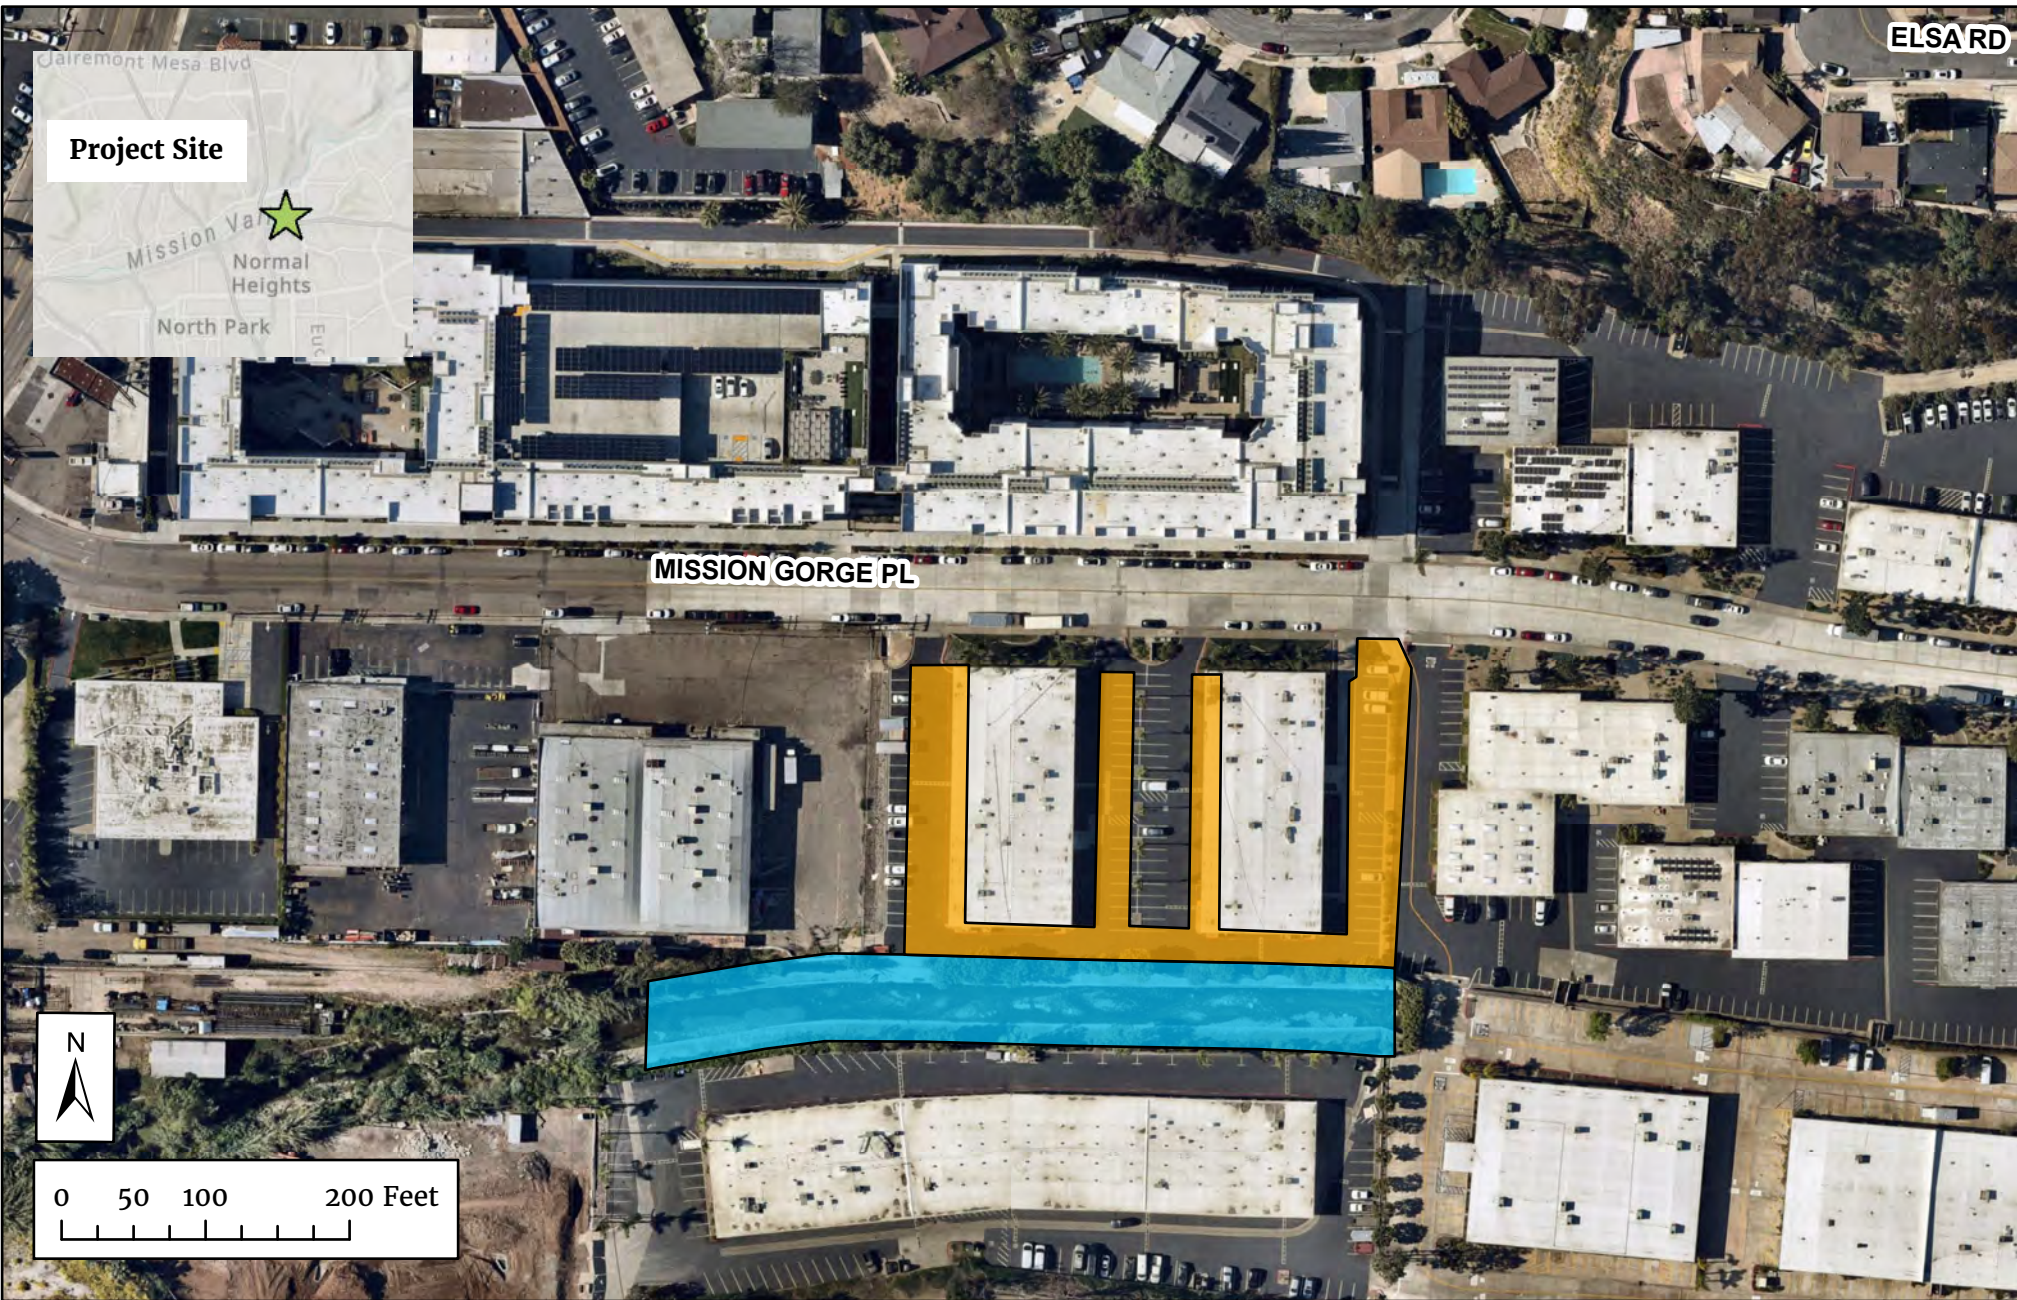
Mission Gorge 2 (4-07-004)
 FY 23 Routine Channel Maintenance
 Municipal Waterways Maintenance Plan Annual Report
 October 2023

Access, Staging, and Stockpiling Area

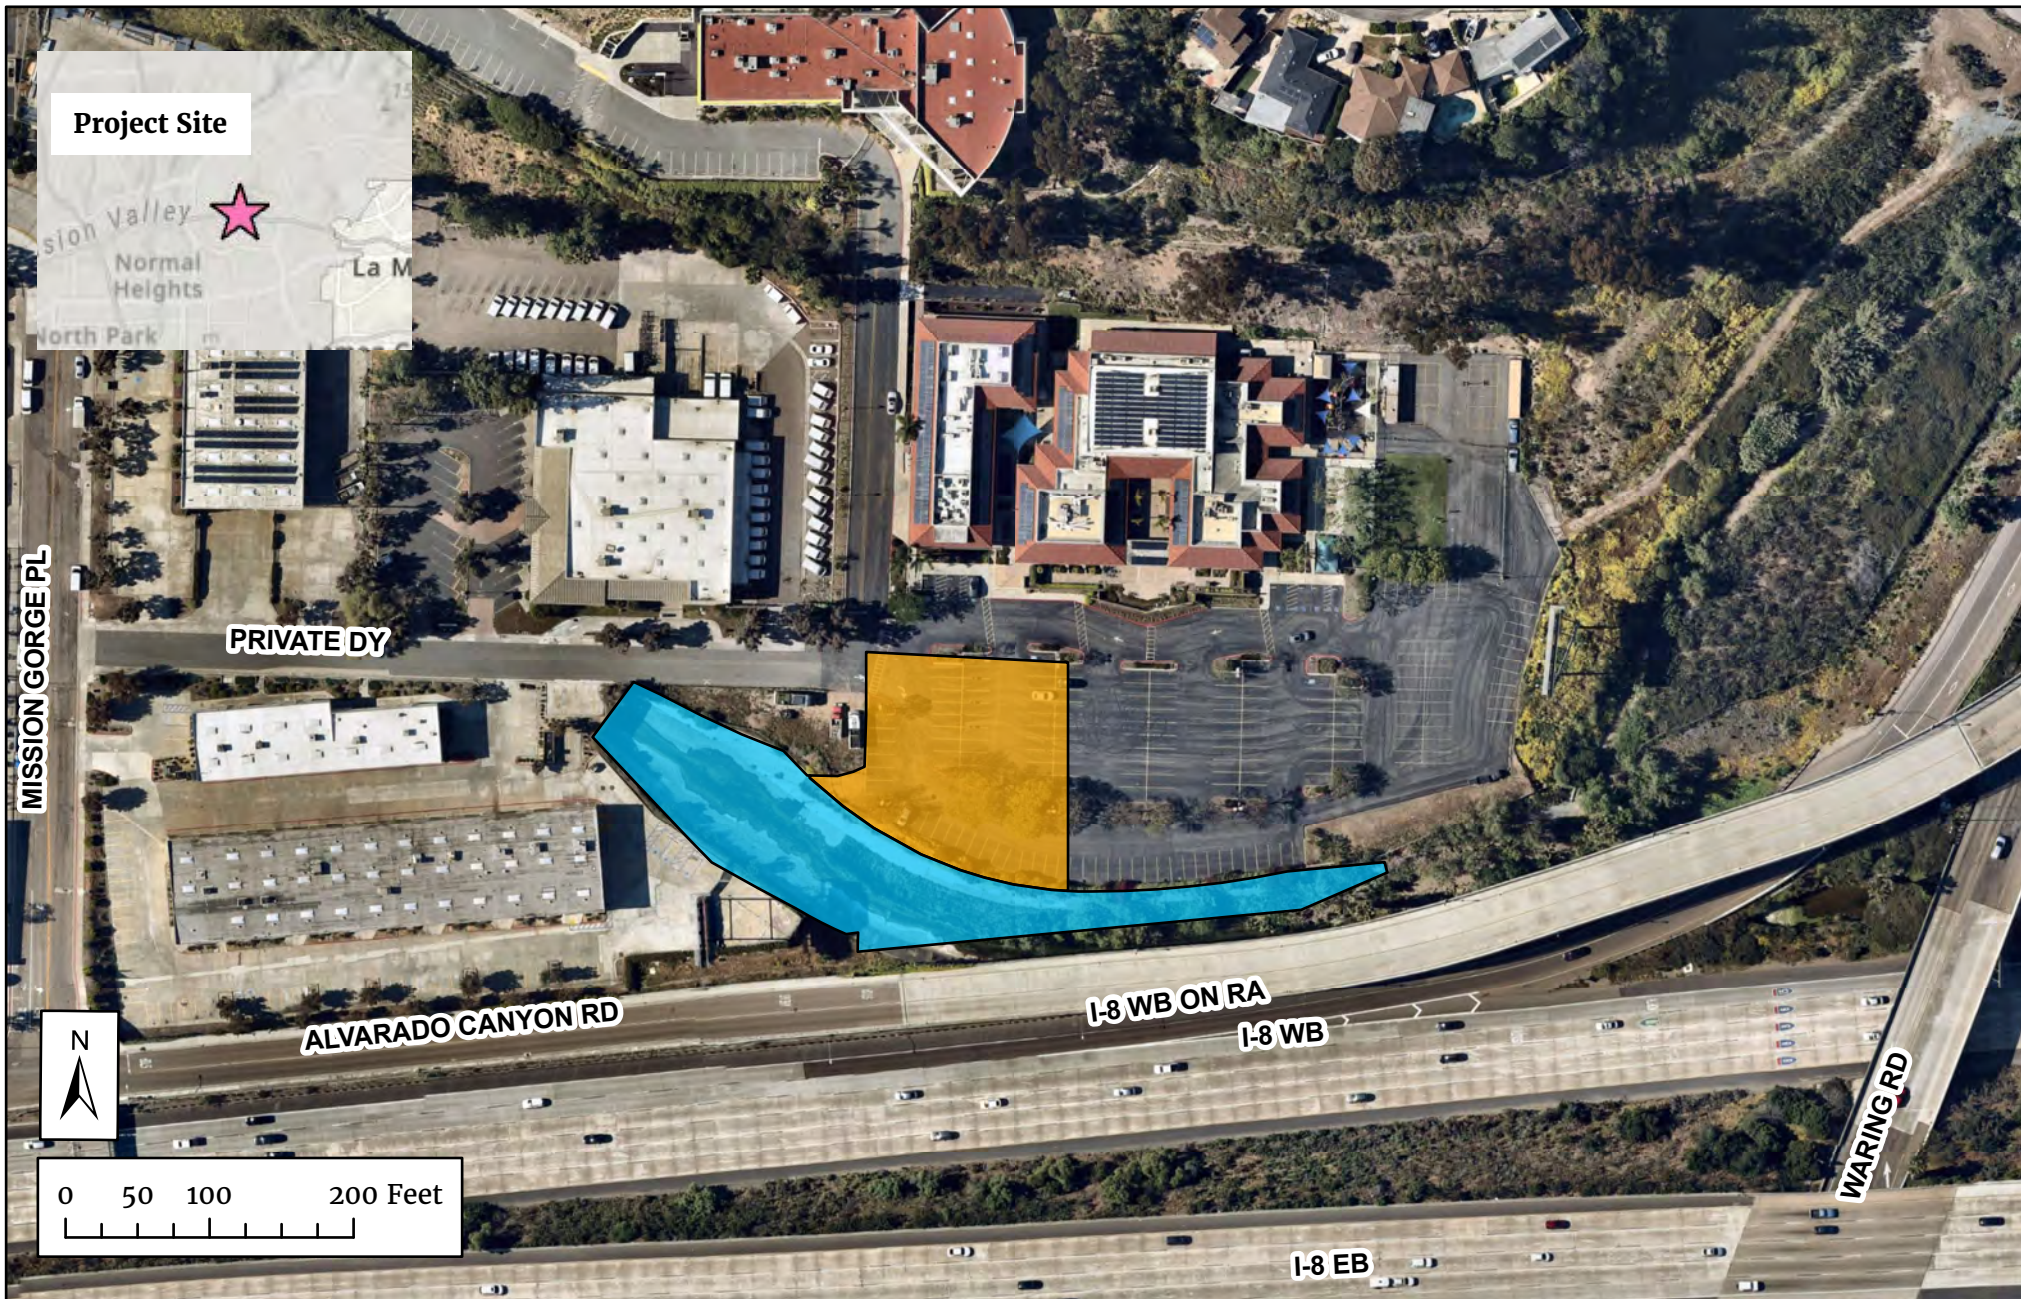
Mission Gorge 3 (4-07-009)
FY 23 Repeat Channel Maintenance
Municipal Waterways Maintenance Plan Annual Report
October 2023

Project Site

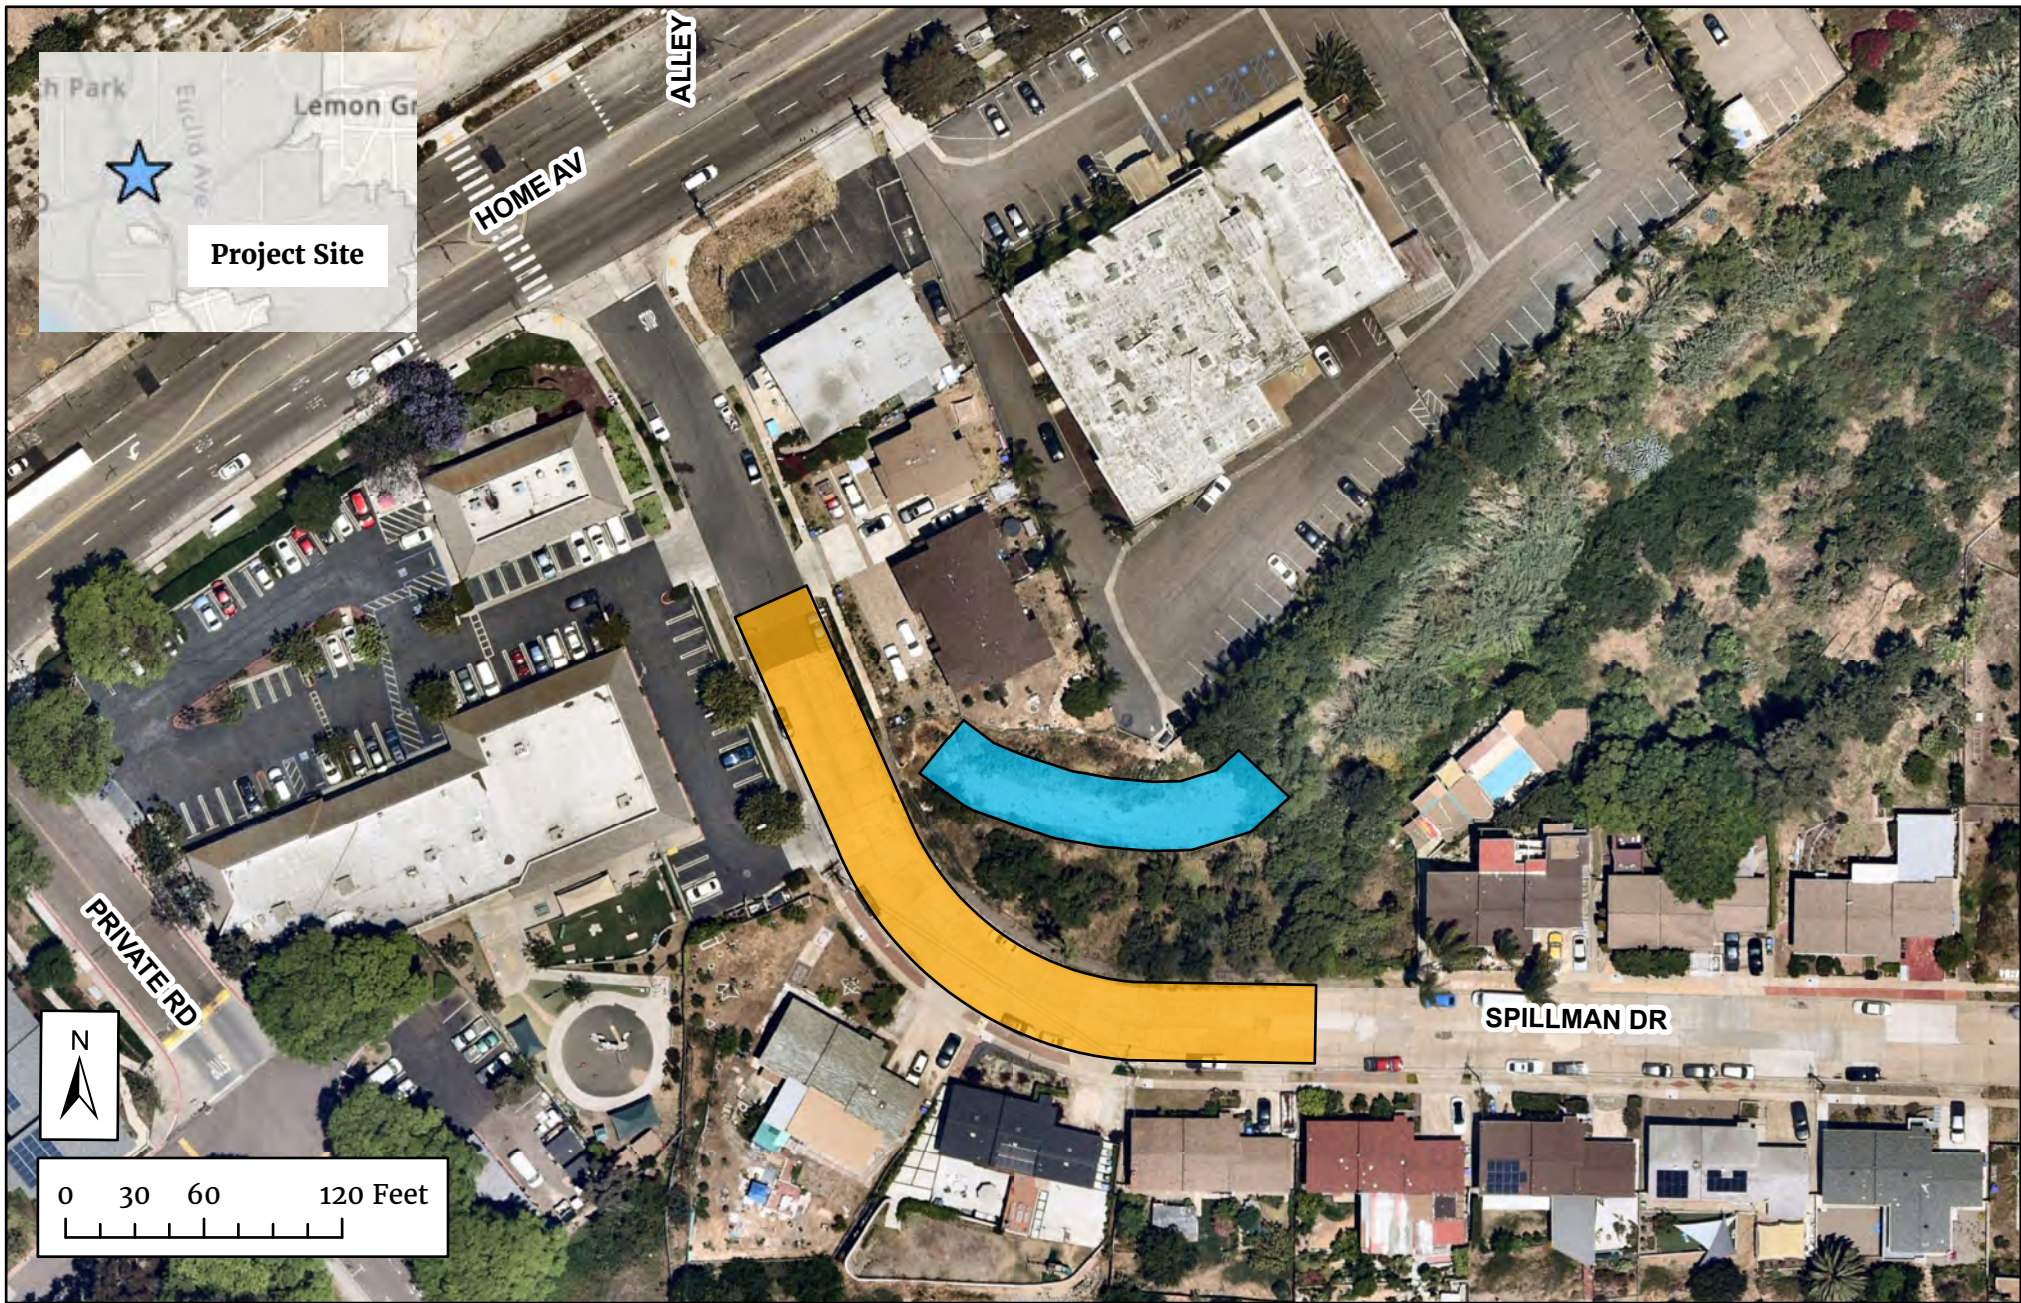
Home 2 (5-04-224)
FY 23 Routine Channel Maintenance
Municipal Waterways Maintenance Plan Annual Report
October 2023

Access, Staging, and Stockpiling Area
Maintenance Area

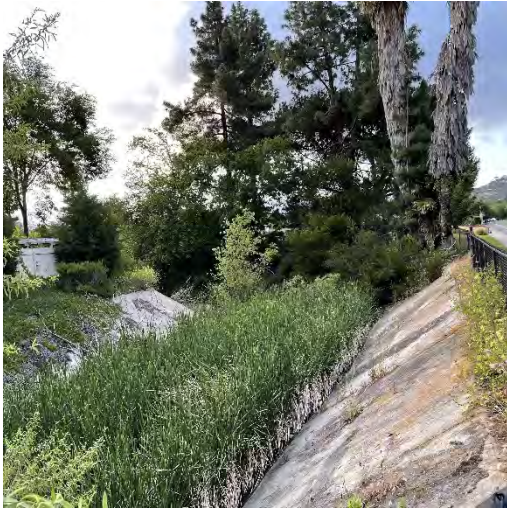
Pomerado 2 Pre-Maintenance

View of Pomerado 2 (concrete channel) looking south at built up vegetation and debris within the channel segment.

(May 10, 2023)

Once routine maintenance activities were completed, City crews removed all temporary flow diversion BMPs from the Pomerado 2 channel segment in accordance with the approved Maintenance Plans. The project was conducted in compliance with all applicable agency approvals and environmental permits. Photographs showing conditions before and after maintenance in FY 2023 are included in Appendix C. The project was monitored by qualified staff and activities were compliant with approved permits and authorizations; no remedial actions were required.

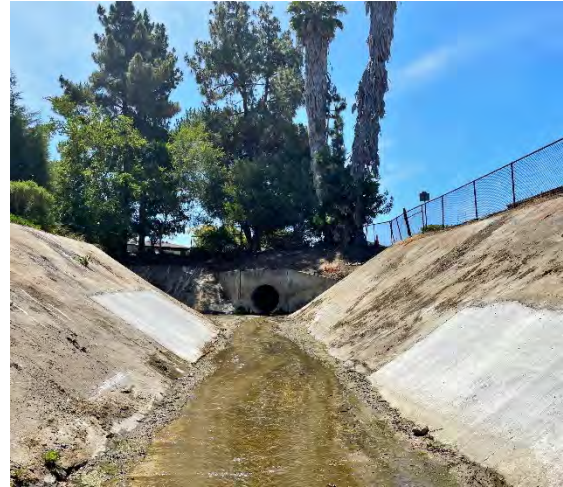
Pomerado 2 Post-Maintenance

View of Pomerado 2 (concrete channel) looking south at the channel segment after the vegetation removal and concrete repair.

(July 12, 2023)

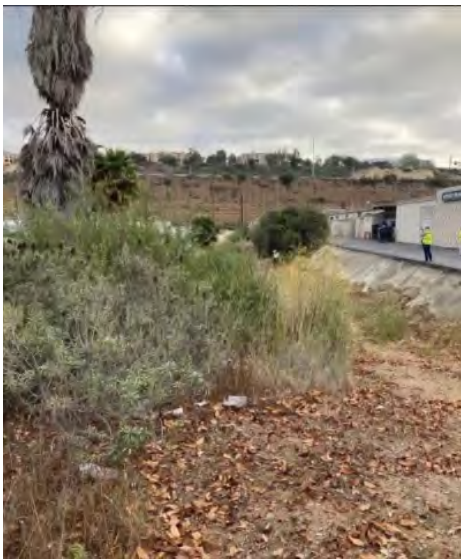
Tripp 1 Pre-Maintenance

View of Tripp 1 (concrete channel) looking northeast from Sorrento Valley Road.

(September 16, 2022)

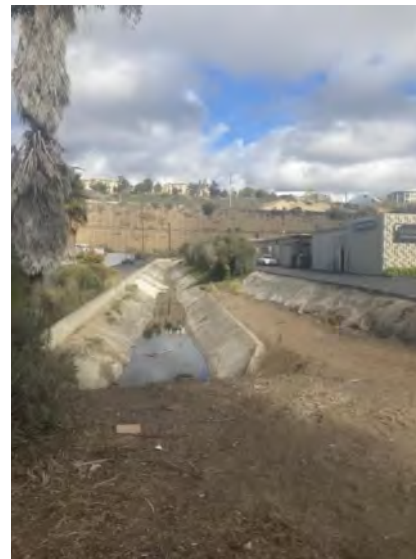
Tripp 1 Post-Maintenance

View of Tripp 1 (concrete channel) looking northeast from Sorrento Valley Road showing the cleared ditch.

(November 7, 2022)

Routine maintenance work resulted in impacts to both vegetated and unvegetated portions of the maintenance areas totaling 0.46 acre (782 linear feet) within Tripp 1. Table 3 provides additional details regarding impacts to specific vegetation communities. Approximately 135 CYs (157 tons) of sediment and vegetation were removed from the Tripp 1 maintenance area. Following removal of vegetation and sediment within the maintenance area, five sections of the concrete lining were identified as needing minor concrete repair. Approximately 24 cubic yards (58 tons) of damaged concrete was removed from the channel and 24 cubic yards of concrete was subsequently discharged into the channel to restore the damaged portions of concrete lining to the original as-built dimensions. During concrete repair, a temporary sandbag berm was installed around each work area to prevent unauthorized discharges, and a diversion hose and by-pass pump were used as needed for dewatering. The minor concrete repairs occurred within

the approved impact area and matched the as-built grade and form of the original concrete-lining such that there were no changes to the channel dimensions as a result of the repairs. Since these additional impacts occurred within the previously approved impact limits, project impacts were consistent with limits authorized by project approvals.

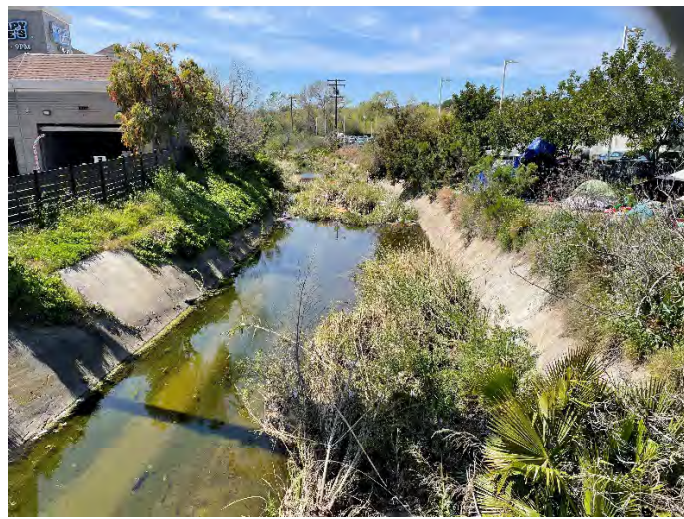
Mission Gorge 1 Pre-Maintenance

View of Mission Gorge 1 (earthen and concrete channel) facing west and looking downstream.

(April 17, 2023)

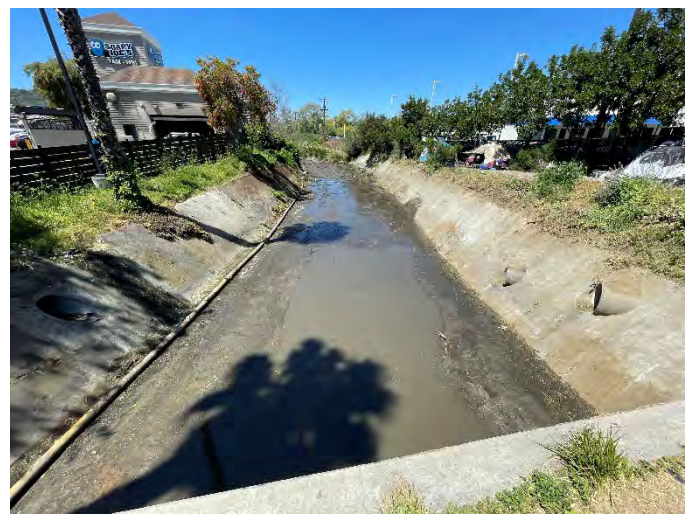
Mission Gorge 1 Post-Maintenance

View of Mission Gorge 1 (earthen and concrete channel) facing west and looking downstream, after maintenance was performed.

(April 24, 2023)

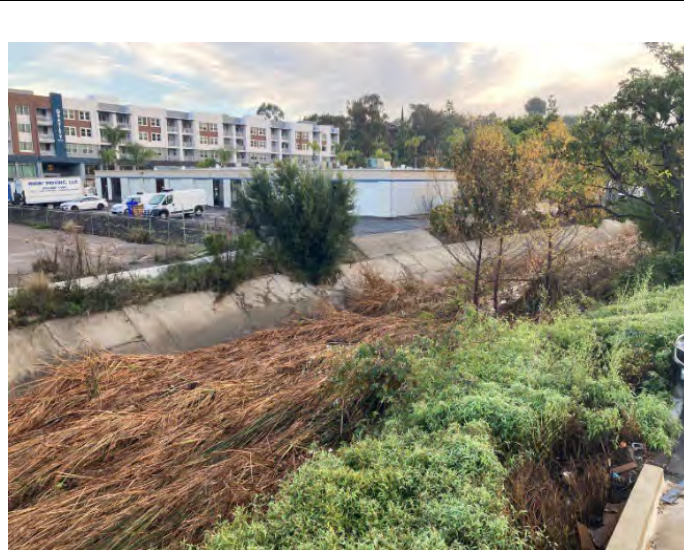
Mission Gorge 2 Pre-Maintenance

View of Mission Gorge 2 (concrete channel) looking at built up vegetation and debris within the channel segment.

(January 6, 2023)

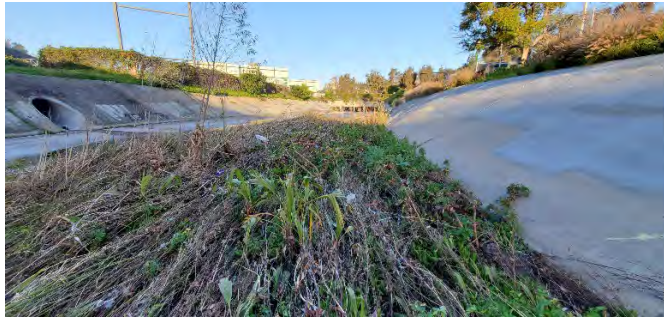
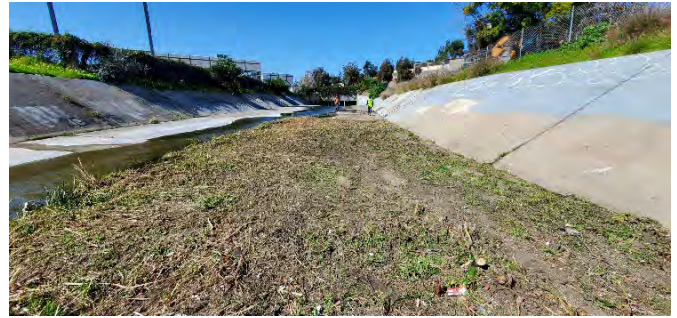
Mission Gorge 3 Pre-Maintenance

View of Mission Gorge 3 (earthen and concrete channel) facing east. Looking at minor vegetation growth.

(February 15, 2023)

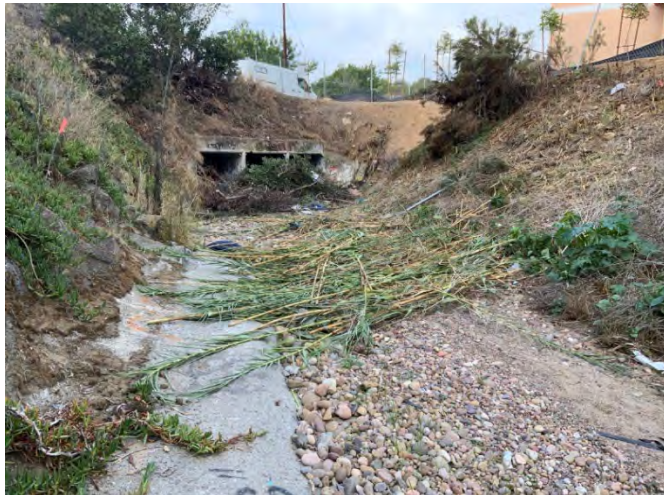
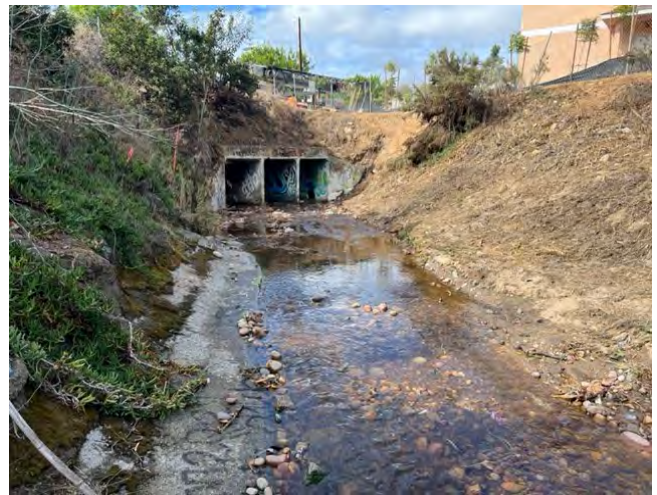
Home 2 Pre-Maintenance

View of Home 2 (earthen channel) facing west, before maintenance work was performed.

(November 2, 2022)

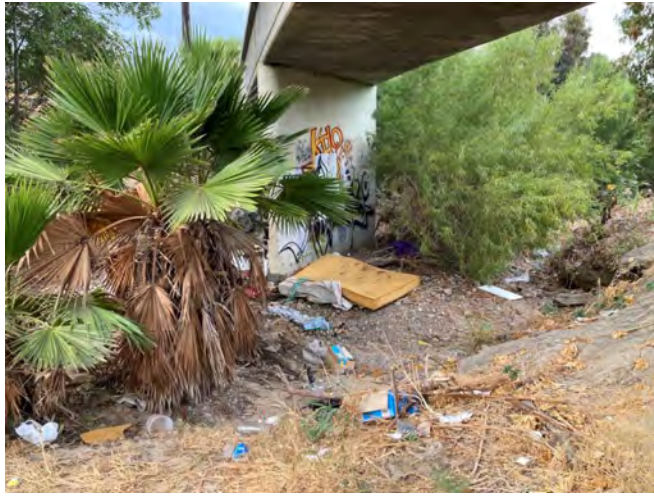
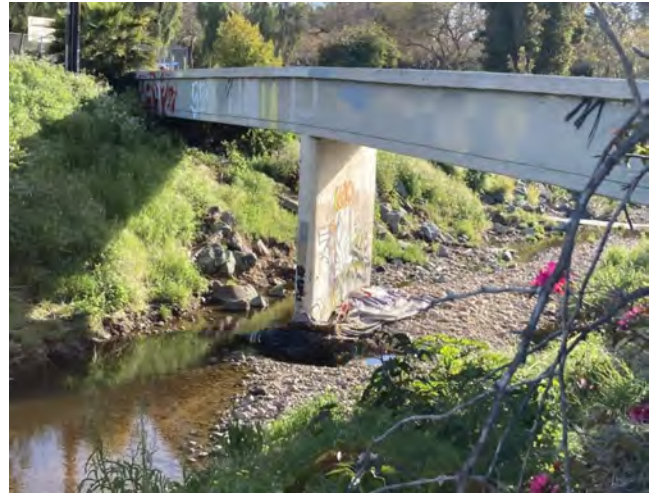
Alpha 1 Pre-Maintenance

View of Alpha 1 (earthen and concrete channel) looking southwest at disturbed land, riparian habitat, and accumulated trash within the upstream section of the channel under the pedestrian bridge.

(February 28, 2023)

A site evaluation was conducted by City engineers on September 7, 2022, at the Alpha 1 (earthen) and Ocean View 1 (concrete/earthen) facility segments to assess levels of sediment, vegetation, and debris in preparation of an intense storm associated with Hurricane Kay that was expected to produce upwards of 0.7 inches of rain beginning on Friday, September 9th and continuing through the afternoon of September 10th. Due to impending conditions and weather patterns expected from the hurricane, emergency actions were deemed necessary to alleviate the threat of flooding to adjacent properties and infrastructure. Based on hydraulic reports for both the Alpha 1 and Ocean View 1 segments, accumulated material had constricted hydraulic capacity in both these channels such that, combined with forecasted rain levels, it was determined that an unexpected threat to life and property involving clear and imminent danger from the potential flooding had developed. On September 7th, 2022, at approximately 7:00 pm emergency actions were determined to be necessary to alleviate the emergency. Due to the sudden nature of the emergency conditions, work was initiated on September 8, 2022.

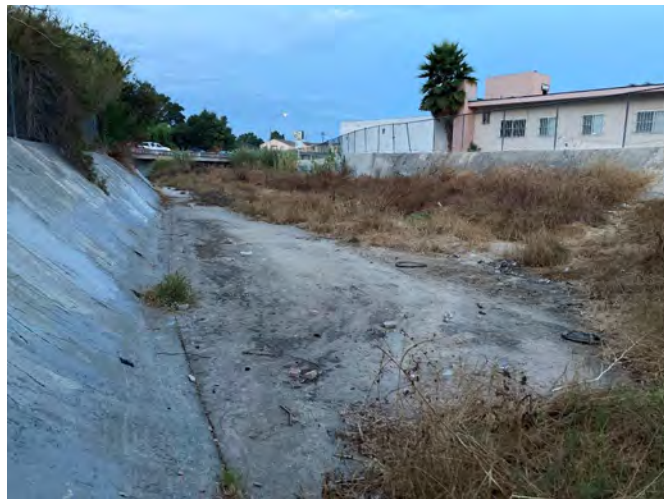
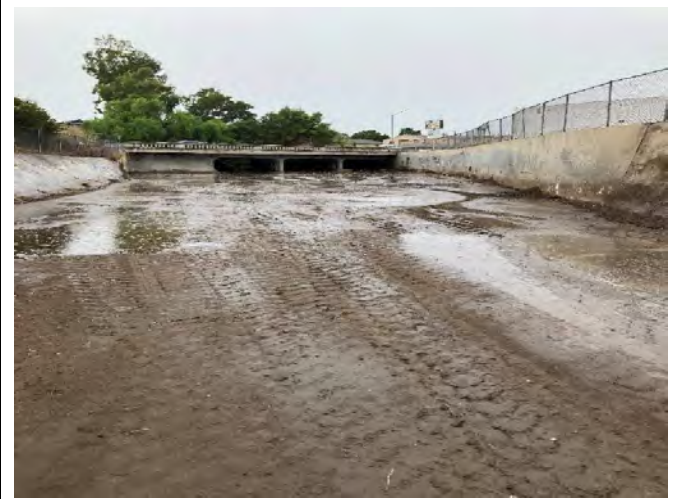
Ocean View 1 Pre-Maintenance

View of Ocean View 1 (earthen and concrete channel) looking south towards the National Ave. bridge at developed concrete-lined channel.
