Municipal Waterways Maintenance Plan Annual Report Fiscal Year 2021

October 2021

City of San Diego Stormwater Department

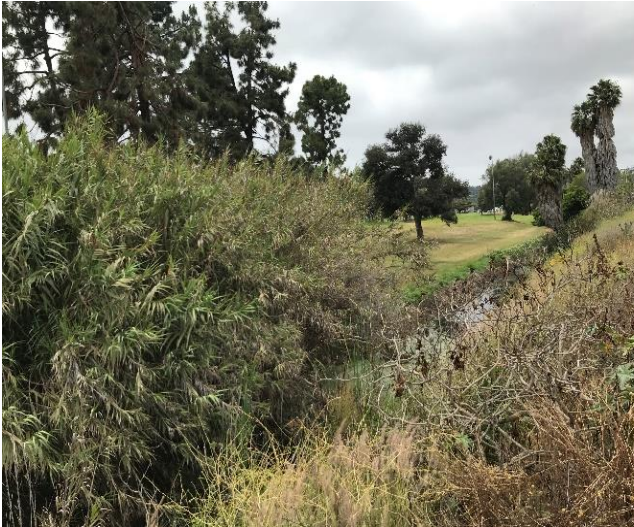
Photo 1: Facing upstream of the Mission Bay Drive-1 Channel pre-maintenance. Taken June 4, 2020.

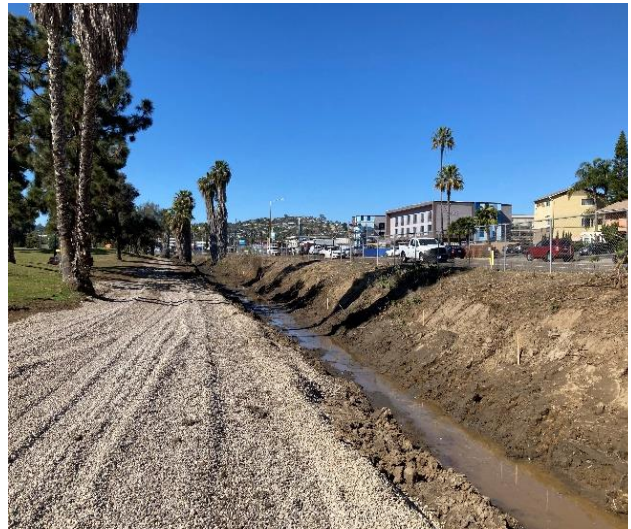
Photo 2: Facing upstream of the Mission Bay Drive-1 Channel following vegetation and sediment removal. Taken February 6, 2021.

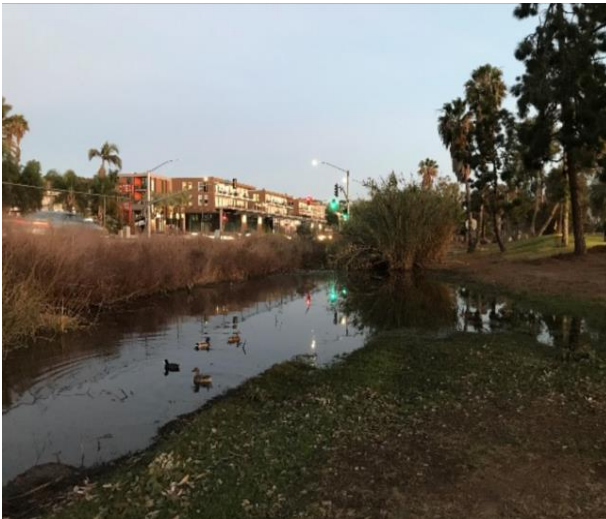
Photo 3: Facing downstream of the Mission Bay Drive-1 Channel prior to maintenance. Taken January 27, 2021.

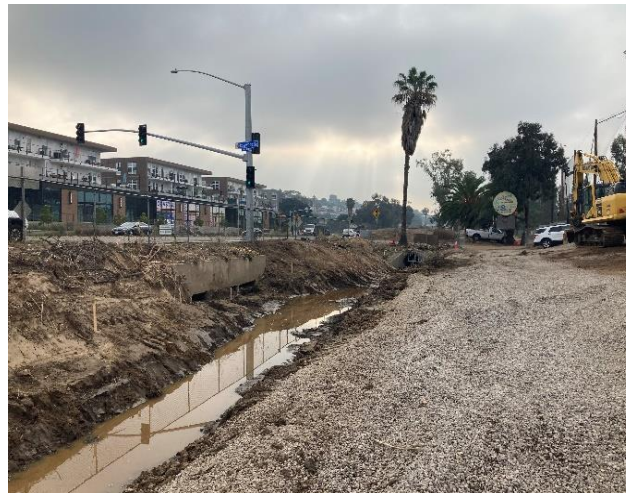
Photo 4: Facing downstream of the Mission Bay Drive-1 Channel following completion of maintenance. Taken February 8, 2021.

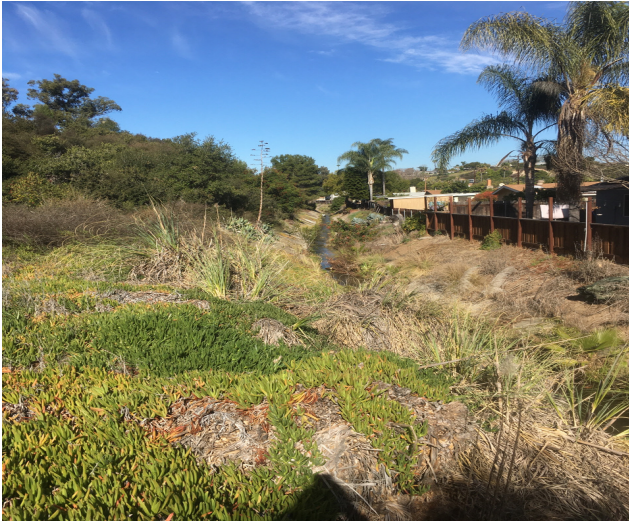
Photo 5: Chateau 1 Channel facing upstream pre-maintenance. Taken January 28, 2021.

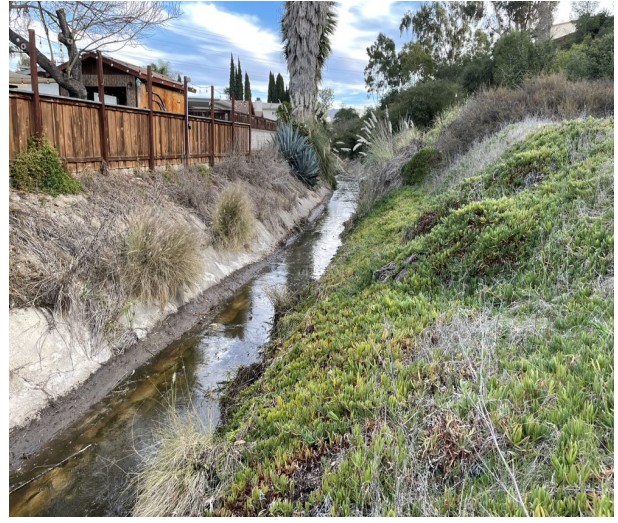
Photo 6: Chateau 1 Channel facing downstream post-maintenance. Taken January 28, 2021.

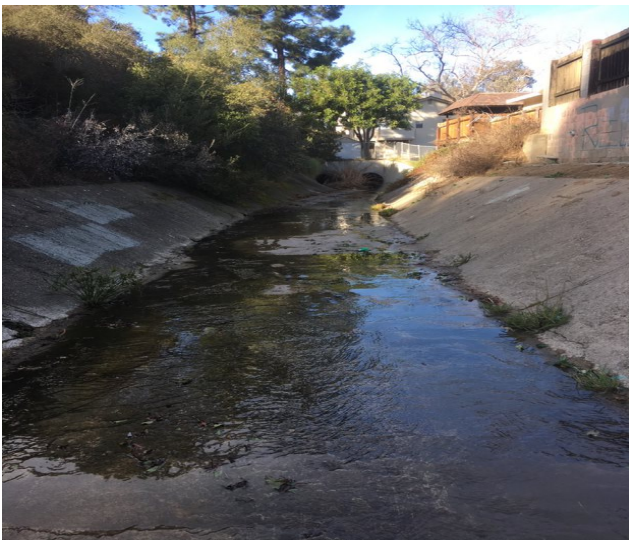
Photo 7: Facing downstream pre-maintenance. Taken January 28, 2021.

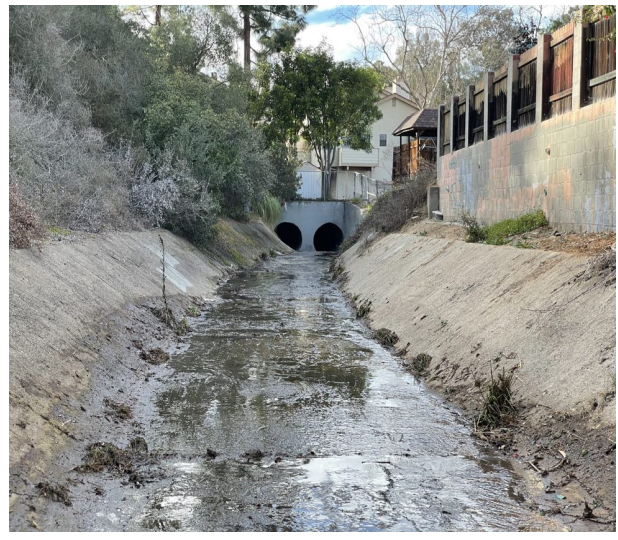
Photo 8: Facing downstream post-maintenance. Taken January 28, 2021.

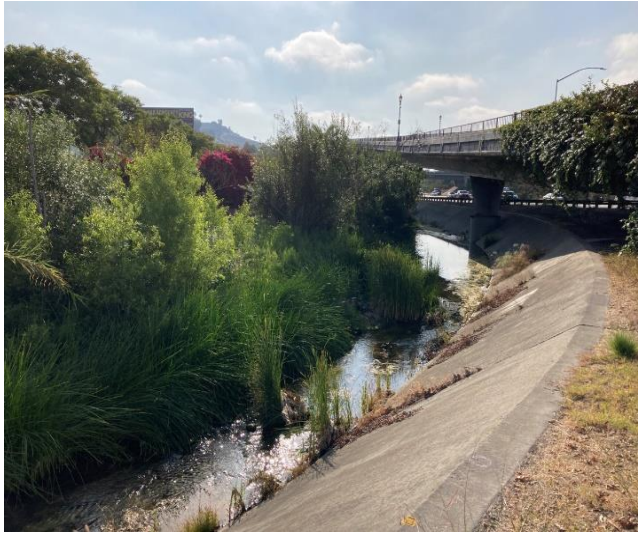
Photo 9: Facing upstream of the Mission Gorge 3 channel segment showing vegetated portion of the earthen section pre-maintenance. Taken June 4, 2021.

Maintenance of the Mission Gorge 3 segment was completed on June 28, 2021 and removed 340 tons of material in addition to installing a coir mat for erosion control within the channel. Routine maintenance at the Mission Gorge 4 section continued into FY 2022 in order to complete additional repairs to the concrete bank which were identified after the start of maintenance. All project activities were completed on August 9,

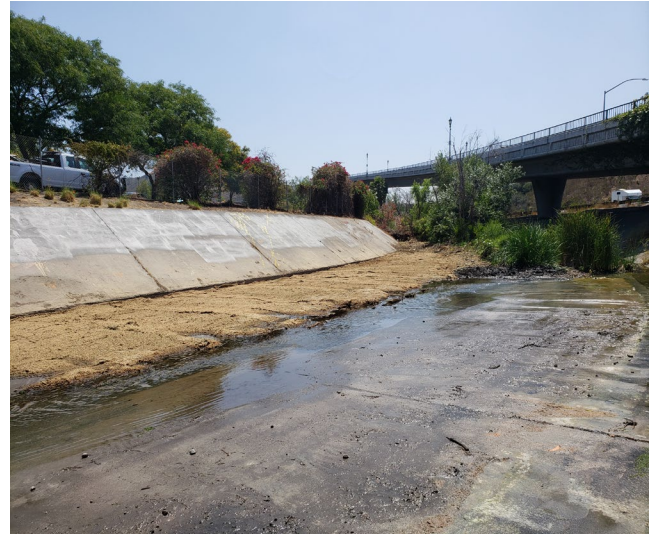
Photo 10: Facing upstream of the Mission Gorge 3 channel segment showing earth section of channel with vegetation removed and coir mat installed. Taken June 29, 2021.

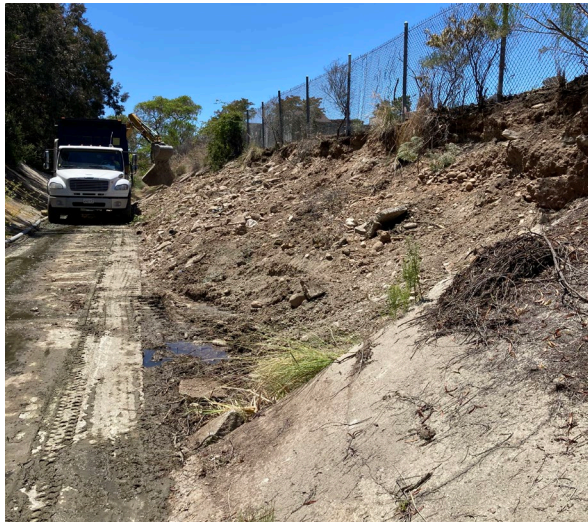
Photo 11: Facing downstream of the Mission Gorge 4 channel segment prior to concrete repairs showing the degraded concrete bank. Taken June 8, 2021.

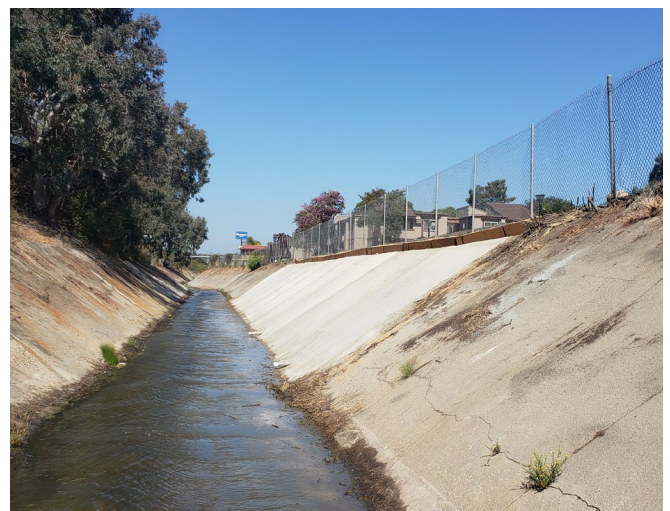
Photo 12: Facing downstream of the Mission Gorge 4 channel segment following completion of maintenance and new concrete panels. Taken September 2, 2021.

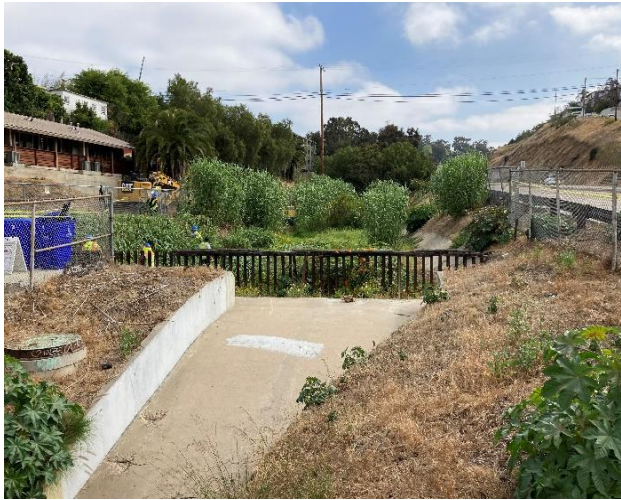
Photo 13: At the downstream section of the Washington 1 segment pre-maintenance with the concrete lined spillway that leads into the downstream culvert in the foreground. Taken June 1, 2021.

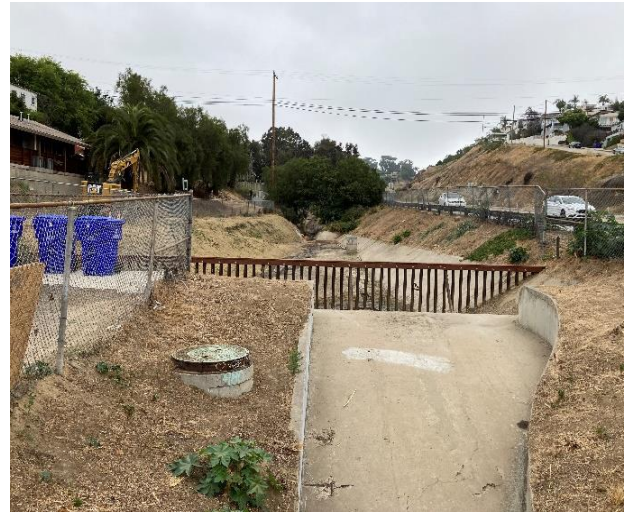
Photo 14: At the downstream section of the Washington 1 segment post-maintenance. Taken June 28, 2021.

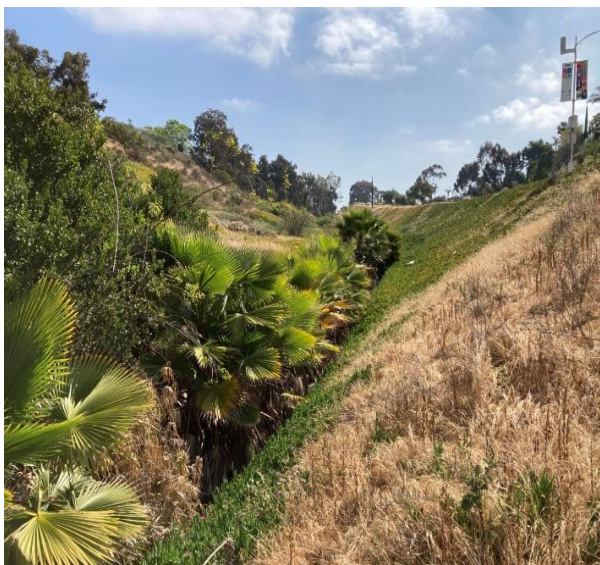
Photo 15: Facing upstream of the Washington 2 segment pre-maintenance. Taken June 1, 2021.

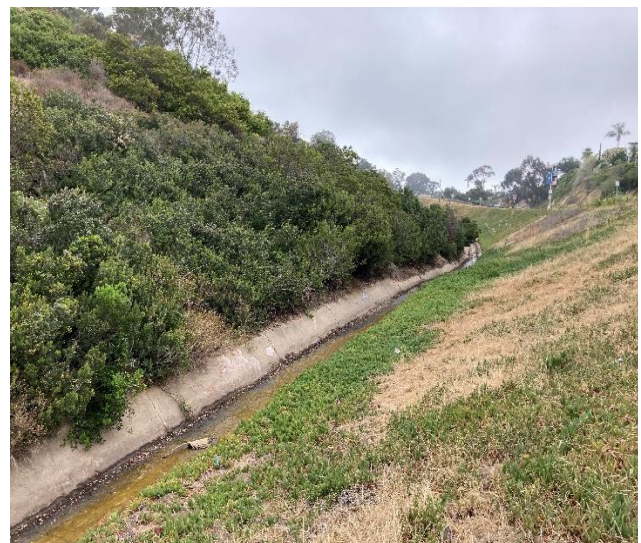
Photo 16: Facing upstream of the Washington 2 segment post-maintenance. Taken June 28, 2021.

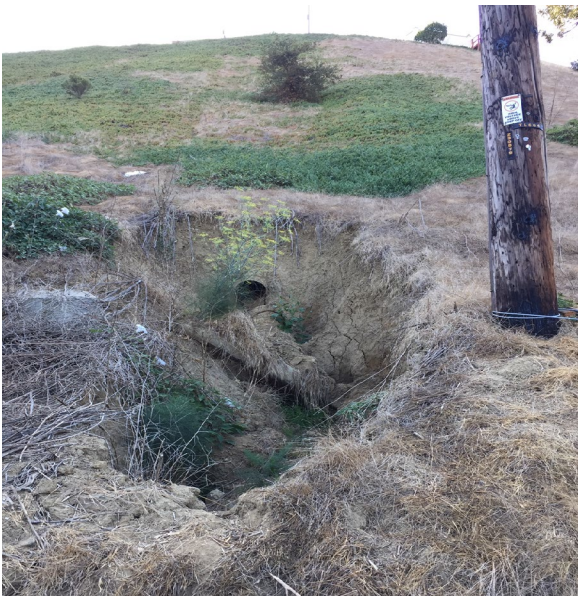
The Angell Avenue Emergency Pipe Repair project was initiated on November 3, 2020 and was completed on December 11, 2020. The emergency project was identified after a sinkhole formed on an undeveloped hillside below the failure point of an existing corrugated metal pipe. The sinkhole came within one foot of an adjacent San Diego Gas & Electric (SDG&E) electrical transmission pole causing concern that the sinkhole may compromise the pole’s foundation. The City and SDG&E determined that immediate action to repair the failed pipe was needed to protect SDG&E infrastructure and surrounding resources.

Photo 17: Facing uphill showing failed pipe and resulting sink hole directly next to the SDG&E transmission pole. Photo taken September 30, 2020.

The project consisted of the replacement of an approximately 70 foot section of failed pipe with an 18-inch high-density polyethylene (HDPE) pipe approximately 5 feet underground and an additional 30 feet of HDPE which was installed above ground within the City’s 10-foot easement. The project also included the installation of a Type-A cleanout, replacement of existing rip rap and concrete sill wall, and post maintenance erosion controls consisting of a silt fence installed at the end of the HDPE pipe, revegetation of the impact area, and installation of jute mesh to prevent erosion on the slope. Approximately 0.0002 acres of temporary impacts and 0.0023 acres of permanent impacts occurred to southern coast live oak riparian forest (CDFW and City jurisdiction only) as a result of project activities. All other impacts were to non-sensitive vegetation communities. The project did not impact USACE or RWQCB jurisdictional resources.

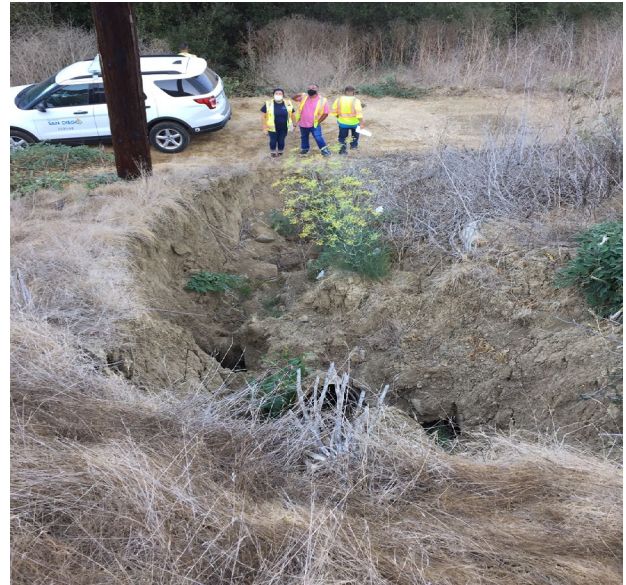
Photo 18: Facing downhill showing failed pipe section and resulting sink hole. Taken September 30, 2020.

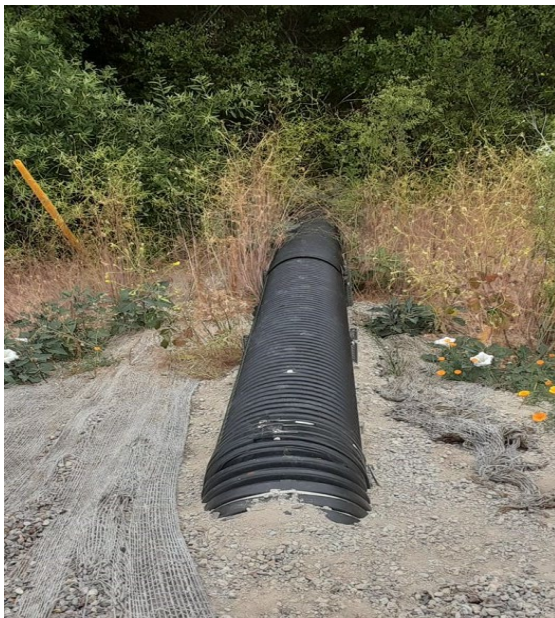
Photo 19: Facing downhill showing above-ground section of new HDPE installed. Taken May 20, 2021.

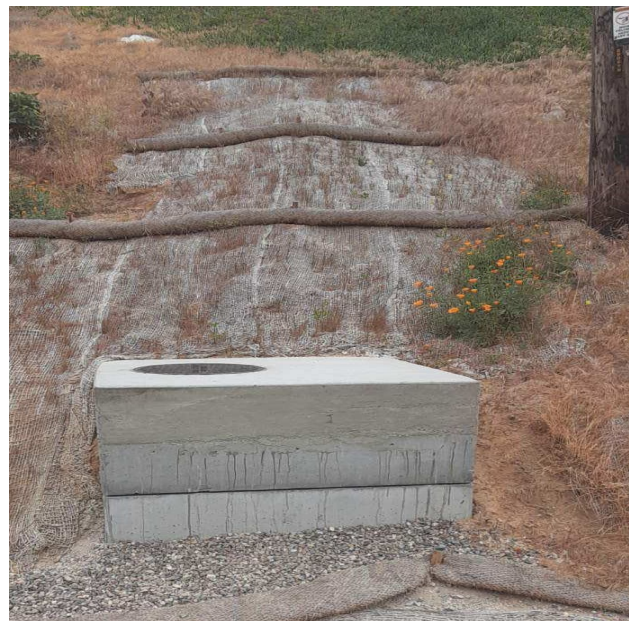
Photo 20: Facing uphill showing re-established slope grade, new Type-A cleanout, and post-maintenance erosion controls. Taken May 20, 2021.
