PHASE II ENVIRONMENTAL SITE ASSESSMENT

Palm and Hollister
555 Hollister Street
San Diego, California

AEC Project No. 19-182SD
January 20, 2020

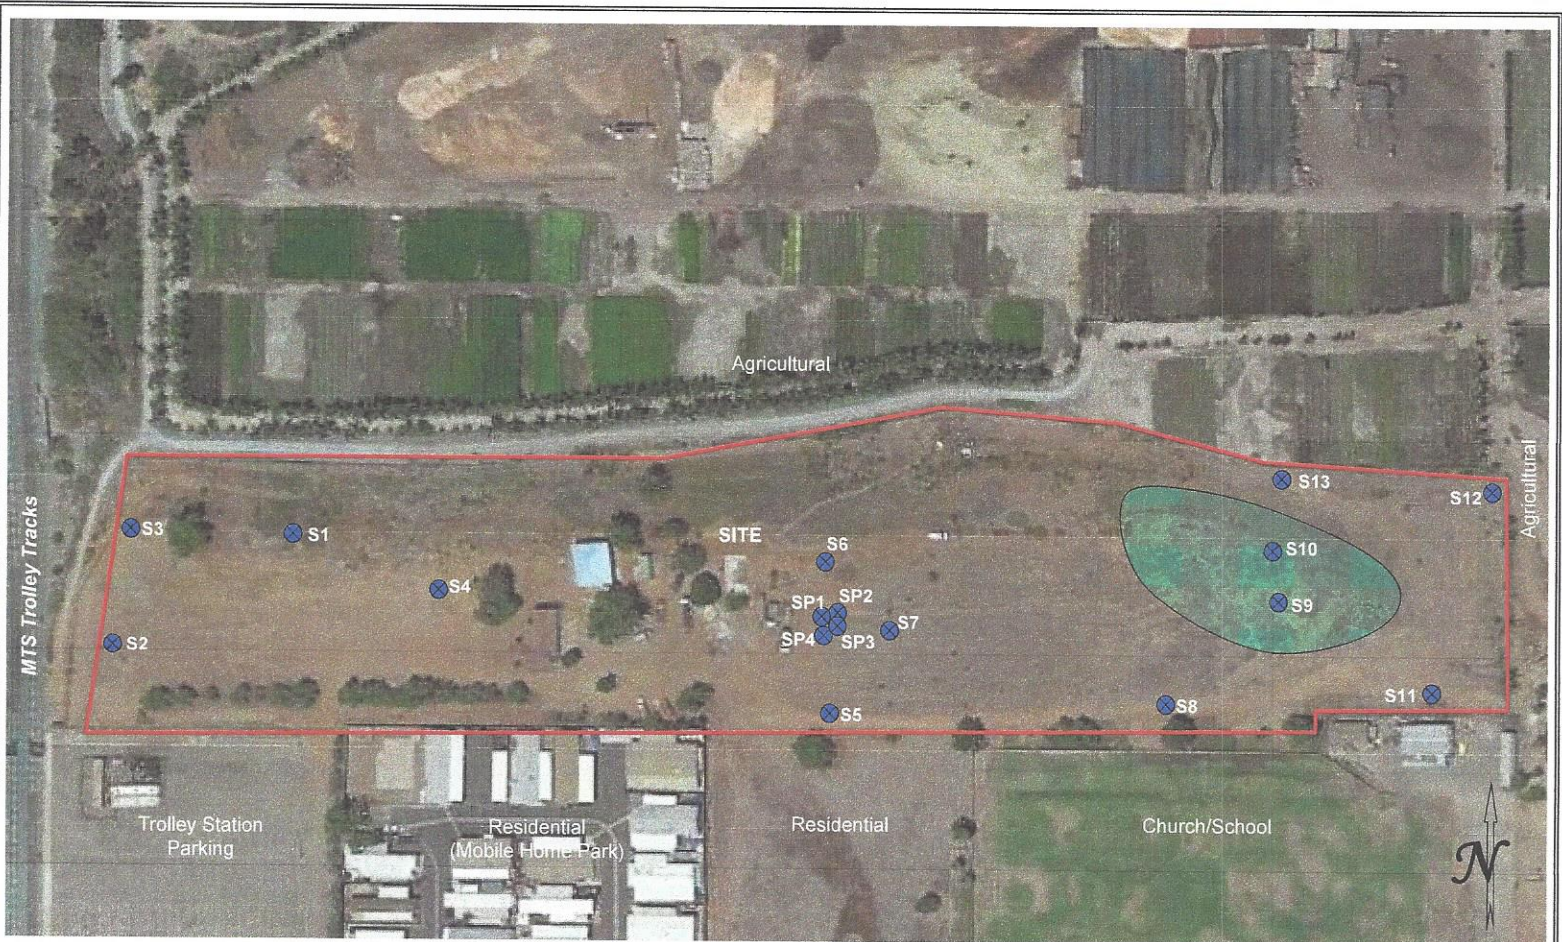
SITE PLAN
 555 Hollister Street
 San Diego, California

In conjunction with geotechnical exploration activities performed by Geosolutions, thirteen test pits were excavated at the Site on December 19, 2019 using a backhoe. A Site Plan depicting the approximate soil sampling locations is included as Figure 2. The target depth of each test pit was 12-13 feet below ground surface (bgs).

Approximately one to two feet of topsoil/fill was encountered at each of the sampling locations followed by native material with the exception of test pits S9 and S10 which are located in the eastern area of the Site and containing buried construction debris and trash. Buried construction debris and trash in S9 and S10 was noted from one to two feet bgs to the bottom of each test pit at approximately 13 feet bgs. No significant staining and/or odors indicative of petroleum hydrocarbons were identified in the remaining test pits during the sampling activities.
