# Master Storm Water System Maintenance Program Annual Report

**SD** Transportation &  
Storm Water

AUGUST 2019

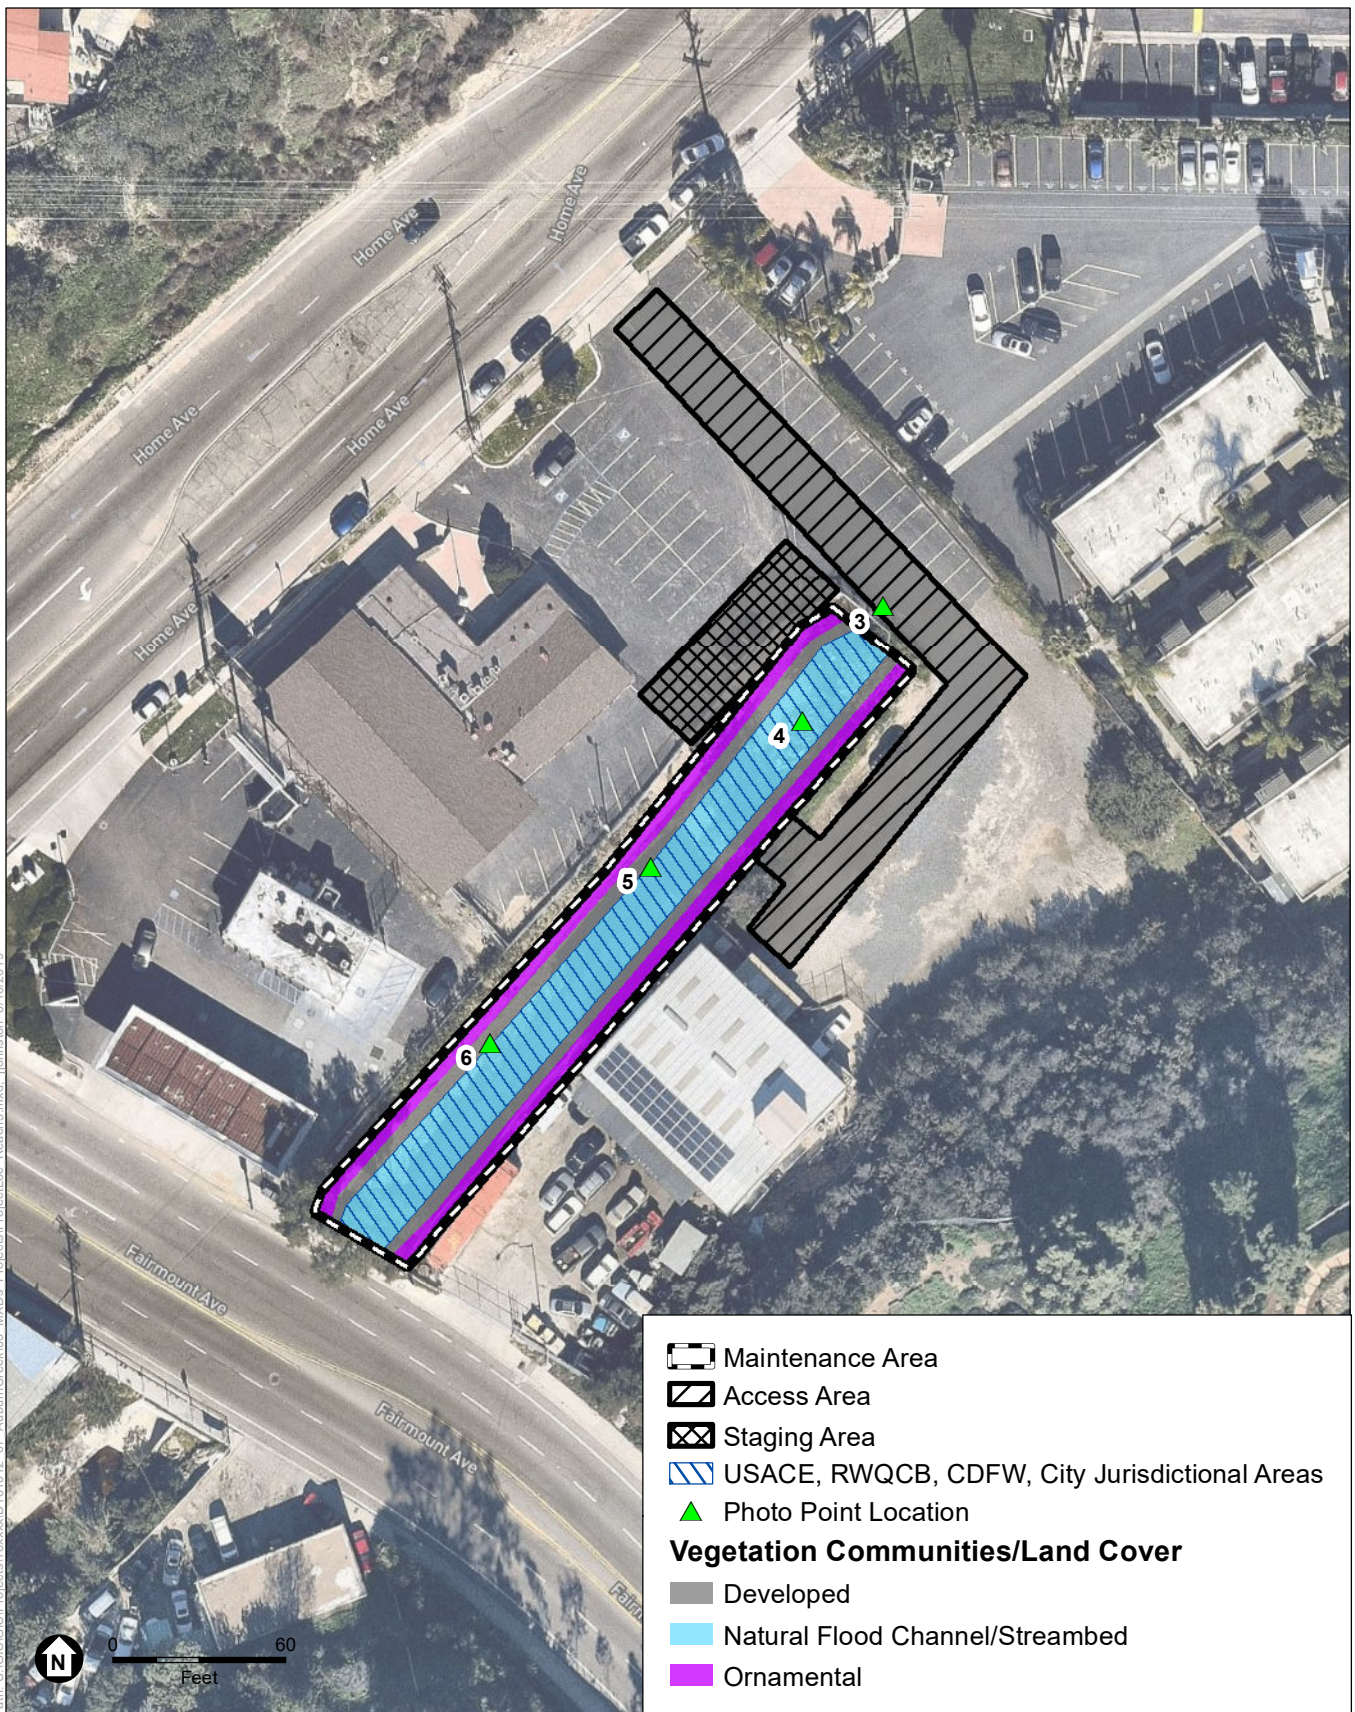
Auburn Creek Reach 5 (Map 70) Pre-Maintenance Conditions

Auburn Creek Reach 1 and 5 (Maps 76 and 70)

Figures 3-6 in Appendix A display pre-maintenance and post-maintenance vegetation. Photographs showing conditions of the channel during maintenance in FY 2019 are included in Appendix C.

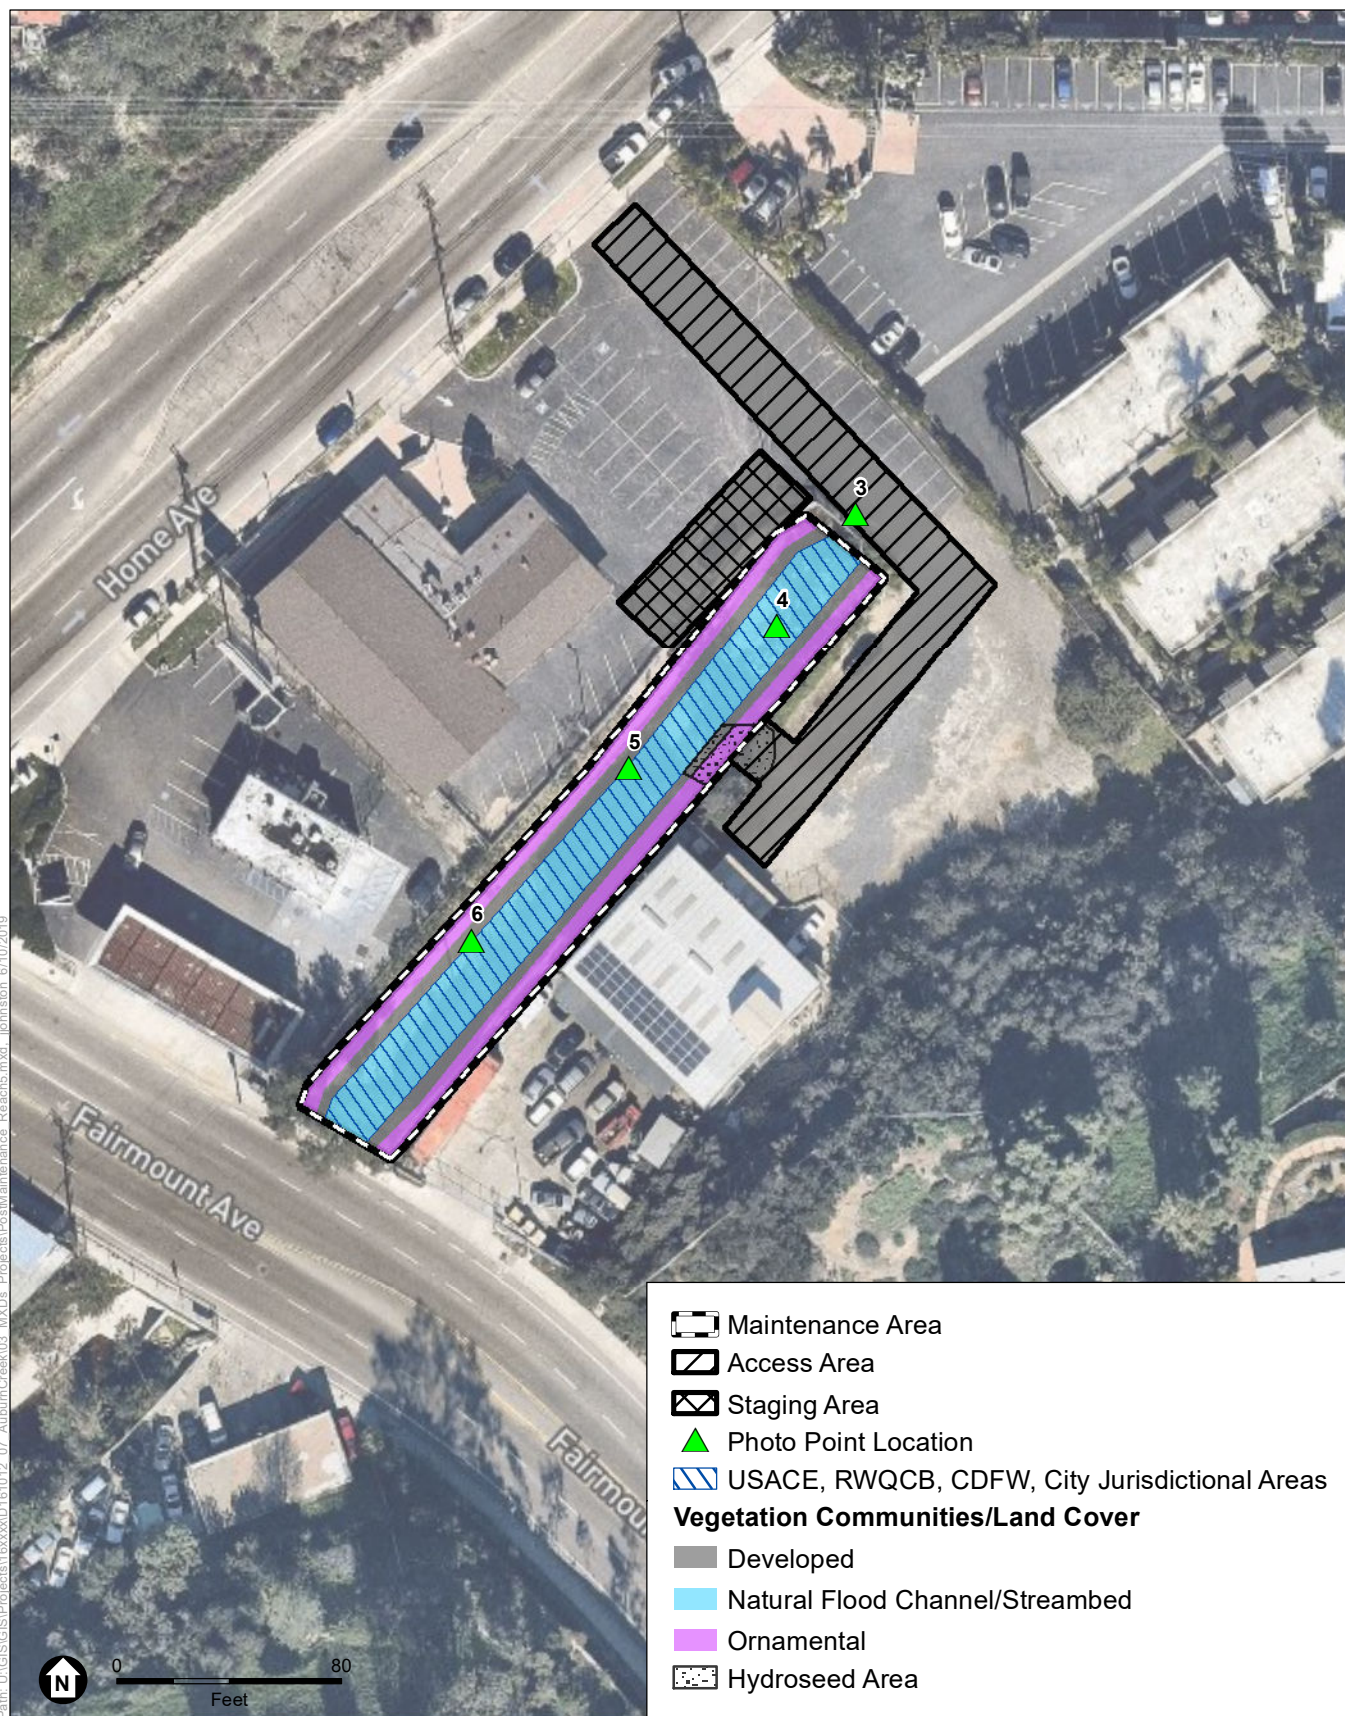
Auburn Creek Reach 5 (Map 70) Post-Maintenance Conditions

Auburn Creek Reach 1 and 5 (Maps 76 and 70)

During maintenance, the full permitted areas of both Maps 70 and 76 were cleared of accumulated sediment, vegetation and debris to return the channel segments to as-built dimensions. Maintenance at Map 70 spanned approximately 274 linear feet of channel and resulted in impacts to 0.11 acre of natural flood channel habitat. The maintenance footprint at Map 70 was previously impacted by emergency maintenance activities in 2016. Maintenance at Map 76 spanned approximately 160 linear feet of channel and resulted in the following habitat impacts: 0.01 acre of disturbed wetland (*Arundo*-dominated), 0.06 acre of natural flood channel, 0.01 acre of chaparral, 0.01 acre of ornamental, 0.05 acre of disturbed lands and 0.24 acre of developed lands. Approximately 0.22 tons of material were removed from Map 70 and approximately 43.52 tons of material were removed from Map 76.

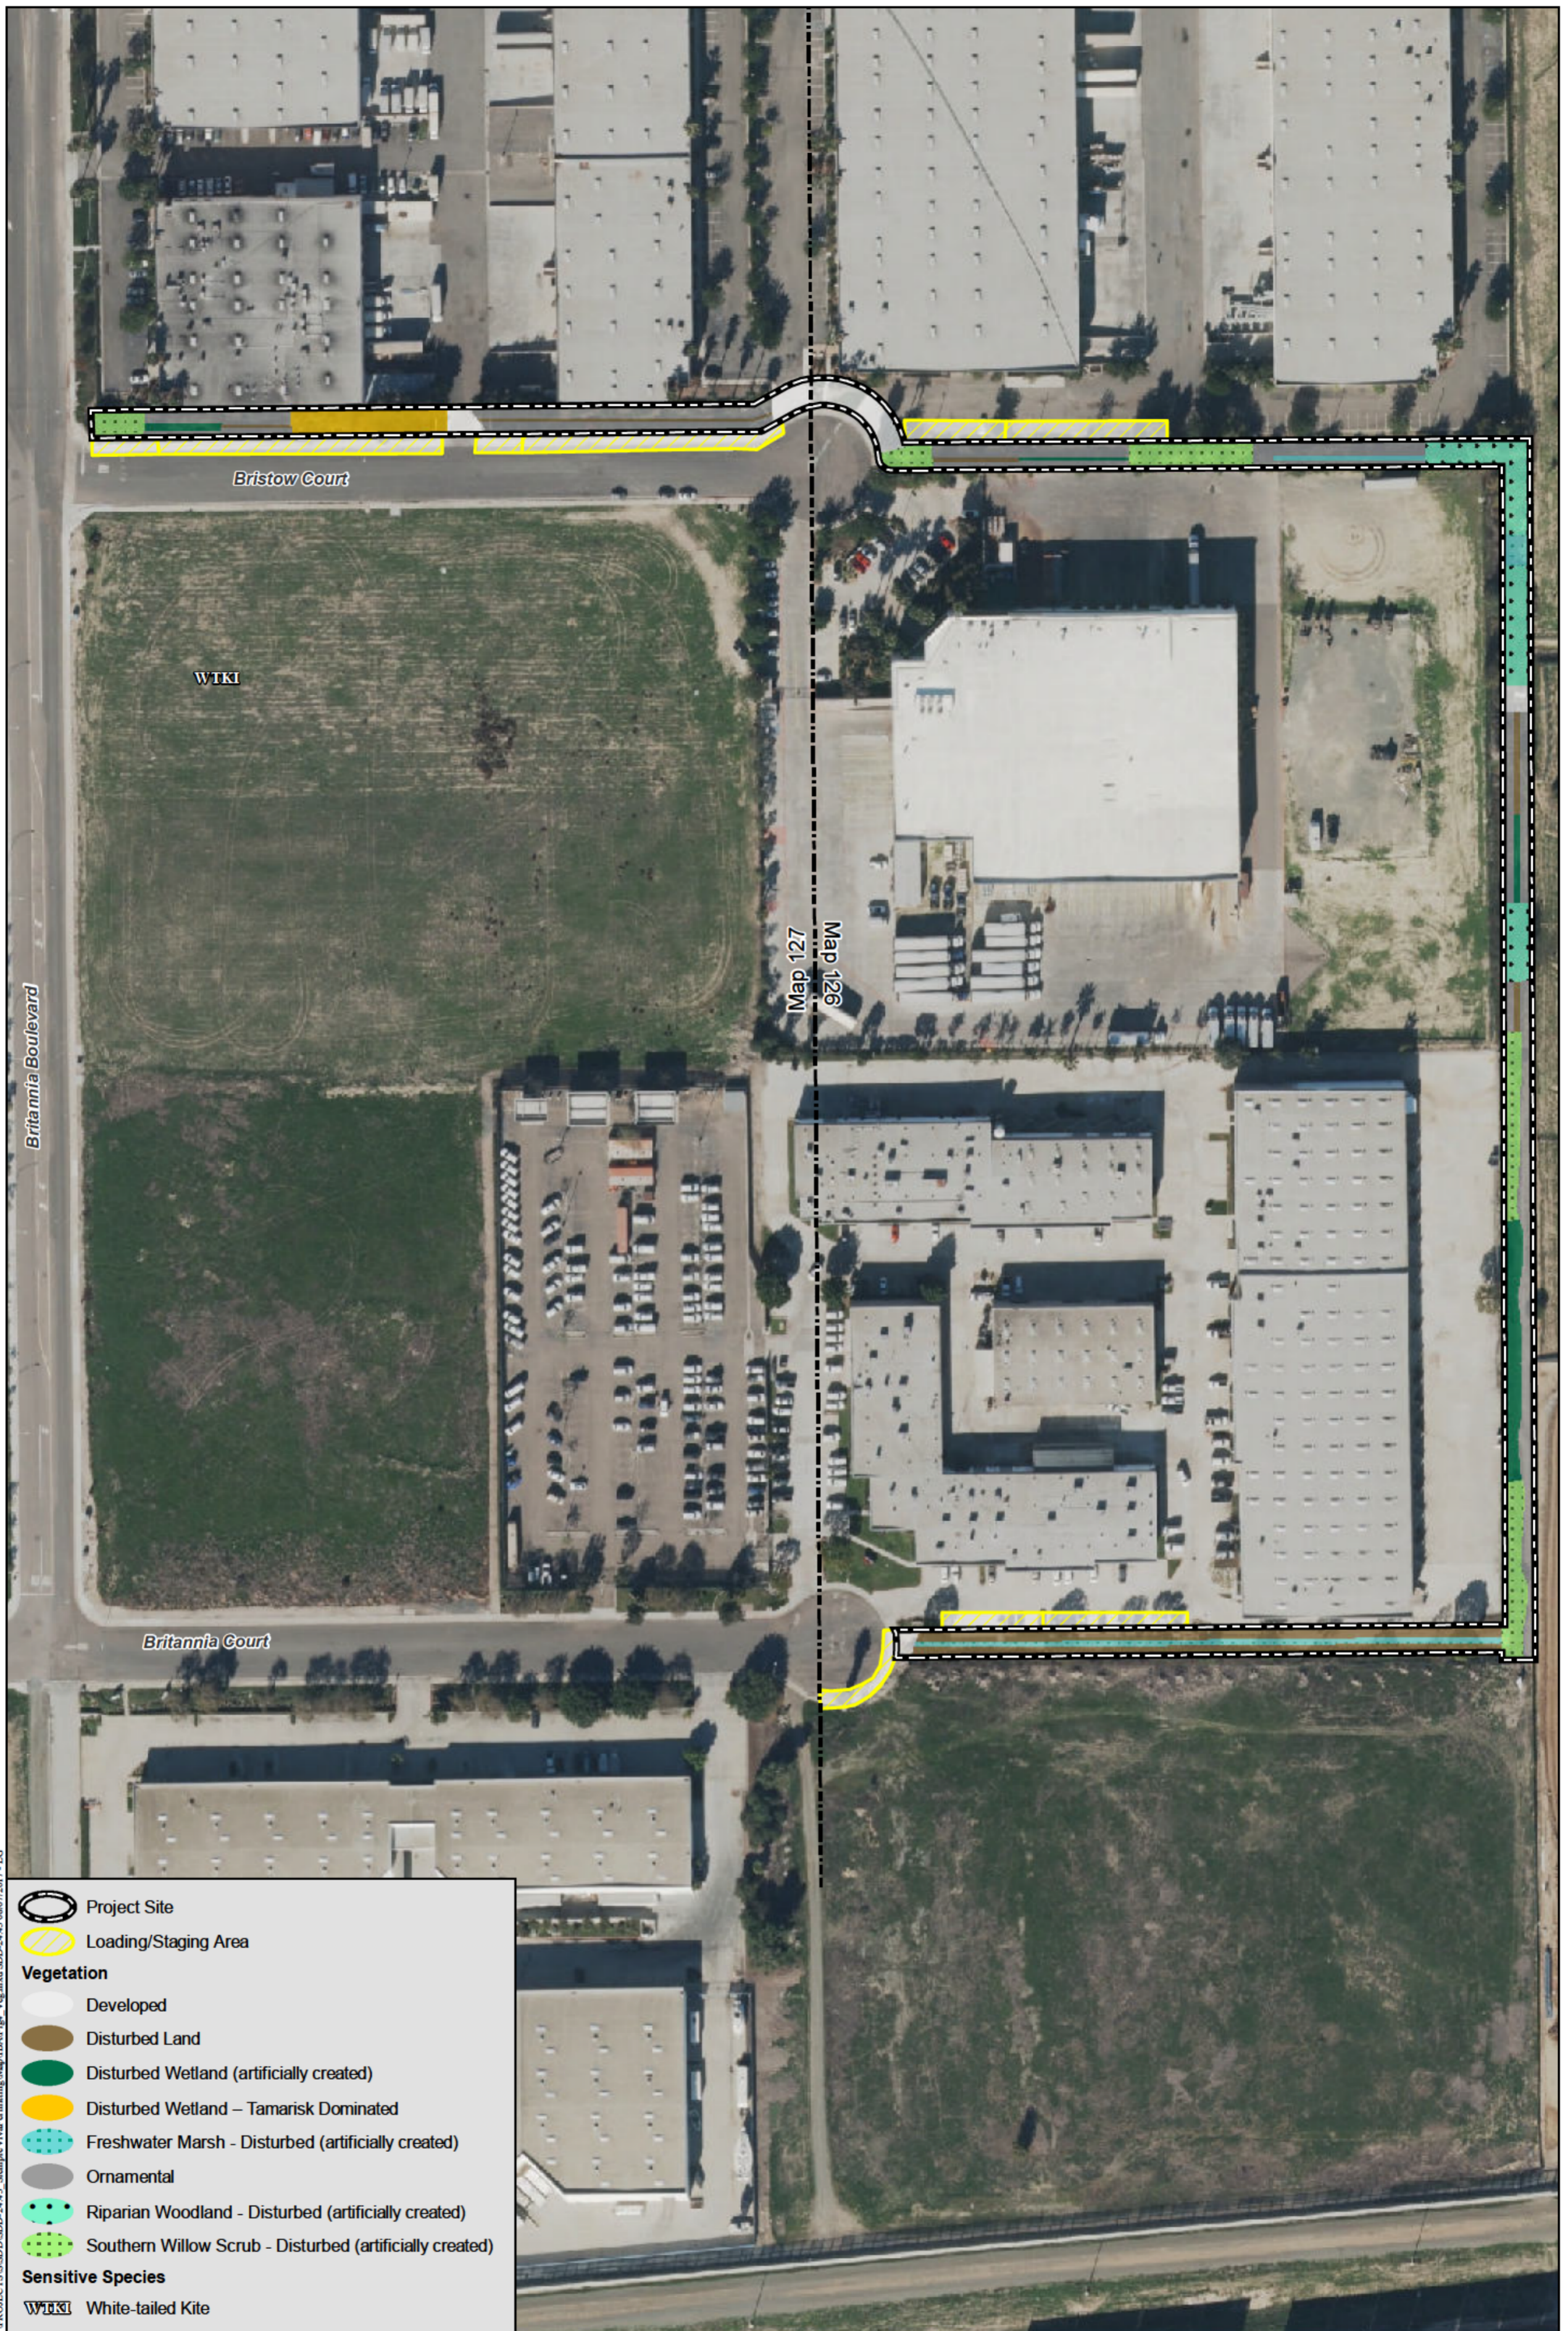
## Vegetation and Sensitive Biological Resources

SIEMPRE VIVA AND BRISTOW STORM WATER DETENTION FACILITY

Photographs showing conditions of the channel during maintenance in FY 2019 are included in Appendix C. Figure 9 in Appendix A displays pre-maintenance vegetation.

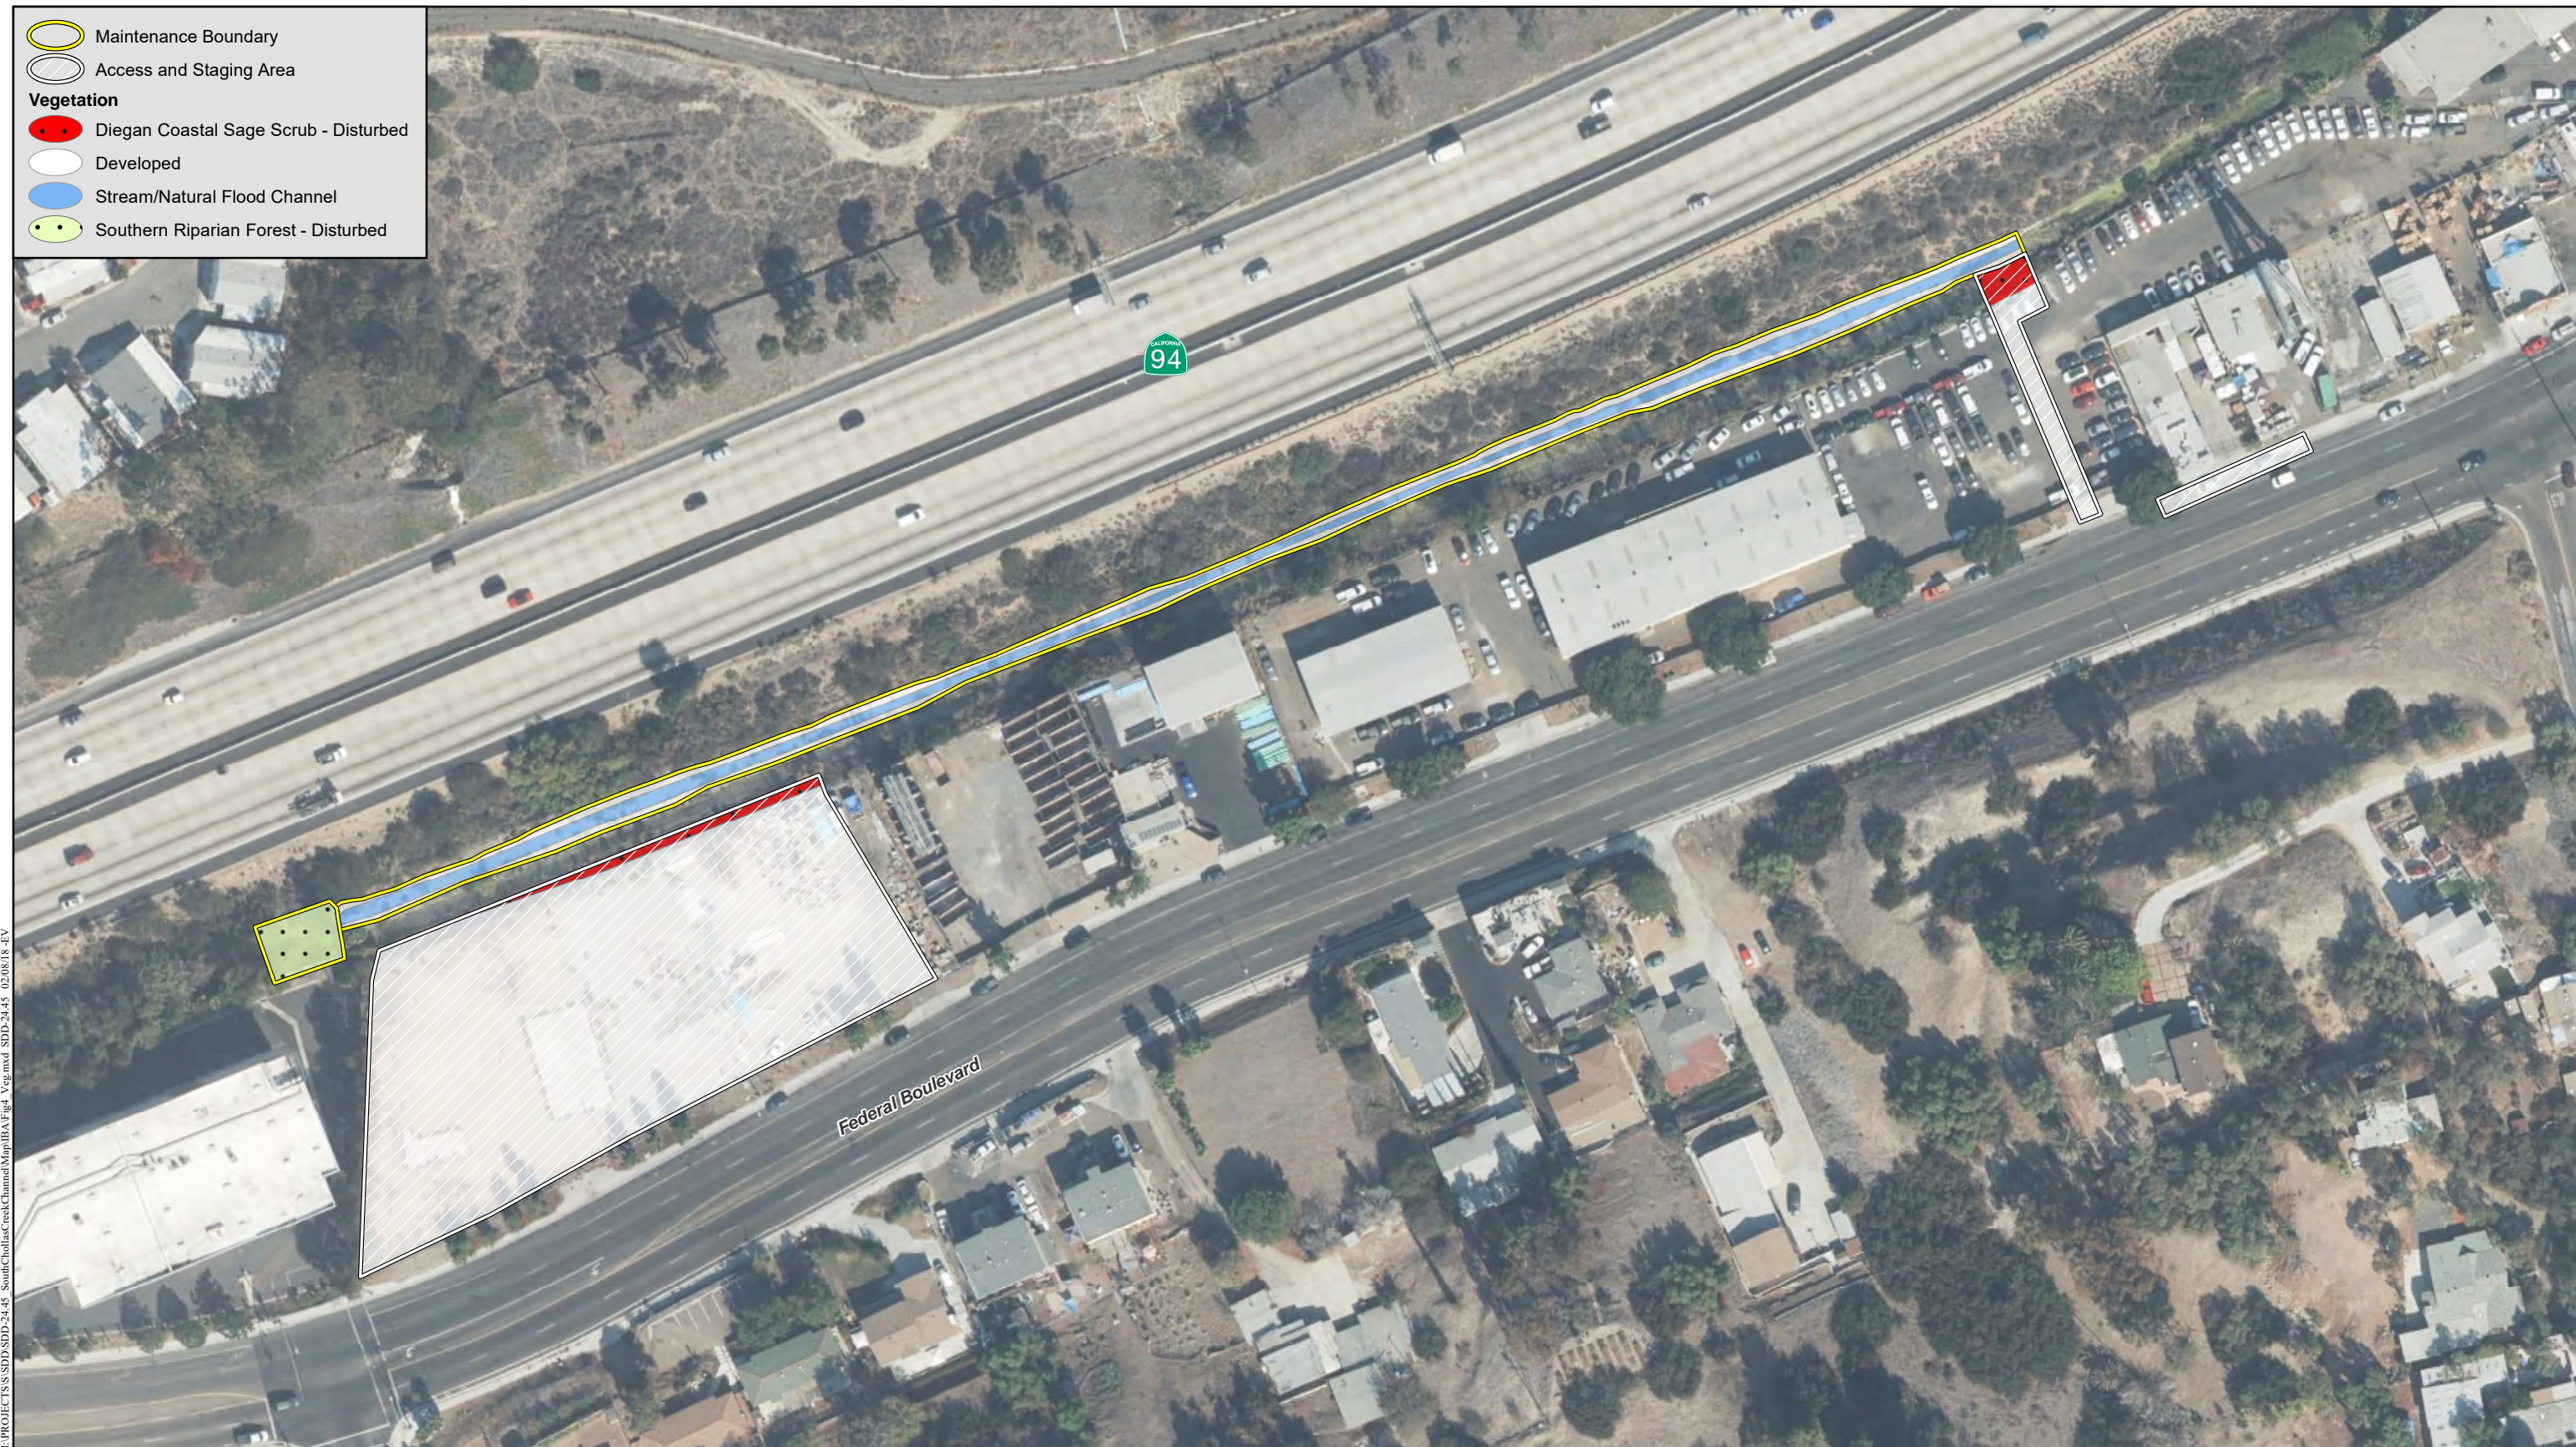
**Vegetation and Sensitive Biological Resources, South Chollas Creek Channel – Map 101**

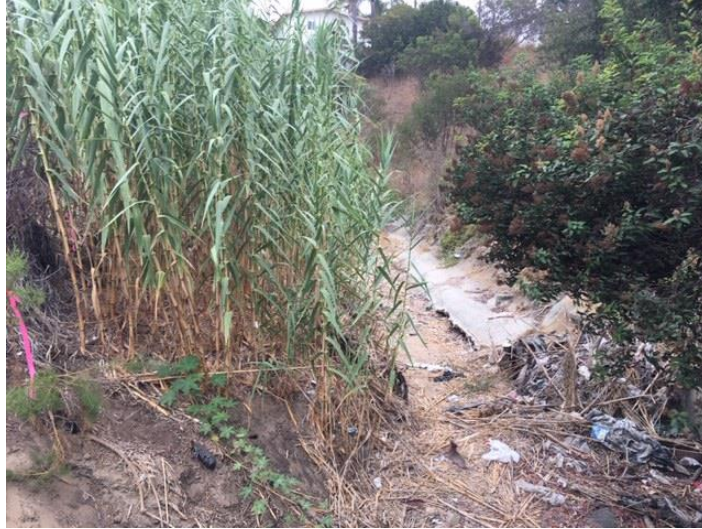
Photo 1. Auburn Channel Maintenance Project (Map 76), pre-maintenance, facing east, 09/24/2018

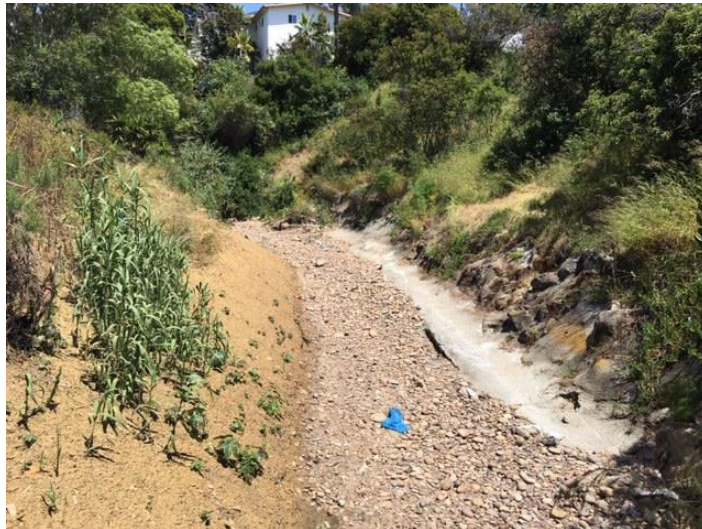
Photo 2. Auburn Channel Maintenance Project (Map 76), post-maintenance, facing east, 05/30/2019

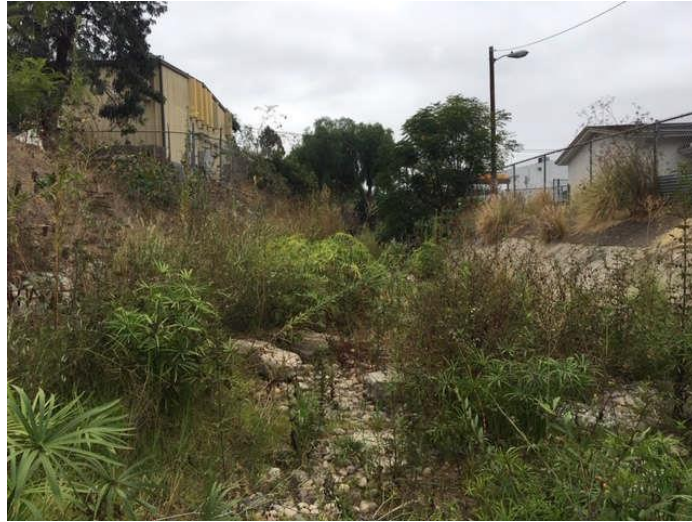
Photo 3. Auburn Channel Maintenance Project (Map 70), pre-maintenance, facing southwest, 09/24/2018

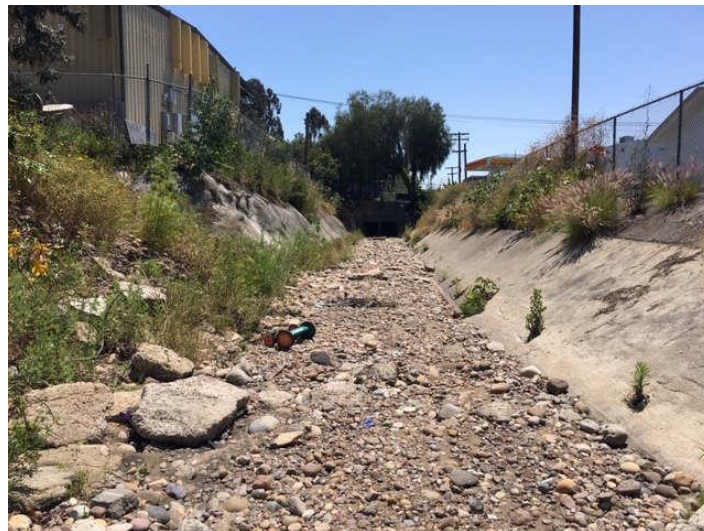
Photo 4. Auburn Channel Maintenance Project (Map 70), post-maintenance, facing southwest, 05/30/2019

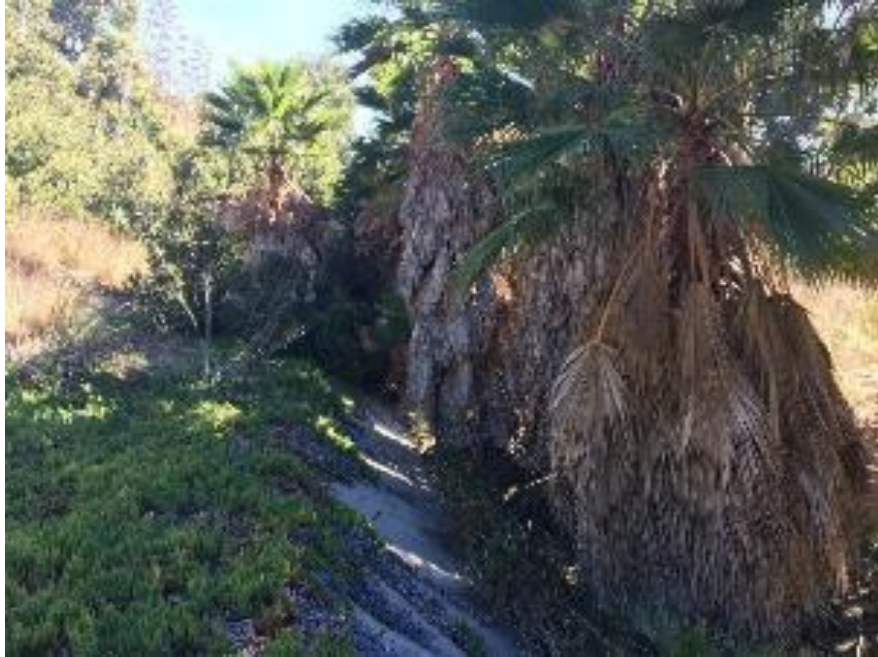
Photo 5. Montezuma Creek Channel Maintenance Project, pre- maintenance, facing east (upstream) toward Montezuma Creek Channel, 04/24/2018

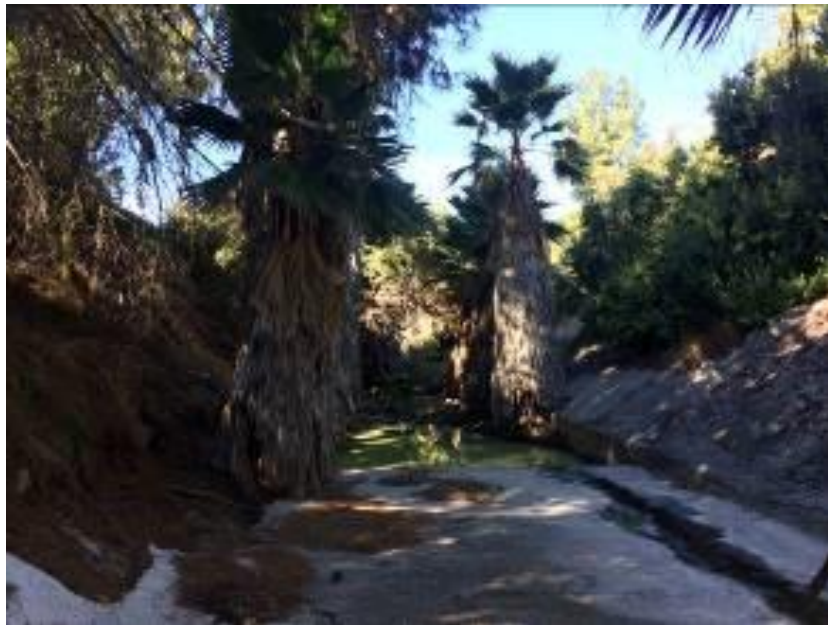
Photo 6. Montezuma Creek Channel Maintenance Project, pre- maintenance, facing west (downstream) toward fan palm stand and ponded surface water at the end of the concrete-lined channel, 04/24/2018

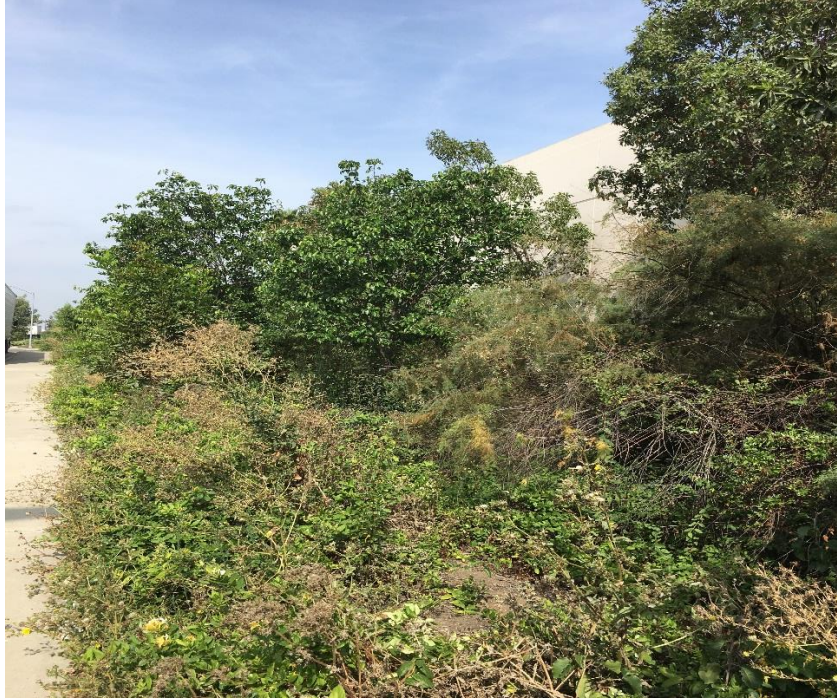
Photo 7. Siempre Viva and Bristow Drainage Facility, pre- maintenance. Facing west from Siempre Viva & Bristow Court cul-de-sac. 8/20/2018.

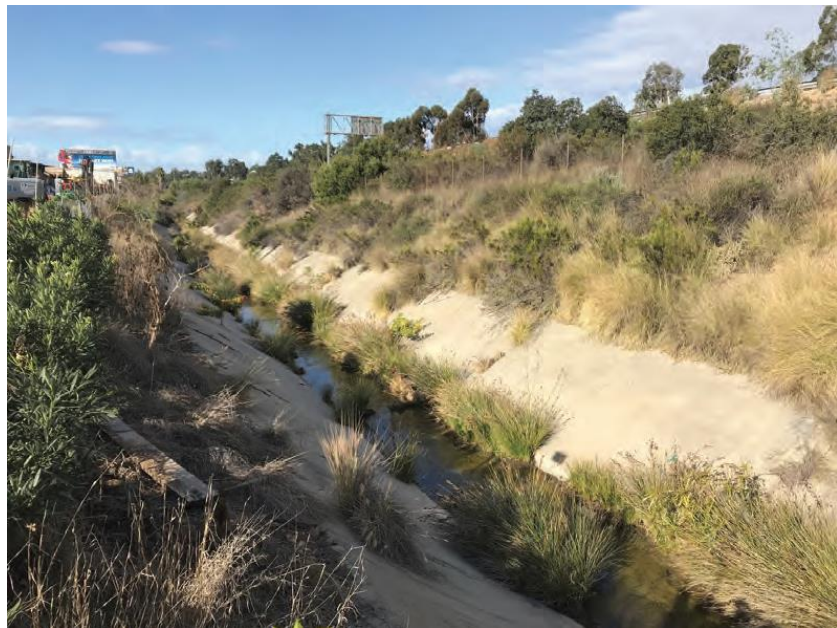
Photo 8. South Chollas Map 101 Channel Maintenance Project, pre maintenance, looking downstream (west) from east end of maintenance area, 2/21/2018.

In FY 2019, 15.1 tons of material (i.e., sediment, trash, vegetation, and debris) was removed from the channel. Approximately 50 feet of the earthen portion of the channel was cleared of vegetation and excavated to its as-built condition during the FY 2019 maintenance period. This portion of the site had dense vegetation within it. Some vegetation was also removed from the concrete portion to allow access to the work area. Additional vegetation removal within the concrete portion (up to 1,370 linear feet) is planned to complete the project in FY 2020. Work was halted in spring due to inundation from rain followed by the presence of nests. Work is anticipated to resume in FY 2020.
