Biological Technical Report - FINAL

Los Peñasquitos Lagoon Restoration

Phase 1

October 11, 2024

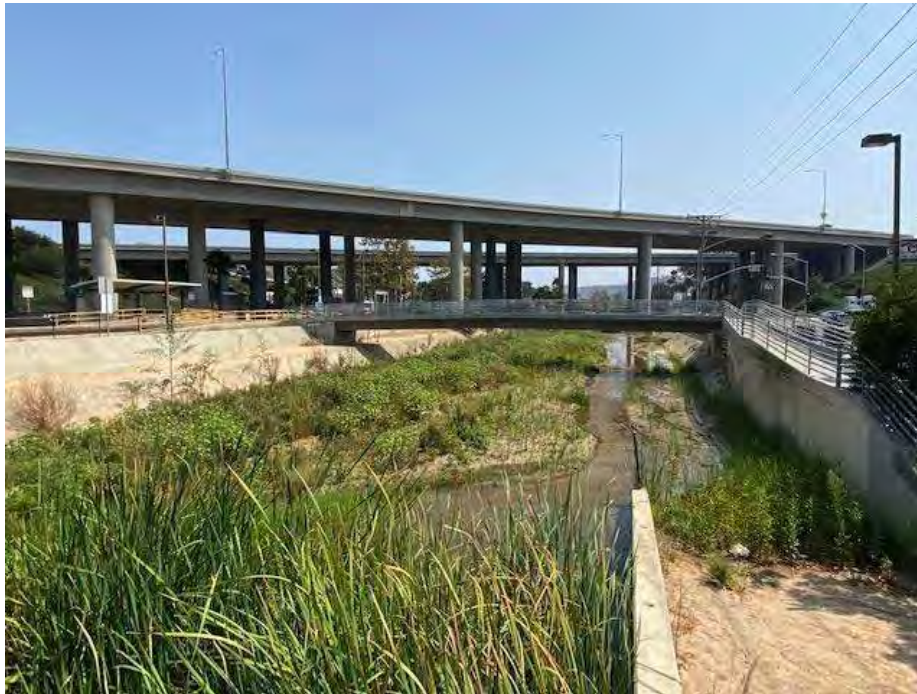
Photo 9: Representative photo of the concrete-lined channel that characterizes the southern extent of the Project site.

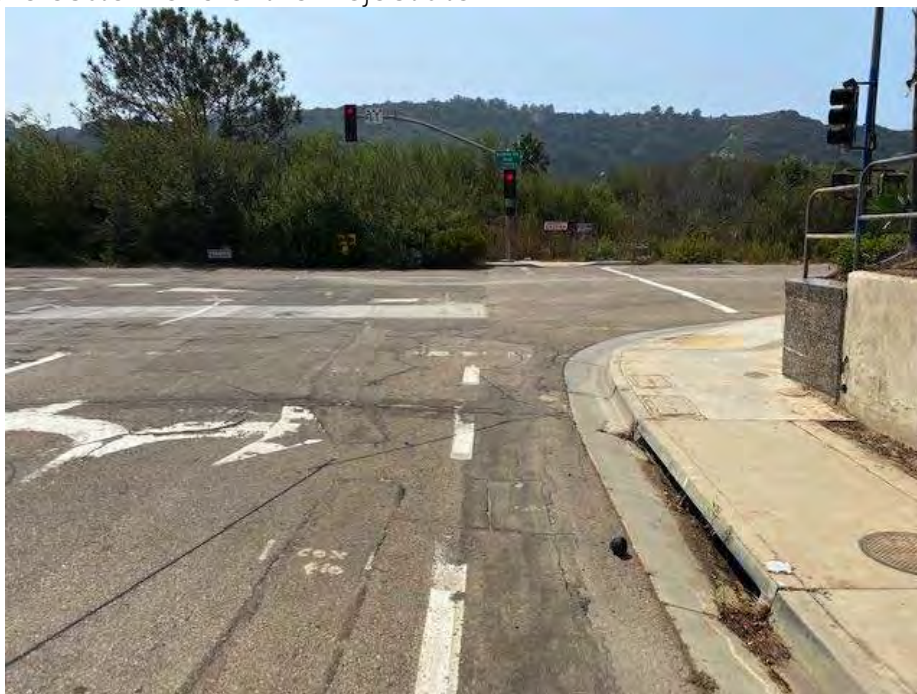
Photo 12: Photo of the proposed outfall area at Carmel Mountain Road with southern willow scrub in the background.

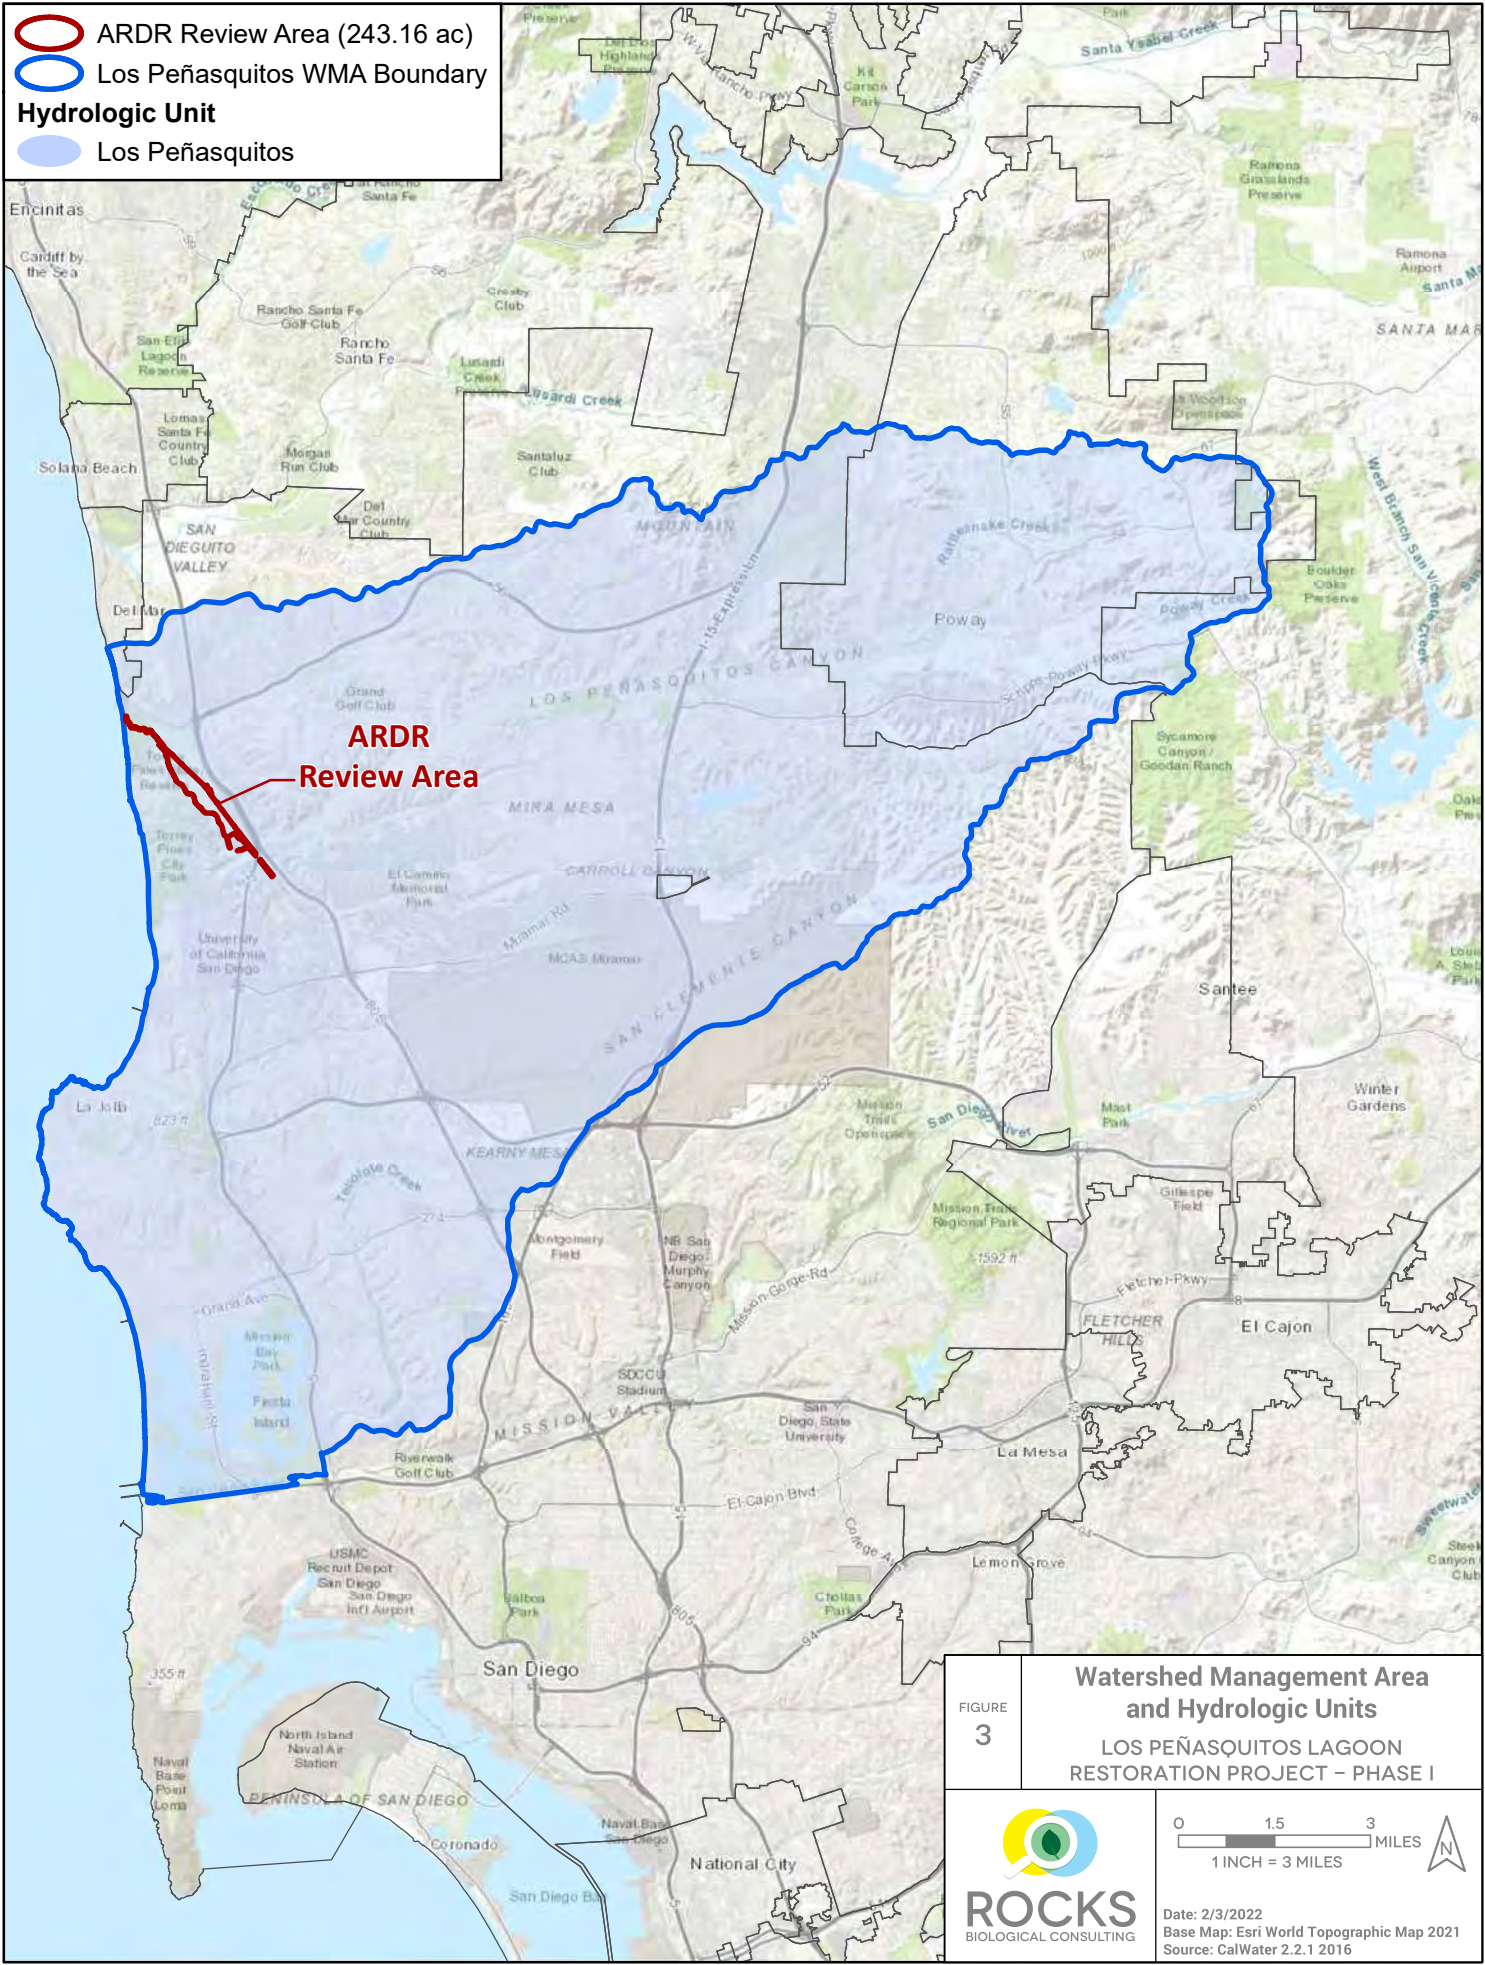
FIGURE
3

In addition to the watersheds defined by the USGS and commonly used by the Corps, the RWQCB also defines watershed boundaries by Hydrologic Units (HUs). The review area is within the San Diego Basin, the Penasquitos HU, and the Miramar Reservoir Hydrologic Subarea (HA) (San Diego RWQCB [SDRWQCB] 2020; Figure 3).

- ARDR Review Area (243.16 ac)
- Los Peñasquitos WMA Boundary
- Hydrologic Unit**
- Los Peñasquitos

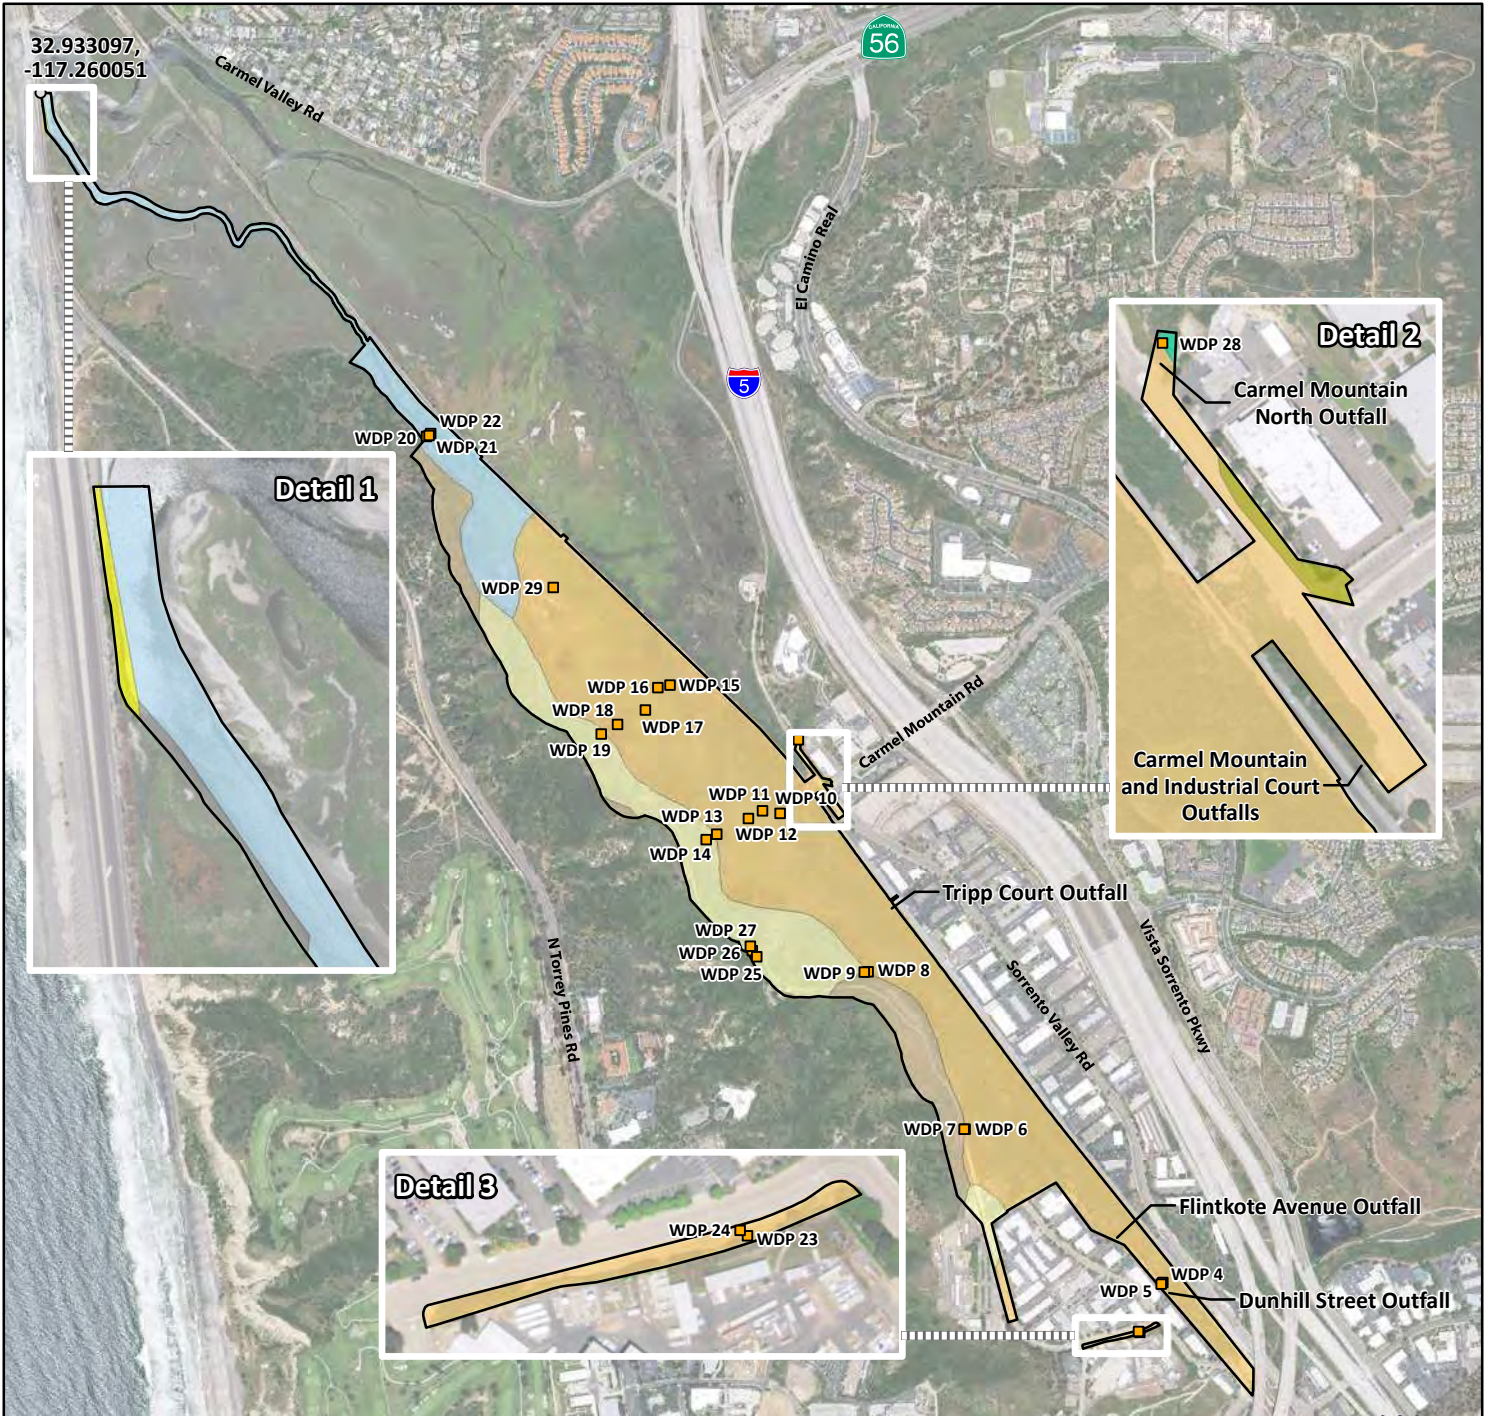
FIGURE 5
NRCS Soils Survey Data
 LOS PEÑASQUITOS LAGOON RESTORATION PROJECT - PHASE I

Based on the NRCS soils data map (Figure 5), nine soil map units, outlined below in Table 2, occur within the review area:

- ARDR Review Area (243.16 ac)
 - Wetland Data Form Point (WDP)
 - Soils**
 - Chino silt loam, saline, 0 to 2 percent slopes*
 - Coastal beaches*
 - Corralitos loamy sand, 0 to 5 percent slopes*
 - Corralitos loamy sand, 5 to 9 percent slopes
 - Huerhuero loam, 15 to 30 percent slopes, eroded
 - Made land
 - Salinas clay loam, 2 to 9 percent slopes
 - Terrace escarpments
 - Tidal flats*
- * Soil rated as hydric per the NRCS.

Known hydrologic sources for the observed on-site drainages, discussed further below, are direct precipitation and runoff from surrounding roads and development. Based on field observations, features within the review area generally drain southeast to northwest towards the Pacific Ocean. Based on historical studies and hydrodynamic modeling of current conditions, tidal hydrology is restricted to the existing tidal channel in the northernmost portion of the review area. Tidal flows are restricted farther upstream from the narrow portion of the review area between the railroad embankment and bluff slopes (“pinch point”) due to persistent freshwater flows and the elevations of the channels and surrounding marsh, which are 4 to 8 feet higher than the tidal channel closer to the lagoon inlet. The majority of the review area is a floodplain that was historically composed of non-tidal salt marsh. Urbanization of the watershed and hydrology alterations in the lagoon have resulted in year-round persistent freshwater flows, greater stormwater flows and retention times, and deposition of sandy sediment, which have degraded the salt marsh habitat and converted upstream portions of Peñasquitos Creek/Lagoon to freshwater wetlands. Specifically within the review area, these flows have originated from the following outfalls: Tripp Court, Carmel Mountain Road, Industrial Court, Carmel Mountain Road “North,” Flintkote Avenue, and Dunhill Street (Figure 5).

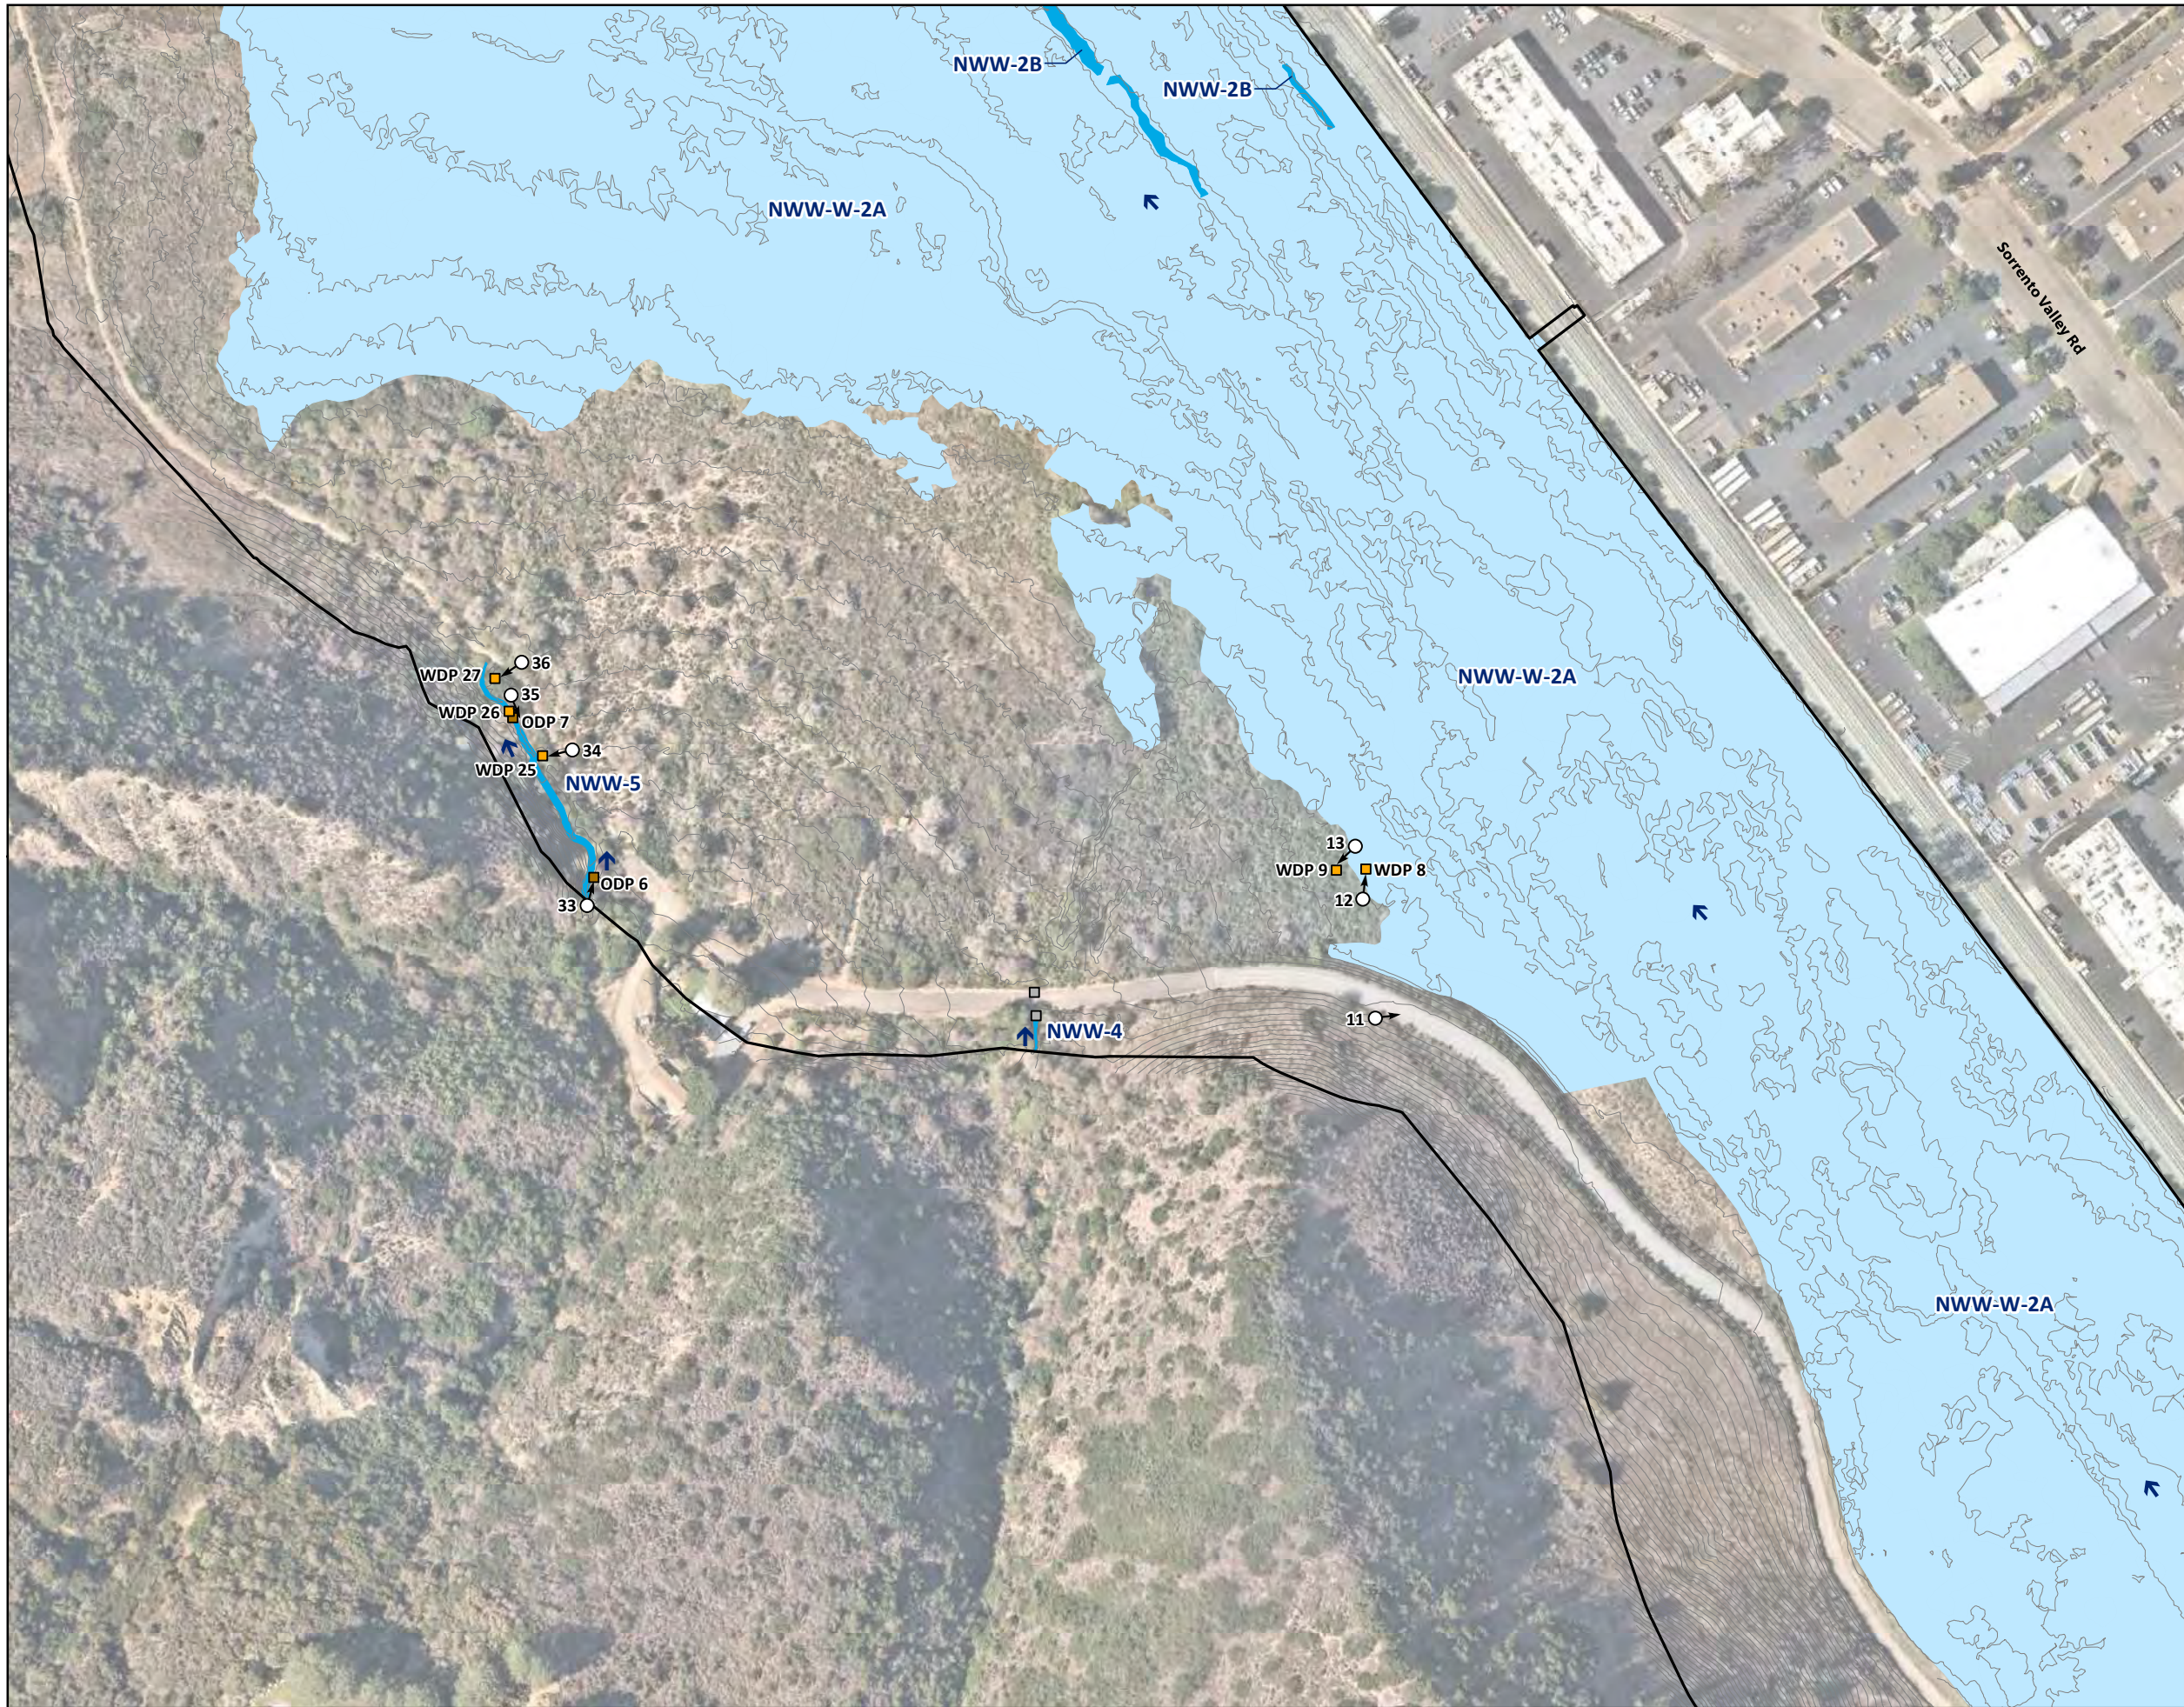
FIGURE 6A	Corps Aquatic Resources
PAGE 3 OF 8	LOS PEÑASQUITOS LAGOON RESTORATION PROJECT - PHASE I
	Date: 3/1/2022 Aerial Photo: Nearmap, 2021

- ARDR Review Area (243.16 ac)
 - Photo Point
 - Culvert
 - Wetland Data Form Point (WDP)
 - OHWM Datasheet Point (ODP)
 - ➔ Flow Direction
- Corps Aquatic Resources**
- Non-Wetland Waters - Federal Wetland (148.62 ac)*
 - Non-Wetland Waters (11.82 ac)
- * Three-parameter wetland within OHWM.

NWW-1B is a concrete-lined, channelized portion of Carroll Canyon Creek (Figure 6A; Table 6; Appendix E, Photo 4). NWW-1B occurs directly downstream of NWW-W-1A, as shown on Figure 6A, generally flows northwest, and travels for approximately 1,748 linear feet on site before

NWW-1C is a channelized portion of Carroll Canyon Creek composed of open water (Figure 6A; Table 6; Appendix E, Photo 5). NWW-1C occurs directly downstream of NWW-1B, as shown on Figure 6A, generally flows northwest, and travels for approximately 1,552 linear feet before converging with NWW-W-2A (see *Non-Wetland Water Wetland 2A* below). NWW-1C did not meet all three federal wetland parameters. See Table 6 for the estimated OHWM and representative OHWM and wetland delineation data for this feature. See Table 7 for the extent of RHA Section 10 navigable waters of the U.S. for this feature.

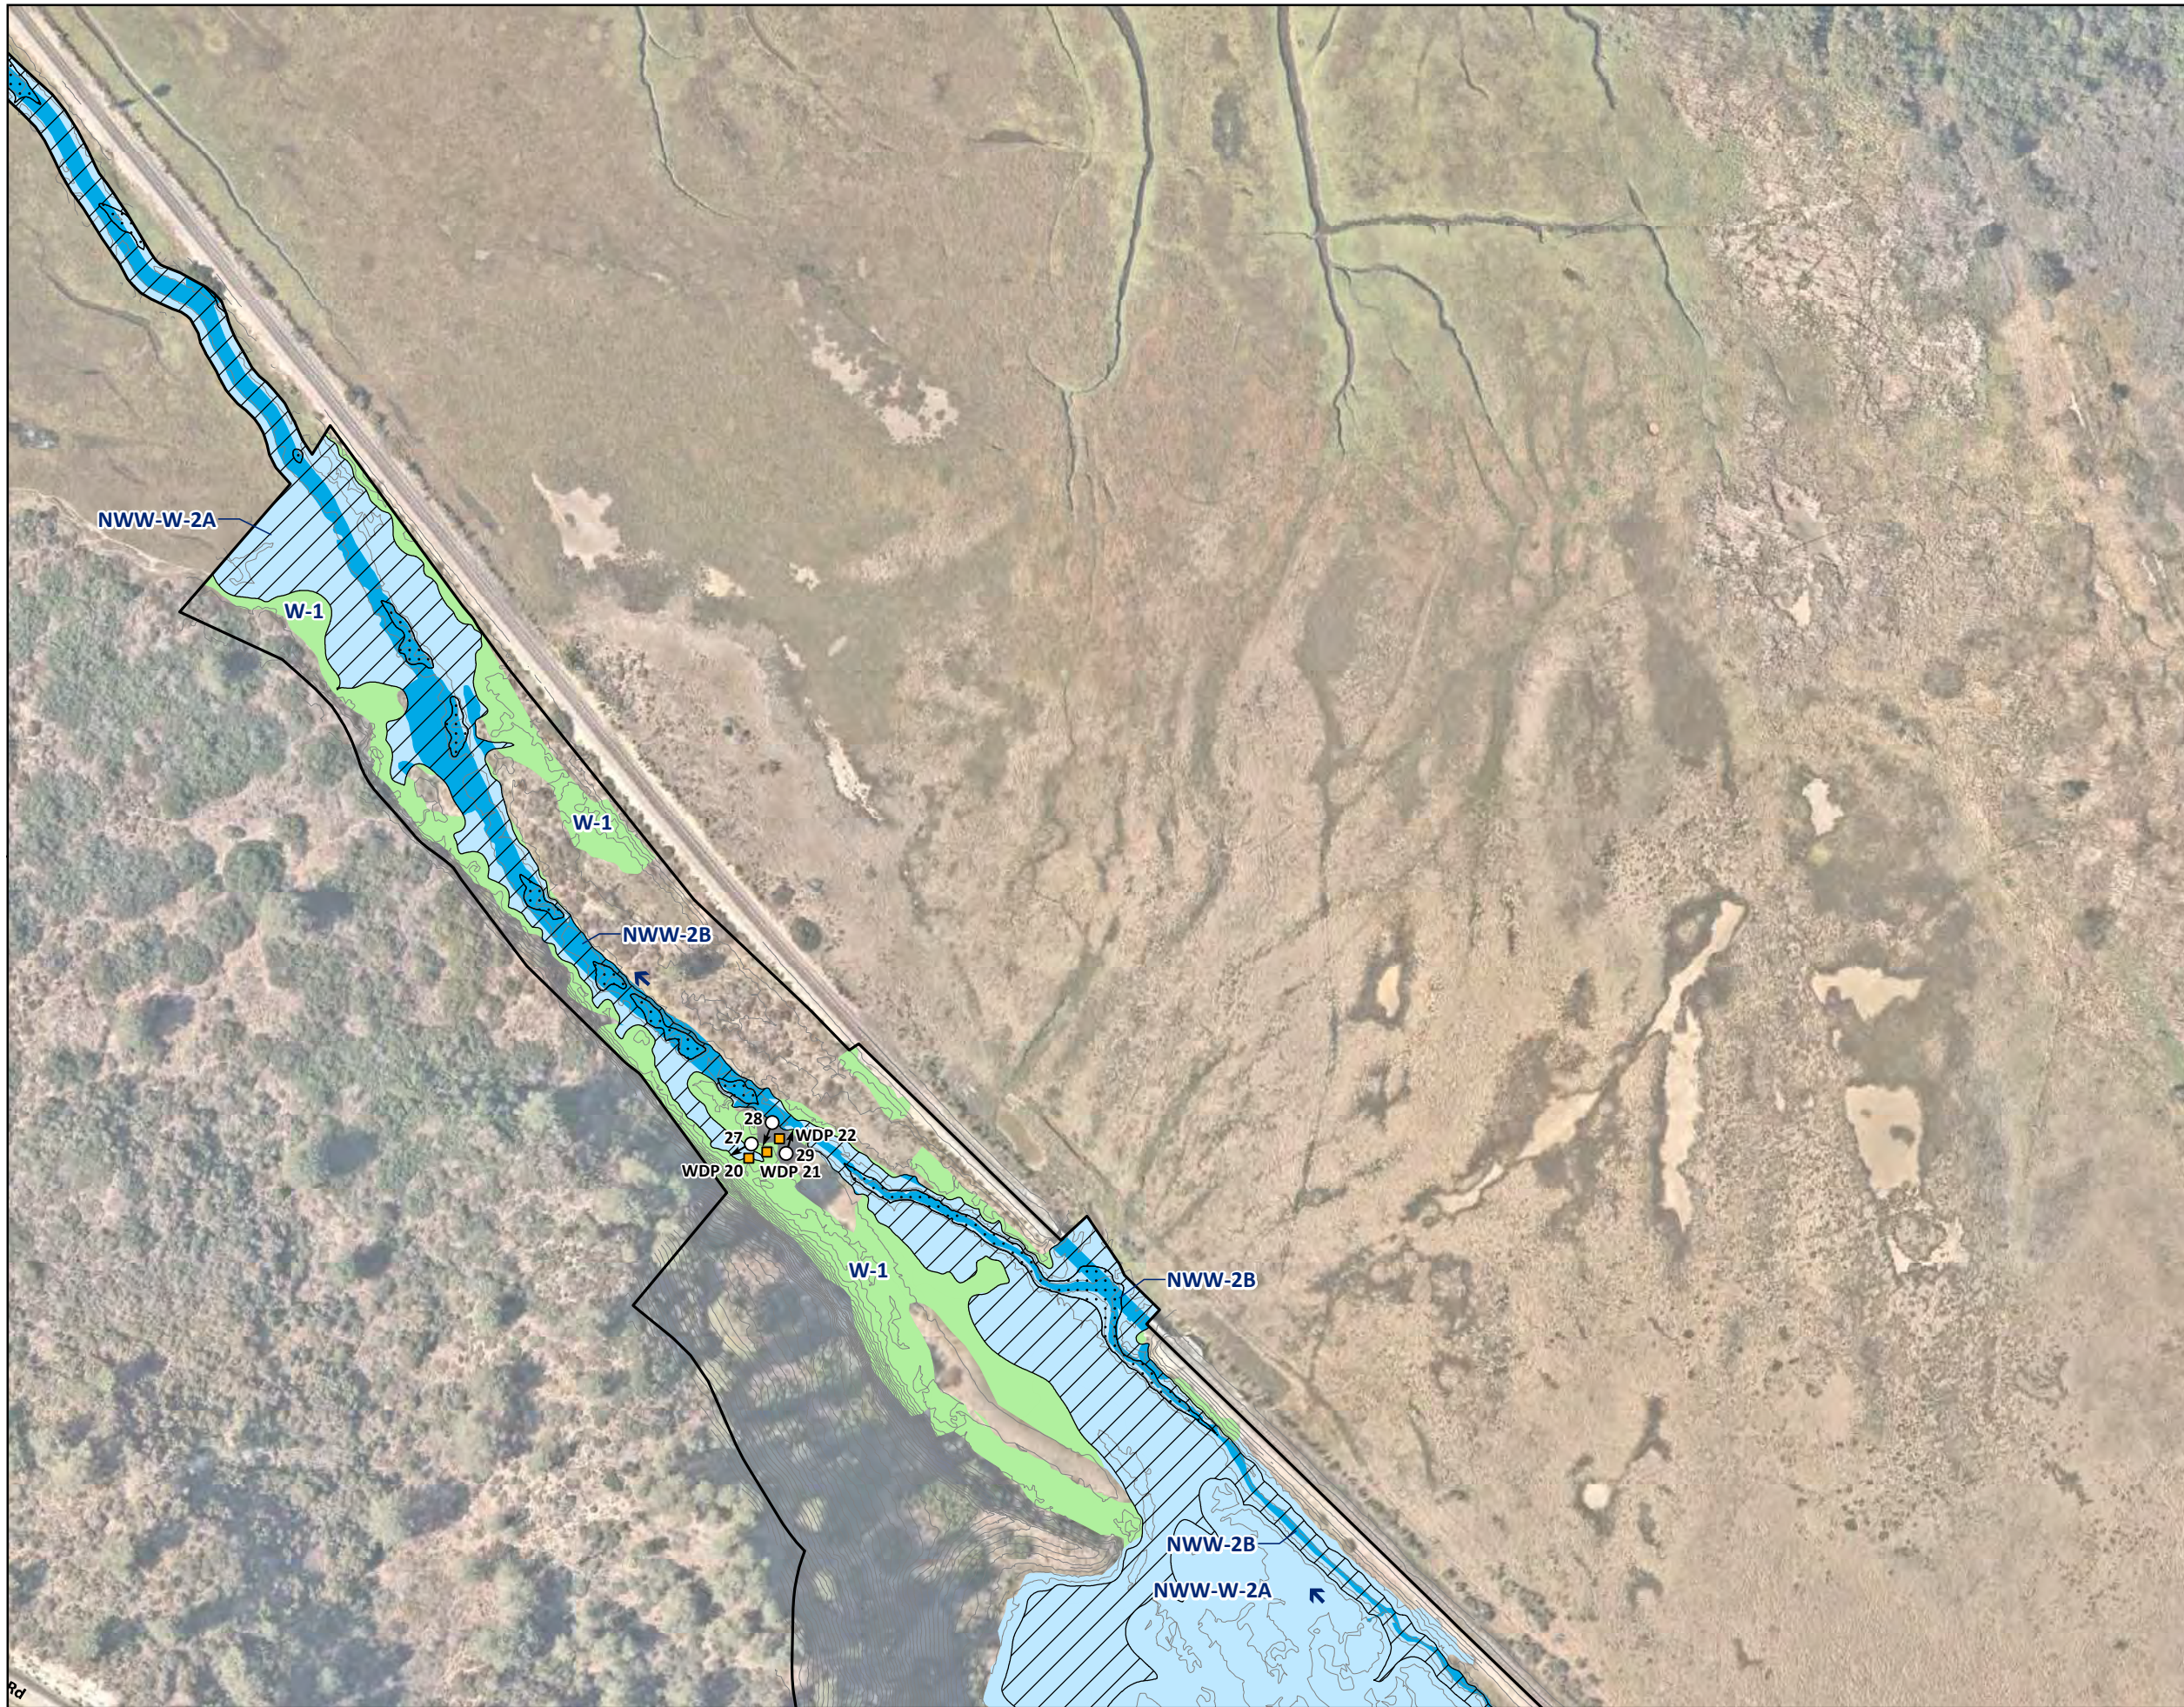
<p>FIGURE 6A</p> <p>PAGE 6 OF 8</p>	<p>Corps Aquatic Resources</p> <p>LOS PEÑASQUITOS LAGOON RESTORATION PROJECT - PHASE I</p>
	<p>0 100 200 FEET</p> <p>1 INCH = 200 FEET</p> <p>Date: 3/1/2022 Aerial Photo: Nearmap, 2021</p>

- ARDR Review Area (243.16 ac)
- Photo Point
- Wetland Data Form Point (WDP)
- ➔ Flow Direction**
- Corps Aquatic Resources**
- Wetland Waters - Federal Wetland (2.30 ac)
- Non-Wetland Waters - Federal Wetland (148.62 ac)*
- Non-Wetland Waters (11.82 ac)
- ▨ Tidal Waters - Section 404 HTL (7.01 feet MLLW)(10.63 ac)
- ⋯ Tidal Waters - Section 10 MHW (4.6 feet MLLW, Overlaps with Section 404 HTL areas.)(5.72 ac)

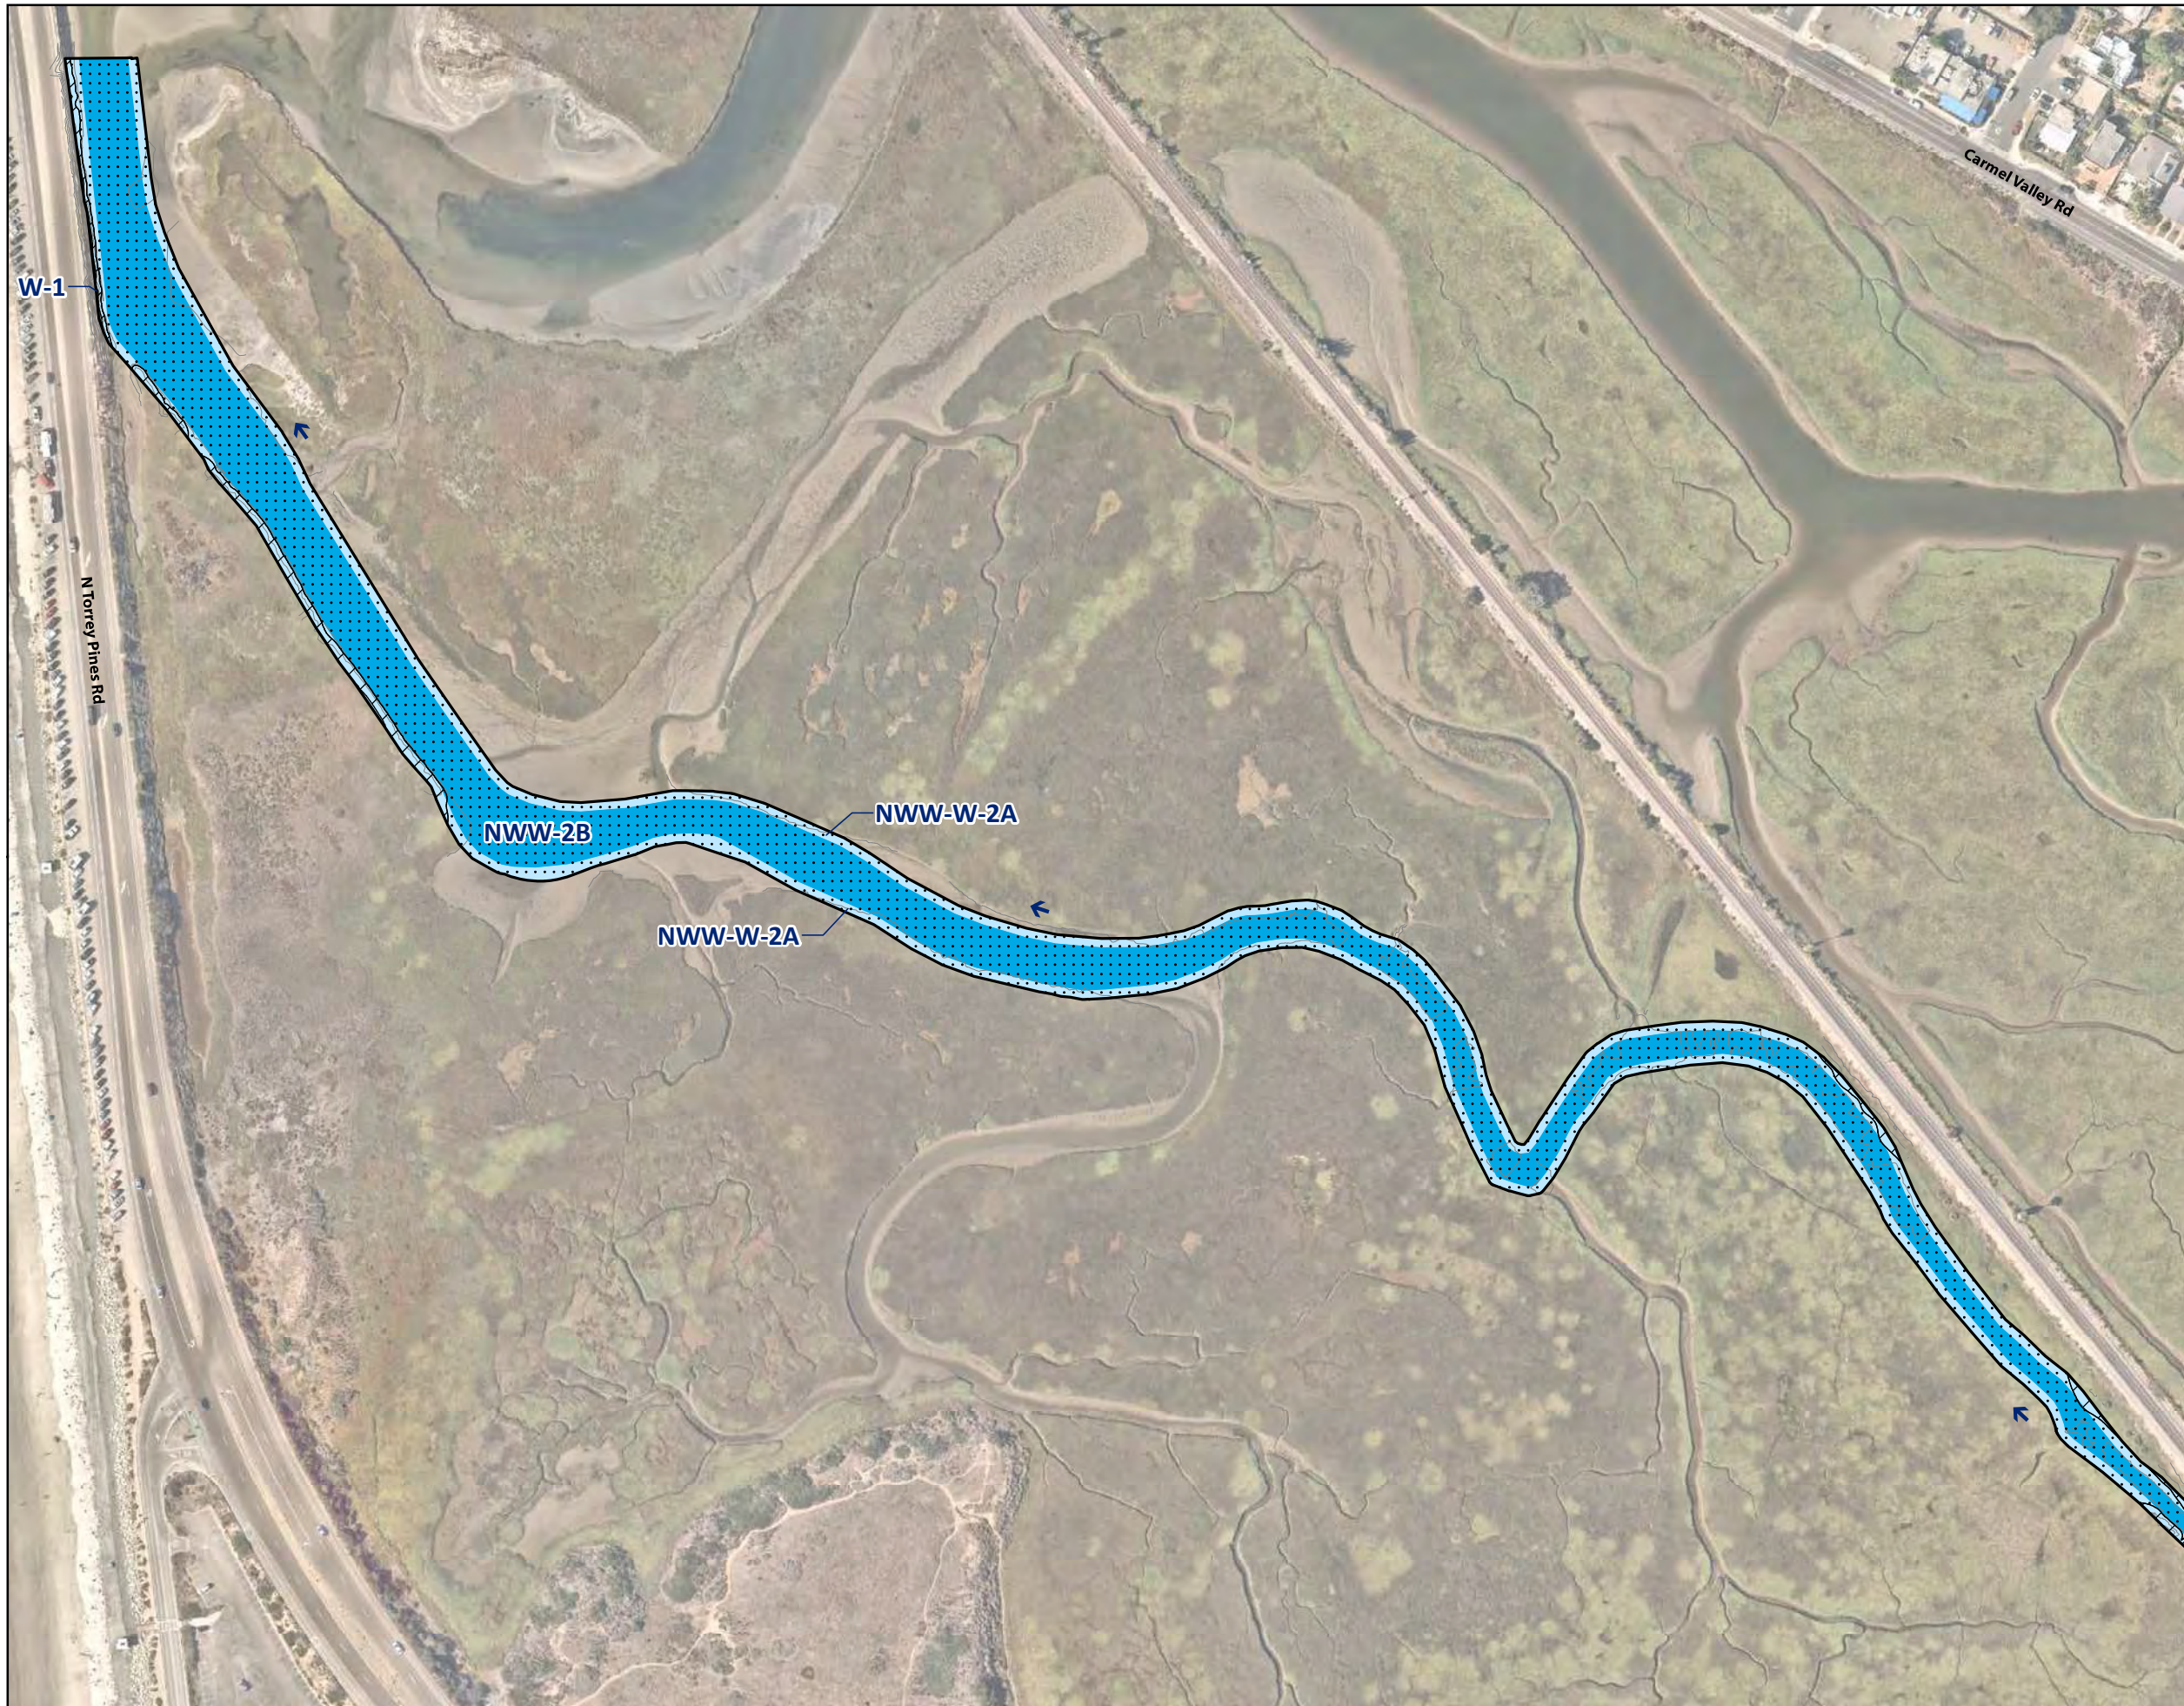
FIGURE 6A PAGE 7 OF 8	Corps Aquatic Resources LOS PEÑASQUITOS LAGOON RESTORATION PROJECT - PHASE I
Date: 3/1/2022 Aerial Photo: Nearmap, 2021

- ARDR Review Area (243.16 ac)
 - Photo Point
 - ➔ Flow Direction**
 - Corps Aquatic Resources**
 - Wetland Waters - Federal Wetland (2.30 ac)
 - Non-Wetland Waters - Federal Wetland (148.62 ac)*
 - Non-Wetland Waters (11.82 ac)
 - ▨ Tidal Waters - Section 404 HTL (7.01 feet MLLW)(10.63 ac)
 - ⋯ Tidal Waters - Section 10 MHW (4.6 feet MLLW, Overlaps with Section 404 HTL areas.)(5.72 ac)
- * Three-parameter wetland within OHWM.
 ** Flow direction arrows account for non-tidal flows associated with Peñasquitos Creek.

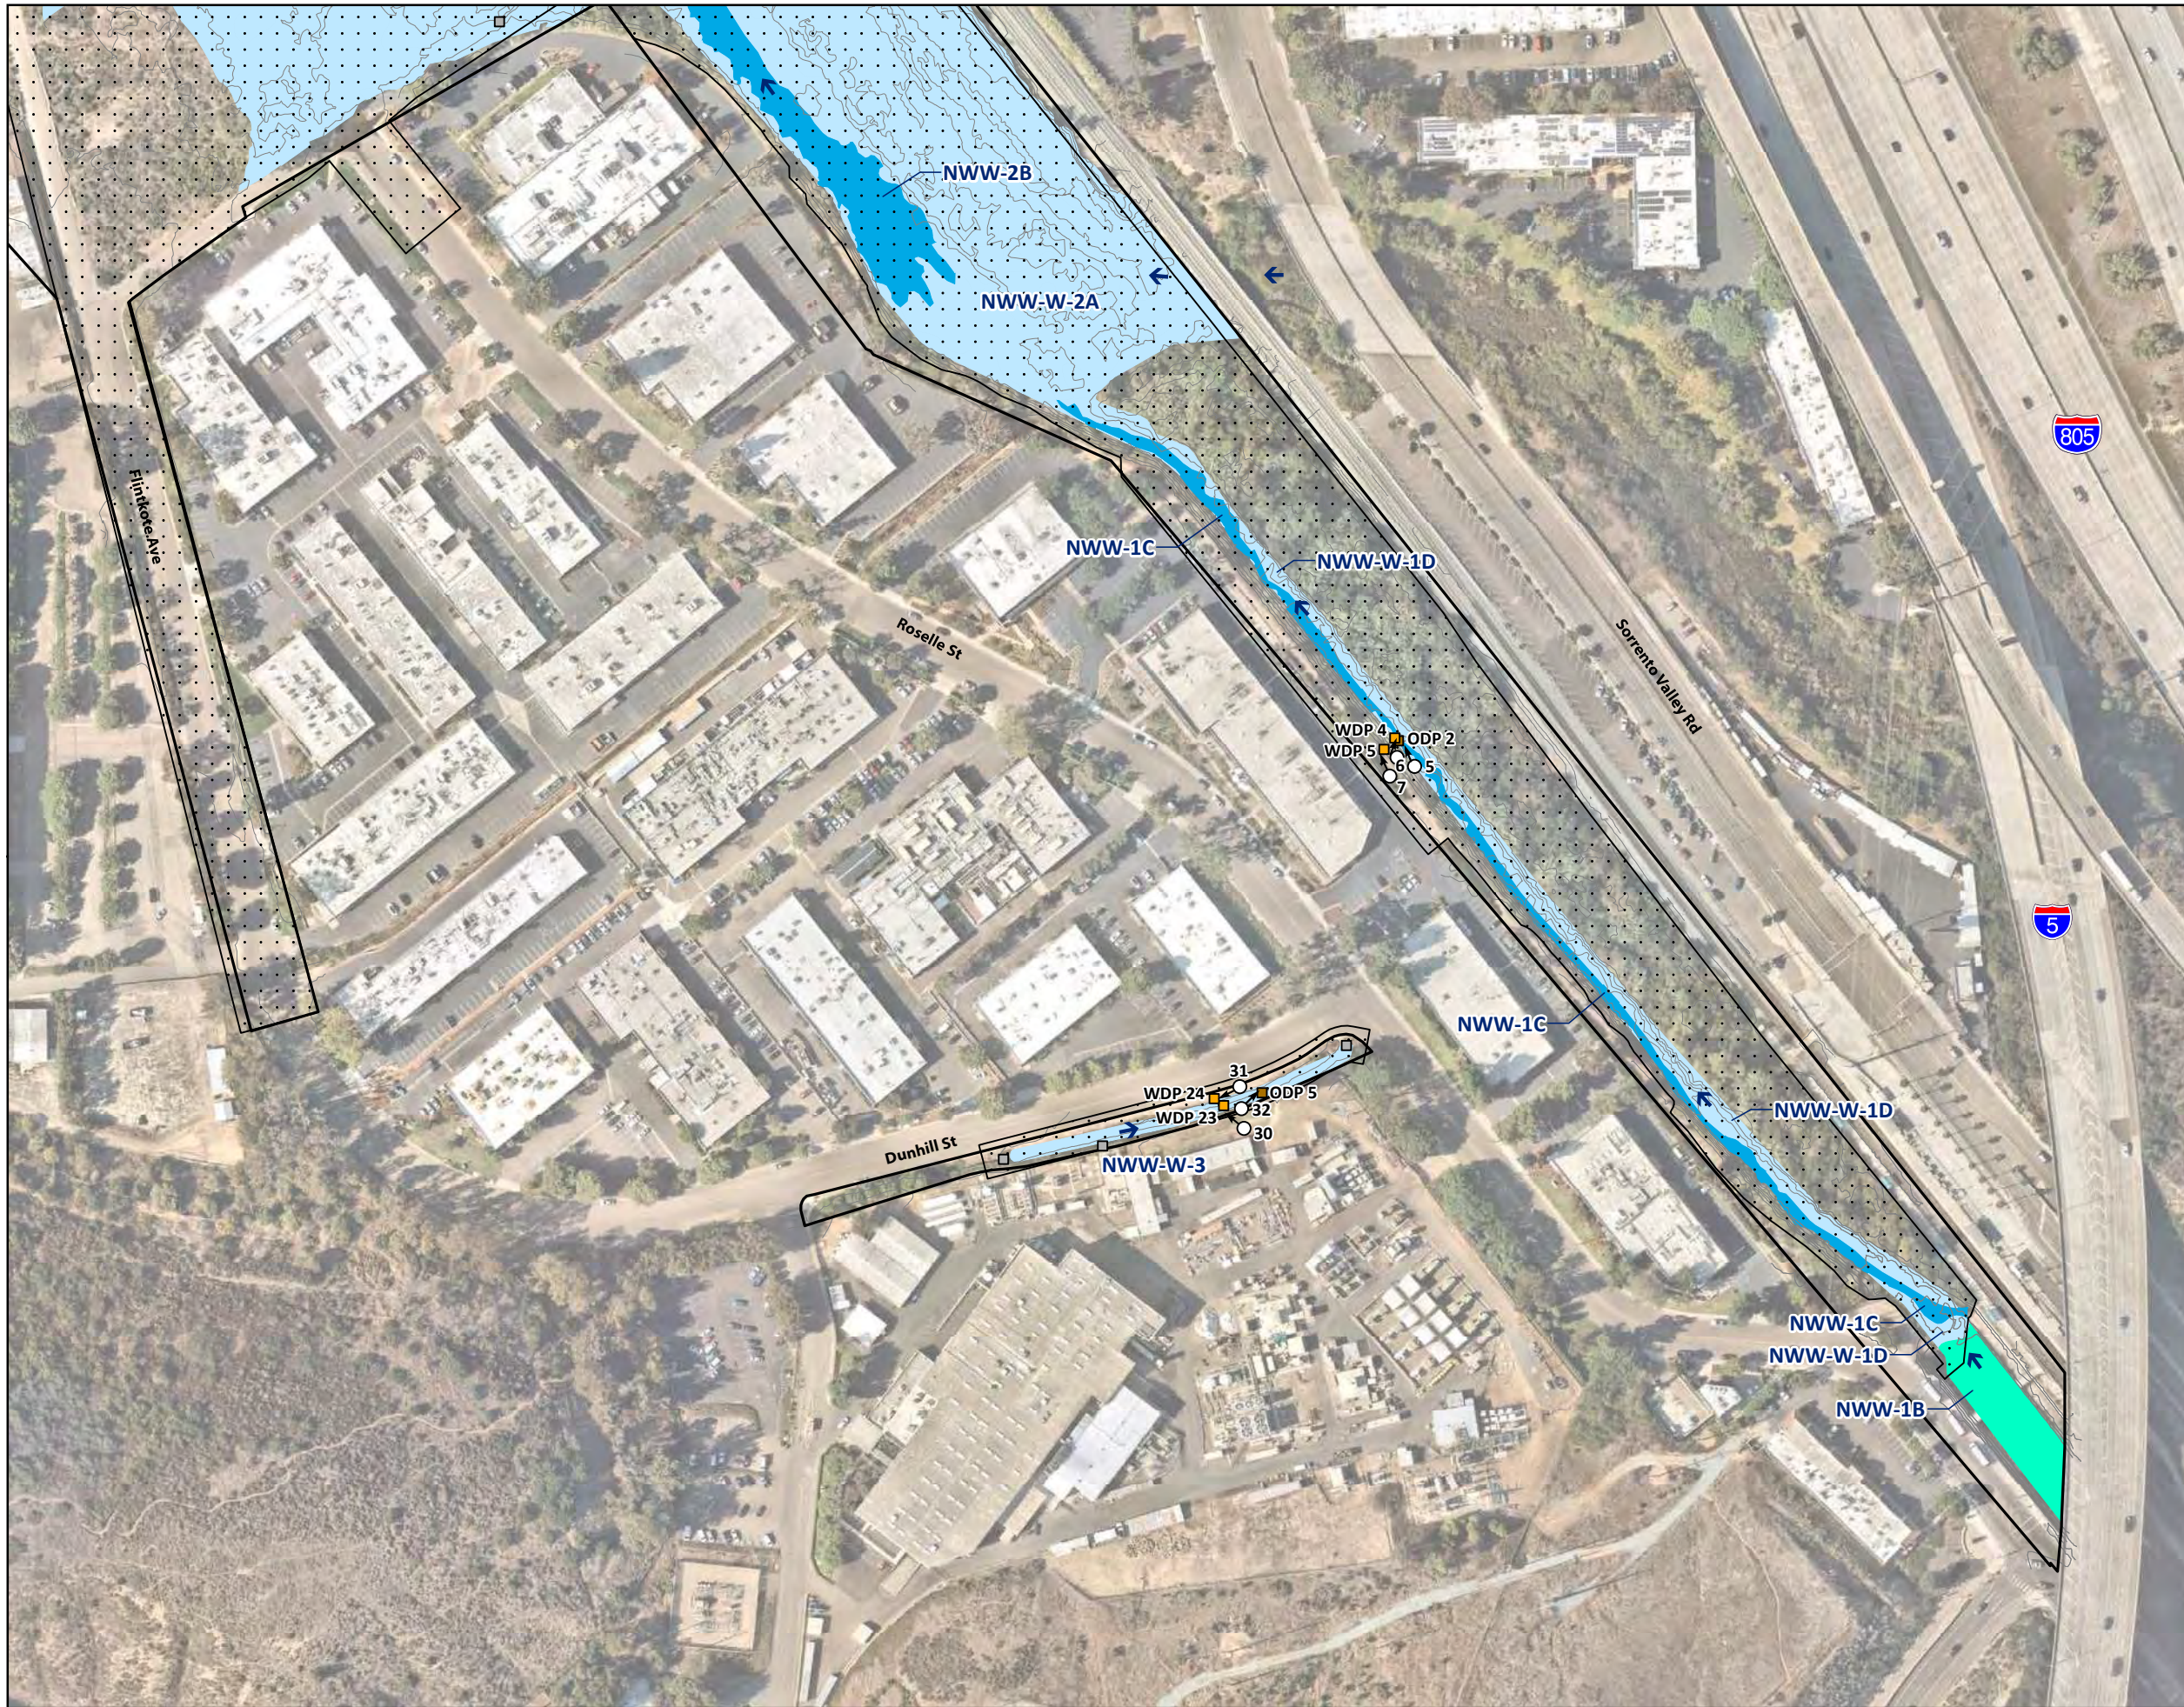
<p>FIGURE 6B</p> <p>PAGE 1 OF 8</p>	<p>RWQCB Aquatic Resources</p> <p>LOS PEÑASQUITOS LAGOON RESTORATION PROJECT - PHASE I</p>
	<p>0 100 200 FEET</p> <p>1 INCH = 200 FEET</p> <p>Date: 7/27/2022 Aerial Photo: Nearmap, 2021</p>

- ARDR Review Area (243.16 ac)
 - Project Footprint
 - Photo Point
 - Culvert
 - Wetland Data Form Point (WDP)
 - OHWM Datasheet Point (ODP)
 - Flow Direction
- RWQCB Aquatic Resources**
- Wetland Waters - Federal/State Wetland (148.62 ac)*
 - Non-Wetland Waters (11.82 ac)
 - Non-Wetland Waters - Concrete-Lined (2.60 ac)
- * Three-parameter wetland within OHWM.
