Biological Technical Report - FINAL

Los Peñasquitos Lagoon Restoration

Phase 1

October 11, 2024

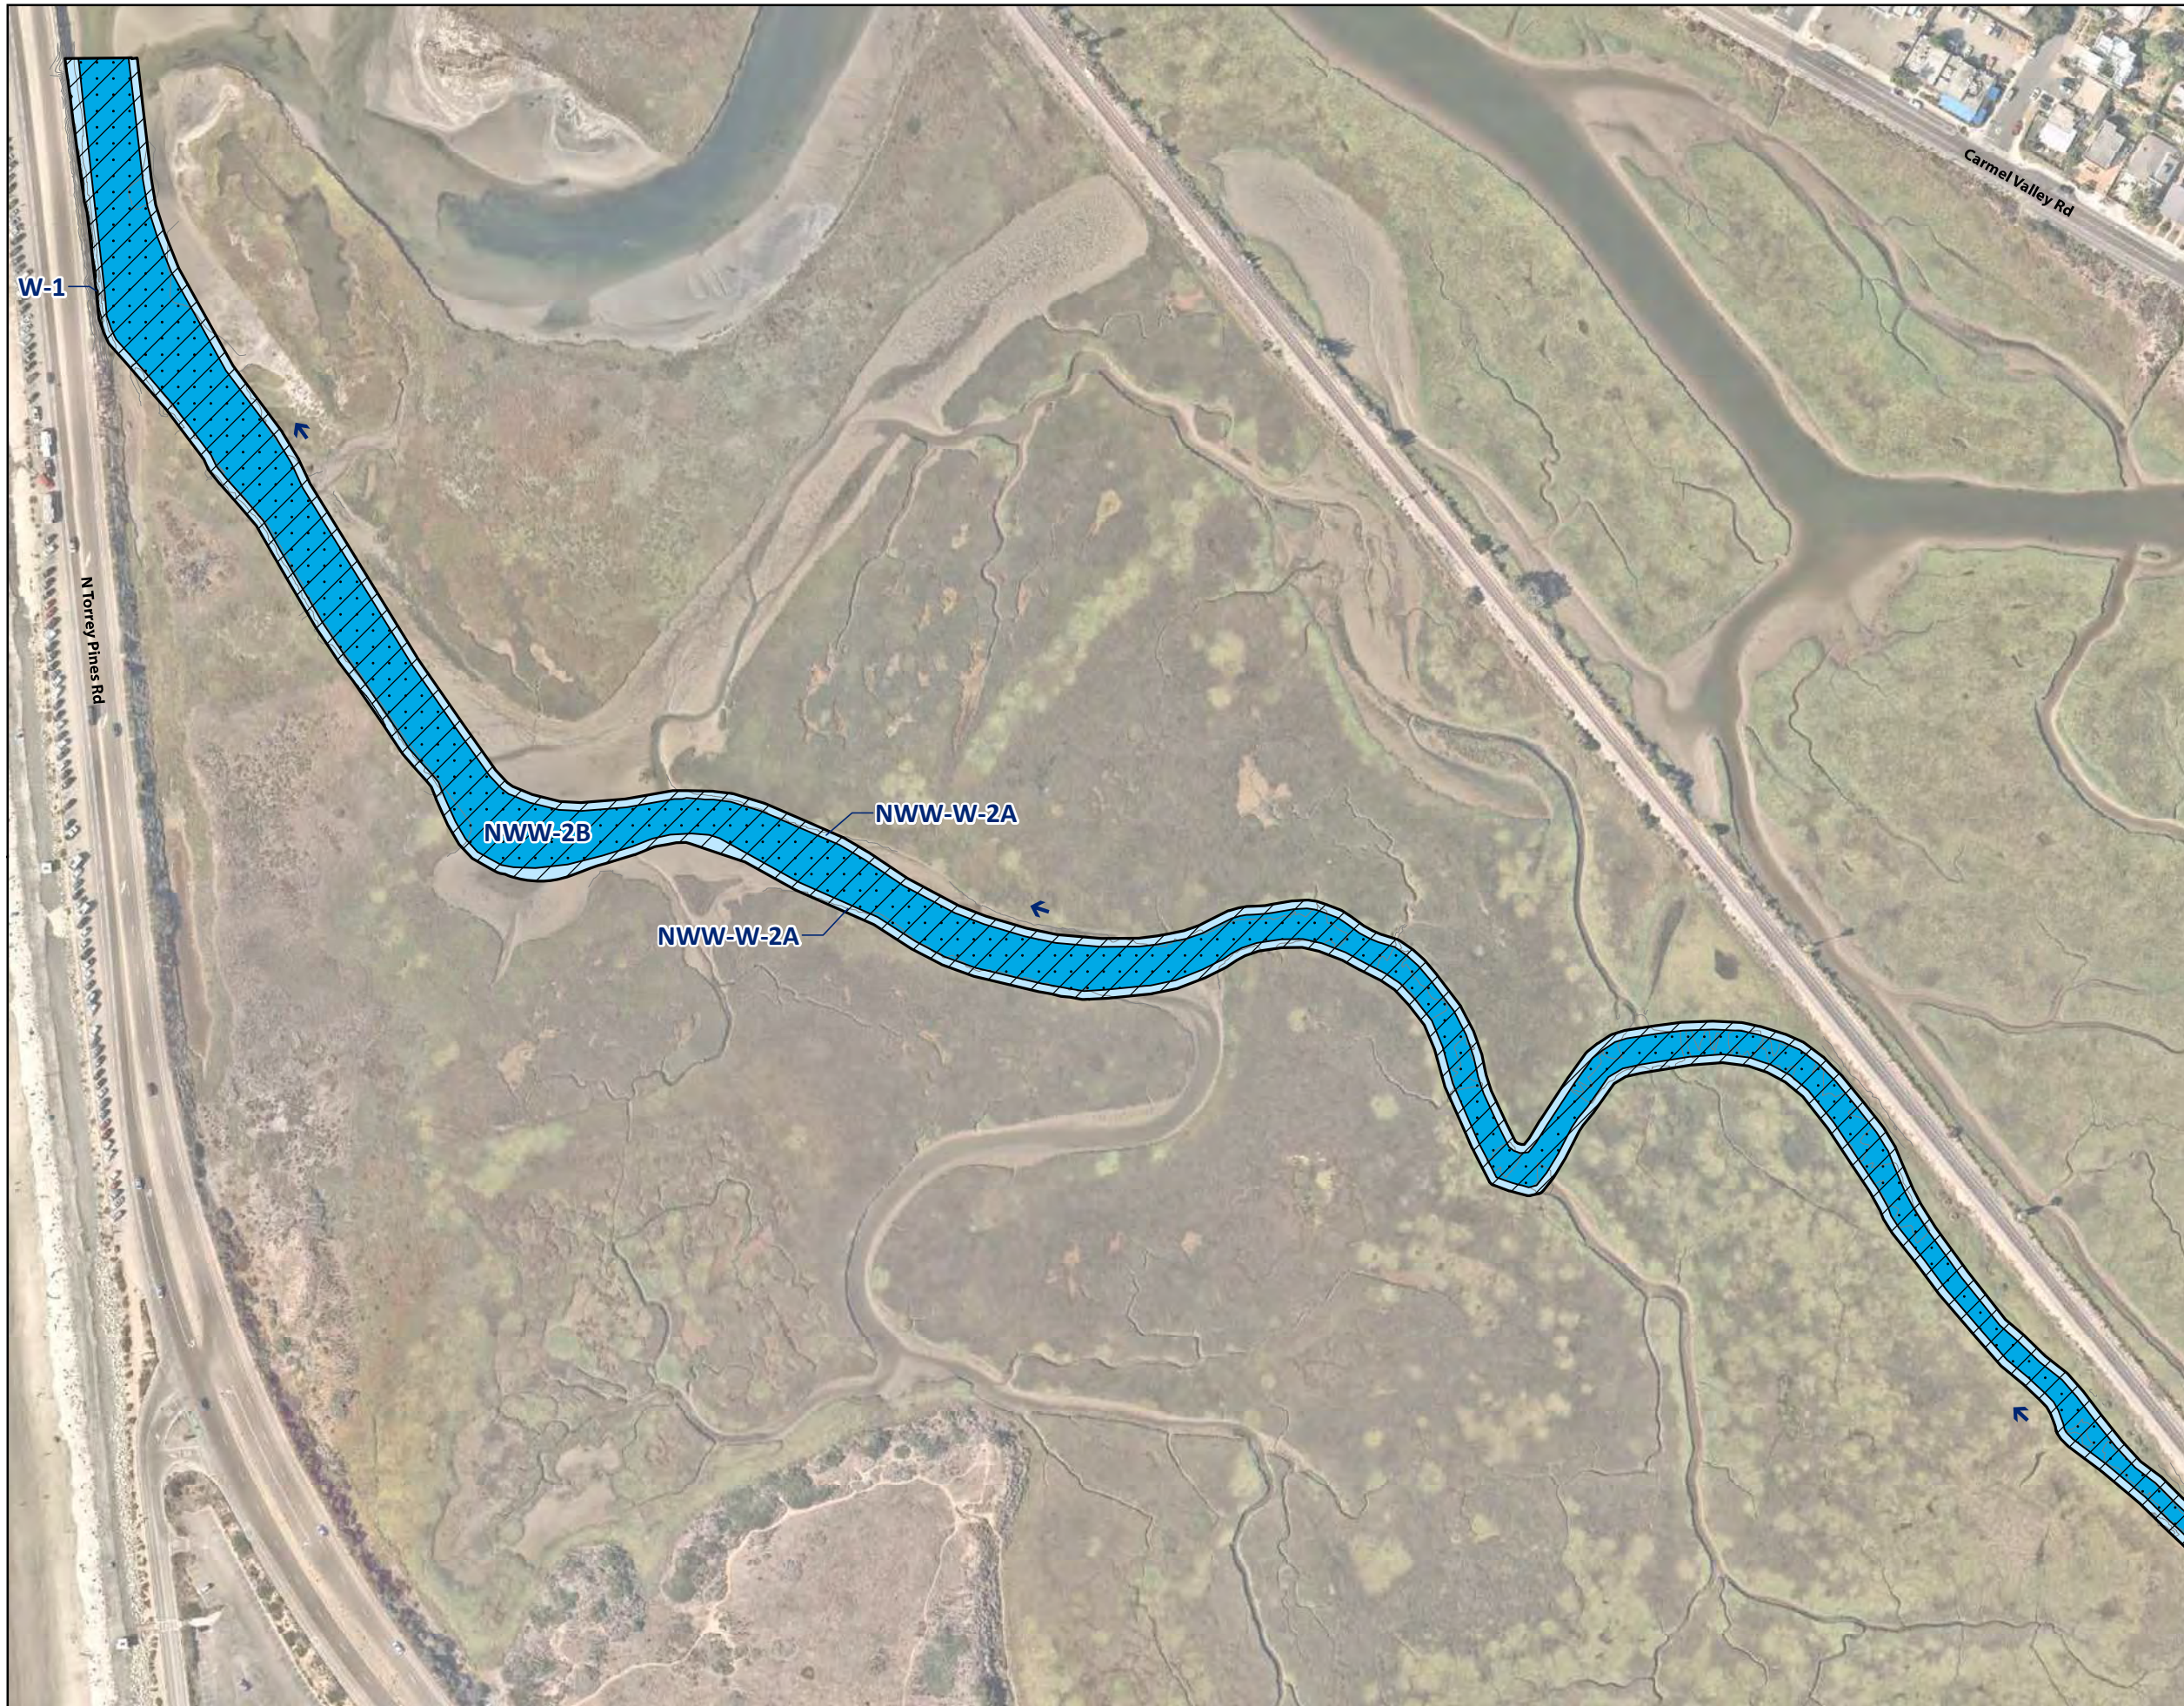
FIGURE 6B PAGE 7 OF 8	RWQCB Aquatic Resources LOS PEÑASQUITOS LAGOON RESTORATION PROJECT - PHASE I
Date: 7/27/2022 Aerial Photo: Nearmap, 2021

- ARDR Review Area (243.16 ac)
 - Project Footprint
 - Photo Point
 - Flow Direction**
 - RWQCB Aquatic Resources**
 - Wetland Waters - Federal/State Wetland (2.30 ac)
 - Wetland Waters - Federal/State Wetland (148.62 ac)*
 - Non-Wetland Waters (11.82 ac)
 - Tidal Waters - Section 404 HTL (7.01 feet MLLW)(10.63 ac)
- * Three-parameter wetland within OHWM.
 ** Flow direction arrows account for non-tidal flows associated with Peñasquitos Creek.

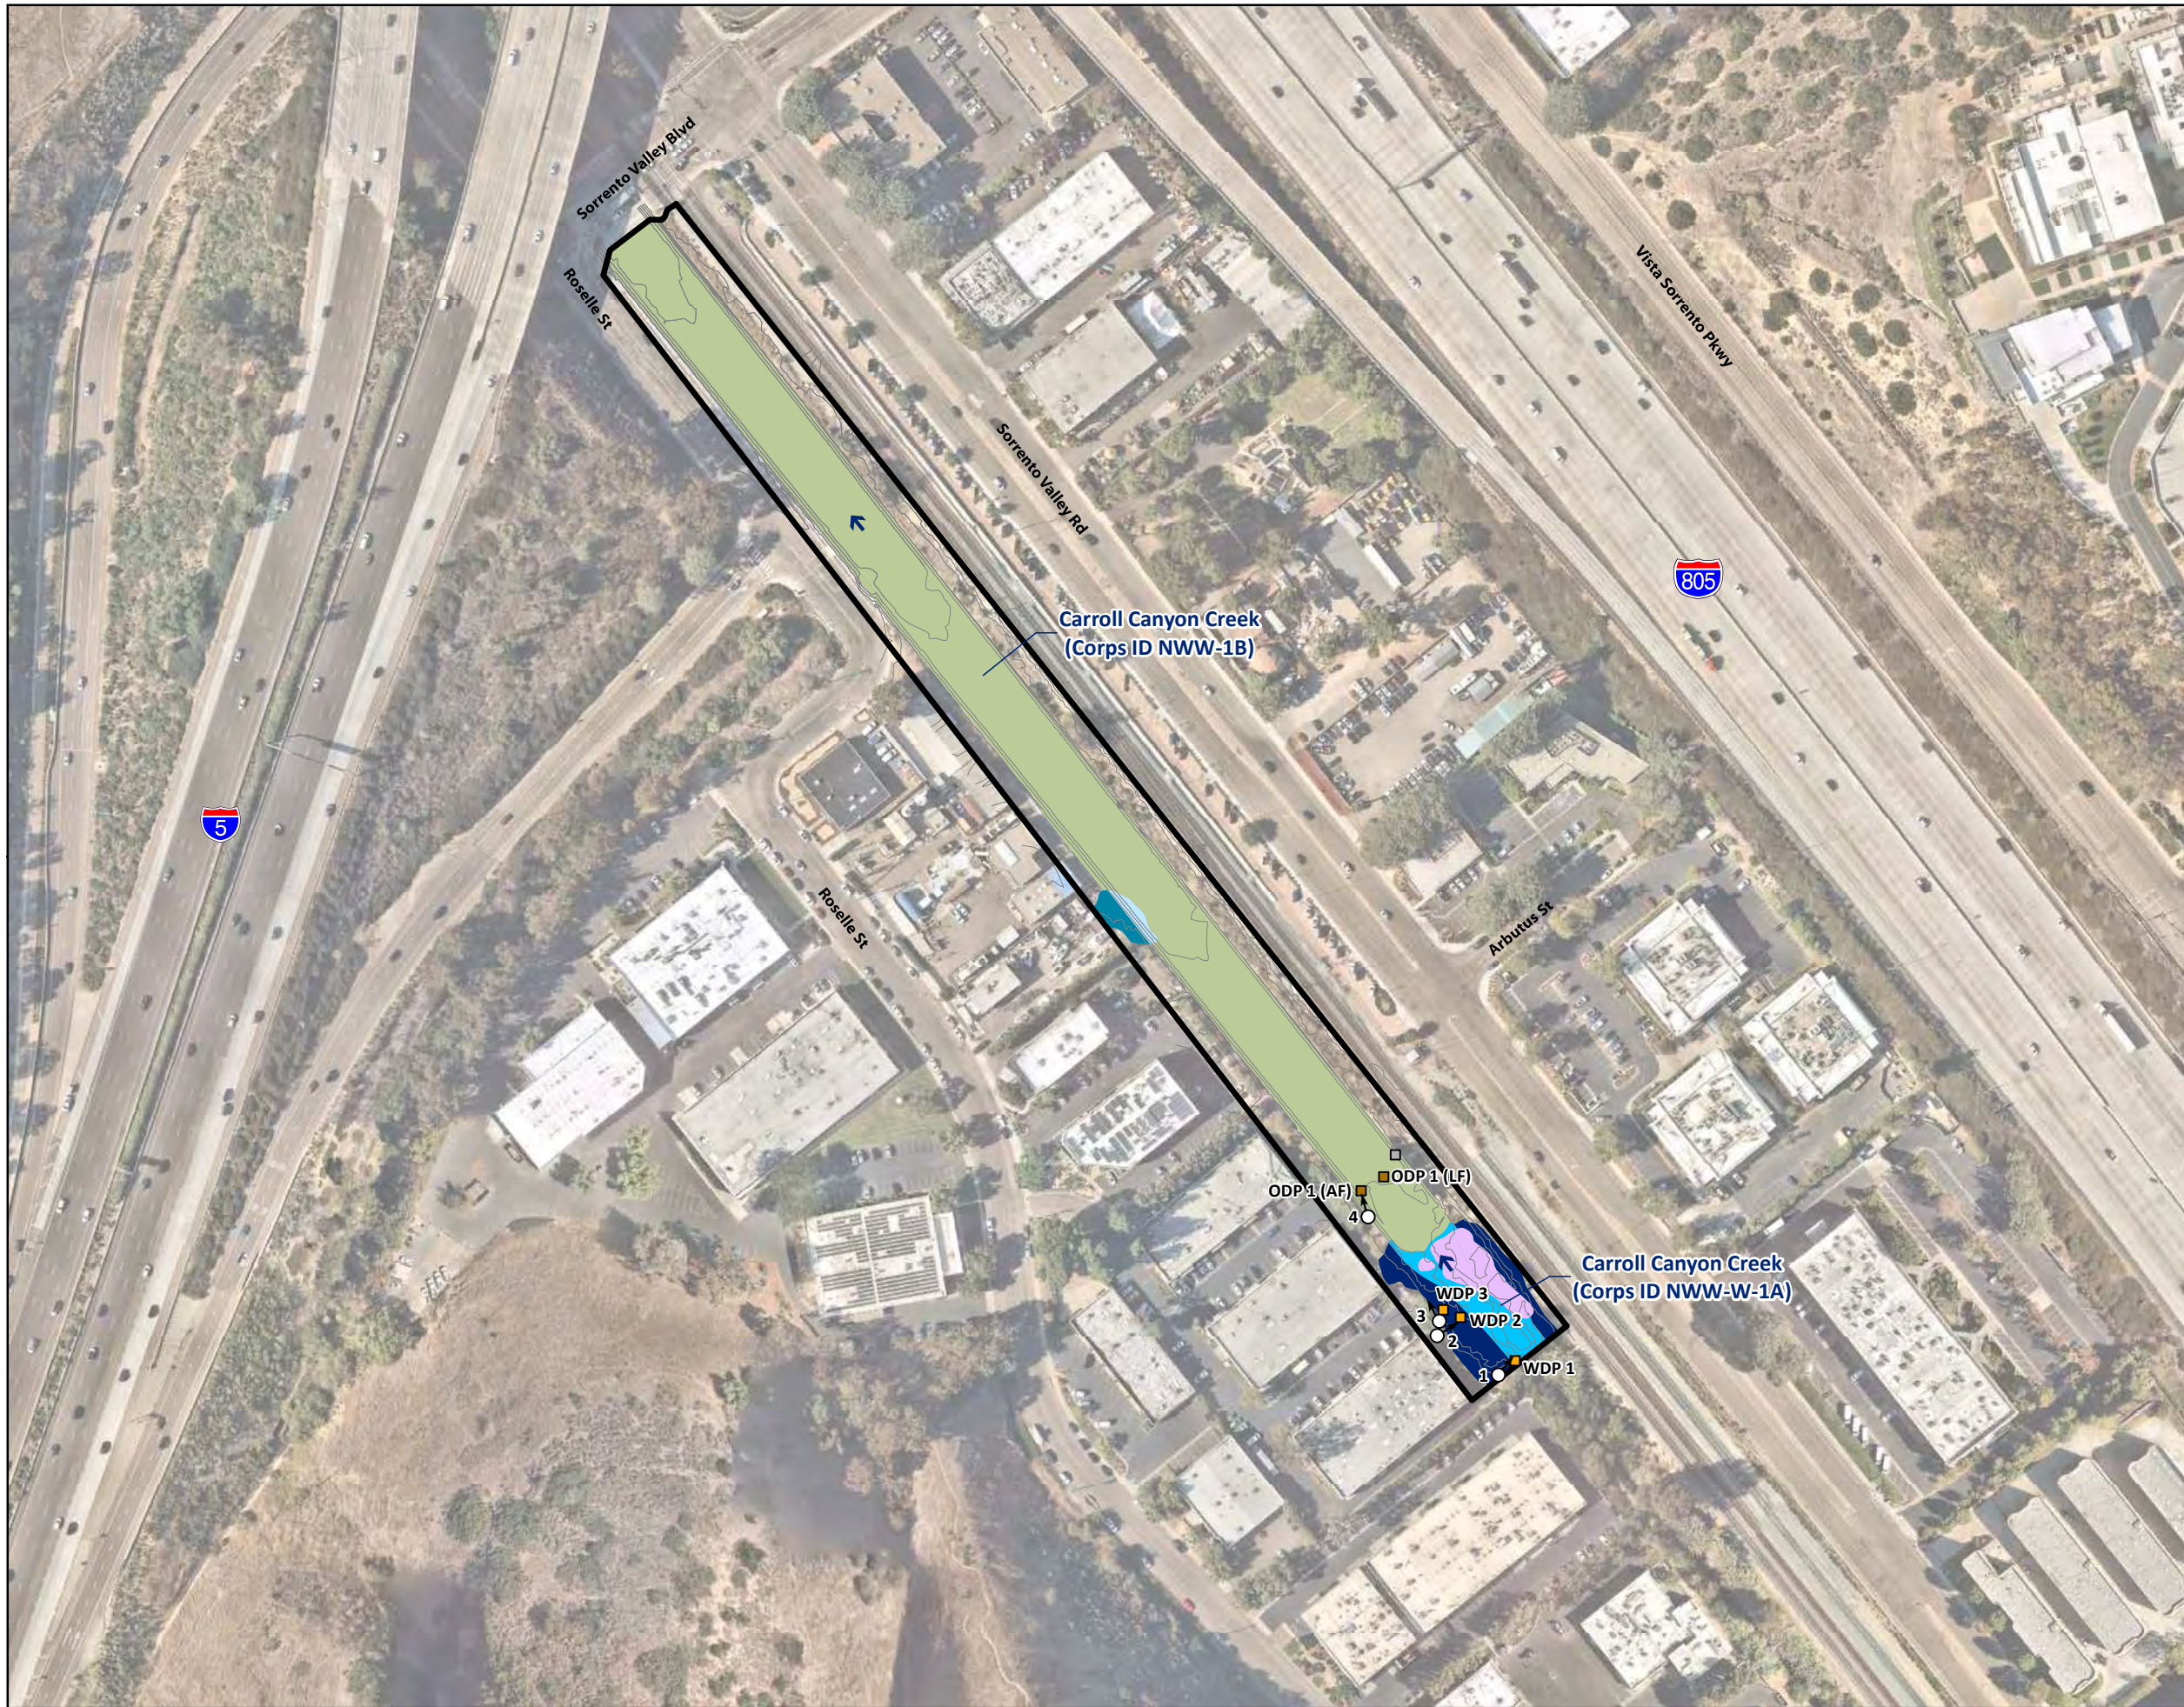
<p>FIGURE 6B</p> <p>PAGE 8 OF 8</p>	<p>RWQCB Aquatic Resources</p> <p>LOS PEÑASQUITOS LAGOON RESTORATION PROJECT - PHASE I</p>
	<p>0 100 200 FEET</p> <p>1 INCH = 200 FEET</p> <p>Date: 7/27/2022 Aerial Photo: Nearmap, 2021</p>

- ARDR Review Area (243.16 ac)
- Photo Point
- Culvert
- Wetland Data Form Point (WDP)
- OHWM Datasheet Point (ODP)
- ➔ Flow Direction
- CDFW Vegetated Streambed**
- Arundo (4.69 ac)
- Southern Willow Scrub (2.55 ac)
- Southern Willow Scrub - Disturbed (0.15 ac)
- CDFW Unvegetated Streambed**
- Non-vegetated Channel (3.14 ac)
- Disturbed Habitat (0.01 ac)
- Developed (0.16 ac)
- CDFW Riparian Habitat**
- Southern Willow Scrub (0.50 ac)
- Southern Willow Scrub - Disturbed (0.22 ac)

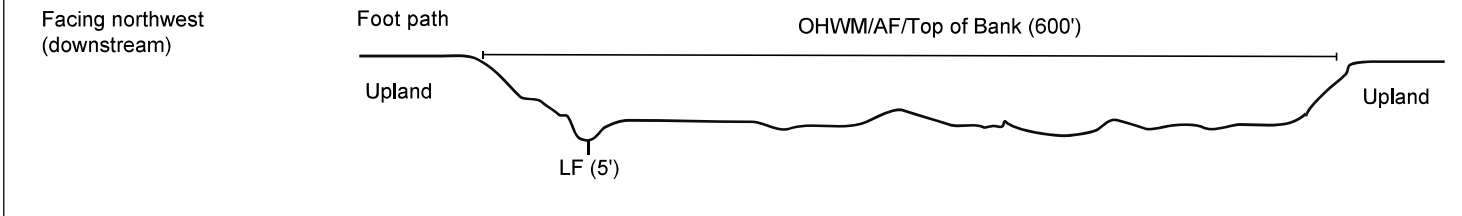
Cross section drawing:

OHWM

GPS point: 32.908752, -117.233316

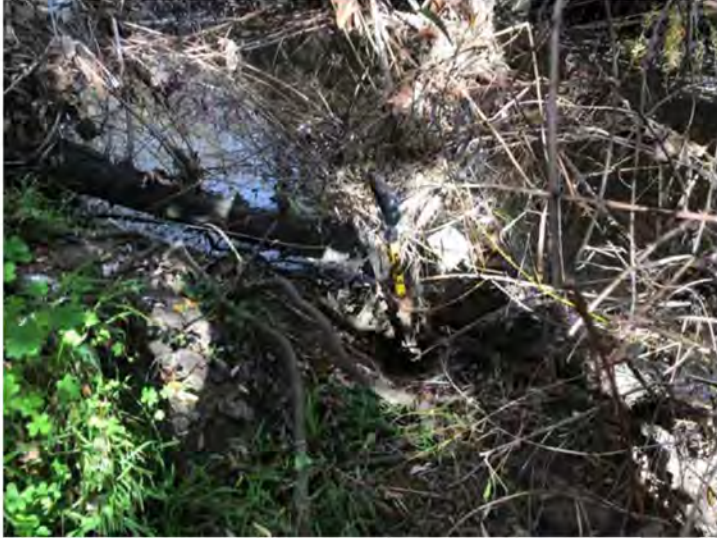
Photo 1. View of Wetland Data Form Point (WDP) 1 within southern willow scrub – disturbed, facing northeast, within Non-Wetland Water (NWW-) Wetland (W-) 1A (Carroll Canyon Creek). WDP 1 met all three wetland parameters (32.896698, -117.220250). January 12, 2022.

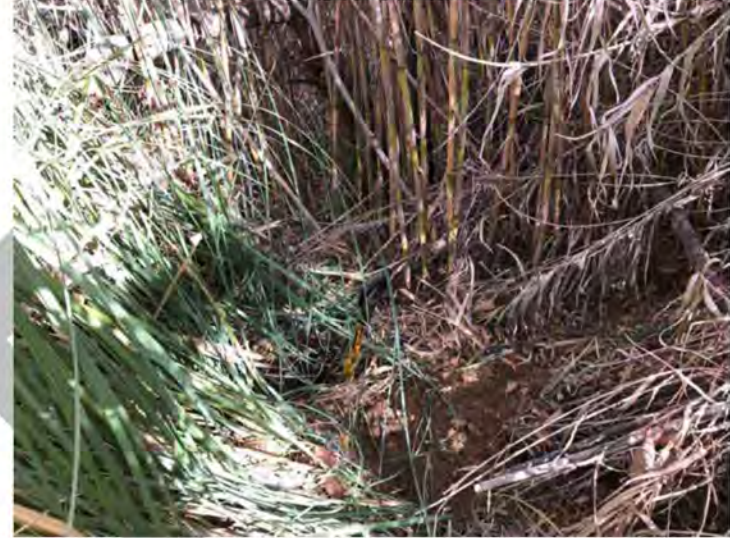
Photo 2. View of WDP 2 within southern willow scrub – disturbed, facing east. WDP 2 did not meet the hydric soil parameter (32.897219, -117.220659). January 12, 2022.

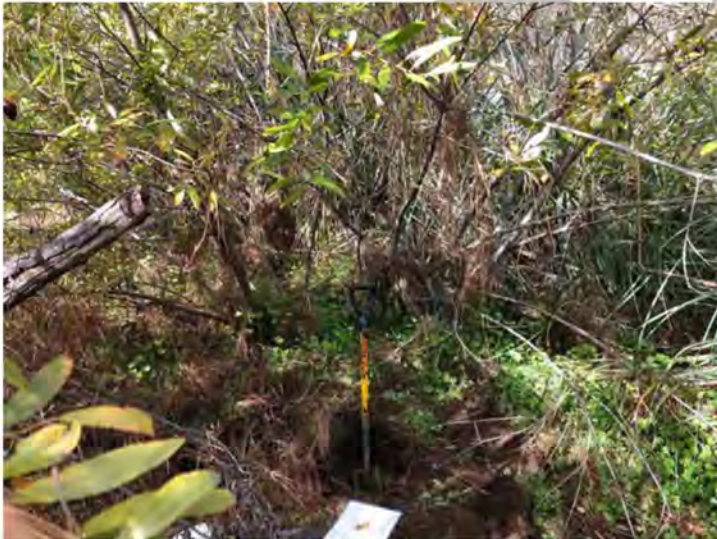
Photo 3. View of WDP 3 within southern willow scrub – disturbed, facing north. WDP 3 did not meet any of the three wetland parameters (32.897321, -117.220419). January 12, 2022.

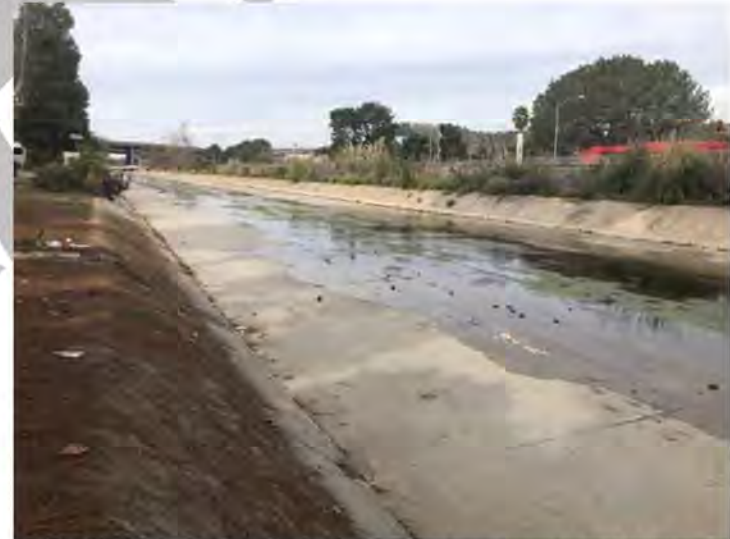
Photo 4. Downstream view of ordinary high water mark (OHWM) Datasheet Point (ODP) 1, facing north, within NWW-1B (Carroll Canyon Creek) (32.897686, -117.220717). January 12, 2022.

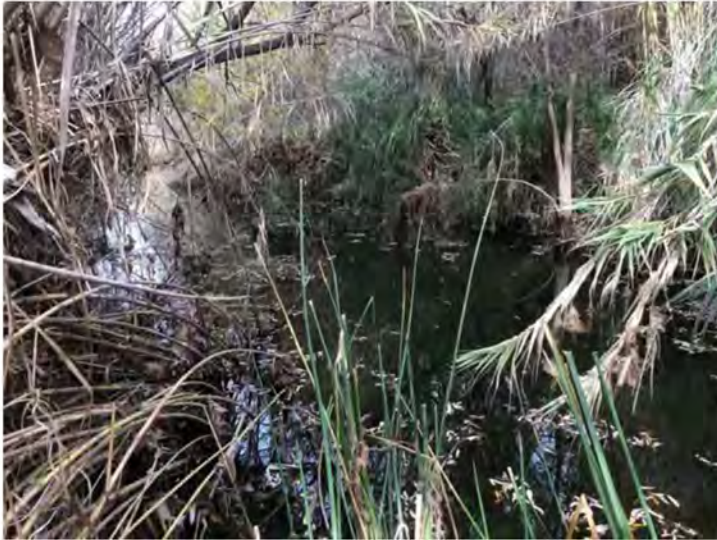
Photo 5. Downstream view of ODP 2, facing north, within NWW-1C/NWW-W-1D (Carroll Canyon Creek) (32.904384, -117.227363). January 12, 2022.

NWW-1C is a channelized portion of Carroll Canyon Creek composed of open water (Figure 6A; Table 6; Appendix E, Photo 5). NWW-1C occurs directly downstream of NWW-1B, as shown on Figure 6A, generally flows northwest, and travels for approximately 1,552 linear feet before converging with NWW-W-2A (see *Non-Wetland Water Wetland 2A* below). NWW-1C did not meet all three federal wetland parameters. See Table 6 for the estimated OHWM and representative OHWM and wetland delineation data for this feature. See Table 7 for the extent of RHA Section 10 navigable waters of the U.S. for this feature.

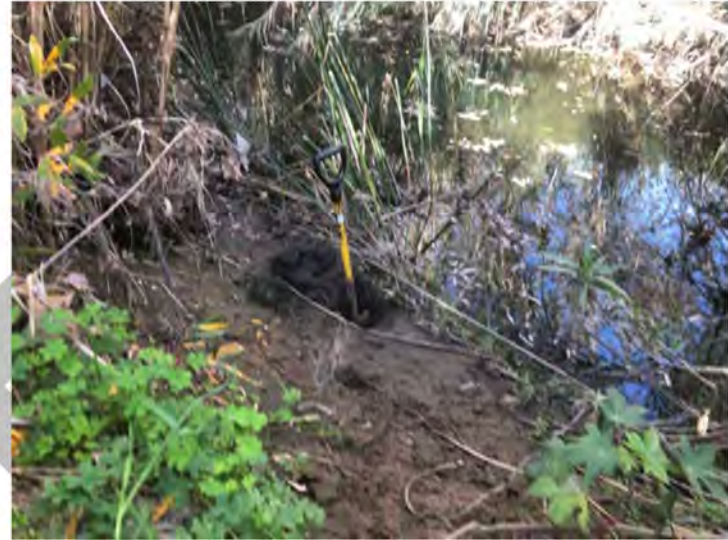
Photo 6. View of WDP 4 within Arundo vegetation community, facing north, within NWW-W-1D (Carroll Canyon Creek). WDP 4 met all three wetland parameters (32.904423, -117.227386). January 12, 2022.

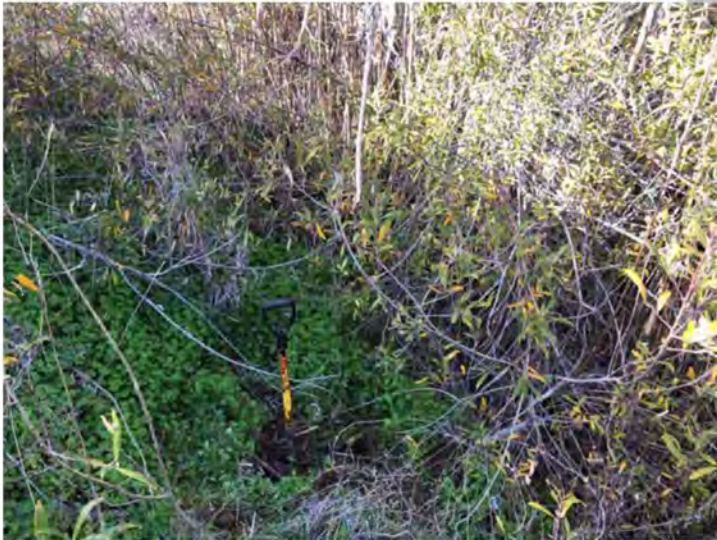
Photo 7. View of WDP 5 within southern arroyo willow riparian forest, facing north. WDP 5 did not meet any of the three wetland parameters (32.904382, -117.227419). January 12, 2022.

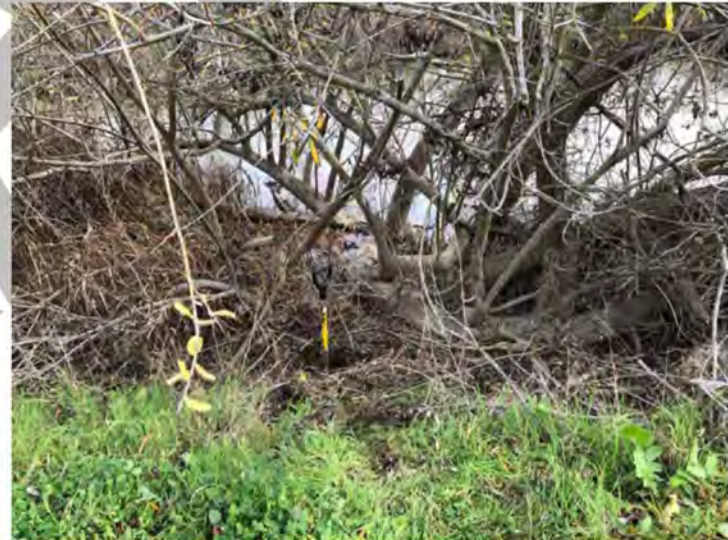
Photo 8. View of WDP 6 within southern arroyo willow riparian forest, facing east, within NWW-W-2A (Peñasquitos Creek/Lagoon). WDP 6 met all three wetland parameters (32.908291, -117.233383). January 12, 2022.

Peñasquitos Creek/Lagoon is an unvegetated and heavily vegetated streambed that travels on site as a channelized feature before converging with Carroll Canyon Creek, and continuing northwest as it transitions to a non-tidal lagoon area (Figure 6C; Table 9; Appendix E, Photos 8, 10 – 12, 14 – 17, 19 – 23, 27 – 29). Continuing northwest, Peñasquitos Creek/Lagoon narrows and transitions to a tidally-influenced lagoon area that receives flows from the Pacific Ocean before continuing off site.

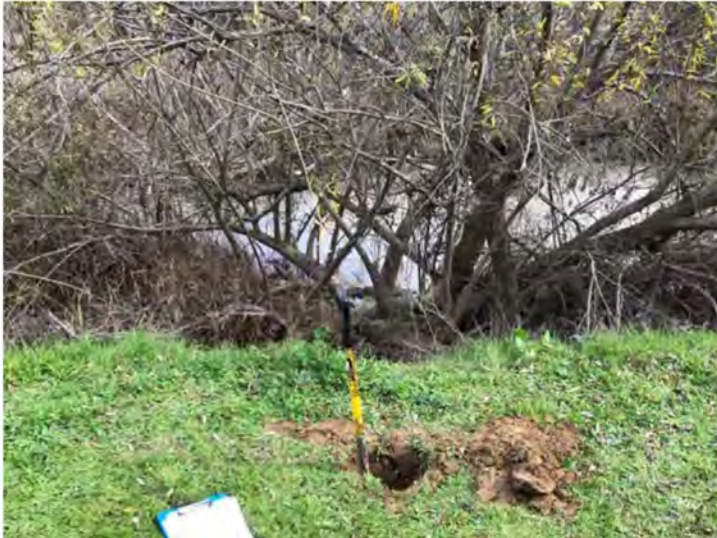
Photo 9. View of WDP 7 within disturbed habitat, facing east. WDP 7 did not meet any of the three wetland parameters (32.908243, -117.233193). January 12, 2022.

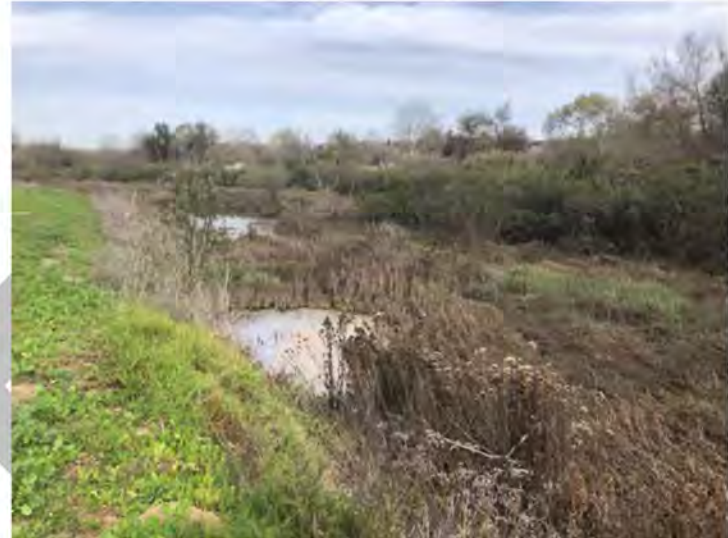
Photo 10. Downstream view of ODP 3, facing north, within NWW-W-2A (Peñasquitos Creek/Lagoon) (32.908838, -117.233373). January 12, 2022.

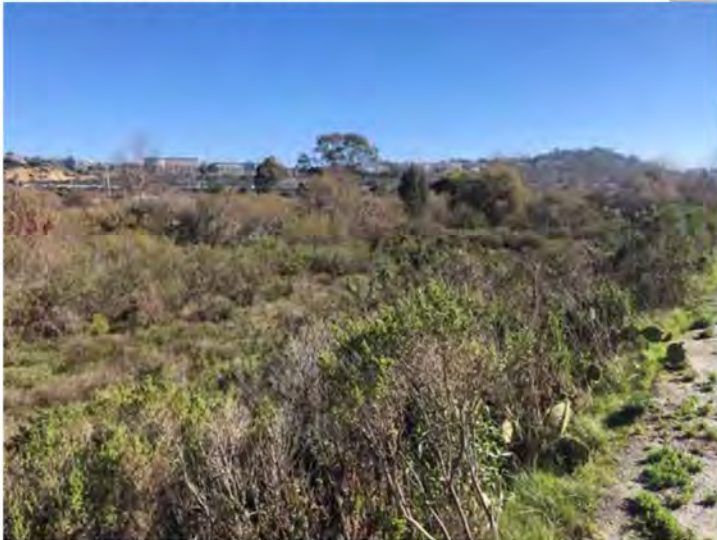
Photo 11. Overview from trail of NWW-W-2A (Peñasquitos Creek/Lagoon), facing east (32.911414, -117.235900). January 20, 2022.

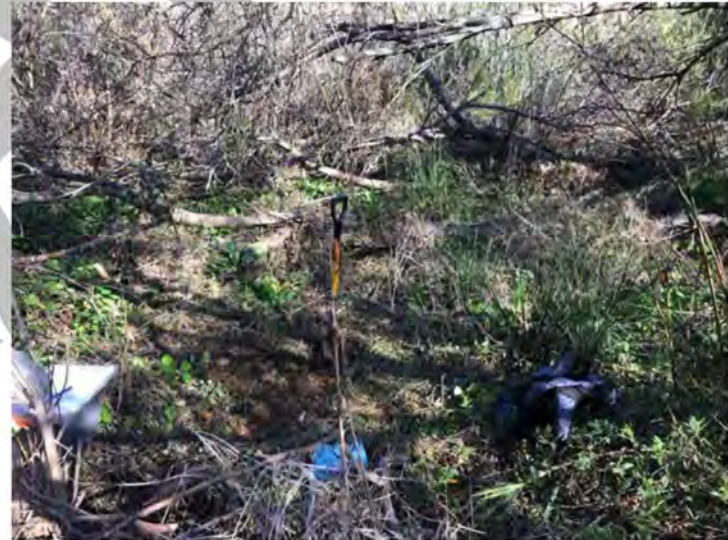
Photo 12. View of WDP 8 within southern arroyo willow riparian forest, facing north, within NWW-W-2A (Peñasquitos Creek/Lagoon). The view of WDP 8 is representative of WDP 10 considering the similar vegetation and wetland hydrology. WDP 8 and WDP 10 met all three wetland parameters (32.911860, -117.235991). January 20, 2022.

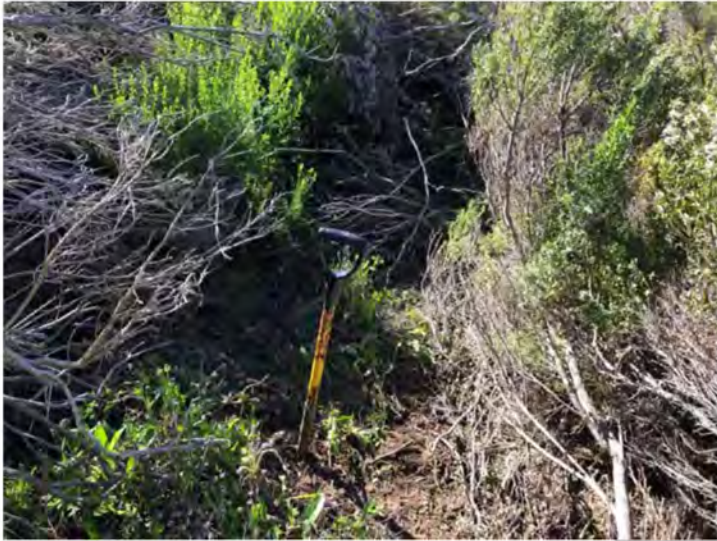
Photo 13. View of WDP 9 within Diegan coastal sage scrub, facing southwest. WDP 9 did not meet any of three wetland parameters (32.911977, -117.236085). January 20, 2022.

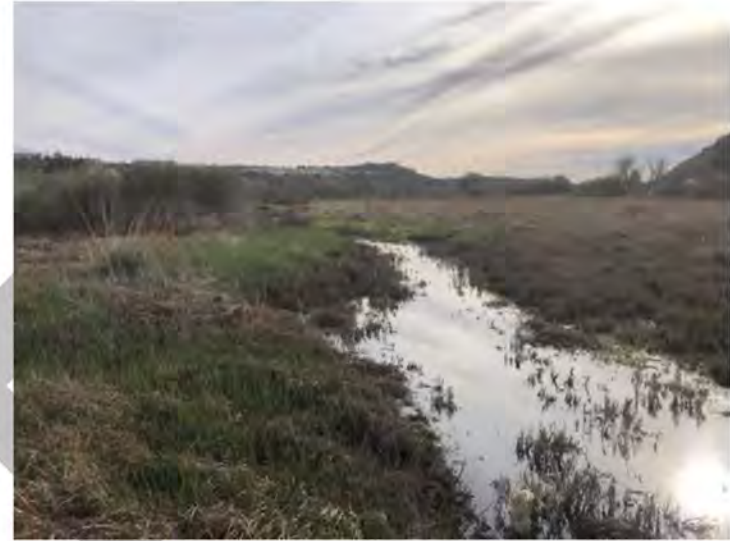
Photo 14. Upstream view of ODP 4, facing east, within NWW-W-2A (Peñasquitos Creek/Lagoon) (32.914702 -117.239918). January 12, 2022.

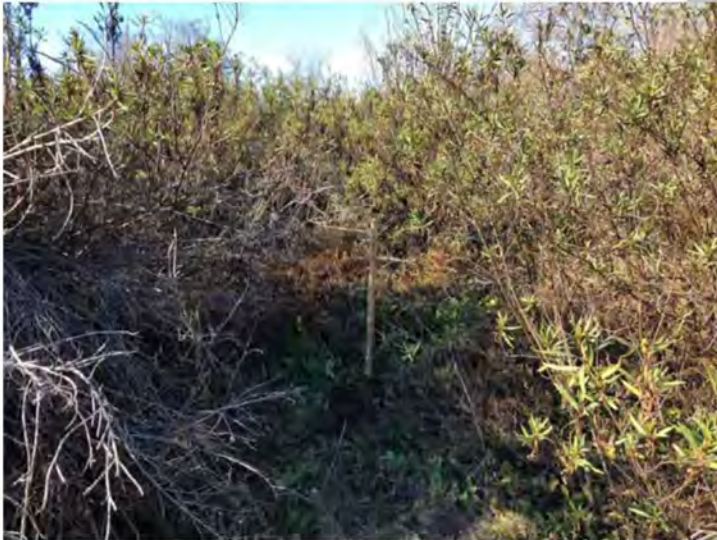
Photo 15. View of WDP 11 within mule fat scrub, facing north, within NWW-W-2A (Peñasquitos Creek/Lagoon). WDP 11 met all three wetland parameters (32.915817, -117.239000). January 11, 2022.

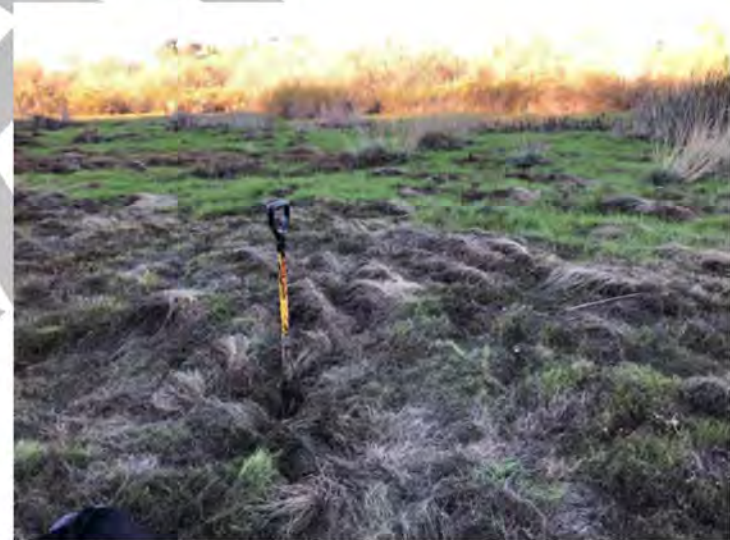
Photo 16. View of WDP 12 within southern coastal salt marsh – degraded, facing north, within NWW-W-2A (Peñasquitos Creek/Lagoon). WDP 12 met all three wetland parameters (32.915639, -117.239461). January 11, 2022.

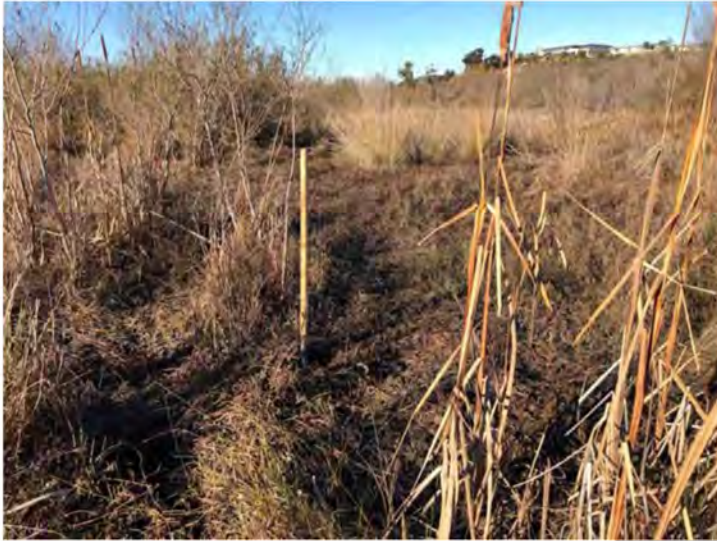
Photo 17. View of WDP 13 within coastal brackish marsh, facing north, within NWW-W-2A (Peñasquitos Creek/Lagoon). WDP 13 met all three wetland parameters (32.915262, -117.240429). January 11, 2022.

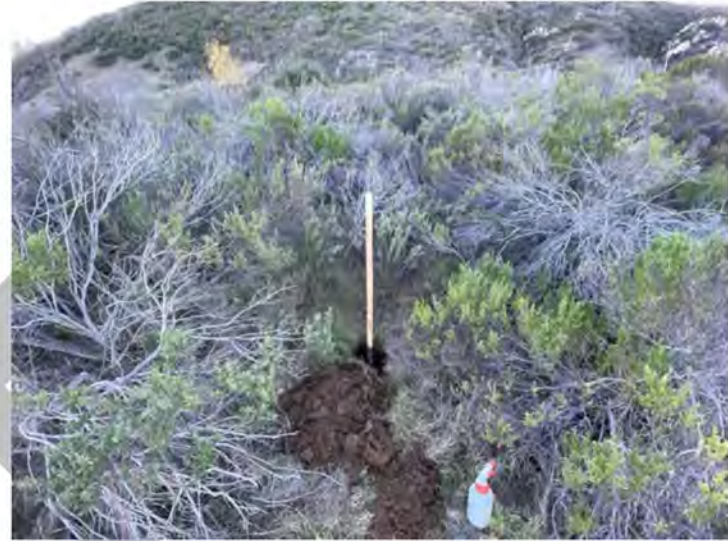
Photo 18. View of WDP 14 within Diegan coastal sage scrub, facing south. WDP 14 did not meet any of the three wetland parameters (32.915104, -117.240693). January 11, 2022.

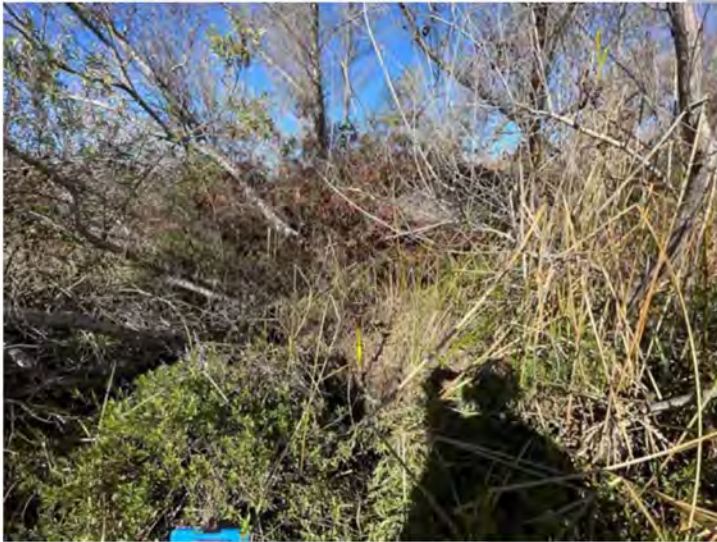
Photo 19. View of WDP 15 within southern willow scrub, facing north, within NWW-W-2A (Peñasquitos Creek/Lagoon). WDP 15 met all three wetland parameters (32.918721, -117.241719). January 11, 2022.

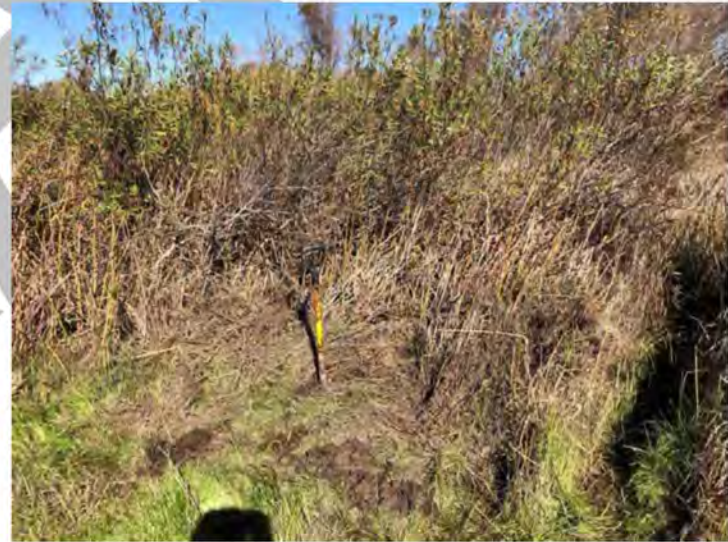
Photo 20. View of WDP 16 within mule fat scrub, facing north, within NWW-W-2A (Peñasquitos Creek/Lagoon). WDP 16 met all three wetland parameters (32.918744, -117.241745). January 11, 2022.

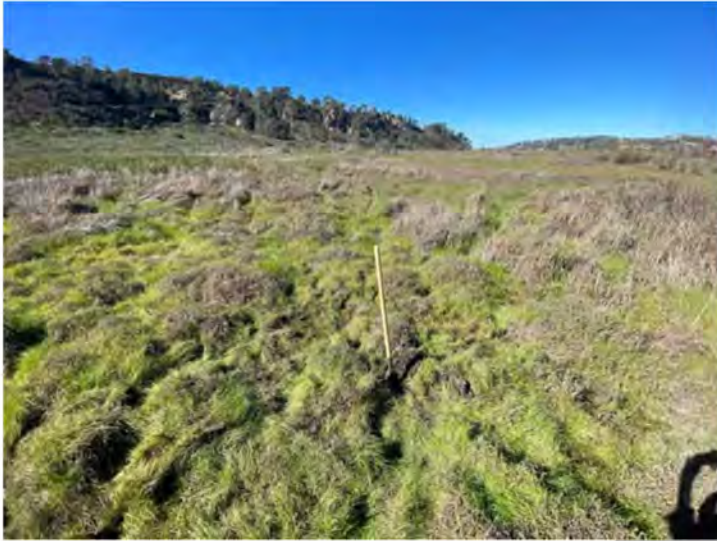
Photo 21. View of WDP 17 within southern coastal salt marsh – degraded, facing west, within NWW-W-2A (Peñasquitos Creek/Lagoon). WDP 17 met all three wetland parameters (32.918240, -117.242401). January 11, 2022.

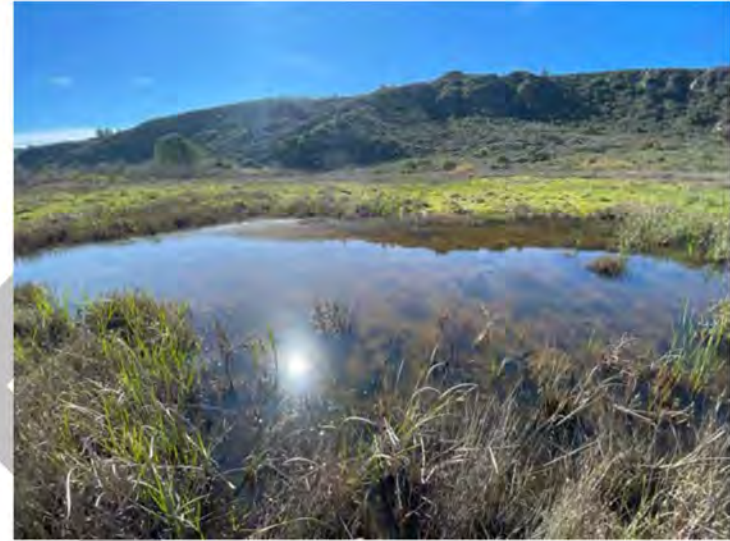
Photo 22. View of alkali meadow, facing south, within NWW-W-2A (Peñasquitos Creek/Lagoon) (32.918127, -117.242455). January 11, 2022.

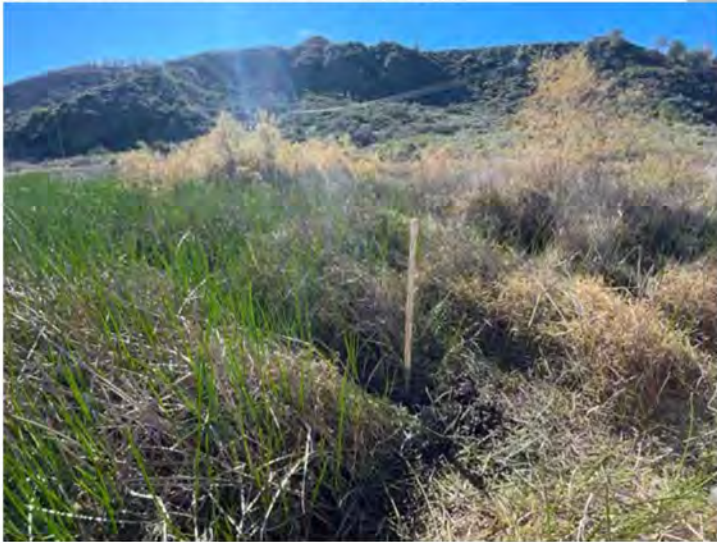
Photo 23. View of WDP 18 within coastal and valley freshwater marsh, facing south, within NWW-W-2A (Peñasquitos Creek/Lagoon). WDP 18 met all three wetland parameters (32.917830, -117.243277). January 11, 2022.

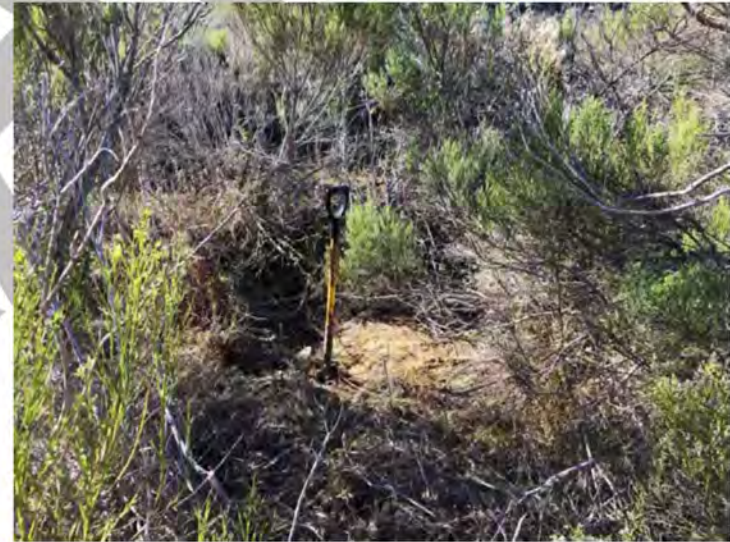
Photo 24. View of WDP 19 within Diegan coastal sage scrub, facing west. WDP 19 did not meet any of the three wetland parameters (32.917736, -117.243726). January 11, 2022.

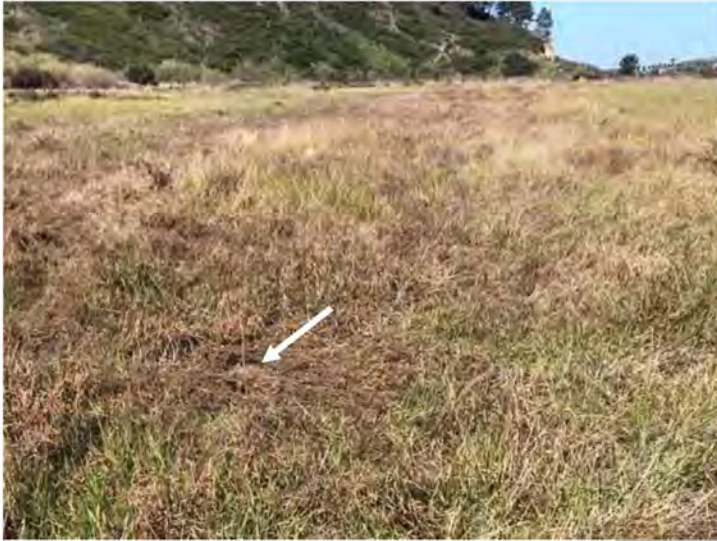
Photo 25. View of WDP 29 (white arrow) within non-native grassland, facing northwest, within NWW-2B (Peñasquitos Creek/Lagoon). WDP 29 did not meet the hydric soil or wetland hydrology parameters (32.921100, -117.245211). January 20, 2022.

NWW-2B consists of the open water and areas of upland vegetation community (areas that did not meet all three federal wetland parameters) within Peñasquitos Creek/Lagoon (Figure 6A; Table 6; Appendix E, Photos 25 – 26). NWW-2B did not meet all three federal wetland parameters. Note that several slightly elevated/bermed areas dominated by non-native grassland were included within the OHWM based on the presence of OHWM indicators. See Table 6 for the estimated OHWM and representative OHWM and wetland delineation data for this feature. See Table 7 for the extent of RHA Section 10 tidal waters, CWA Section 404 tidal and non-tidal waters, and RHA Section 10 navigable waters of the U.S. for this feature.

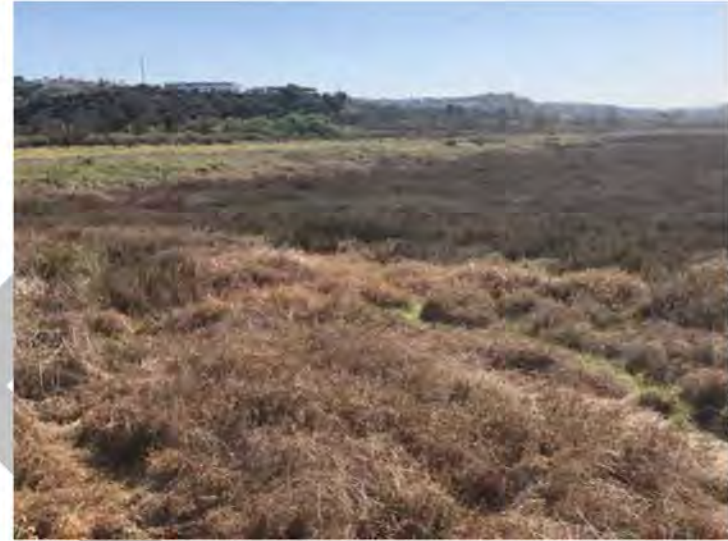
Photo 26. Upstream view of ODP 9, facing east, within NWW-W-2A/NWW-2B (Peñasquitos Creek/Lagoon) (32.921695, -117.246492). January 20, 2022.

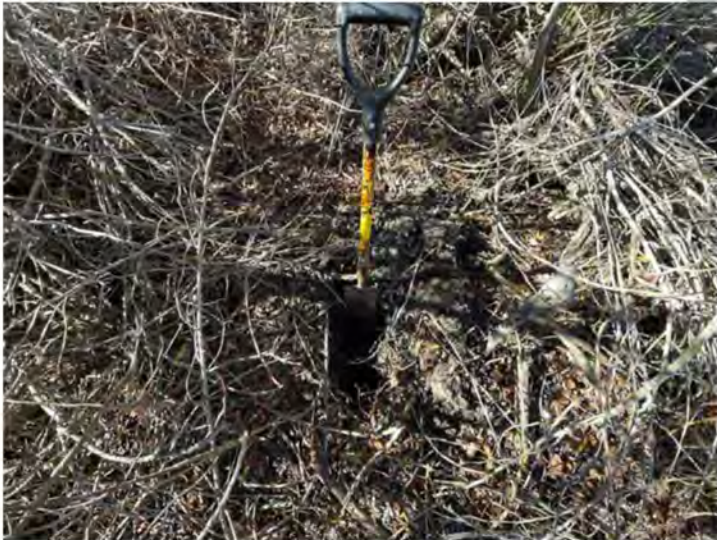
Photo 27. View of WDP 20 within southern willow scrub, facing west, within NWW-W-2A (Peñasquitos Creek/Lagoon). WDP 20 met all three wetland parameters (32.924831, -117.248820). January 11, 2022.

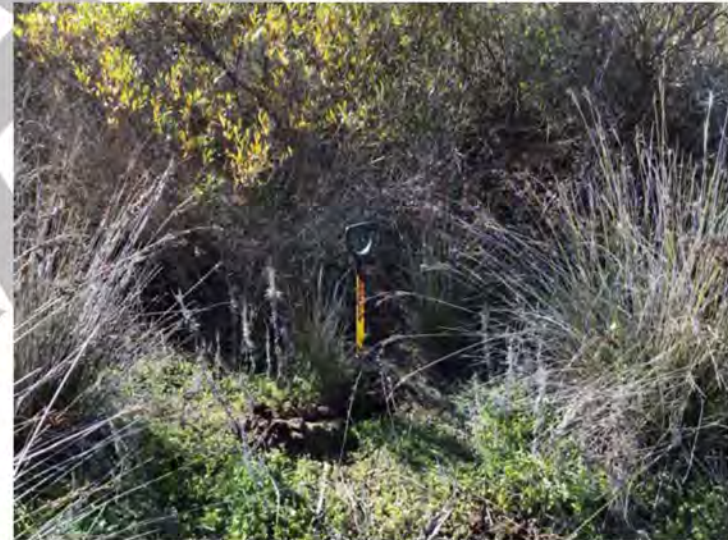
Photo 28. View of WDP 21 within southern coastal salt marsh, facing south, within Wetland (W-) 1 (Peñasquitos Creek/Lagoon). WDP 21 met all three wetland parameters (32.924822, -117.248906). January 11, 2022.

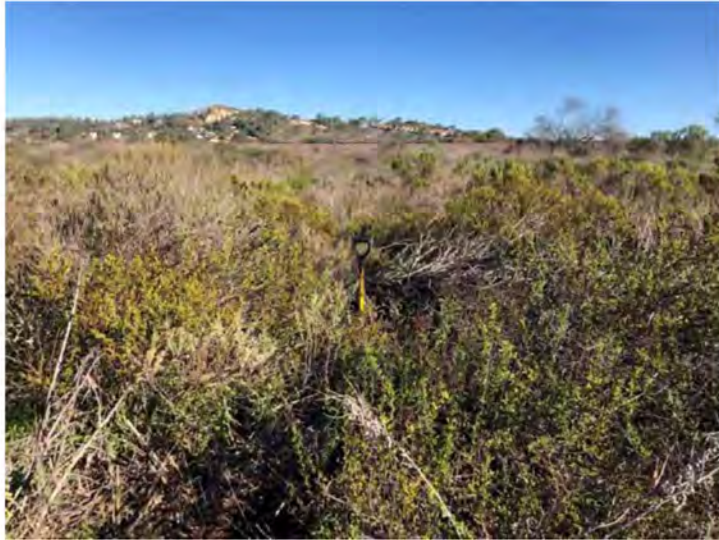
Photo 29. View of WDP 22 within Diegan coastal sage scrub, facing north, within a portion of Peñasquitos Creek/Lagoon only jurisdictional by the California Department of Fish and Wildlife (CDFW) (i.e., within CDFW top of bank, but outside of Corps Section 404 High Tide Line [HTL]). WDP 22 did not meet any of the three wetland parameters (32.924866, -117.248754). January 11, 2022.

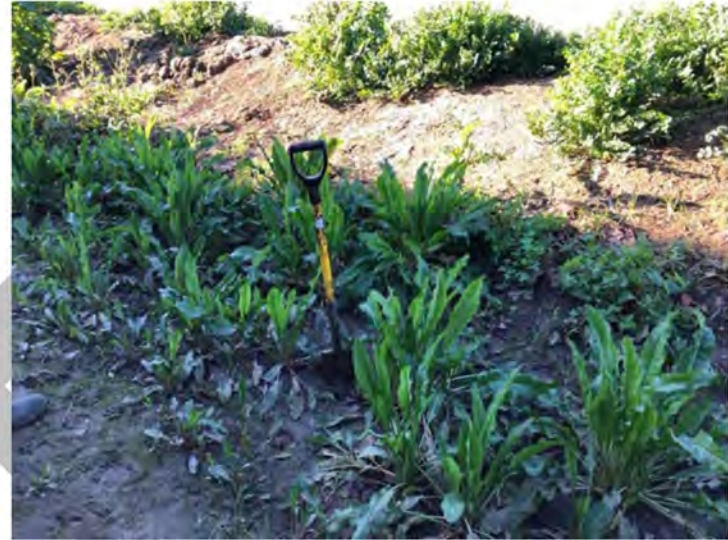
Photo 30. View of WDP 23 within disturbed wetland, facing north, within NWW-W-3 (NWW-1 for CDFW). WDP 23 met all three wetland parameters (32.903219, -117.228116). January 20, 2022.

NWW-W-3 is a vegetated, roadside drainage composed of disturbed wetland (Figure 6A; Table 6; Appendix E, Photos 30 and 32). NWW-W-3 originates at a culvert south of Dunhill Street, as shown on Figure 6A, generally flows east/northeast, and travels for approximately 433 linear feet before entering a culvert. NWW-W-3 met all three federal wetland parameters and occurs entirely within the delineated OHWM. Although this feature met the three-parameter wetland definition, because it is located within the defined OHWM it is considered a non-wetland water of the U.S. per Corps' protocols (i.e., wetlands occurring within the OHWM are non-wetland waters by regulation and guidance). See Table 6 for the estimated OHWM and representative OHWM and wetland delineation data for this feature.

NWW-1 is a vegetated streambed composed of disturbed wetland (Figure 6C; Table 9; Appendix E, Photos 30 and 32). NWW-1 originates at a culvert south of Dunhill Street, as shown on Figure 6C, generally flows east/northeast, and travels for approximately 433 linear feet before entering a culvert. See Table 9 for the estimated extent of CDFW jurisdiction for this feature.

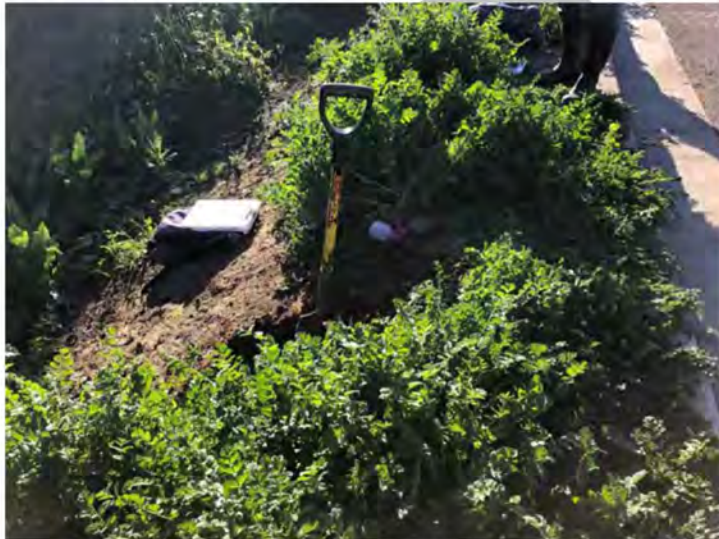
Photo 31. View of WDP 24 within disturbed habitat, facing west. WDP 24 did not meet any of the three wetland parameters (32.903154, -117.228546). January 20, 2022.
