Biological Technical Report - FINAL

Los Peñasquitos Lagoon Restoration

Phase 1

October 11, 2024

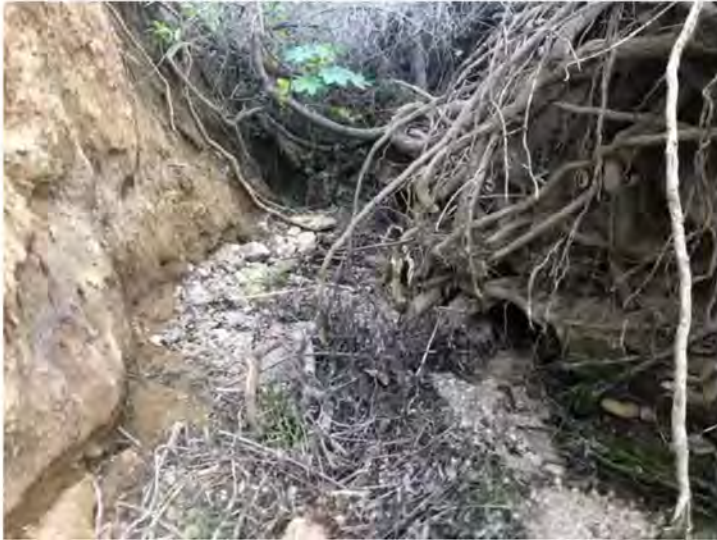
Photo 33. Downstream view of ODP 6, facing north, within NWW-5 (NWW-3 for CDFW) (32.911857, -117.239011). January 12, 2022.

NWW-5 is a sparsely vegetated drainage within an area of Diegan coastal sage scrub and southern willow scrub (Figure 6A; Table 6; Appendix E, Photos 33 and 35). NWW-5 enters the review area then travels northwest for approximately 334 linear feet before dissipating at the trail/foot path. NWW-5 did not meet all three federal wetland parameters. See Table 6 for the estimated OHWM and representative OHWM and wetland delineation data for this feature.

NWW-3 is a sparsely vegetated streambed within an area of Diegan coastal sage scrub and southern willow scrub (Figures 6C; Table 9; Appendix E, Photos 33 and 35). NWW-3 enters the review area then travels northwest for approximately 334 linear feet before dissipating at the trail/foot path. Riparian habitat observed as directly associated with the delineated NWW-3 streambed includes southern willow scrub (Figure 6C; Appendix E, Photo 32). See Table 9 for the estimated extent of CDFW jurisdiction for this feature.

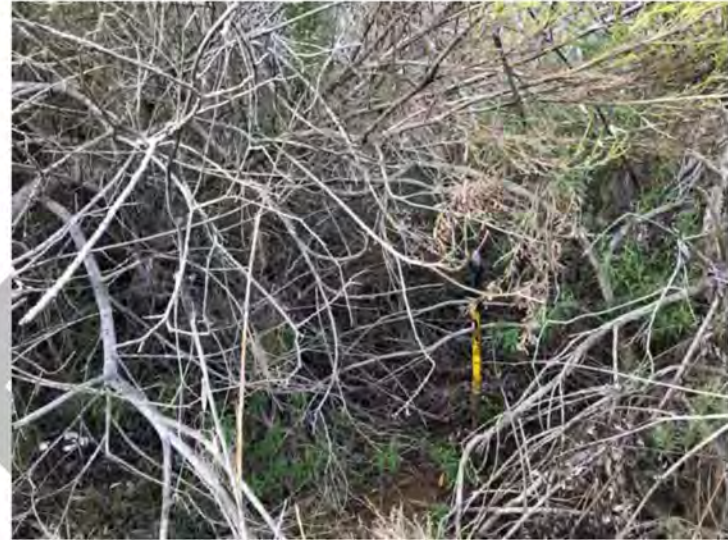
Photo 34. View of WDP 25 within southern willow scrub, facing west. WDP 25 did not meet the hydrophytic vegetation or wetland hydrology parameters (32.912300, -117.239121). January 12, 2022.

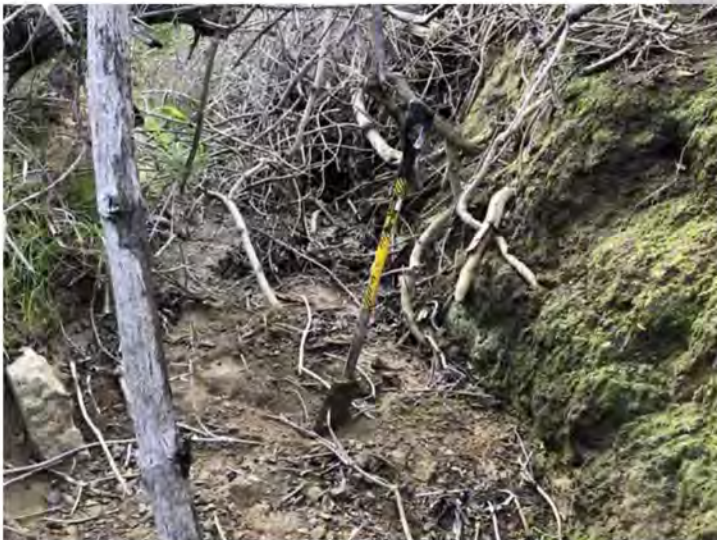
Photo 35. View of WDP 26 and upstream view of ODP 7 within Diegan coastal sage scrub, facing south, within NWW-5 (NWW-3 for CDFW). WDP 26 did not meet any of the three wetland parameters (32.912402, -117.239287). January 12, 2022.

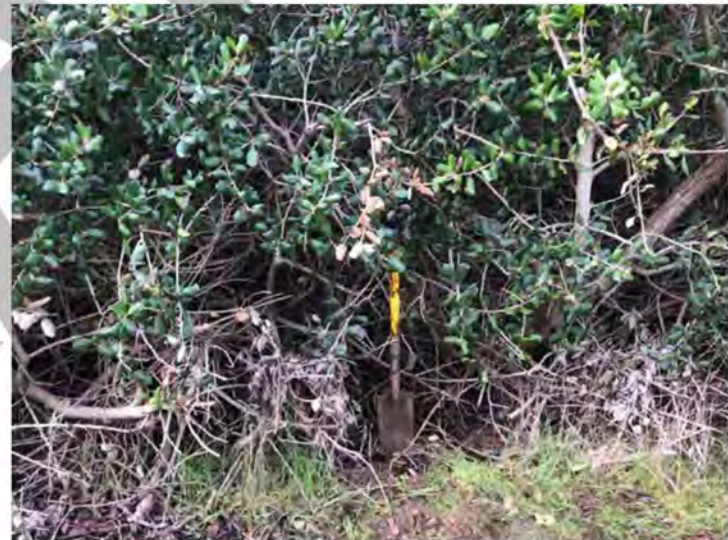
Photo 36. View of WDP 27 within Diegan coastal sage scrub, facing west. WDP 27 did not meet any of the three wetland parameters (32.912545, -117.239058). January 12, 2022.

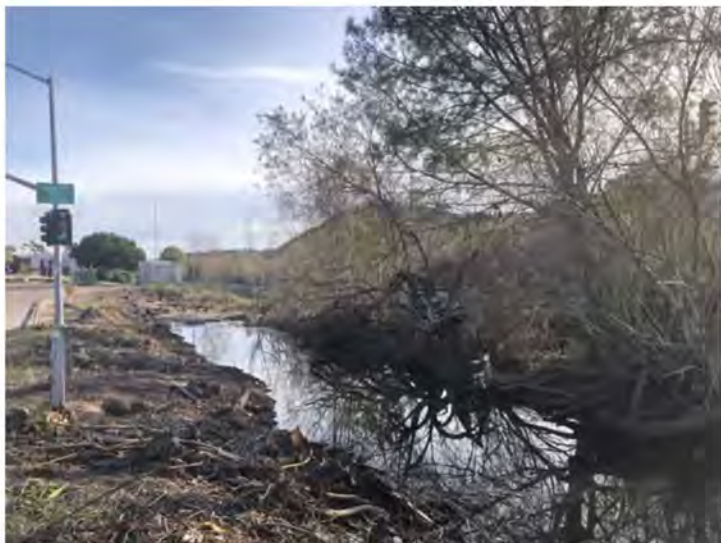
Photo 37. Upstream view of ODP 8, facing south, within NWW-6 (NWW-4 for CDFW) (32.9163400, -117.237378). January 12, 2022.

NWW-6 is an unvegetated drainage within an area of southern willow scrub between Sorrento Valley Road and the railroad tracks (Figure 6A; Table 6; Appendix E, Photo 37). The drainage receives storm flows from two outfalls: Industrial Court and Carmel Mountain Road. NWW-6 conveys flows for approximately 301 linear feet and connects to NWW-W-2A (see *Non-Wetland Water Wetland 2A* above) via a culvert under the railroad tracks. NWW-6 did not meet all three federal wetland parameters. See Table 6 for the estimated OHWM and representative OHWM and wetland delineation data for this feature.

NWW-4 is an unvegetated streambed within an area of southern willow scrub, developed, and non-vegetated channel, between Sorrento Valley Road and the railroad tracks (Figure 6C; Table 9; Appendix E, Photo 37). NWW-4 travels for approximately 301 linear feet and likely connects to Peñasquitos Creek/Lagoon via a culvert under the railroad tracks, although due to restricted access and high water, this could not be confirmed. Riparian habitat observed as directly associated with the delineated NWW-4 streambed includes southern willow scrub (Figure 6C). See Table 9 for the estimated extent of CDFW jurisdiction for this feature.

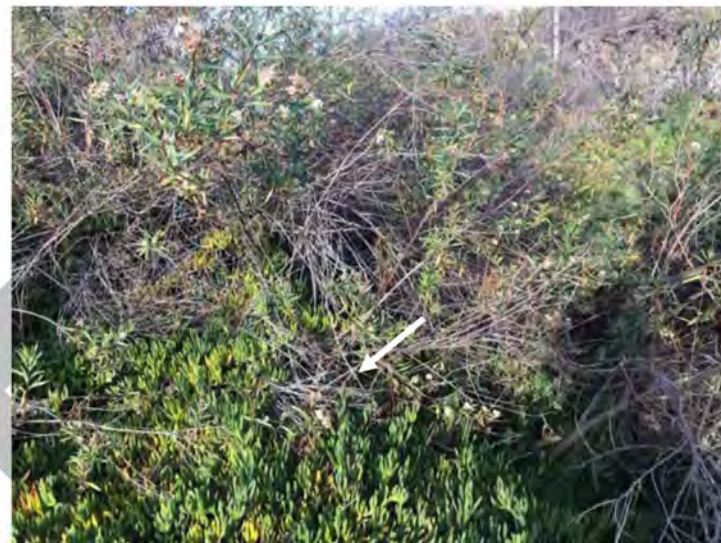
Photo 38. View of WDP 28 (white arrow) within mule fat scrub, facing north, within NWW-7 (NWW-5 for CDFW). WDP 28 did not meet any of the three wetland parameters (32.917501, -117.238035). January 12, 2022.

NWW-7 is a heavily vegetated drainage within an area of mule fat scrub (Figure 6A; Table 6; Appendix E, Photo 38). NWW-7 enters the review area then travels south for approximately 57 linear feet before dissipating at Sorrento Valley Road. NWW-7 did not meet all three federal wetland parameters. See Table 6 for the estimated OHWM and representative OHWM and wetland delineation data for this feature.

NWW-5 is a heavily vegetated streambed that occurs within an area of mule fat scrub and disturbed habitat (Figure 6C; Table 9; Appendix E, Photo 38). Specifically, NWW-5 enters the review area then travels south for approximately 57 linear feet before dissipating at Sorrento Valley Road. Riparian habitat observed as directly associated with the delineated NWW-5 streambed includes mule fat scrub (Figure 6C). See Table 9 for the estimated extent of CDFW jurisdiction for this feature.
