Appendix G
Previous Environmental Reports

Phase II Environmental Site Assessment Report

Midway Rising

Portions of Assessor's Parcel Number 441-590-04
3220, 3240, 3250, 3350, and 3500 Sports Arena
Boulevard, San Diego, California 92110

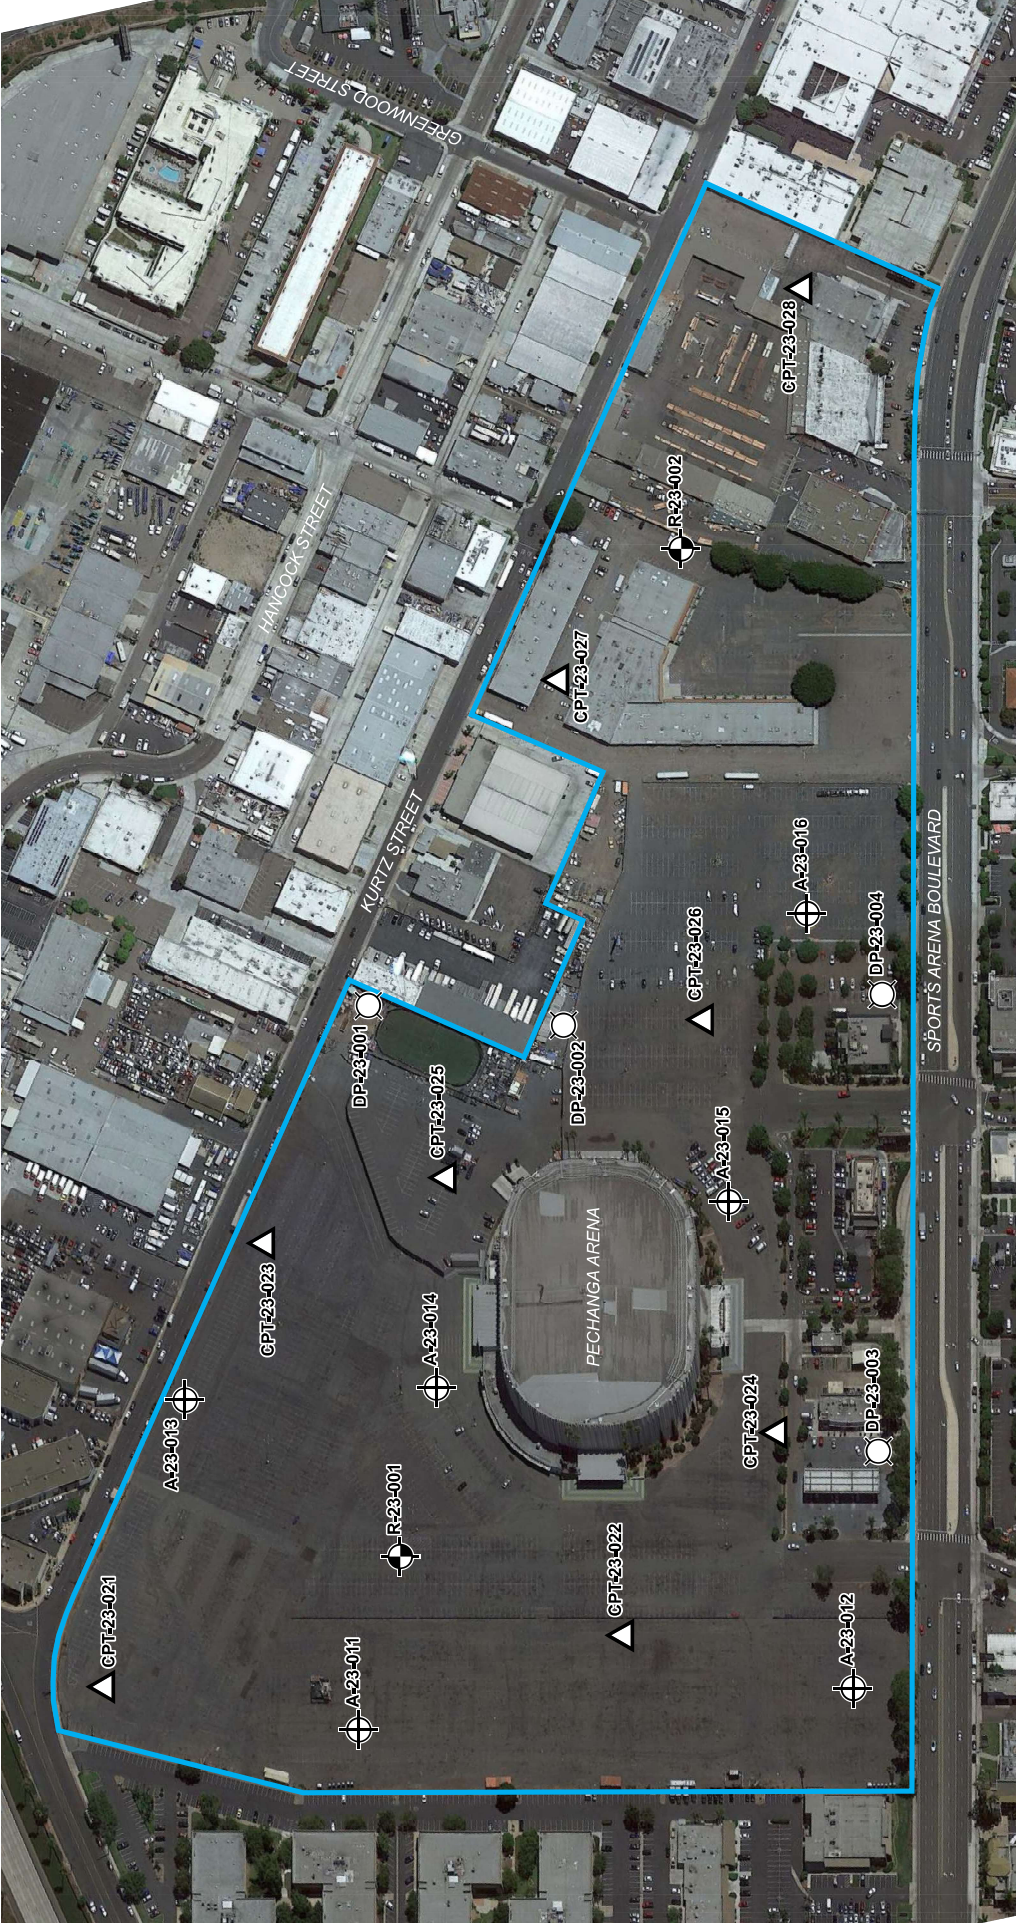
FIGURE NAME
**PROPOSED
 EXPLORATION LOCATIONS**

- APPROXIMATE LIMITS OF SITE DEVELOPMENT
- APPROXIMATE LOCATION OF HOLLOW-STEM AUGER BORING
- APPROXIMATE LOCATION OF MUD ROTARY WASH BORING
- APPROXIMATE LOCATION OF DIRECT PUSH BORING
- APPROXIMATE LOCATION OF CONE PENETRATION TEST (CPT)

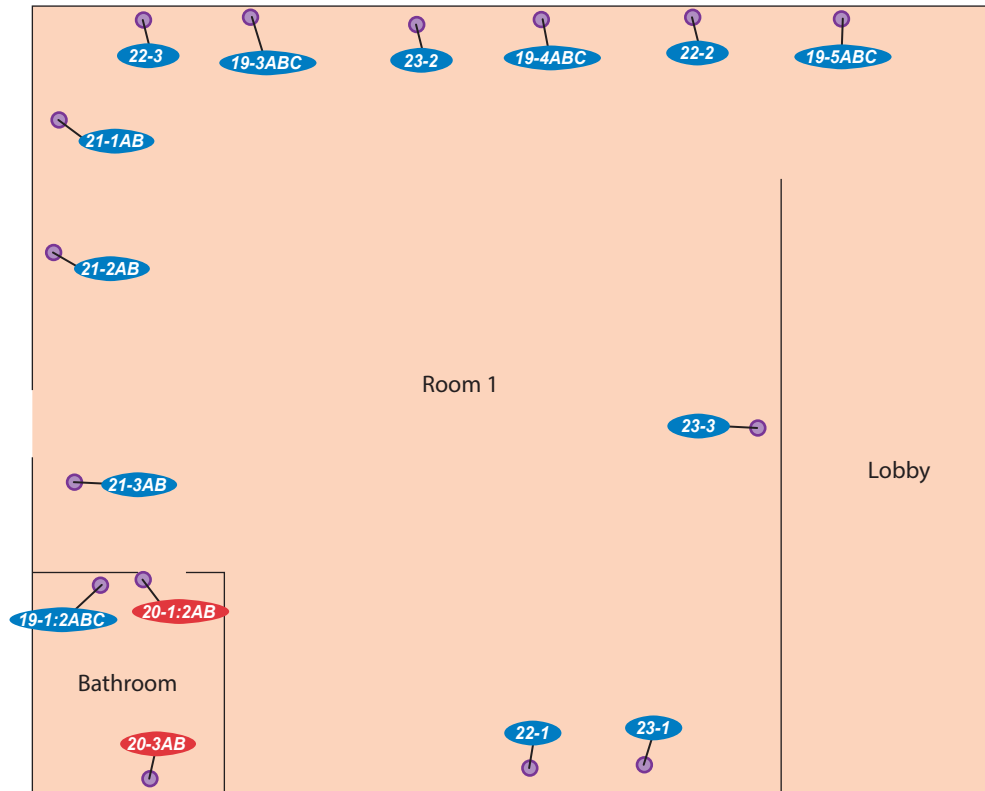
**3350 Sports Arena Boulevard
Crack in the Wall, Suite G**

- 22-2 Non-asbestos-containing sample location
- 20-3AB Asbestos-containing sample location

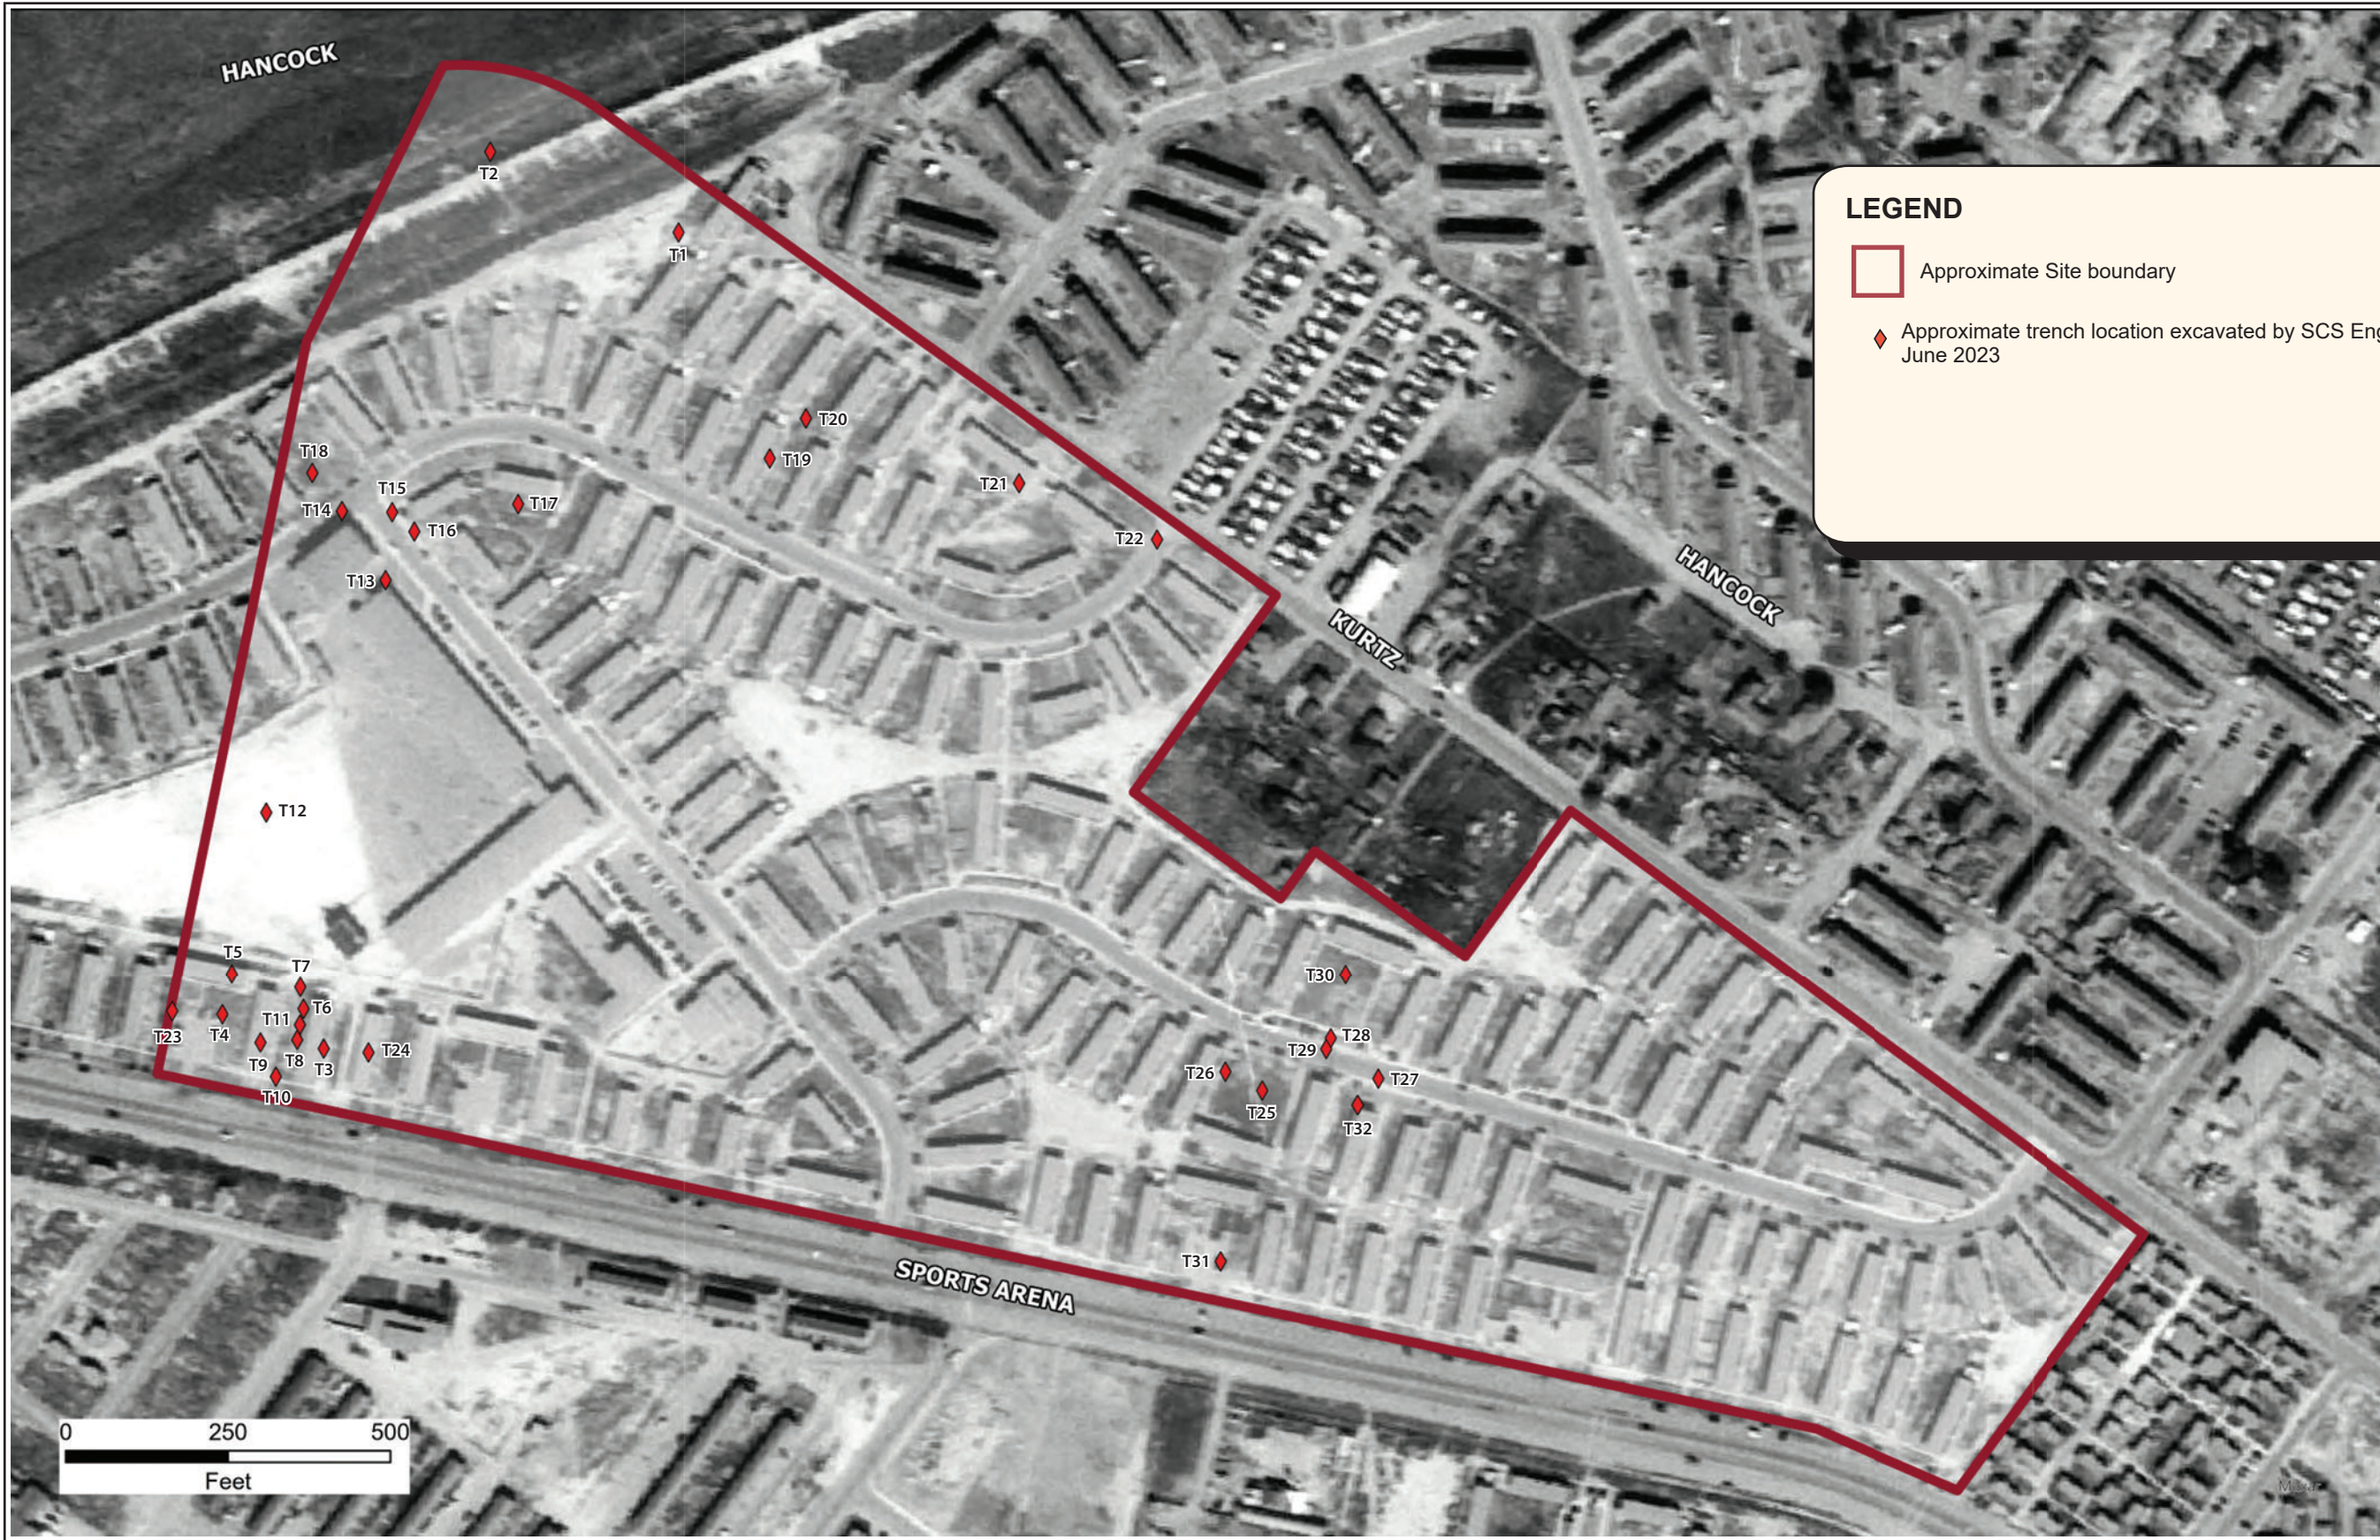
Figure 2

- Approximate Site boundary
- ◆ Approximate trench location excavated by SCS Engineers in June 2023

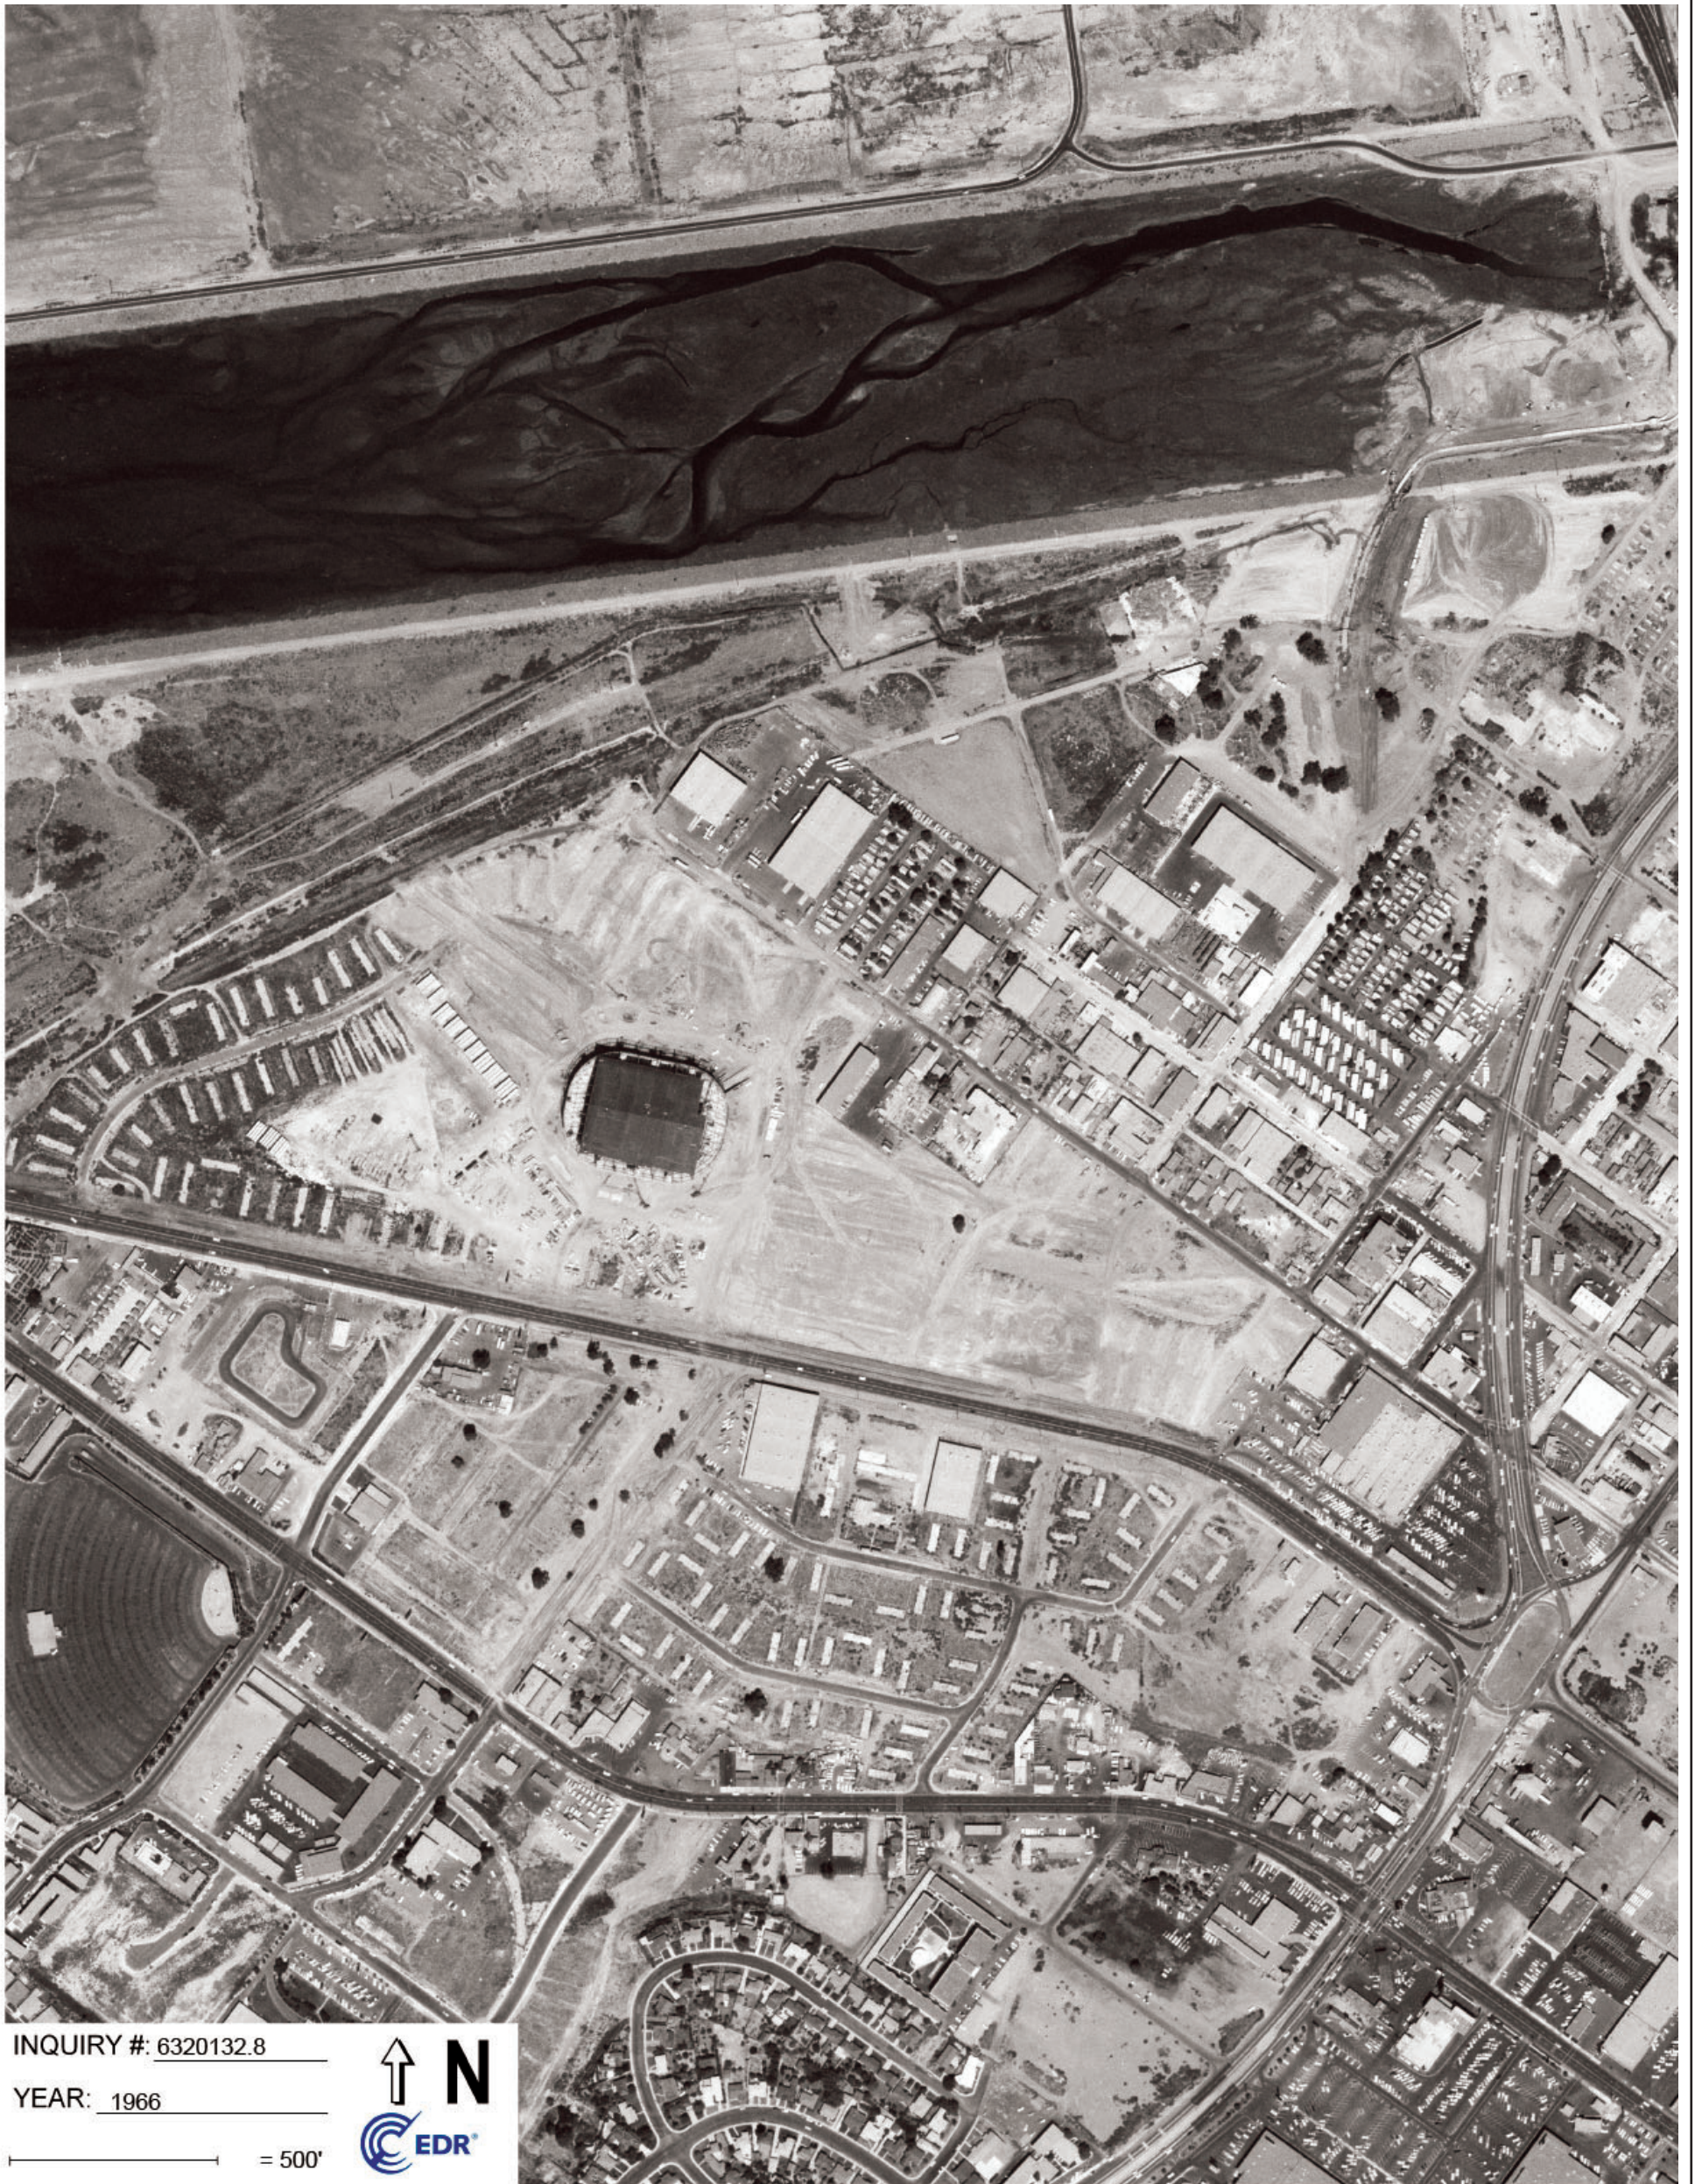
YEAR: 1966

Frontier Housing occupied the entire Midway Rising Site and was present from 1944 until the mid-1960s when the Sports Arena was constructed. In 1928, the Site was generally vacant with possible agricultural land use, based on review of a 1928 aerial photograph. According to a September 10, 1992 article that appeared in the San Diego Reader², Frontier Housing was “a war-workers’ project, built mainly to house Convair employees and their families.” Figure 3 is a copy of a 1949 aerial photograph depicting the barracks-type structures of Frontier Housing and the “L” shaped structure that was Frontier School. The approximate trench locations are also depicted on this figure. Figure 4 is a copy of a 1966 aerial photograph. This photo appears to depict the sports arena structure under construction with some of the Frontier Housing units still present to the west of the arena.

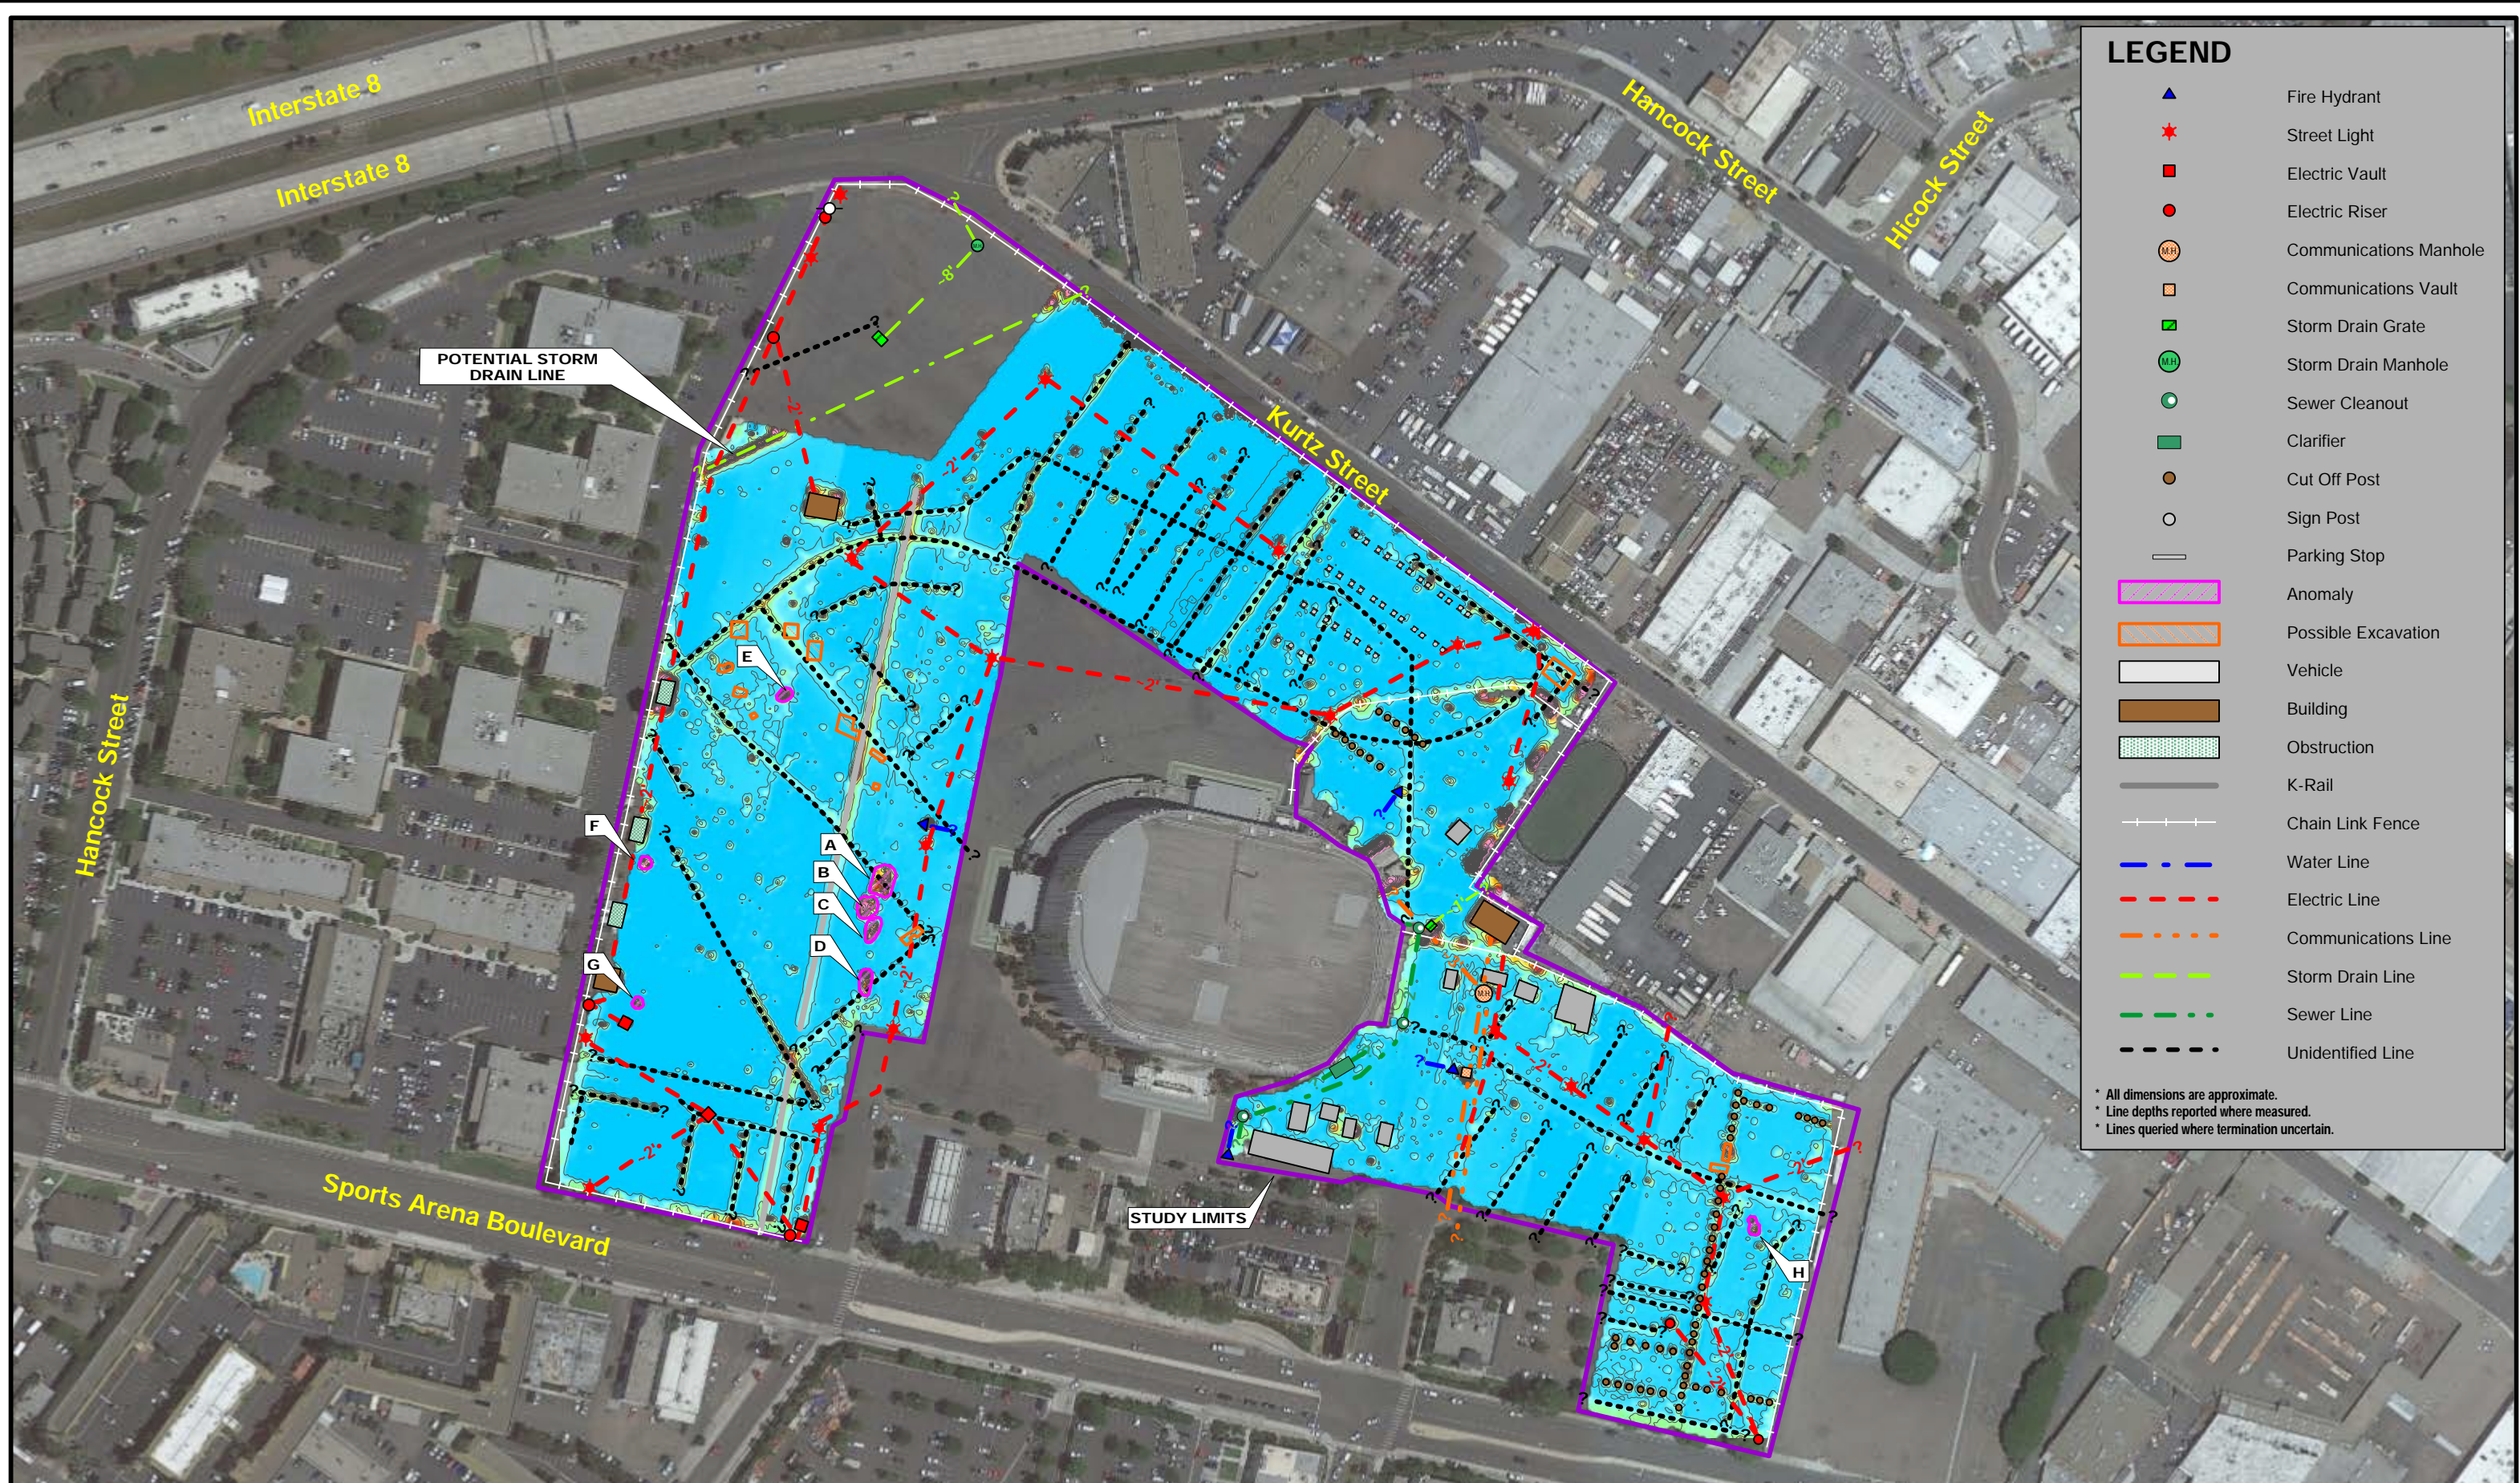
Fire Hydrant
	Street Light
	Electric Vault
	Electric Riser
	Communications Manhole
	Communications Vault
	Storm Drain Grate
	Storm Drain Manhole
	Sewer Cleanout
	Clarifier
	Cut Off Post
	Sign Post
	Parking Stop
	Anomaly
	Possible Excavation
	Vehicle
	Building
	Obstruction
	K-Rail
	Chain Link Fence
	Water Line
	Electric Line
	Communications Line
	Storm Drain Line
	Sewer Line
	Unidentified Line

Figure 5 depicts a combination of the 1949 aerial photograph and the geophysical survey map including subsurface features such as metallic pipelines, possible excavations, and possible underground storage tanks (USTs). Figure 6 depicts the EM31 In-Phase data obtained during the geophysical survey. The EM31 is used to assess the presence of conductors and non-conductors in the subsurface. There are two components to the magnetic field measured by the EM31: quadrature phase and in-phase. The in-phase measurement is more sensitive to large metallic objects than the quadrature phase and so is presented here as Figure 6.

Specific features called out in the geophysics report (Appendix A) are depicted on Figures 5 and 6 as A through H. Most of these features were interpreted not to represent subsurface features of concern. However, two features, E and H, were interpreted to have characteristics consistent with subsurface metallic anomalies such as USTs. The trench located at feature “E” (Trench T13) encountered a UST approximately 12 feet long and 4 feet in diameter (Figure 6). Visible staining of soil was observed near the bottom of this UST, and results of soil sample analysis (discussed below) was generally consistent with a diesel fuel-type product. The trench located at feature “H” (Trench T32) encountered several sections of metallic pipe at a depth of approximately 1.5 to 2 feet, but no UST or other feature of concern.

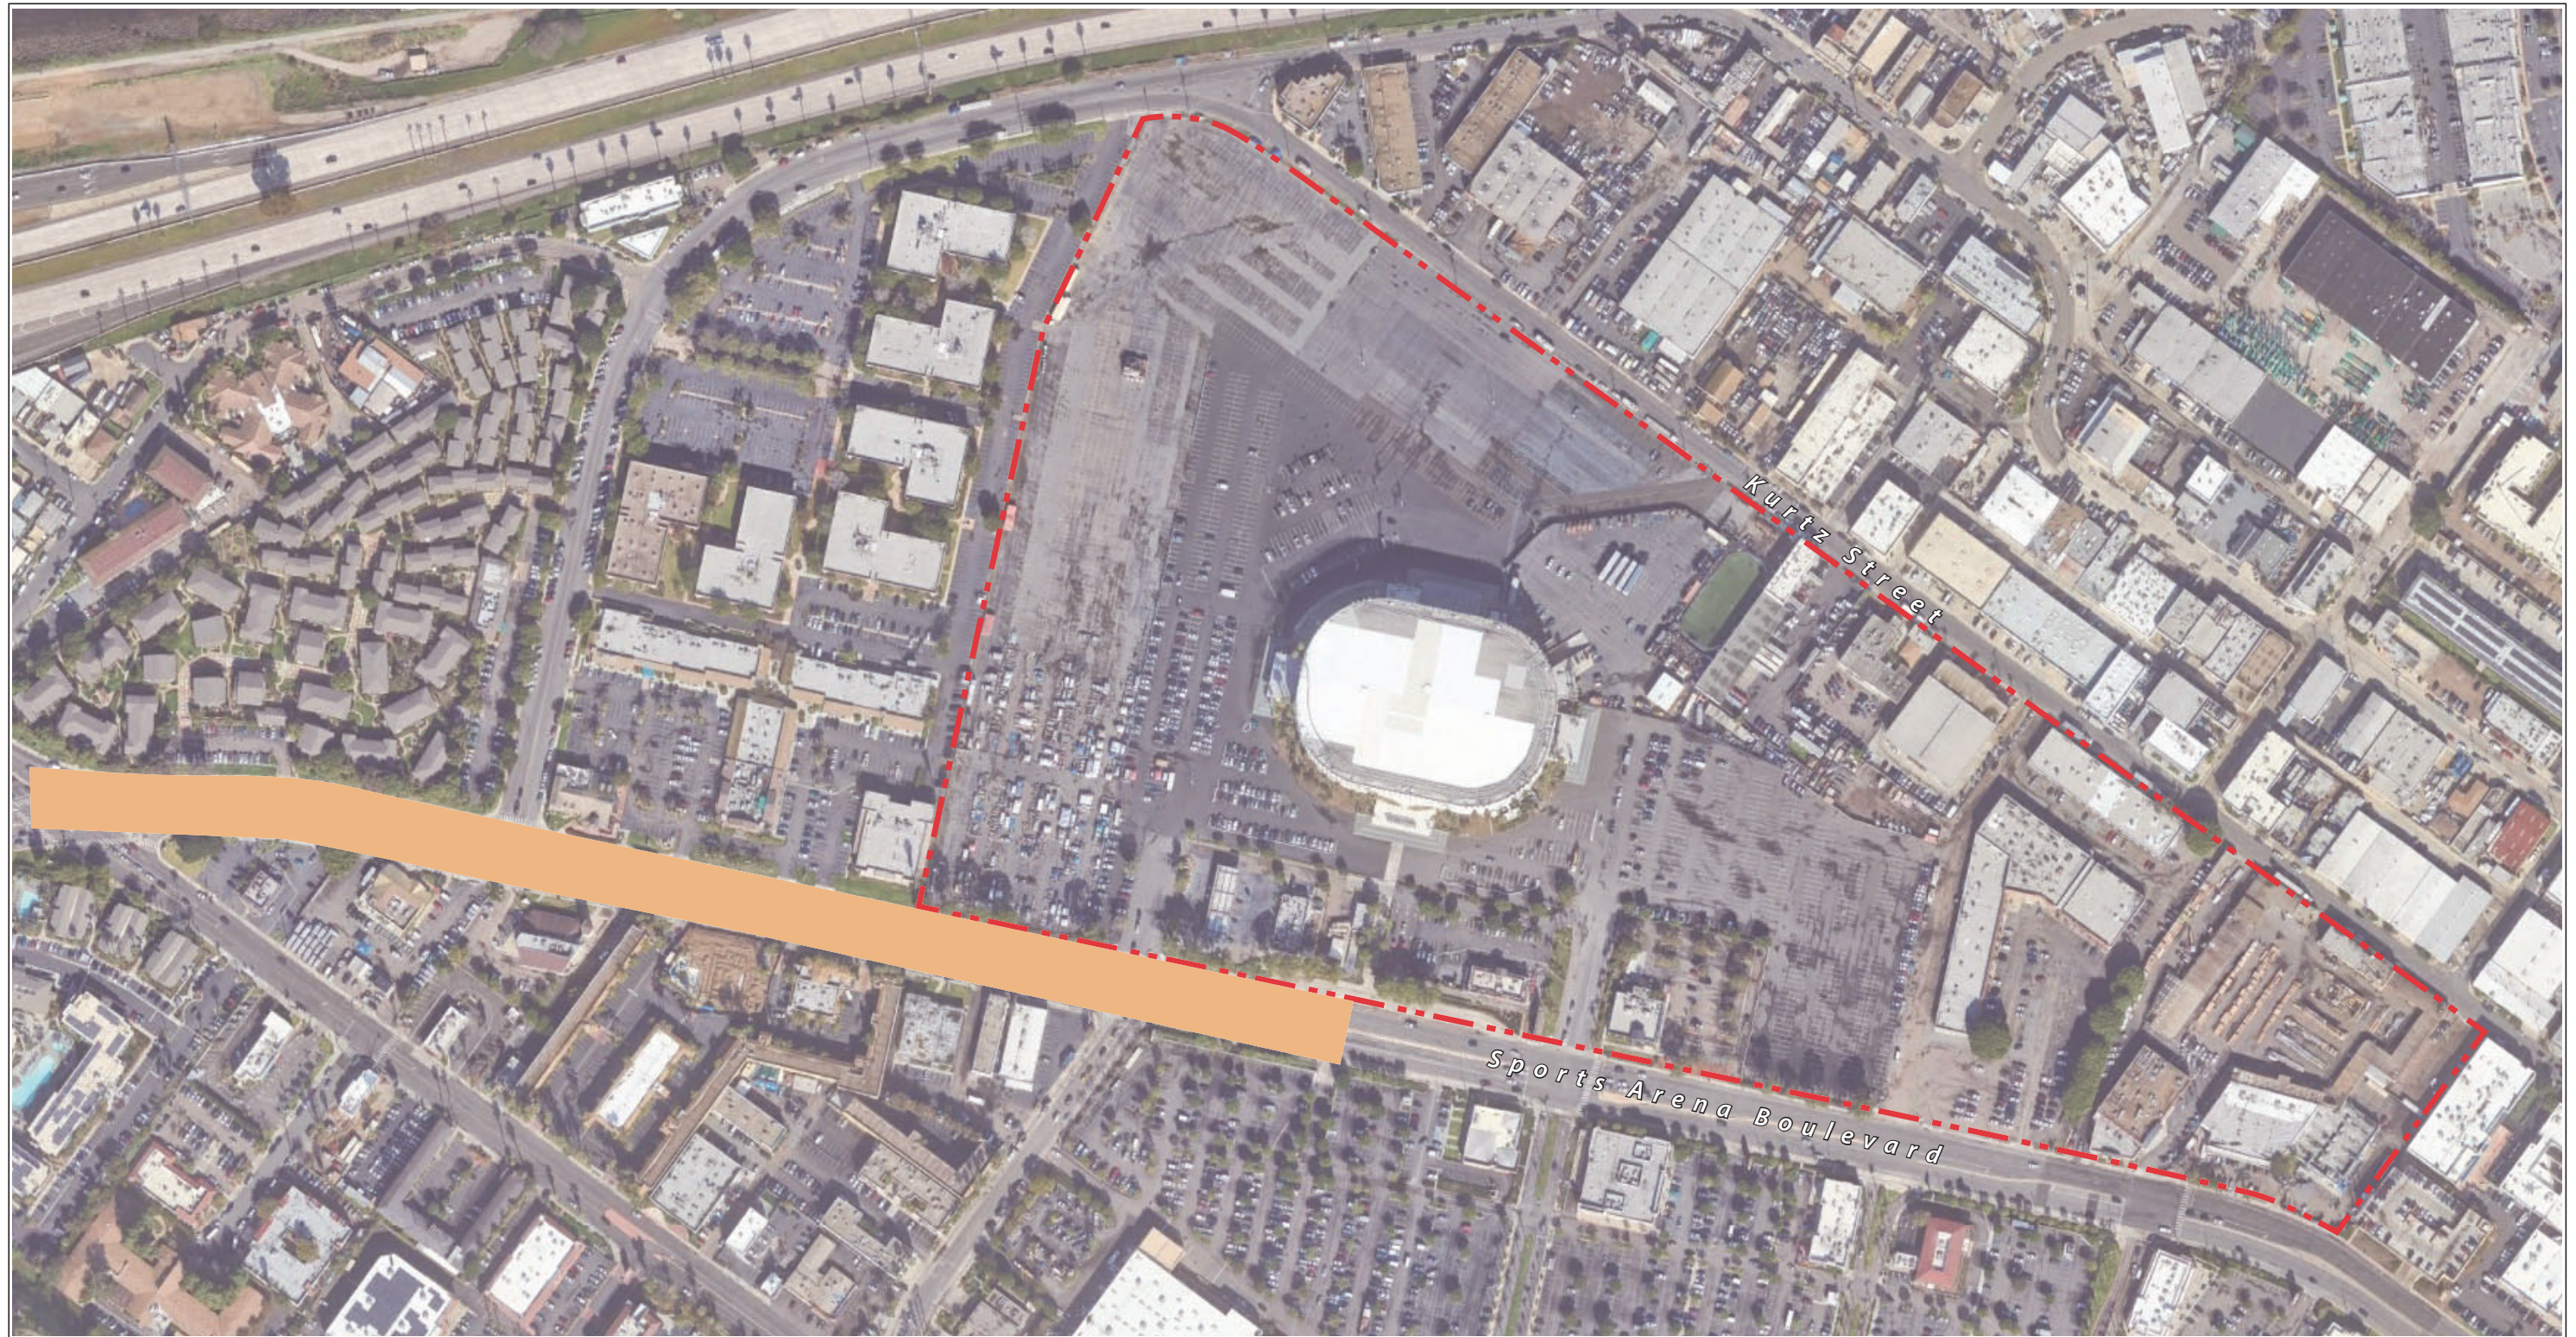
- Approximate Site boundaries
- Interpreted extent of Point Loma Burn Dump that overlaps with Project right-of-ways proposed for excavation
