Facility Maintenance Plan

Washington Canyon Creek - Washington Facility Group

Washington Canyon Creek - Washington Facility Group Facility Maintenance Plan

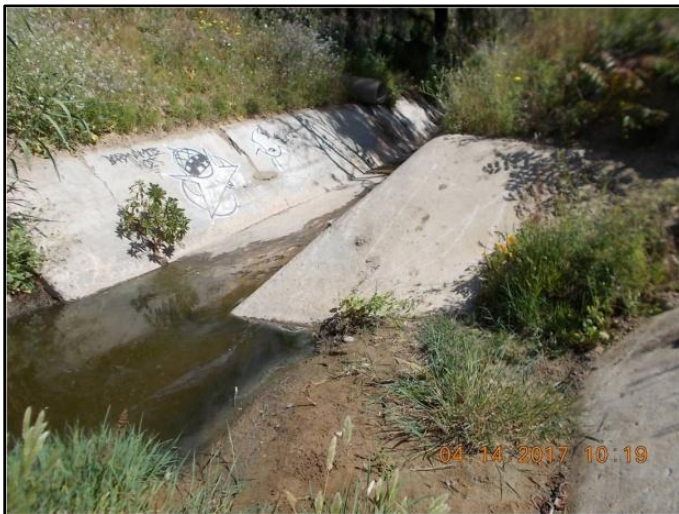
Figure 1: April 2017, looking upstream at transition from Washington 2

Current Conditions Affecting Facility Capacity	Vegetation was observed to be light to dense with up to 1 foot of sediment deposition
---	---

Maintenance Recommendation	Remove accumulated sediment, debris, and vegetation from Station 89 to Station 306. Maintain/repair existing debris fence as needed.
-----------------------------------	---

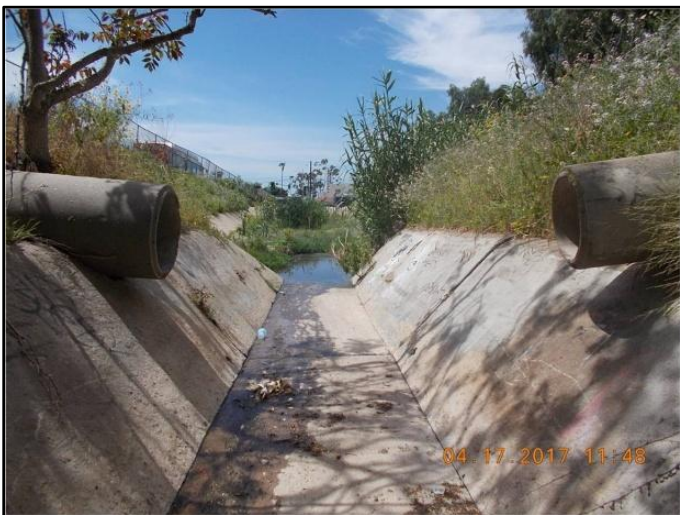
Figure 1: April 2017, looking downstream at transition to Washington 1

Current Conditions Affecting Facility Capacity	Vegetation was observed to be light to dense with up to 1 foot of sediment deposition					
Hydrologic Peak Flows						
Storm Event	2-year	5-year	10-year	25-year	50-year	100-year
Q (cubic feet per second [cfs])	82	105	123	147	165	183
Hydraulic Capacity of Facility						
Current Capacity	70 cfs					
Proposed MWMP Maintained Capacity	183 cfs					
Maintenance Recommendation	Remove accumulated sediment, debris, and vegetation in concrete ditch from Station 306 to Station 2516					
In-Stream Post-Maintenance Erosion Control Recommendation	None

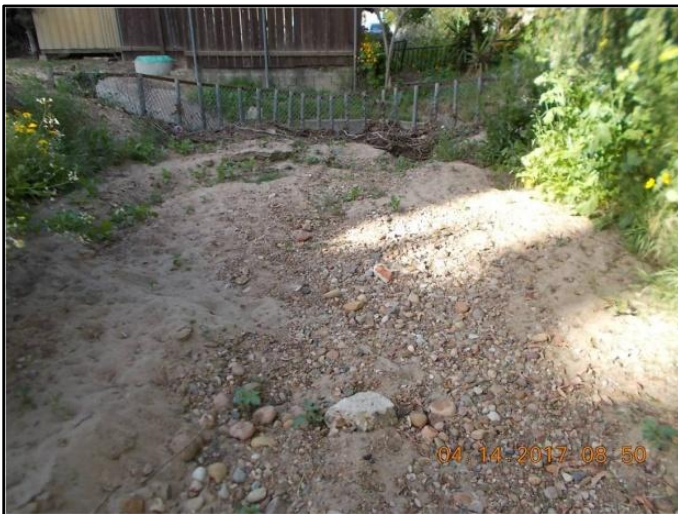
Figure 1: April 2017, looking downstream at sediment and debris accumulated at debris fence

Culvert Maintenance	No
Post-Maintenance Erosion Control Recommendation	No
Trash/Debris Fence Repair and Maintenance	Yes; see Appendix A-4
Facility Type	Earthen channel
Existing Plans and/or As-Builts?	None
Substrate Detail³	Earthen bottom and banks
Facility Dimensions (Approximate)	Length: 207 feet Top width: 40 feet Bottom width: 10–20 feet Depth: 3–8 feet

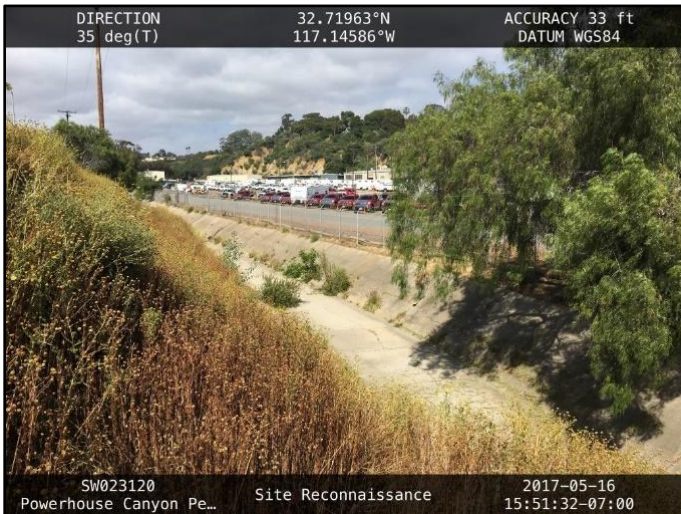
Figure 1: May 2017, Looking upstream near the downstream end of the segment

Current Conditions Affecting Facility Capacity The segment was observed to vary from clean concrete to dense vegetation

Maintenance Recommendation Remove accumulated sediment, debris, and vegetation from Station 332 to Station 1930

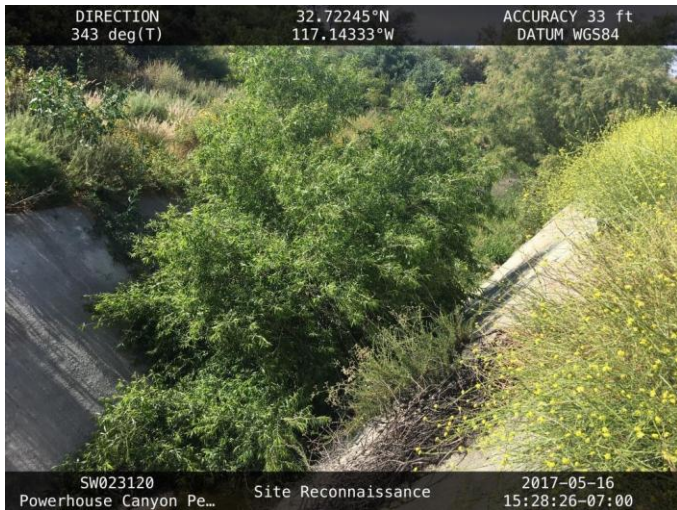
Figure 1: May 2017, looking upstream from the Pershing Drive bridge

Current Conditions Affecting Facility Capacity The segment was observed to be relatively clean

Maintenance Recommendation Remove accumulated sediment, debris, and vegetation from Station 0 to Station 437

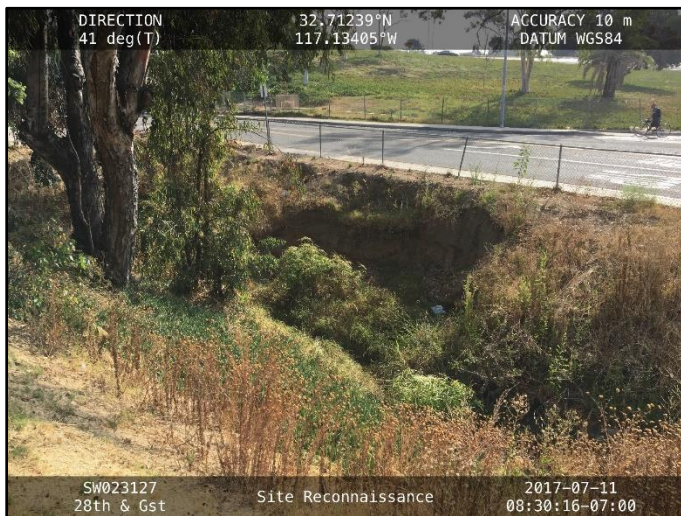
Figure 1: July 2017, looking upstream towards the eroded eastern sidewall

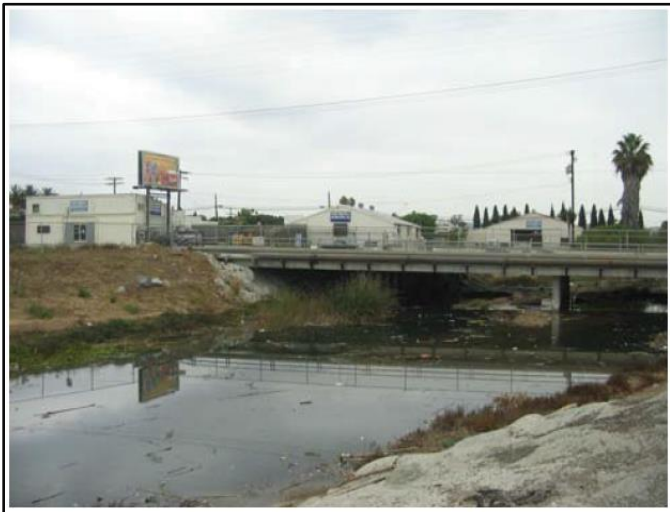
Figure 1: October 2009, looking upstream where the channel crosses under National Avenue, representative of low vegetation

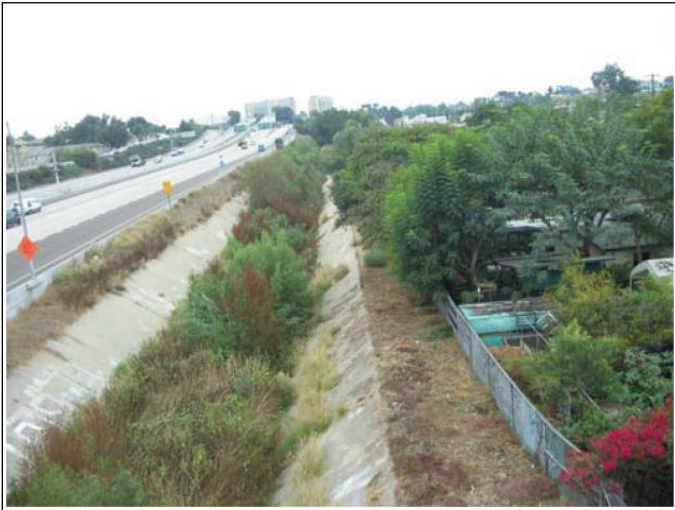
Figure 1: October 2009, looking downstream, representative of medium to dense vegetation

Current Conditions Affecting Facility Capacity	In October 2009, moderate to dense vegetation was observed throughout the channel. The sediment depth was estimated to be 0.3 to 1 foot. Current conditions were reviewed in relation to the hydraulic analysis for this segment in 2019 and documented in the current conditions assessment memorandum in Appendix A of the Hydrology and Hydraulics Technical Report.
---	---

Current Capacity	2,000 cfs
Proposed MWMP Maintained Capacity	4,350 cfs
Maintenance Recommendation	Remove sediment, debris and vegetation throughout the channel from Station 2066 to 4774
In-Stream Post-Maintenance Erosion Control Recommendation	None

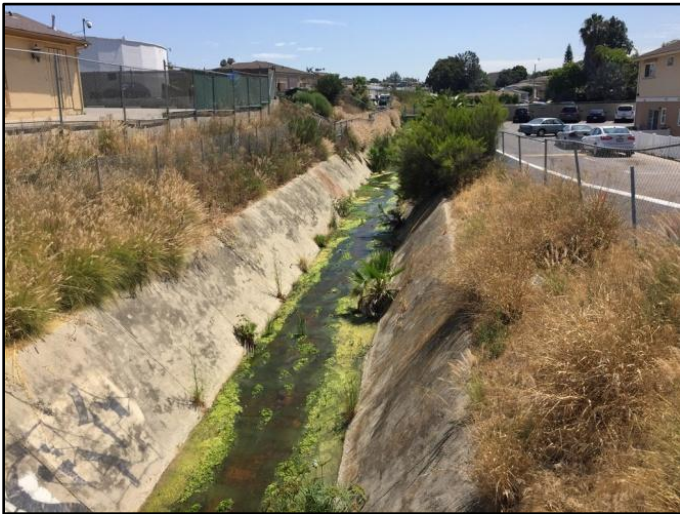
Figure 1: July 2017, looking upstream from downstream end segment

Current Conditions Affecting Facility Capacity	The segment was observed to be relatively clean and light vegetation was observed in some locations					
Hydrologic Peak Flows						
Storm Event	2-year	5-year	10-year	25-year	50-year	100-year
Q (cubic feet per second [cfs])	577	707	793	943	986	1,157
Hydraulic Capacity of Facility						
Current Capacity	829 cfs					
Proposed MWMP Maintained Capacity	829 cfs					
Maintenance Recommendation	Remove accumulated sediment, debris, and vegetation from segment bottom from Station 6272 to Station 6646. Remove accumulated sediment and debris in culvert from Station 6222 to Station 6272.					
In-Stream Post-Maintenance Erosion Control Recommendation	None

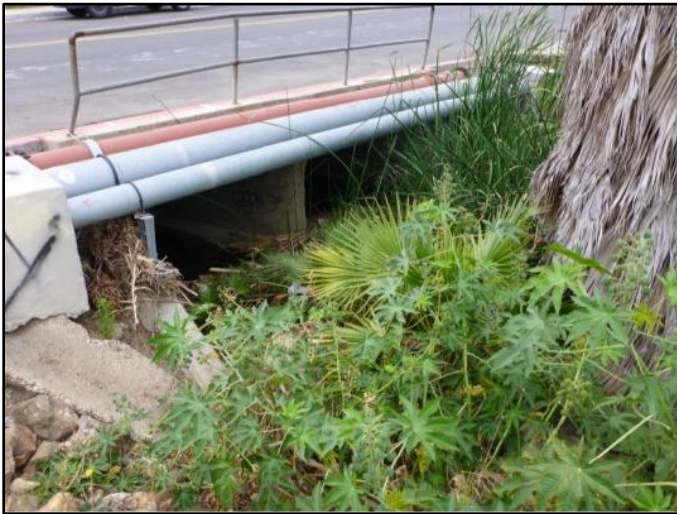
Figure 1: May 2015, looking towards the double 8-foot wide by 5-foot, 2-inch tall RCB culvert at downstream end of segment

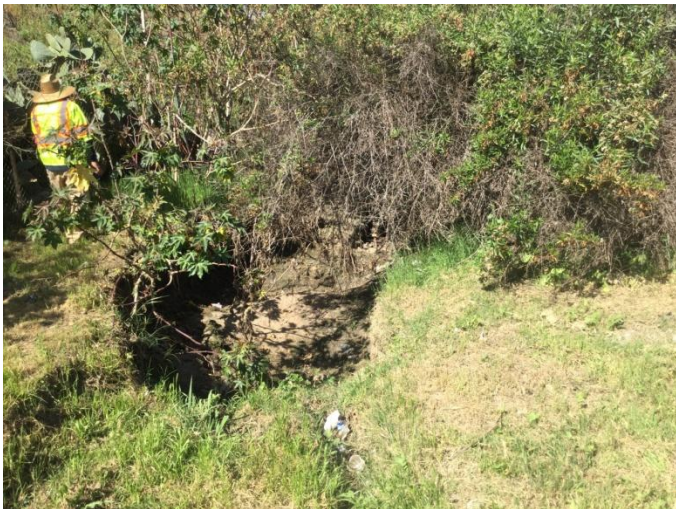
Figure 1: July 2017, looking downstream at scoured ditch bed

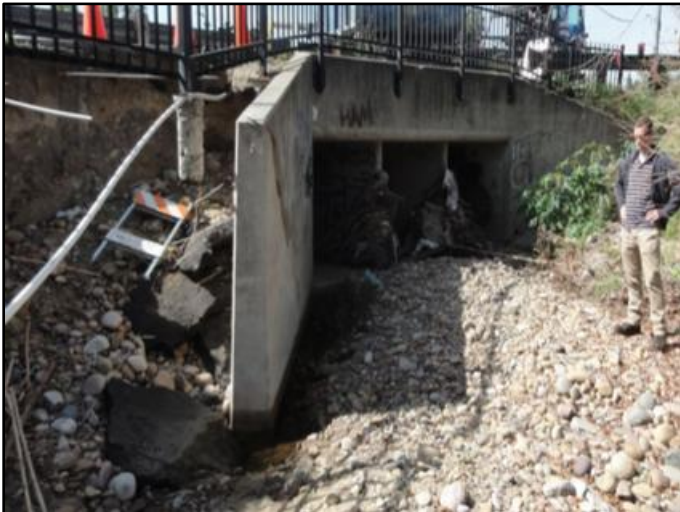
Figure 1: February 2017, standing along east bank of segment, looking southwest at erosion behind east wing wall at downstream end

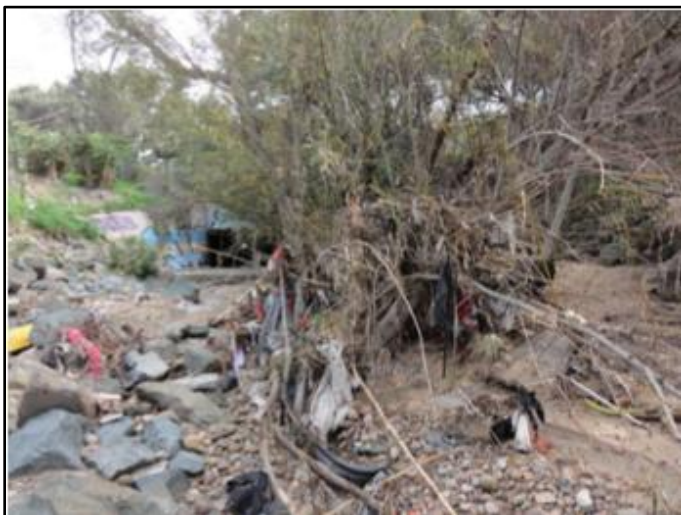
Figure 1: March 2016, looking upstream at the vegetation and displaced riprap downstream of the double 7-foot wide by 6-foot tall RCB culvert

Current Conditions Affecting Facility Capacity	In February 2017, the channel was observed to contain extensive sediment as well as cobbles along the bottom of the channel and dense vegetation at the upstream end
---	--

Maintenance Recommendation	Remove accumulated sediment, debris, and vegetation from the bed and banks of the segment from Station 5 to Station 165. Remove accumulated sediment, debris, and vegetation from culvert at Station 5.
-----------------------------------	--

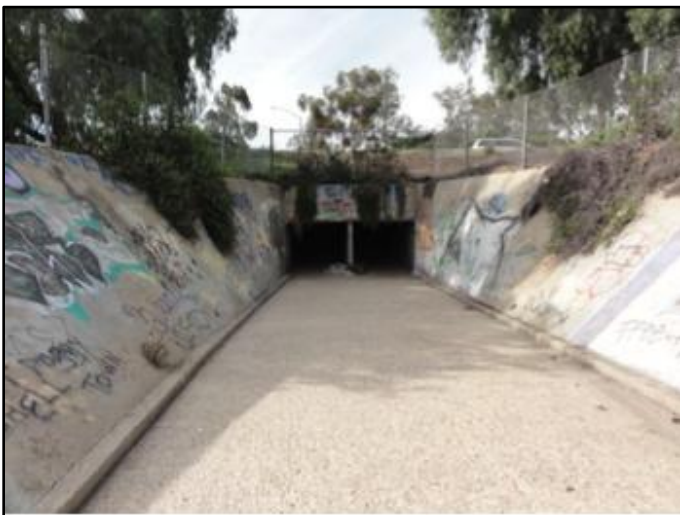
Figure 1: March 2016, looking downstream towards 7-foot wide by 6-foot tall double RCB culvert. Note clean channel.

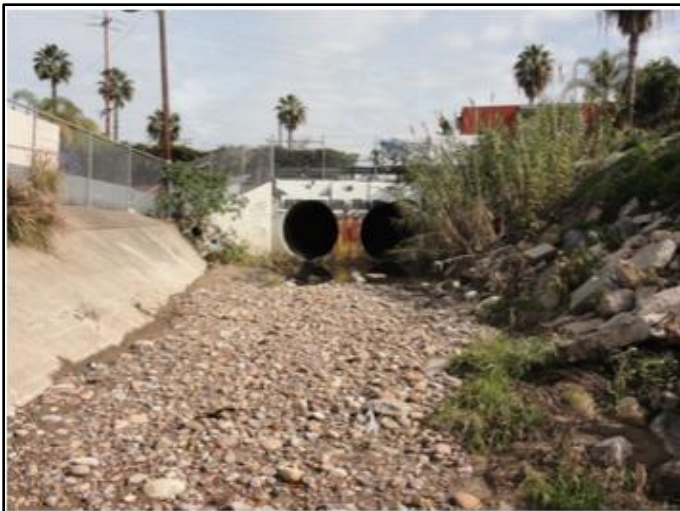
Figure 1: March 2016, looking upstream at the double-barrel 74-inch-diameter RCP culvert

Current Conditions Affecting Facility Capacity	In February 2017, the amount of vegetation in the channel was observed to be light to medium and cobbles were observed along the bottom					
Hydrologic Peak Flows						
Storm Event	2-year	5-year	10-year	25-year	50-year	100-year
Q (cubic feet per second [cfs])	120	290	430	630	950	1,200
Hydraulic Capacity of Facility						
Current Capacity				630 cfs		
Proposed MWMP Maintained Capacity				630 cfs		
Maintenance Recommendation		Remove accumulated sediment, debris, and vegetation from bottom of segment from Station 3018 to Station 3293. Remove accumulated sediment and debris from culvert at Station 2916 to Station 3018.				
In-Stream Post-Maintenance Erosion Control Recommendation				None

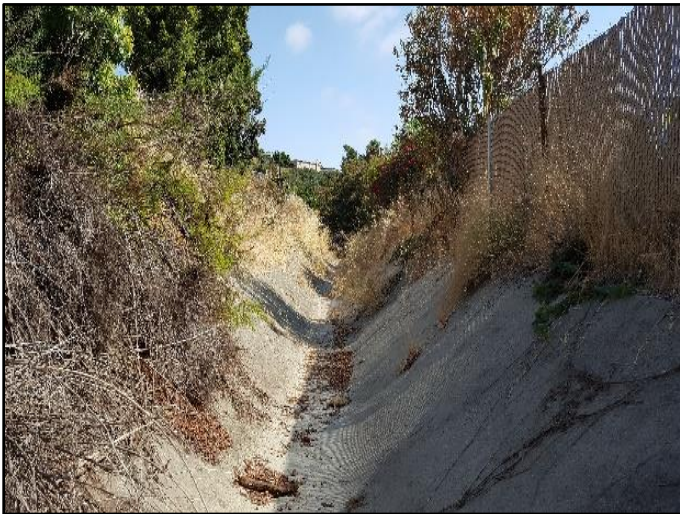
Figure 1: July 2017, looking upstream at concrete ditch

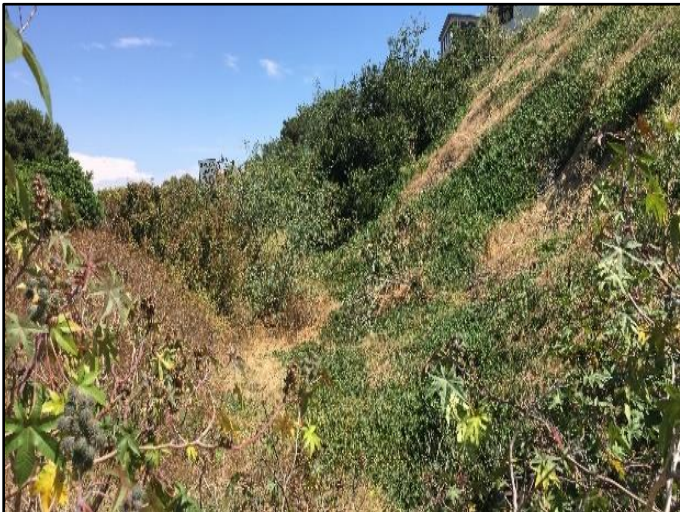
Figure 1: July 2017, looking upstream near upstream end at vegetation

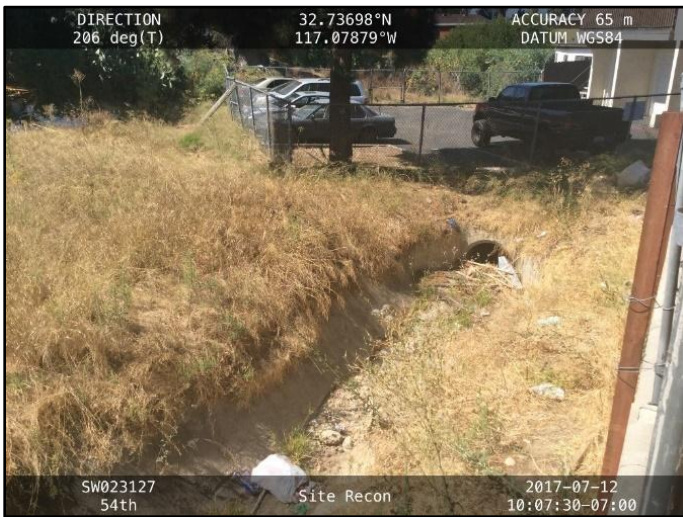
Figure 1: July 2017, looking downstream towards the culvert; conveys flows beneath parking lot, then discharges back into ditch

Current Conditions Affecting Facility Capacity	Accumulated sediment and patches of dense vegetation in the bottom of the ditch were observed and sediment deposition was estimated to be 2 inches within the ditch and up to 2 feet within the culvert
---	---

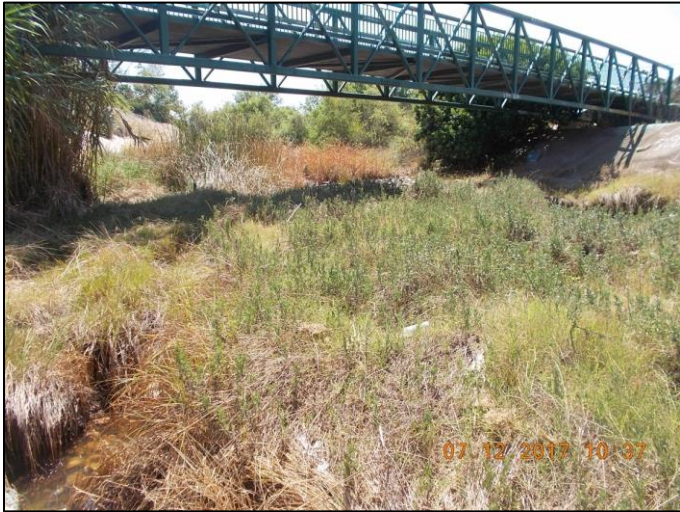
Figure 1: July 2017, looking downstream under the pedestrian bridge located just east of I-5

Current Conditions Affecting Facility Capacity	The vegetation observed ranged from light to dense with evidence of sediment deposition
---	---

Maintenance Recommendation	Remove accumulated sediment, debris, and overgrown vegetation from Station 4788 to Station 5135, Station 5613 to Station 5734, and Station 6195 to 6277. Trim vegetation from Station 5135 to Station 5316. Perform bank repair on the earthen bank from Station 5456 to Station 5556. Private segments to be maintained by private property owners (Station 5734 to Station 6195 and Station 6277 to Station 6580).
-----------------------------------	---

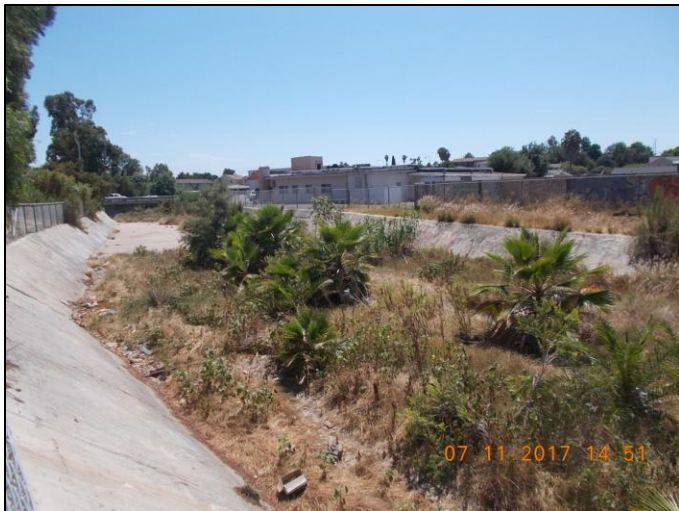
Figure 1: July 2017, looking downstream toward the start of the concrete bottom channel

Current Conditions Affecting Facility Capacity The channel was relatively clean with very little evidence of vegetation or sediment deposition

Maintenance Recommendation No maintenance currently proposed; however vegetation, sediment and debris removal, or concrete repair/replacement activities should be performed if the conditions change

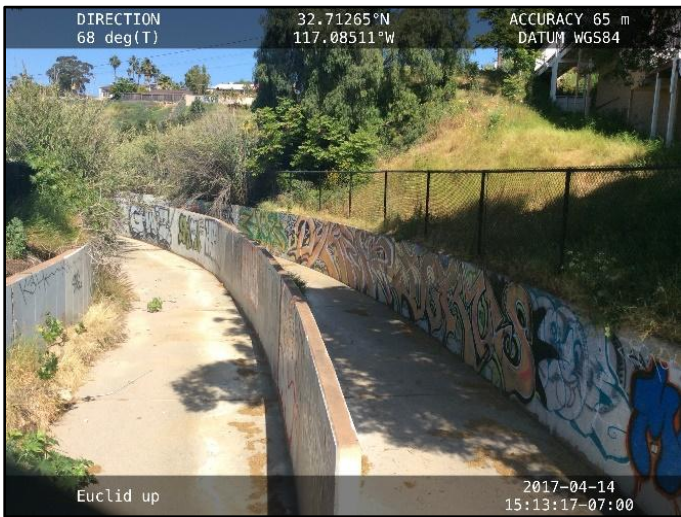
Figure 1: April 2017, representative of concrete portion of channel

Current Conditions Affecting Facility Capacity	The channel was observed to be relatively clean with very little evidence of vegetation or sediment deposition
---	--

Current Capacity	225 cfs
Proposed MWMP Maintained Capacity	N/A
Maintenance Recommendation	No maintenance currently proposed; however vegetation, sediment and debris removal, or concrete repair/replacement activities should be performed if the conditions change

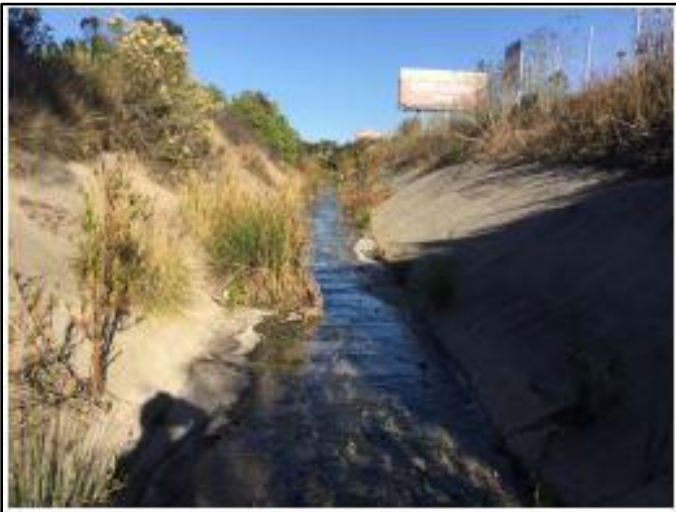
Figure 1: November 2016, looking northeast at the concrete-lined ditch. Note the minimal vegetation established within the ditch.

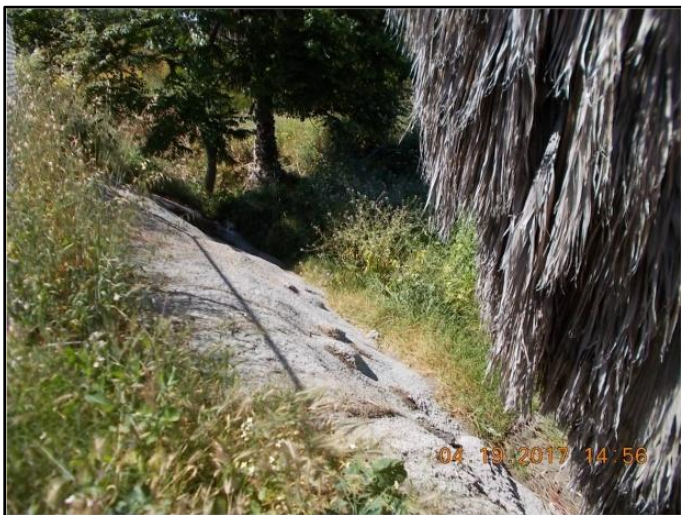
Figure 1: April 2017, looking downstream at vegetation and gunite lining on left bank

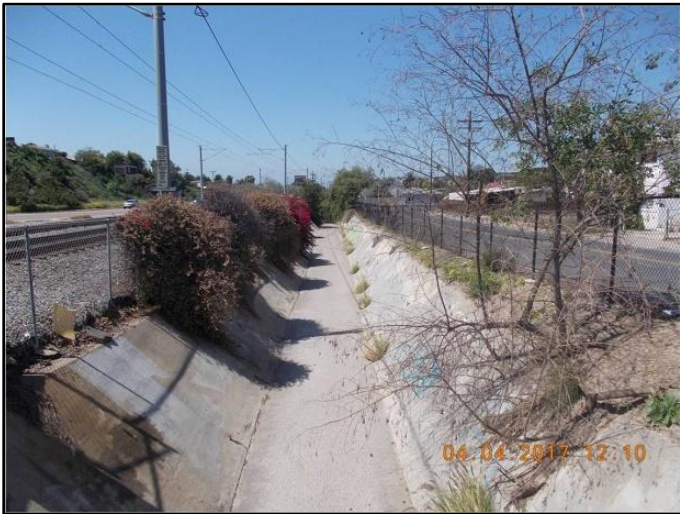
Figure 1: April 2017, looking downstream at concrete channel near 60th Street

Current Conditions Affecting Facility Capacity	The channel was observed to be relatively clean with very little evidence of vegetation or sediment deposition					
Hydrologic Peak Flows						
Storm Event	2-year	5-year	10-year	25-year	50-year	100-year
Q (cubic feet per second [cfs])	563	851	1,100	1,762	2,600	3,400
Hydraulic Capacity of Facility						
Current Capacity	3,400 cfs					
Proposed MWMP Maintained Capacity	N/A					
Maintenance Recommendation	No maintenance currently proposed; however vegetation, sediment and debris removal, or concrete repair/replacement activities should be performed if the conditions change					
In-Stream Post-Maintenance Erosion Control Recommendation	None

Facility Group	South Chollas Creek Encanto Branch - Imperial
Segment Name	Imperial 2
Facility No.	5-05-306
Facility Location	From west of 60th Street to the upstream end of Imperial 1 segment
Coastal Zone	No
MWMP Proposed Maintenance	Maintenance of concrete-lined channel per as-built dimensions and Hydrology and Hydraulics recommendations
Hydrology and Hydraulics Recommendation²	No maintenance currently proposed; however vegetation, sediment and debris removal, or concrete repair/replacement activities should be performed if the conditions change
Maintenance Activities	Vegetation grubbing, trimming, and removal Invasive plant species treatment and removal Sediment removal Concrete repair
Maintenance Method	Excavation; mechanized equipment inside and outside the channel Temporary access/loading Temporary staging Temporary diversions Hand removal of vegetation
Bank Repair	No
Concrete Repair	Yes; see Appendix A-4

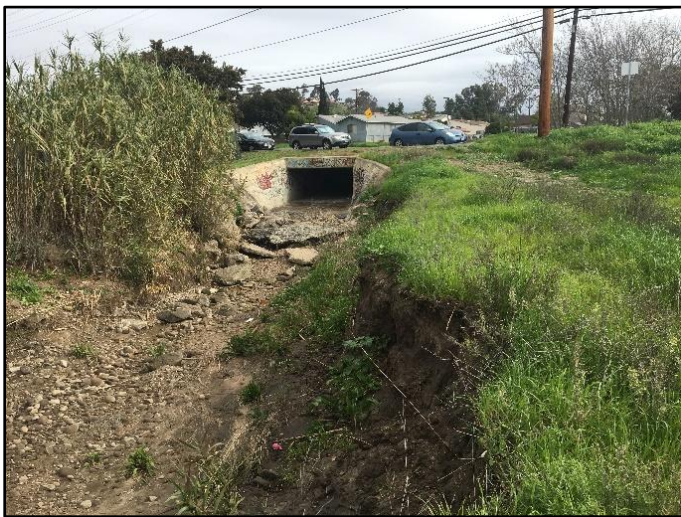
Figure 1: April 2016, upstream of 10-foot-wide by 5-foot-high RCB culvert beneath 69th Street facing west

Current Conditions Affecting Facility Capacity The amount of vegetation was observed to vary from light to dense and sediment deposition near the culverts was estimated to be 1 to 2 feet

Maintenance Recommendation Remove accumulated sediment, debris, and vegetation from bottom of segment from Station 1441 to Station 1457, Station 1523 to Station 1996, and Station 2110 to Station 2324.
Remove accumulated sediment and debris in culverts from Station 1457 to Station 1523 and Station 1996 to Station 2110.

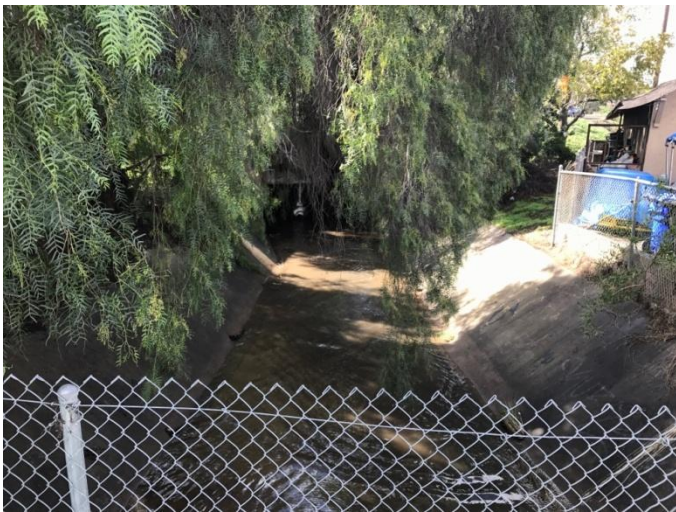
Figure 1: May 2015, looking downstream at concrete channel

Current Conditions Affecting Facility Capacity	In May 2015, the amount of vegetation was observed to range from moderate to dense in the bottom of the channel and many trees. The sediment deposition was estimated to be 0.2 feet.
---	---

Hydraulic Capacity of Facility	
Current Capacity	630 cfs
Proposed MWMP Maintained Capacity	678 cfs
Maintenance Recommendation	Remove accumulated sediment, debris, and vegetation from Station 1006 to Station 1091, and Station 1163 to Station 1578. Remove accumulated sediment and debris in culverts at Station 1006 and from Station 1091 to Station 1163.
In-Stream Post-Maintenance Erosion Control Recommendation	None

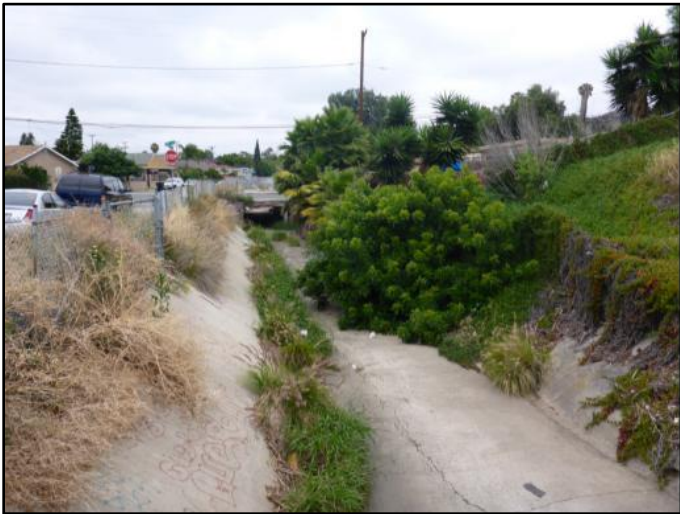
Figure 1: May 2015, looking upstream from double 9-foot-wide by 5-foot-tall RCB culvert at 40th Street

Current Conditions Affecting Facility Capacity	In May 2015, the vegetation was observed to range from moderate to dense vegetation in the bottom of the channel and many trees. The sediment deposition was estimated to be 0.2 feet.
---	--

Hydraulic Capacity of Facility	
Current Capacity	519 cfs
Proposed MWMP Maintained Capacity	522 cfs
Maintenance Recommendation	Remove accumulated sediment, debris, and vegetation from Station 1765 to Station 1892, Station 1951 to Station 3095, and Station 3152 to Station 3782. Remove accumulated sediment and debris in culverts from Station 1578 to Station 1765, Station 1892 to Station 1951, and Station 3095 to Station 3152.
In-Stream Post-Maintenance Erosion Control Recommendation	None

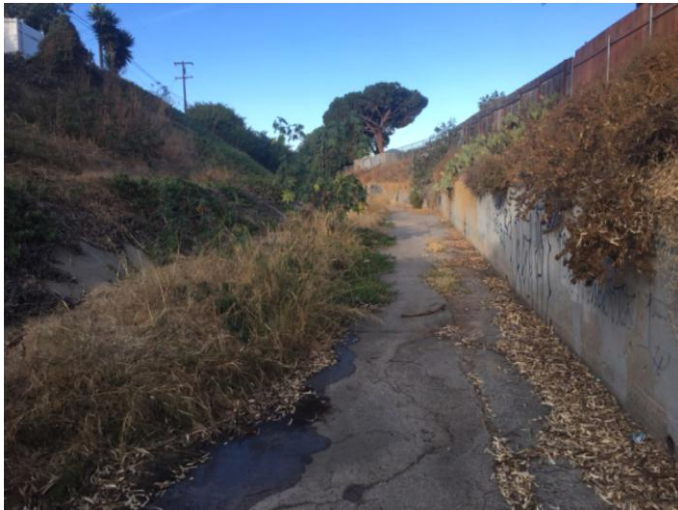
Figure 1: April 2017, looking downstream at accumulated sediment and debris in concrete channel

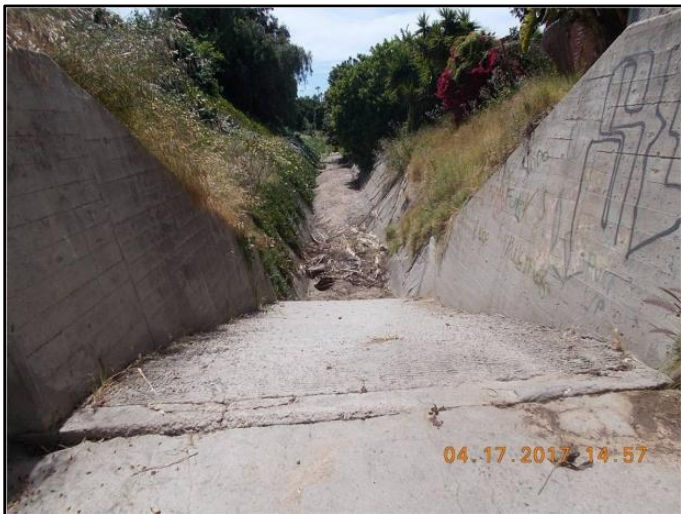
Figure 1: April 2017, looking downstream at second drop structure and sediment accumulated at bottom of structure

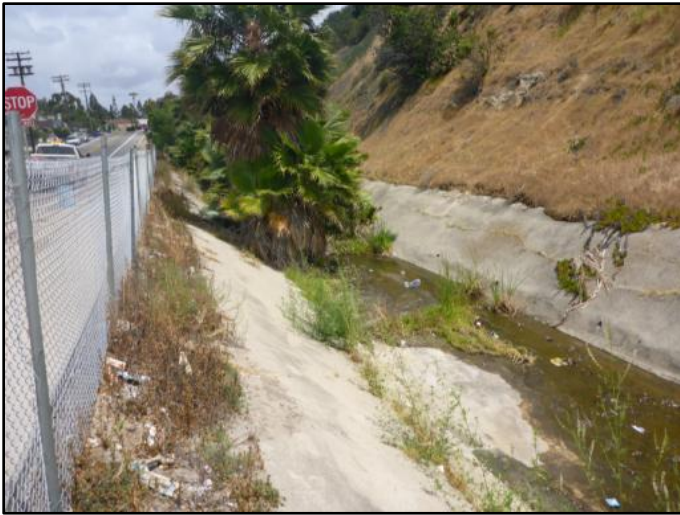
Figure 1: May 2015, representative of channel (with moderate vegetation), looking upstream

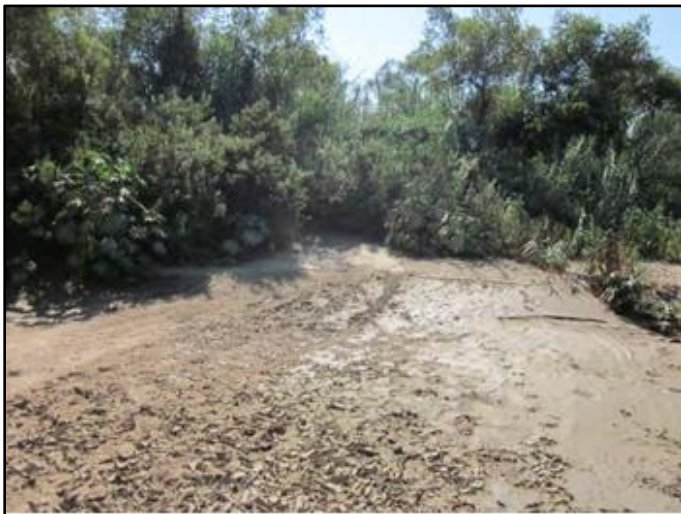
Figure 1: September 2012, looking south at the confluence point with the Smuggler's Gulch tributary

Current Conditions Affecting Facility Capacity The vegetation was observed to range from light to dense and sediment deposition was estimated to be 3 to 4.5 feet. Ponded water was present. Current conditions were reviewed in relation to the hydraulic analysis for this segment in 2018 and documented in the current conditions assessment memorandum in Appendix A of the Hydrology and Hydraulics Technical Report.

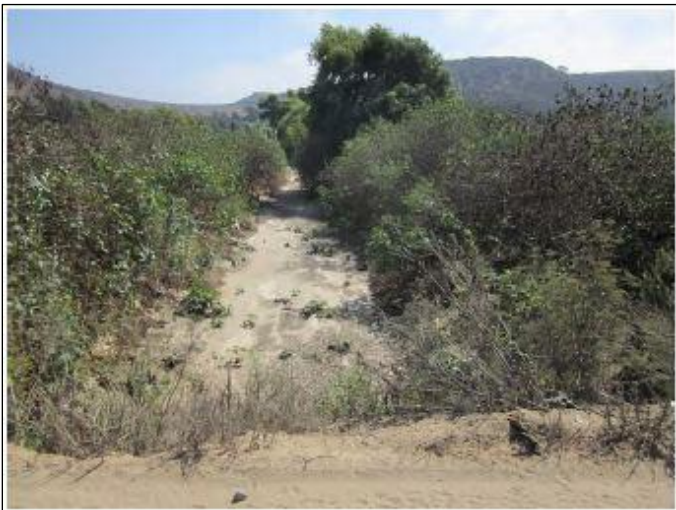
Figure 1: September 2012, looking south (upstream) from atop the Disney Crossing. Vegetation is very thick on the side slopes, while the streambed is mainly unvegetated.

The vegetation was observed to be dense and sediment deposition was estimated to be 2 feet. A large amount of trash and debris was noted as well. Current conditions were reviewed in relation to the hydraulic analysis for this segment in 2018 and documented in the current conditions assessment memorandum in Appendix A of the Hydrology and Hydraulics Technical Report.

Maintenance Recommendation	<p>Remove accumulated sediment, debris, and vegetation from channel bottom from Station 1000 to Station 2530 and Station 2550 to Station 4046.</p> <p>Remove accumulated sediment and debris from culverts Station 2530 to Station 2550.</p> <p>Repair/replace concrete grout near the outlet of the 52-inch CMP culvert at Station 4046.</p>
-----------------------------------	---

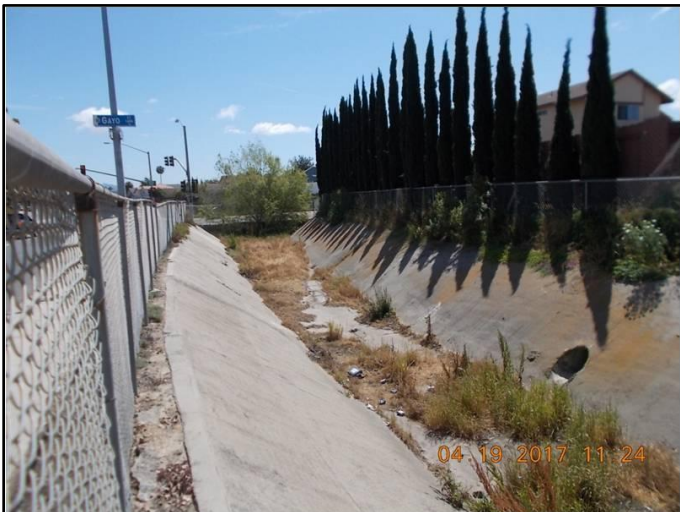
Figure 1: April 2017, looking upstream at vegetation

Current Conditions Affecting Facility Capacity The vegetation was observed to vary from fairly clean concrete to patches of low grasses and a small stand of trees located near the Hollister Street bridge

Maintenance Recommendation Remove accumulated sediment, debris, and vegetation from Station 1702 to Station 2725 and Station 2804 to Station 4279. Remove accumulated sediment and debris in culverts from Station 1424 to Station 1702 and Station 2725 to Station 2804. A maintenance area from Station 1414 to Station 1424 has been identified for maintenance of the culvert at Station 1424.

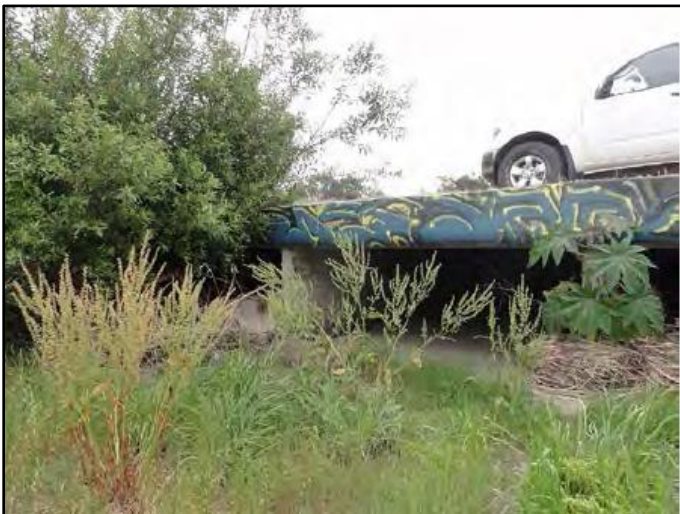
Figure 1: April 2015, looking downstream at entrance to quadruple 12-foot-wide by 4-foot-high RCB culvert beneath Interstate 5

Current Conditions Affecting Facility Capacity	The vegetation was observed to be dense with no evidence of sediment deposition					
Hydrologic Peak Flows						
Storm Event	2-year	5-year	10-year	25-year	50-year	100-year
Q (cubic feet per second [cfs])	657	854	1,051	1,116	1,182	1,314
Hydraulic Capacity of Facility						
Current Capacity				1,182 cfs		
Proposed MWMP Maintained Capacity				1,314 cfs		
Maintenance Recommendation			Trim the vegetation from channel bottom from Station 310 to Station 430. Remove sediment and debris in culvert from Station 430 to Station 558.			
In-Stream Post-Maintenance Erosion Control Recommendation					None

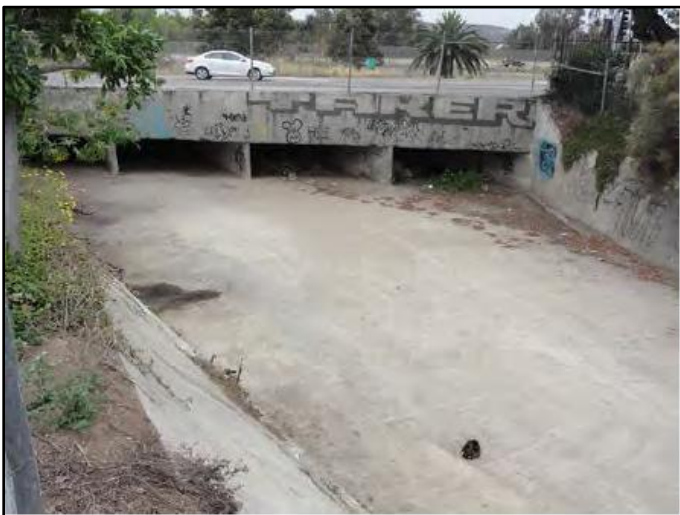
Figure 1: April 2015, looking downstream at entrance to quadruple 12-foot-wide by 4-foot-high RCB culvert beneath West San Ysidro Boulevard

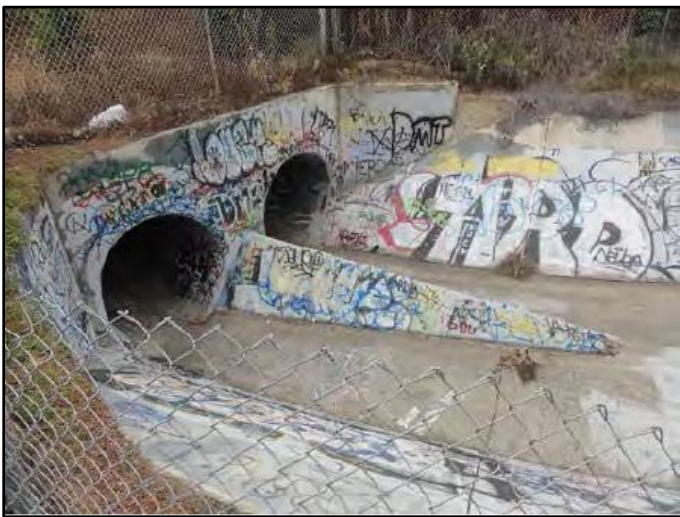
Figure 1: April 2015, entrance to double-barrel 72-inch-diameter RCP culvert under Vista Lane

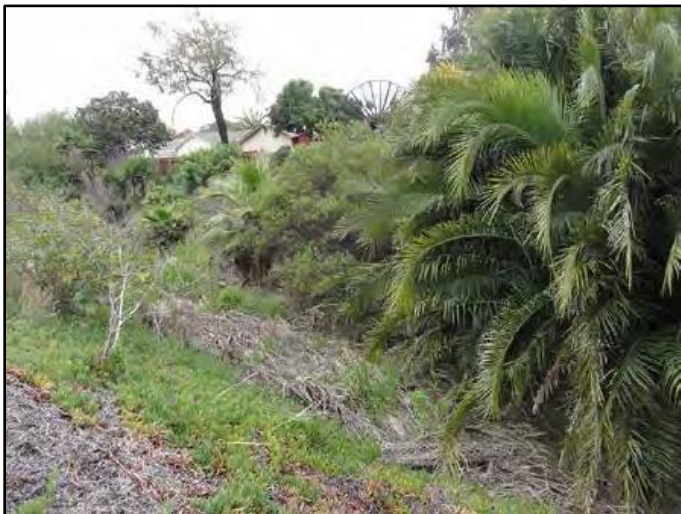
Figure 1: April 2015, looking upstream at channel

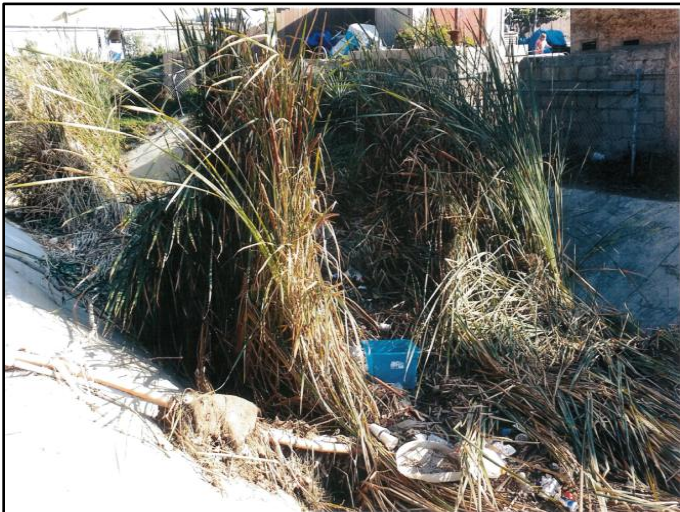
Figure 1: December 2014, looking upstream at dense vegetation, and sediment and debris within ditch

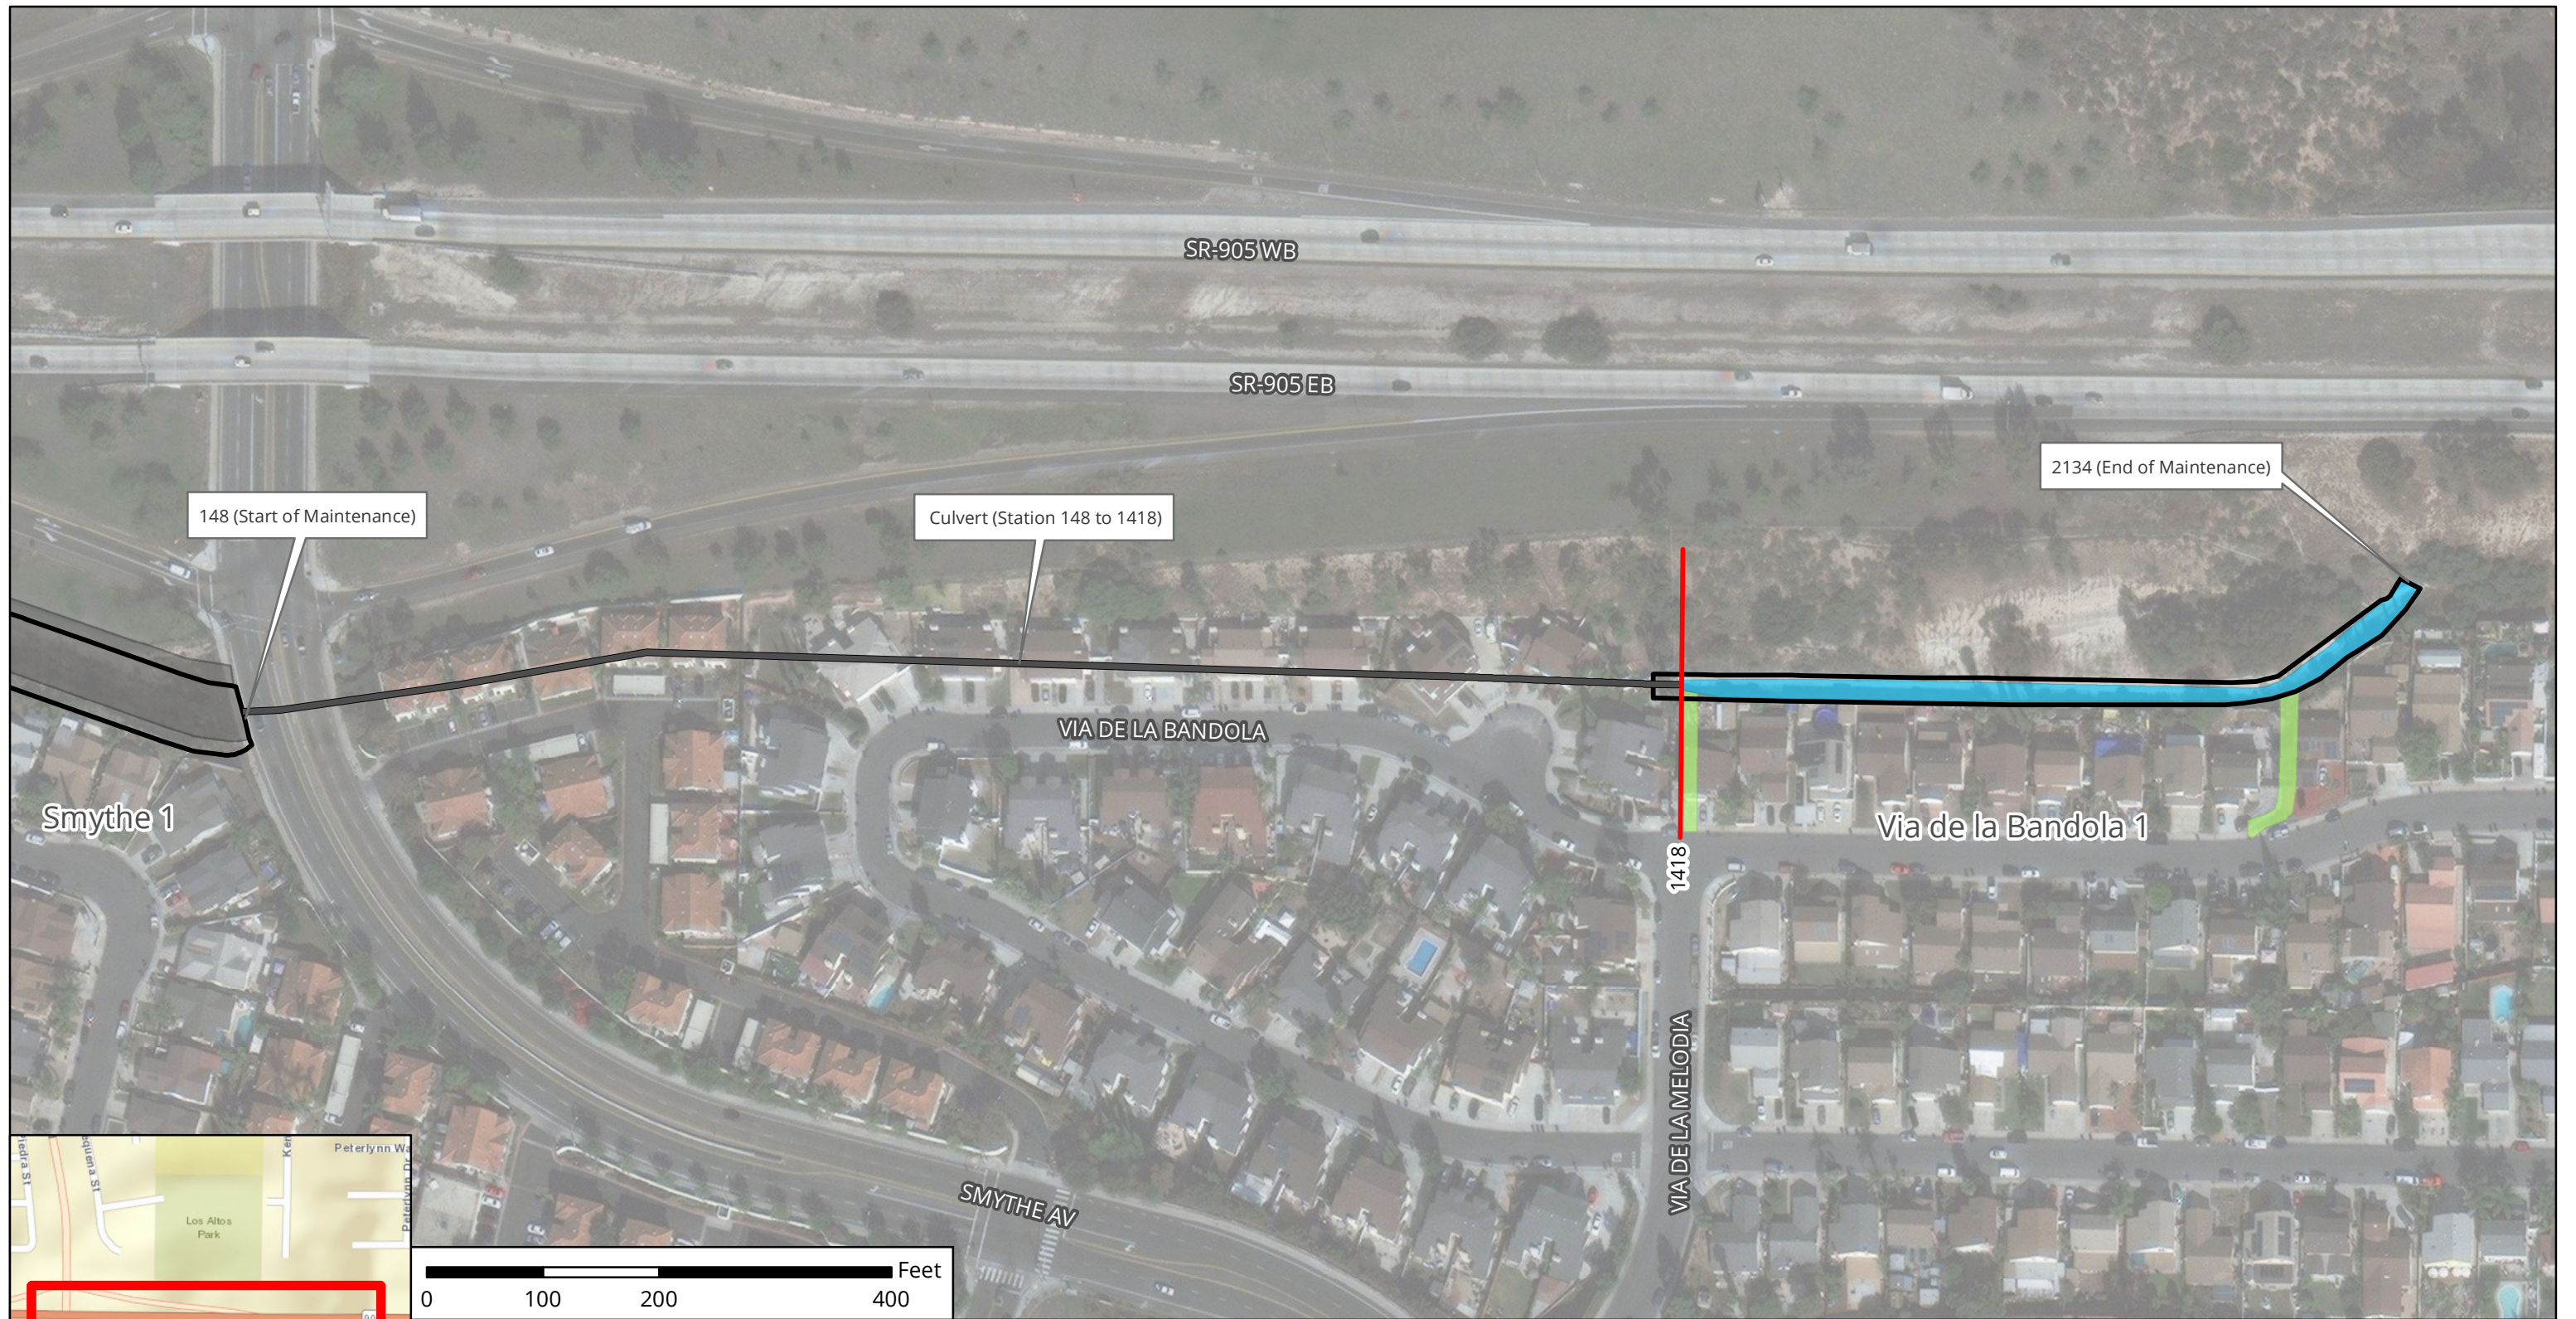
Map A: General Site Plan
Facility Group Name: Tijuana River - Smythe
Segment Name: Via de la Bandola 1
Facility No: 6-03-150
Facility Maintenance Plan
Municipal Waterways Maintenance Plan

Current Conditions Affecting Facility Capacity	In December 2014, the amount of vegetation was observed to be dense with many large trees. Sediment deposition was estimated to be 2 feet. Current condition: relatively clean, leaf debris.					
Hydrologic Peak Flows						
Storm Event	2-year	5-year	10-year	25-year	50-year	100-year
Q (cubic feet per second [cfs])	550	715	880	935	990	1,100
Hydraulic Capacity of Facility						
Current Capacity				295 cfs		
Proposed MWMP Maintained Capacity				295 cfs		
Maintenance Recommendation				Remove accumulated sediment and vegetation from bottom and sides of concrete ditch from Station 1418 to Station 2134. Remove accumulated sediment and debris in the culvert from Station 148 to Station 1418.		
In-Stream Post-Maintenance Erosion Control Recommendation				None

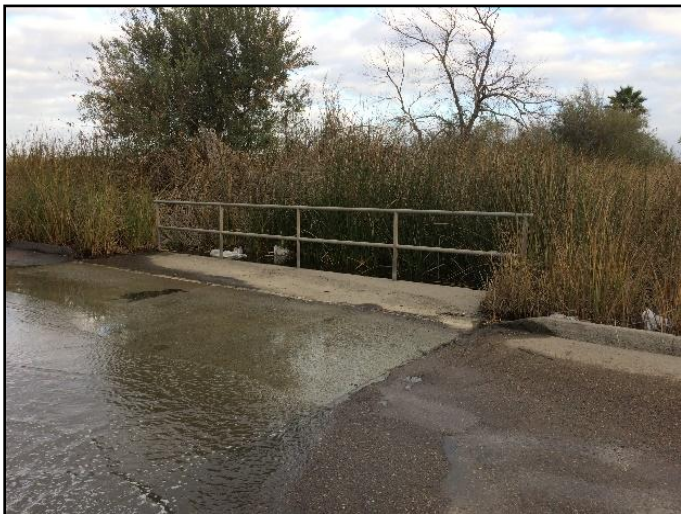
Figure 1: April 2017, looking upstream at conservation area from Airway Road

Current Conditions Affecting Facility Capacity The vegetation was observed to be dense and the sediment deposition was estimated to be 1.5 feet

Maintenance Recommendation	Remove accumulated sediment, debris, and vegetation from north side of culvert at Airway Road and extending 4.5 feet upstream. Remove accumulated sediment and debris in culvert from Station 4030 to Station 4080.
-----------------------------------	--
