Municipal Waterways Maintenance Plan Annual Report Fiscal Year 2022

THINK BLUE®
City of San Diego
Stormwater Department

October 2022

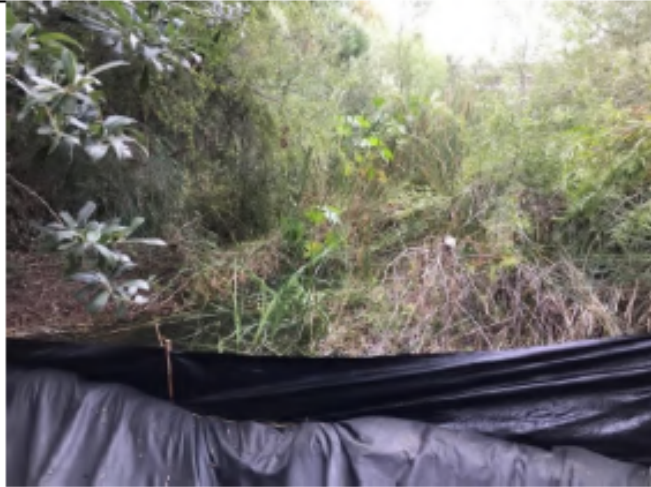
Roselle Pre-Maintenance - Photo 7: View of Roselle 1 (earthen channel), looking south. Silt fencing in view with non-native vegetation shown in background.

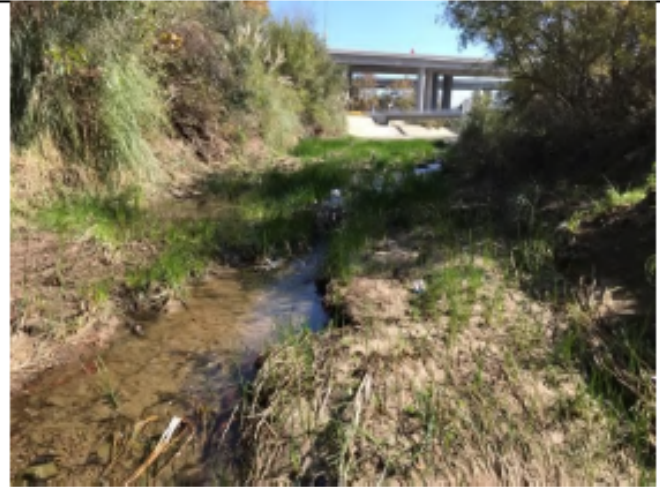
Roselle Post-Maintenance - Photo 7: View of Roselle 1 (earthen channel), looking south. Maintenance activities shown to be complete

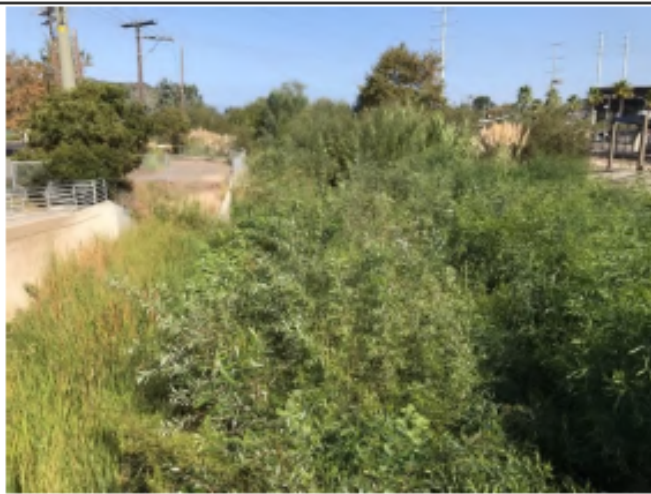
Roselle Pre-Maintenance - Photo 8: view showing both Roselle 1 & 2 taken from pedestrian crossing over Roselle 2, looking northwest. Thick vegetation shown to exist in channel.

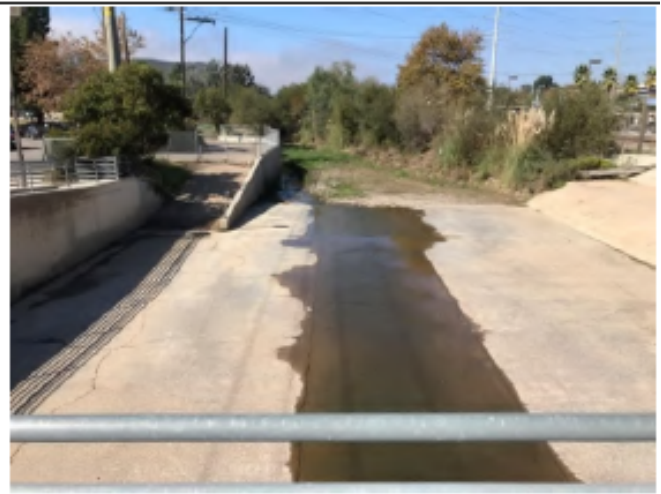
Roselle Post-Maintenance - Photo 8: view showing both Roselle 1 & 2 taken from pedestrian crossing over Roselle 2, looking northwest. Maintenance activities shown to be complete.

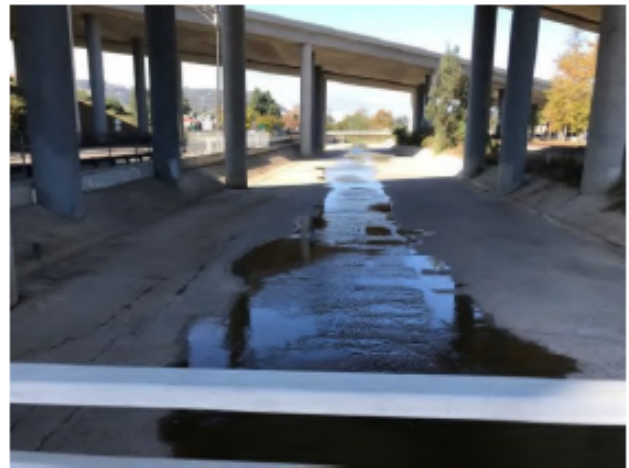
Roselle Post-Maintenance - Photo 10: view of Roselle 2 looking east from approximately the center of the channel showing vegetated and unvegetated sections of concrete-lining.

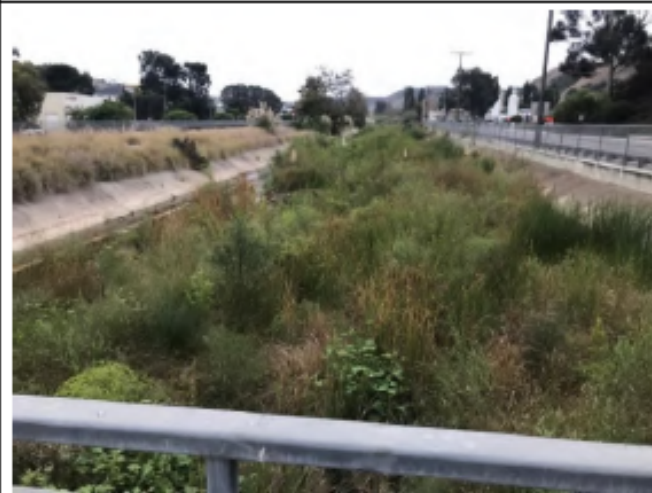
Roselle Pre-Maintenance - Photo 11: view of Roselle 2 looking east from approximately the center of the channel showing vegetated and unvegetated sections of concrete-lining.

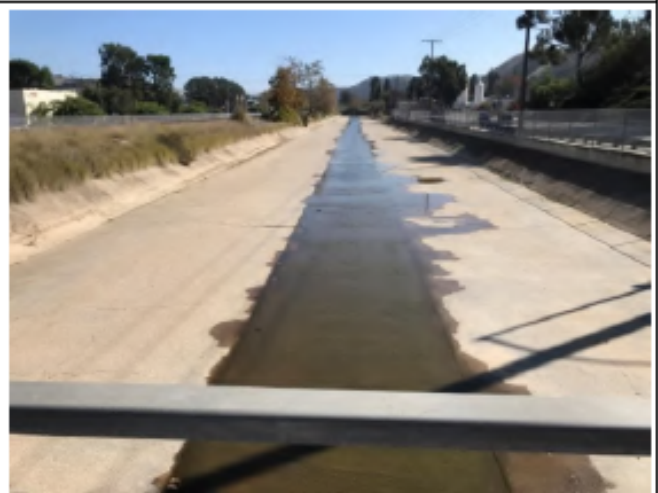
Roselle Post-Maintenance - Photo 11: view of Roselle 2 looking east from approximately the center of the channel showing vegetated and unvegetated sections of concrete-lining.

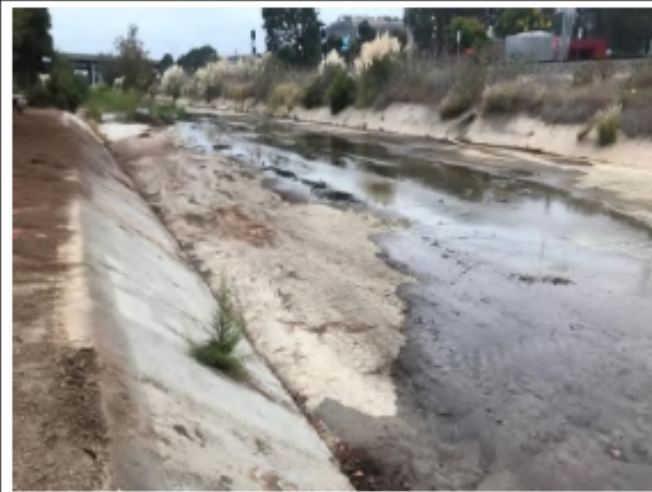
Roselle Pre-Maintenance - Photo 12: view of Roselle 2 looking north from southern end of maintenance area. Sediment and vegetation shown in channel bed.

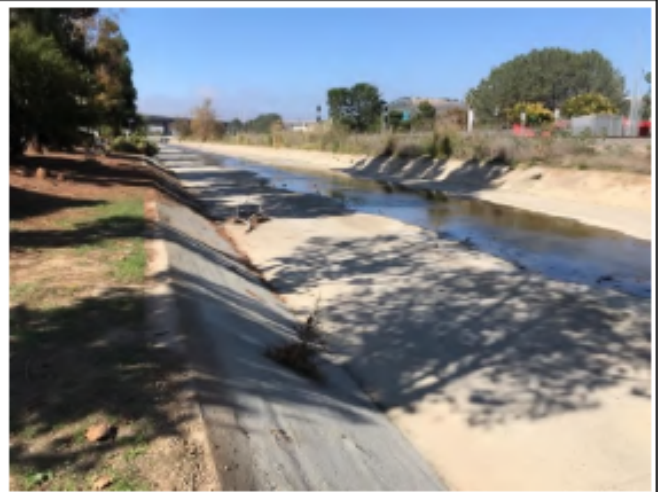
Roselle Post-Maintenance - Photo 12: view of Roselle 2 looking north from southern end of maintenance area. Maintenance activities shown to be complete.

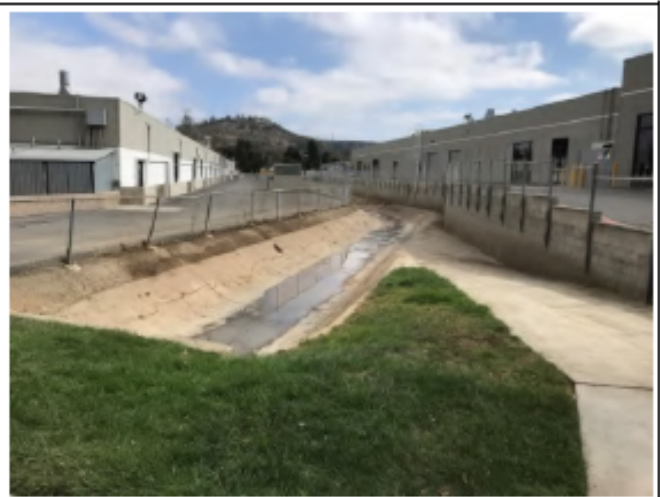
Flintkote Post-Maintenance - Photo 1: view of Flintkote 1 looking northeast. Taken from western edge of project site. Maintenance activities shown to be complete
(November 4, 2021)

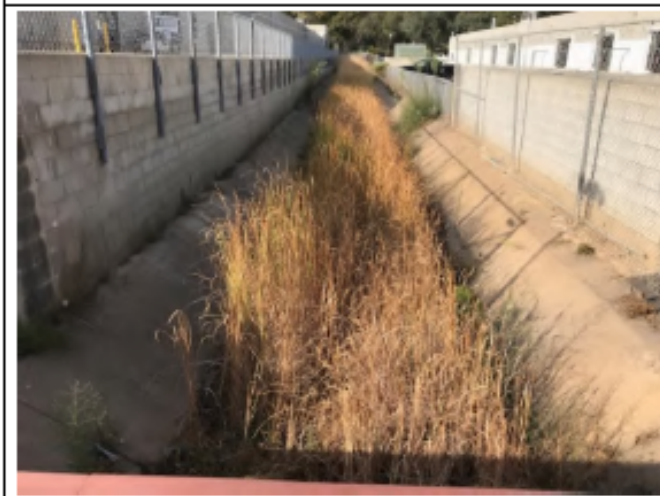
Flintkote Pre-Maintenance - Photo 2: View of Flintkote 1 looking south west towards the edge of the project site, taken from pedestrian footbridge. Vegetation shown in bed of channel.
(September 16, 2021)

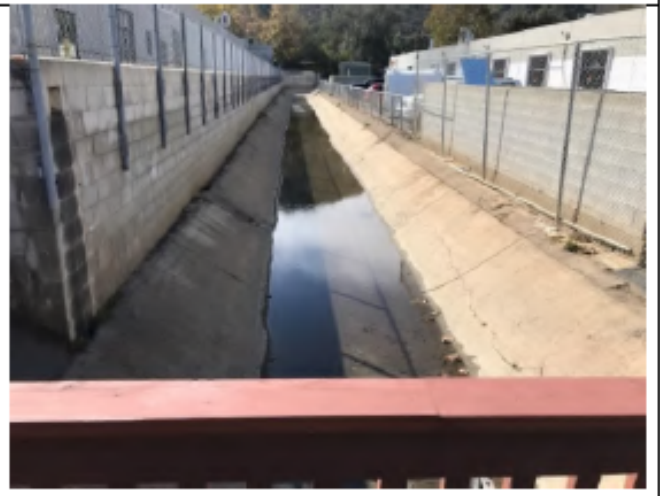
Flintkote Post-Maintenance - Photo 2: View of Flintkote 1, looking southwest towards the edge of the project site, taken from pedestrian footbridge. Maintenance activities shown to be complete
(November 4, 2021)

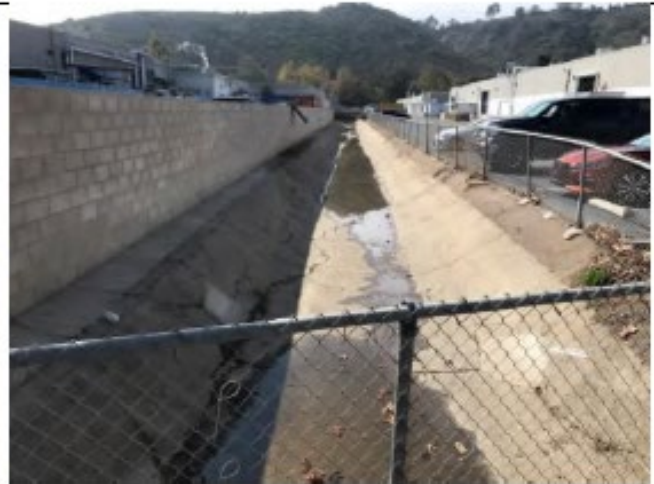
Flintkote Post-Maintenance - Photo 4: View of Flintkote 1 looking south from Roselle Street crossing. Vegetation removal shown to be completed.

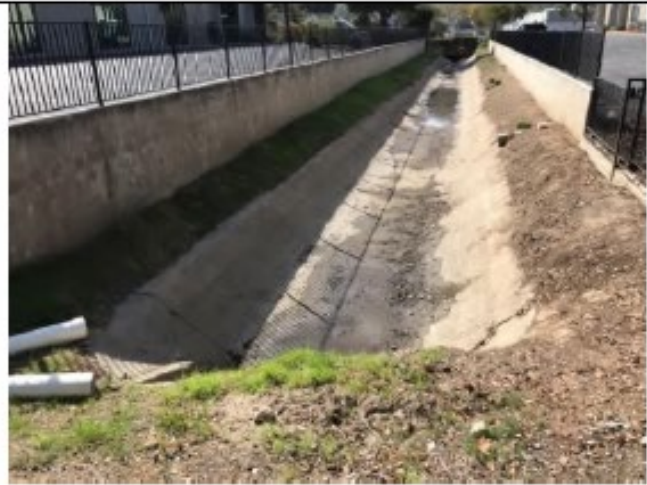
Flintkote Post-Maintenance - Photo 6: View of Flintkote 1 looking southwest from eastern edge of the project. Maintenance activities shown to be complete.
(November 4, 2021)

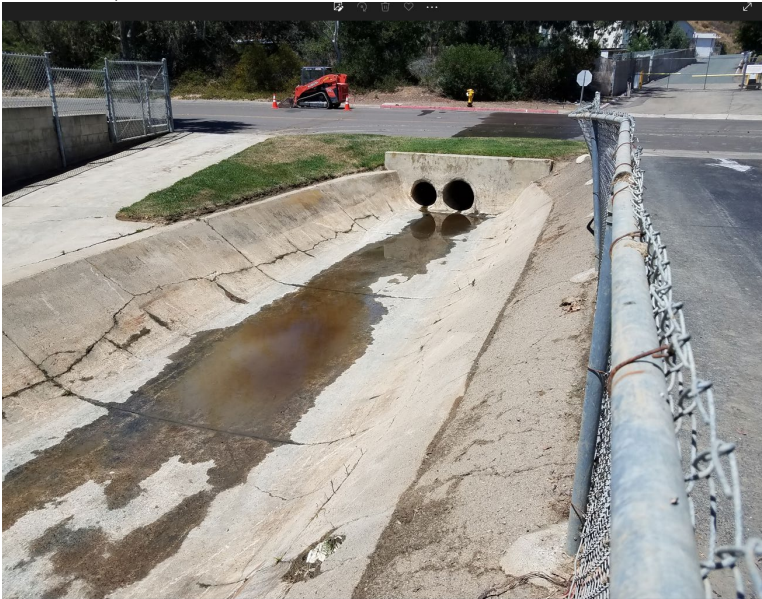
Flintkote post maintenance photo western terminus looking towards culverts and Flintkote Avenue
(June 25, 2022)

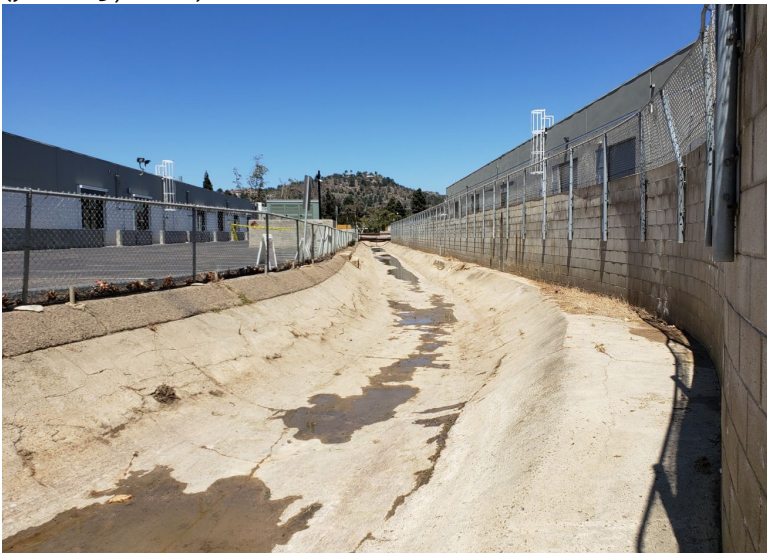
Flintkote post maintenance photo looking from the equipment access ramp on the western terminus east towards a mid-channel bridge crossing (June 25, 2022)

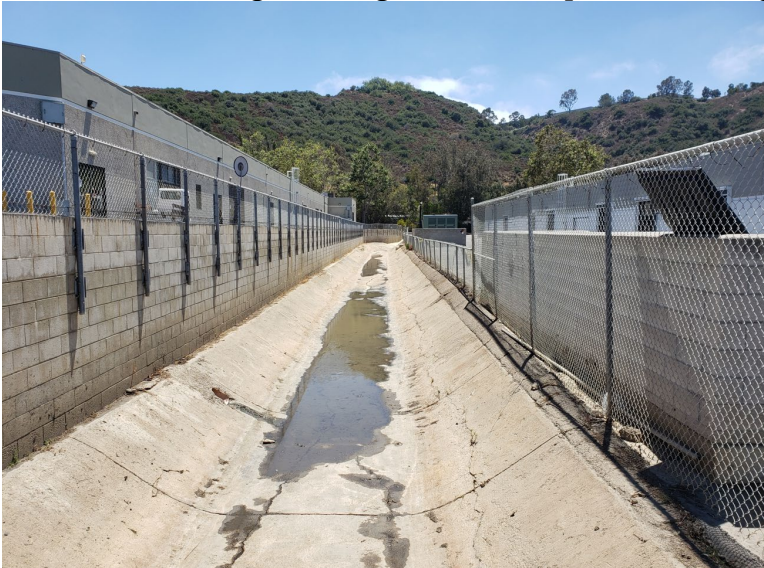
Flintkote post maintenance photo looking from mid-channel bridge crossing west towards Flintkote Avenue (June 25, 2022)

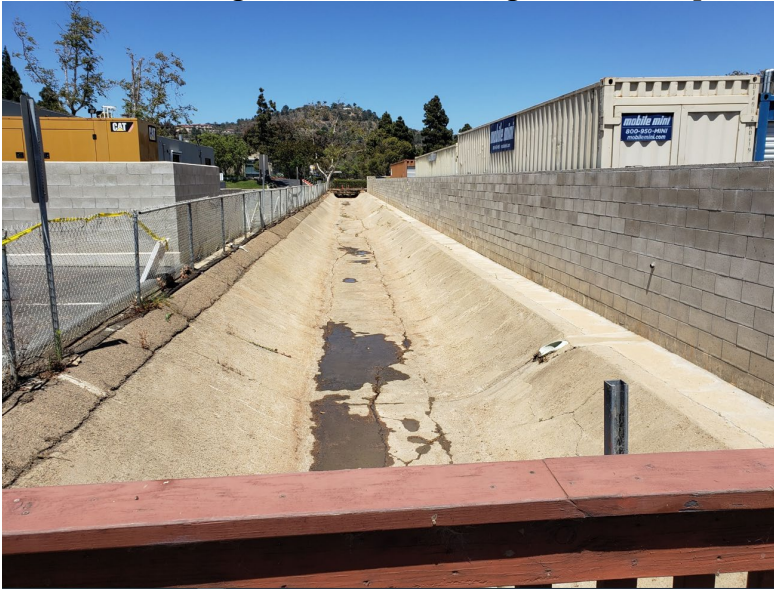
Flintkote post maintenance photo looking from mid-channel bridge crossing east towards Roselle Street (June 25, 2022)

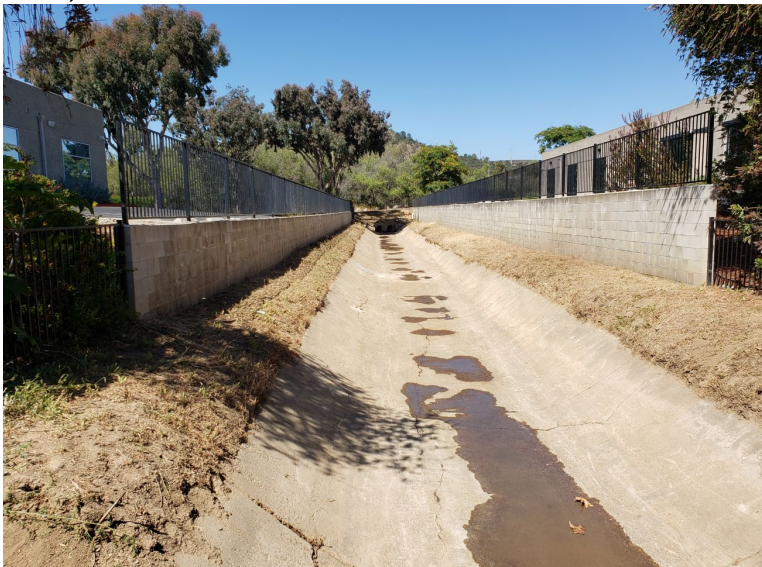
Flintkote post maintenance photo looking near Roselle Street east towards culverts that enter the Roselle channel (June 25, 2022)

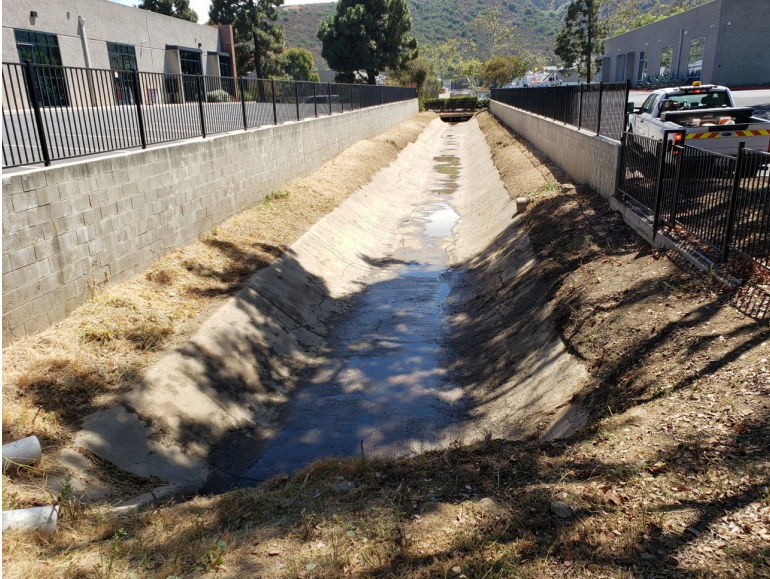
Flintkote post maintenance photo at the eastern terminus looking towards Roselle Street (June 25, 2022)

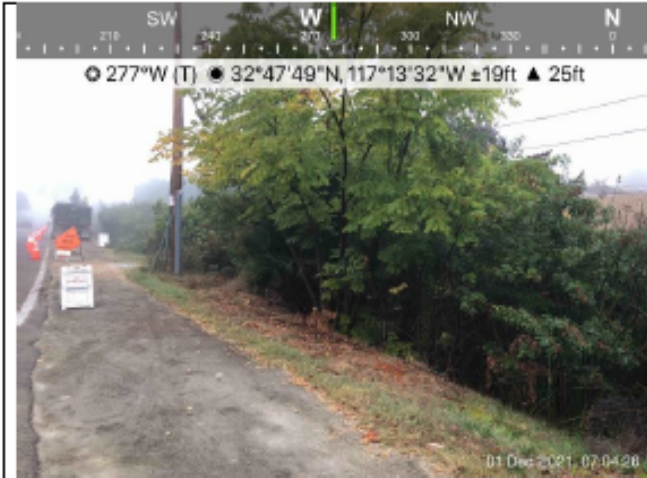
Photo Point 3 - Pre-maintenance: photo looking northwest at dense vegetation within the PB-Olney 1 channel segment (12/1/2021).

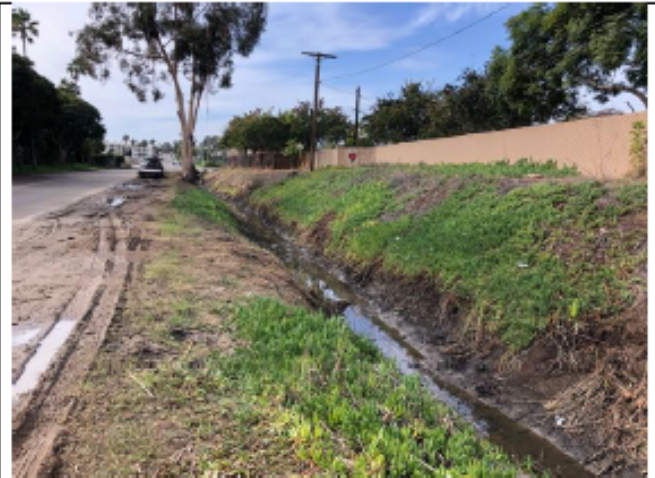
Photo Point 3 - Post-maintenance: photo looking northwest at where vegetation was removed from the PB-Olney 1 channel segment (12/10/2021).

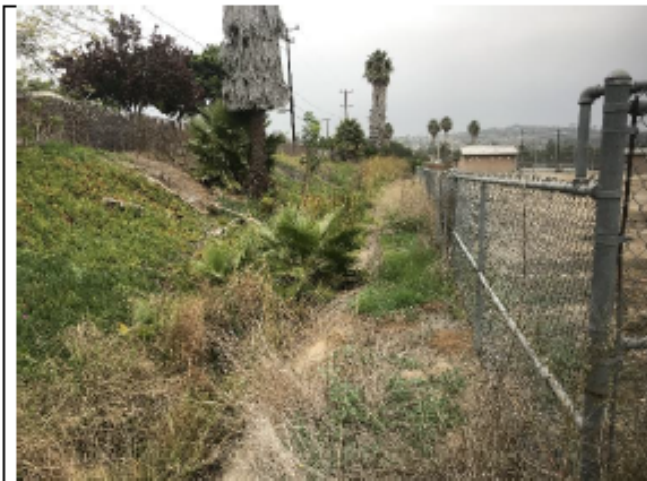
Photo Point 4 - Pre-maintenance: photo looking northwest at dense vegetation within the MBHS 1 channel segment (12/1/2021).

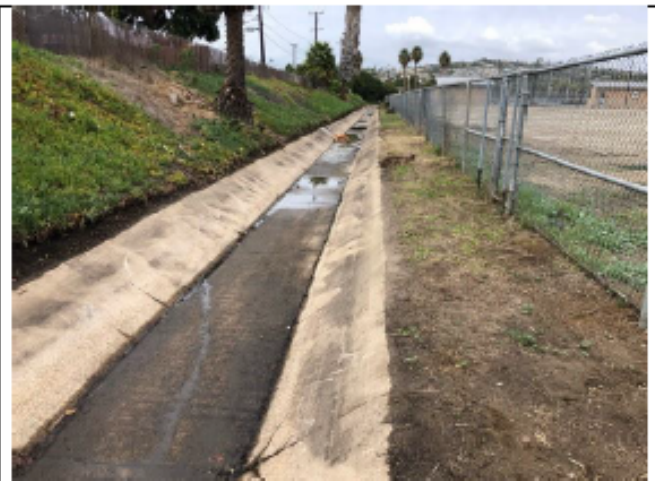
Photo Point 4 - Post-maintenance: photo looking northwest at where vegetation was removed from the MBHS 1 channel segment (12/10/2021).

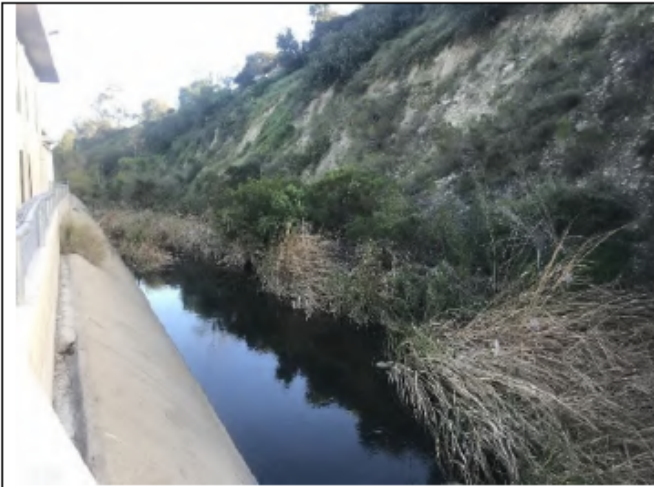
Photo Point 1 – Pre-Maintenance: Looking southwest within Alvarado 1 from the staging area at overgrown vegetation within the channel (January 26, 2022).

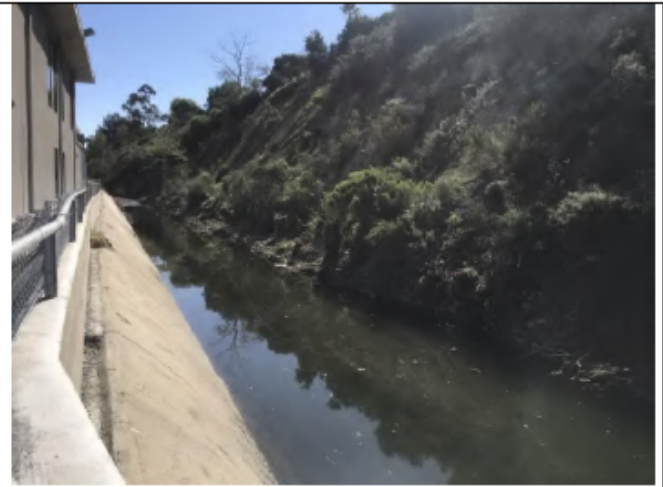
Photo Point 1 – Post-maintenance: Looking southwest within Alvarado 1 from the staging area at the channel cleared from excess vegetation (February 14, 2022).

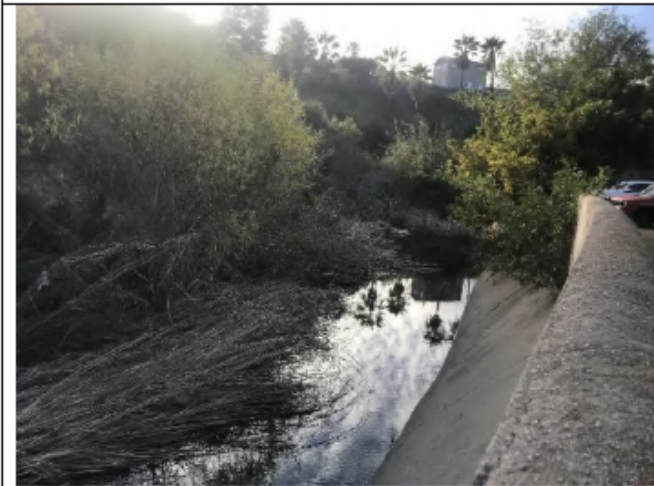
Photo Point 2 – Pre-maintenance: Looking southwest within Alvarado 1 from the staging area at overgrown vegetation within the channel (January 26, 2022).

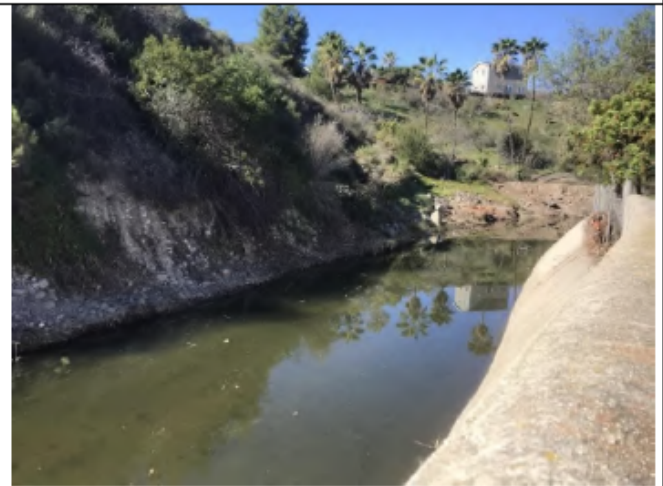
Photo Point 2 – Post-maintenance: Looking southwest within Alvarado 1 from the staging area at the channel cleared from vegetation and debris (February 14, 2022).

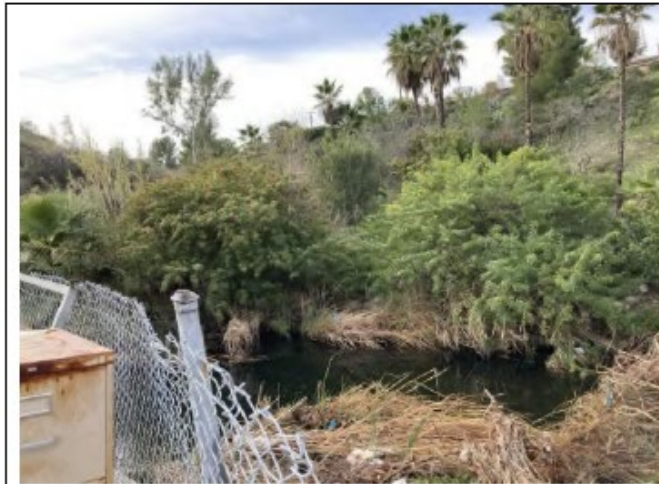
Photo Point 3 – Pre-Maintenance: Looking southwest within Alvarado 1 from the staging area at overgrown vegetation along the banks of the channel (January 26, 2022).

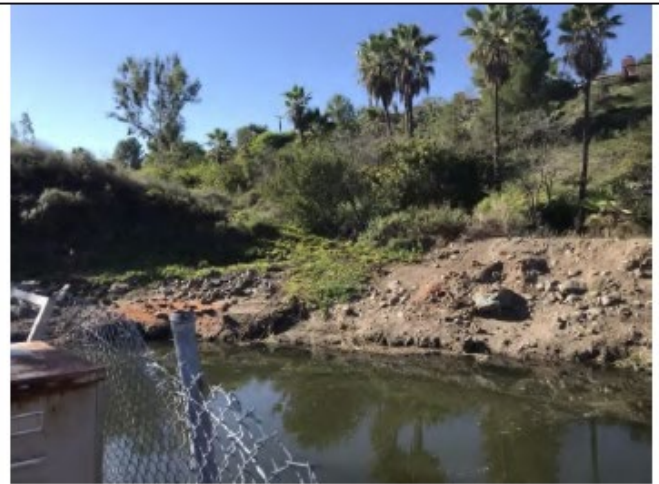
Photo Point 3 – Post-maintenance: Looking southwest within Alvarado 1 from the staging area at the banks of the channel cleared of invasive vegetation (February 14, 2022).

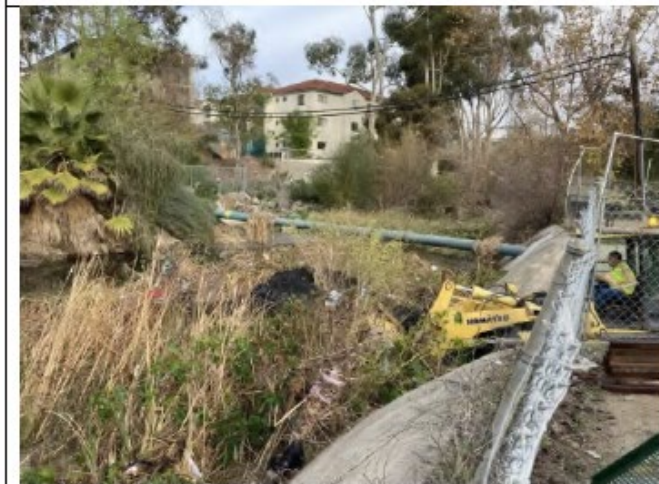
Photo Point 4 – During-maintenance: Looking northwest within Alvarado 1 from the staging area at overgrown vegetation and debris within the channel (January 31, 2022).

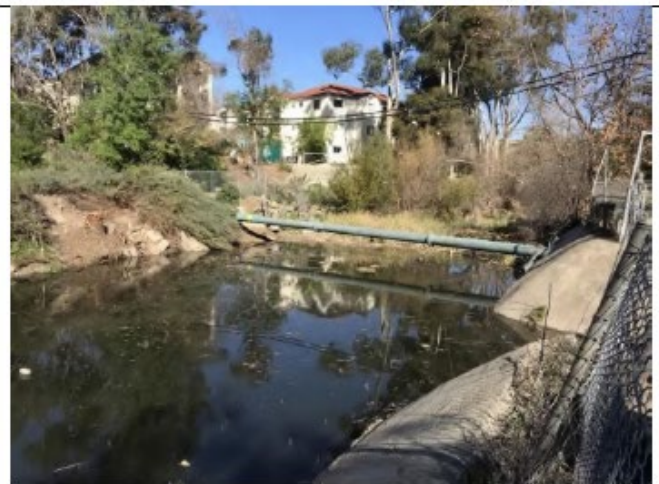
Photo Point 4 – Post-maintenance: Looking northwest within Alvarado 1 from the staging area at the channel cleared from vegetation and debris (February 14, 2022).

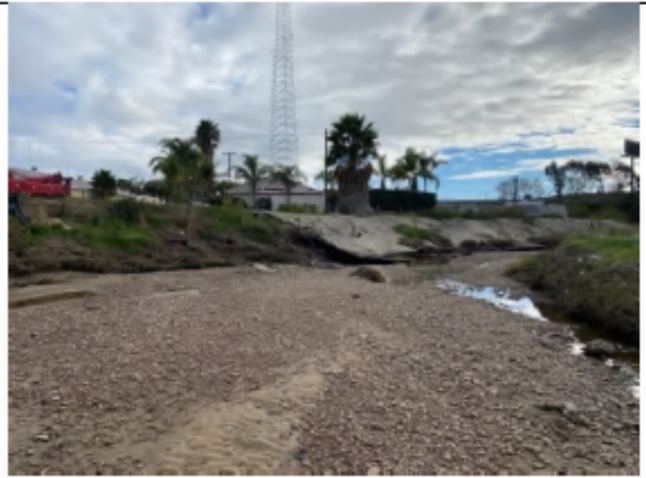
Photo Point 1 – Post-maintenance: Looking south within National 1 from below the National Ave. bridge at post-maintenance conditions (January 17, 2022)

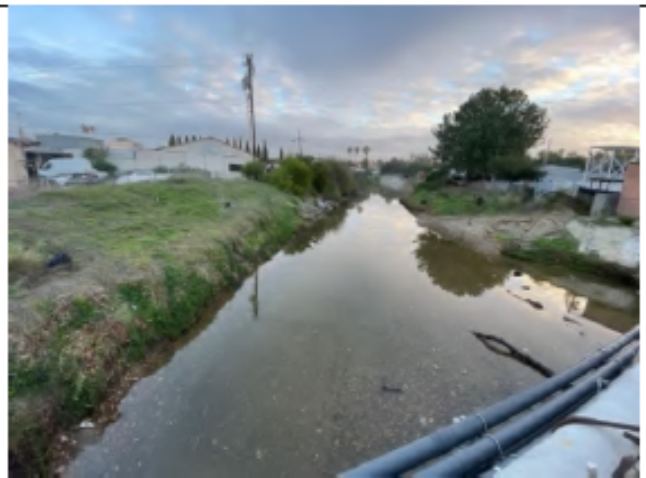
Photo Point 2 – Post-maintenance: Looking northeast above channel from National Ave. bridge at maintenance area following sediment and vegetation removal (January 17, 2022).

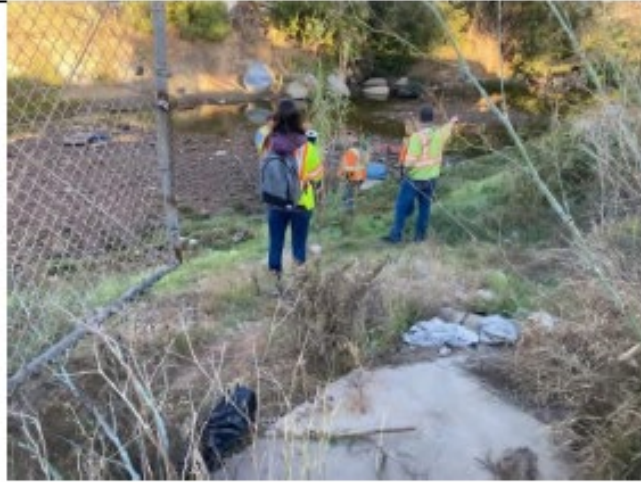
Photo Point 3 – Pre-maintenance: Looking northwest at access ramp prior to the start of maintenance (October 21, 2021).

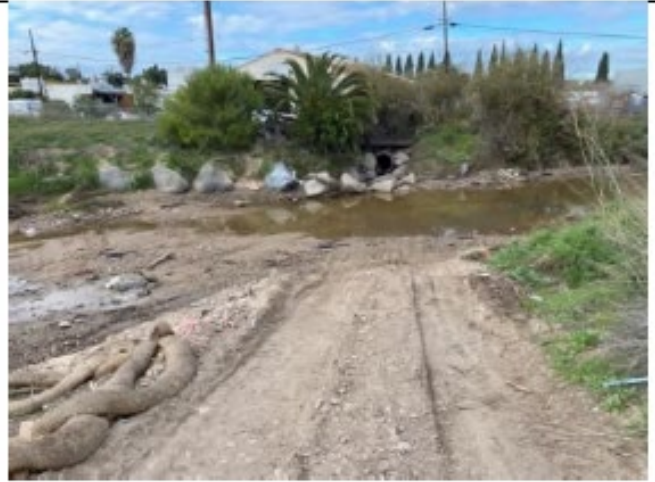
Photo Point 3 – Post-maintenance: Looking northwest at access ramp following completion of channel maintenance activities (January 17, 2022).

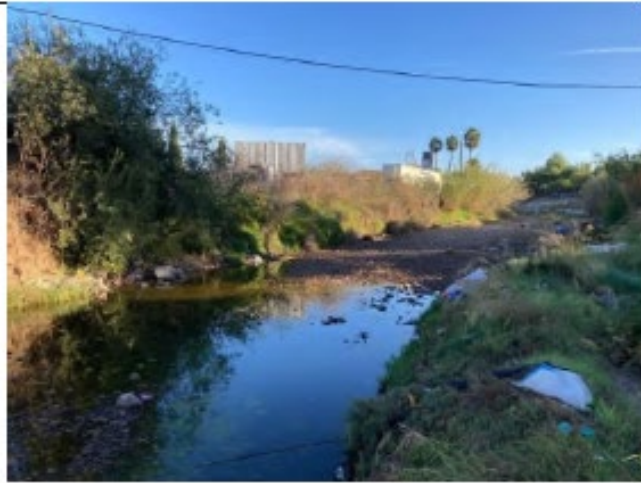
Photo Point 4 – Pre-maintenance: Looking north within National 1 from within the channel north of the National Ave. bridge towards National 2 prior to the start of maintenance (October 21, 2021).

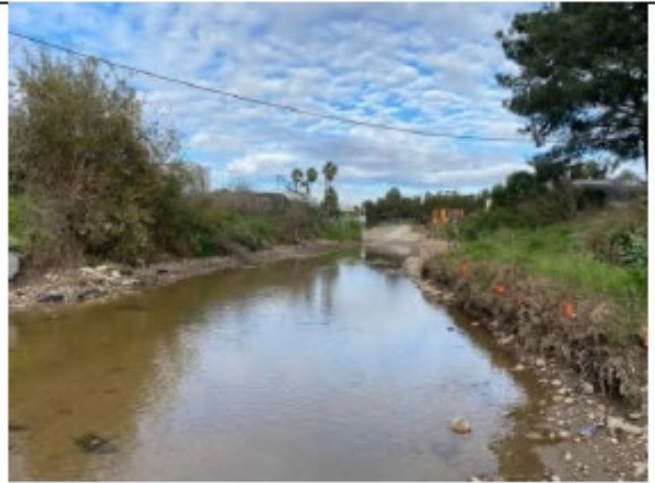
Photo Point 4 – Post-maintenance: Looking north within National 1 from within the channel north of the National Ave. bridge towards National 2 following completion of maintenance activities (January 17, 2022).

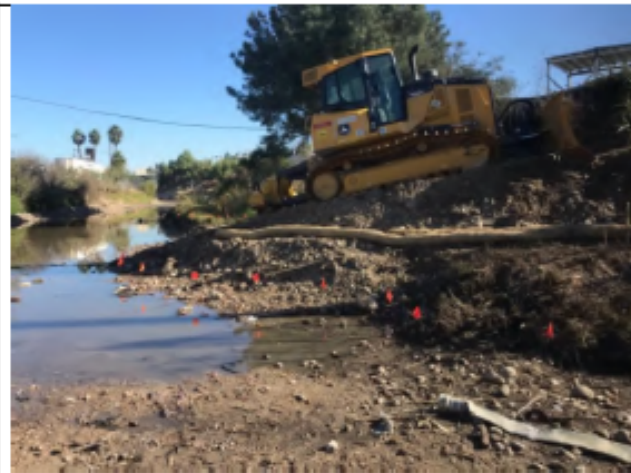
Photo – During-maintenance: Looking northeast within National 2 showing widened access ramp and sediment deposition as well demarcated disturbed coastal salt marsh (October 29, 2021).

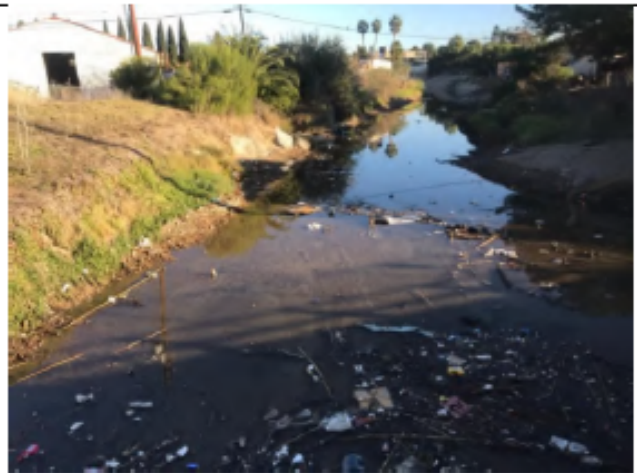
Photo – During-maintenance: Looking northeast from National Ave. bridge into the National 1 channel where water has inundated the maintenance area during high tides (November 15, 2021).

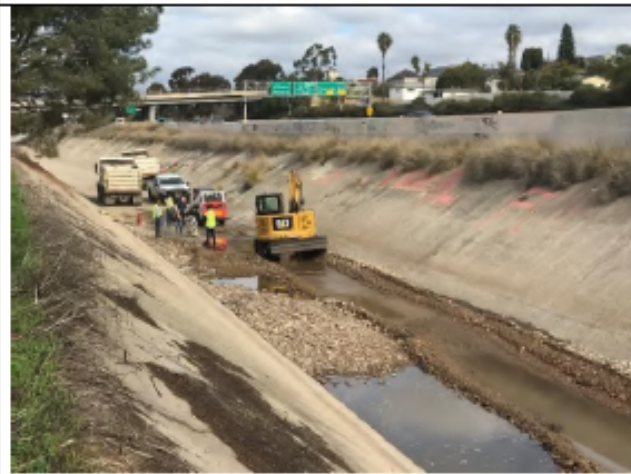
Photo – During-maintenance: Looking northeast within National 2 showing an excavator and dump trucks working within the concrete-lined channel (January 8, 2022).

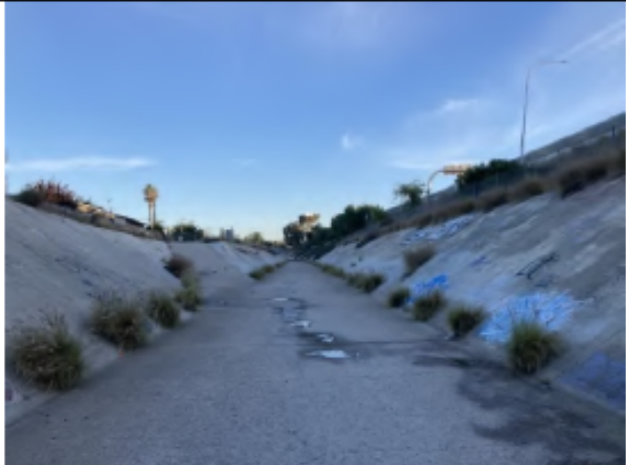
<p>Photo Point 8 – Pre-maintenance: Looking north from within National 2 at the northern end of the maintenance area and concrete access ramp prior to maintenance (October 21, 2021).</p>	<p>Photo Point 8 – Post-maintenance: Looking north from within National 2 at the northern end of the maintenance area and concrete access ramp following completion of maintenance activities (January 17, 2022).</p>

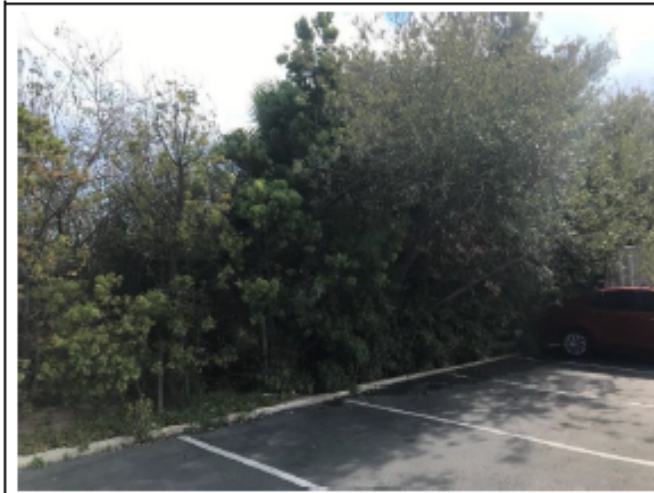
Pre-Maintenance - Photo 1: Pre-maintenance photo facing south from the 11815 Sorrento Valley Road parking lot looking at vegetation present in the Industrial 2 channel.
(October 4, 2021)

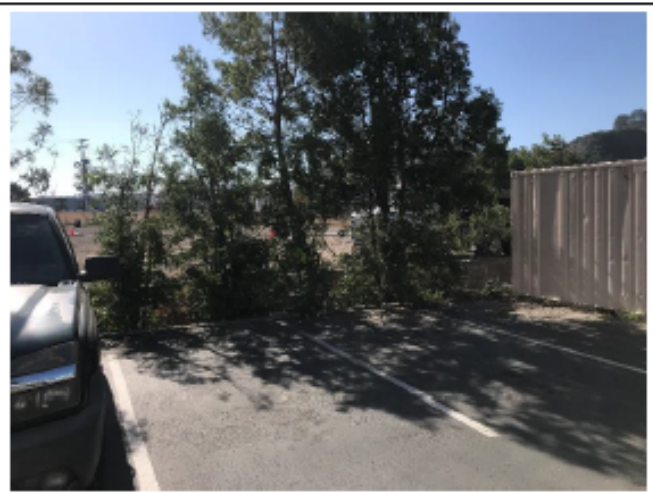
Post-Maintenance - Photo 1: Pre-maintenance photo facing south from the 11815 Sorrento Valley Road parking lot following completion of native wetland vegetation removal in the Industrial 2 channel.
(November 11, 2021)

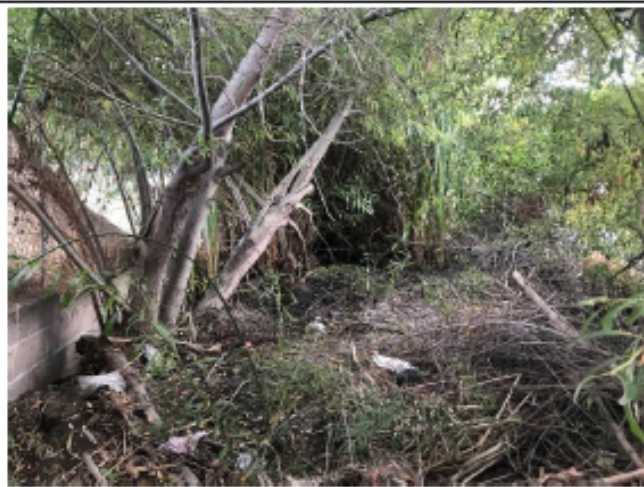
Pre-Maintenance - Photo 2: Pre-maintenance photo facing northeast from within the developed concrete lined channel looking at vegetation accumulated in the downstream end of the Industrial 2 channel maintenance area.
(October 4, 2021)

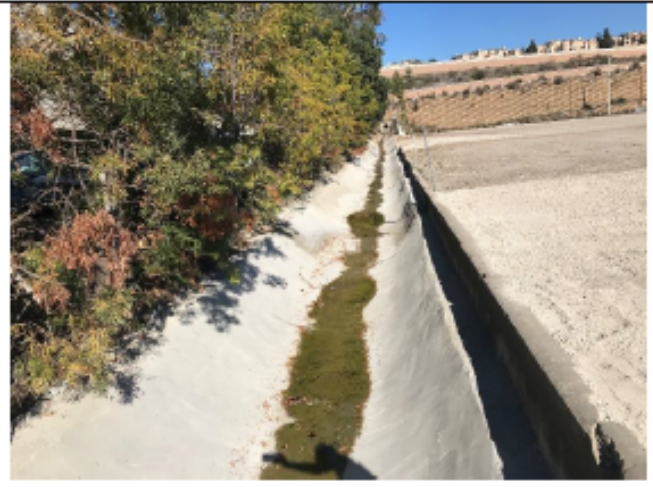
Post-Maintenance - Photo 2: Post-maintenance photo facing northeast from looking the cleared and repaired concrete lining within the Industrial 2 channel.
(November 11, 2021)

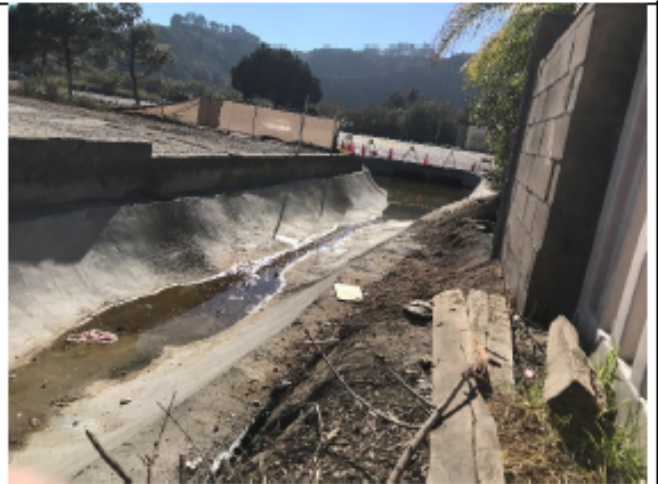
Post-Maintenance - Photo 3: Post-maintenance photo facing southwest looking towards the culvert inlet under Sorrento Valley Boulevard at the cleared and repaired concrete lining within the Industrial 2 channel.

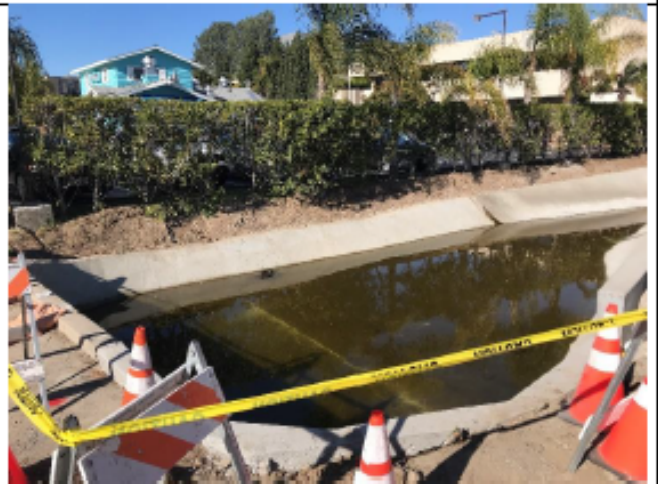
Post-Maintenance - Photo Point 4: Post-maintenance photo facing northeast from Sorrento Valley Road (east side) looking at vegetation and sediment removal area in the downstream end of the Industrial 2 channel. Water accumulated here due to off-site, downstream blockage on MTS property (outside City-jurisdiction).

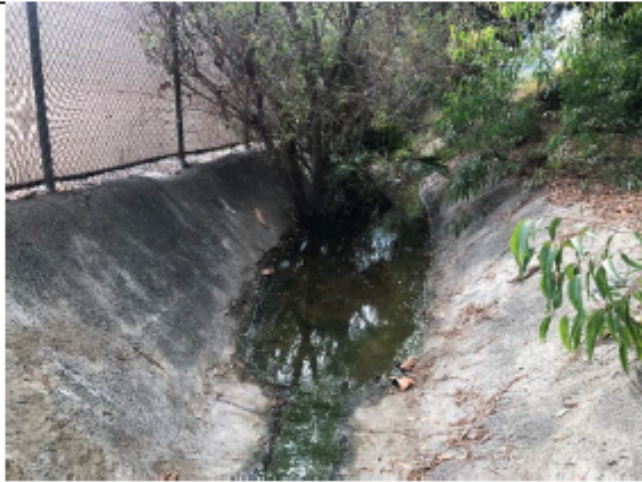
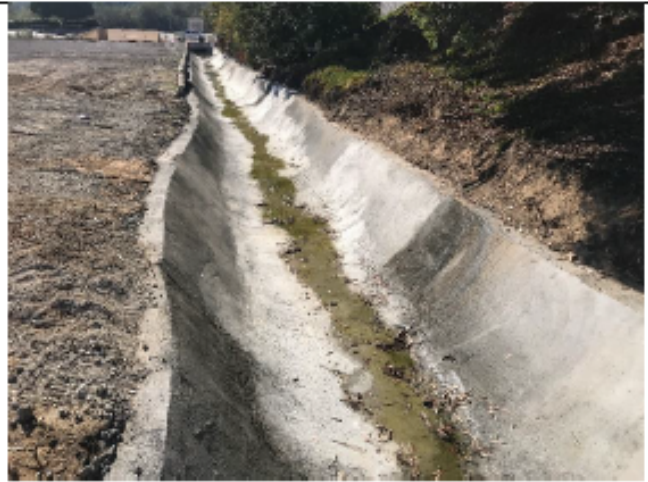
Pre-Maintenance - Photo Point 5: Pre-maintenance photo facing southwest from the developed concrete-lined channel looking at the upstream limits of vegetation accumulated in the Industrial 2 channel

Post-Maintenance - Photo Point 5: Post-maintenance photo facing southwest from the developed concrete-lined channel looking at the cleared and repaired concrete lining in the Industrial 2 channel. Fence in pre-maintenance photo in developed area will be re-installed at a later date.

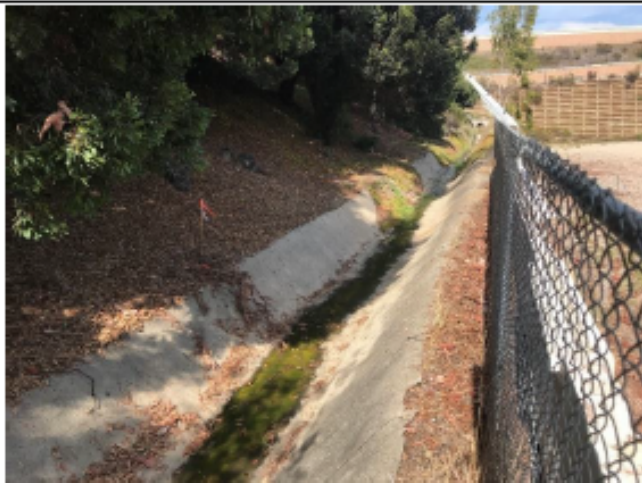
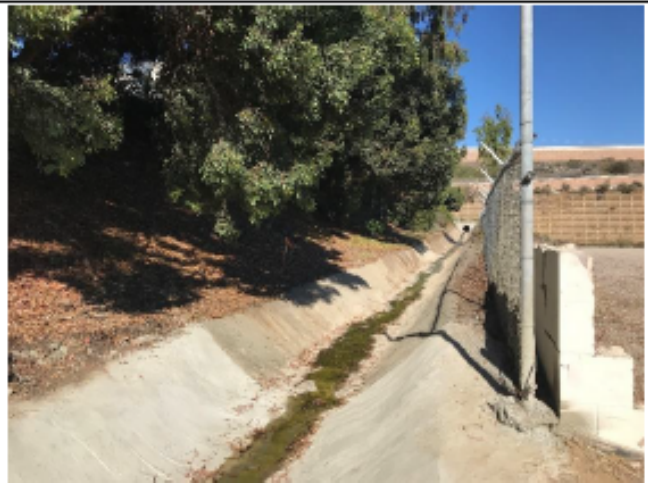
Pre-Maintenance - Photo Point 6: Pre-maintenance photo facing northeast from the developed concrete-lined channel looking at upstream limits of the Industrial 2 channel

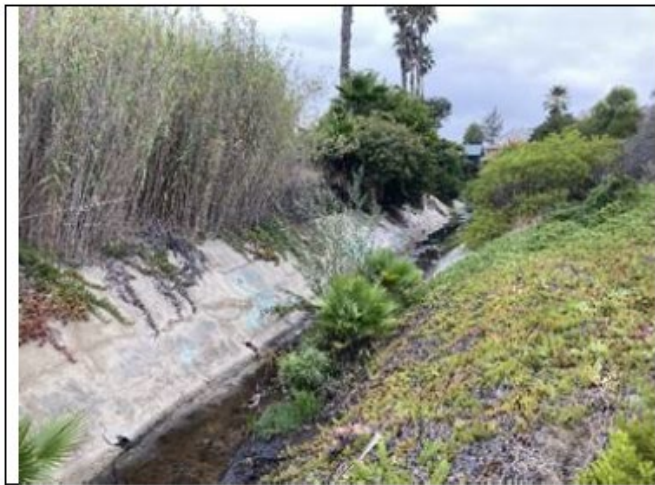
<p>Pre-Maintenance (PP-5)</p>	<p>Post-Maintenance (PP-5)</p>
<p>Looking northwest at palm trees established in the channel (10/7/2021).</p>	<p>Looking northwest in channel, vegetation removal shown to be complete (12/6/2021).</p>

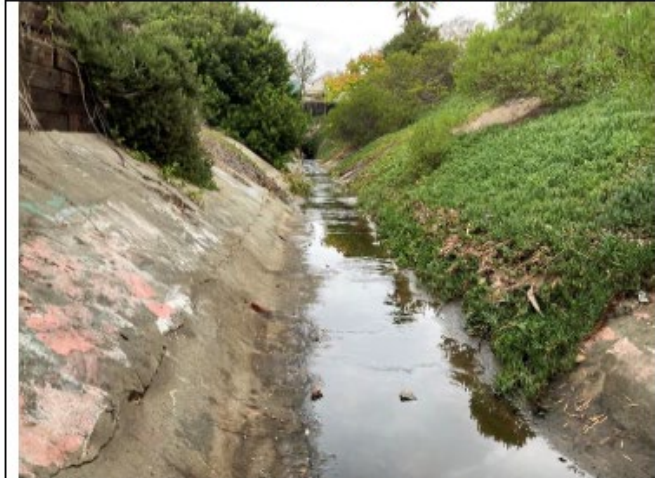
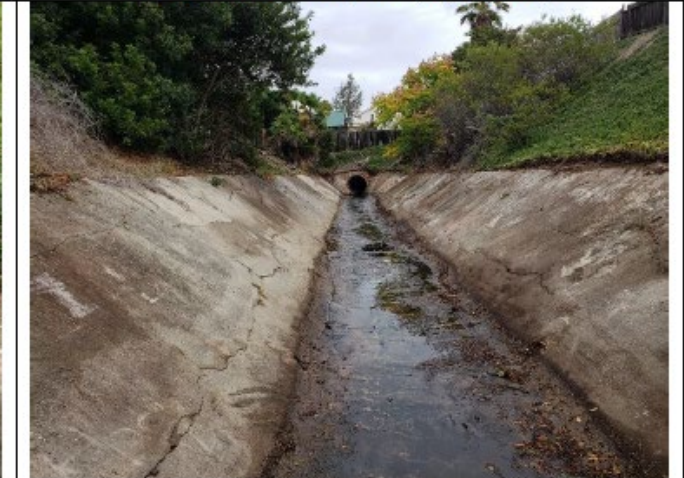
<p>Pre-Maintenance (PP-6)</p>	<p>Post-Maintenance (PP-6)</p>
<p>Looking northwest at accumulated sediment and pooled water in the channel (10/7/2021).</p>	<p>Looking northwest in channel, sediment and vegetation removal shown to be complete (12/6/2021).</p>

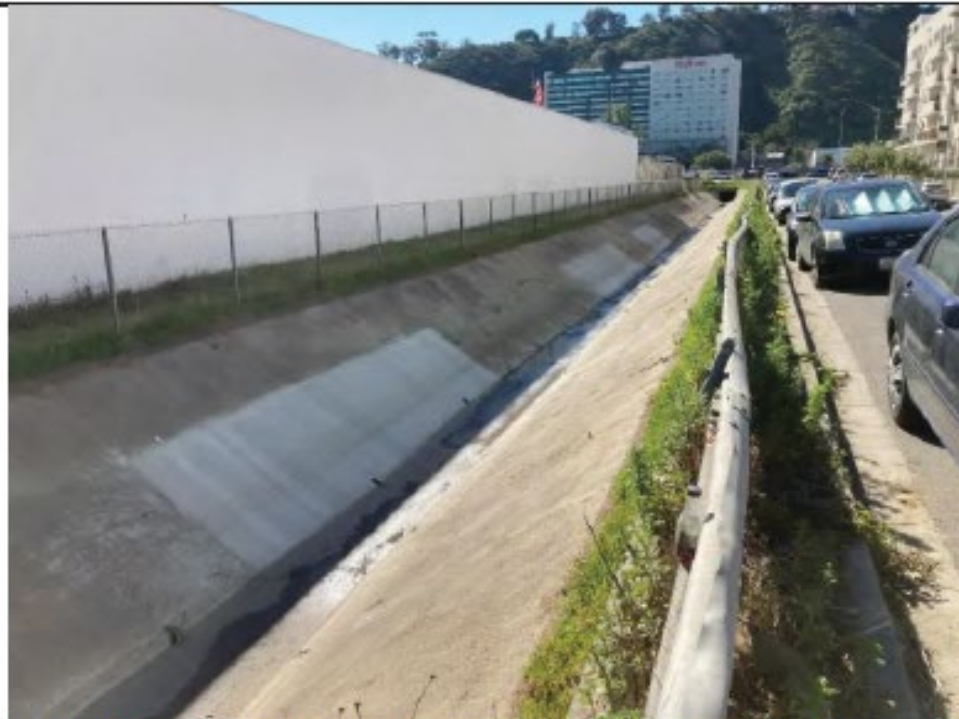
Post-Maintenance Photo Point 2: Looking southeast from the western edge of Camino del Arroyo 1 – vegetation shown to be removed from channel, concrete repair shown (3/2/2022).

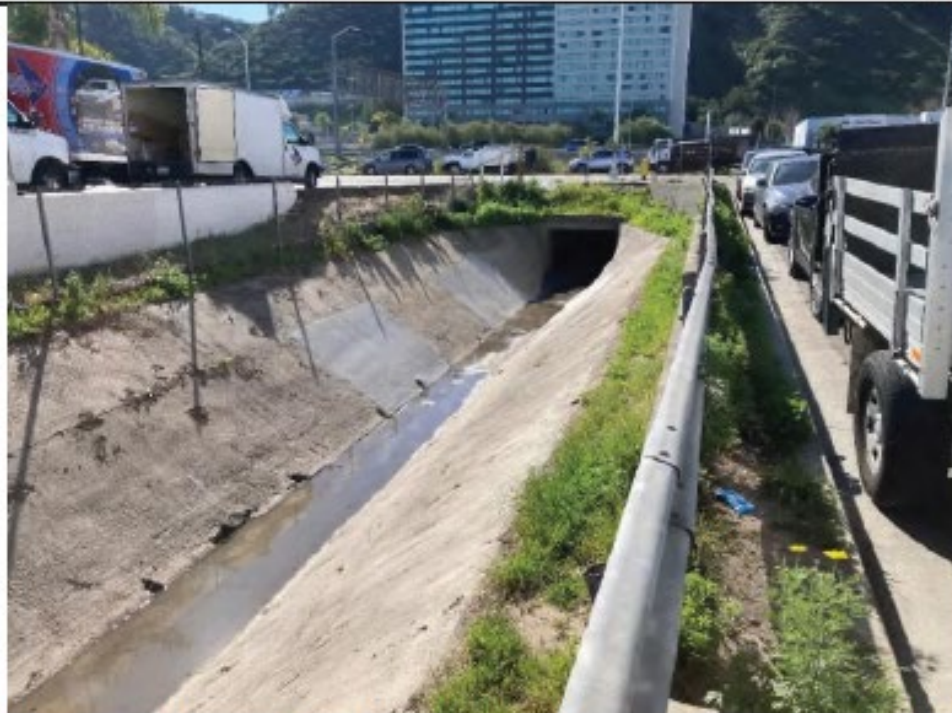
Post-Maintenance Photo Point 3: Looking south from the southern end of Camino del Arroyo 1 – vegetation shown to be removed from channel. Concrete repair areas shown. (3/2/2022).

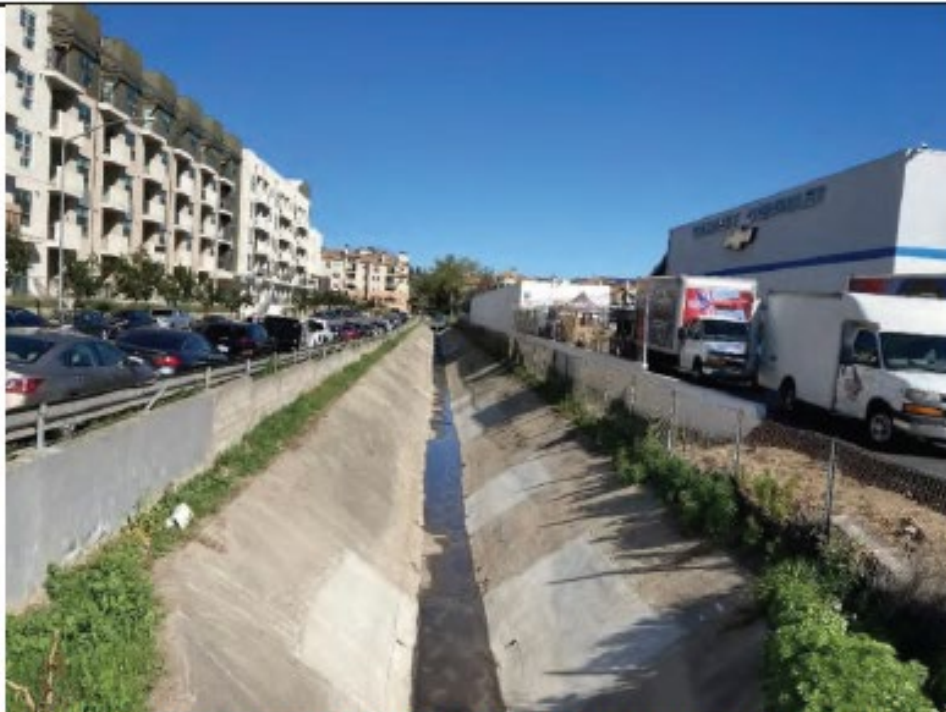
Post-Maintenance Photo Point 4: Looking north from the southern end of Camino del Arroyo 1 – vegetation shown to be removed from channel and concrete repair areas visible (3/2/2022).
