Municipal Waterways Maintenance Plan Annual Report Fiscal Year 2022

THINK BLUE®
City of San Diego
Stormwater Department

October 2022

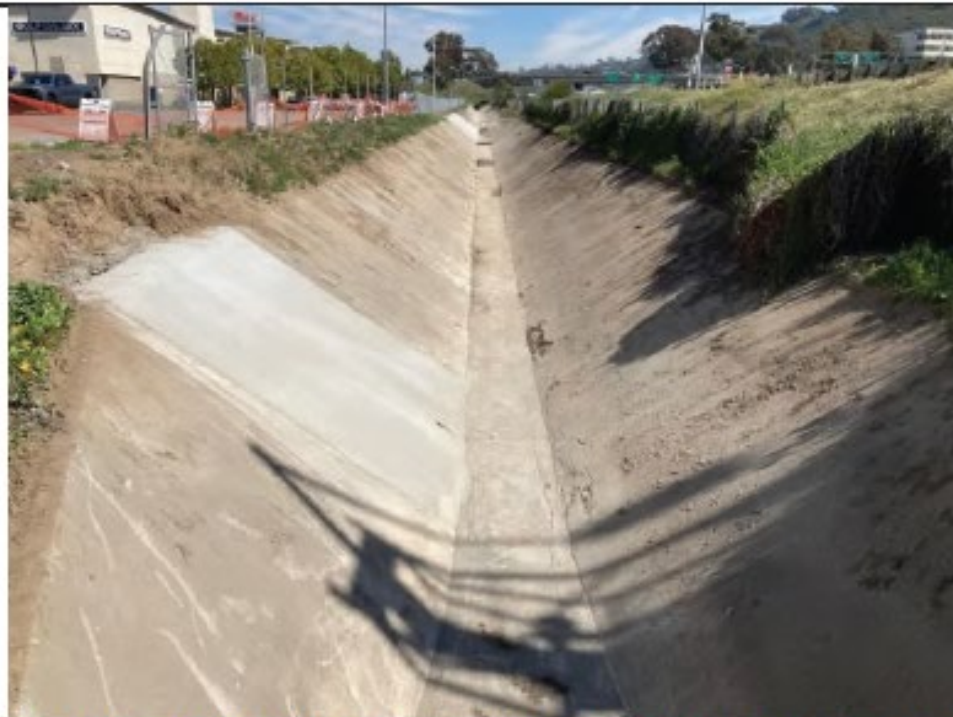
Post-Maintenance Photo Point 5: Looking east from western end of Camino del Rio 1. Vegetation had been removed from channel, concrete repair shown on left (3/2/2022).

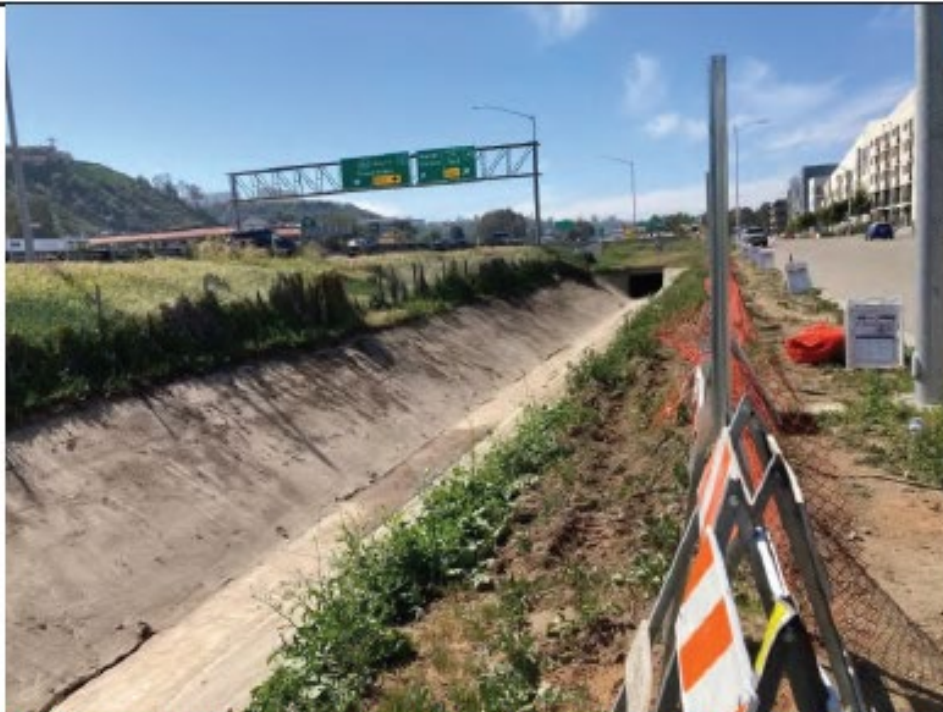
Post-Maintenance Photo Point 6: Looking southwest from north bank of Camino del Rio 1 at location where vegetation and soils were removed from channel (3/2/2022).

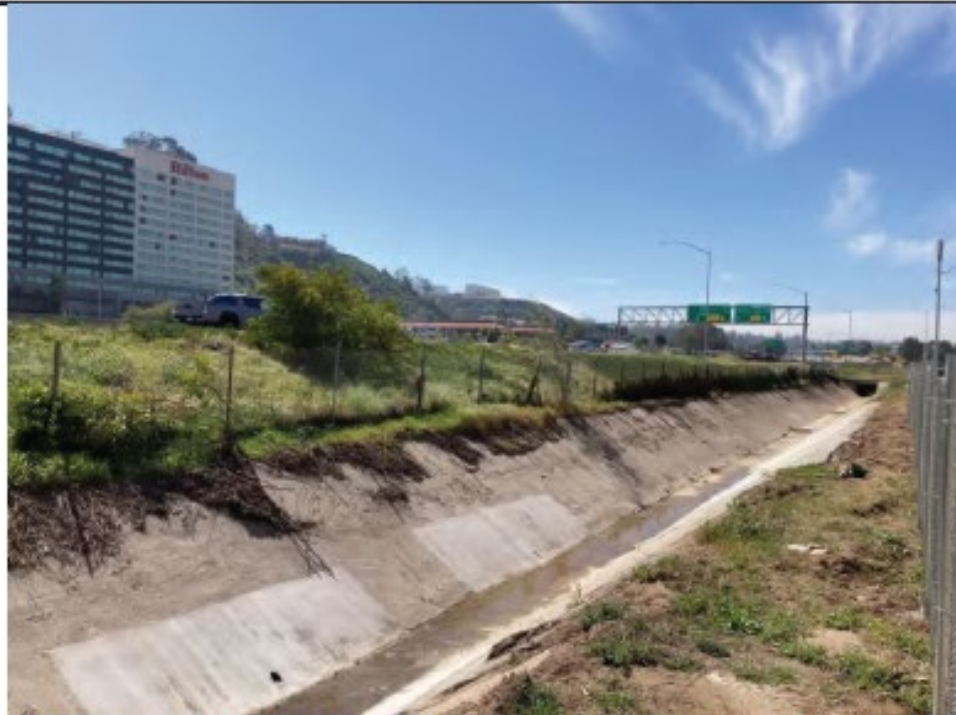
Post-Maintenance Photo Point 7: Looking northwest from the southern end of Camino del Rio 1 – vegetation shown to be removed from channel (3/2/2022).

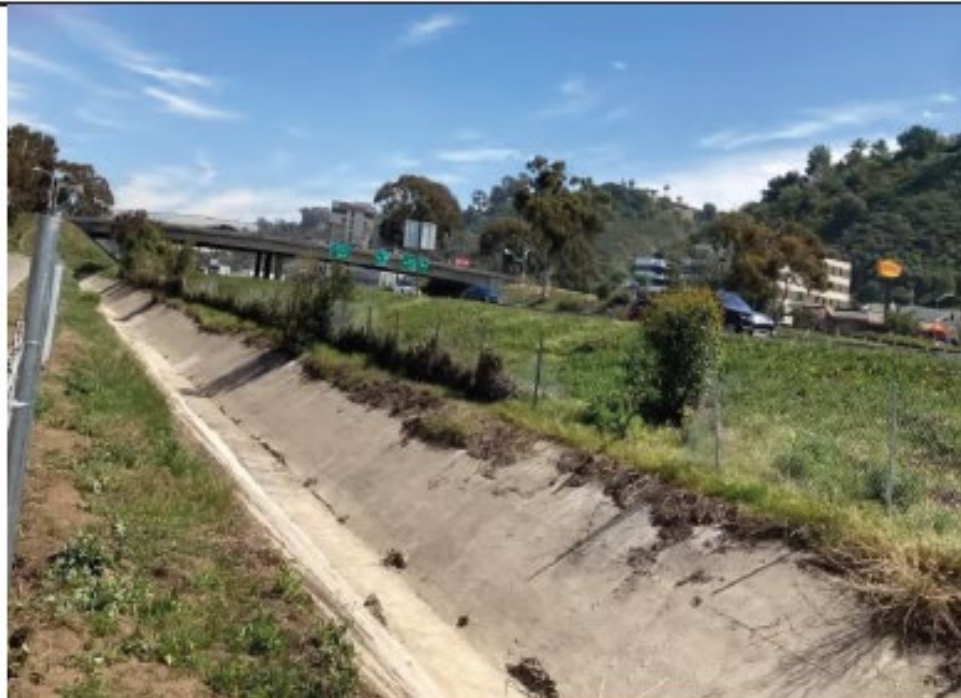
Post-Maintenance Photo Point 8: Looking east from the northern side of Camino del Rio 1 –vegetation and soil materials shown to be removed from channel, concrete repair shown (3/2/2022).

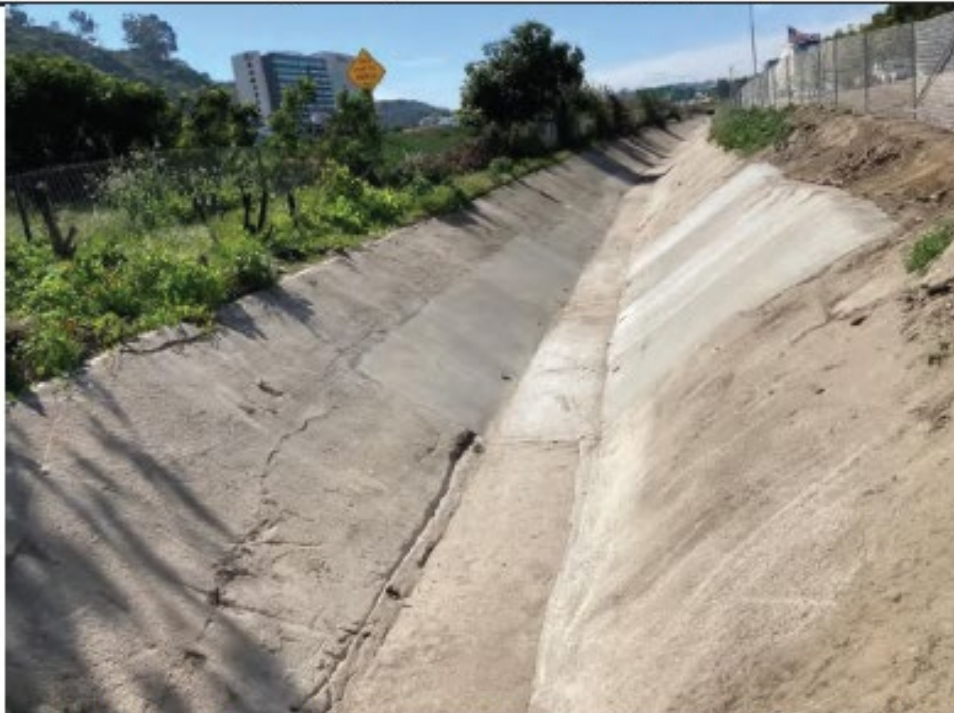
Post-Maintenance Photo Point 9: Looking southwest from the eastern, upstream end of Camino del Rio 1 where vegetation and material was removed. Concrete repair areas visible (3/2/2022).

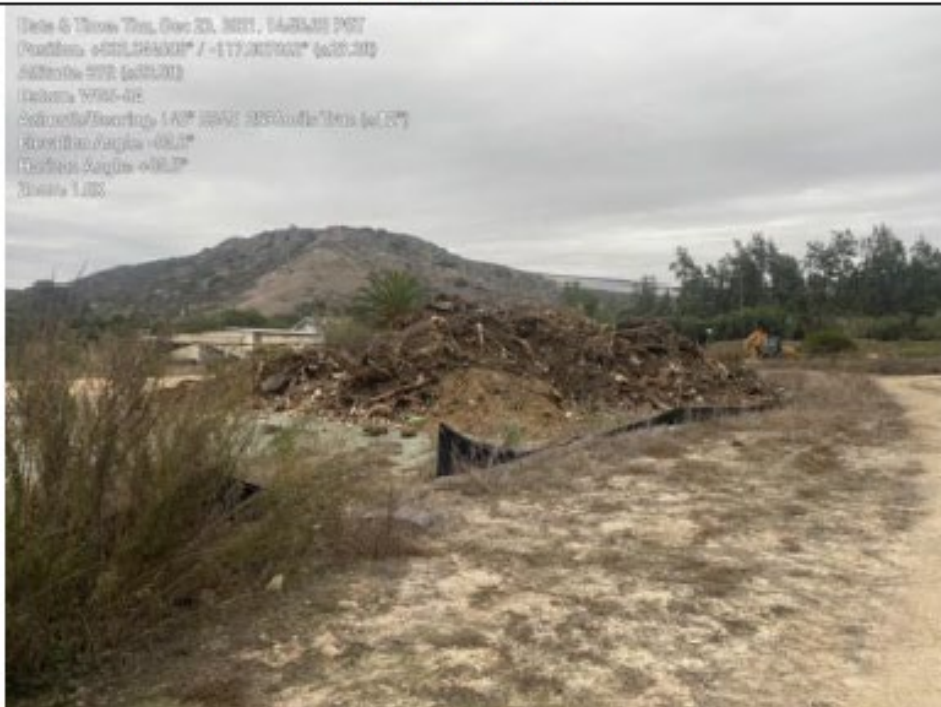
Photo 4: Stockpile in staging area with silt fence and fiber rolls installed (12/23/2021).

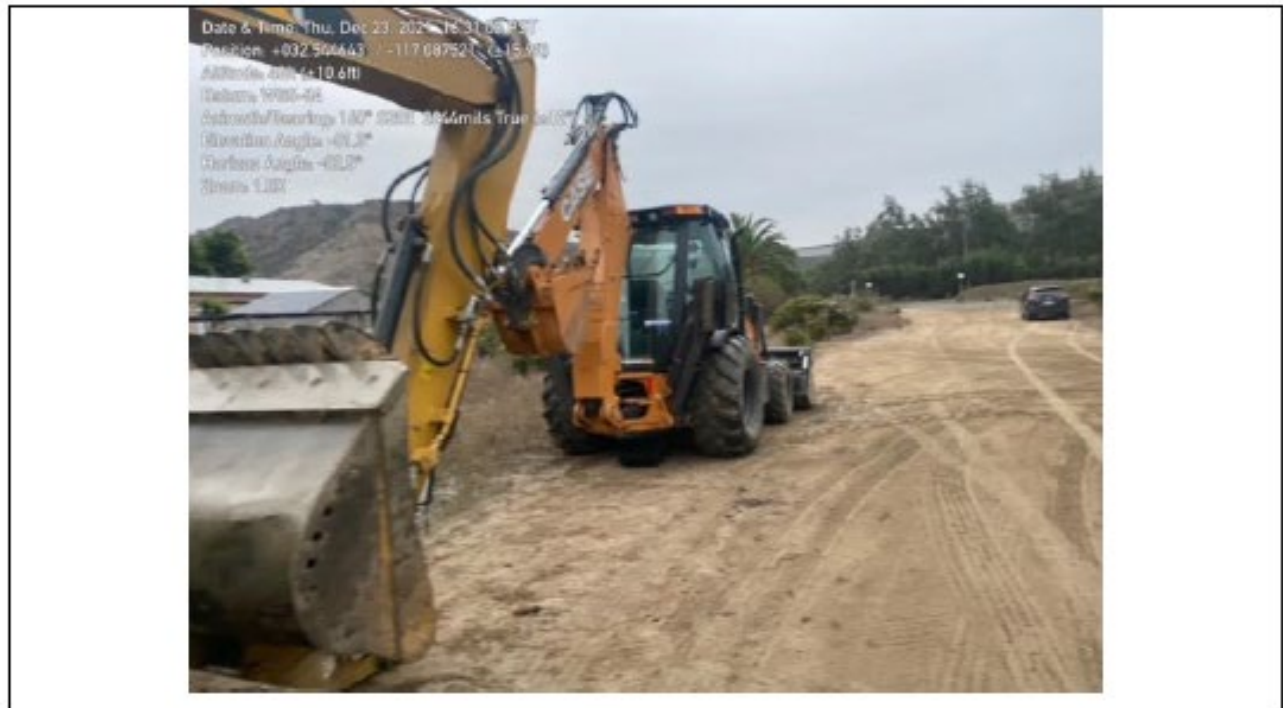
Photo 5: Drip pans placed under equipment parked in staging area (12/23/2021).

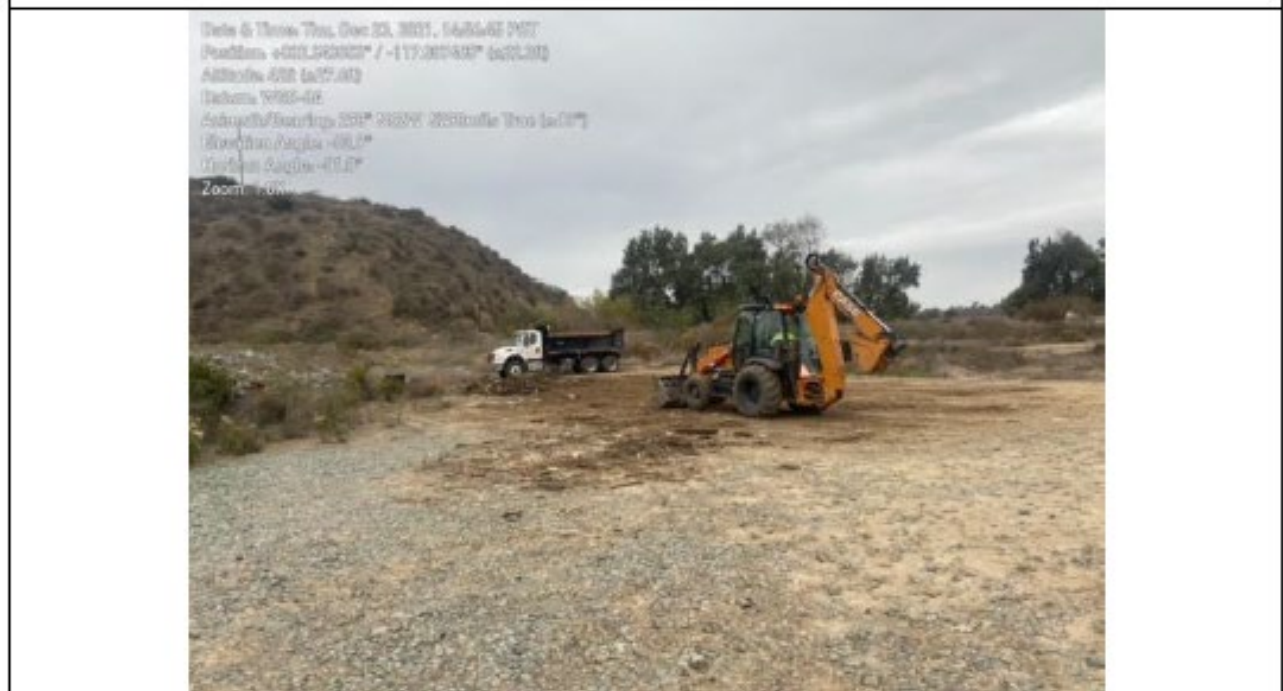
Photo 6: Debris from a stockpile in staging area being managed and loaded for removal by heavy machinery (12/23/2021).

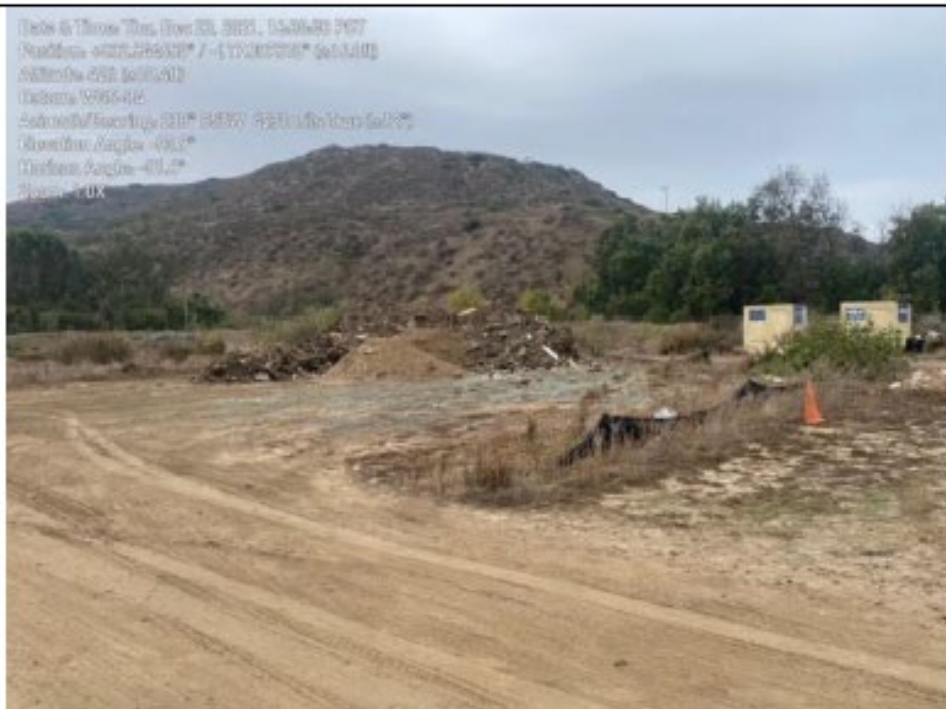
Photo 8: Trash, debris, and detritus stockpiled in staging area for removal during the following site visit (12/23/2021).

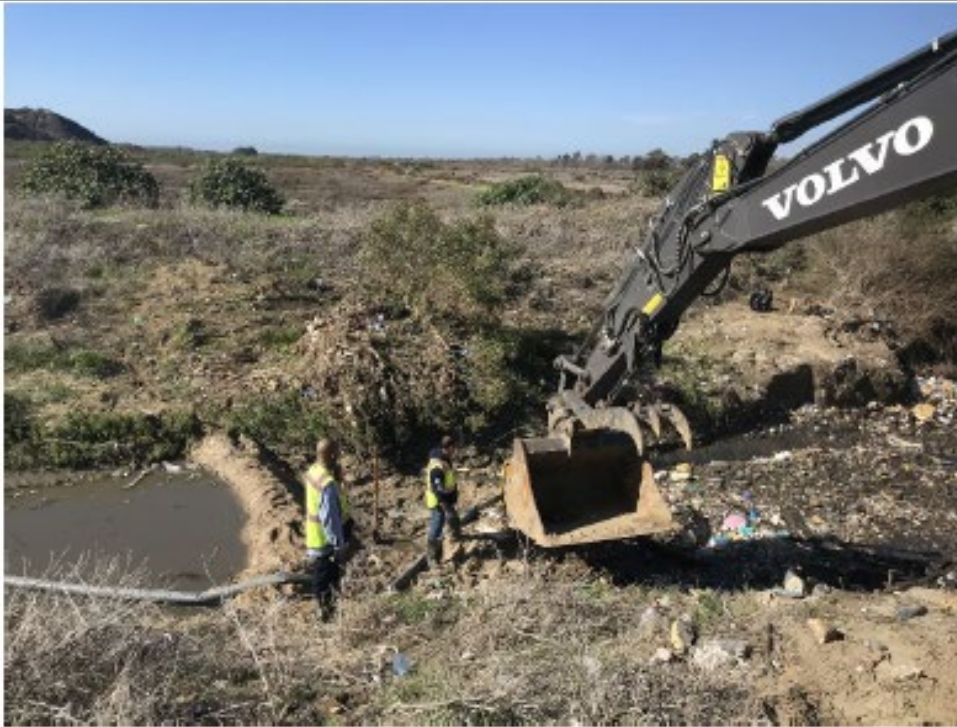
Photo 9: Dirt berm and pump being used to divert water flows away from the work area (1/04/2022).

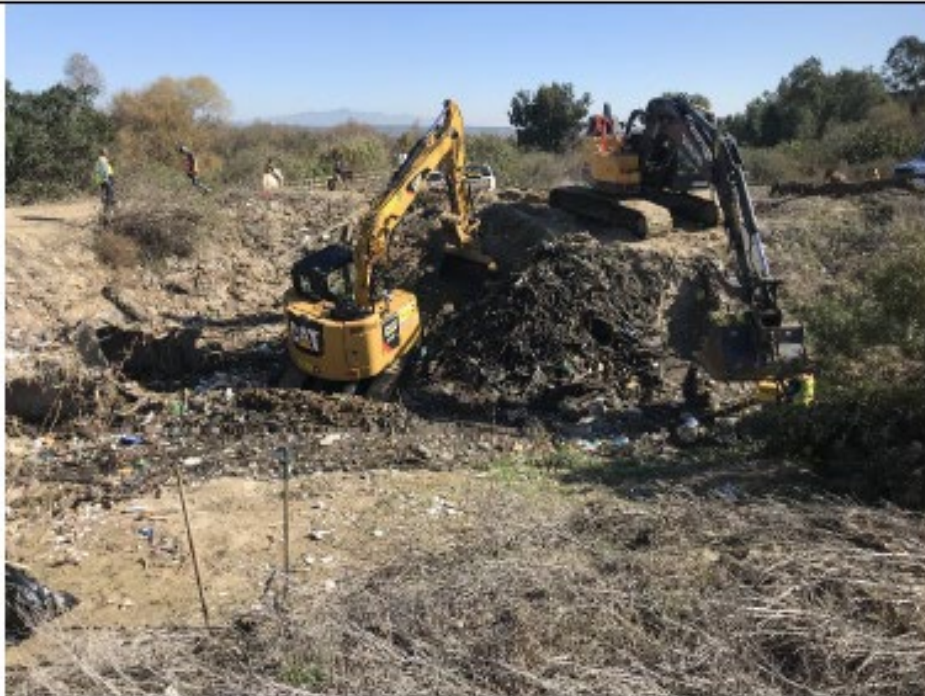
Photo 10: Excavators used to continue the removal of trash, debris, and detritus from the channel (1/04/2022).
