CERTIFIED ARBORIST REPORT

Date: August 1 , 2022

Tree Inspection at Clairemont Village Shopping Center
3089 Clairemont Drive
San Diego, CA 92117

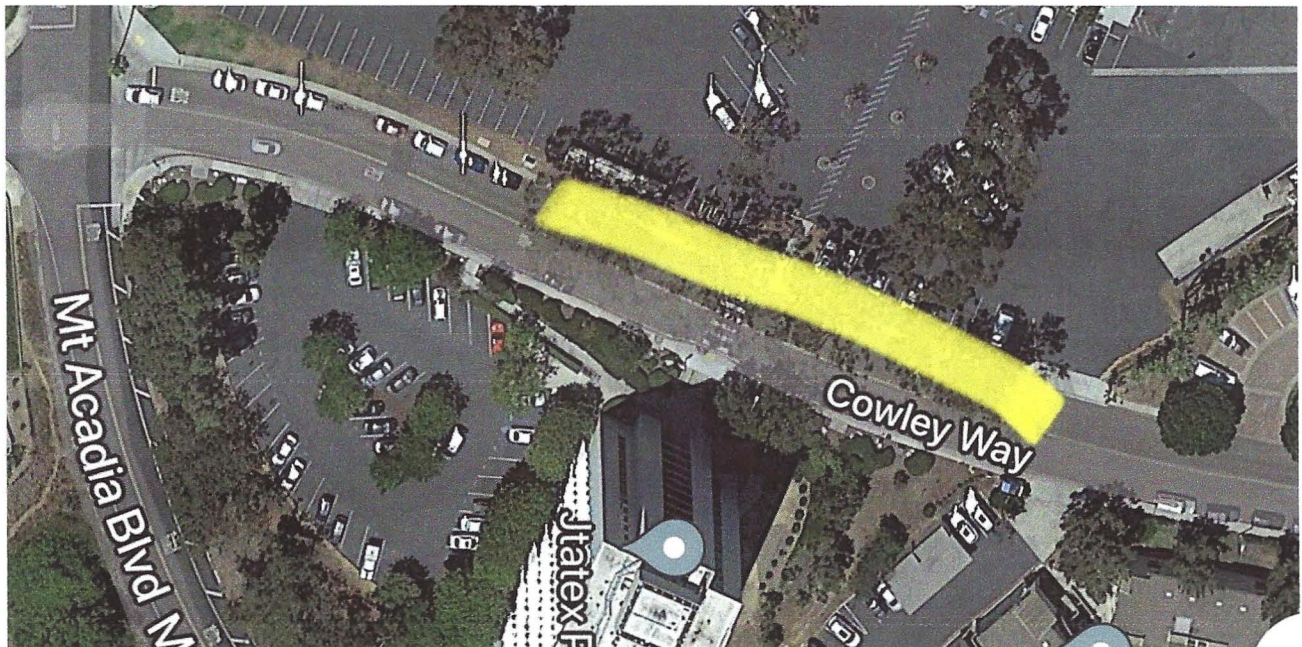
Along Cowley Way sit eight Tasmanian blue gum trees that possess varying DBH's (diameter at breast height) ranging from 19 inches to 28 inches. These trees are at least 25-years-old and have been trimmed many times.

Most of the eucalyptus trees in this lineup are healthy and in decent shape—however, one appears to be in a stress response. It possesses dead limbs and overall, does not look as healthy as the rest of the trees.
