**Appendix M. Geotechnical and Geological Hazards
Technical Memorandum**

To: Jordan Moore, Senior Planner, City of San Diego
From: Kelsey Hawkins, Project Manager, Harris & Associates
RE: Revised De Anza Natural Amendment to the Mission Bay Park Master Plan – Geotechnical and Geologic Hazard Evaluation
Date: March 6, 2023
Att: Figures; 1, 2019 Geotechnical and Geologic Hazard Evaluation

**GEOTECHNICAL AND GEOLOGIC HAZARD EVALUATION
DE ANZA AND MARSHLAND RESTORATION AREA REVITALIZATION PLAN
SAN DIEGO, CALIFORNIA**

APRIL 2019
PROJECT NO. 9127001

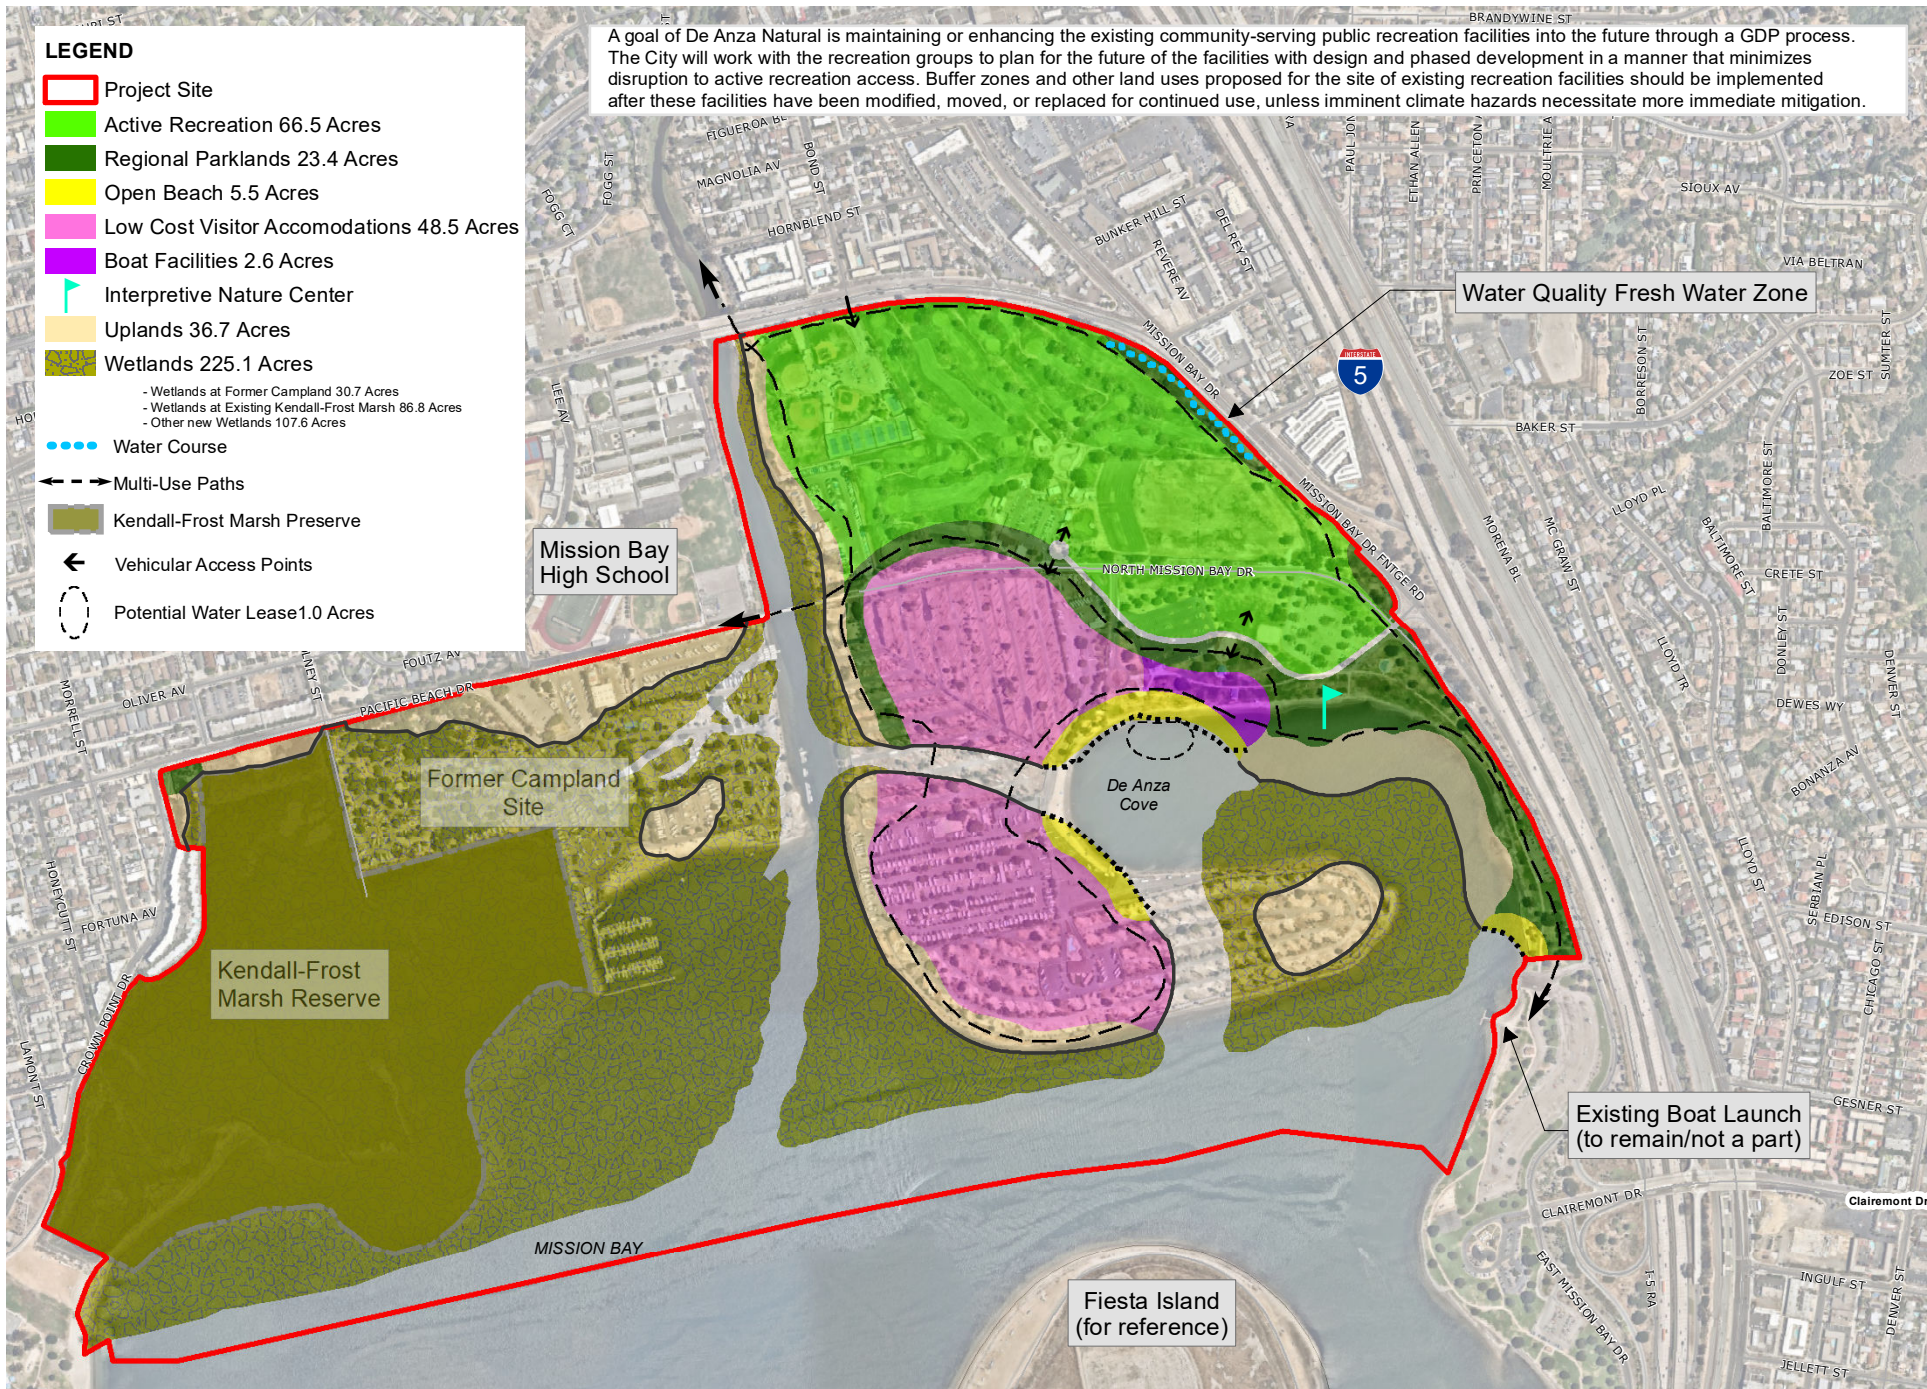
Figure 3
Site Plan

Source: City of San Diego 2023.
