**Seismic and Geologic  
Technical Background Report**

**SEISMIC AND GEOLOGIC TECHNICAL BACKGROUND  
REPORT FOR THE CITY OF SAN DIEGO MIDWAY-PACIFIC  
HIGHWAY AND OLD TOWN COMMUNITY PLAN UPDATES,  
AND ENVIRONMENTAL IMPACT REPORT, CITY OF SAN  
DIEGO, SAN DIEGO COUNTY, CALIFORNIA**

Wilson Geosciences Inc.  
Altadena, California 91001  
626-791-1589  
[wilsongeo@earthlink.net](mailto:wilsongeo@earthlink.net)

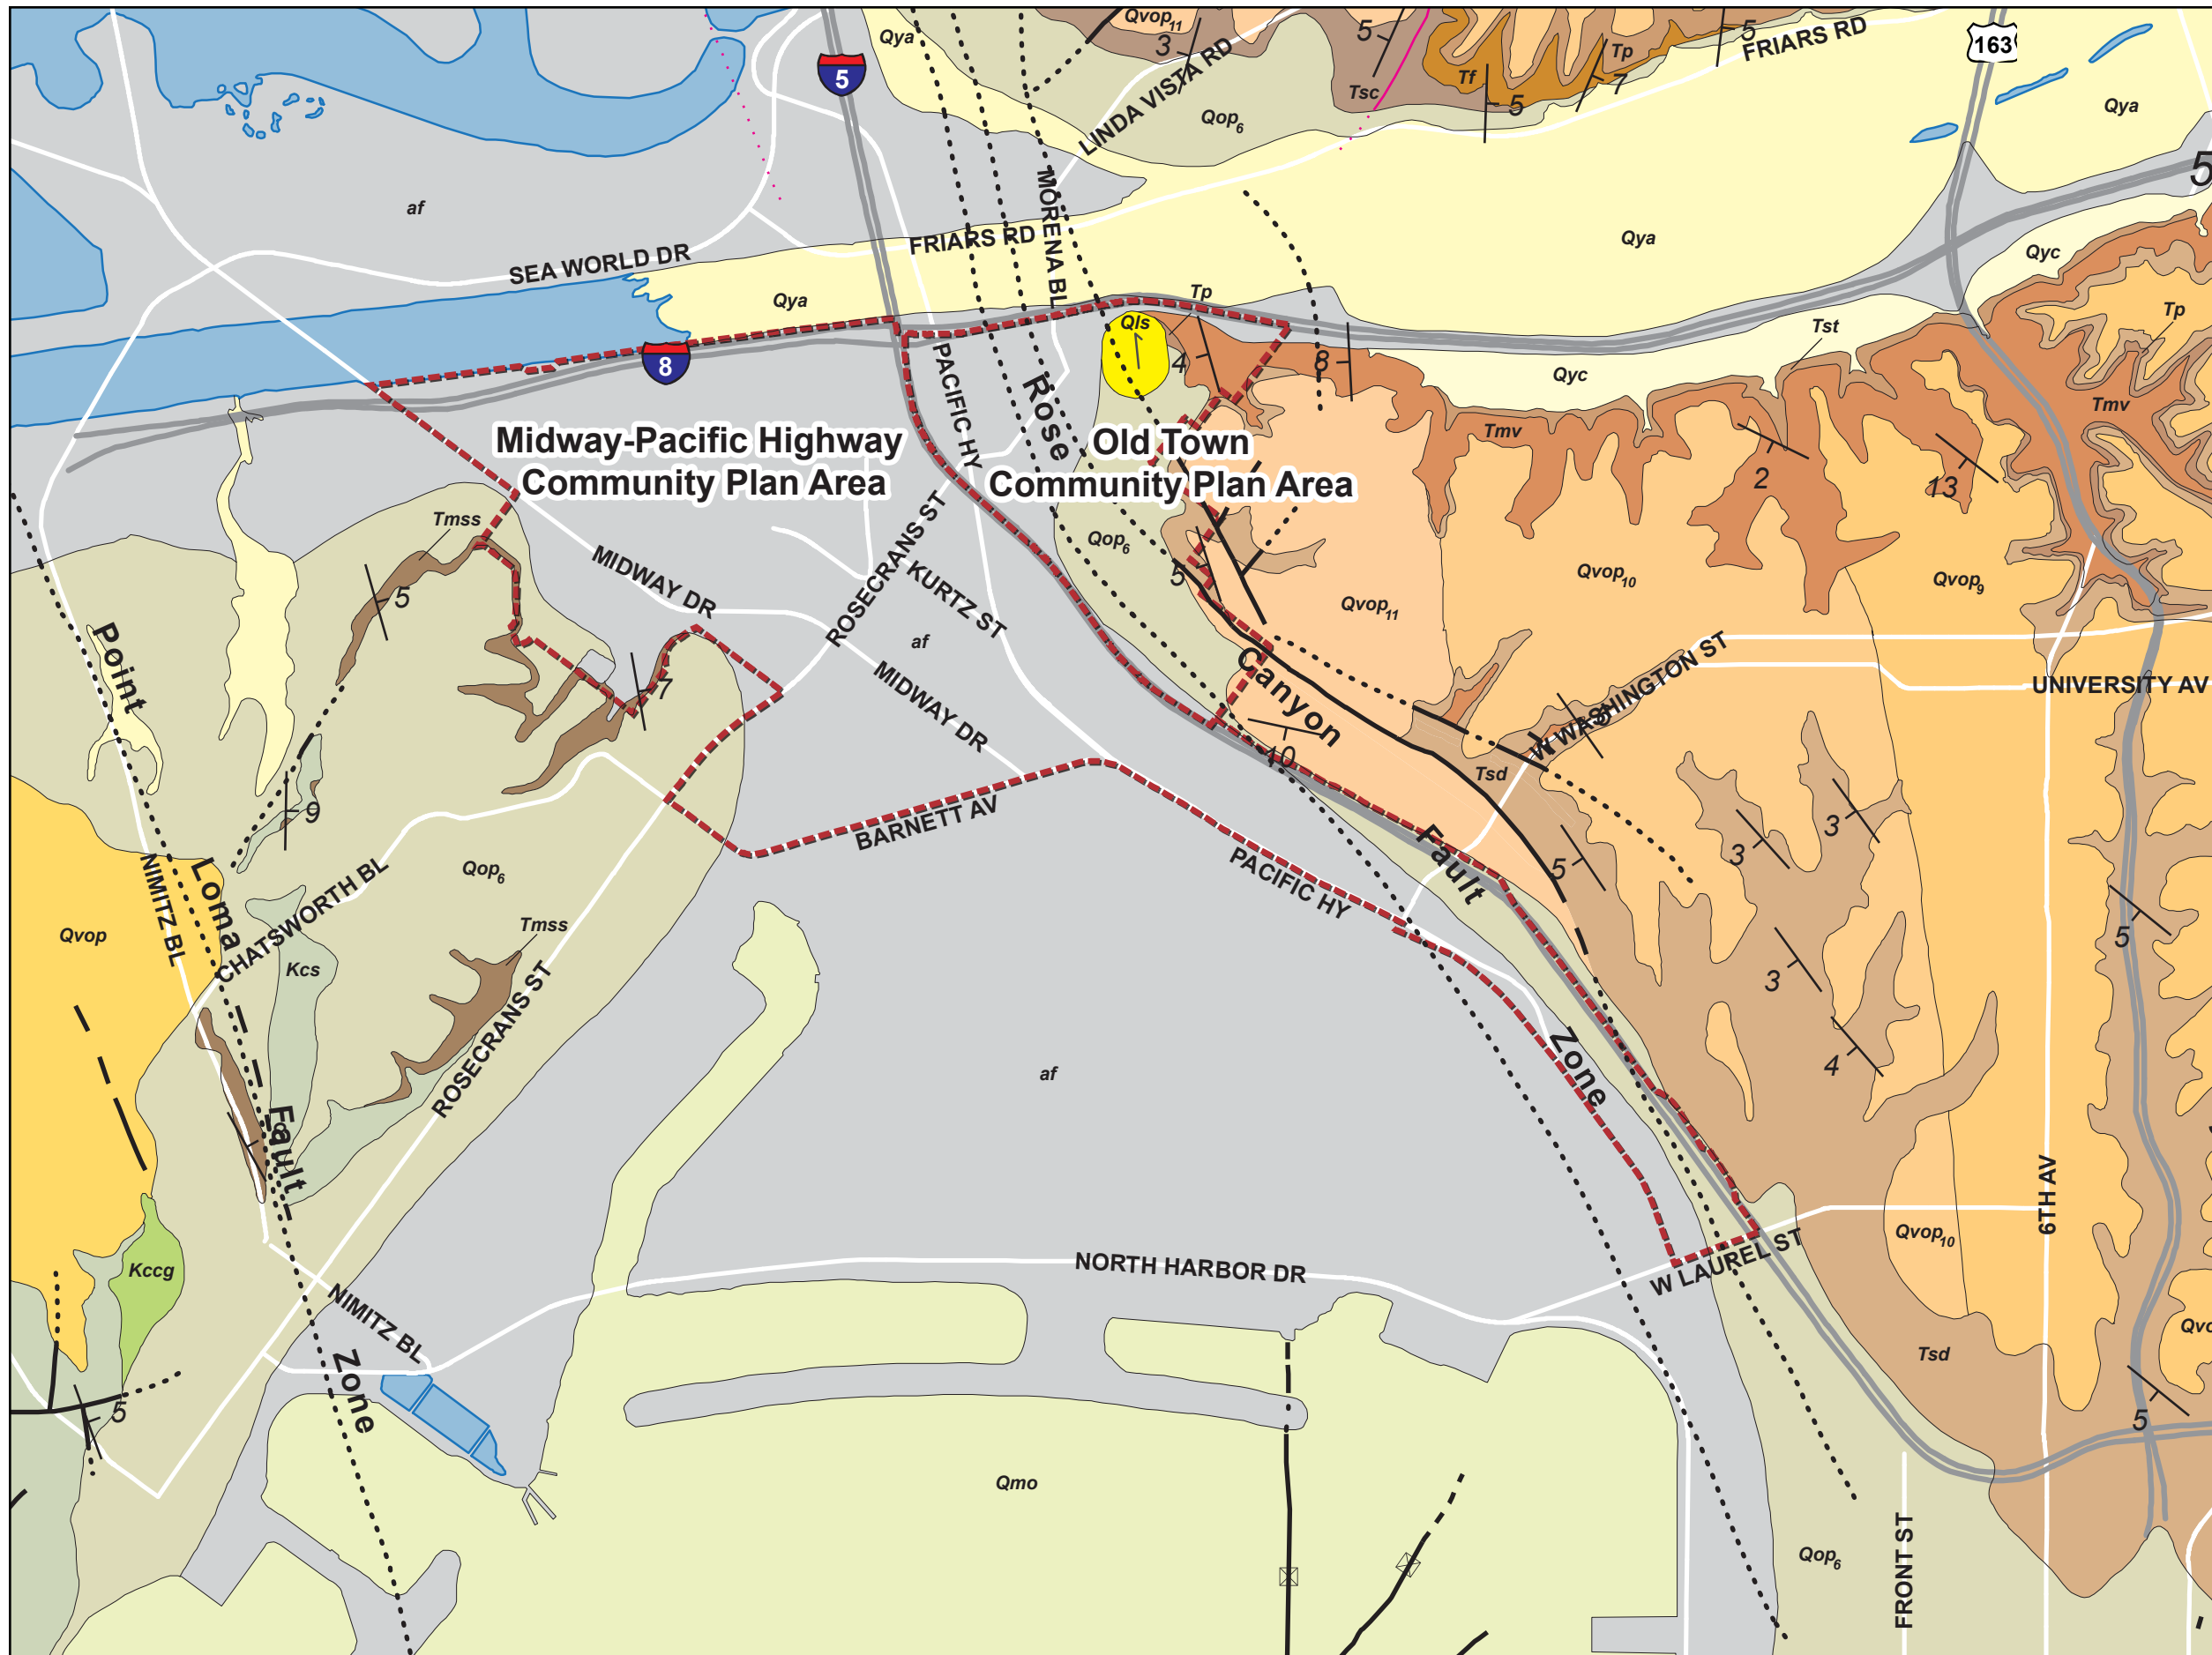
**Figure 1: Geologic Conditions**

Source: Kennedy and Tan, 2008

**Figure G-1** - Geologic Conditions

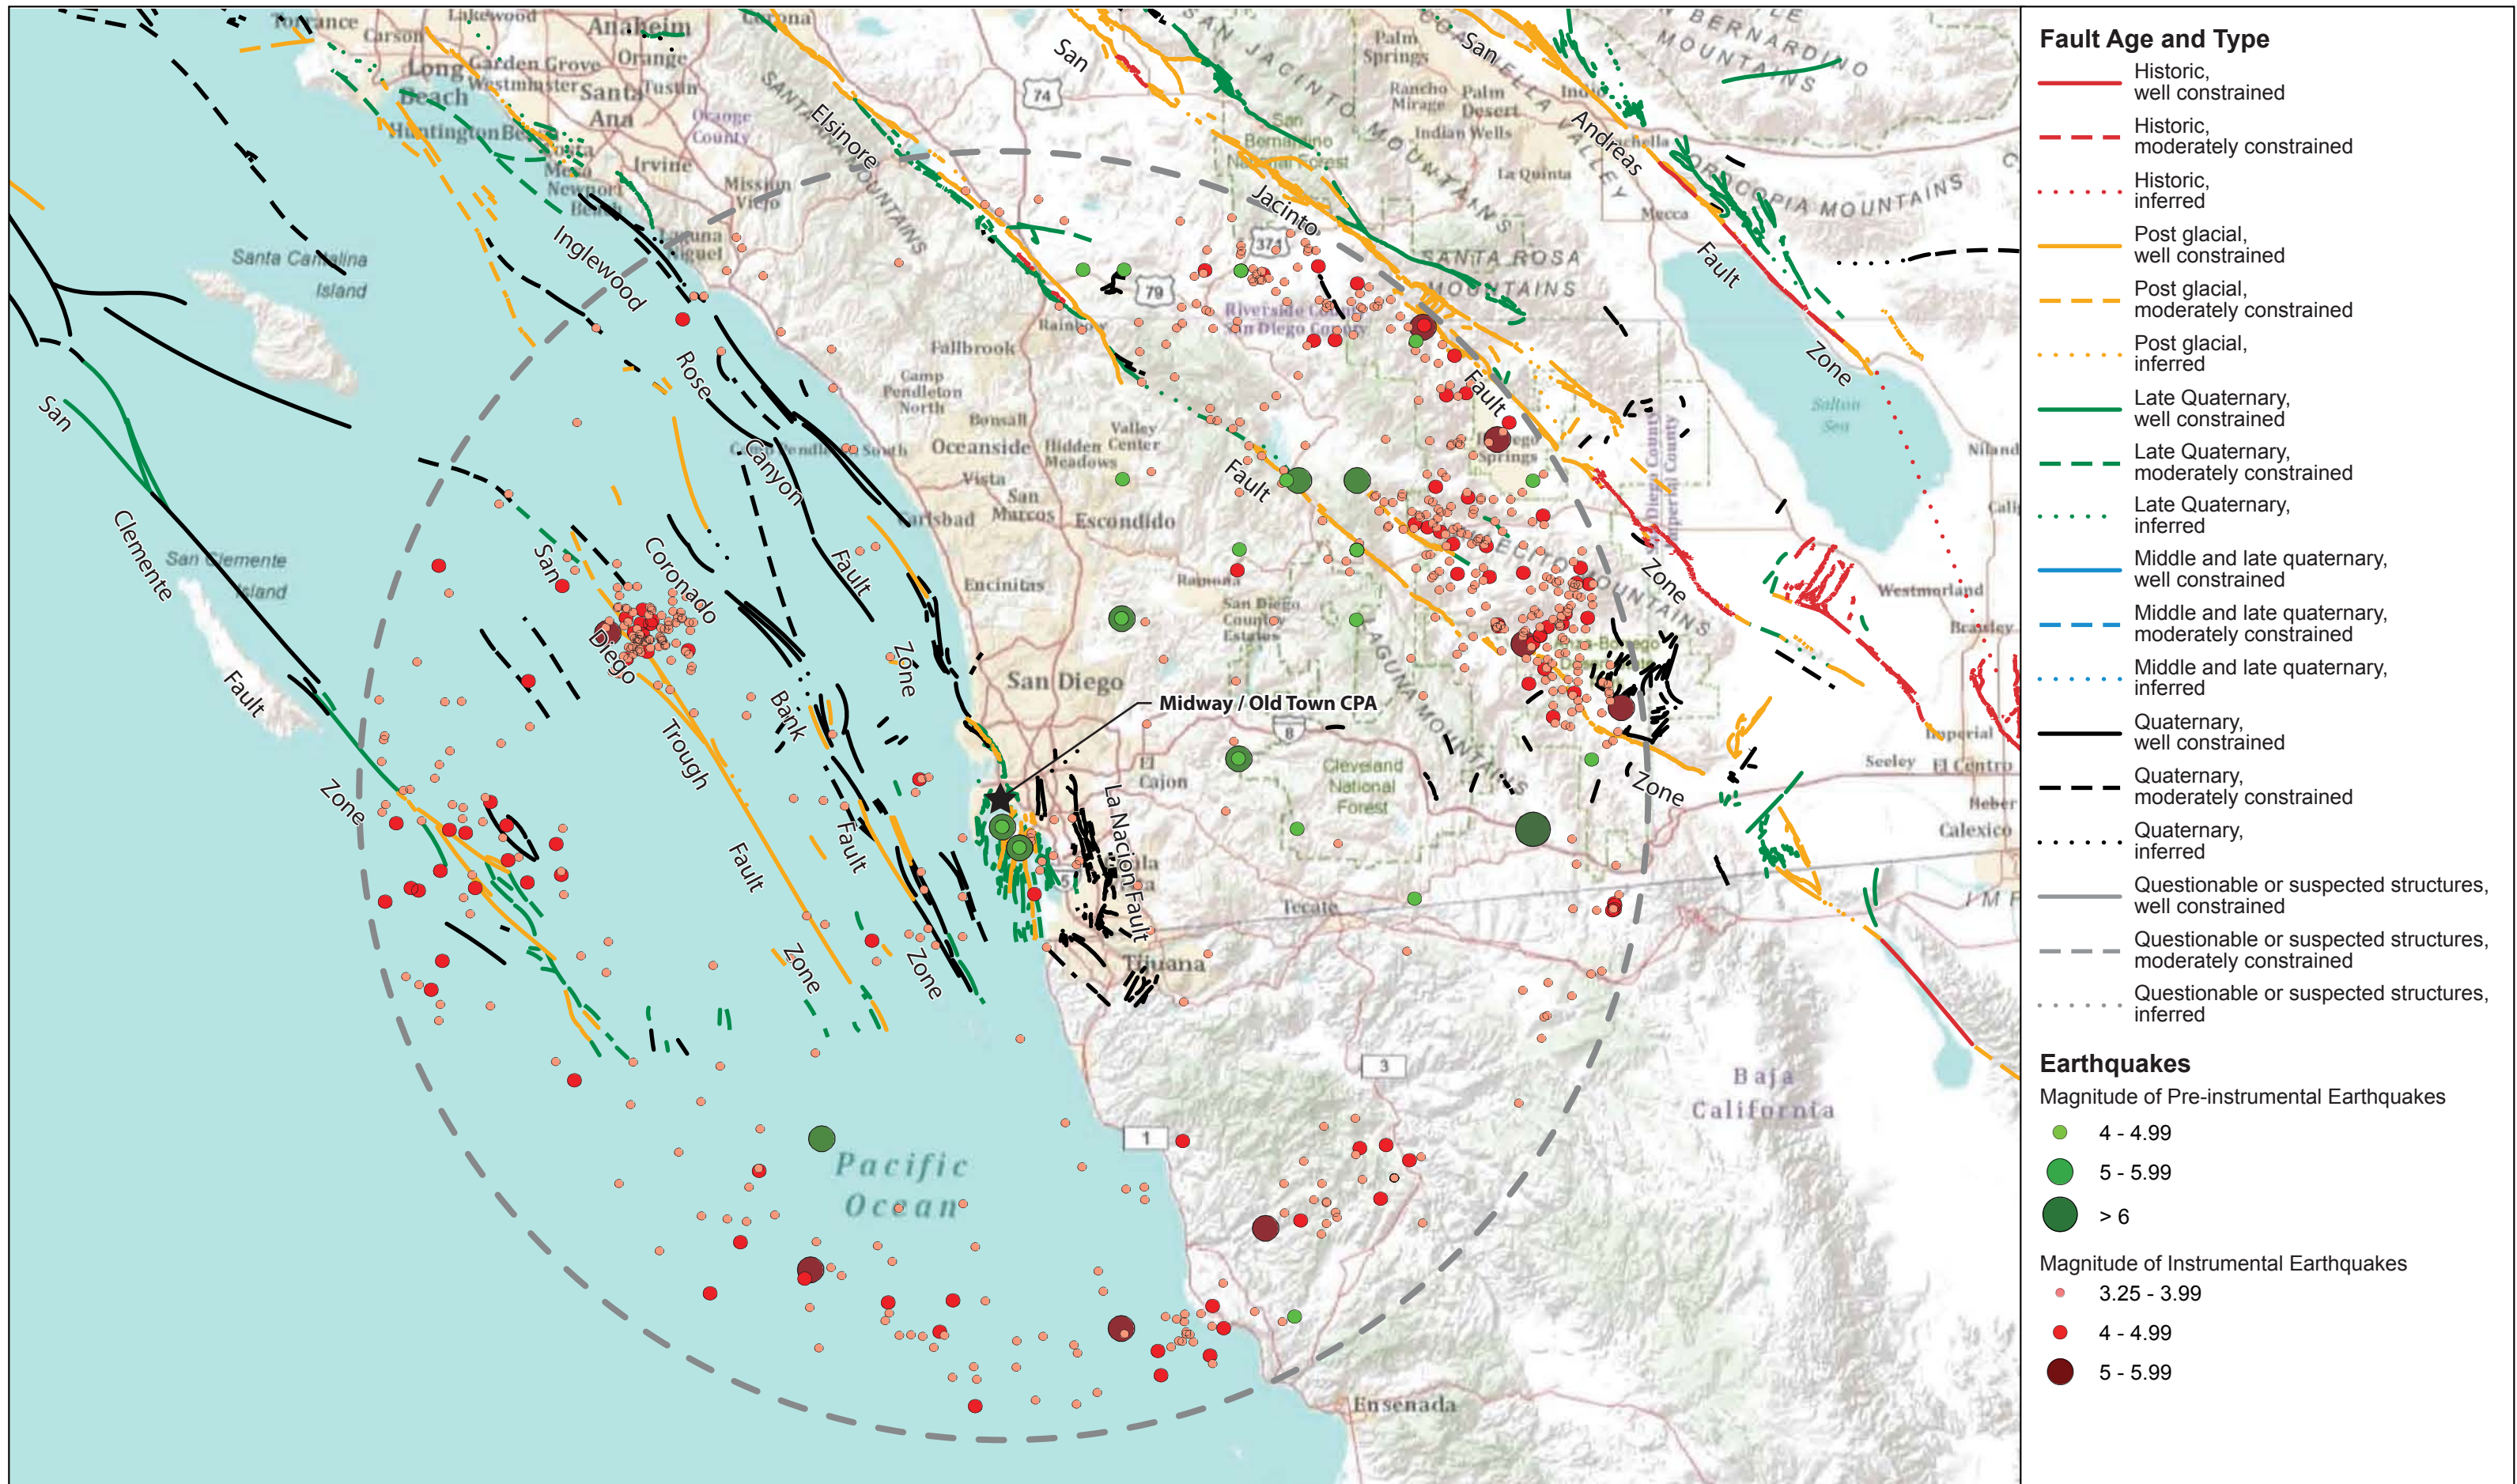
**Figure 2: Regional Faults and Earthquakes (Magnitude > 3.25 within 100km)**

Source: USGS and CGS, 2010

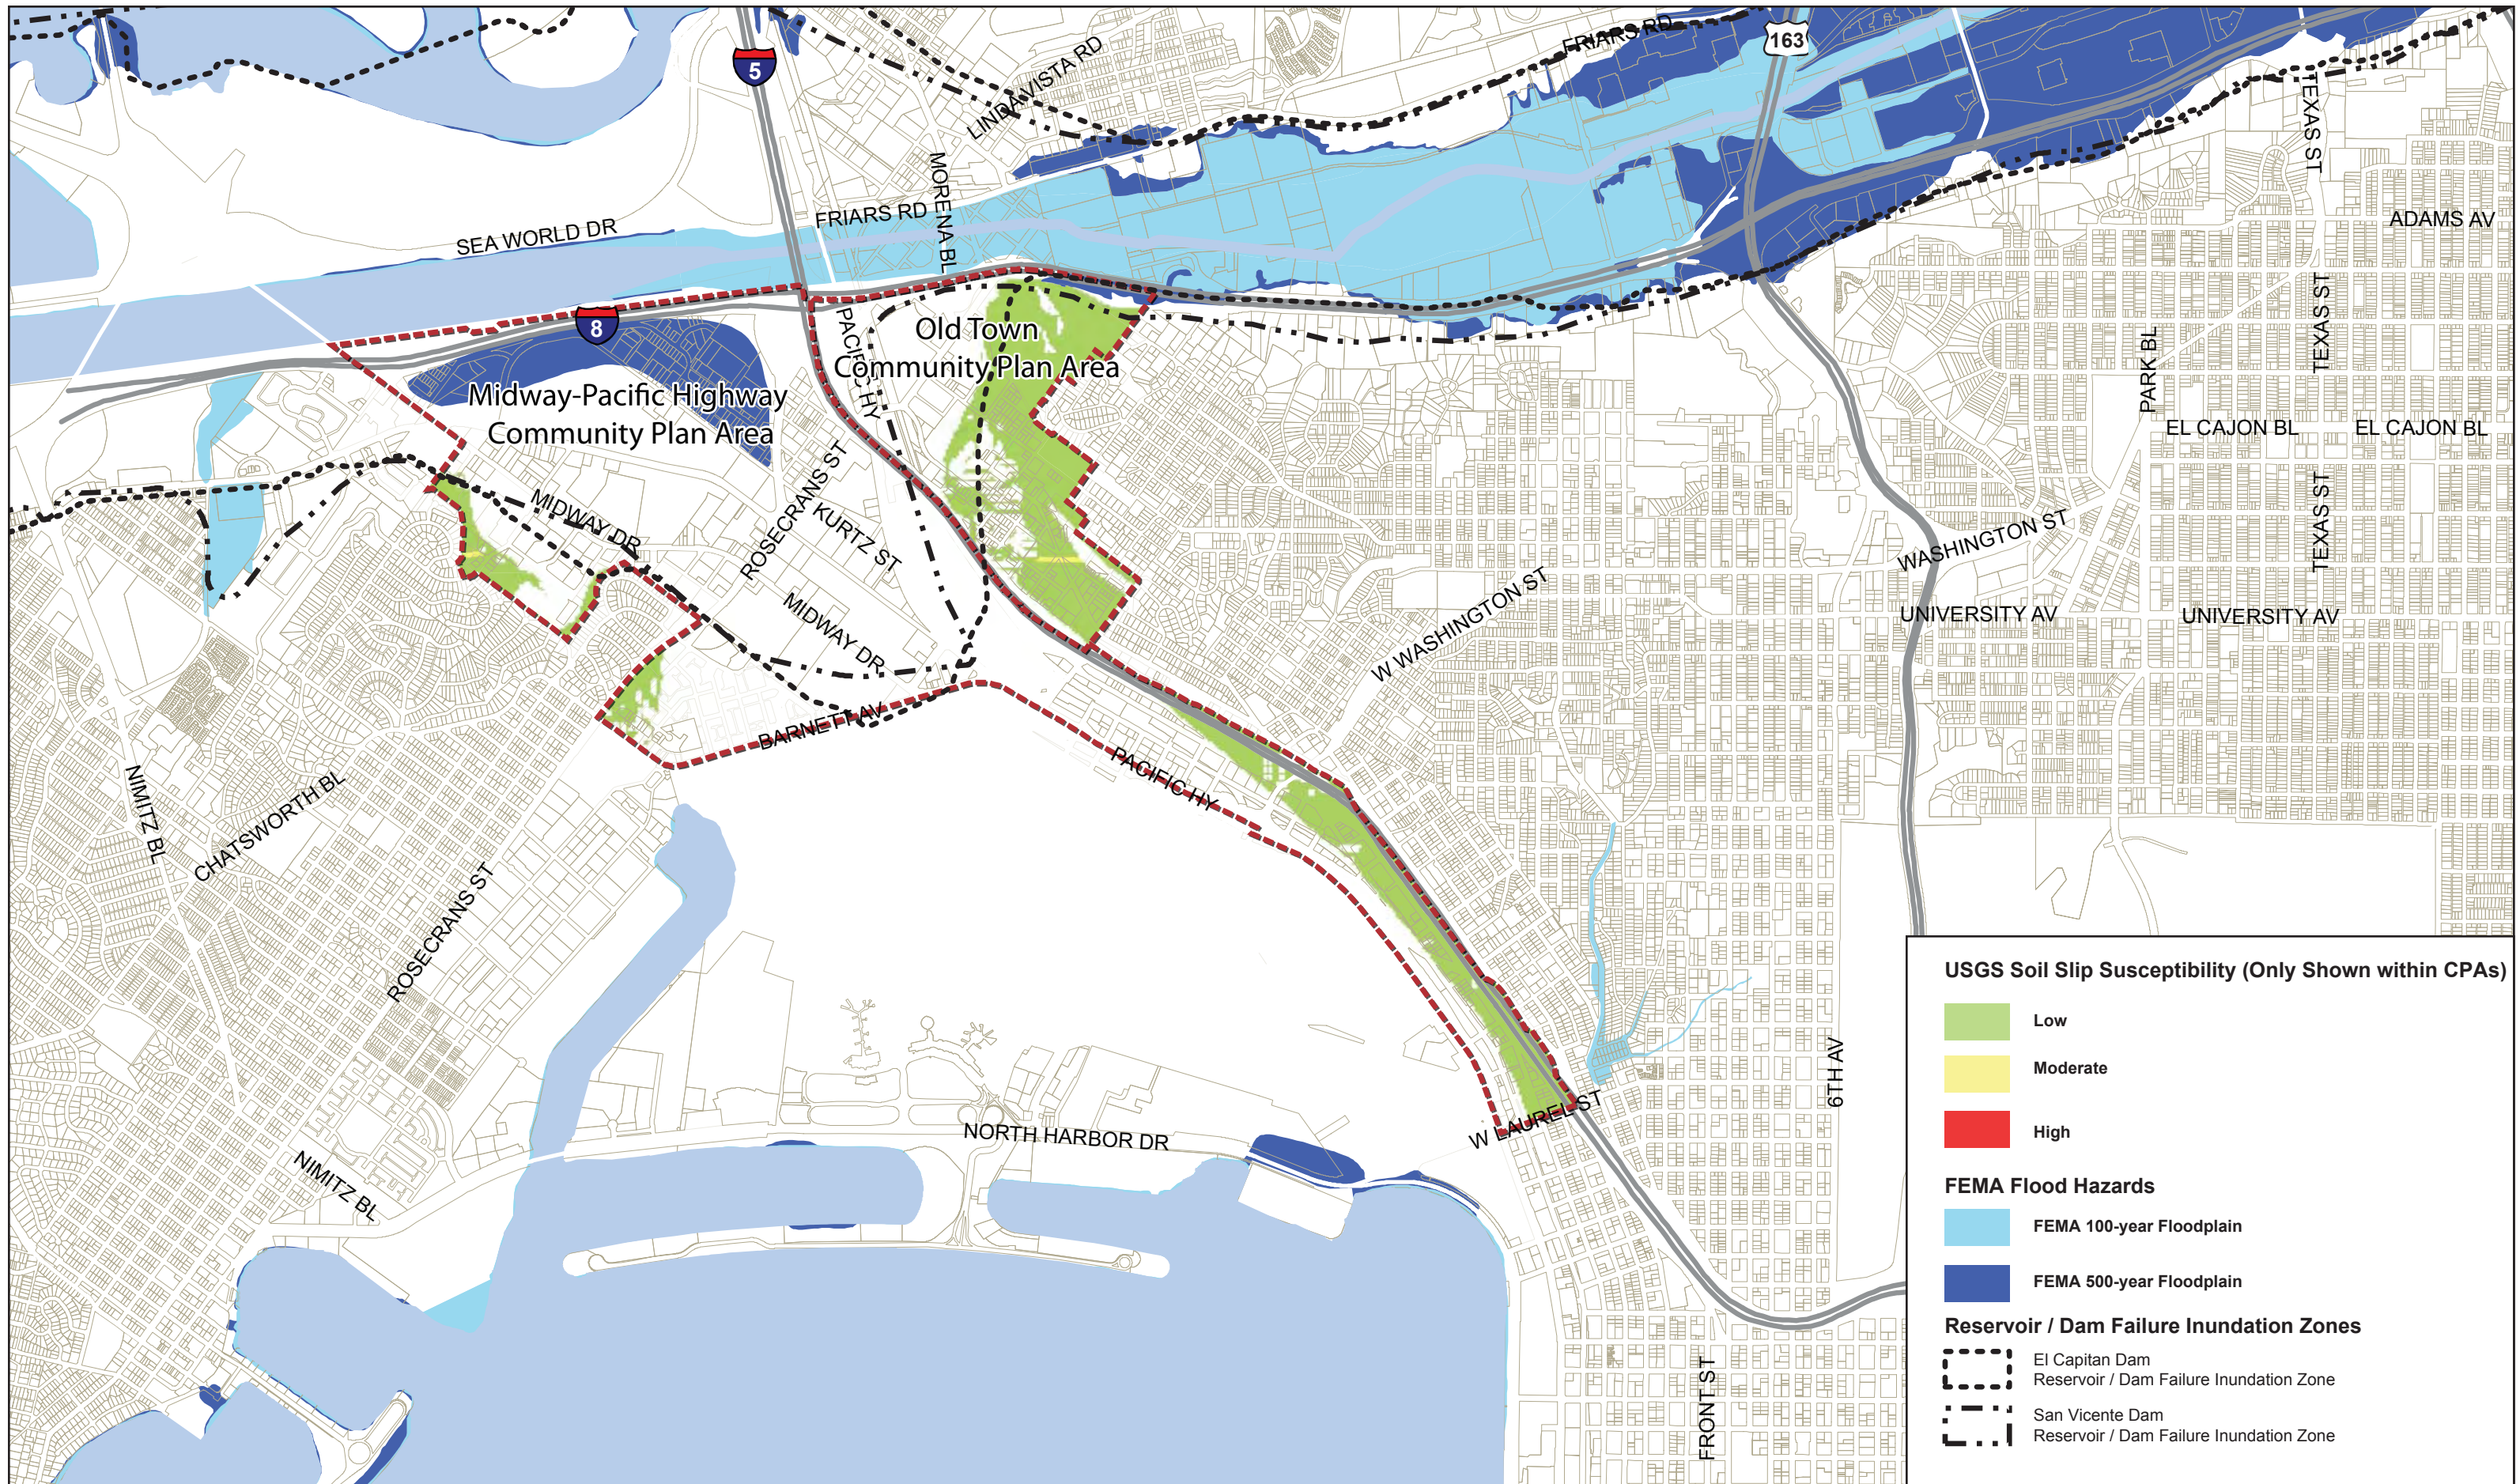
**Figure 3: FEMA Flood Hazards, Reservoir/Dam Failure Inundation Zones, USGS Soil Slip Susceptibility**

Source: SanGIS, 2011

**Figure G-3** – FEMA Flood Hazards, Reservoir/Dam Failure Inundation Zones, and USGS Soil Slip Susceptibility

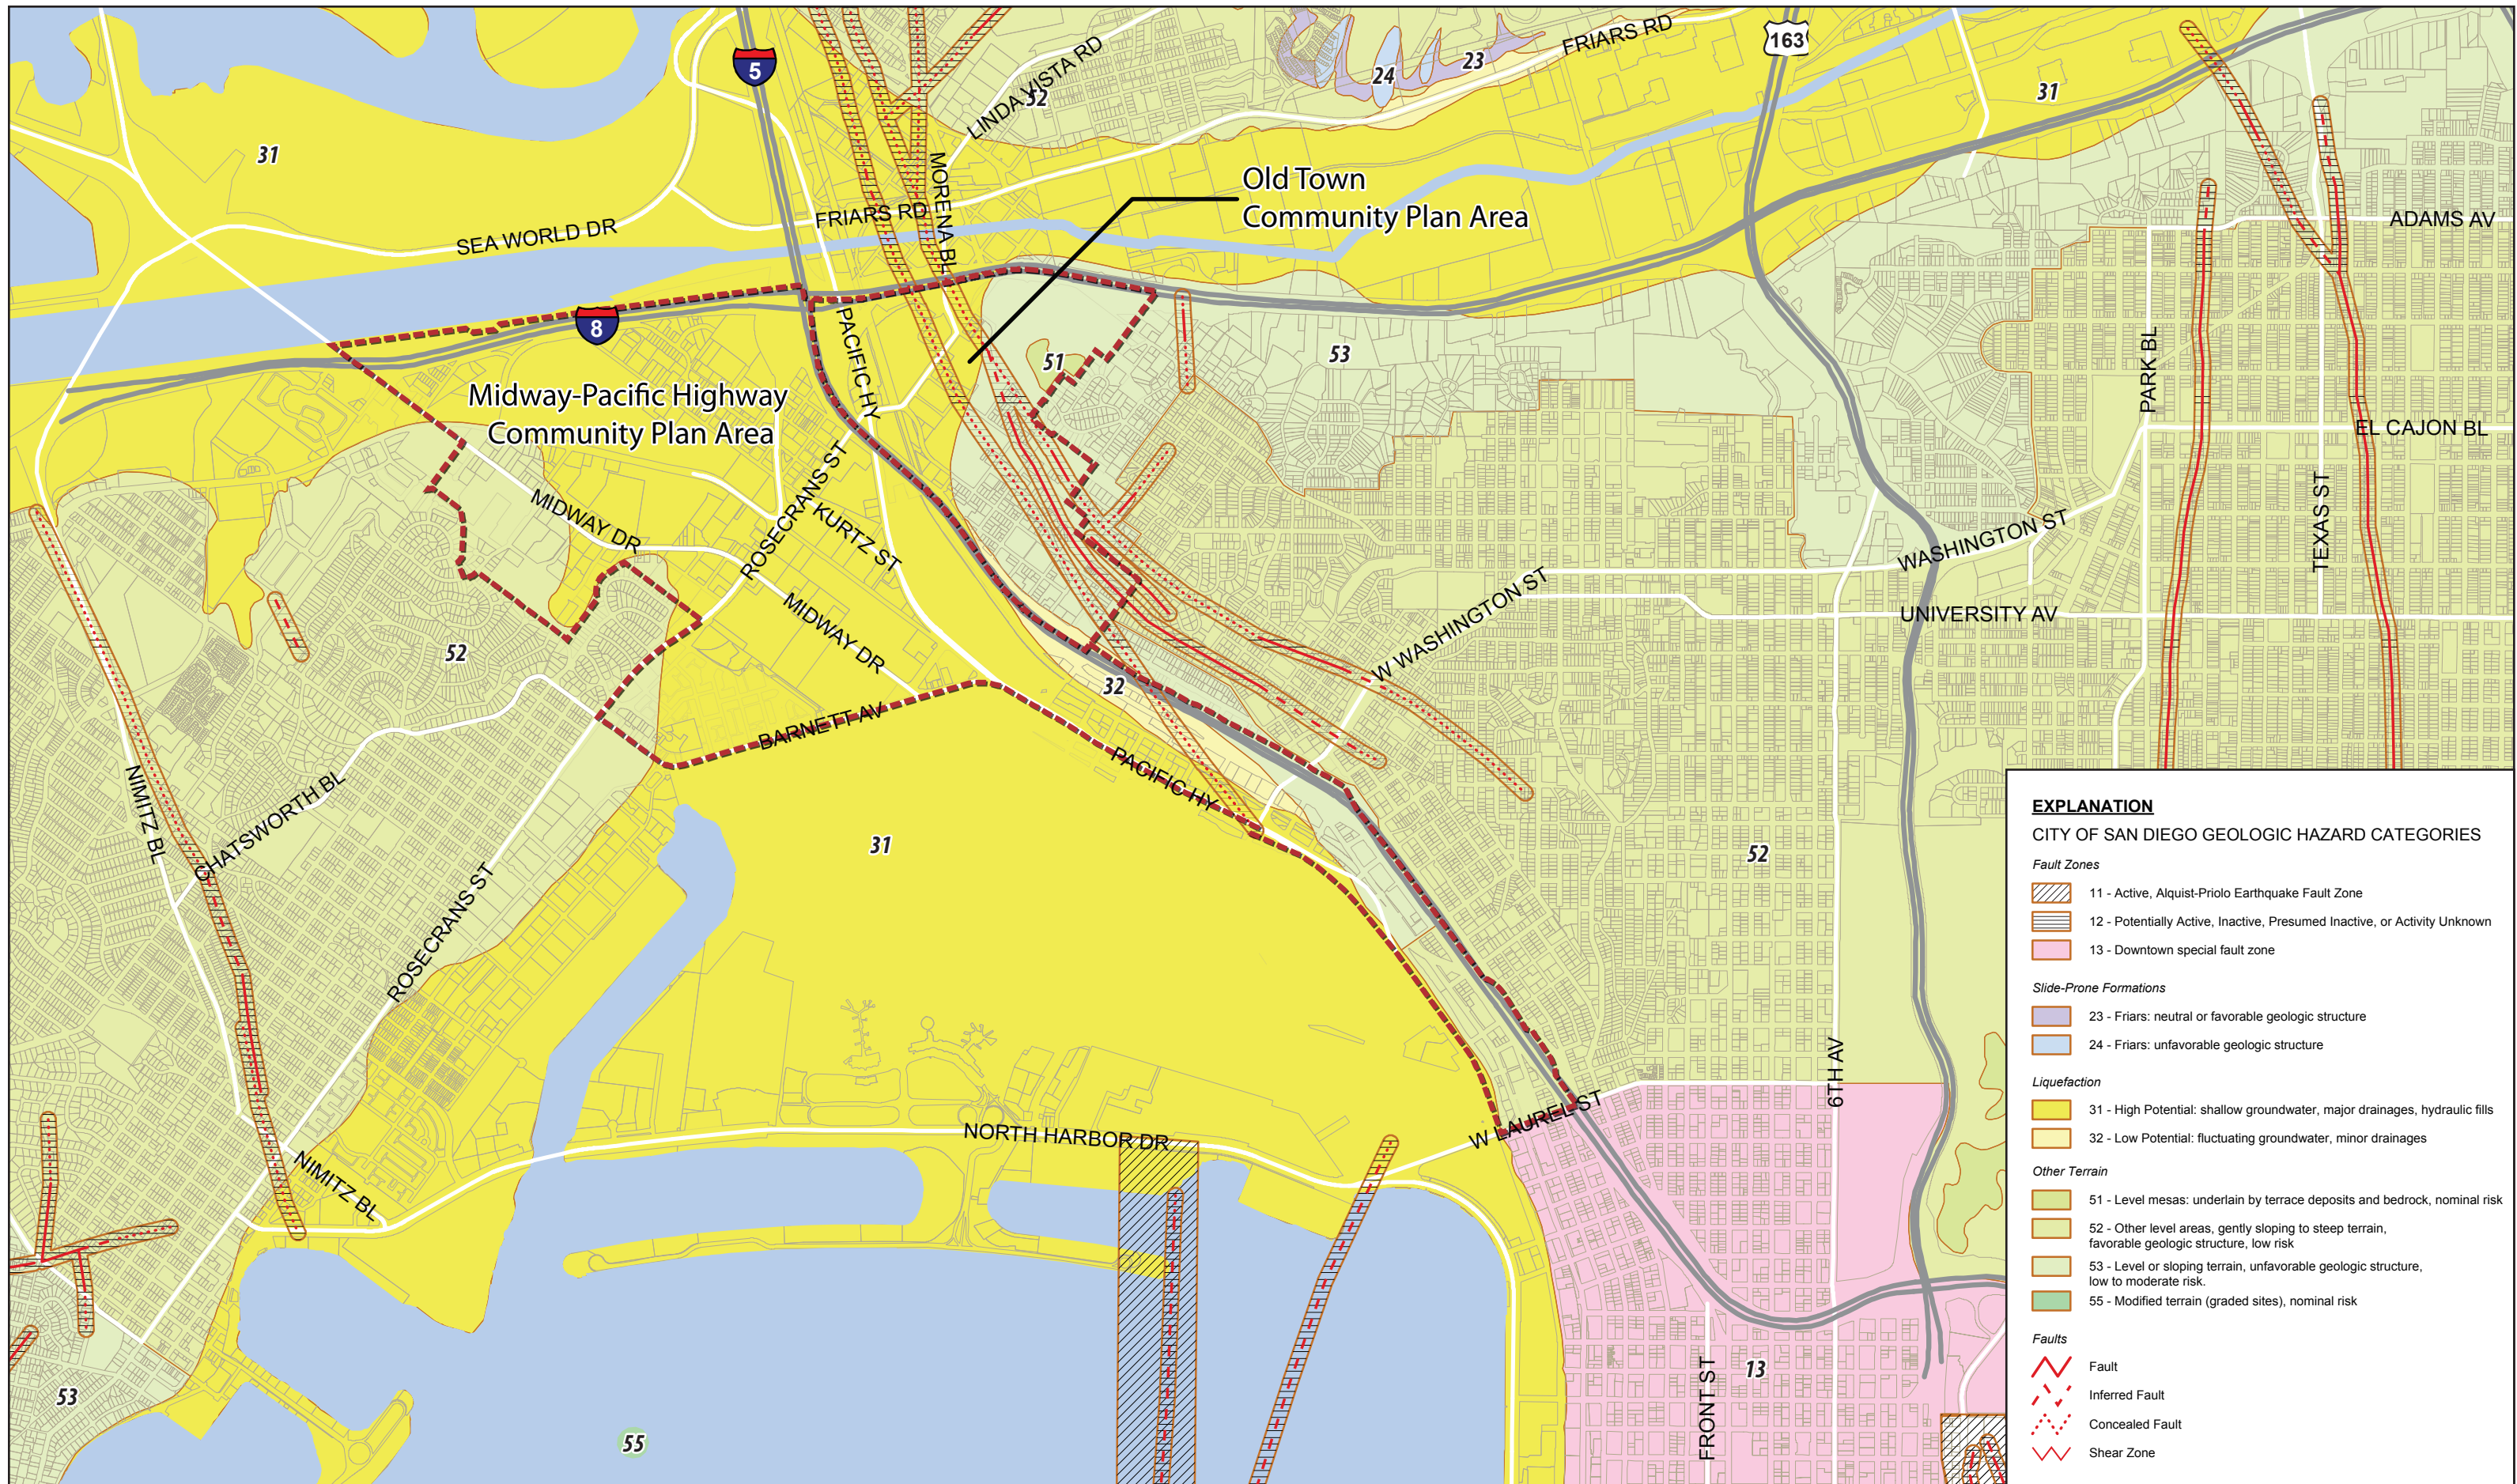
**EXPLANATION**  
**CITY OF SAN DIEGO GEOLOGIC HAZARD CATEGORIES**

Source: SanGIS, City of San Diego, 2011

**Figure G-4** –City of San Diego Geologic Hazards

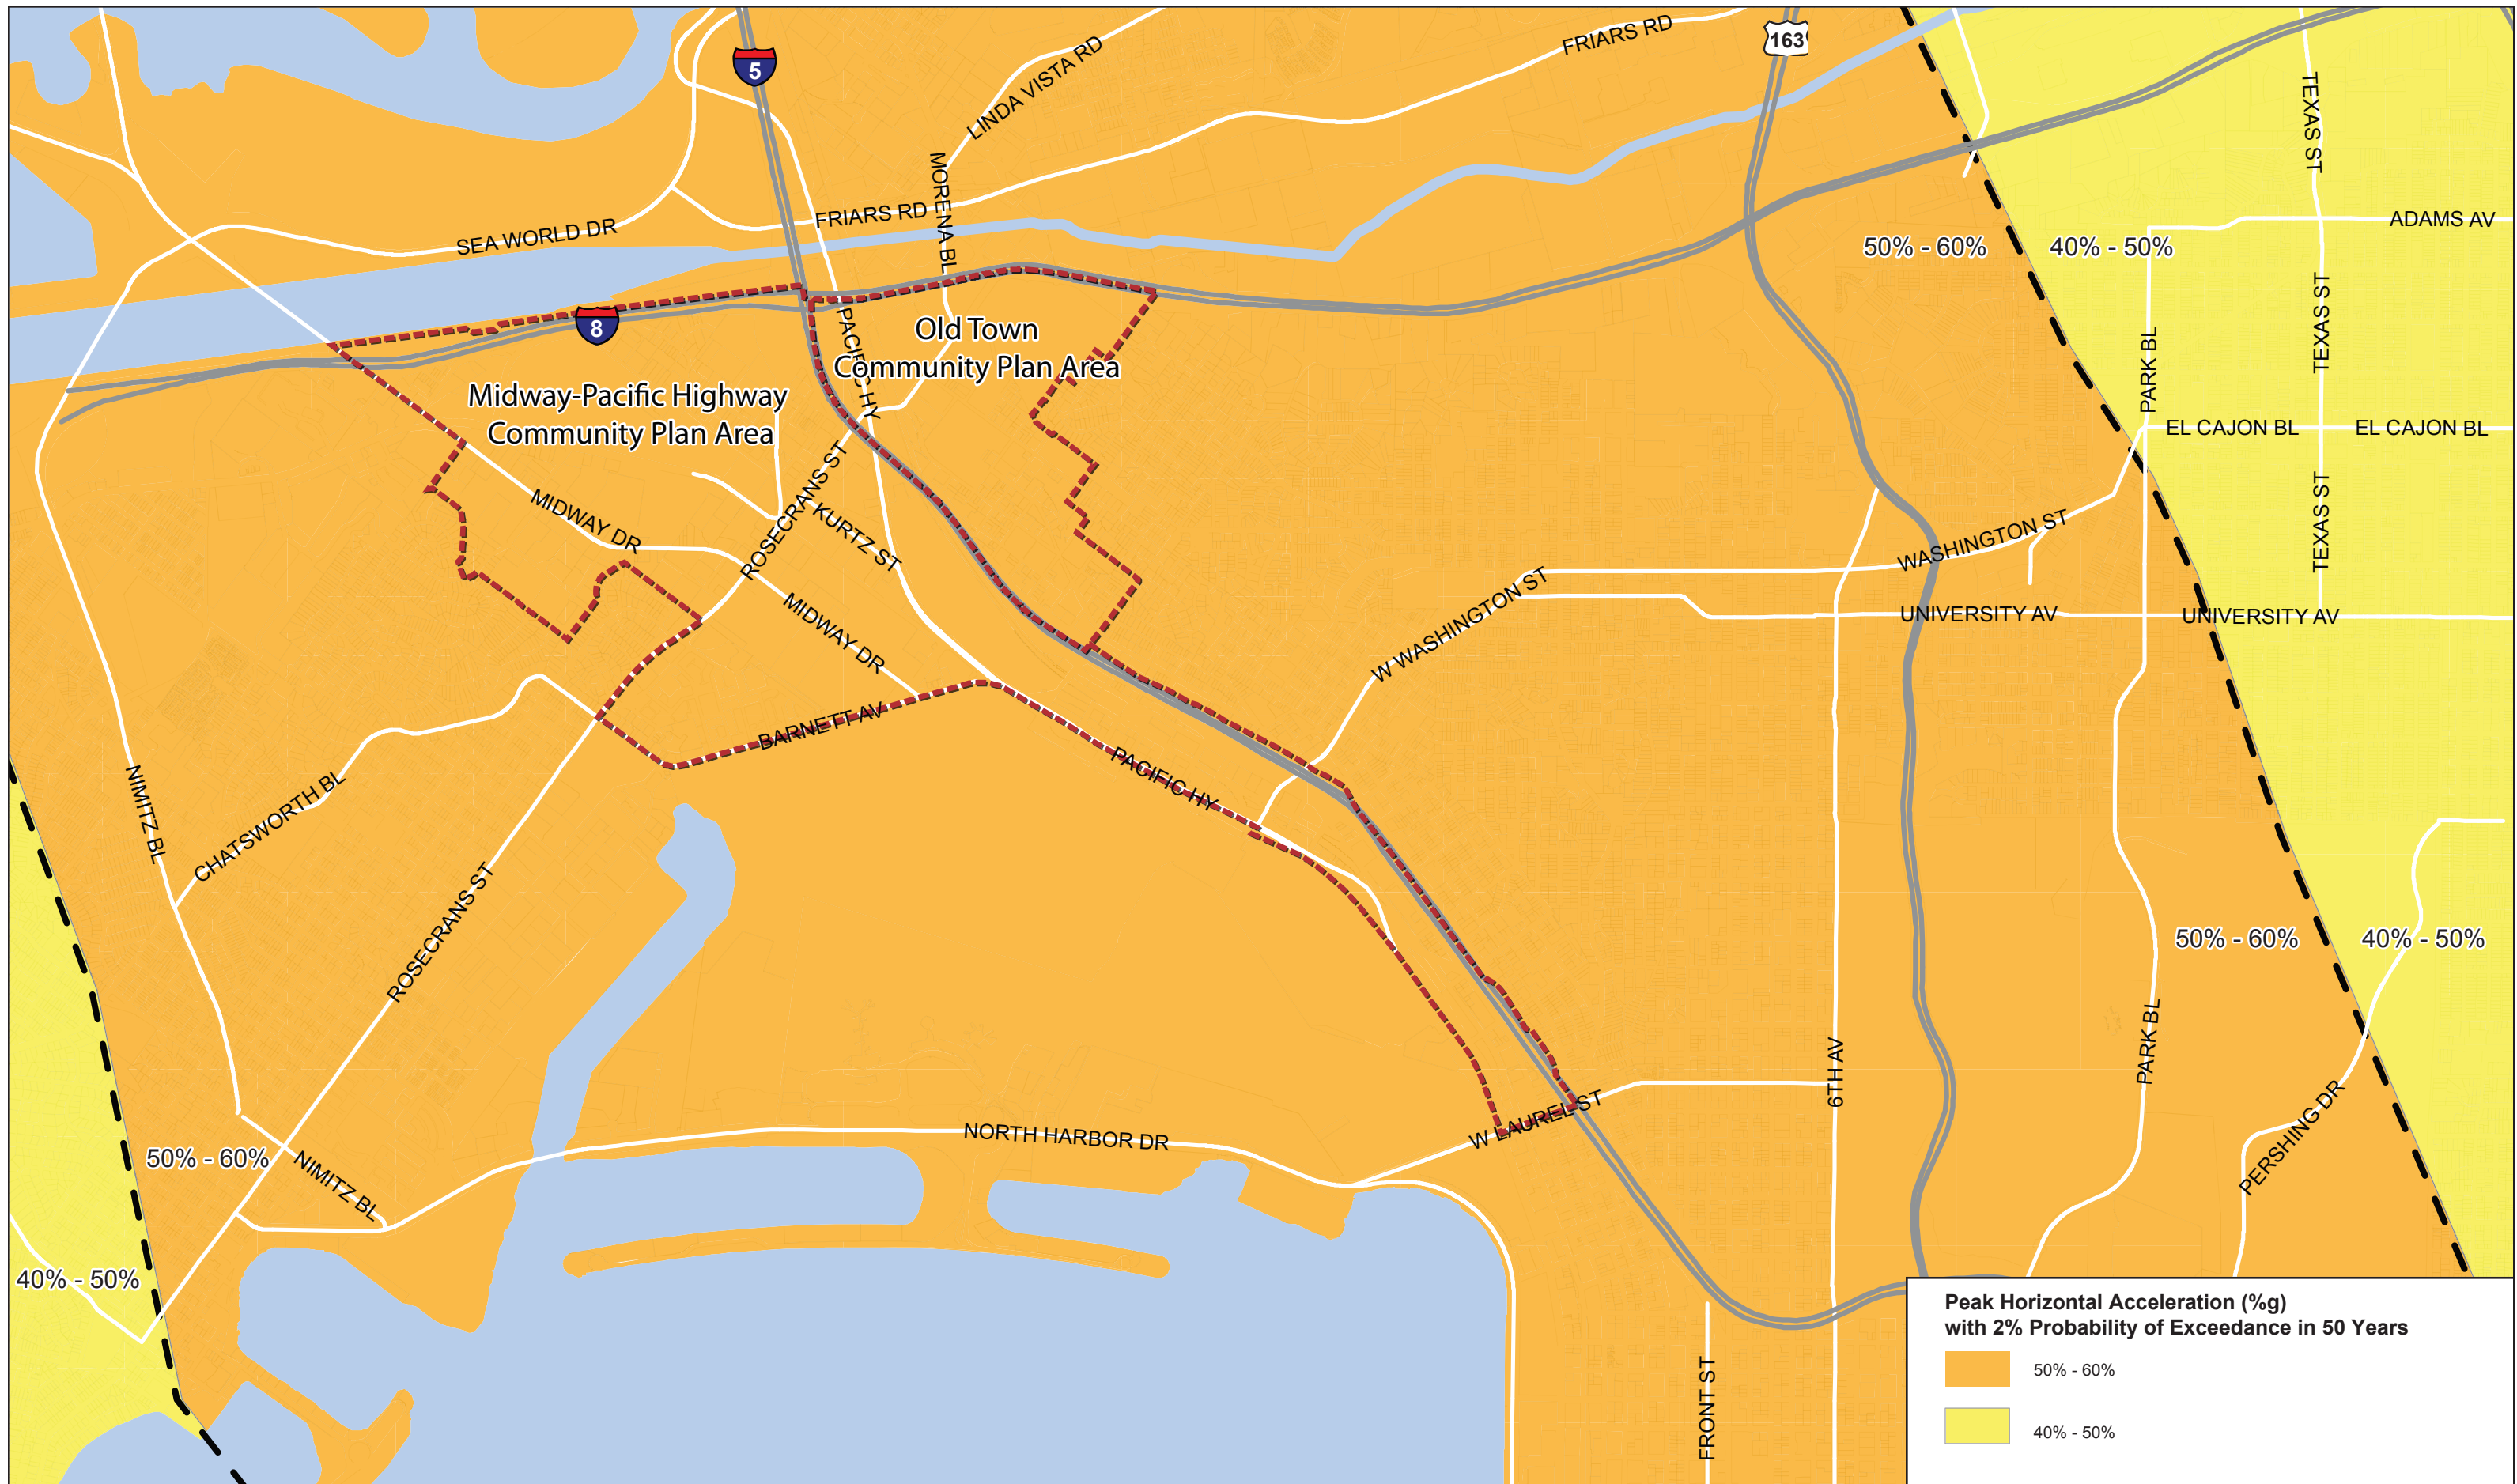
**Figure 5: Seismic Shaking Potential**

Source: USGS, 2008
