REPORT OF PRELIMINARY GEOTECHNICAL INVESTIGATION

**PROPOSED REMODEL, ADDITION, AND FUTURE SINGLE-FAMILY RESIDENCES
PARCELS 1, 2, 4, & 5, PARCEL MAP 17817
7727 LOOKOUT DRIVE, LA JOLLA, CALIFORNIA**

**Subject: Report of Preliminary Geotechnical Investigation
Proposed Remodel, Addition, and Future Single-Family Residences
Parcels 1, 2, 4, & 5, Parcel Map 17817, 7727 Lookout Drive, La Jolla, California**

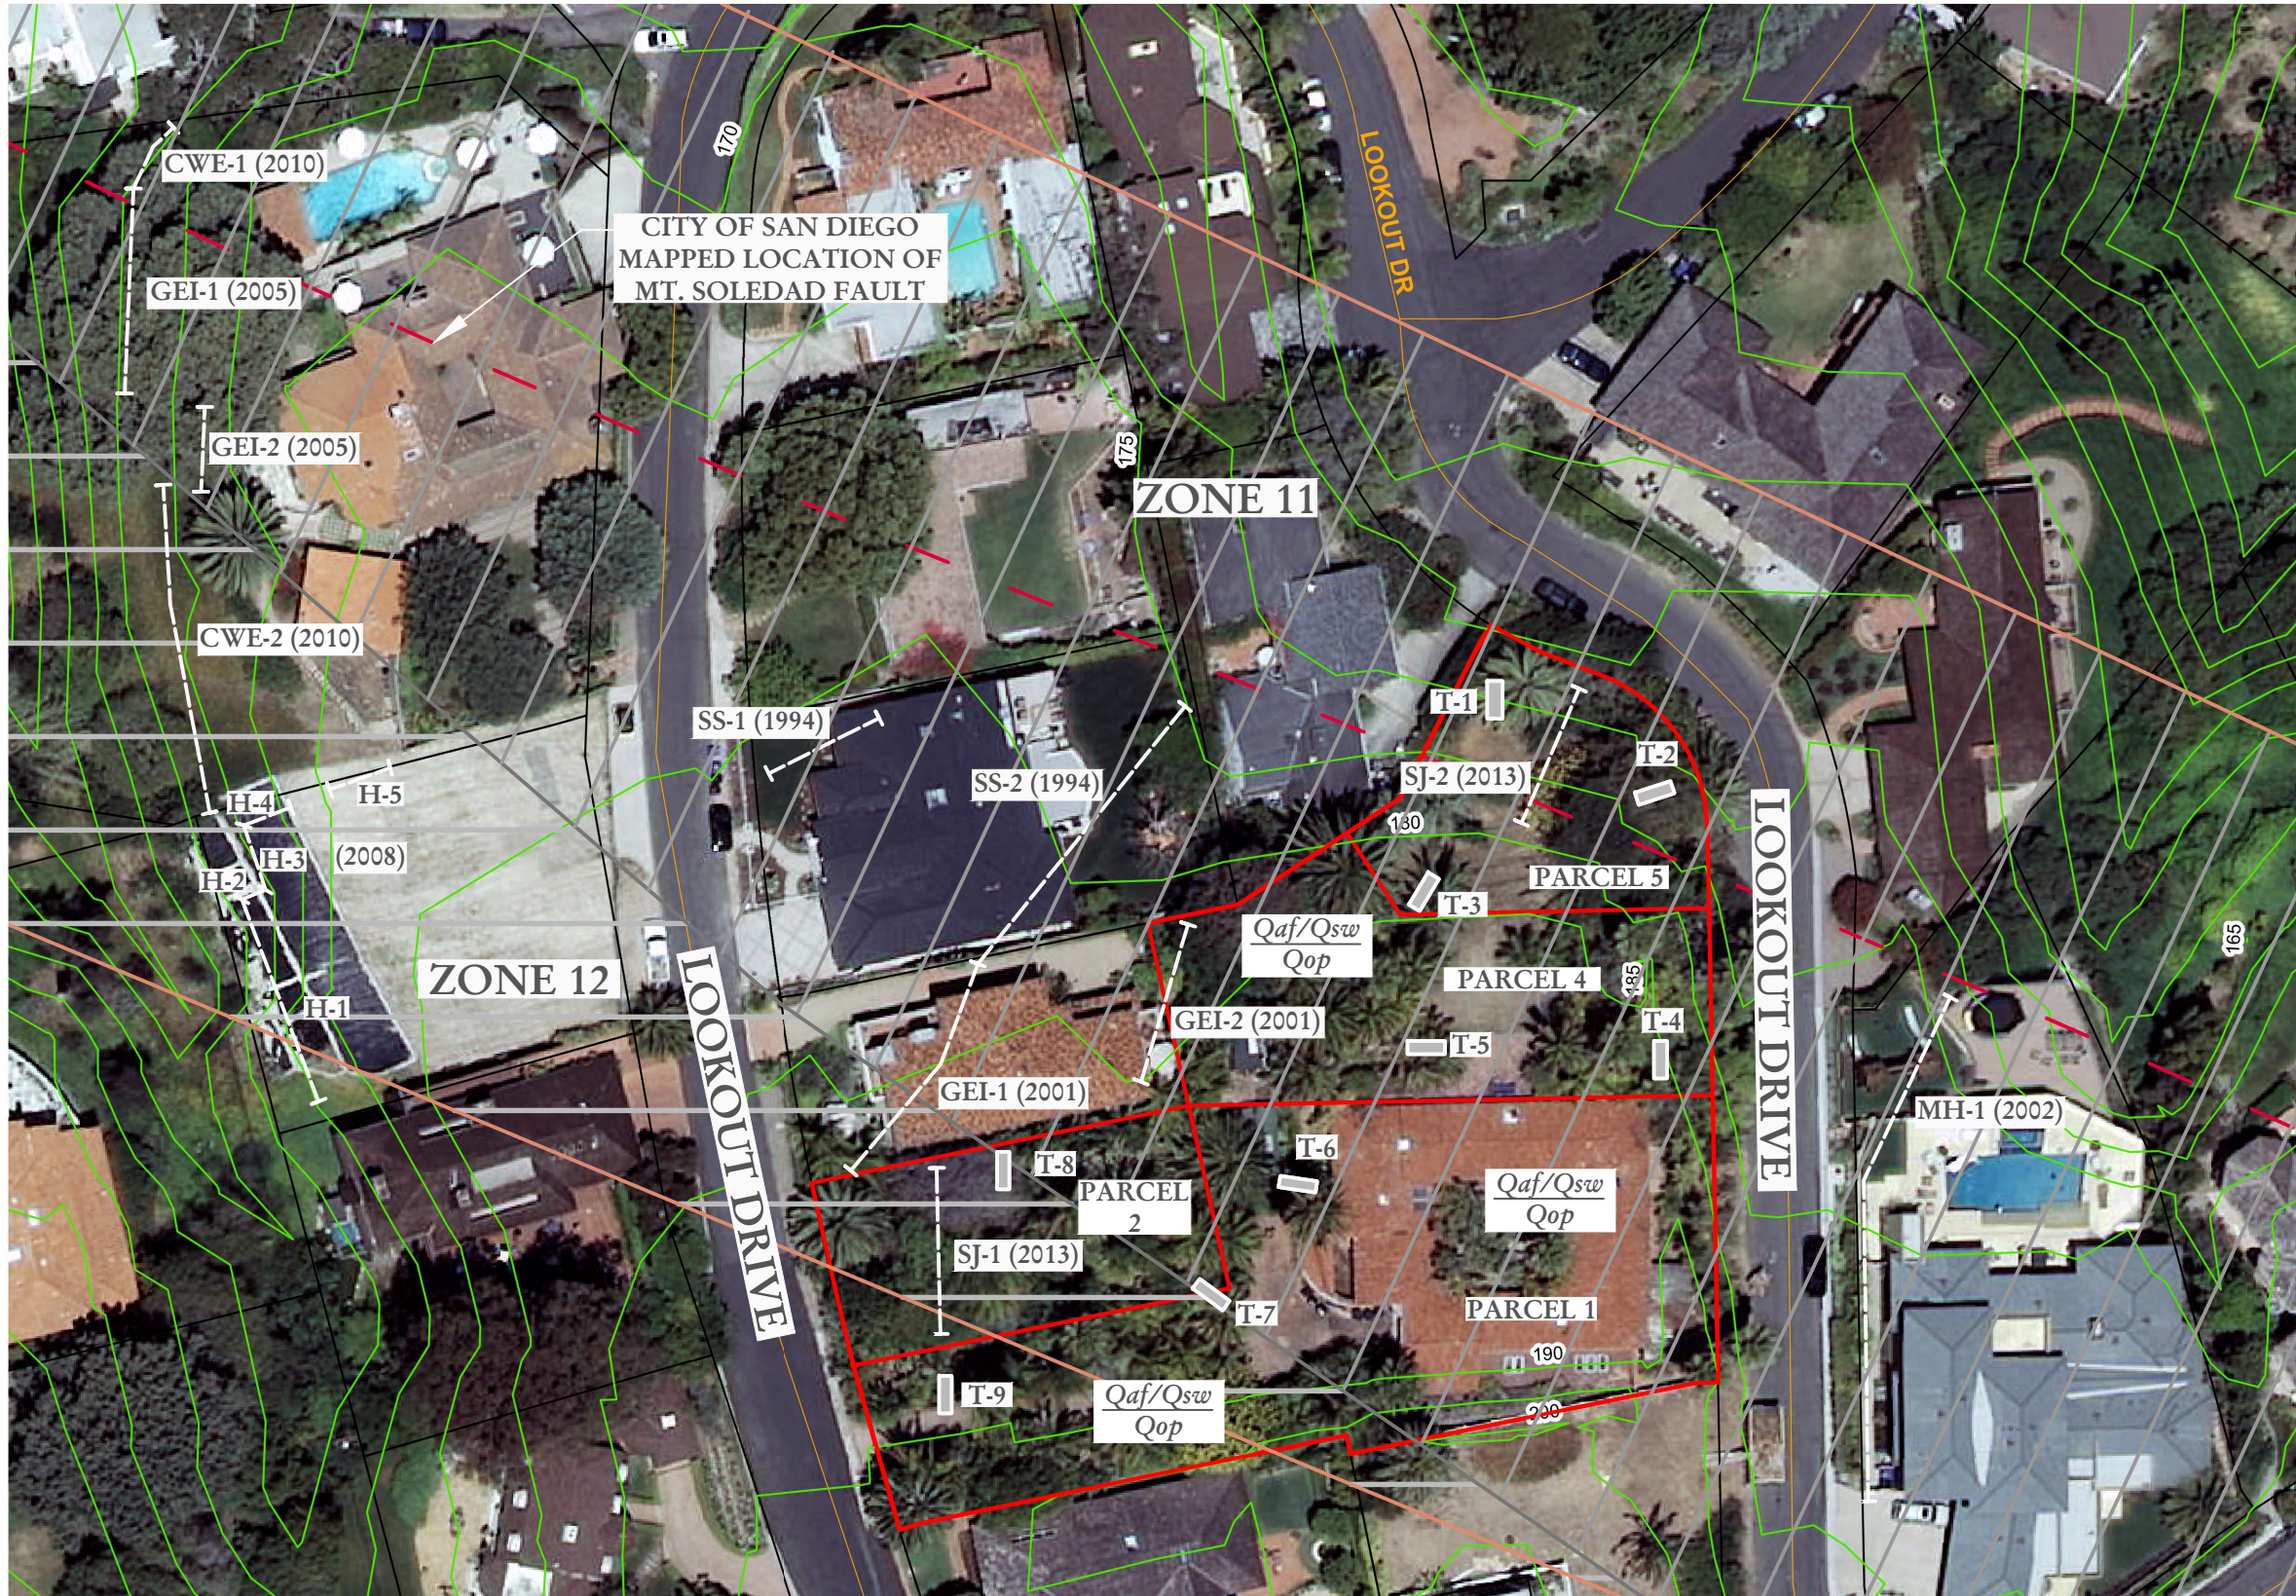
PROPOSED REMODEL, ADDITION, AND SINGLE-FAMILY RESIDENCES PARCELS 1, 2, 4, & 5, PARCEL MAP 17817 7727 LOOKOUT DRIVE LA JOLLA, CALIFORNIA			
DATE:	APRIL 2014	JOB NO.:	2130434.01
BY:	MLM	PLATE NO.:	1

CWE LEGEND	
	T-9 APPROXIMATE TEST TRENCH LOCATION
	SS-2 APPROXIMATE TEST TRENCH LOCATION (STEVEN C. SUITT & ASSOC., 1994)
	GEI-2 APPROXIMATE TEST TRENCH LOCATION (GEOTECHNICAL EXPLORATION, 2001a, b)
	SJ-2 APPROXIMATE TEST TRENCH LOCATION (STEPHEN E. JACOBS, 2013)
	MH-1 APPROXIMATE TEST TRENCH LOCATION (MICHAEL W. HART, 2002)
	H-5 APPROXIMATE TEST TRENCH LOCATION (MILLER-HICKS, 2008)
	GEI-2 APPROXIMATE TEST TRENCH LOCATION (GEOTECHNICAL EXPLORATION, 2005)
	CWE-1 APPROXIMATE TEST TRENCH LOCATION (CWE REPORT 2090707.03, 2010)
	ZONE 11 ACTIVE, ALQUIST-PRIOLO EARTHQUAKE FAULT ZONE (CITY OF SAN DIEGO SEISMIC SAFETY STUDY, 2008)
	ZONE 12 POTENTIALLY ACTIVE (CITY OF SAN DIEGO SEISMIC SAFETY STUDY, 2008)
	Qaf/Qsw Qop ARTIFICIAL FILL AND/OR SLOPEWASH OVER OLD PARALIC DEPOSITS

SURFACE RUPTURE AND SOIL CRACKING: As noted previously, the majority of the site is within an Alquist-Priolo Earthquake Fault Zone established by the State Geologist in 1991 around the active, Rose-Canyon Fault Zone. In addition, the western portion of the site is located within the City’s Geologic Hazard Category 12, which is an overlay category assigned to areas adjacent to faults that are not currently considered to be active. Appendix C of this report includes a copy of a fault hazard evaluation performed for the subject site by Steven E. Jacobs, CEG, in which it was concluded that the subject site is not underlain by active or potentially active faulting. Additionally, Appendices D through I of this report present copies of fault/geologic studies prepared by Geotechnical Exploration Inc. (2001 and 2005), Michael W. Hart, CEG (2002), Steven C. Suitt and Associates (1994), Bryan Miller-Hicks, CEG (2008), and Christian Wheeler Engineering (2010) for sites immediately west, north, and east of the subject site. Based on the observations made within the test trenches conducted for each of these investigations as well as correlation with other nearby explorations, like the Jacobs’ report, each of these reports also concluded that those sites of study/investigation are not underlain by active or potentially active faulting. The locations of the fault trenches excavated during the generation of the above-described fault hazard studies are presented on Plate Nos. 1 and 2 of this report.

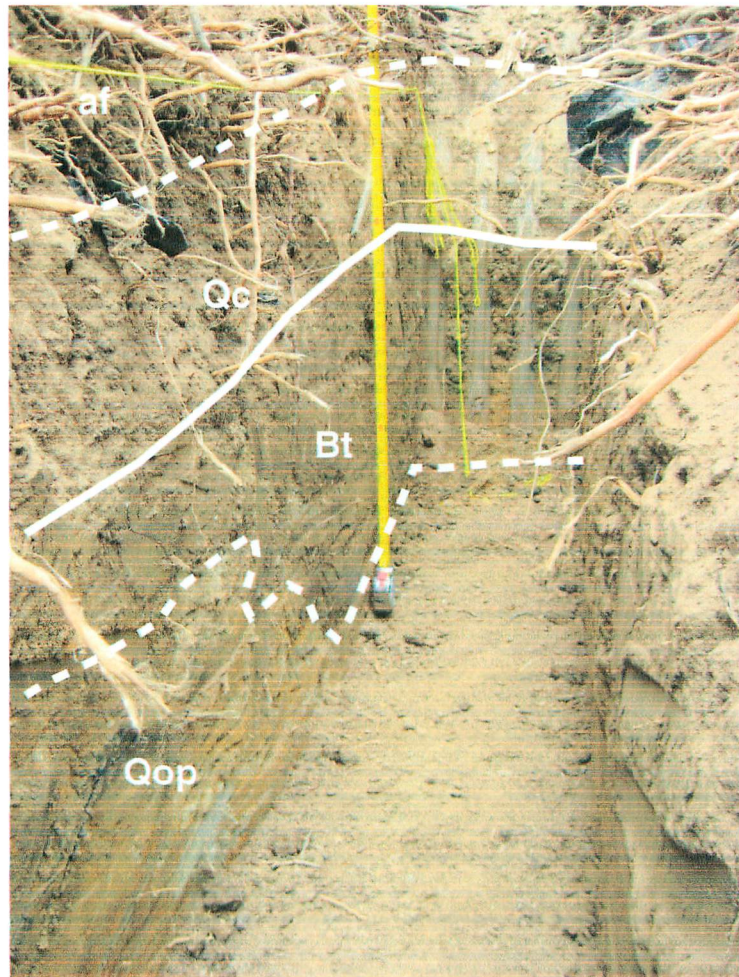
Photo 2. Another view of soil profile toward north end of fault trench (af = fill; Qc = colluvium/topsoil; Bt = argillic horizon; Qop = old paralic deposits)
