**GEOTECHNICAL
MATERIALS
SPECIAL INSPECTION**

March 6, 2024
NOVA Project No. 2023274.1

Subject: Geotechnical Addendum and Response to City Review Comments
Stormwater Diversion at Point Loma Wastewater Treatment Plant
1902 Gatchell Road, San Diego, CA
PRJ-1084313

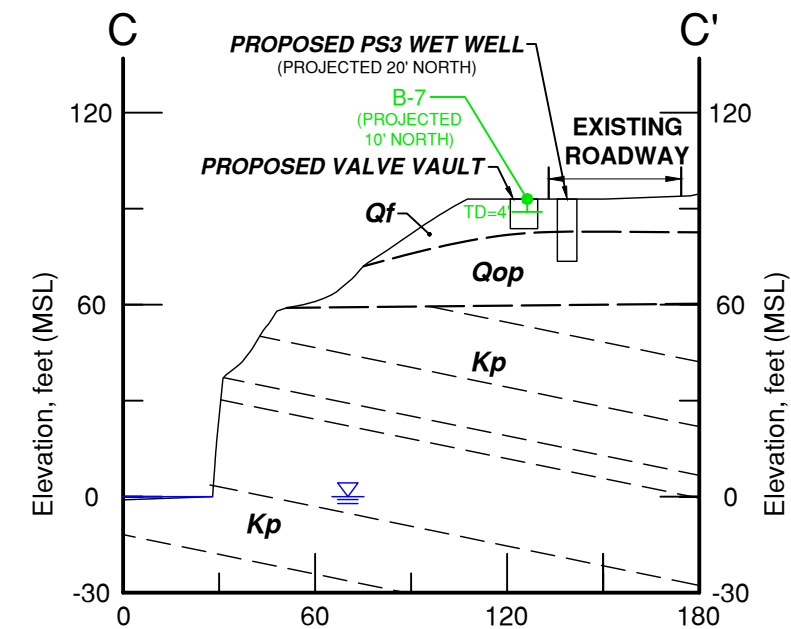
Qr	RIP RAP
Qf	FILL
Qcol	COLLUVIUM
Qop	OLD PARALIC DEPOSITS
Kp	POINT LOMA FORMATION

Response: NOVA performed slope stability analyses of Geologic Cross-Sections A-A', B-B', C-C', and D-D' as shown on Plate 3. Analyses were performed using SLIDE2 V9.019 software to calculate factors of safety (FS) against slope failure using Spencer's method, which satisfies both force and moment equilibrium. Five different materials were defined to represent the subsurface conditions. The materials include existing fill, colluvium, old paralic deposits, Point Loma Formation, and previously placed rip rap. The properties of the materials selected for the analyses are listed in Table 1.

Geologic Cross-Section	Existing Condition	Proposed Condition	
	Static Factor of Safety	Static Factor of Safety	Pseudostatic Factor of Safety
A-A'	1.99	1.99	1.65
B-B'	3.08	3.04	2.25
C-C'	1.68	1.68	1.52
D-D'	1.56	1.56	1.29

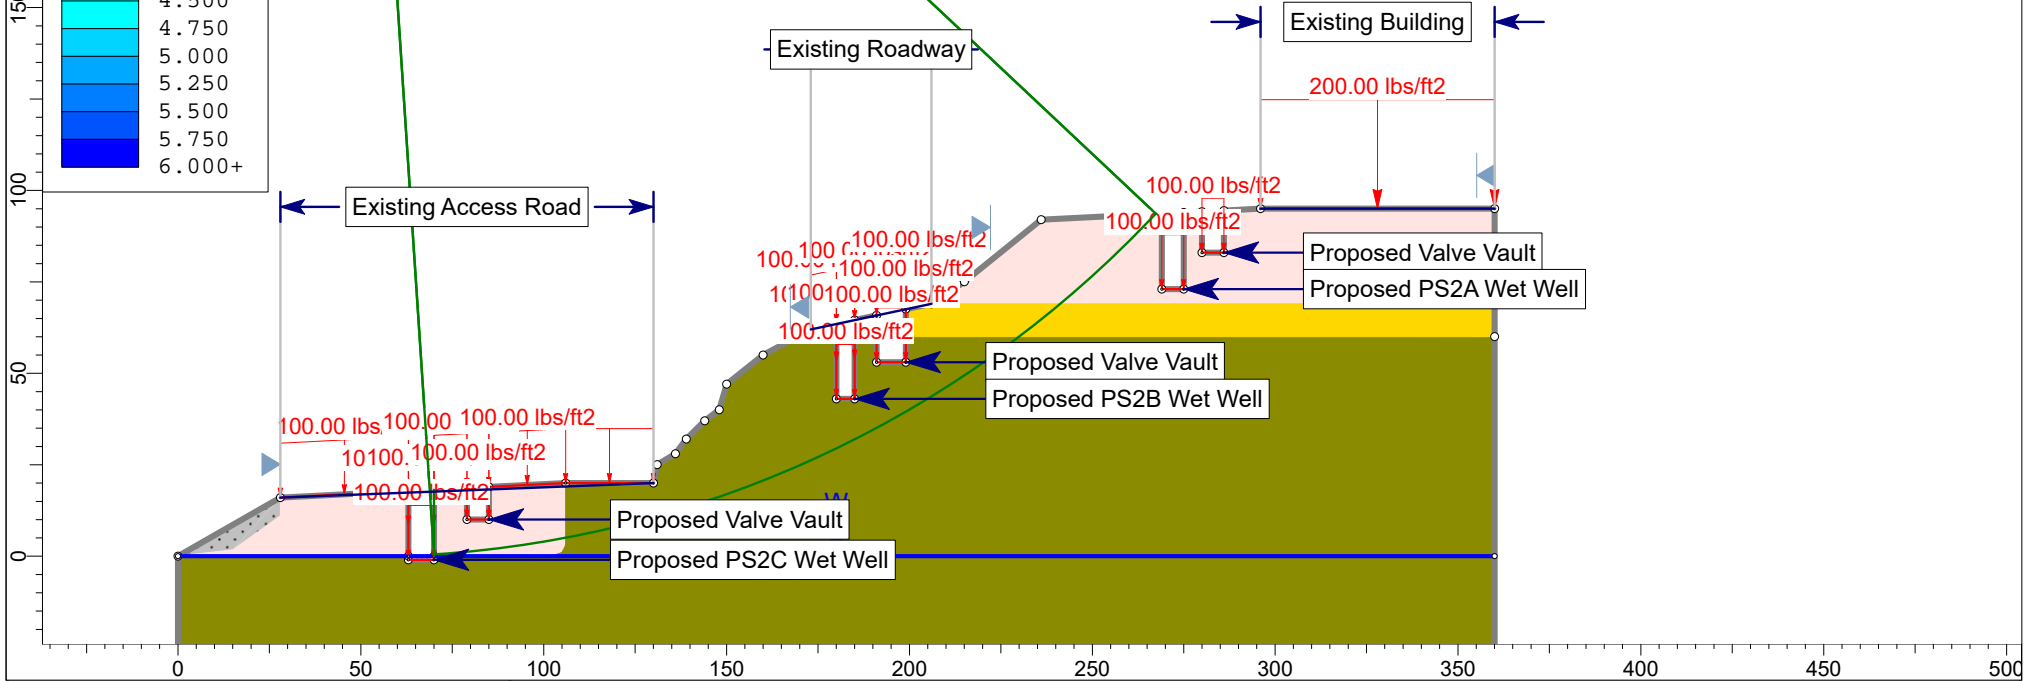
Figure No.: C.6

Cross Section B-B': Proposed Condition

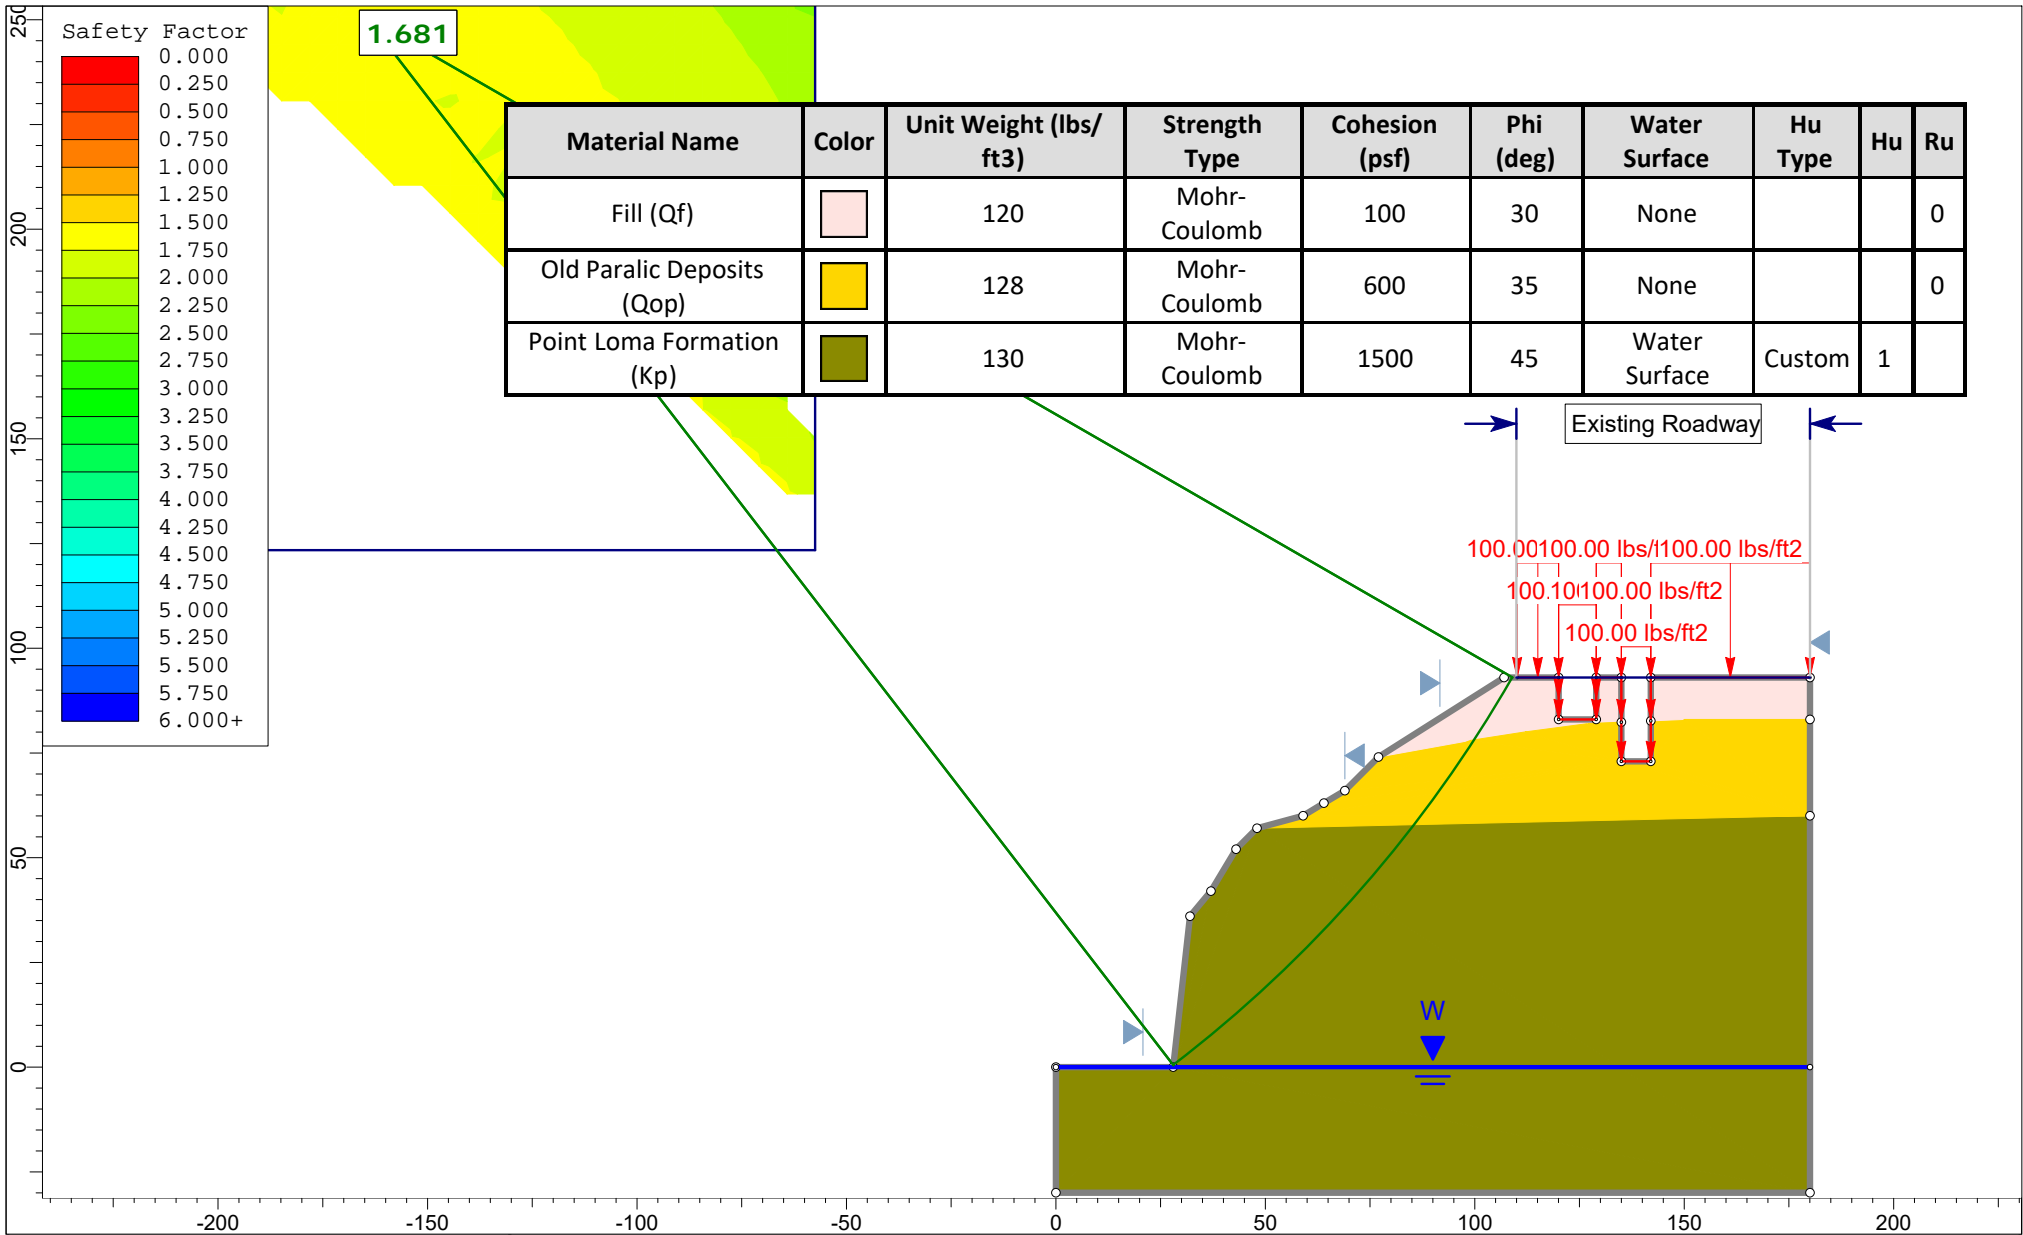
Figure No.: C.8

Material Name	Color	Unit Weight (lbs/ft3)	Strength Type	Cohesion (psf)	Phi (deg)	Water Surface	Hu Type	Hu	Ru
Fill (Qf)		120	Mohr-Coulomb	100	30	None			0
Old Paralic Deposits (Qop)		128	Mohr-Coulomb	600	35	None			0
Point Loma Formation (Kp)		130	Mohr-Coulomb	1500	45	Water Surface	Custom	1

Cross Section C-C': Proposed Condition

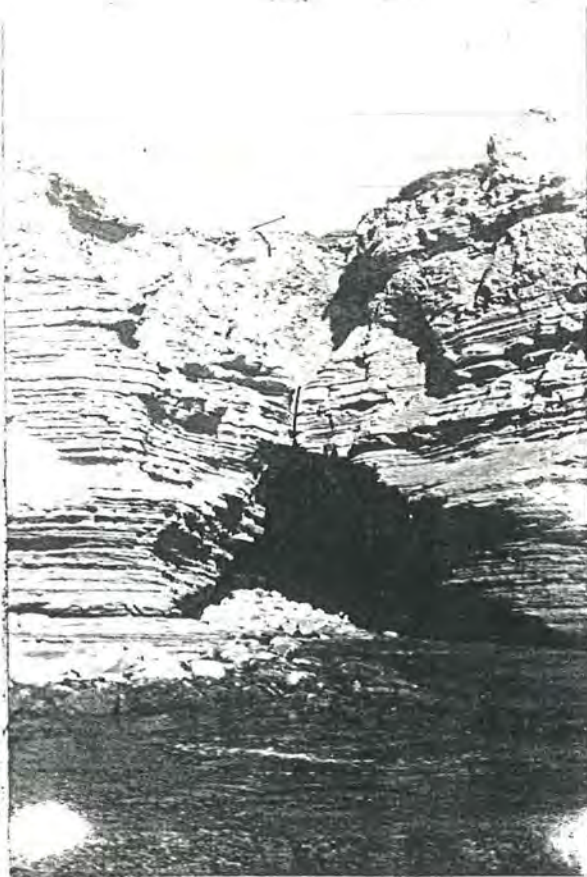
Photograph #1.

Sea cave resulting from wave erosion in zone of weakness provided by fault shown by line. Note slumping of strata on the sides and in the roof of the cave.

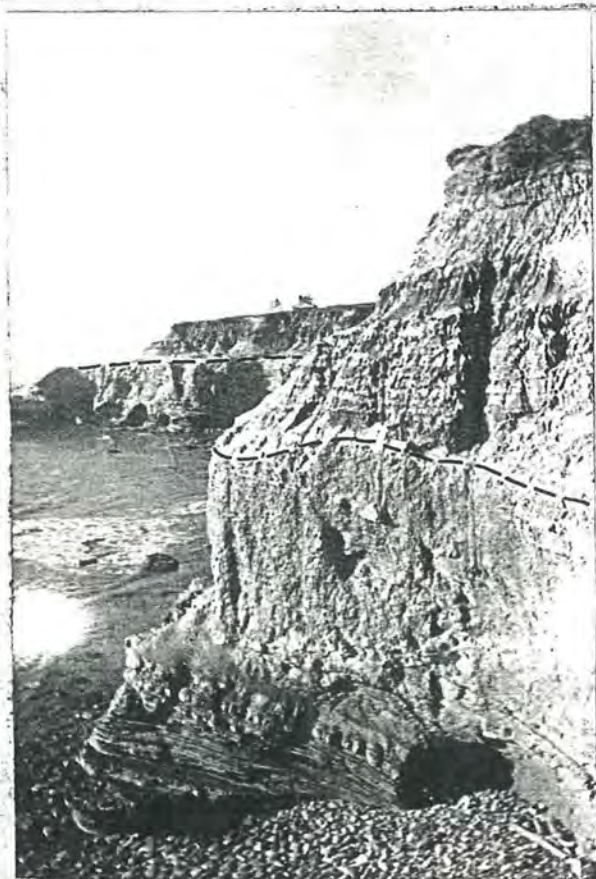
Photograph #2.

View of coastline showing present wave cut terrace exposed at low tide, 60-foot terrace and 100-foot terrace. The Chico formation (Cretaceous) forms the steep cliff below the 60-foot terrace, while the Terrace formation (Pleistocene) has been deposited on the 60-foot terrace (indicated by dashed line). Photograph taken facing north from a headland seaward of rifle range.

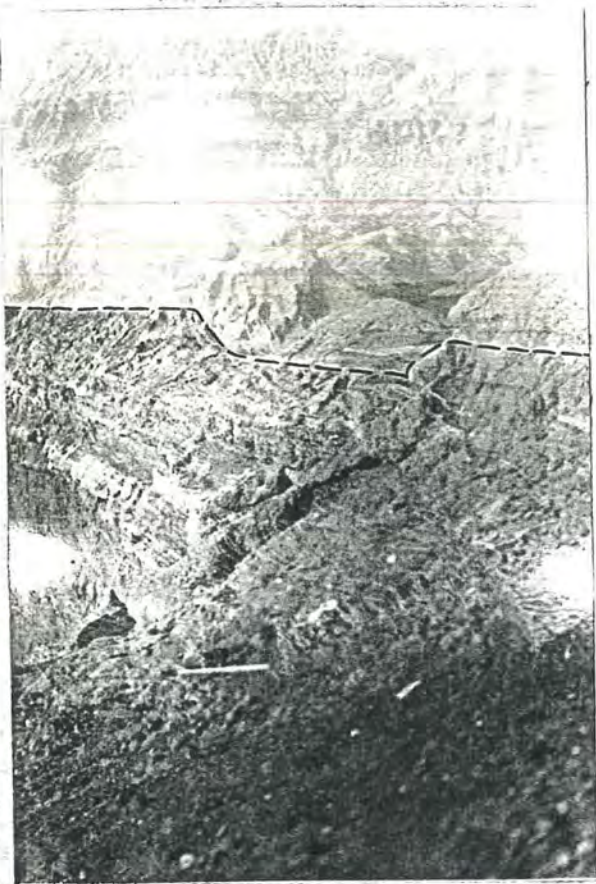
Photograph #3.

Photograph of contact between Terrace formation (above dashed line) and Chico formation. Note that the mouth of the small stream valley is truncated by the cliffs and that the stream has cut a foot or two into the Chico formation.

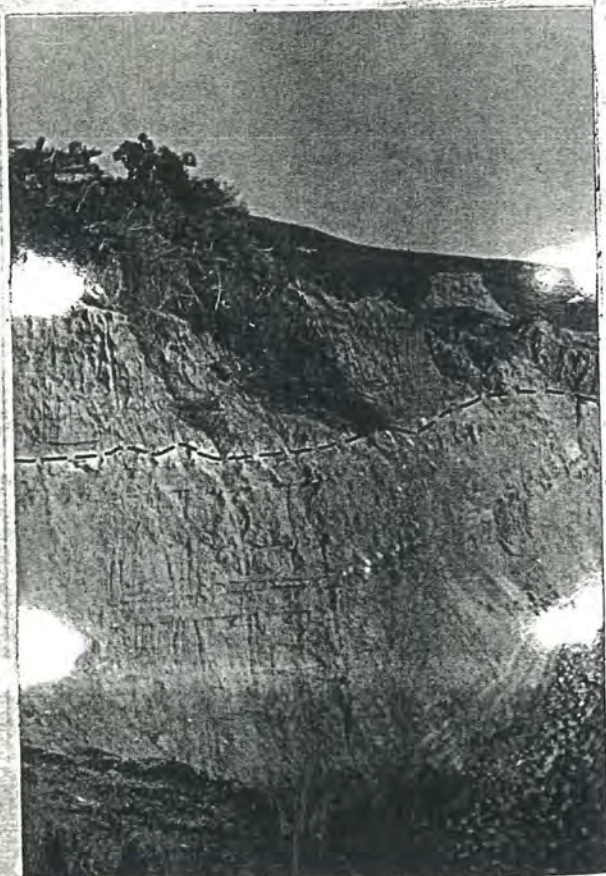
Photograph #4.

Photograph taken facing south from the point where photographs 2 and 3 were taken. Dashed line indicates contact between Terrace and Chico formations.

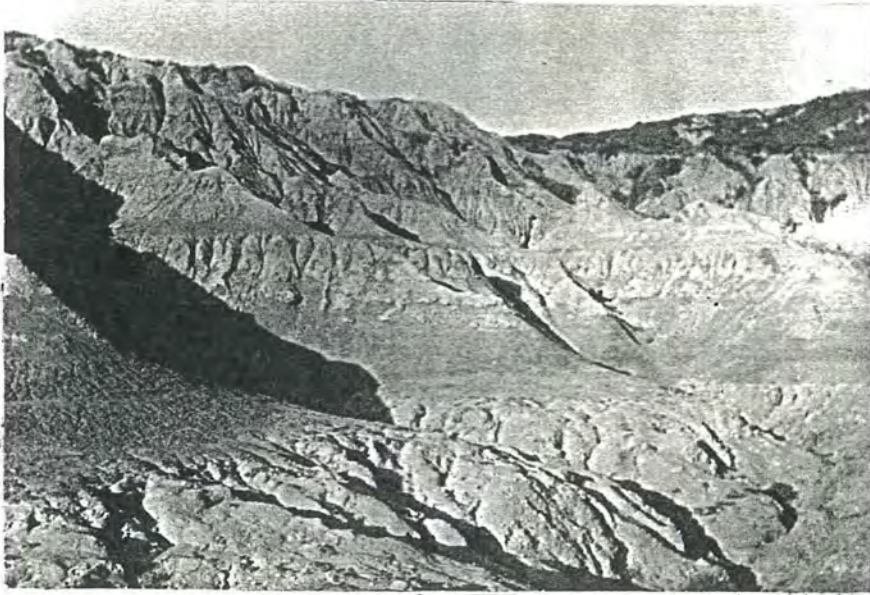
Photograph #5.

Nearly horizontal bedding in Terrace material indicated by erosional benches parallel to the bedding. The flat terraces are underlain by more resistant material than that composing the slopes.

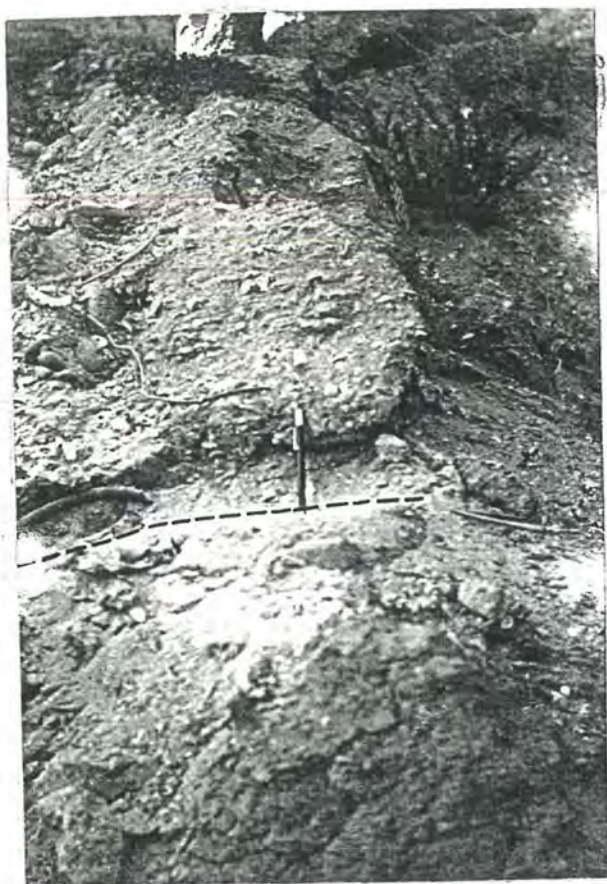
Photograph #6.

Contact between Chico formation (below dashed lines) and basal, shelly Terrace formation (above dashed line) exposed at the mouth of a canyon located in Figure 1.

The terrace is exposed where
a pebbly bed containing
shells (Photograph #6).
at that location. This appears
on page 70 of their report,
1934.

The terrace is exposed in road cuts
(Photographs 6, 7). However, this
is eroded by running water.
The typical of erosion by
running water in soft, unconsolidated material.
The erosion of the Terrace
formation results

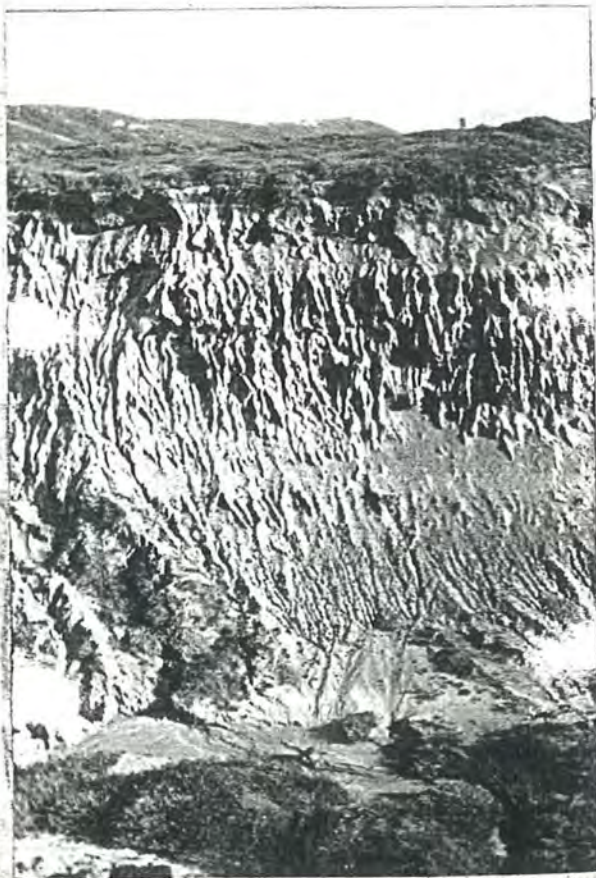
Photograph #7.

View showing badlands gullying typically developed in Terrace formation. Note gently sloping 100-foot terrace just above the valley in which the photograph was taken.

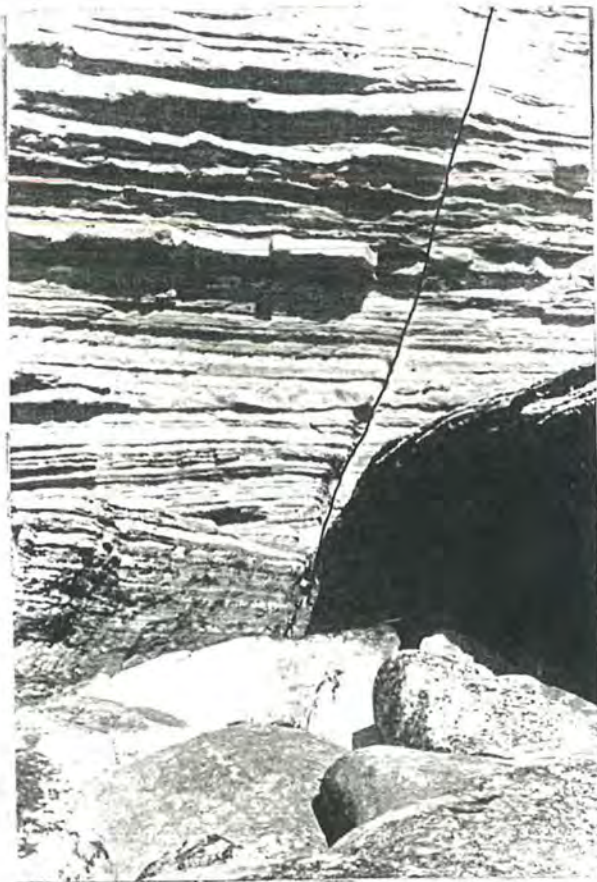
Photograph #8.

Small fault in Chico formation. Photograph taken from an indentation in the cliff produced by selective wave erosion following the line of weakness provided by the fault. Right side of fault has moved upward about one foot relative to left side, as shown by displacement of sandstone beds in the upper part of the photograph.

Similarly, there also appear to be two sets of faults, one striking north-south and the other striking approximately east-west (Fig. 1). All the faults seen are vertical or nearly so. Displacements range from a few inches, such as shown along the small fault in Photograph 8, to 15 feet along the second fault north of the southern boundary of the area investigated.

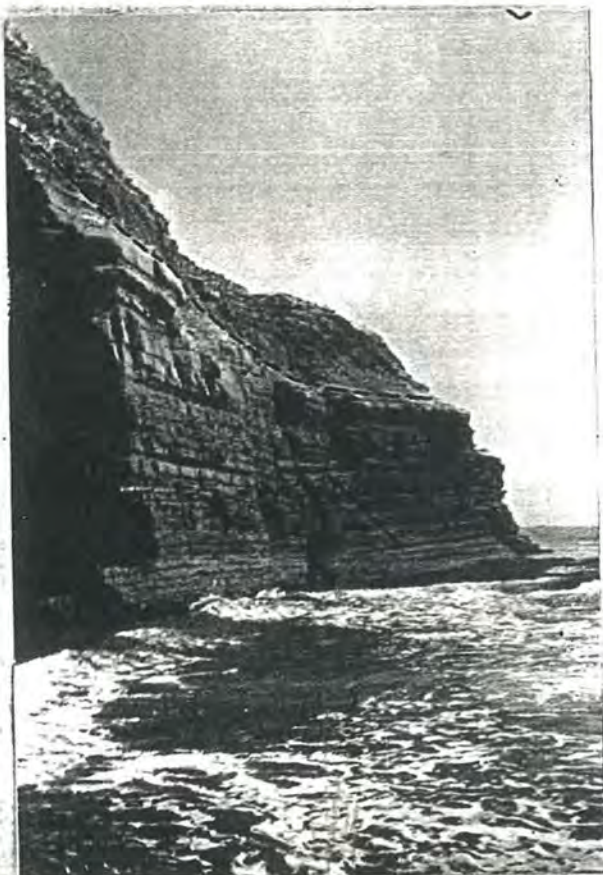
Photograph #9.

The sea cliff bordering the area investigated. Note the fault (indicated by arrow) and the dashed line indicating the contact between the Terrace and Chico formations. Note that the fault does not extend into the Terrace formation, but is truncated by the unconformity between the latter and the Chico formation.

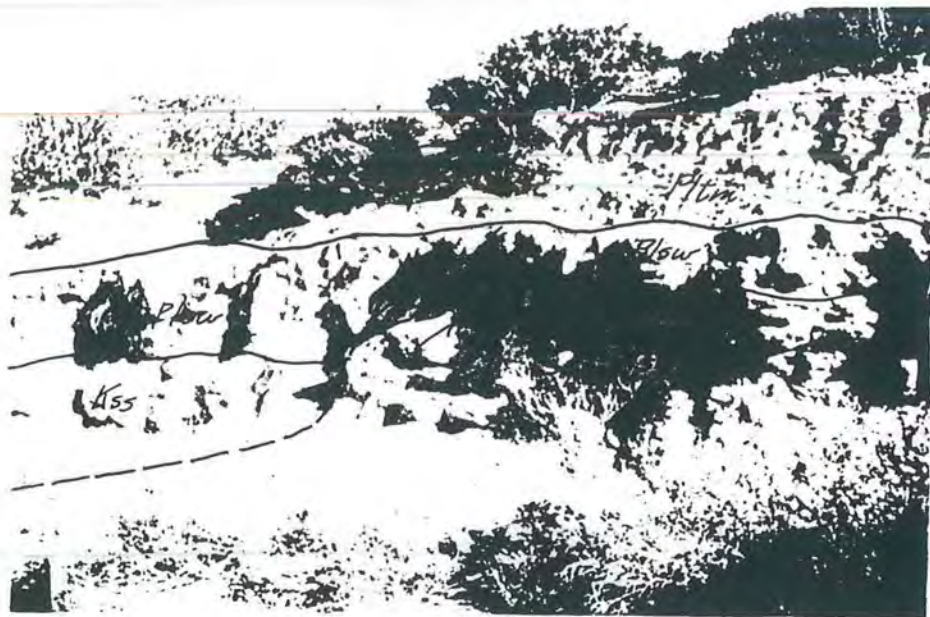
fig. 1 : Fault southwest of McClellan Road displacing the Cretaceous sandstone member (Kss) and the Sweitzer formation (Plsw) but not the Late Pleistocene terrace materials (Pltm). Note the surface on which the Pltm sets. This surface truncates the faulted Plsw showing that considerable erosion preceded the deposition of the Pltm.

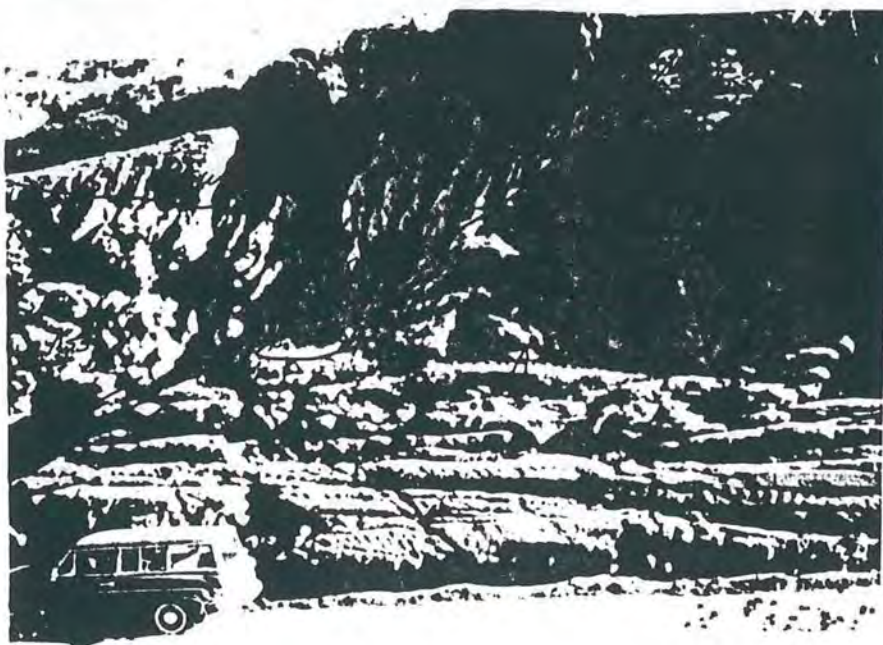
fig. 2 : Road cut in McClellan Road showing change in relative movements along fault. Compressional pre-Sweitzer faulting, displacement of bed "A" in Kss up on left side of fault; tensional post-Sweitzer faulting, Plsw faulted down on left side of fault. Note depositional occurrence of Pltm along eroded fault zone subsequent to faulting and covering part of fault.

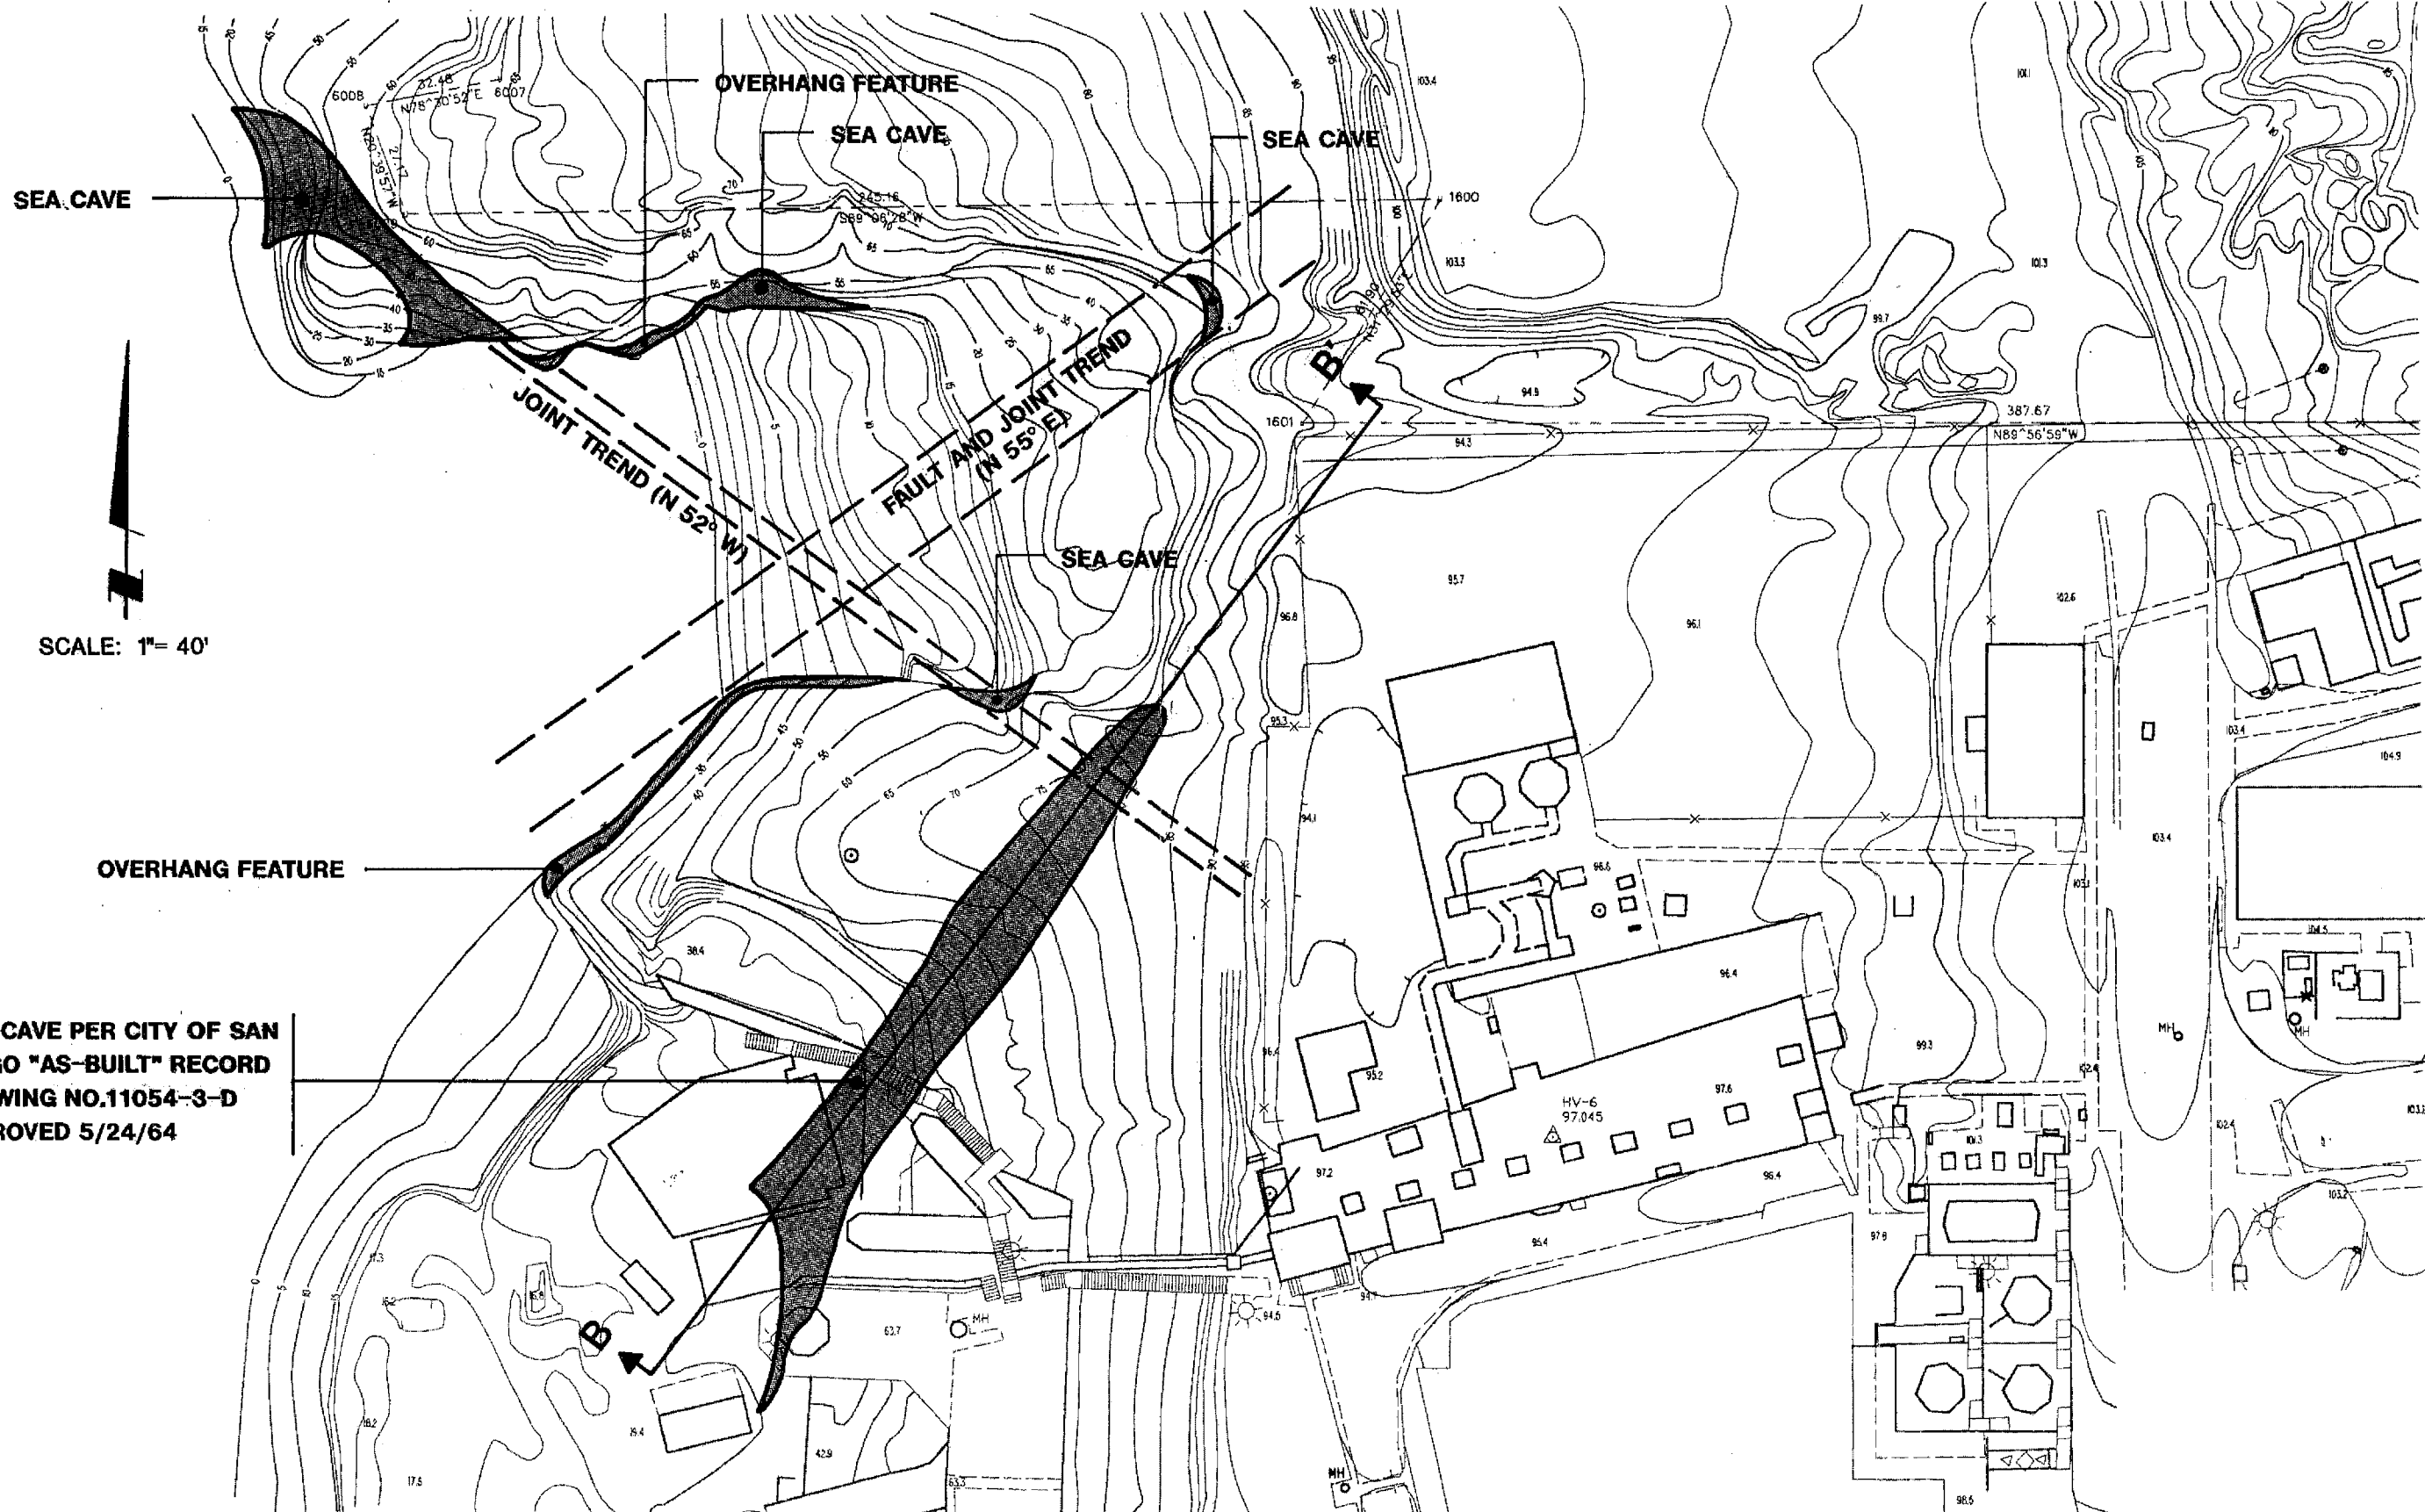
Figure **A-3**

SEA CAVE PER CITY OF SAN
 DIEGO "AS-BUILT" RECORD
 DRAWING NO.11054-3-D
 APPROVED 5/24/64

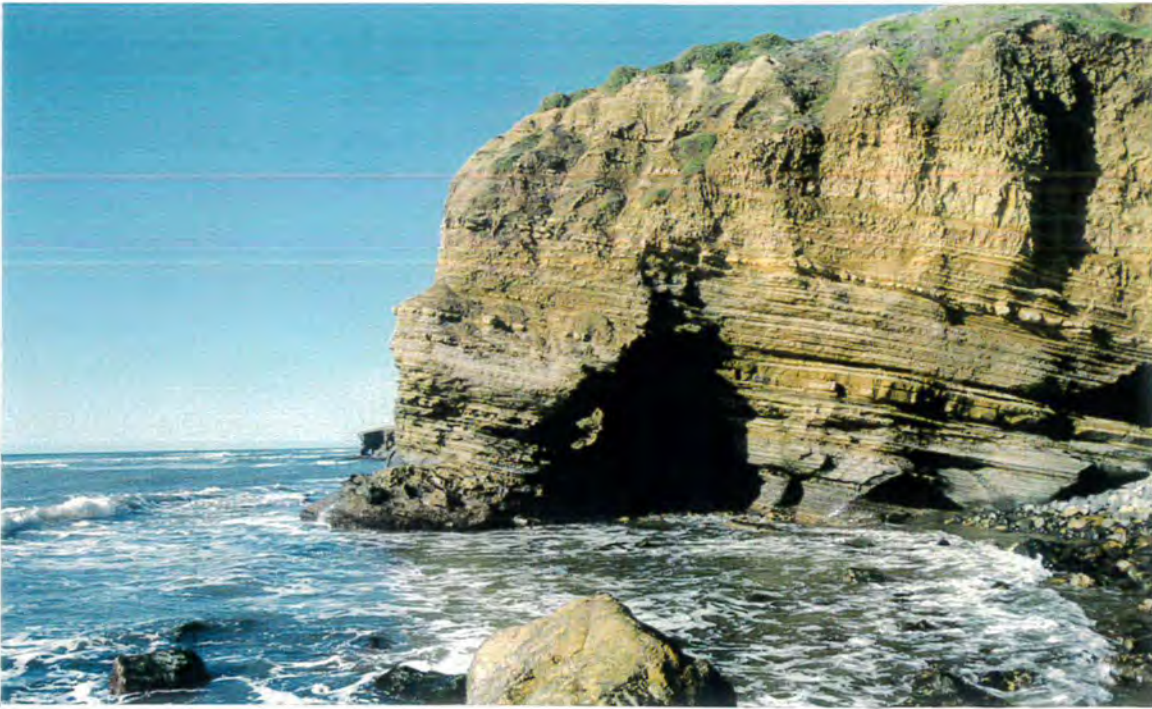
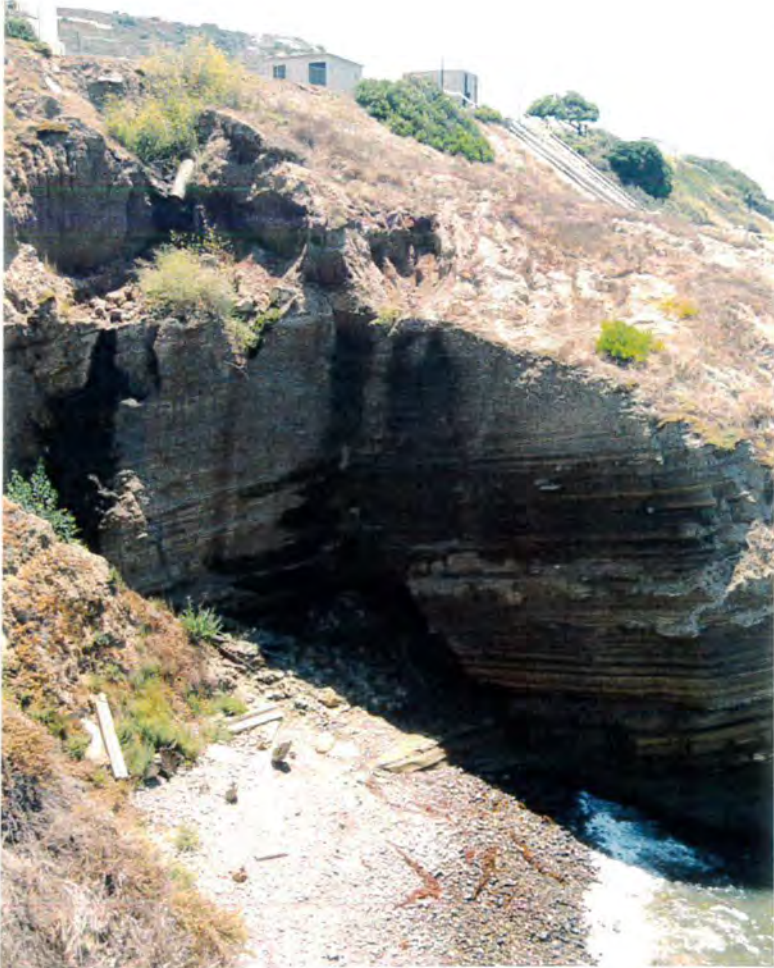
WAVE ENERGY, FOCUSED ALONG THE ALIGNMENT OF A JOINT TREND (N52°W), HAS ERODED TWO SEA CAVES, ONE AT THE NORTHWEST CORNER (ABOVE PHOTO), AND THE OTHER AT THE SOUTHEAST CORNER (LEFT PHOTO) OF THE COVE. THE COVE ITSELF REPRESENTS A REMNANT COLLAPSED SEA CAVE.

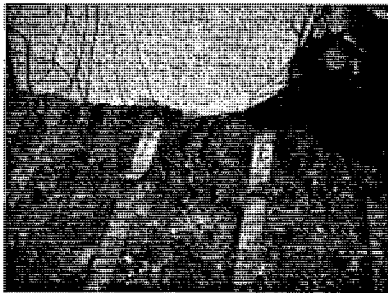
Reinforcing strips fitted with gauges.

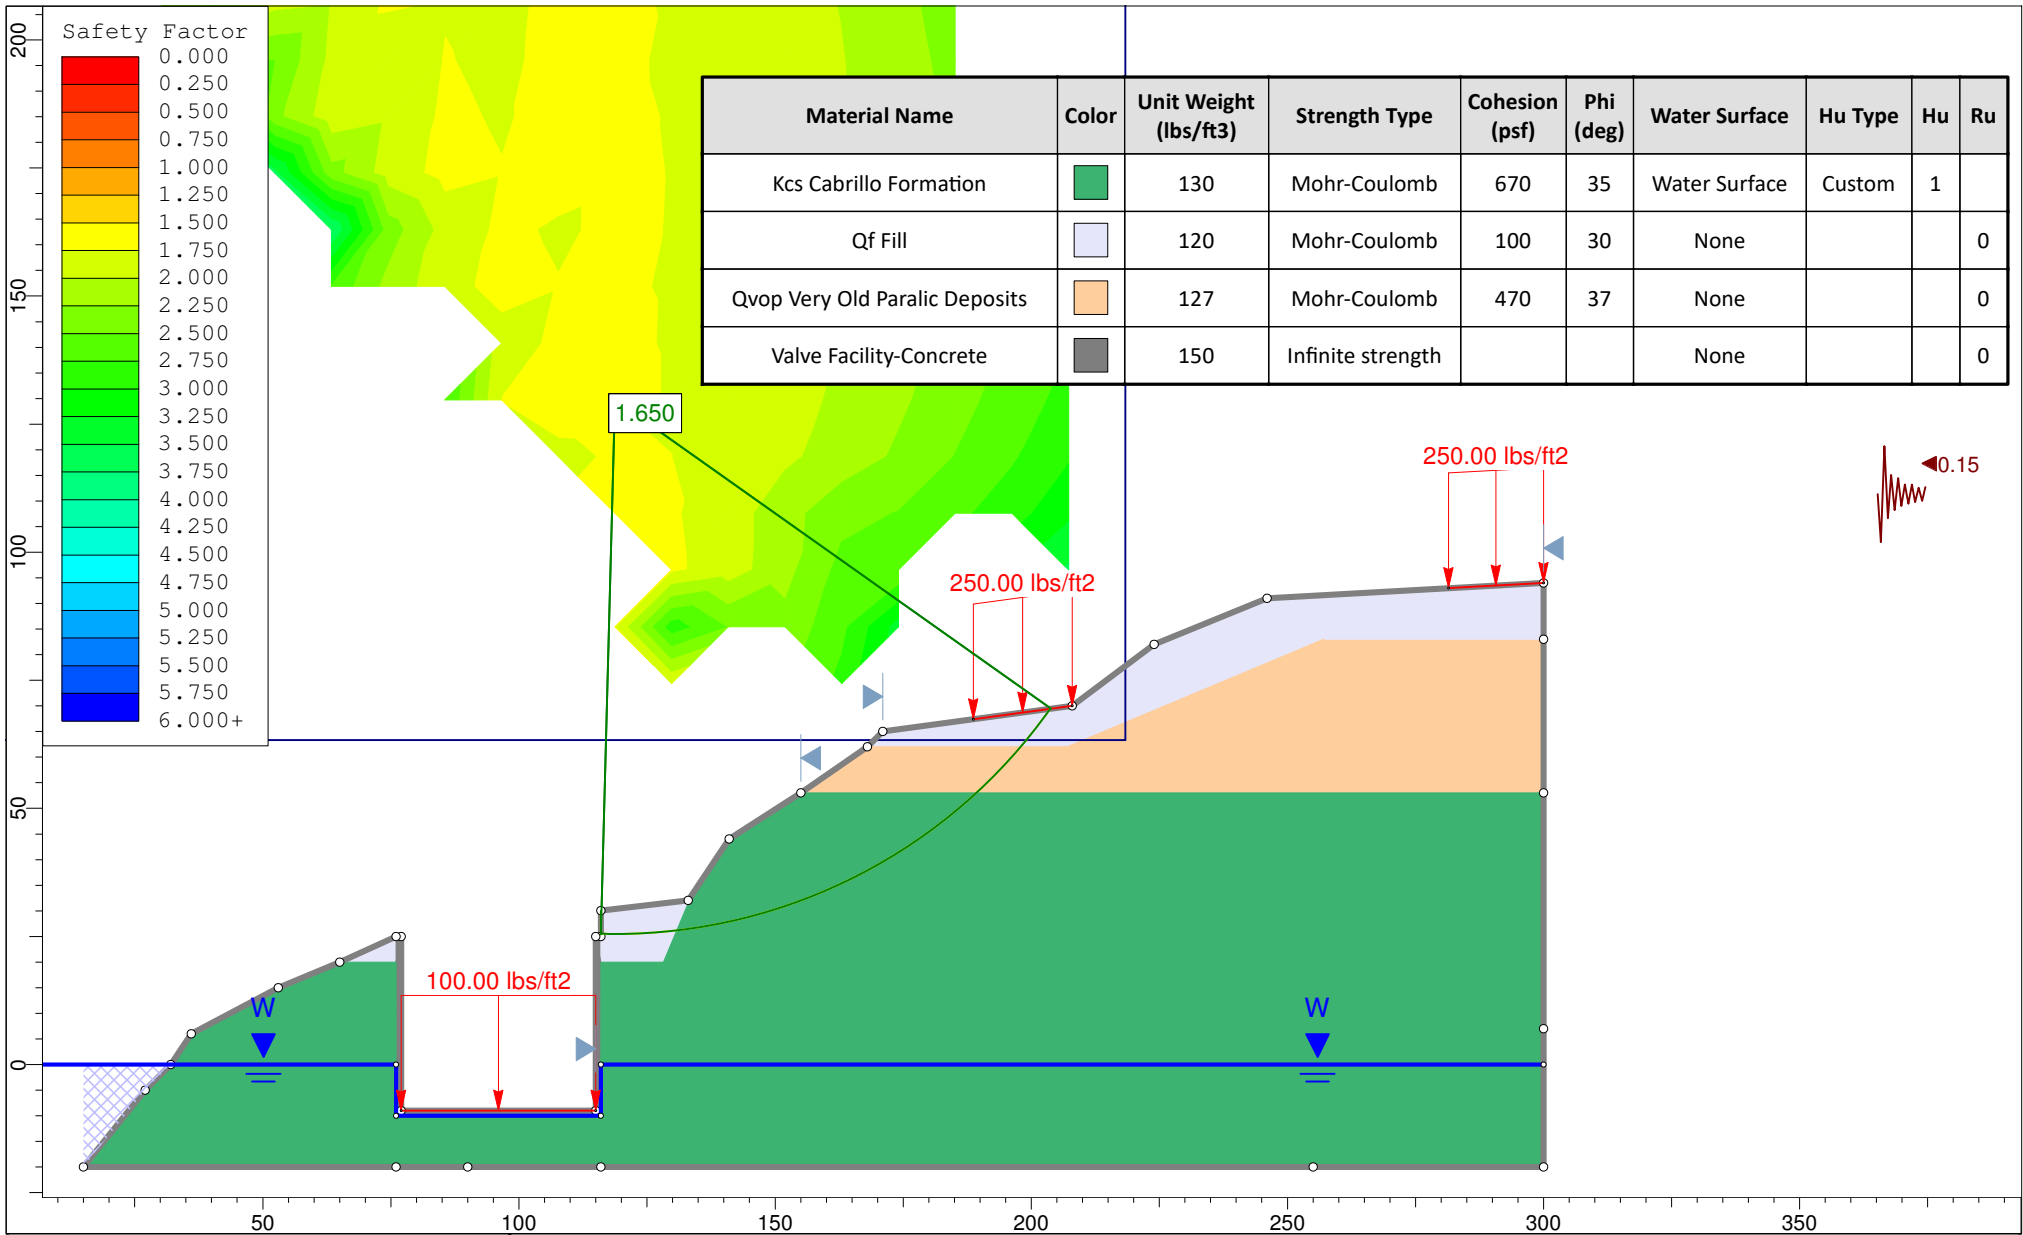
Cross Section A-A': Local 1

Project: Point Loma Wastewater Treatment Plant		Location: San Diego, California	
	Analysis Method: Spencer Method - Pseudostatic Analysis		Client: HDR	
	Date: September, 2020	Analysis By: THC	Job No.: 190329P4.3	Figure No.: III-4

Analyses of the existing conditions were performed on Cross-Section A-A' (Figure 3). The results are presented in Appendix III and summarized in Table 4.
