## **GEOTECHNICAL INVESTIGATION**

### **POINT LOMA WASTEWATER TREATMENT PLANT SITE IMPROVEMENTS**

San Diego, California

Atlas No. 190329P4.3  
Report No. 1

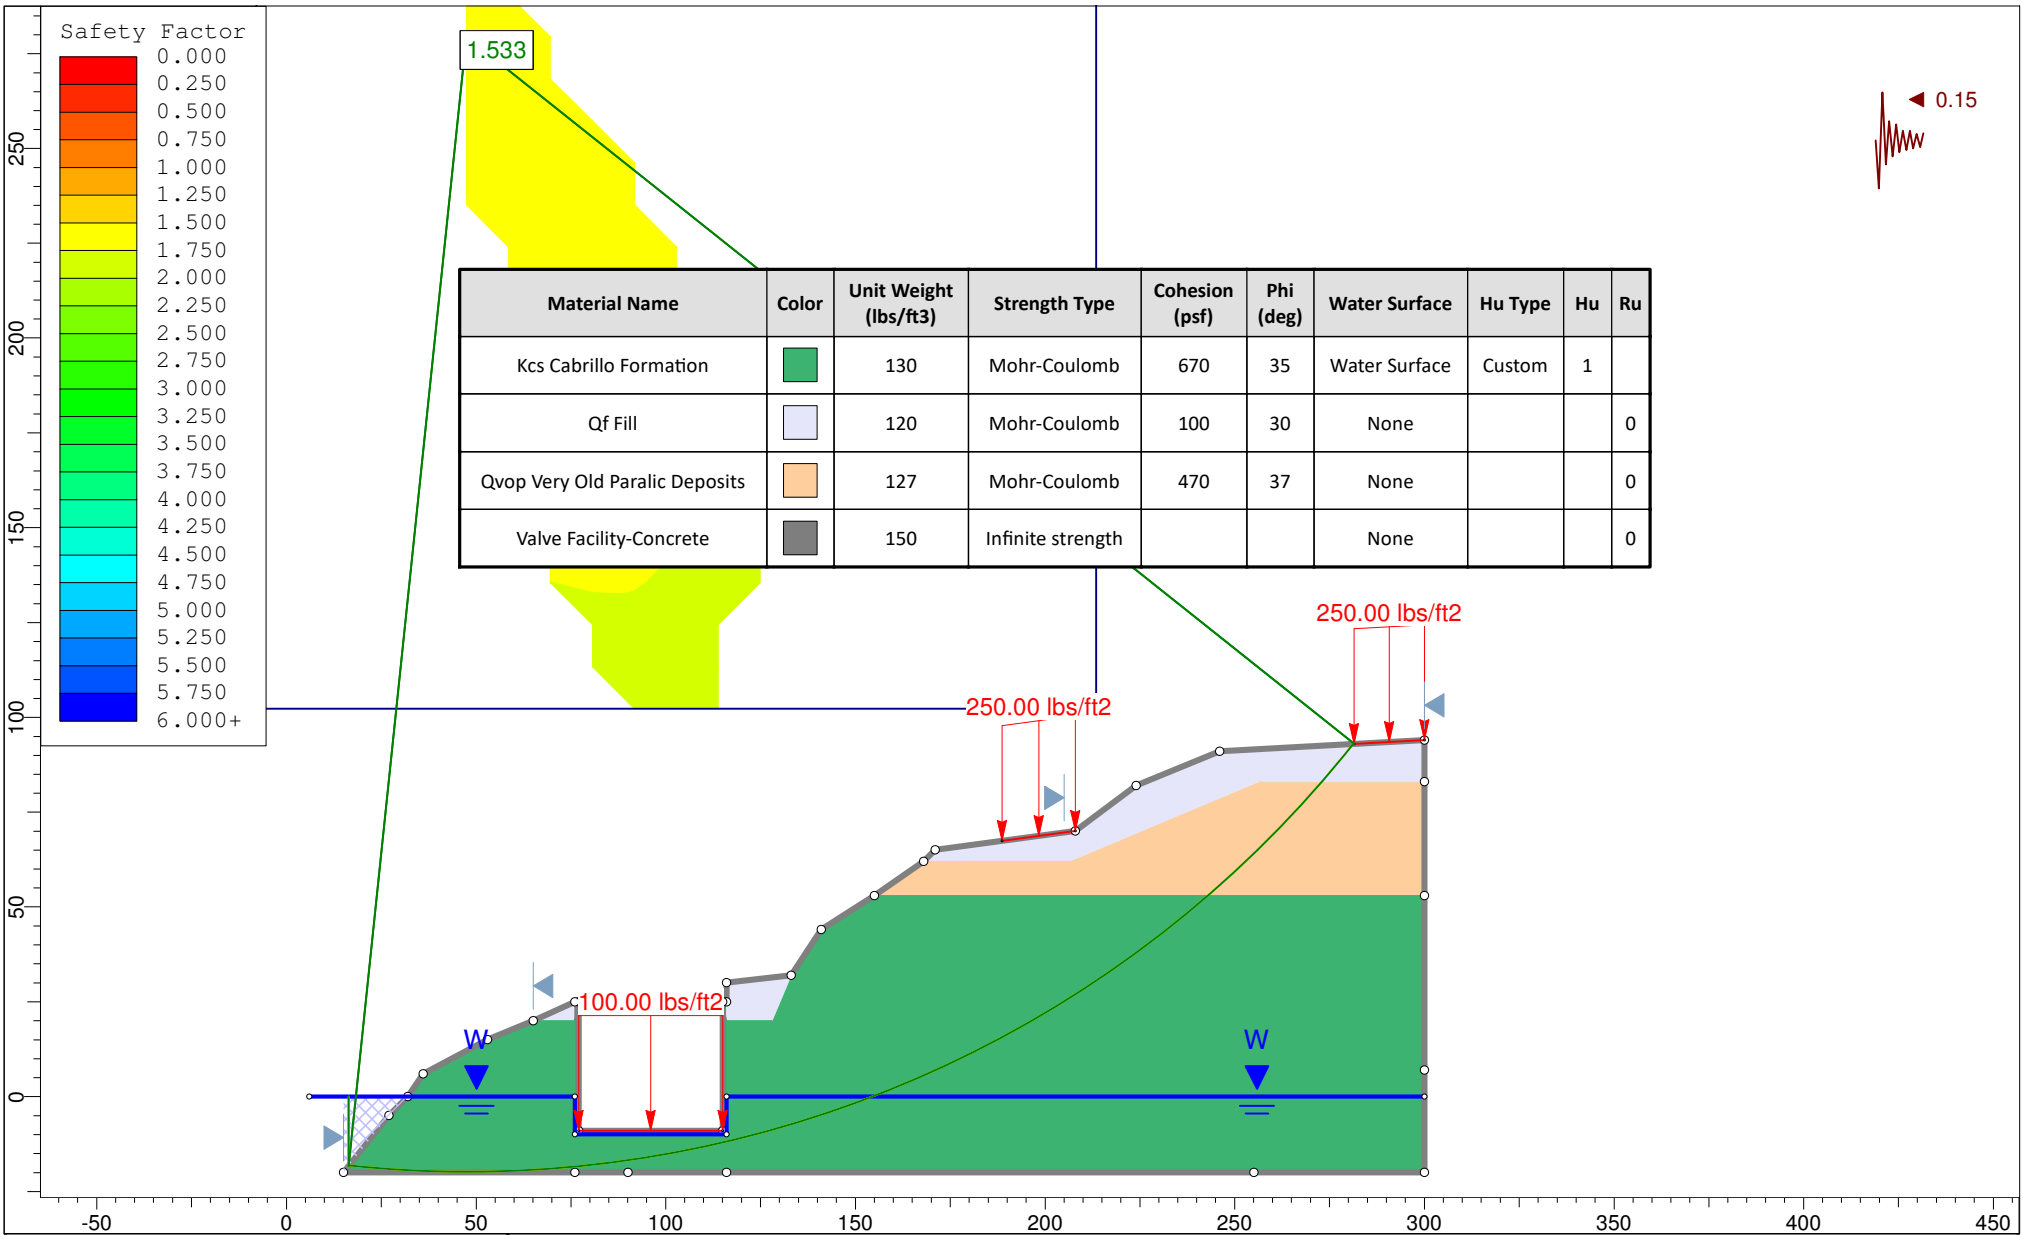
| | | Date: September, 2020 | Analysis By: THC | Job No.: 190329P4.3 | Figure No.: III-2 |

| | | <b>Cross Section A-A': Global</b> | | | |
| | | Analysis Method: Spencer Method - Pseudostatic Analysis | | Client: HDR | |
