GEOLOGIC RECONNAISSANCE

**CLAIREMONT VILLAGE
FIELD STREET AND COWLEY WAY
SAN DIEGO, CALIFORNIA**

**CLAIREMONT VILLAGE QUAD, LLC
SAN DIEGO, CALIFORNIA**

**OCTOBER 28, 2021
PROJECT NO. G1992-52-03**

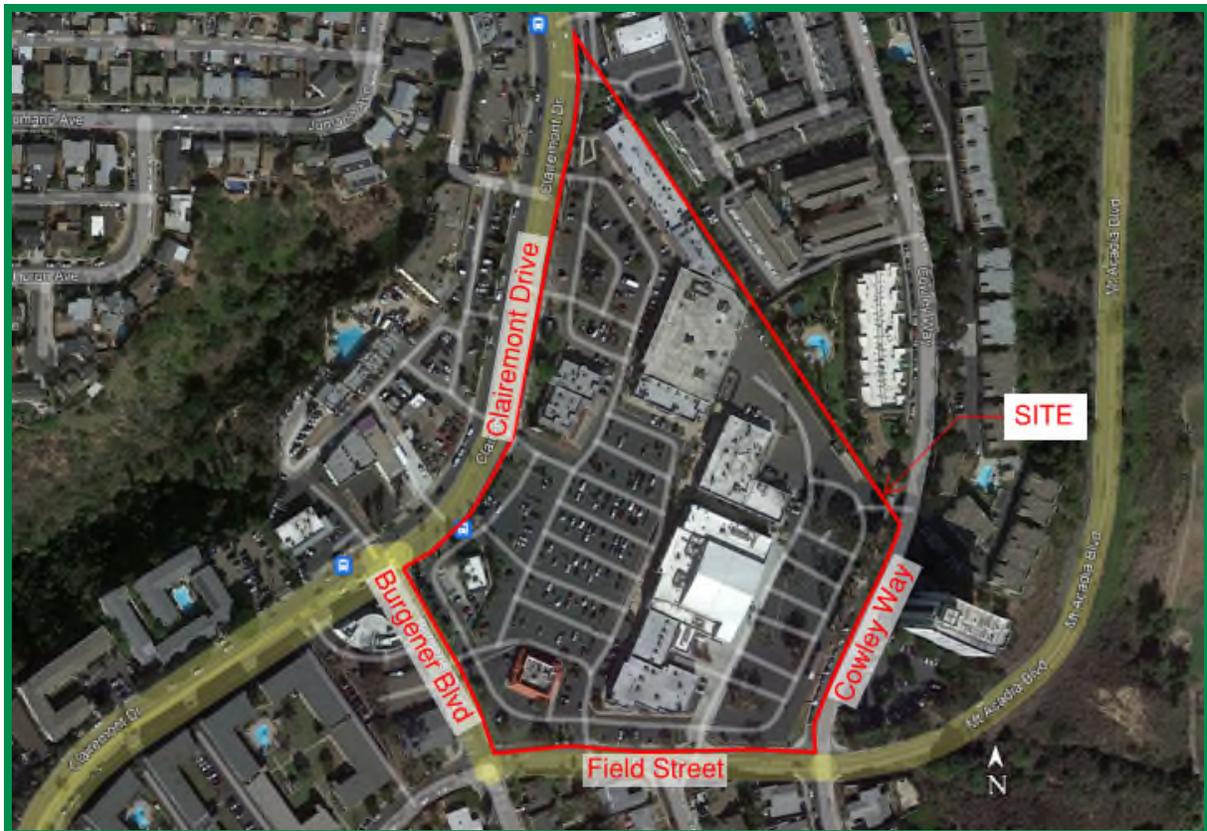
The property is located east of Clairemont Drive, northeast of Burgener Boulevard, north of Field Street and east of Cowley Way in the Clairemont area of San Diego, California. The site is currently a part of a commercial complex with accompanied asphalt concrete and Portland cement concrete parking and drive lanes. The commercial property includes a Sprouts grocery store, Carl's Jr. restaurant, Starbucks, Rite Aid, dental office, restaurant building and other retail stores. The buildings are single-story and consist of wood and stucco. We expect the structures are supported on conventional shallow foundations. Landscaping exists within planter wells in the parking lot areas and the parkways adjacent to the roadways. The retail complex is relatively flat with an elevation of about 295 feet above Mean Sea Level (MSL) in the southeast end of the property to 323 feet MSL at the northwest corner of the property. The Existing Site Map shows the site conditions.

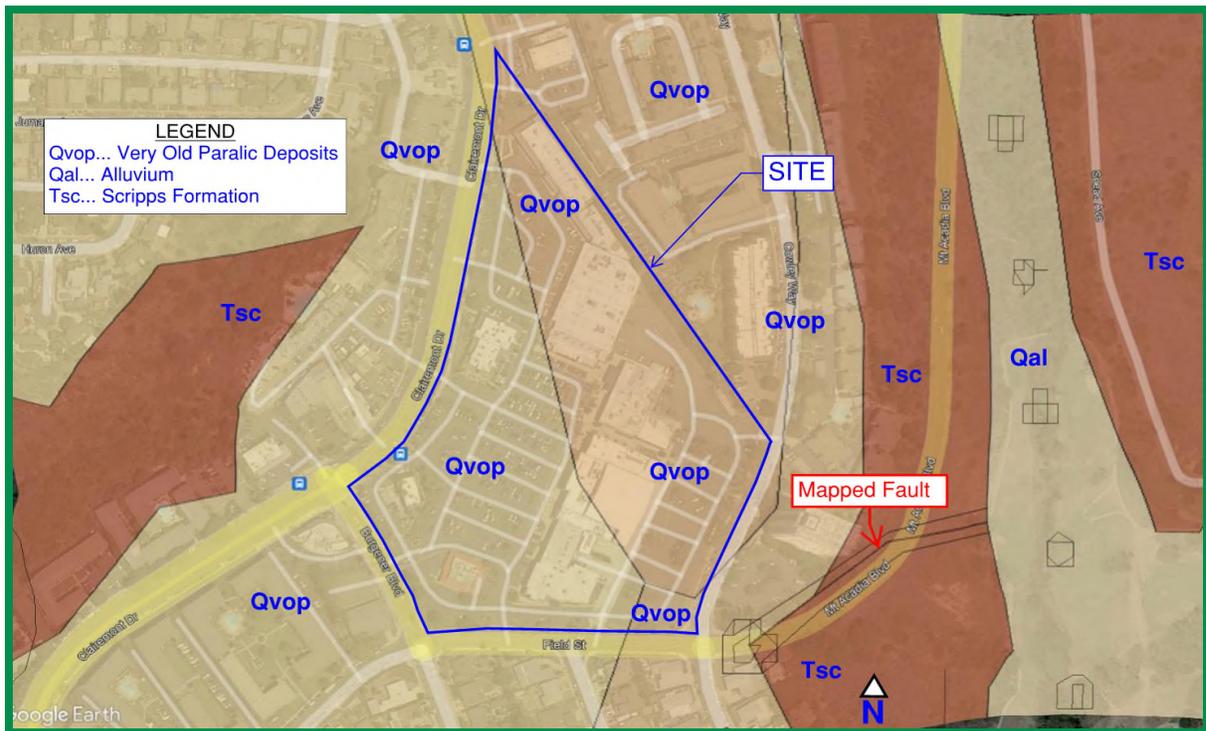
Regional Geologic Map

The site is located on the central portion of the coastal plain. Sedimentary units make up the geologic sequence encountered on the site and consist of Eocene-age Stadium Conglomerate (Kennedy and Tan, 2008). The mapped regional geology at the site is shown on the Regional Geologic Map.

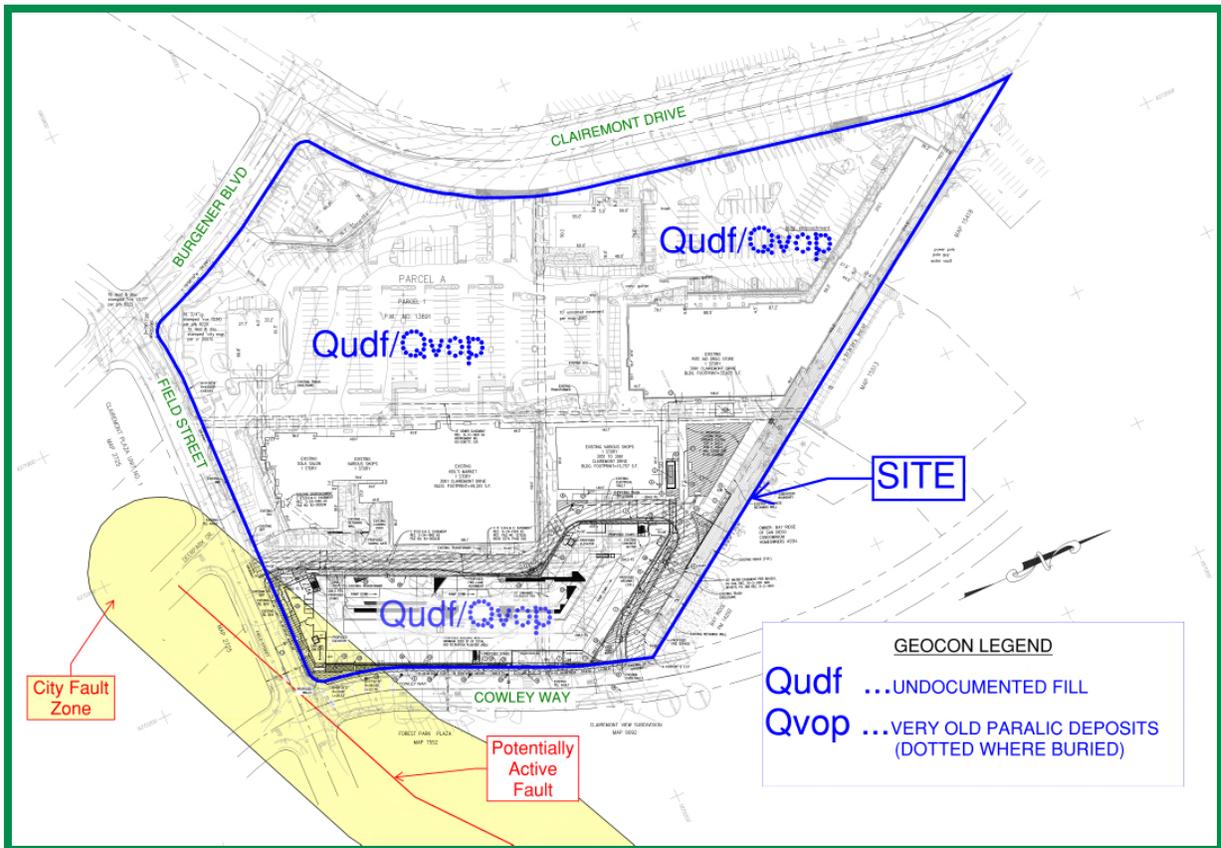
Geologic Map

Based on our review of previous reports and published maps, we expect the site is underlain by shallow undocumented fill (Qudf) placed during the previous grading for the development, overlying formational materials of the Very Old Paralic Deposits (Qvop). The fill is considered undocumented, because we did not observe the placement and compaction of the fill during the grading operations during the original site development. The surficial soil and geologic units are described herein in order of increasing age. The approximate lateral extent of the geologic conditions is presented on the Geologic Map.

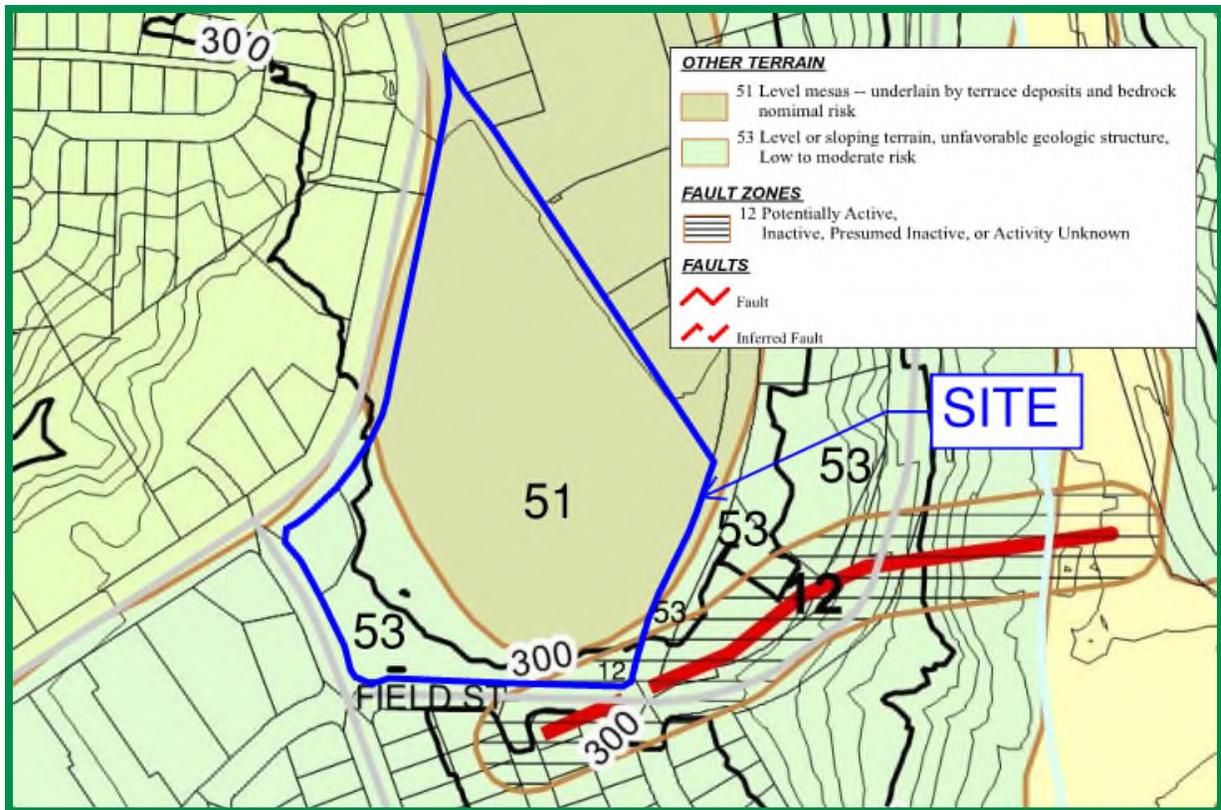
Hazard Category Map

The City of San Diego Seismic Safety Study, Geologic Hazards and Faults, Sheet 25 defines the northern portion of the site with *Hazard Category 51: Level mesas, underlain by terrace deposits and bedrock, nominal risk*. The southern portion of the site is defined as *Hazard Category 53: Level or sloping terrain, unfavorable geologic structure, low to moderate risk*. A fault is mapped southeast of the site and is labeled as *Hazard Category 12: potentially active, inactive, presumed inactive, or activity unknown* (as shown on the Hazard Category Map).

- 8.1.2 The City of San Diego Seismic Safety Study, Geologic Hazards and Faults, Sheet 25 indicates a fault southeast of the site, and the fault zone labeled as *Hazard Category 12: potentially active, inactive, presumed inactive, or activity unknown* is mapped within the southeast corner of the site (as shown on the Hazard Category Map). We did not observe faulting during a recent investigation, and are currently preparing a fault investigation report for the that will summarize our observations.

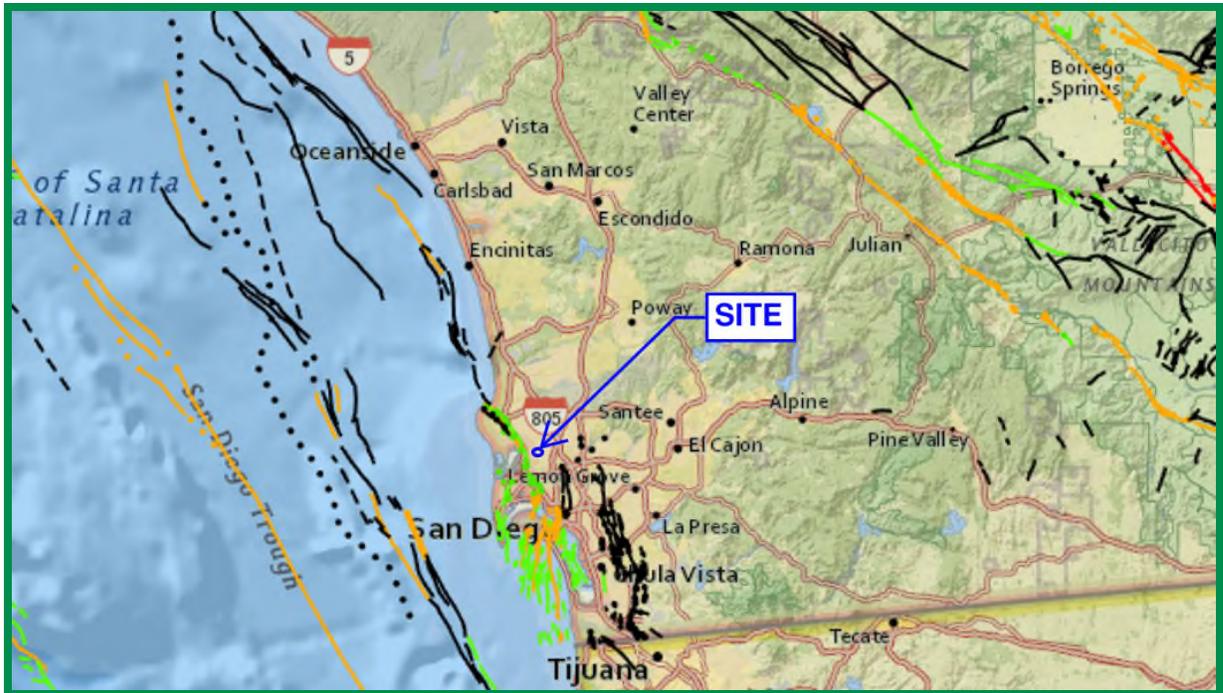
Faults in Southern California

The USGS has developed a program to evaluate the approximate location of faulting in the area of properties. The following figure shows the location of the existing faulting in the San Diego County and Southern California region. The fault traces are shown as solid, dashed and dotted that represent well-constrained, moderately constrained and inferred, respectively. The fault line colors represent fault with ages less than 150 years (red), 15,000 years (orange), 130,000 years (green), 750,000 years (blue) and 1.6 million years (black).

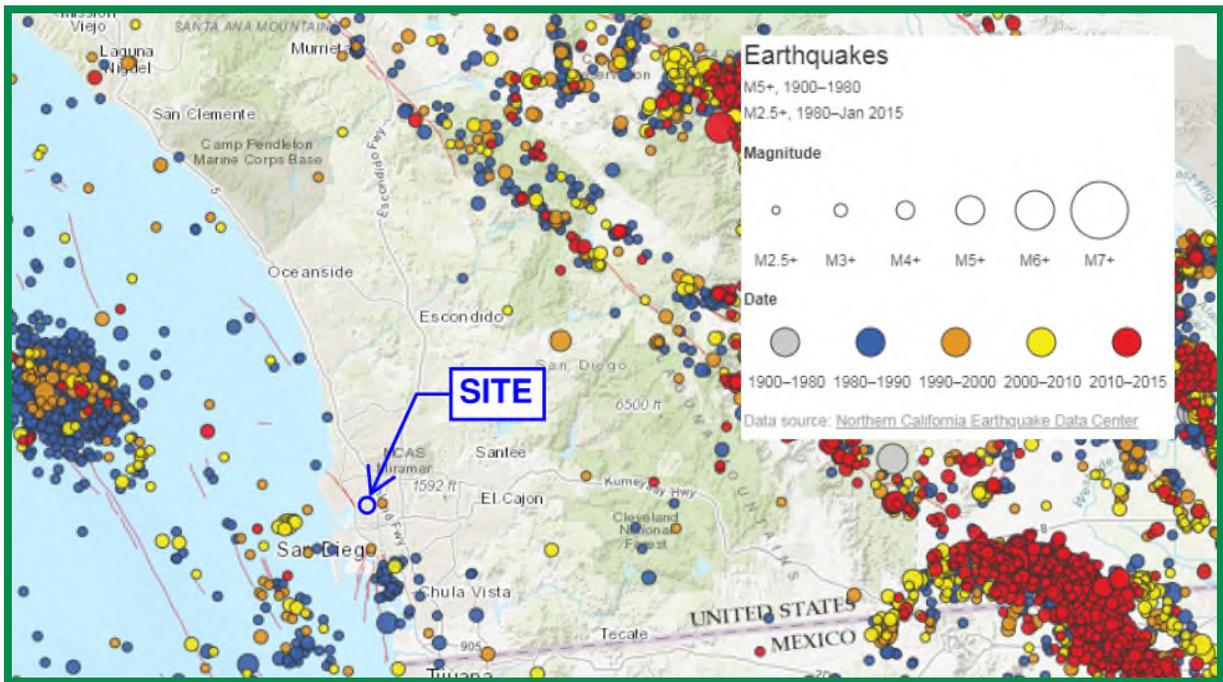
Earthquakes in Southern California

The San Diego County and Southern California region is very seismically active. The following figure presents the occurrence of earthquakes with a magnitude greater than 2.5 from the period of 1900 through 2015 according to the Bay Area Earthquake Alliance website.

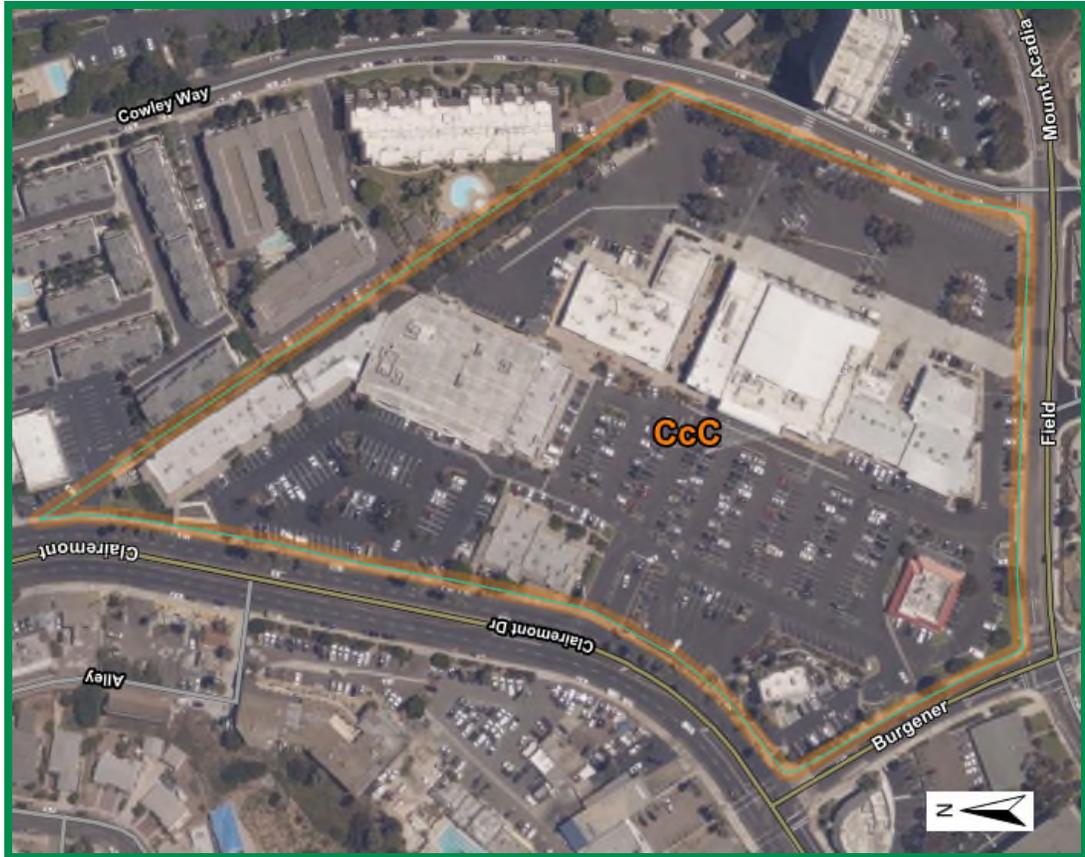
- 8.5.3 The Hydrologic Soil Group Map presents output from the USDA website showing the limits of the soil units.

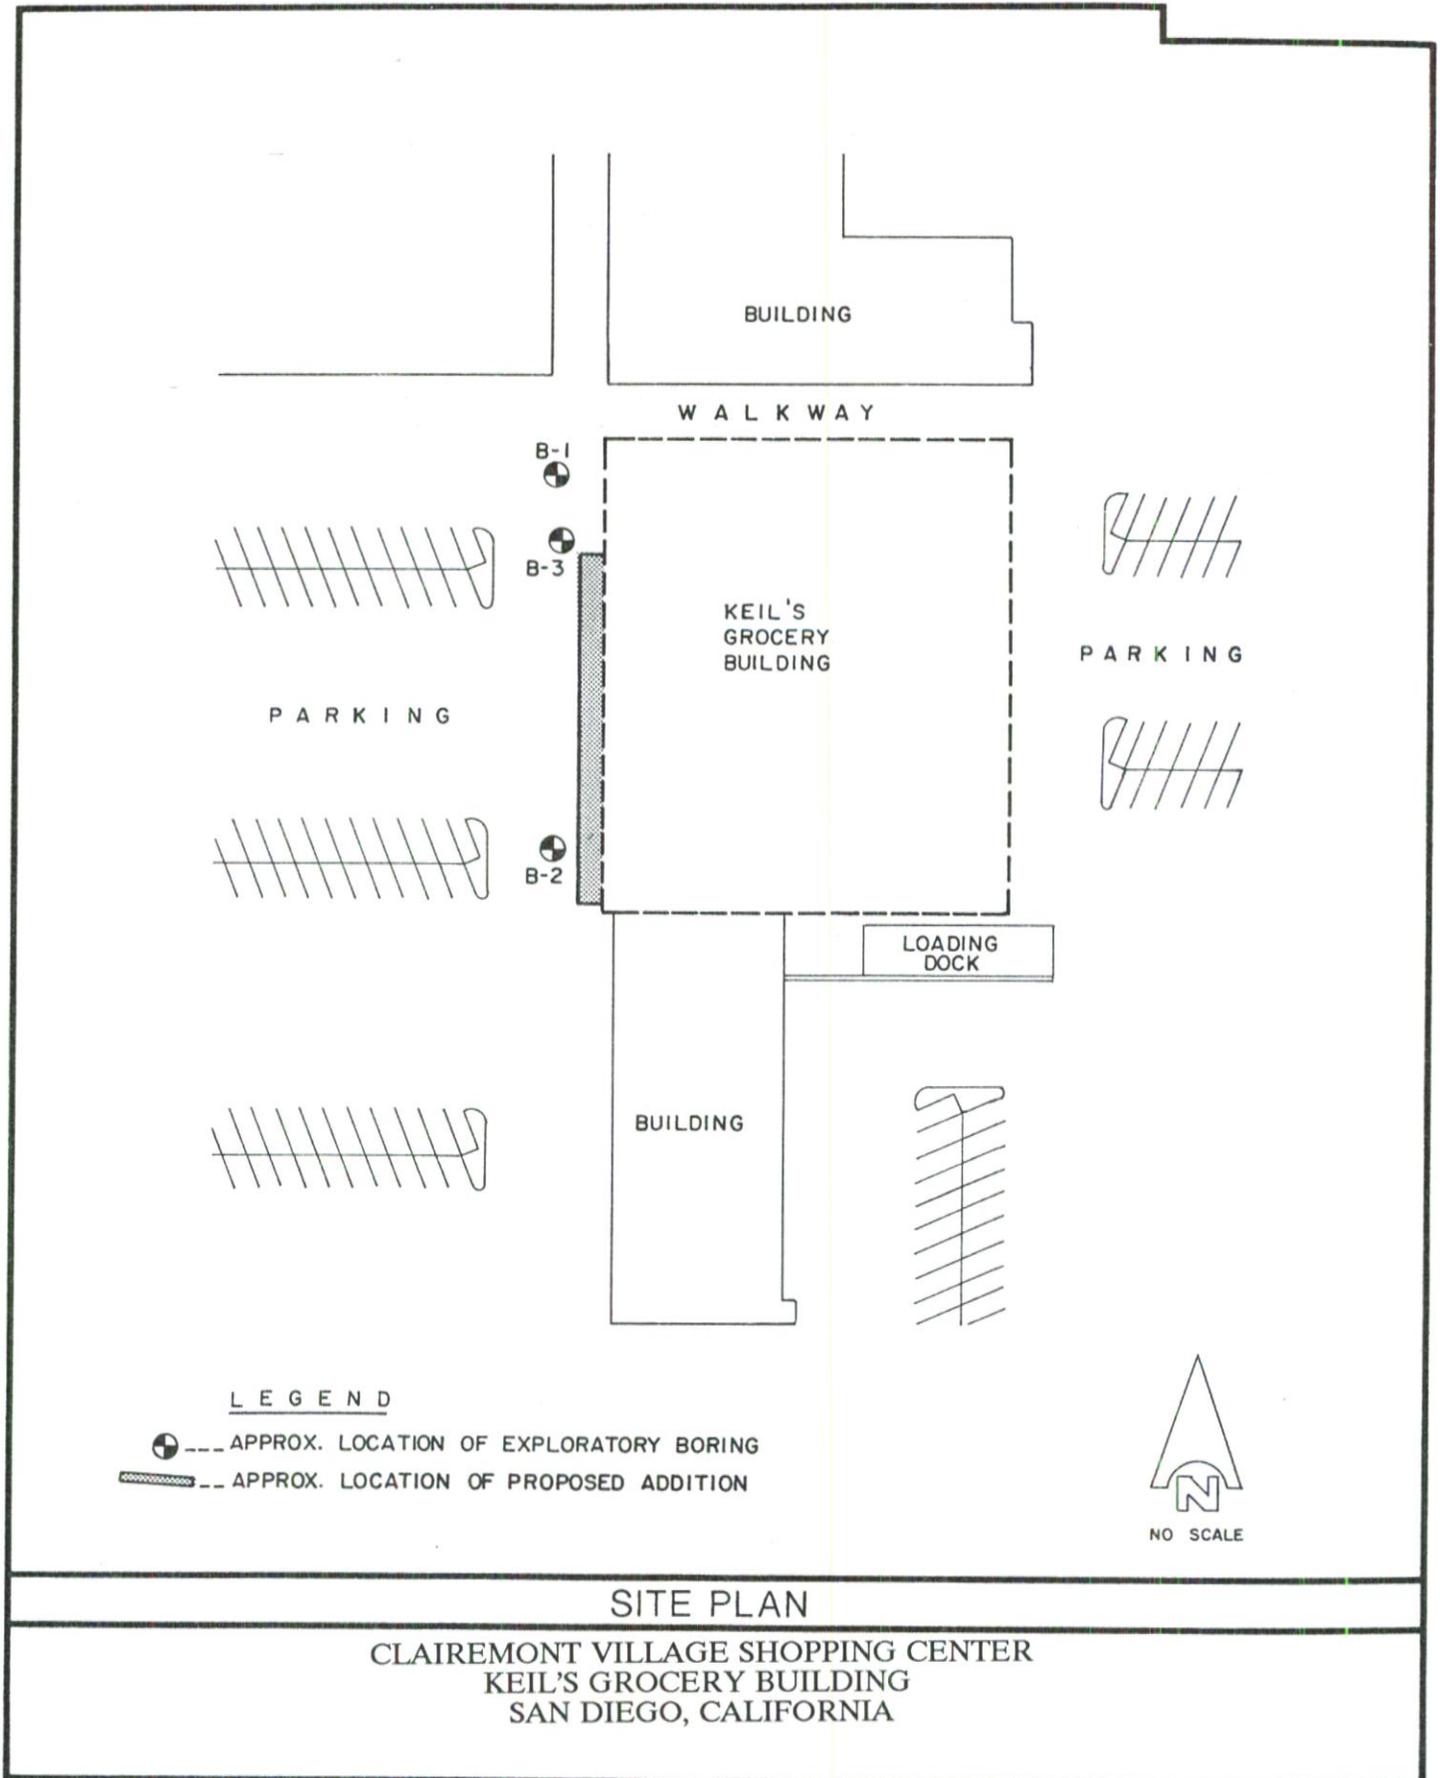
Figure 2

DEPTH IN FEET	SAMPLE NO.	LITHOLOGY	GROUNDWATER	BORING B 1		PENETRATION RESISTANCE (BLOWS/FT.)	DRY DENSITY (P.C.F.)	MOISTURE CONTENT (%)
				SOIL CLASS (USCS)	ELEVATION _____ DATE COMPLETED <u>10/22/90</u>			
					EQUIPMENT <u>MOBILE B61 DRILL RIG</u>			
MATERIAL DESCRIPTION								
0		■			ASPHALT/CONCRETE - 2 inches			
2		SM			BASE MATERIAL - 6 inches			
					FILL Loose, slightly moist, reddish brown, fine to medium, Silty <u>SAND</u> , with trace clay -Encountered brick, reinforced concrete and electrical wire at 2 feet			
					BORING TERMINATED AT 3 FEET

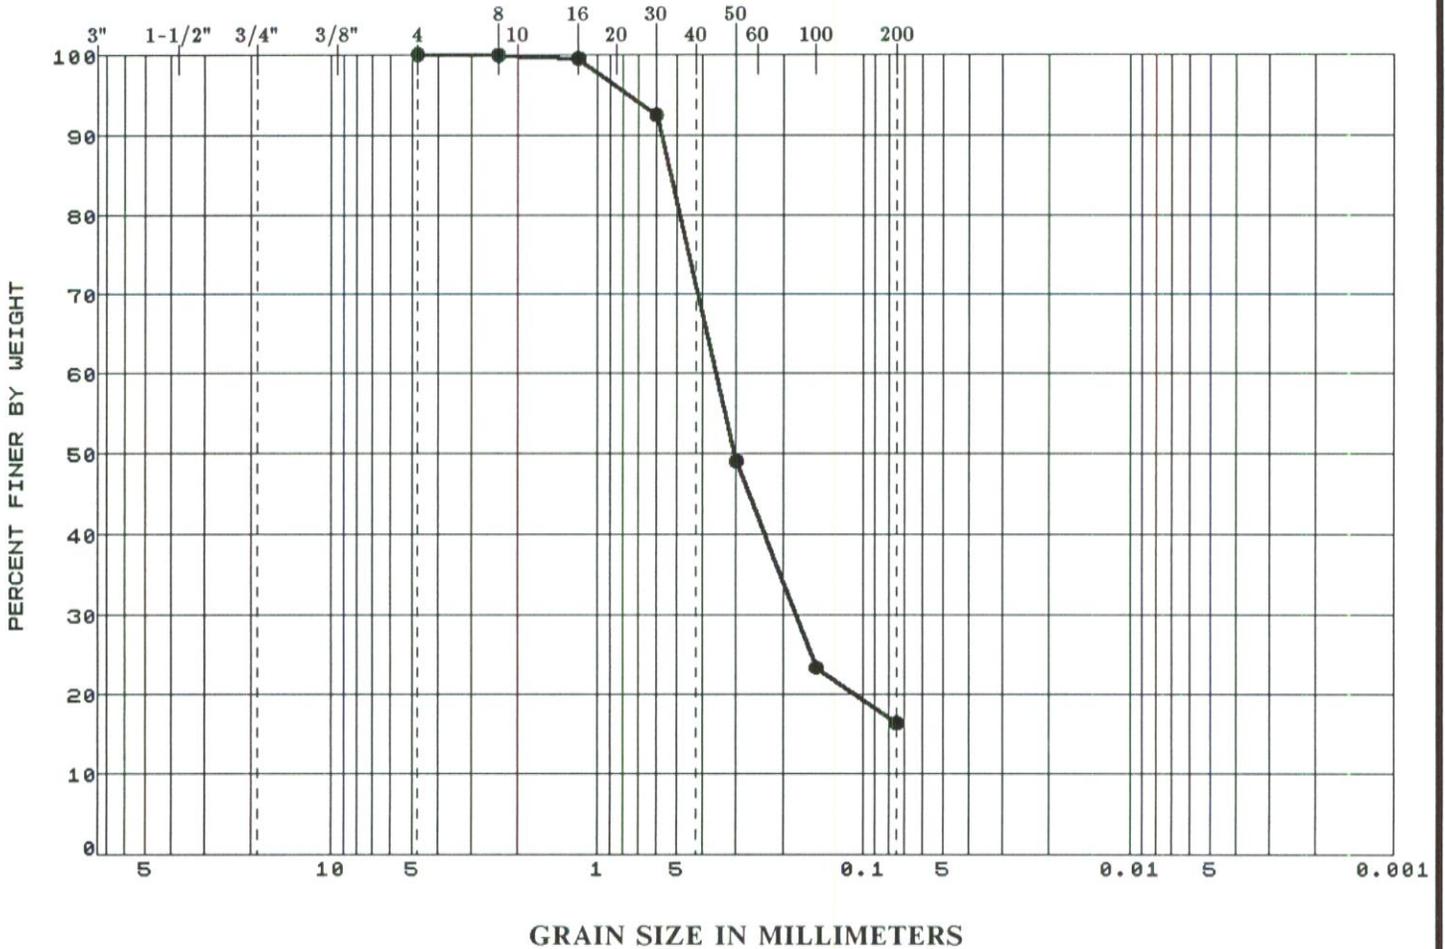
GRADATION CURVE

SAMPLE	Depth (ft)	CLASSIFICATION	NAT WC	LL	PL	PI
● B2-1	3	(SM) Silty, fine to medium SAND

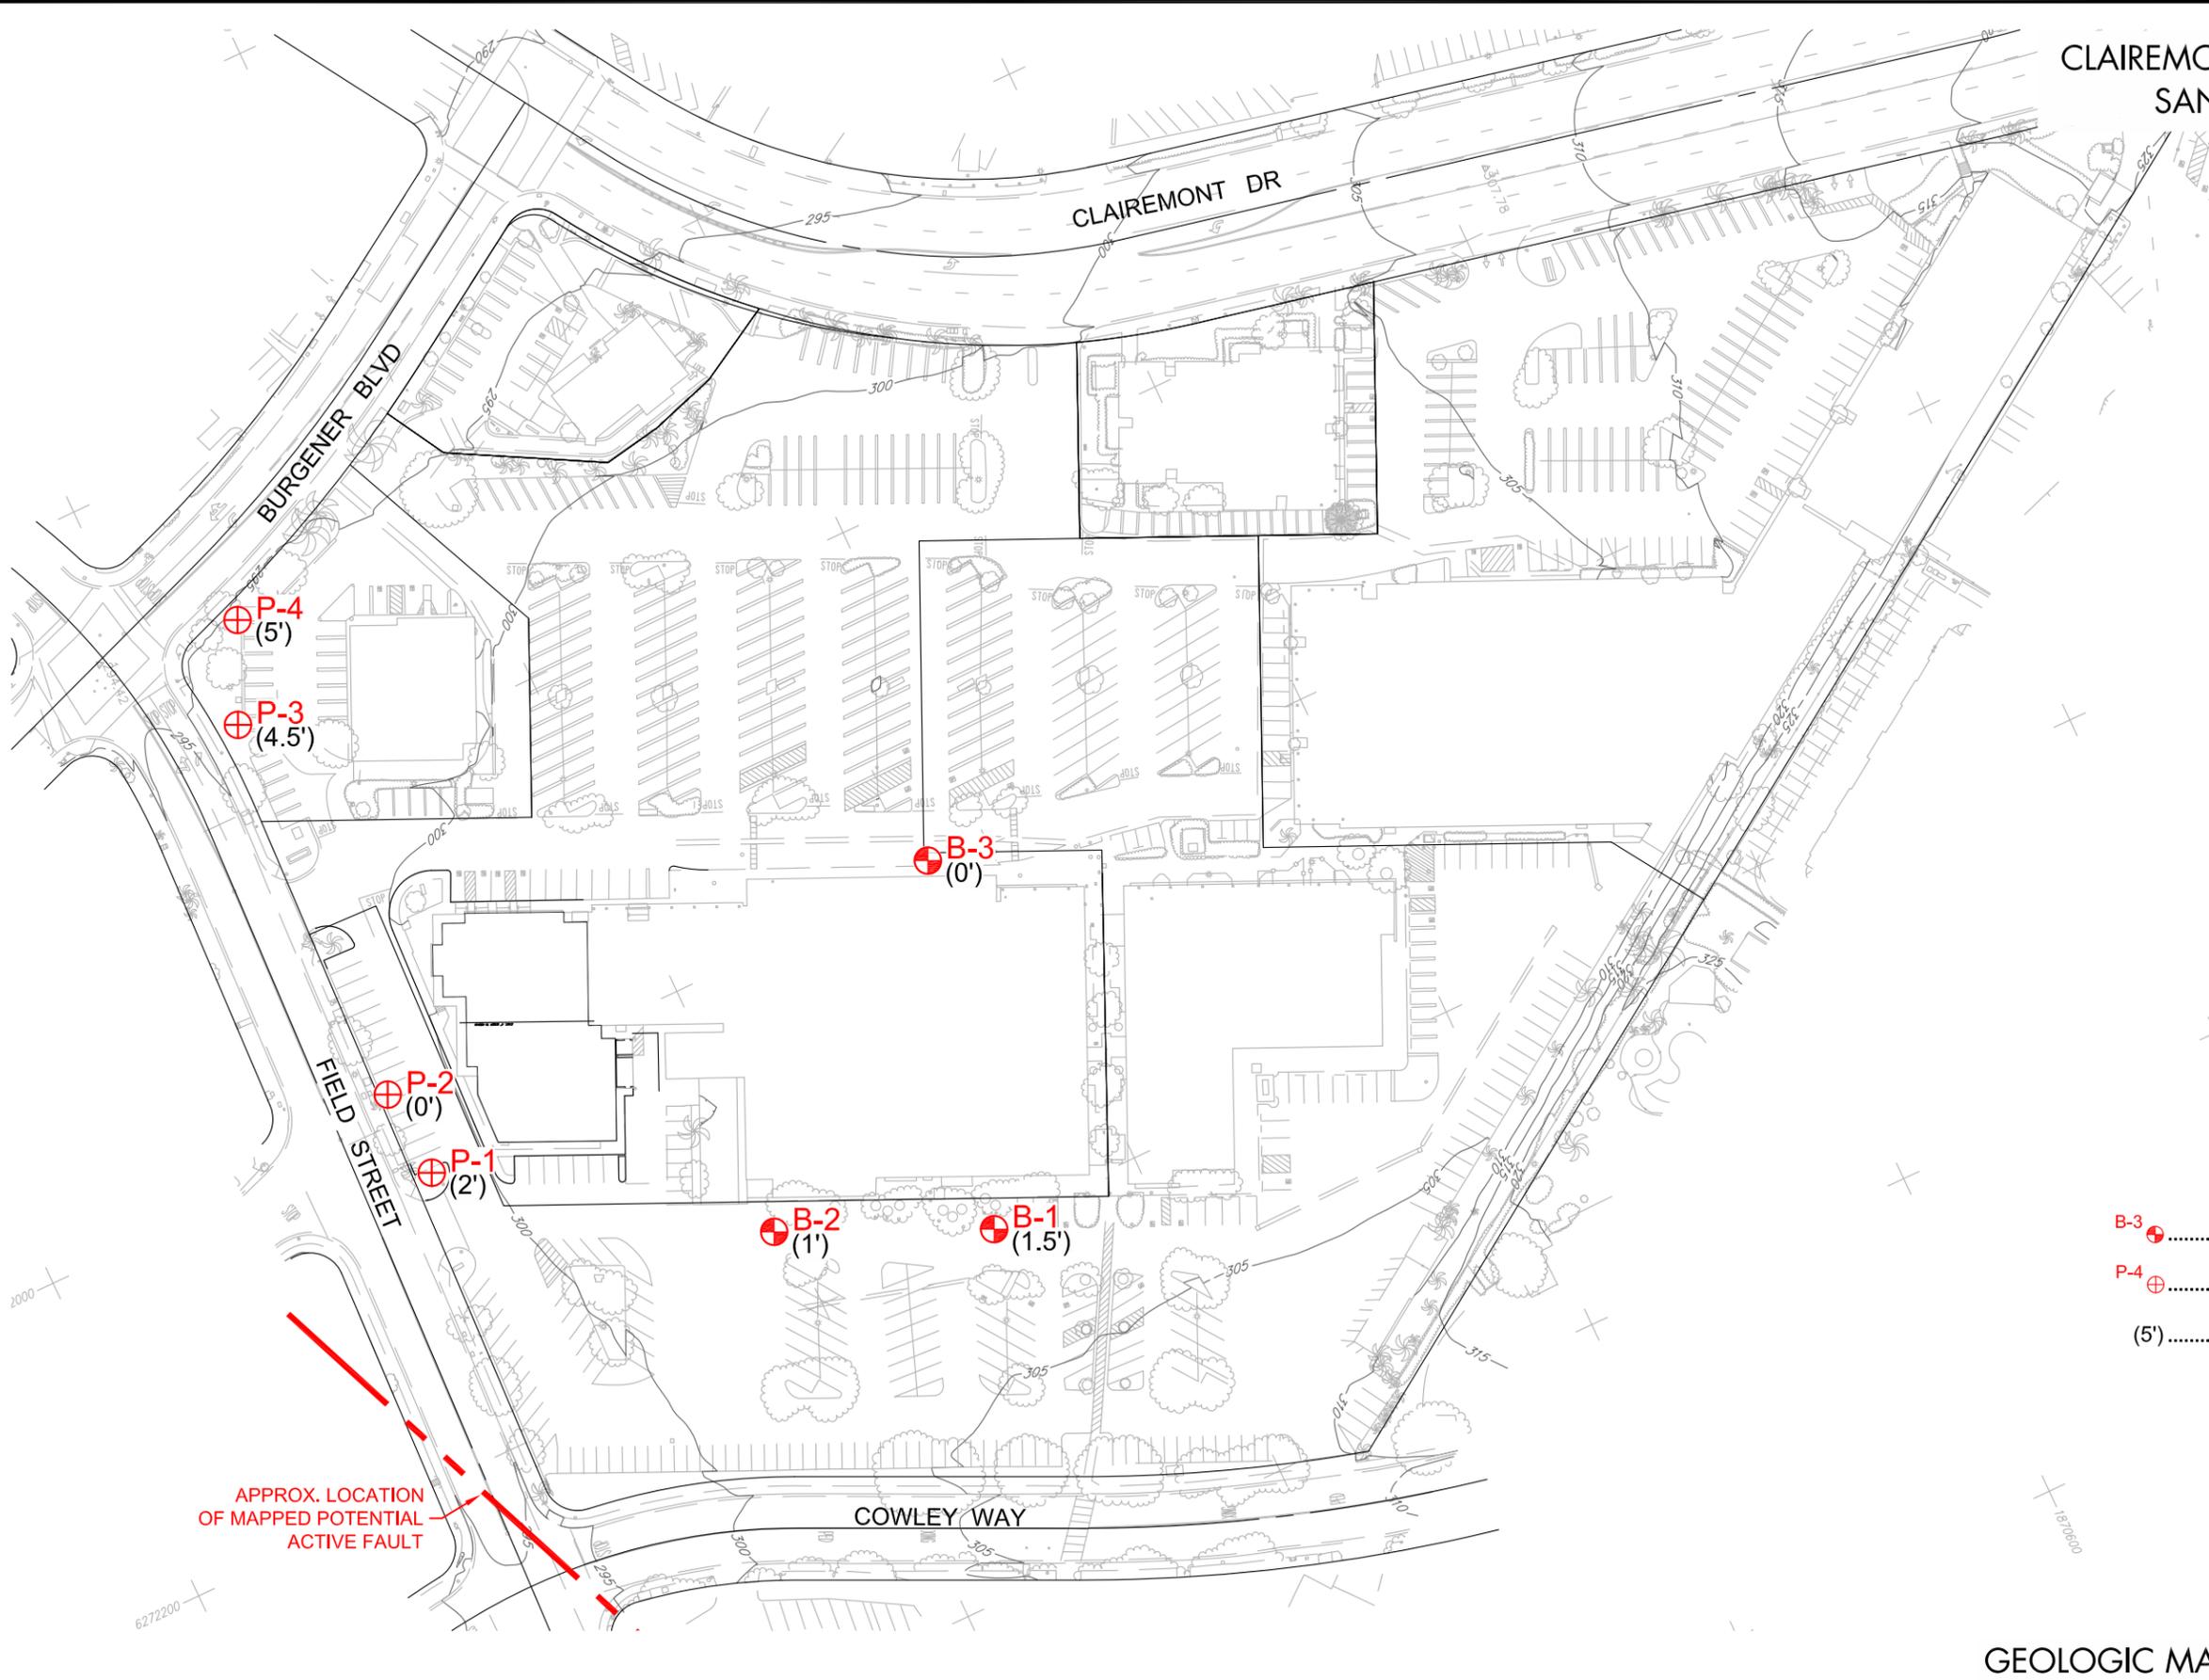
- B-3 ⊕APPROX. LOCATION OF EXPLORATORY BORING
- P-4 ⊕APPROX. LOCATION OF PERMEABILITY TEST
- (5')APPROX. DEPTH TO FORMATION (Feet)

We performed geotechnical borings in 2016 for a proposed remodel and pavement improvements to the existing grocery store as shown in Appendix C. The borings were located within the drive lanes at the east and west sides of the existing grocery store building. We also performed borings for infiltration testing along the south side of the property near Field Street and southwest of the Carl's Jr. building near Field Street and Burgener Boulevard. The borings performed for that investigation indicate that in the vicinity of the grocery building the depth of existing compacted fill/depth to formation ranged from 0 to 2 feet. The two borings located in the landscaped areas southwest of the existing Carl's Jr. building encountered 4½ to 5 feet of fill below existing grade above the formation.

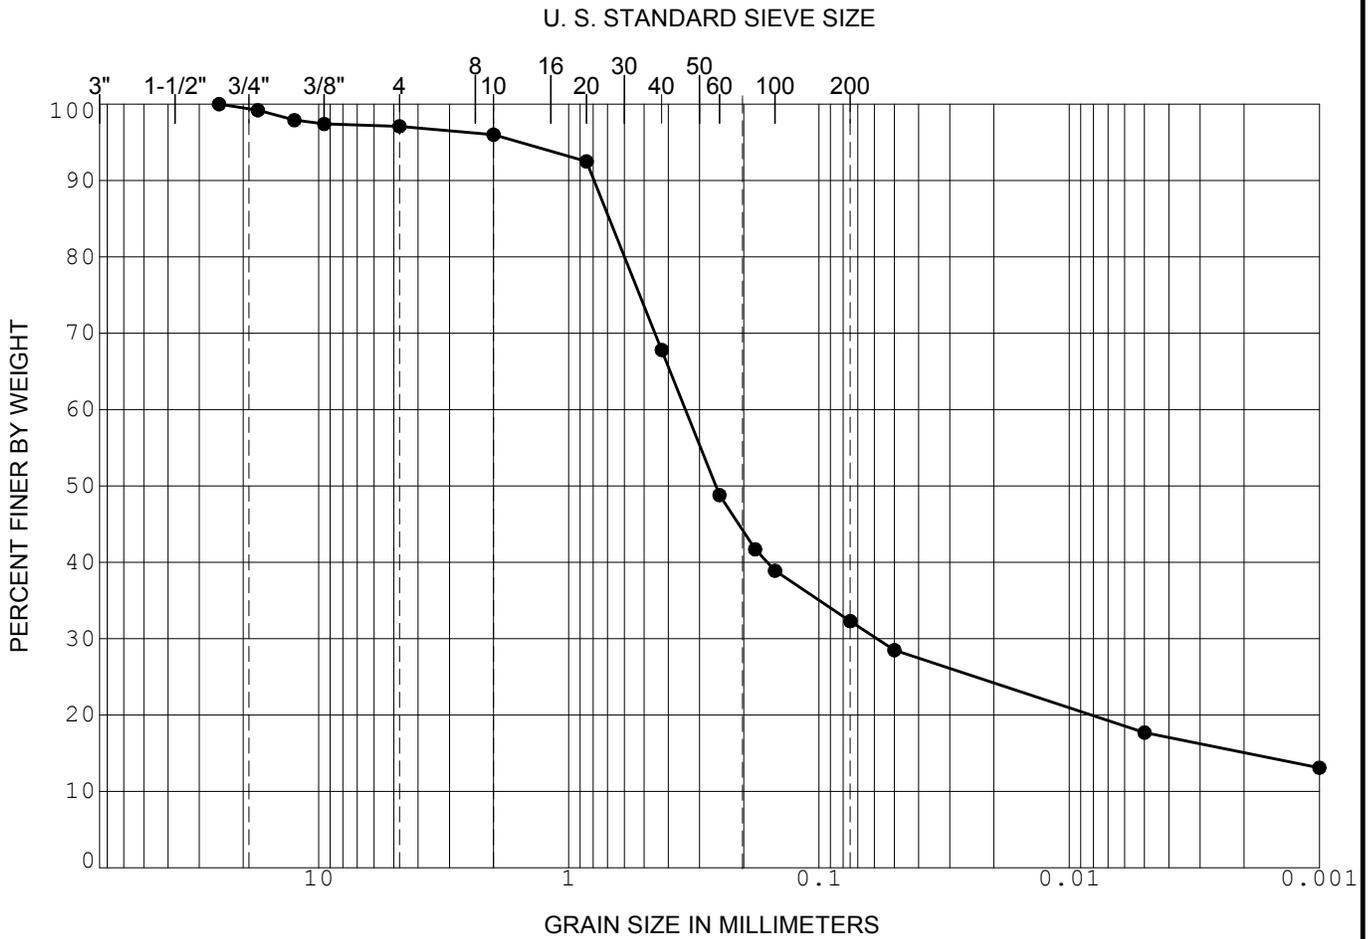
GRADATION CURVE

SAMPLE	DEPTH (ft)	CLASSIFICATION	NAT WC	LL	PL	PI
●	P4-2	8.5	(SM) Silty SAND				
☒							
▲

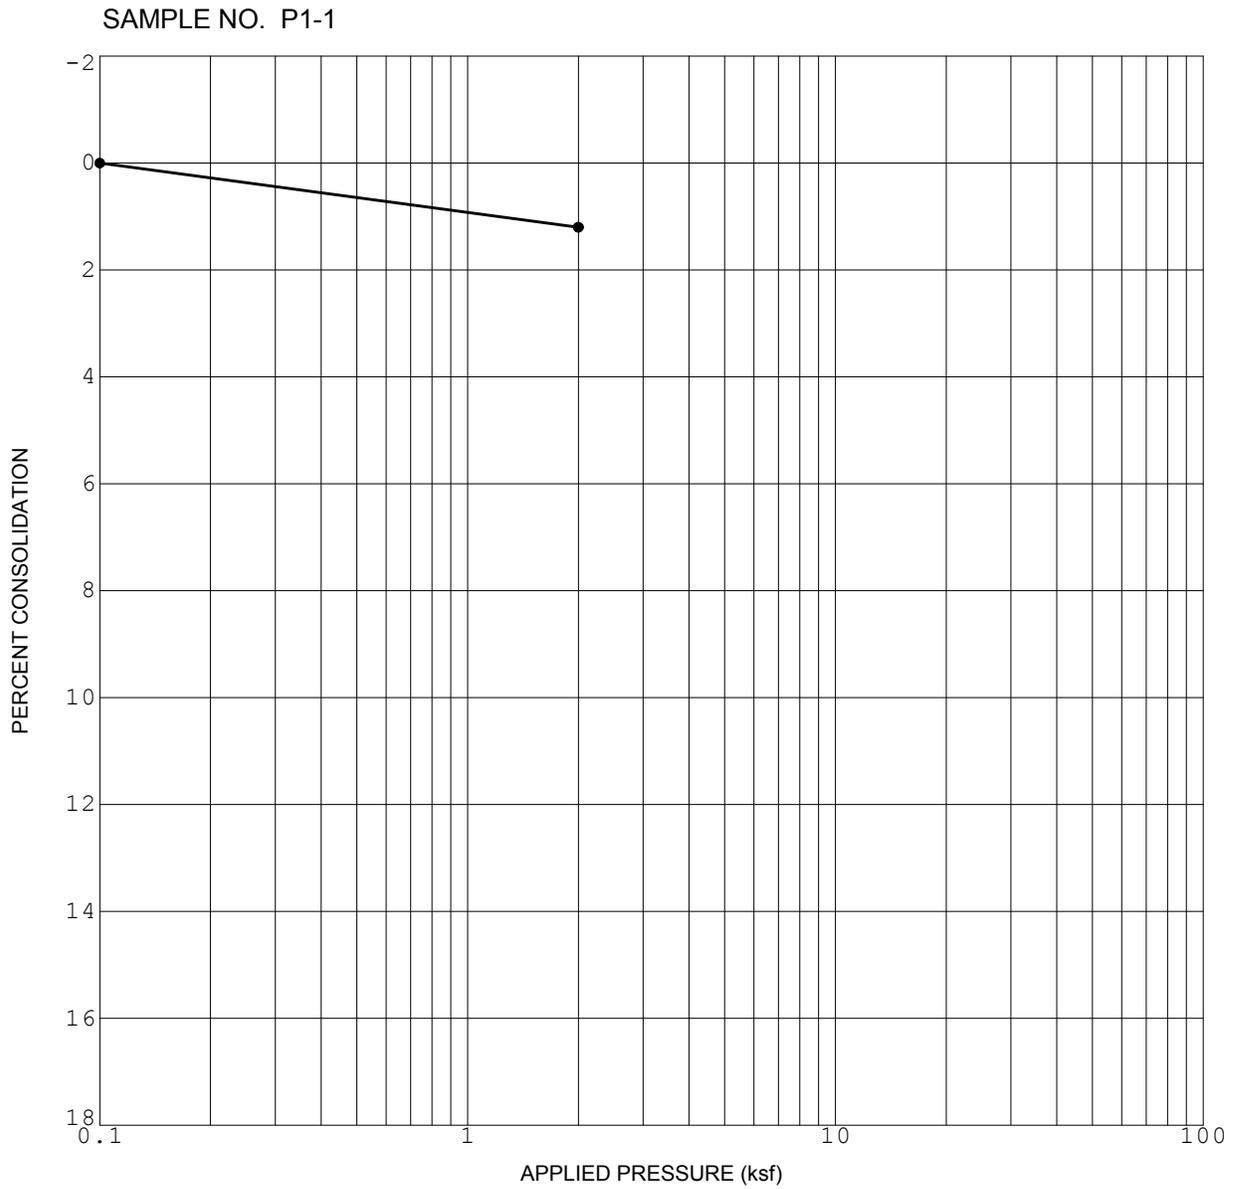
Initial Dry Density (pcf)	117.4
Initial Water Content (%)	15.9

Initial Saturation (%)	100
Sample Saturated at (ksf)	2.0

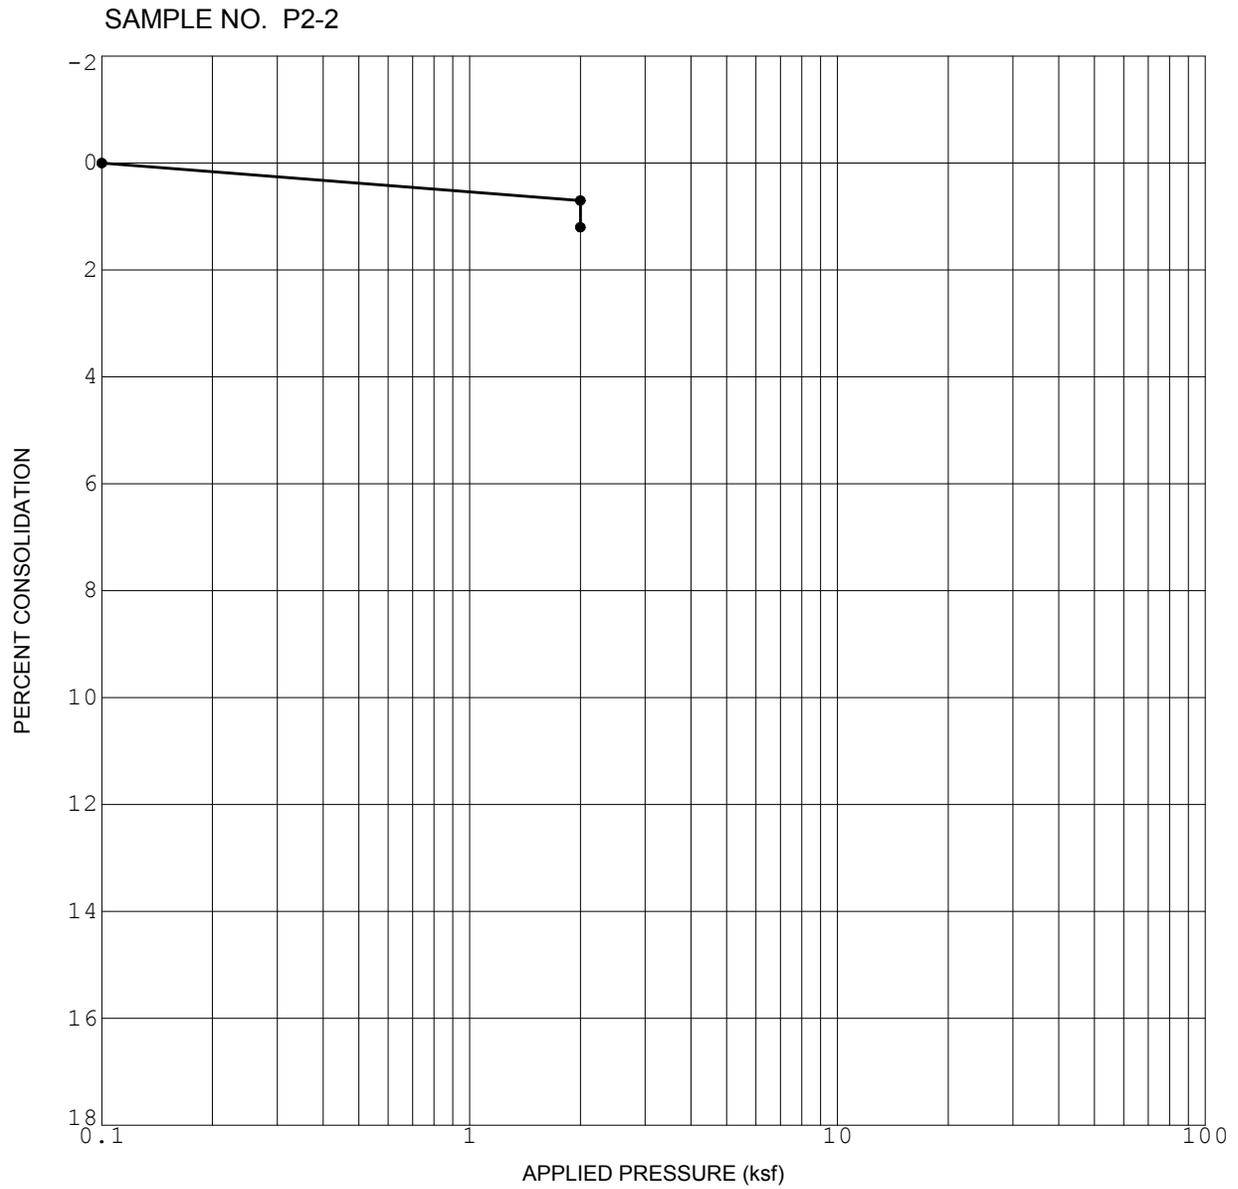
Initial Dry Density (pcf)	115.4
Initial Water Content (%)	10.4

Initial Saturation (%)	63.1
Sample Saturated at (ksf)	2.0

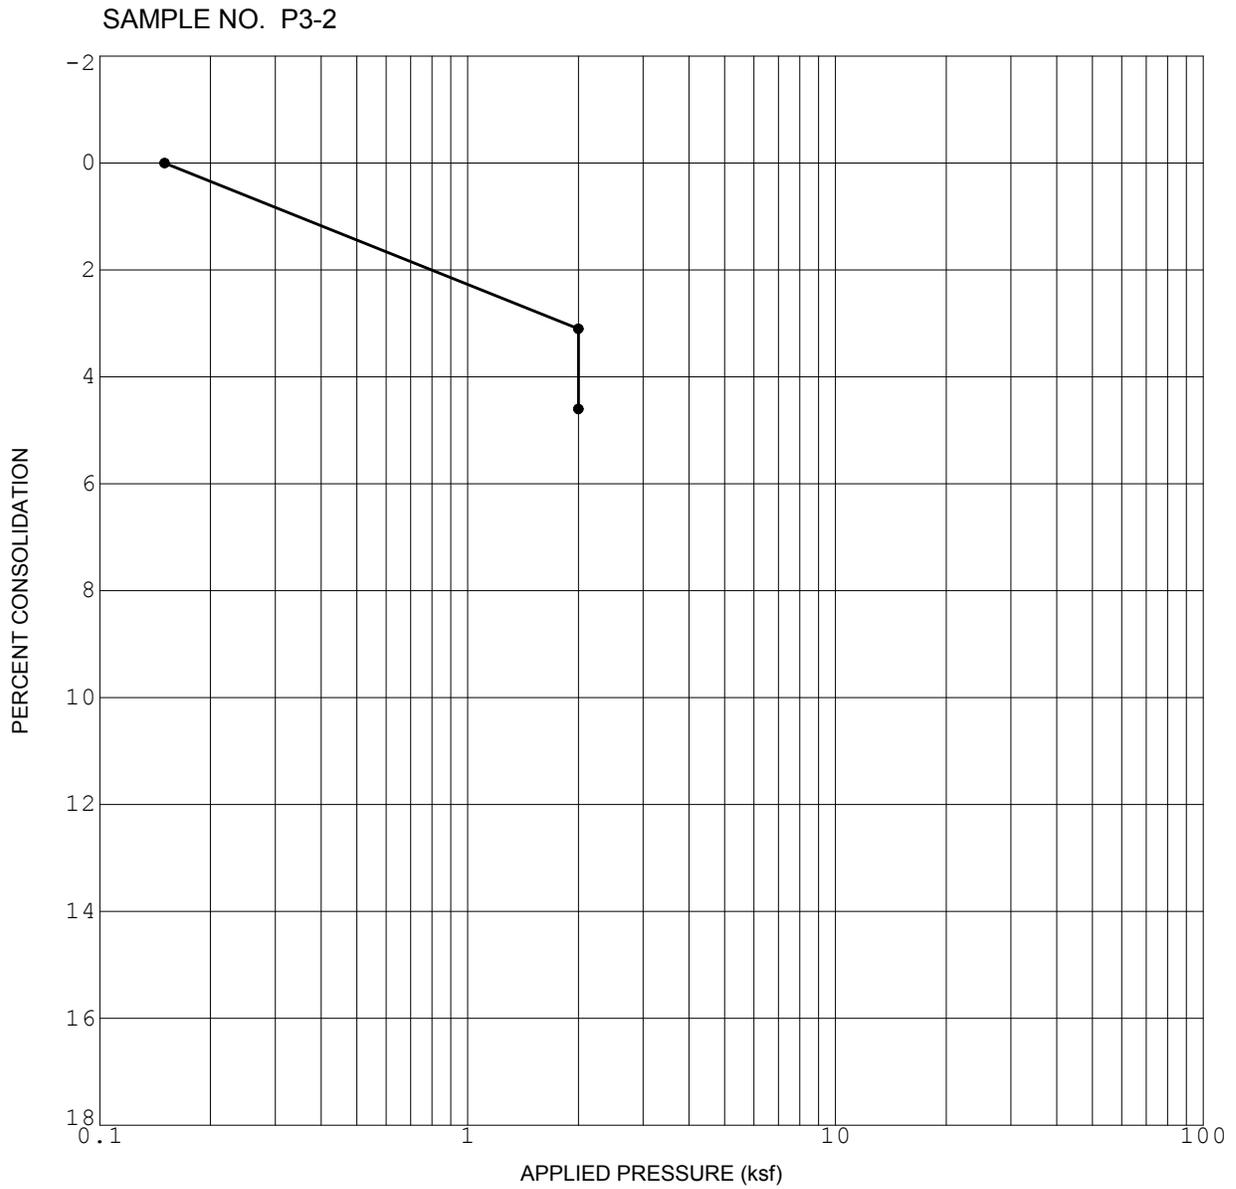
Initial Dry Density (pcf)	107.4
Initial Water Content (%)	11.2

Initial Saturation (%)	54.4
Sample Saturated at (ksf)	2.0
