# **Geotechnical Exploration, Inc.**

#### Subject: Response to DSD-Geology Comments

The Reserve – Romero Subdivision Romero Drive APN 352-300-11-00 La Jolla, California

Report of Geotechnical Investigation – Third Update – October 14, 2022

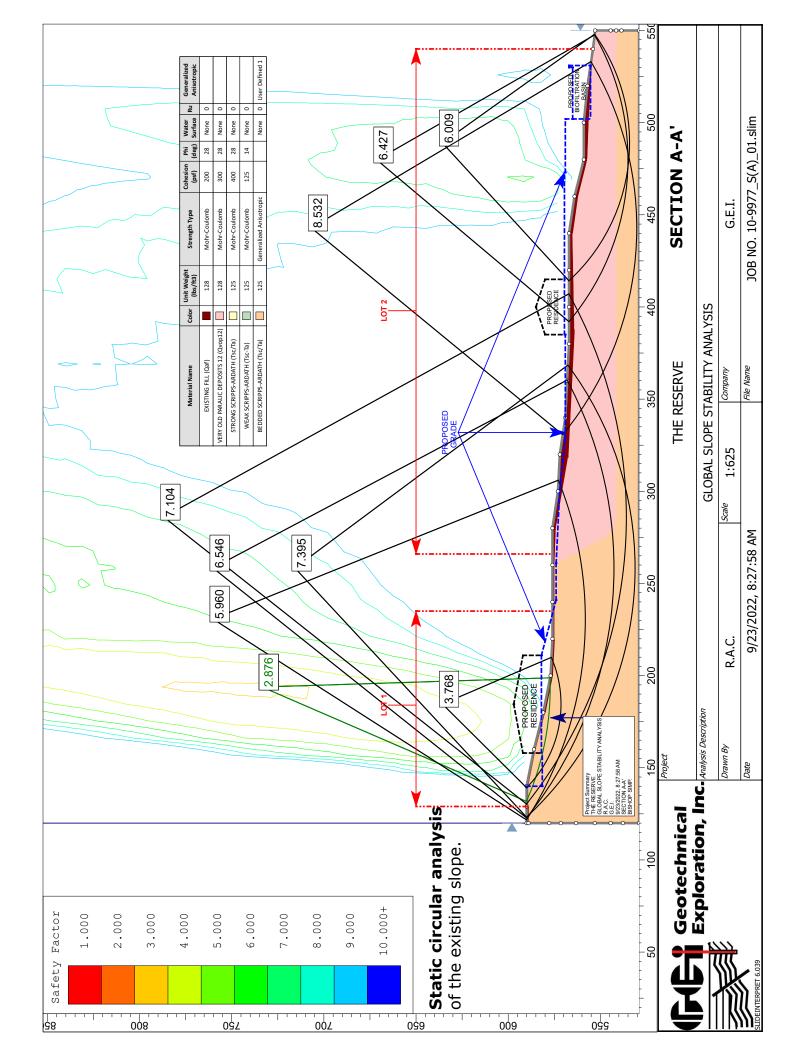
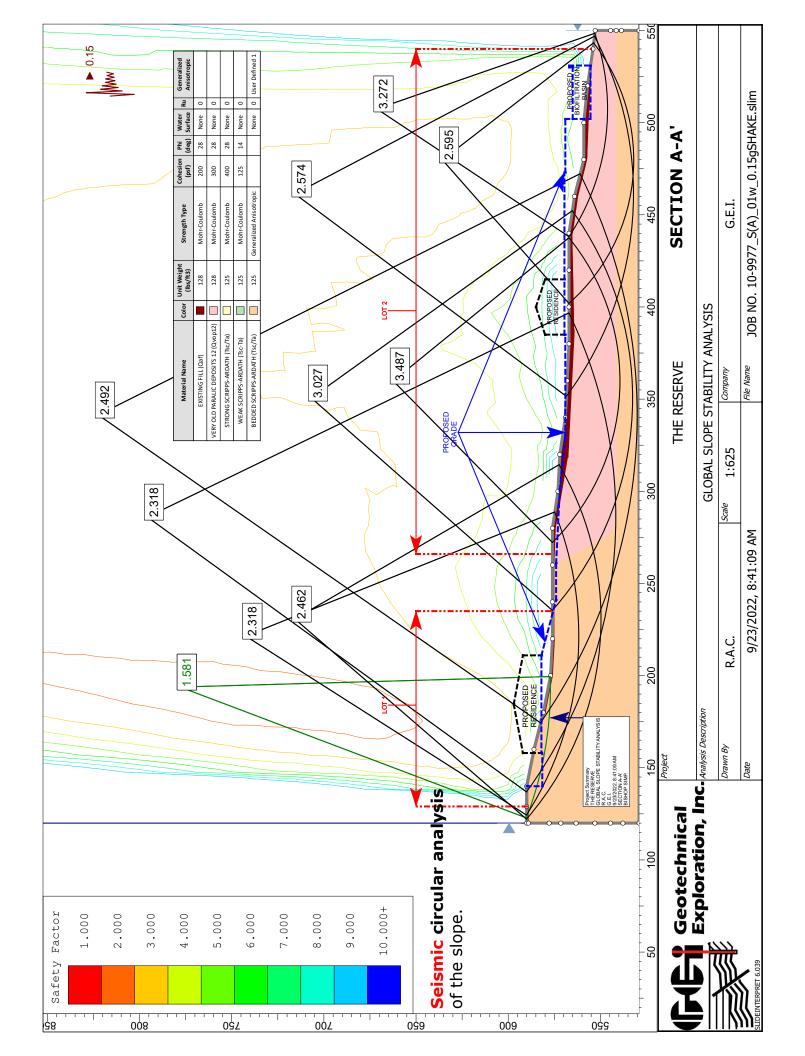
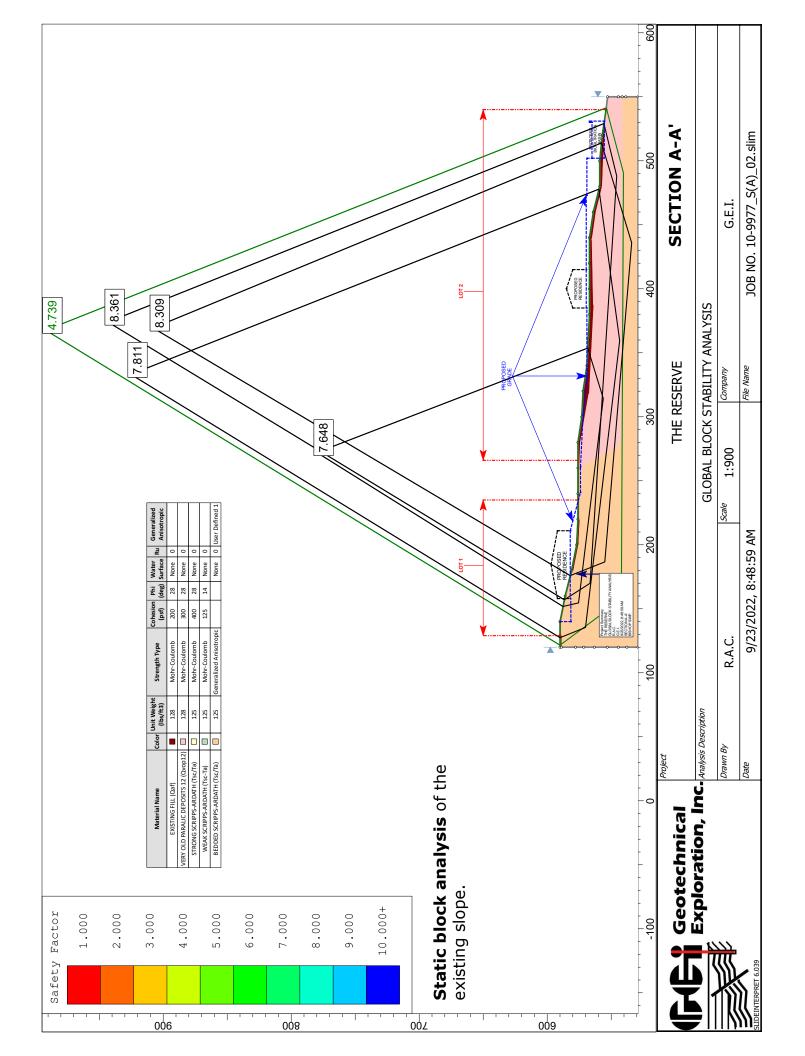
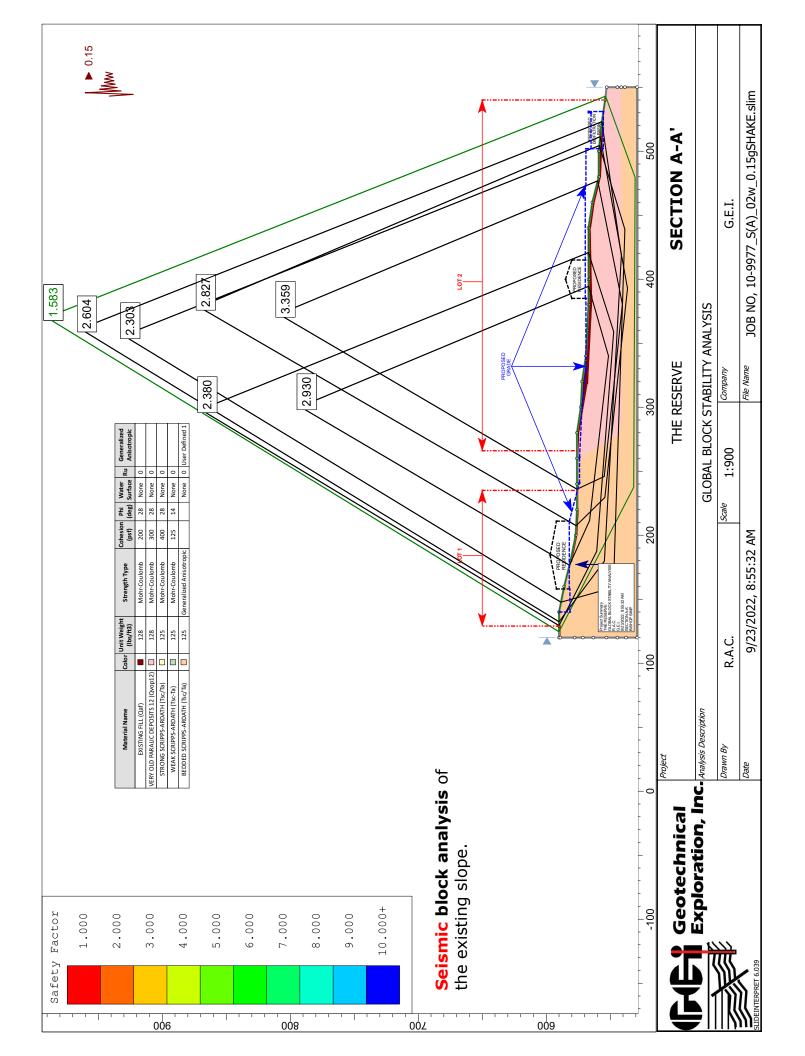
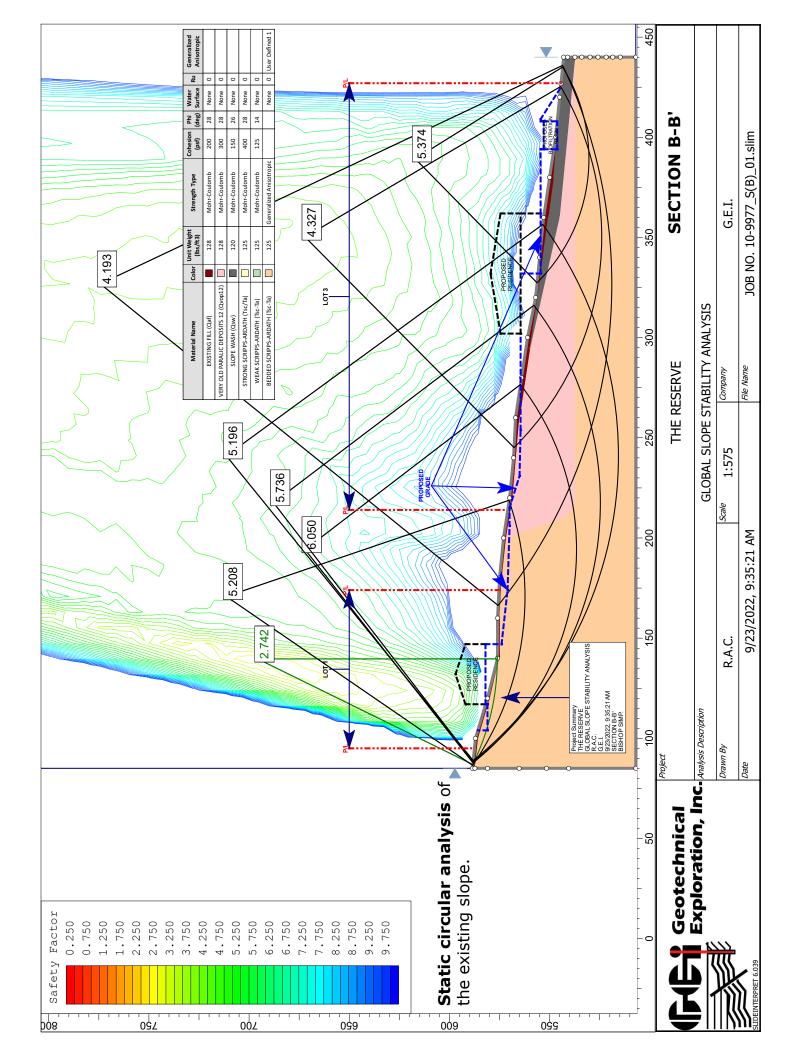
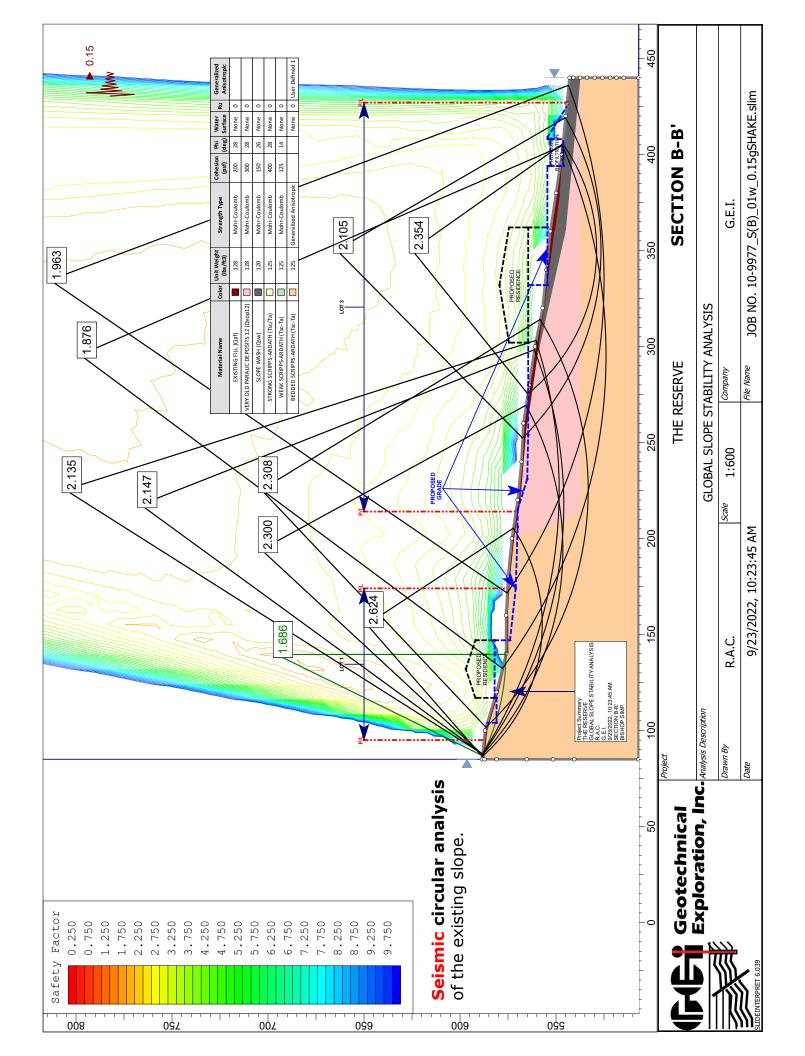
The static gross and surficial slope stability factors of safety were calculated and yielded a factor of safety value above 1.5 and greater for circular and block analyses of the existing slope conditions.

The surficial slope stability calculations not performed since as we have previously stated, the proposed grades are preliminary and until the final grade configurations have been determined, we will provide a surficial slope stability analysis.

We performed gross slope stability calculations using the *SLIDE 6* program by Roc Science. The program is a limit equilibrium method, slope stability program that allows the use of several slope stability methods to calculate the factors of safety against shear failure. On this project, the Bishop Simplified method was used as the basis for calculations when using circular slide and block glide surfaces for analysis through the site geologic cross sections.

The program calculates the factor of safety against shear failure for potential slide surfaces over a selected range. We chose the range of slide surfaces where failures are most likely to occur. The printout shows a block with contours of different colors and shades that correspond to the different factors of safety calculated that can be obtained for the analyzed range of slide surfaces for Section A-A', B-B', C-C', D-D', and E-E' which include the most unfavorable slope conditions at the site (see attached printouts). The green circular or block surface with the green value displayed in the printout is the lowest possible factor of safety located within the search range of each analysis. Soil strength values, geometry, and water conditions (seepage was not encountered) used in the program were based on geological information at the site, obtained by our project geologist. Direct shear test results from the on-site soils were performed and were used for the gross stability analysis. Shear strength values were conservatively adjusted.

The Bishop Simplified method was used to calculate the global shear failure surfaces and the localized circular shear and block failure surfaces of the existing slope surface. It is our understanding that the plans are preliminary and have not been finalized. Once finalized, we will analyze the slope with its proposed configuration accordingly.
