Project No. 07516-42-02
February 9, 2022

Subject: ADDENDUM GEOTECHNICAL REPORT AND
RESPONSE TO CITY OF SAN DIEGO REVIEW COMMENTS
NAKANO
SAN DIEGO, CALIFORNIA

We prepared this addendum to provide an updated geologic map and to respond to review comments from the City of San Diego, LDR-Geology department (Reference 1). The updated geologic map and the log from a recent boring and test pit are appended. The review comments and our responses are presented below.

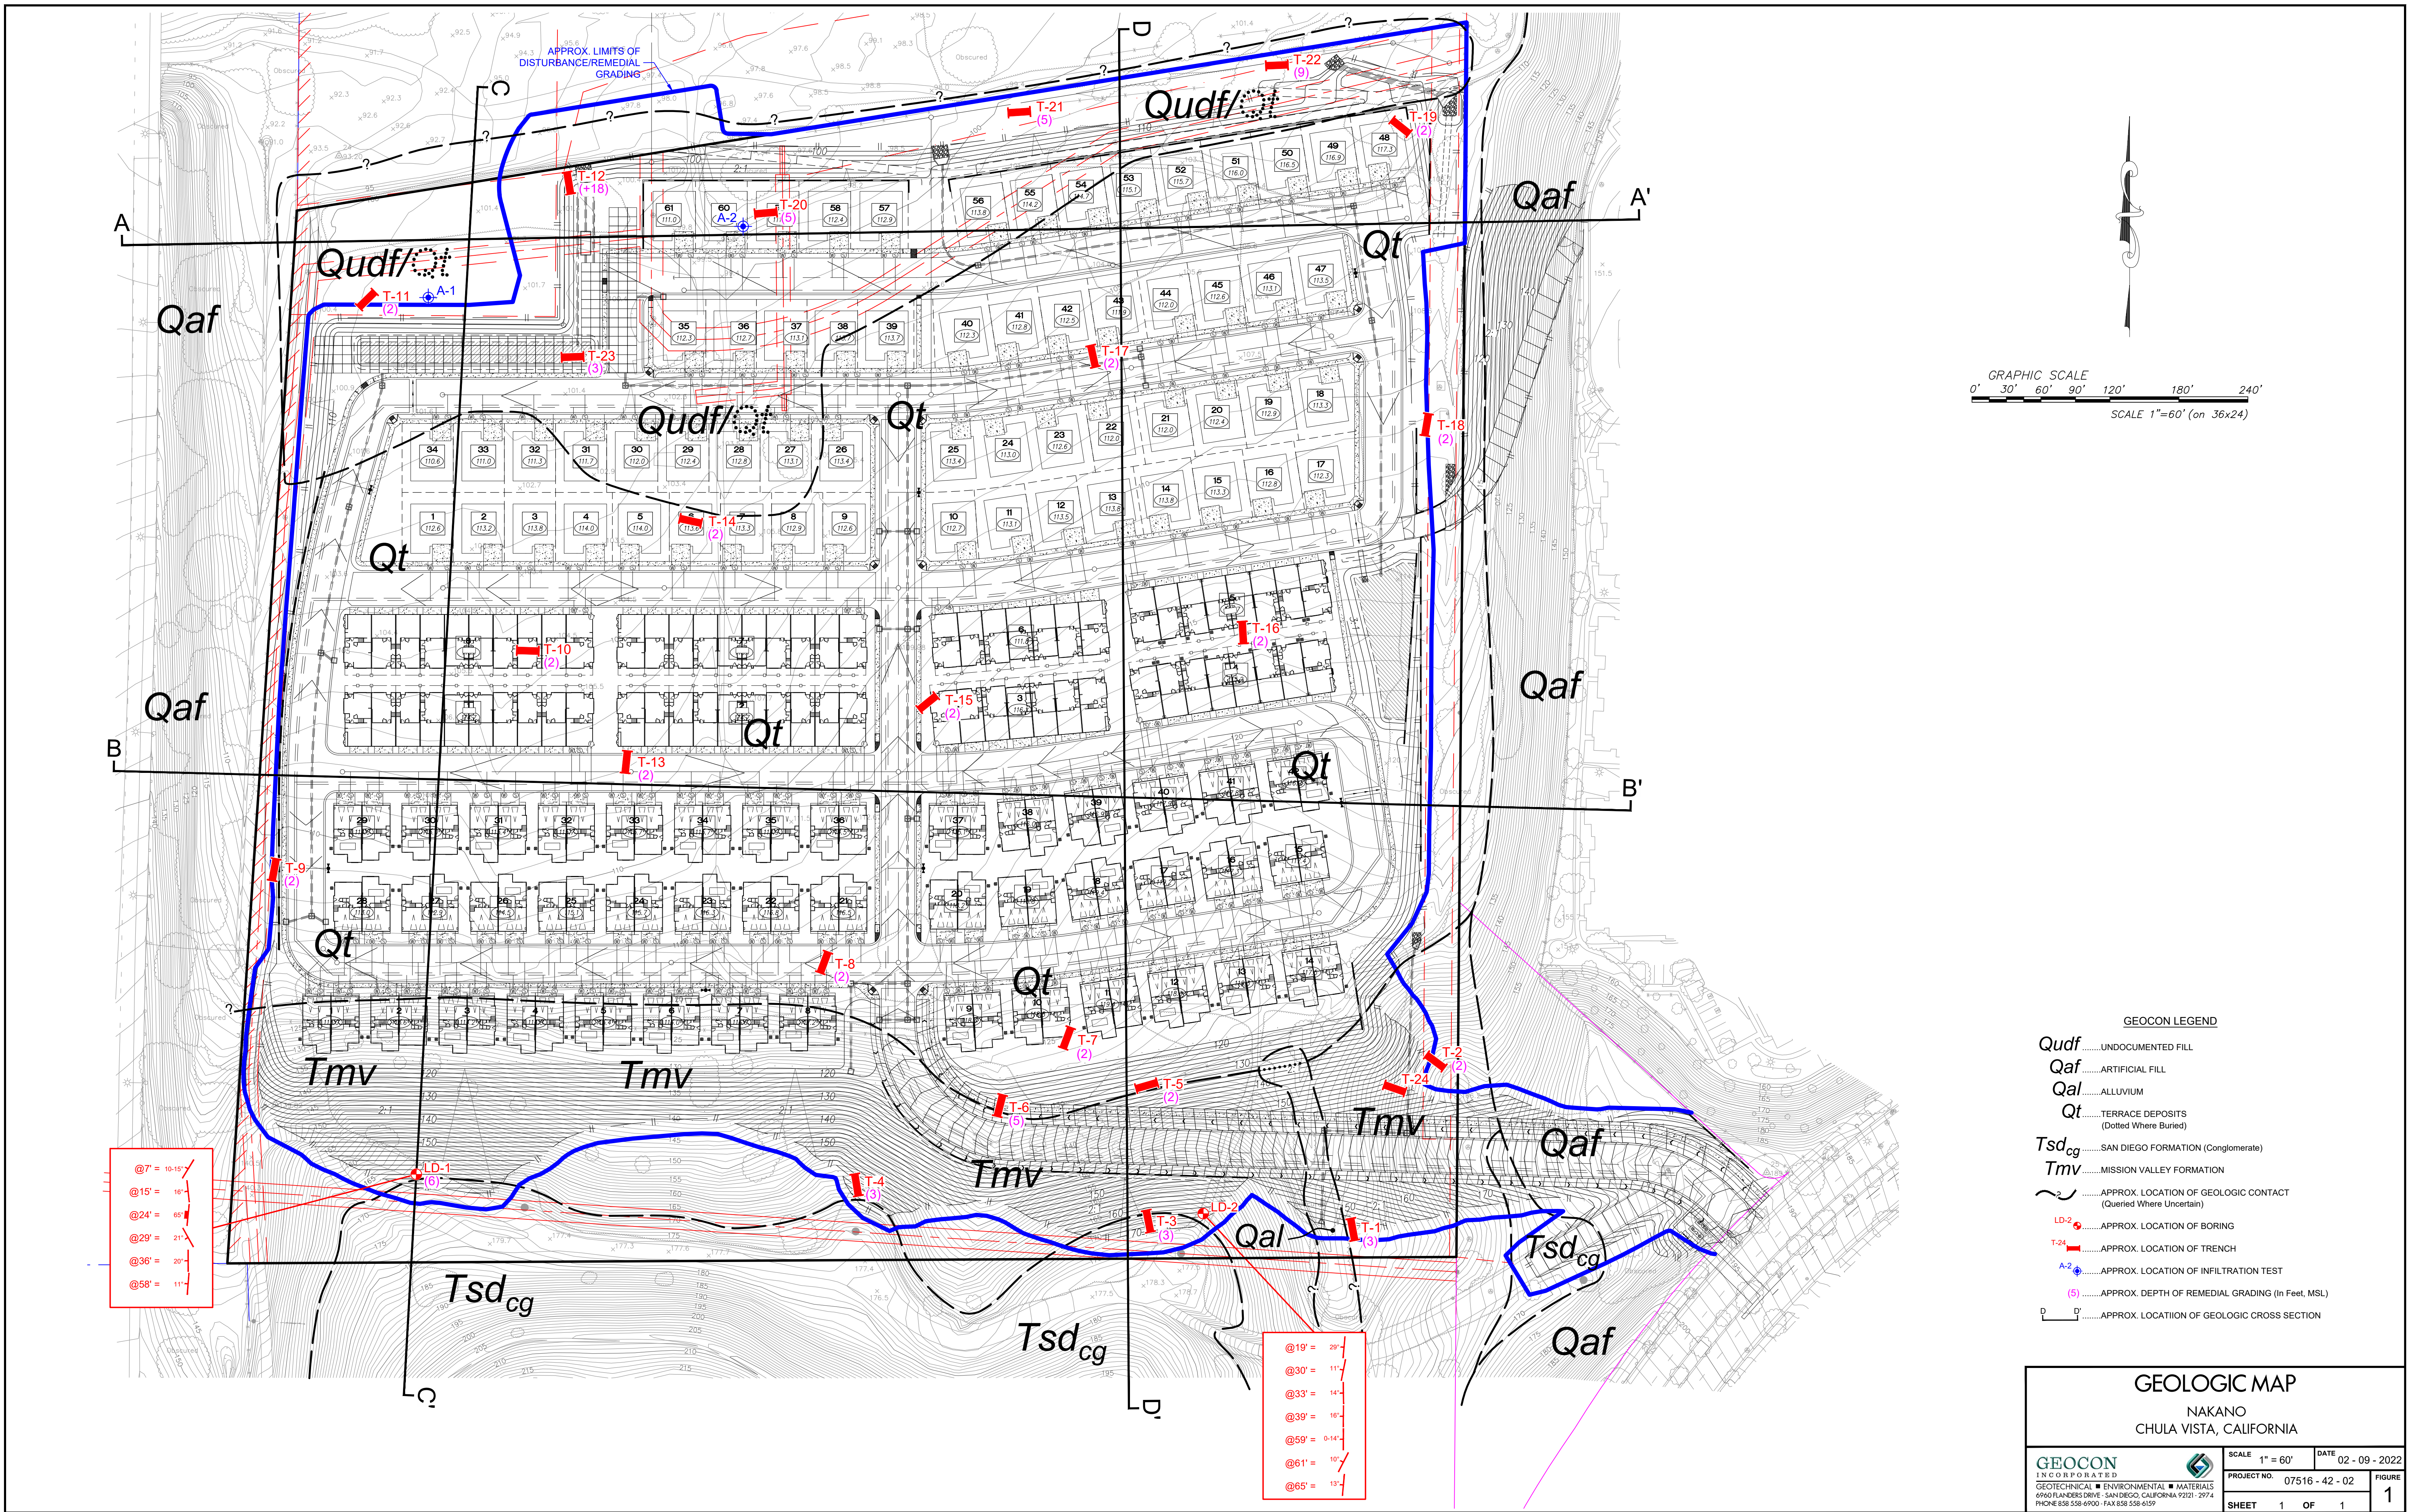
GEOCON INCORPORATED GEOTECHNICAL ■ ENVIRONMENTAL ■ MATERIALS 6940 ANDERS DRIVE ■ SAN DIEGO, CALIFORNIA 92121-2974 PHONE 858.558.4900 ■ FAX 858.558.6159	SCALE 1" = 60'	DATE 02 - 09 - 2022
	PROJECT NO. 07516 - 42 - 02	FIGURE 1
	SHEET 1 OF 1

- Qudf* UNDOCUMENTED FILL
- Qaf* ARTIFICIAL FILL
- Qal* ALLUVIUM
- Qt* TERRACE DEPOSITS
(Dotted Where Buried)
- Tsd_{cg}* SAN DIEGO FORMATION (Conglomerate)
- Tmv* MISSION VALLEY FORMATION
- ~ APPROX. LOCATION OF GEOLOGIC CONTACT
(Queried Where Uncertain)
- LD-2 APPROX. LOCATION OF BORING
- T-24 APPROX. LOCATION OF TRENCH
- A-2 APPROX. LOCATION OF INFILTRATION TEST
- (5) APPROX. DEPTH OF REMEDIAL GRADING (in Feet, MSL)
- 0-0' APPROX. LOCATION OF GEOLOGIC CROSS SECTION

Response: The southeast corner of the property is not underlain by a landslide. A second large diameter boring (LD-2) was drilled to a depth of 70 feet at the east end of the proposed cut slope (Figure 1 and appended boring log). The boring bottom elevation is approximately 16 feet below proposed pad grade at toe of slope. Observations made during downhole logging show similar geologic conditions to those observed in LD-1, i.e., a massive to poorly bedded very fine-grained silty sandstone dipping approximately 14 degrees due west. There are no slide planes, bedding plane shears, or other geologic features indicative of landsliding present in LD-1 or LD-2.

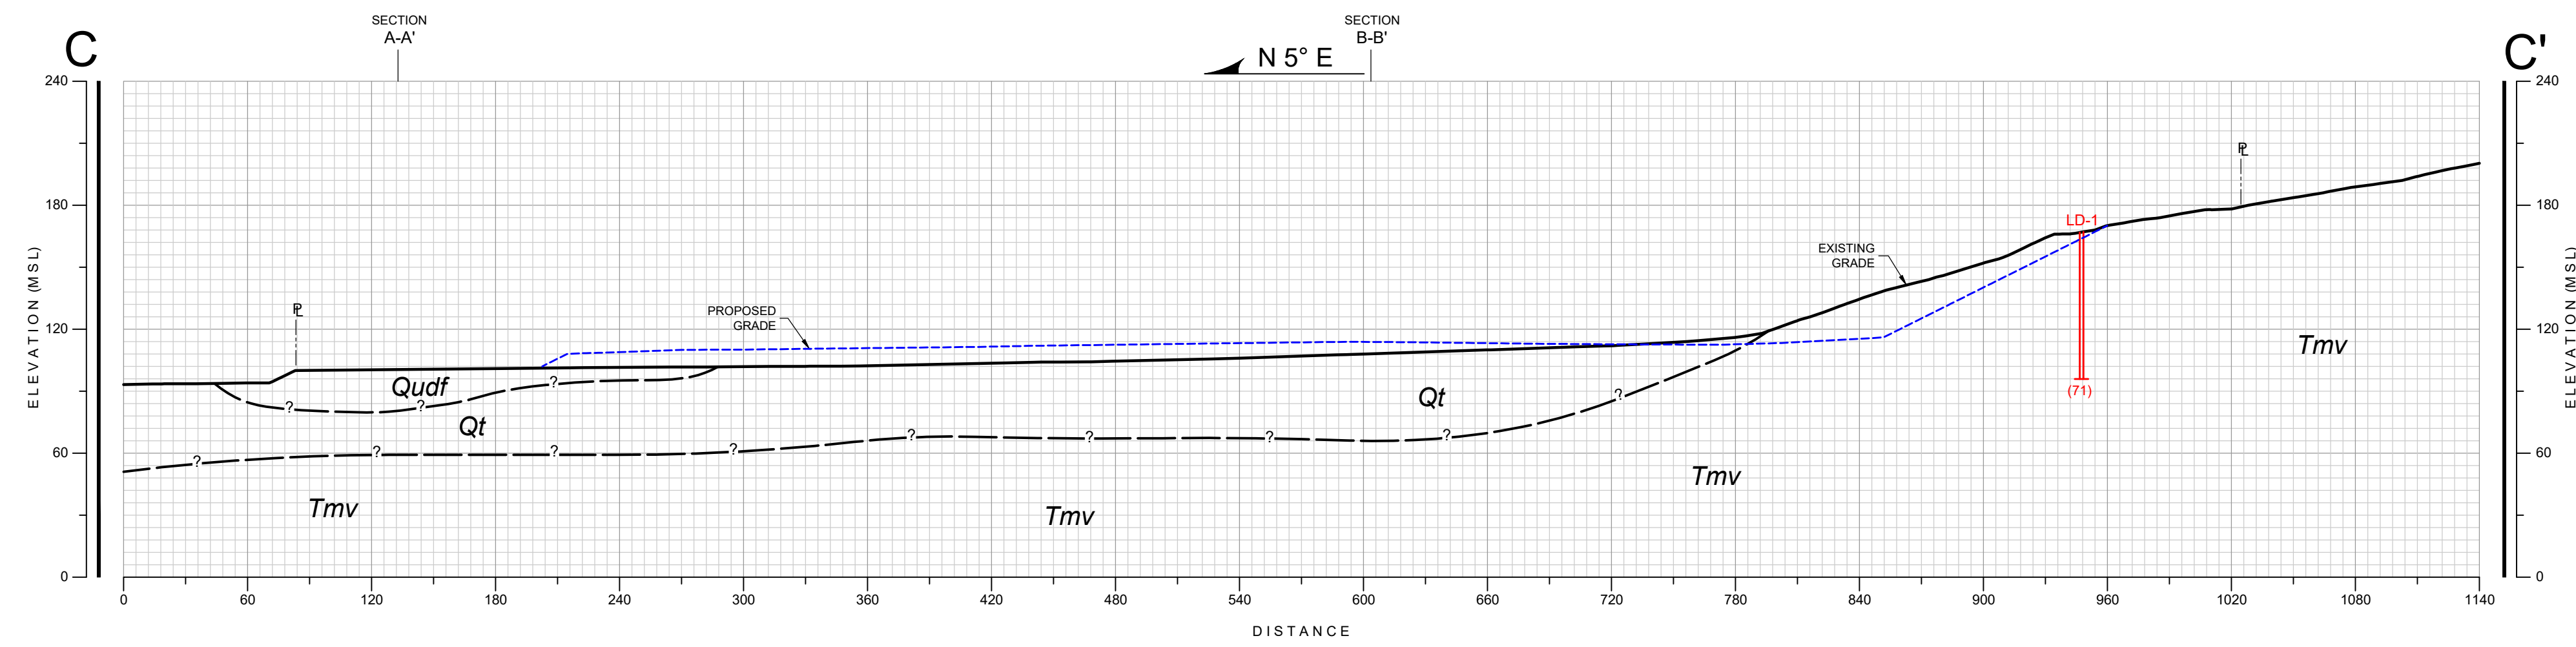
GEOLOGIC CROSS-SECTION C-C'
SCALE: 1" = 60' (Vert. = Horiz.)

- GEOCON LEGEND**
- Qudf* UNDOCUMENTED FILL
 - Qaf* ARTIFICIAL FILL
 - Qt* TERRACE DEPOSITS
 - Tmv* MISSION VALLEY FORMATION
 - ~? APPROX. LOCATION OF GEOLOGIC CONTACT (Queried Where Uncertain)

Response: We performed a seismic slope stability analysis for cross sections C-C' and D-D' in accordance with *Recommended Procedures for Implementation of DMG Special Publication 117: Guidelines for Analyzing and Mitigating Landslide Hazards in California*, prepared by the Southern California Earthquake Center (SCEC), dated June 2002.

Using the parameters discussed herein, an equivalent site acceleration, k_{EQ} , of approximately 0.1g was calculated (see Figure 4). Using this k_{EQ} , we get a factor of safety of 1.86 for Section C-C' (see Figure 5) and 2.2 for Section D-D' (see Figure 6). A slope is considered acceptable by the screening analysis if the calculated factor of safety is greater than 1.0 using k_{EQ} ; therefore, the slopes pass the screening analysis for seismic slope stability.
