Project No. 07516-42-02
May 10, 2023

Subject: RESPONSE TO CITY OF SAN DIEGO REVIEW COMMENTS
NAKANO
SAN DIEGO, CALIFORNIA

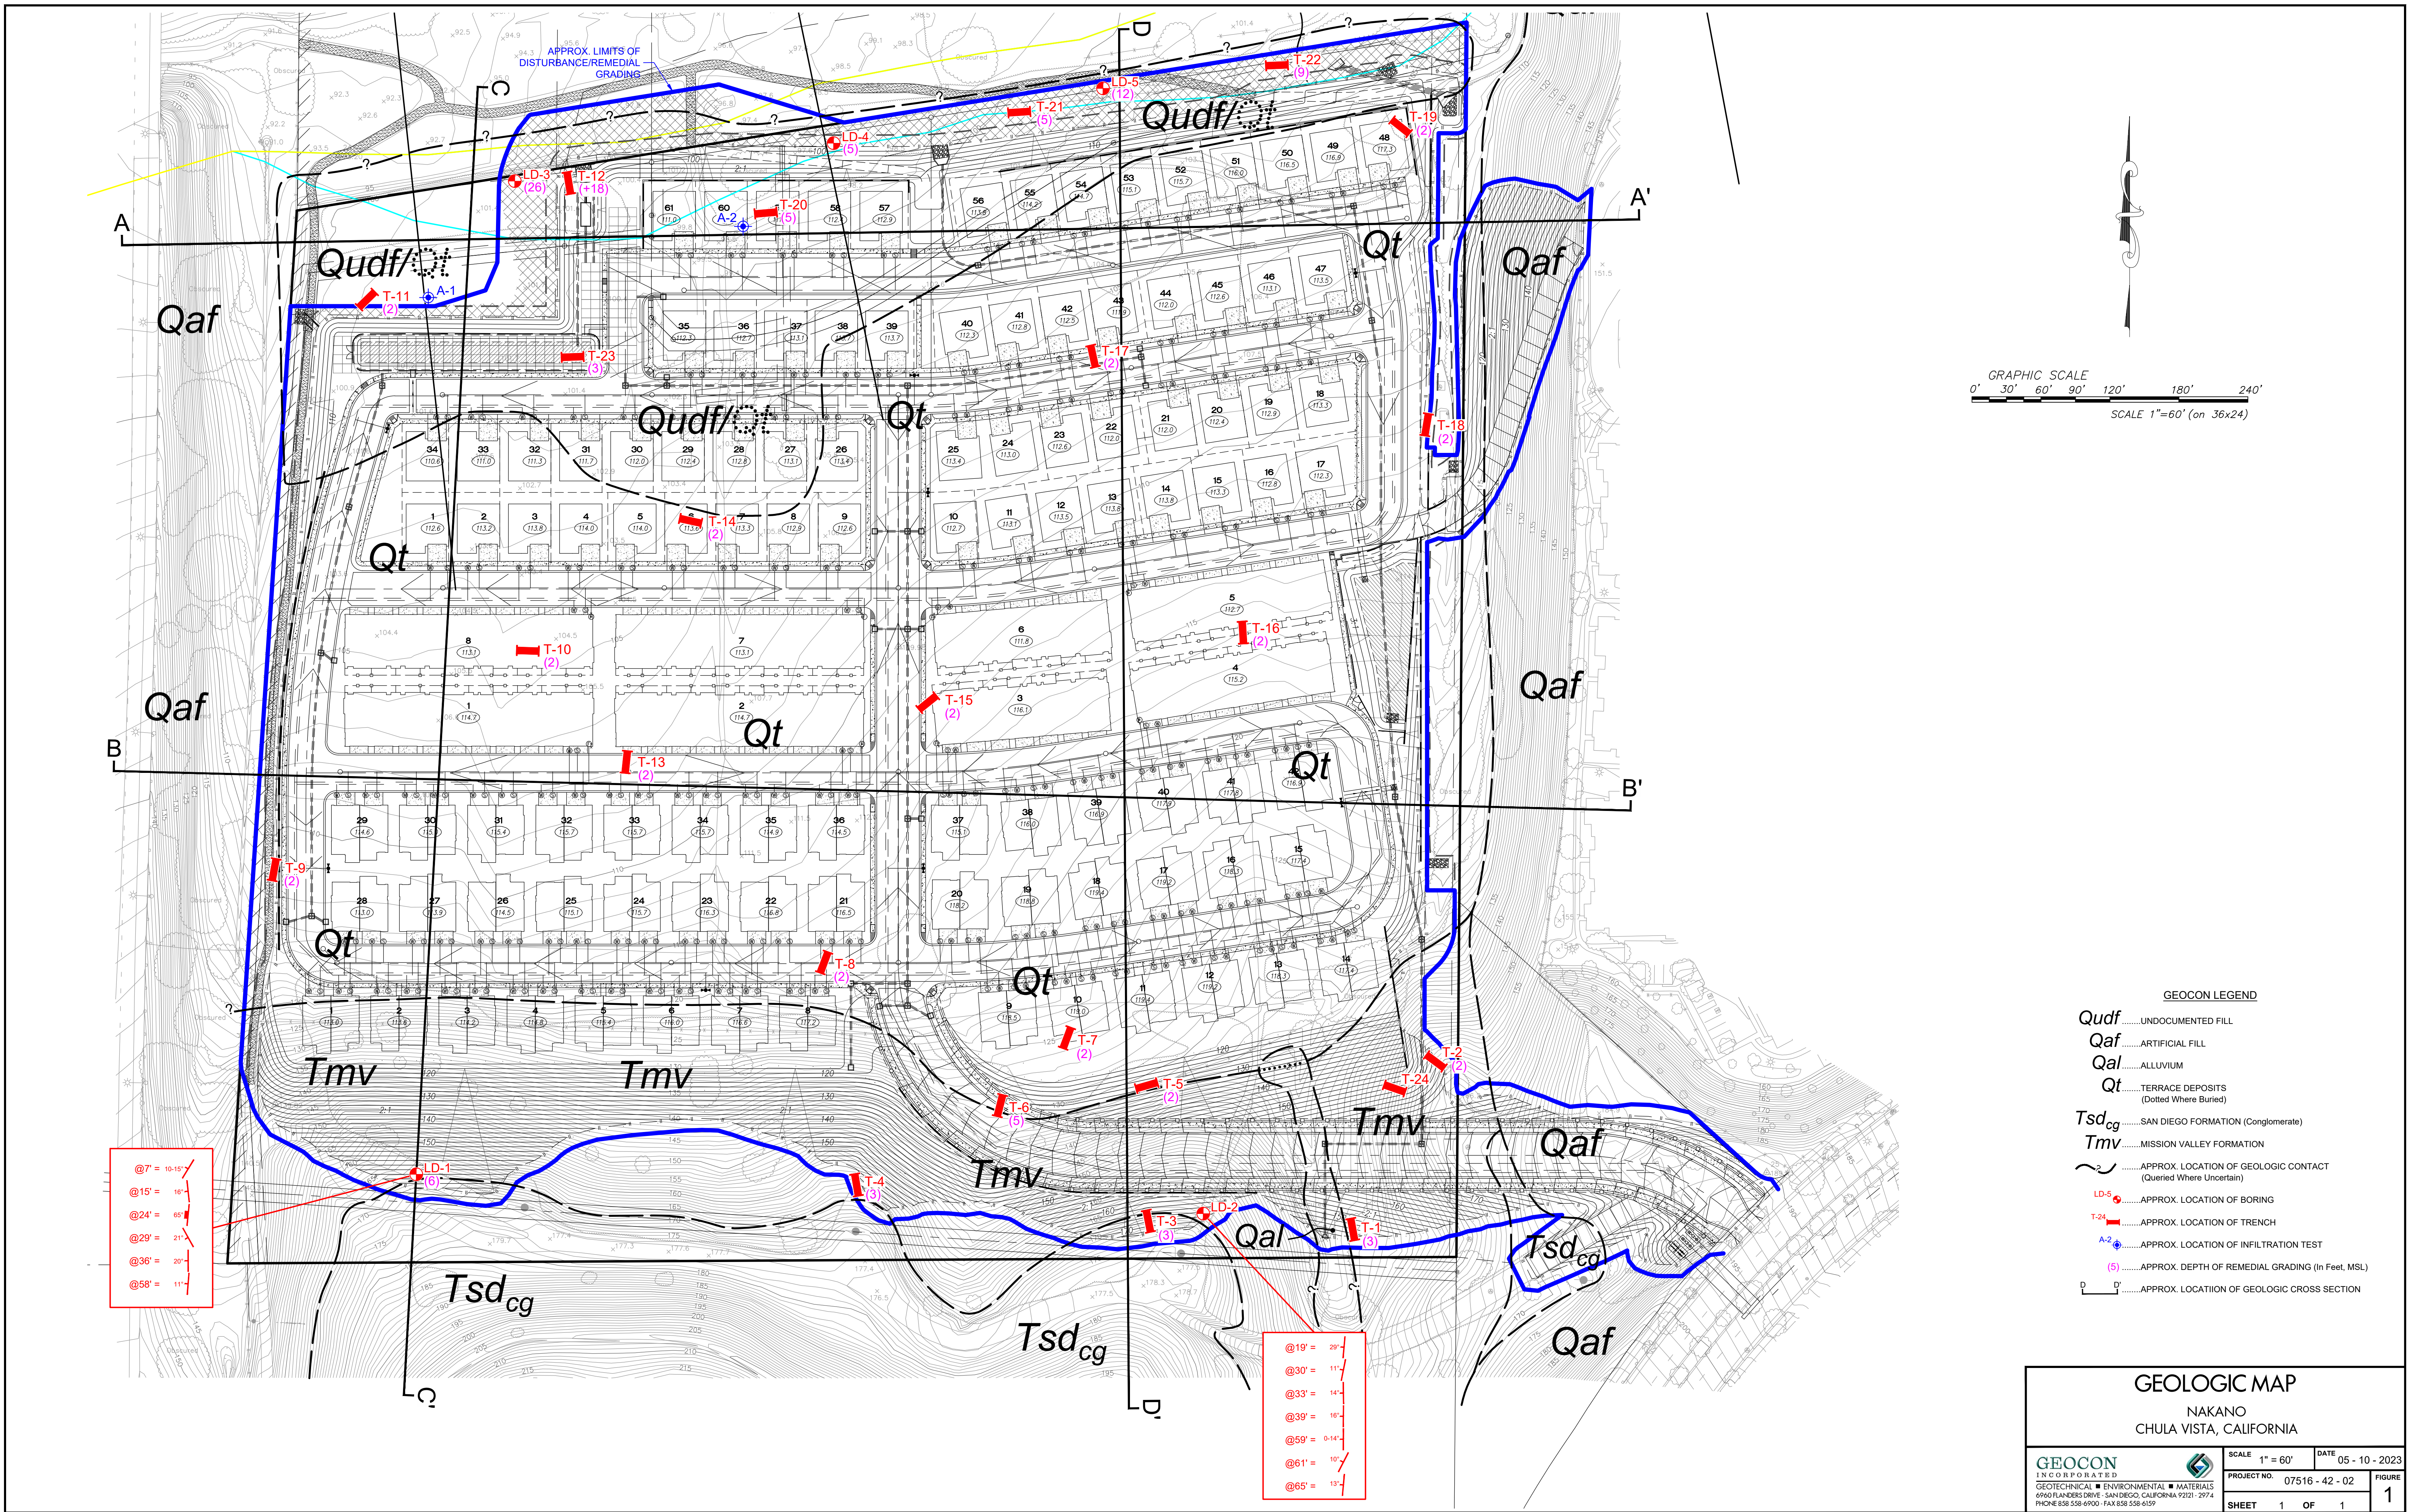
<p>GEOCON INCORPORATED GEOTECHNICAL ■ ENVIRONMENTAL ■ MATERIALS 6940 ANDERS DRIVE ■ SAN DIEGO, CALIFORNIA 92121-2974 PHONE 858.558.4900 ■ FAX 858.558.6159</p>	SCALE 1" = 60'	DATE 05 - 10 - 2023	
	PROJECT NO. 07516 - 42 - 02		FIGURE 1
	SHEET 1 OF 1

Response: Figure 1 is the requested updated geologic map using a CAD file of Reference 4 as the base map. Figure 1 shows the proposed development and the disturbance limits and limits of anticipated remedial grading. Cross sections are provided on Figures 2 and 3.

Response: To evaluate the potential for liquefaction and groundwater impacting removals, we performed three large-diameter borings on the norther edge of the development at the locations shown on Figure 1 (Borings LD-3 through LD-5). We encountered undocumented fill overlying alluvium and terrace deposits. Seepage was encountered near a depth of 33 feet in boring LD-3. The seepage is below the expected removal bottom and within the underlying terrace deposits. Logs of the borings are appended.
