# PRIORITY DEVELOPMENT PROJECT (PDP) STORM WATER QUALITY MANAGEMENT PLAN (SWQMP) FOR

2072 Via Casa Alta

**Project Name: 2072 Via Casa Alta**

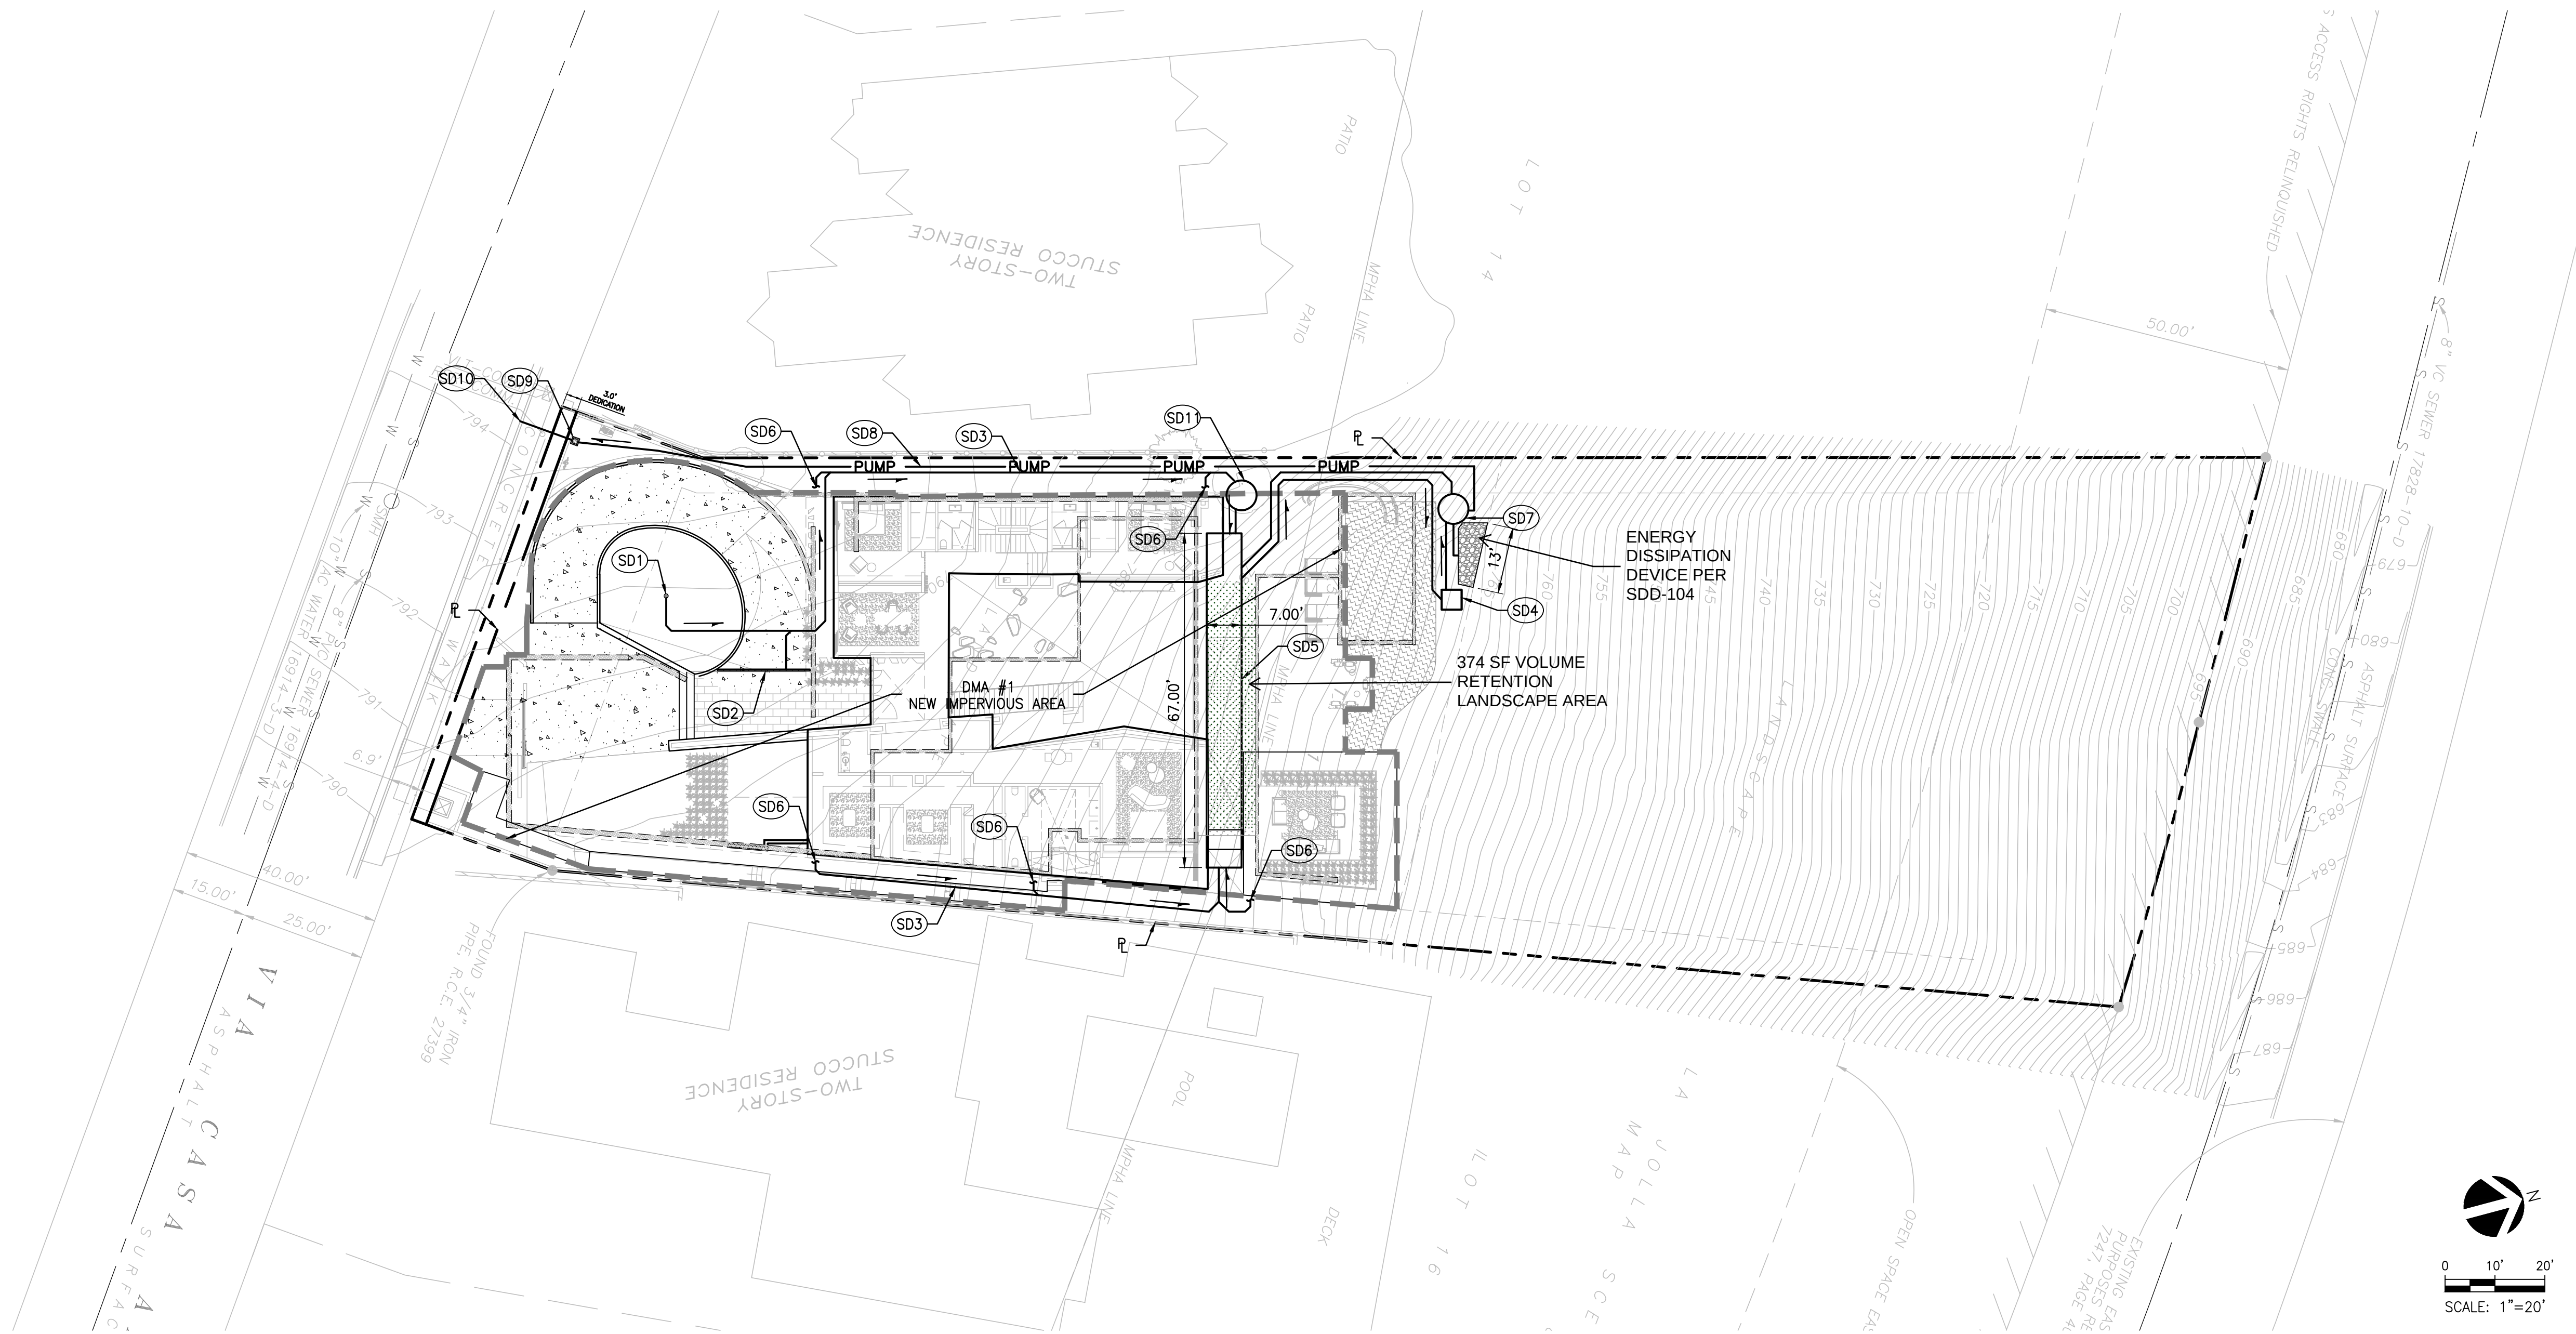
# C300

PROPERTY LINE  
 CONCRETE PAVING  
 PLANTER AREA  
 BASEMENT BUILDING WALL  
 RETAINING WALL  
 STORM DRAIN PIPE  
 AREA DRAIN

- (SD1) INSTALL 6" AREA DRAIN BY NDS OR APPROVED EQUIVALENT.
- (SD2) INSTALL TRENCH DRAIN BY ACO OR APPROVED EQUIVALENT.
- (SD3) INSTALL 6" STORM DRAIN PIPE. S=1% MIN.
- (SD4) INSTALL CONTECH BIOFILTRATION SYSTEM MWS-L-4-4-V PER DETAIL 1, SHEET C310.
- (SD5) INSTALL 2,542 CF CONTECH DETENTION SYSTEM PER DETAIL 1, SHEET C311.
- (SD6) DOWNSPOUT POINT-OF-CONNECTION. SEE ARCHITECTURAL DRAWINGS FOR CONTINUATION.
- (SD7) INSTALL SUMP PUMP AND VAULT.
- (SD8) INSTALL FORCE MAIN.
- (SD9) INSTALL 12"x12" CATCH BASIN BY JENSEN OR APPROVED EQUIVALENT.
- (SD10) INSTALL CURB-O-LET CURB DRAIN.
- (SD11) INSTALL CONTECH CDS PRETREATMENT SYSTEM PER DETAIL 2, SHEET C310.

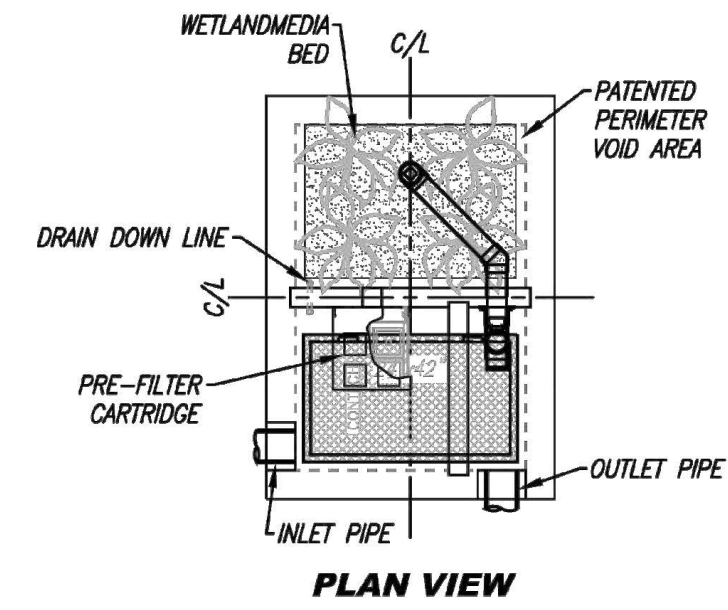
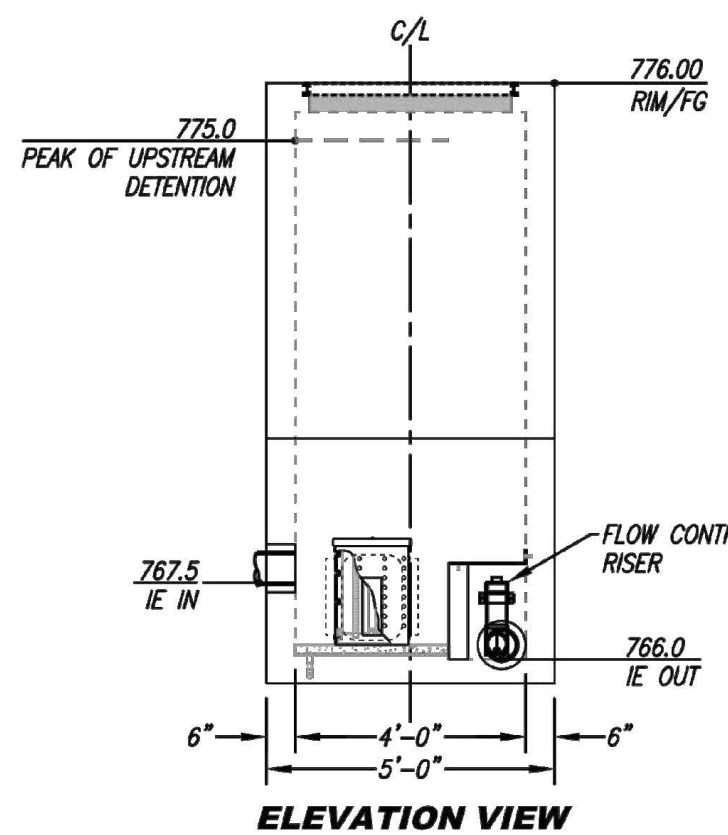
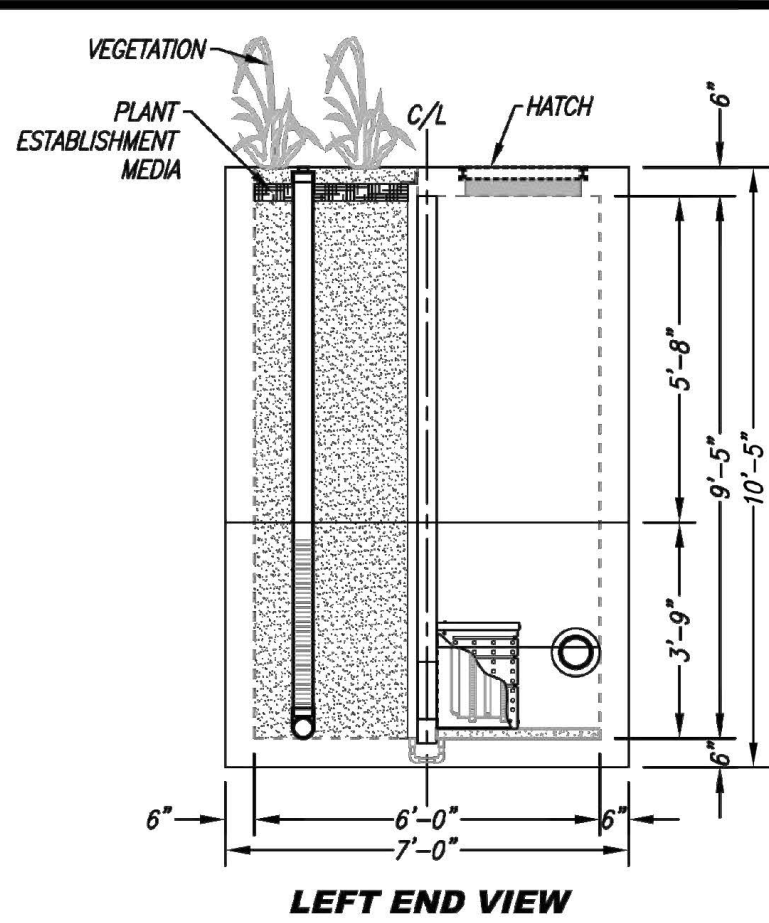
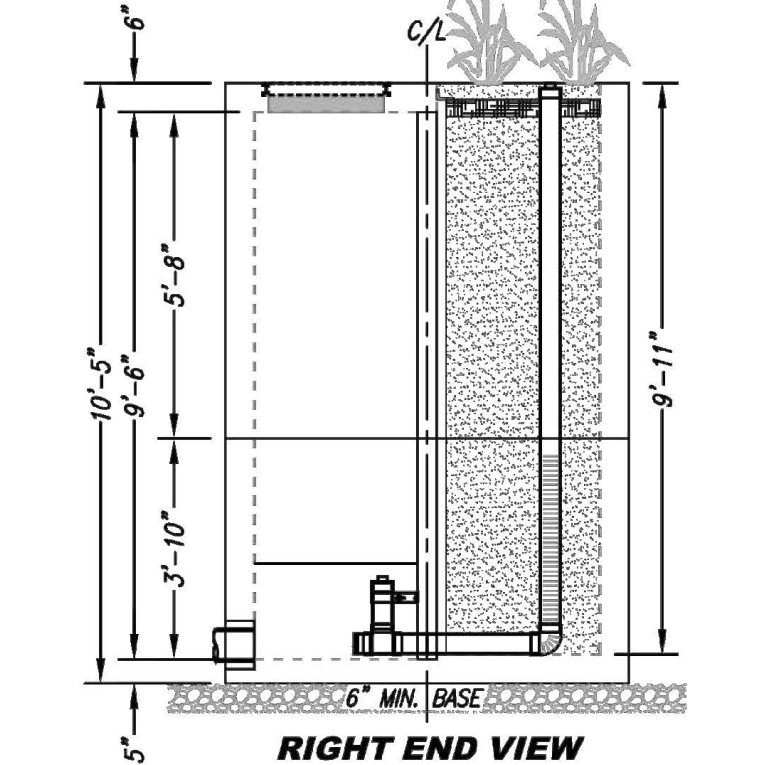
MWS-L-4-6-9'-11"-V  
STORMWATER BIOFILTRATION SYSTEM  
STANDARD DETAIL

- UNIT MUST BE INSTALLED ON LEVEL BASE. MANUFACTURER RECOMMENDS A MINIMUM 6" LEVEL ROCK BASE UNLESS SPECIFIED BY THE PROJECT ENGINEER. CONTRACTOR IS RESPONSIBLE FOR VERIFYING PROJECT ENGINEER'S RECOMMENDED BASE SPECIFICATIONS.

- MANUFACTURER TO PROVIDE ALL MATERIALS UNLESS OTHERWISE NOTED.
- ALL DIMENSIONS, ELEVATIONS, SPECIFICATIONS AND CAPACITIES ARE SUBJECT TO CHANGE. FOR PROJECT SPECIFIC DRAWINGS DETAILING EXACT DIMENSIONS, WEIGHTS AND ACCESSORIES PLEASE CONTACT CONTECH.

| WETLANDMEDIA INFILTRATION RATE (IN/HR) | 26 |
| WETLANDMEDIA LOADING RATE (GPM/SF) | OR 0.26 |

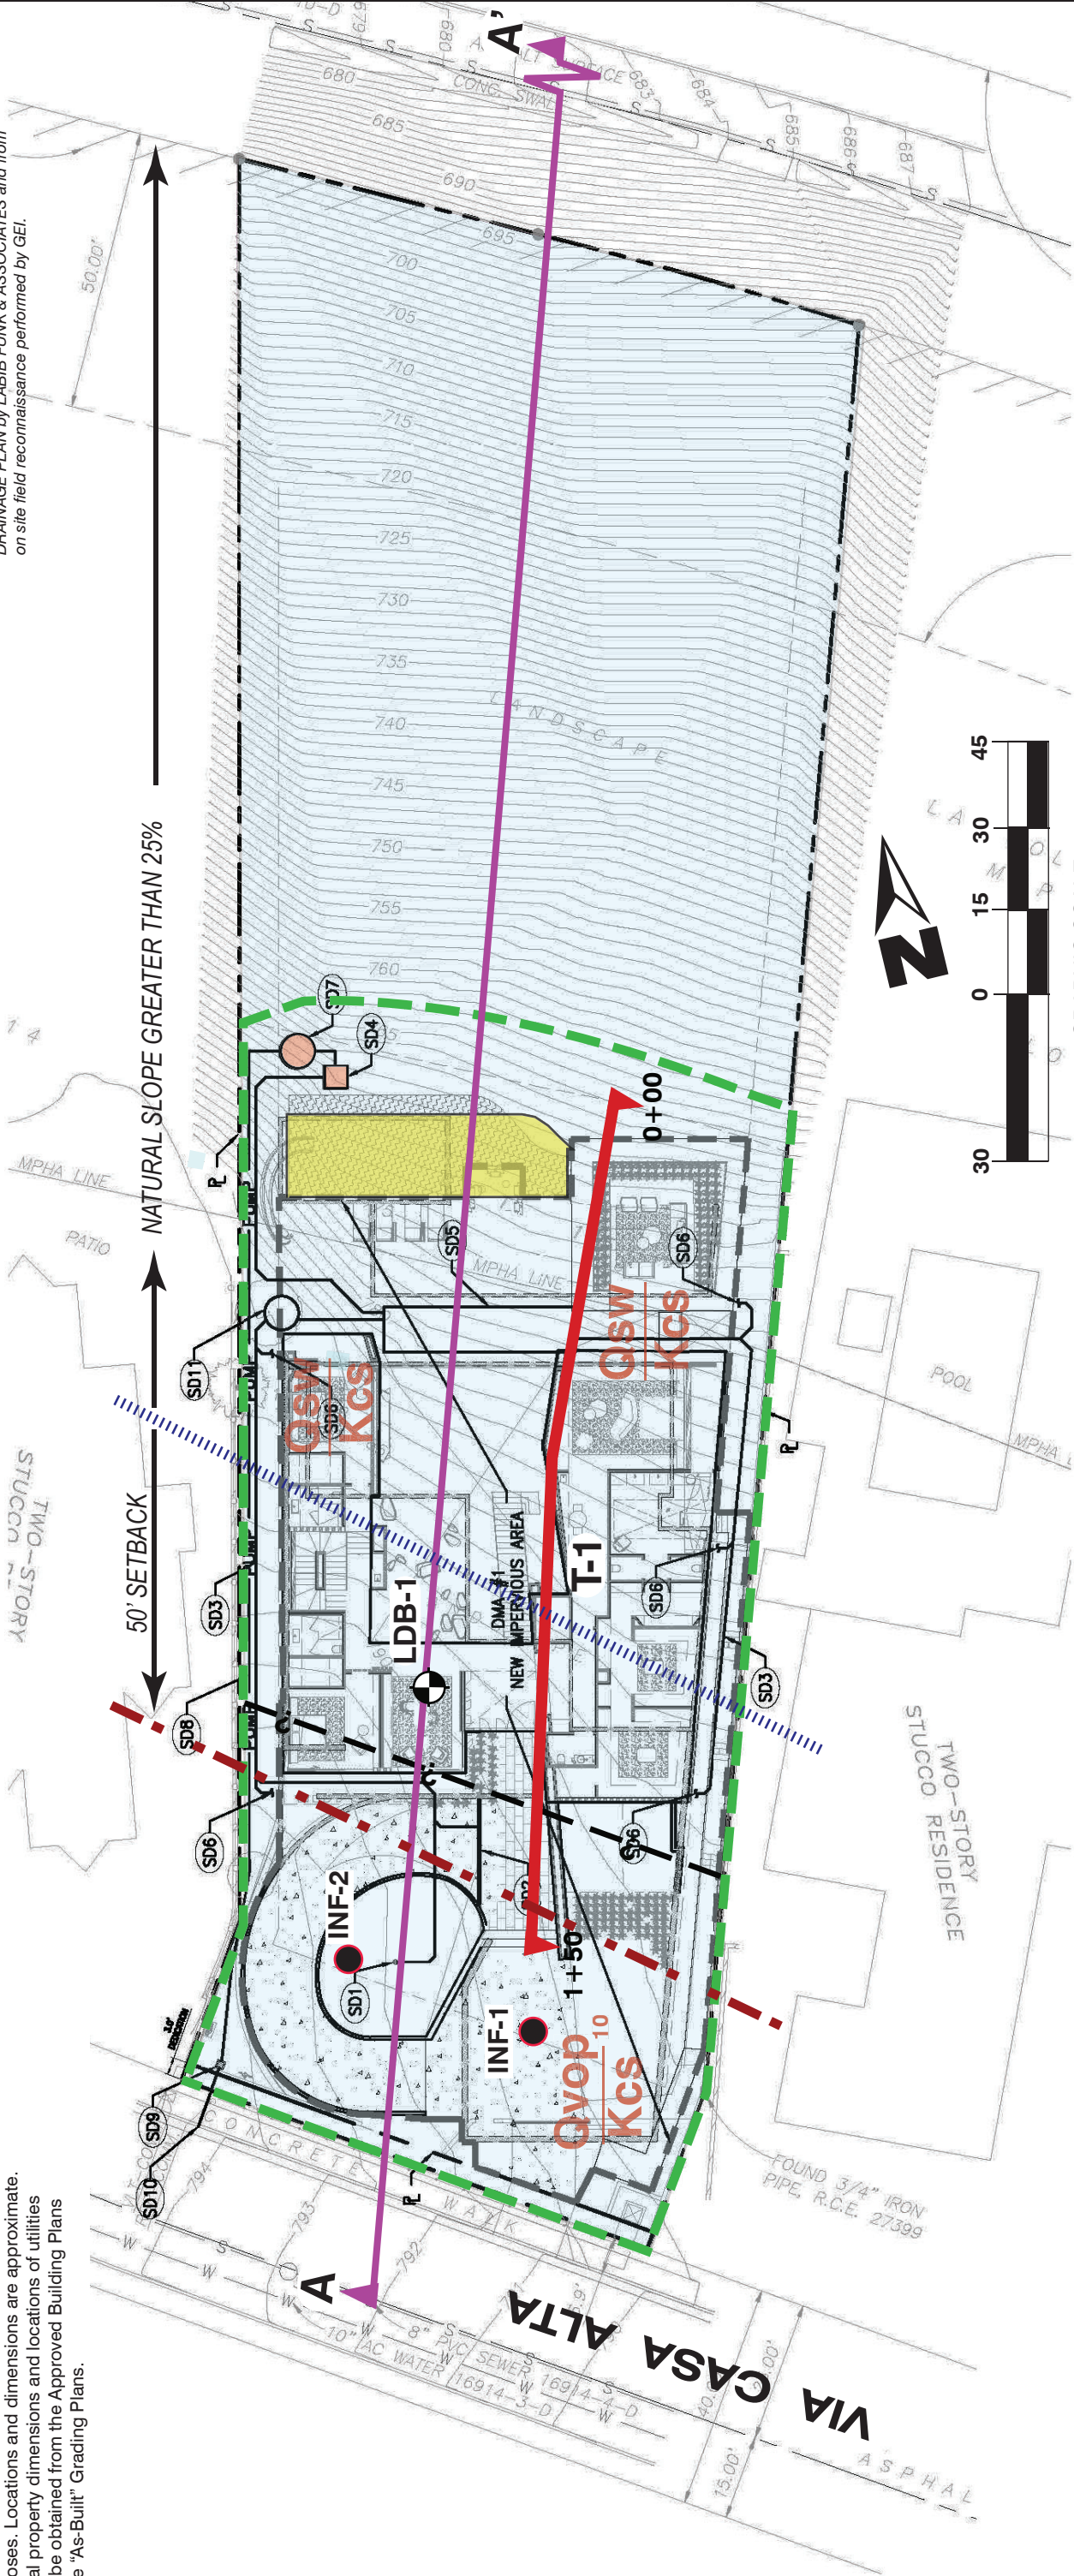
REFERENCE: This Plot Plan is not to be used for legal purposes. Locations and dimensions are approximate. Actual property dimensions and locations of utilities may be obtained from the Approved Building Plans or the "As-Built" Grading Plans.

REFERENCE: This Plot Plan was prepared from an undated DRAINAGE PLAN by LABIB FUNK & ASSOCIATES and from on site field reconnaissance performed by GEI.

- Approximate Location of Biofiltration BMP's
- Approximate Location of Infiltration Test
- Approximate Location of Exploratory Trench with Station Numbers
- Approximate Location of Large Diameter Boring
- Approximate Limits of Geotechnical Investigation

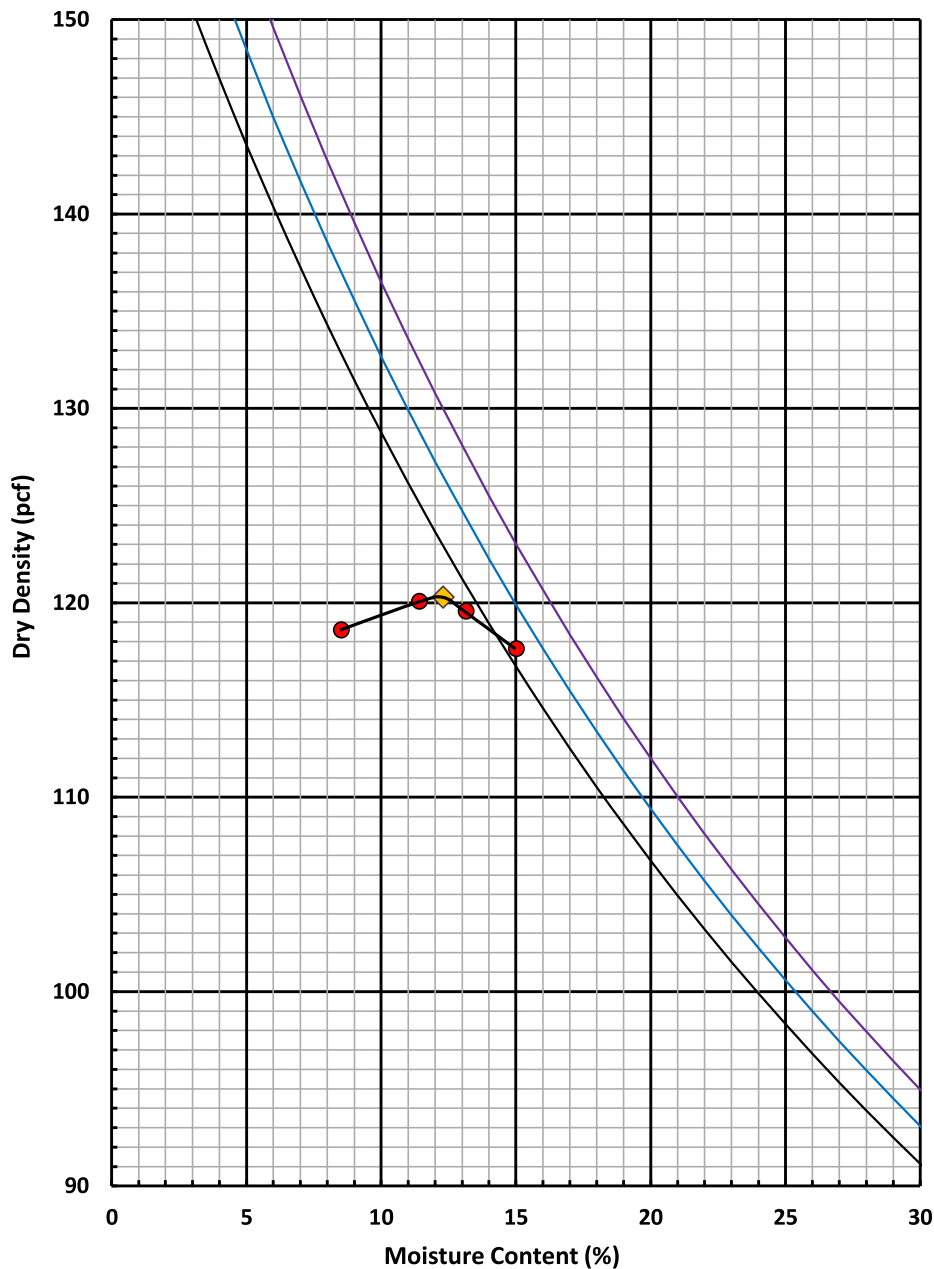
## Compaction Curve

# Laboratory Test Results

| Source of Material | LDB-1 |
| Depth | 30-31 FT. |

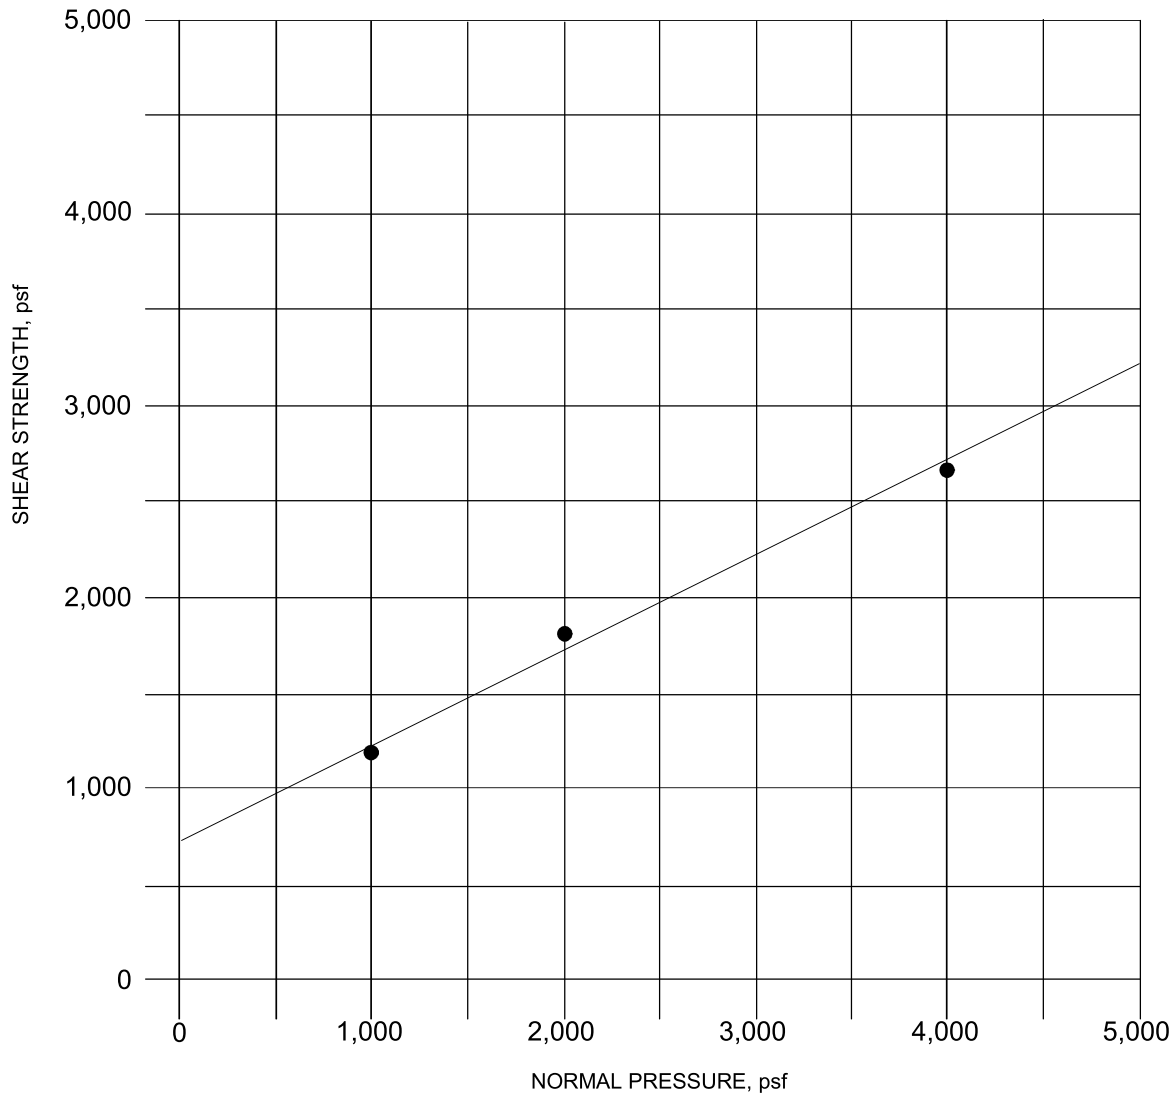
# Laboratory Test Results

| Specimen I.D. | Classification | $\gamma_d$ | MC% | c | $\phi$ |
| ● T-1 @ 29-29.5' | SILTY SAND (SM), Undisturbed, Saturated | | | 756 | 25.9 |

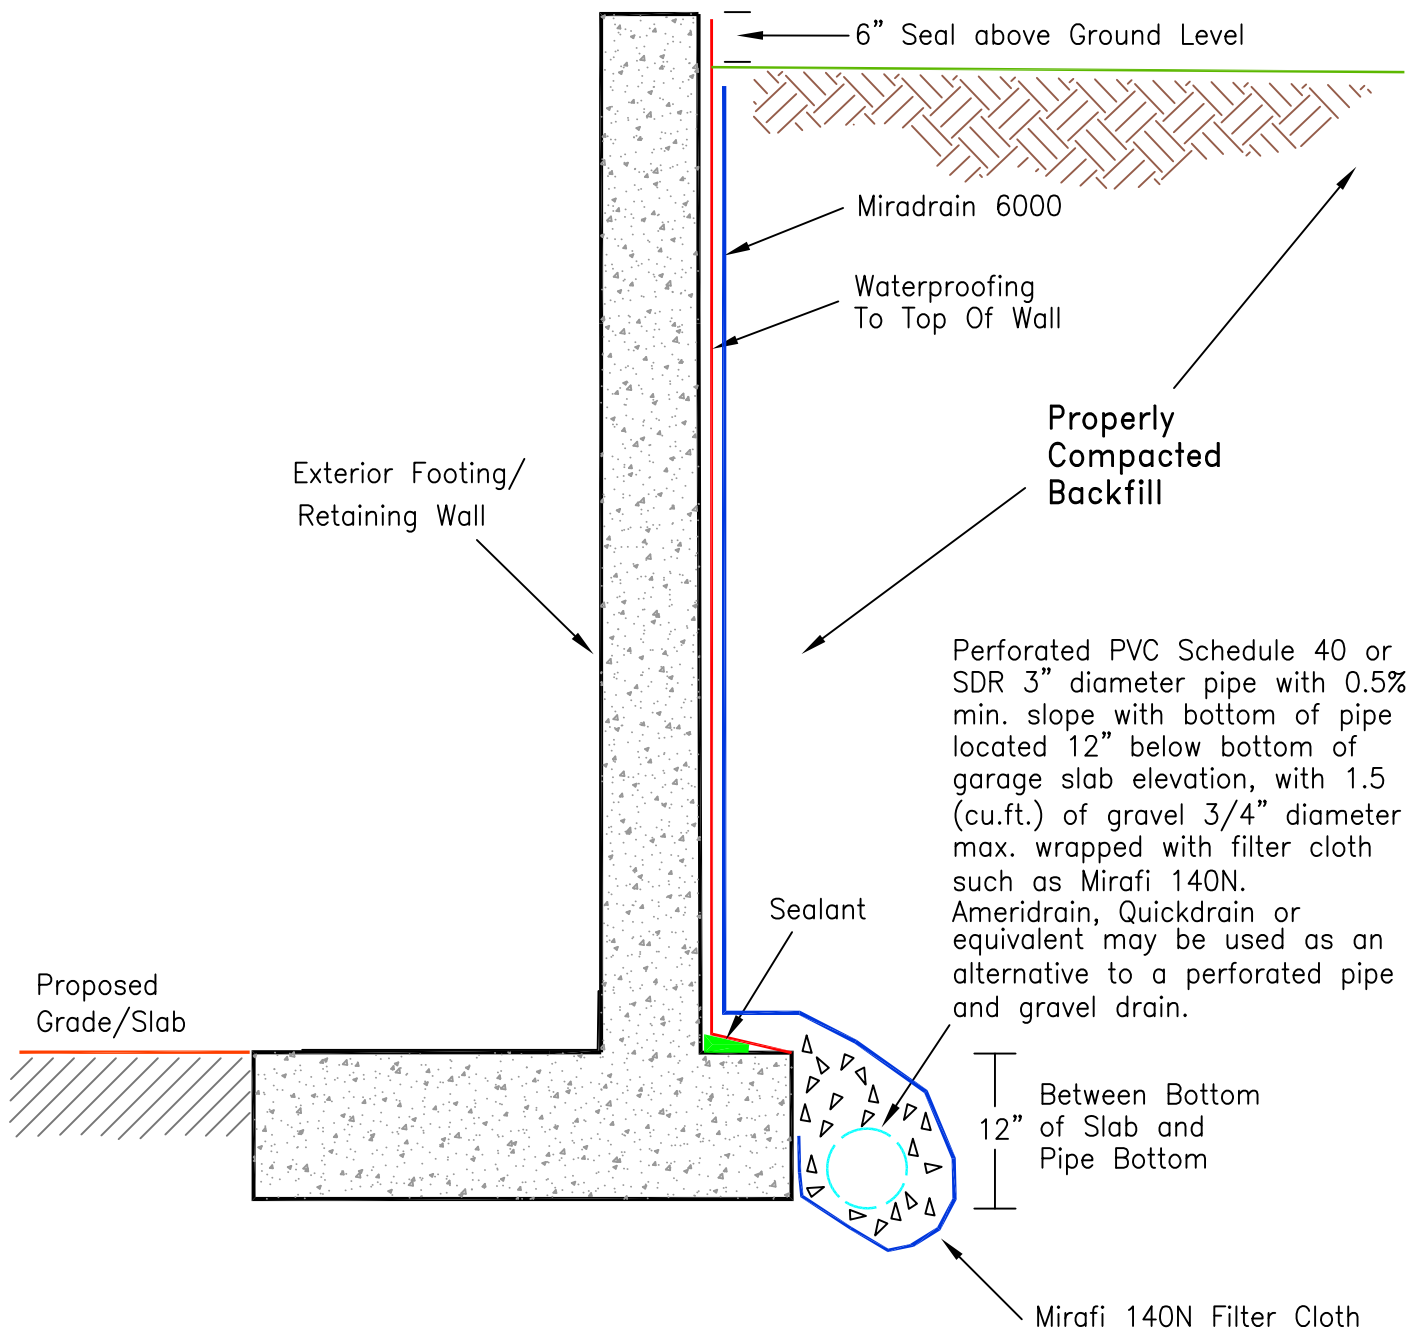
# SUBGRADE RETAINING WALL DRAINAGE RECOMMENDATIONS

**NOT TO SCALE**

NOTE: As an option to Miradrain 6000, gravel or crushed rock 3/4" maximum diameter may be used with a minimum 12" thickness along the exterior face of the wall and 2.0 cu/ft of pipe.

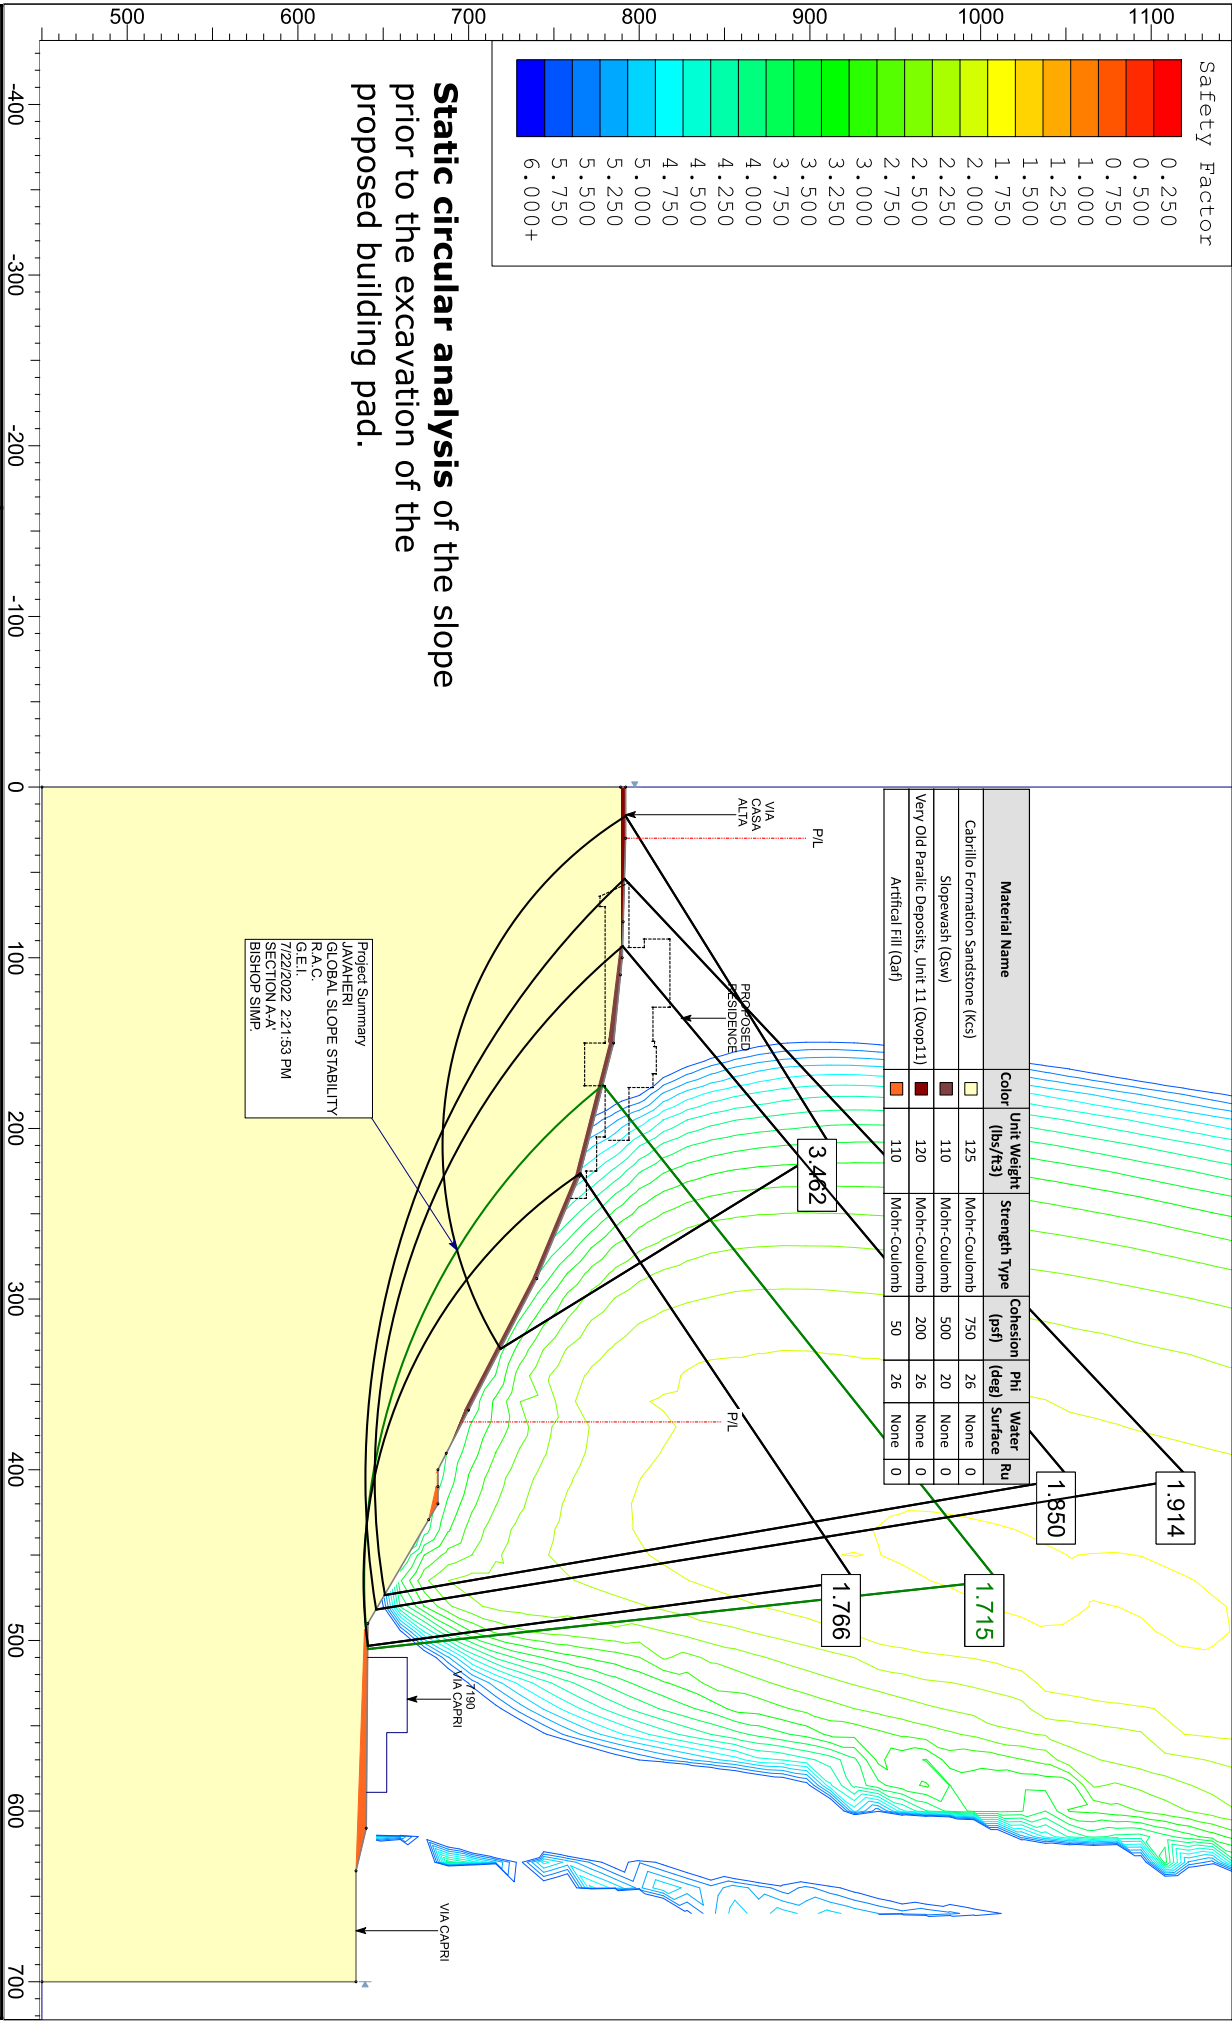
Static circular analysis of the slope prior to the excavation of the proposed building pad.

Analysis Description

GLOBAL SLOPE STABILITY

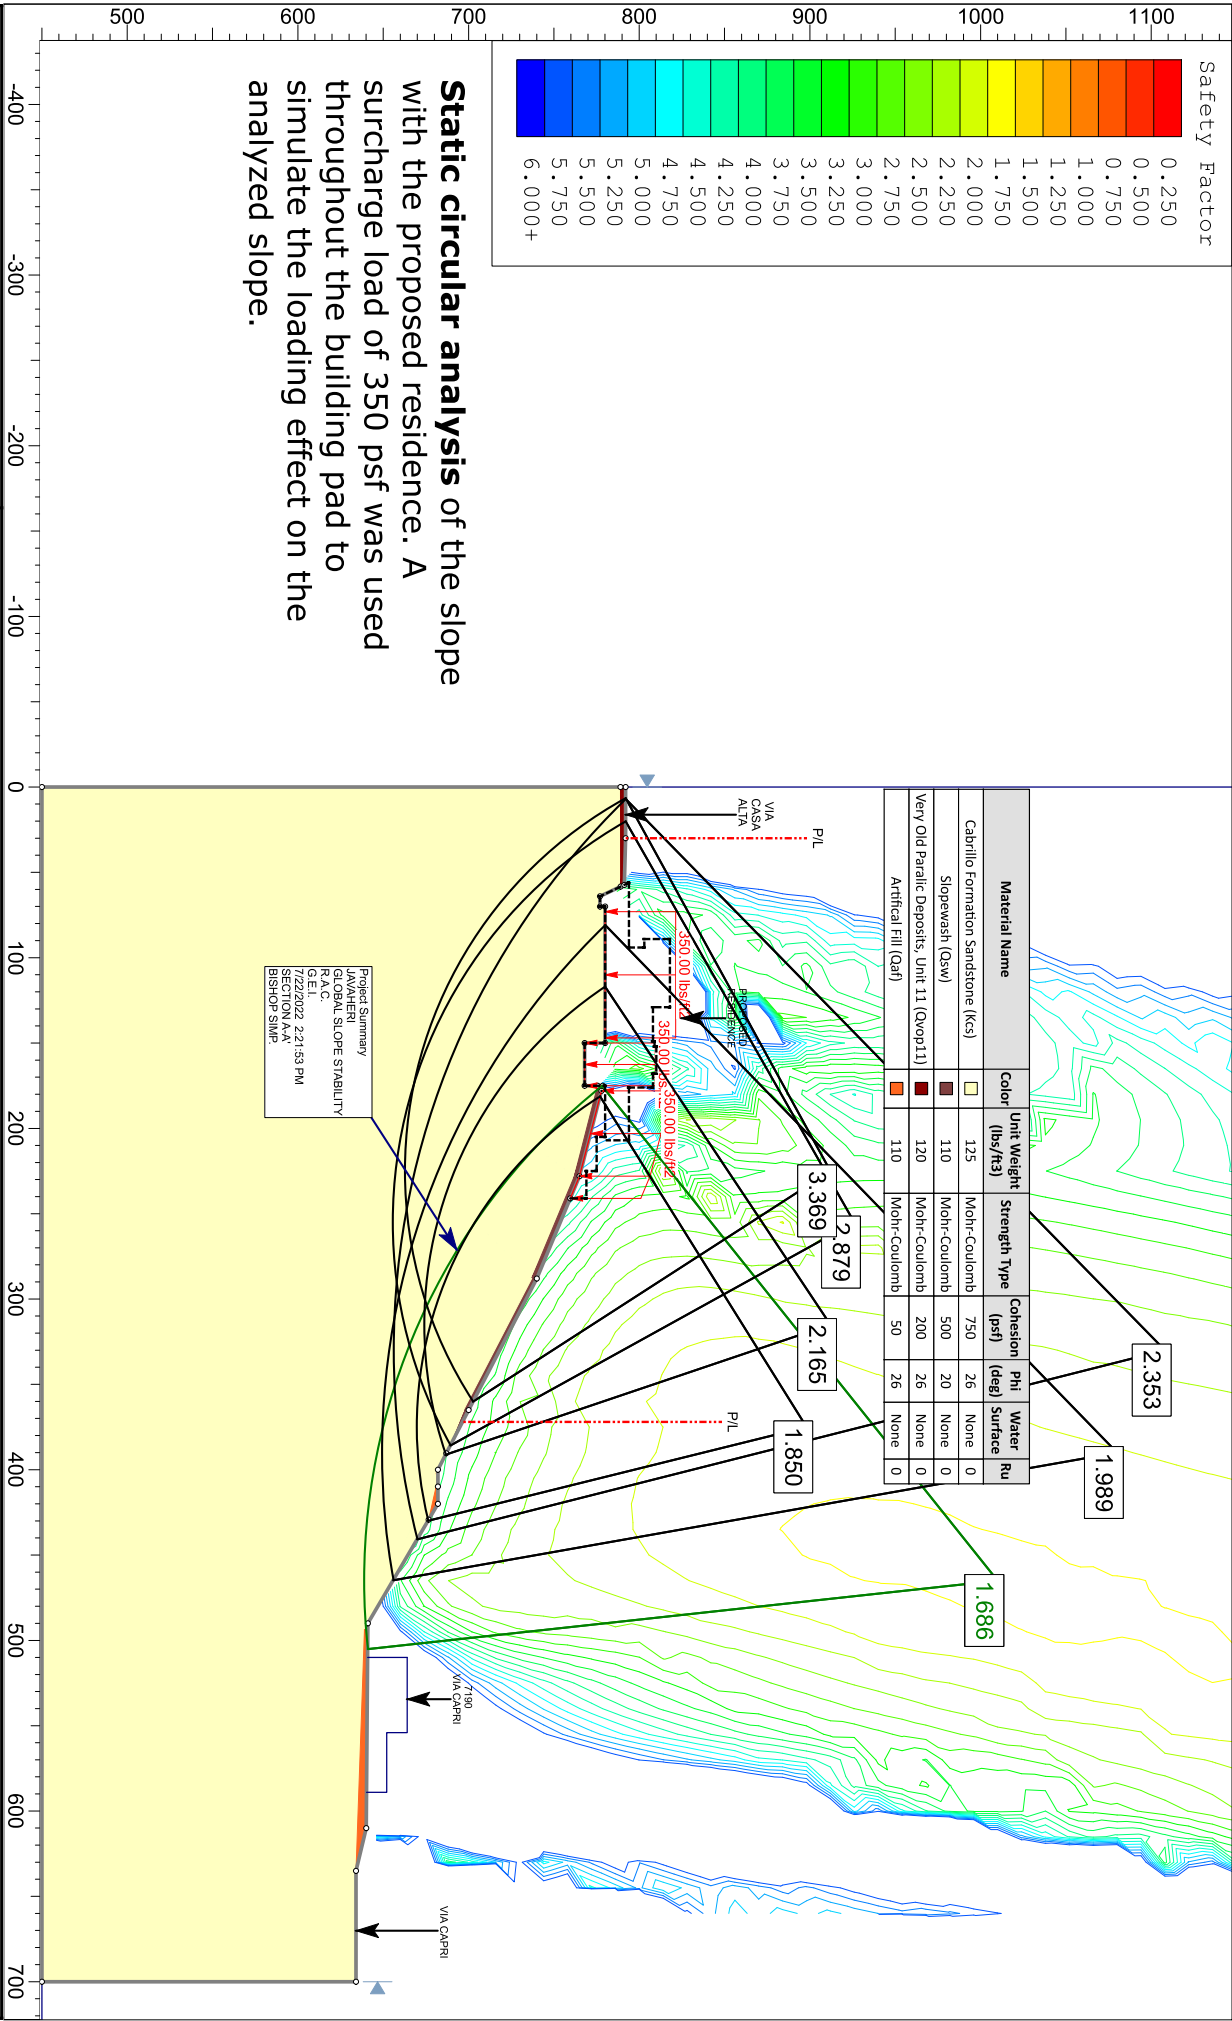
**Static circular analysis of the slope** with the proposed residence. A surcharge load of 350 psf was used throughout the building pad to simulate the loading effect on the analyzed slope.

Analysis Description

GLOBAL SLOPE STABILITY
