**SUPPLEMENTAL  
GEOTECHNICAL INVESTIGATION  
5030 COLLEGE AVENUE  
SAN DIEGO, CALIFORNIA**

**SCST No. 140568N**  
**Report No. 2**

Subject: SUPPLEMENTAL GEOTECHNICAL INVESTIGATION  
5030 COLLEGE AVENUE  
SAN DIEGO, CALIFORNIA

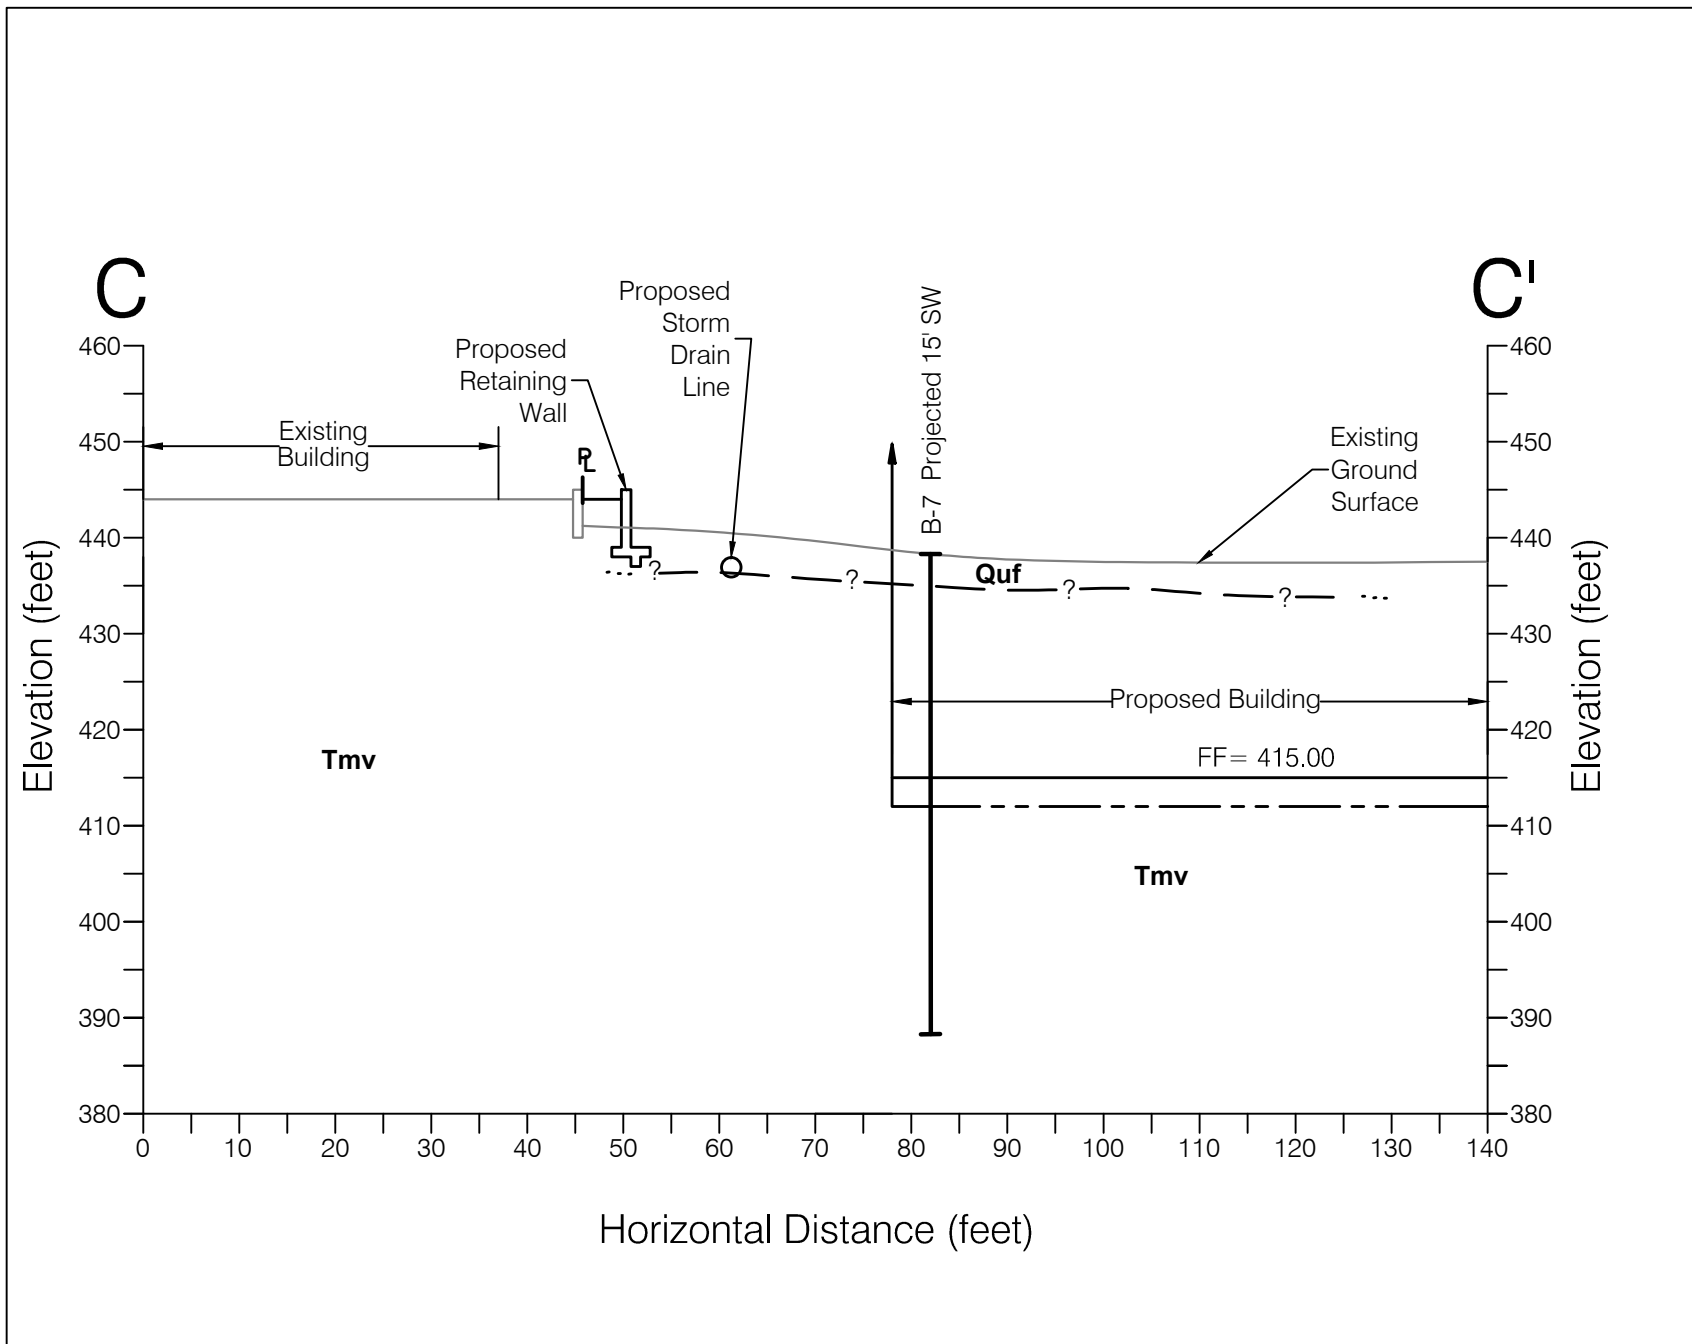
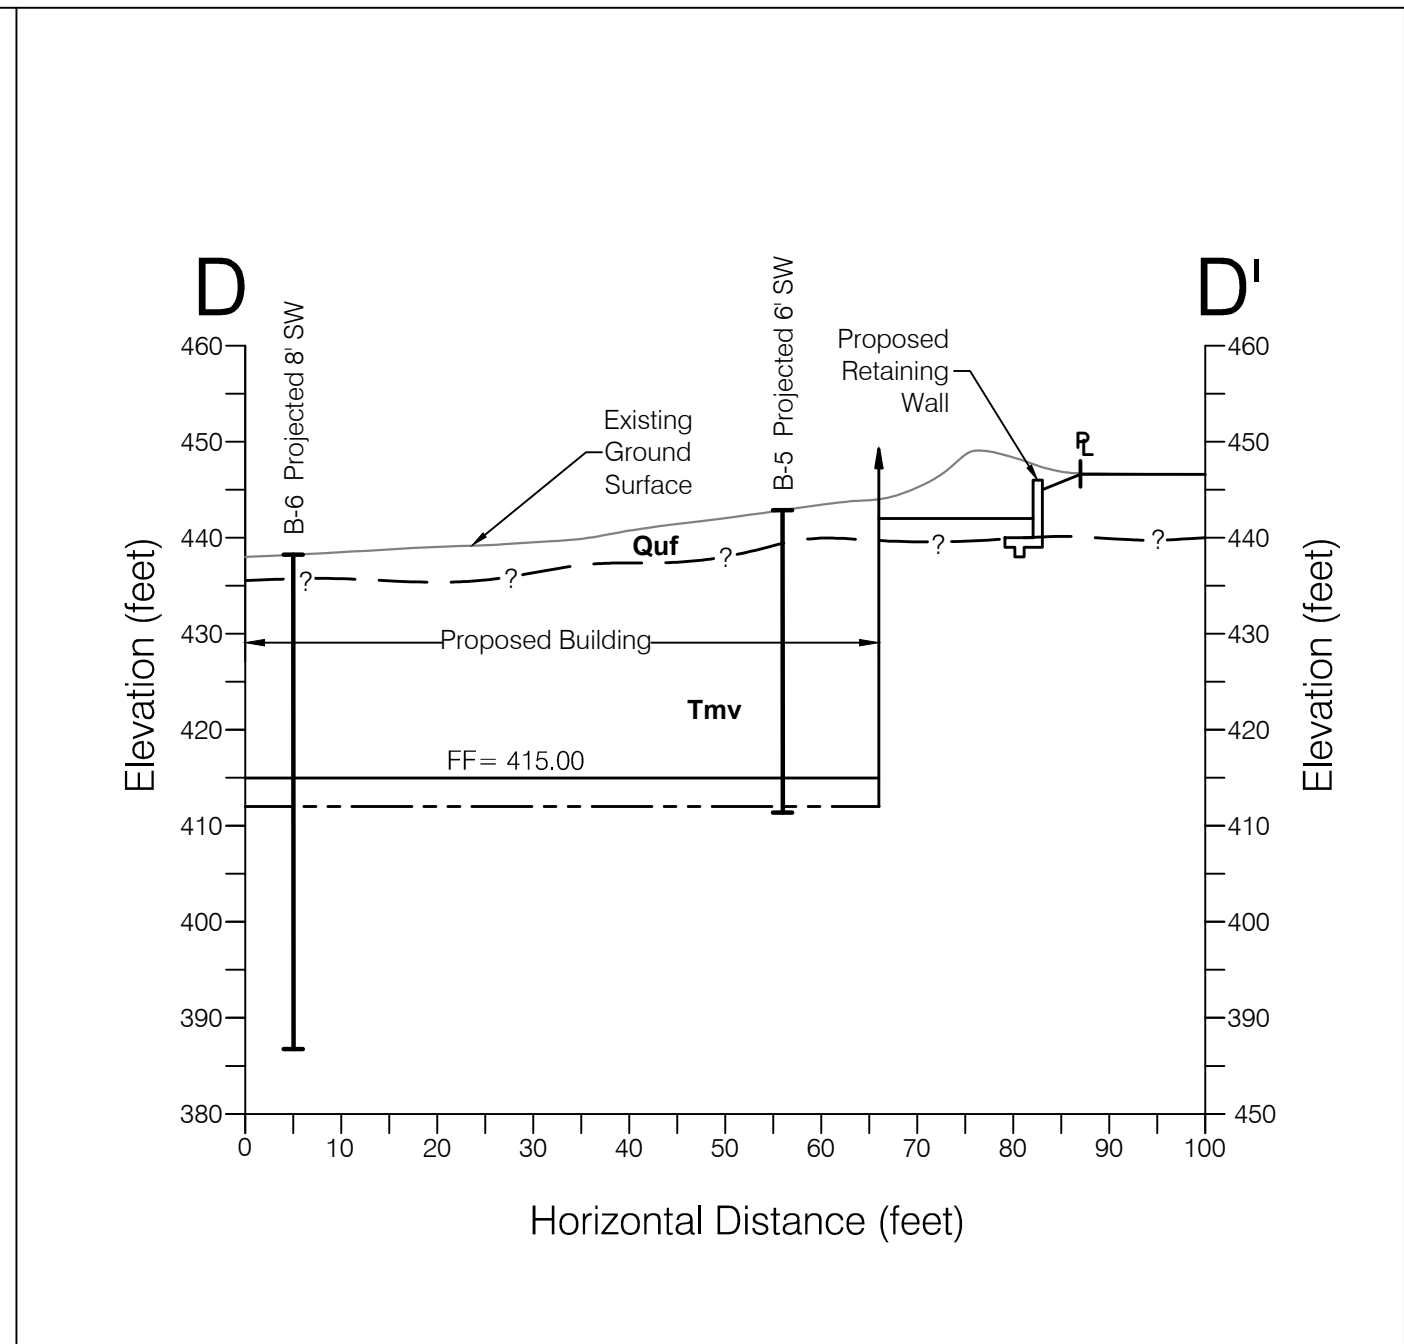
Figure:  
**3**

**SCST LEGEND:**

- Approximate Location of Boring      Mission Valley Formation      Approximate Bottom of Proposed Excavation
- Undocumented Fill      Approximate Geologic Contact, Queried Where Uncertain      Property Line

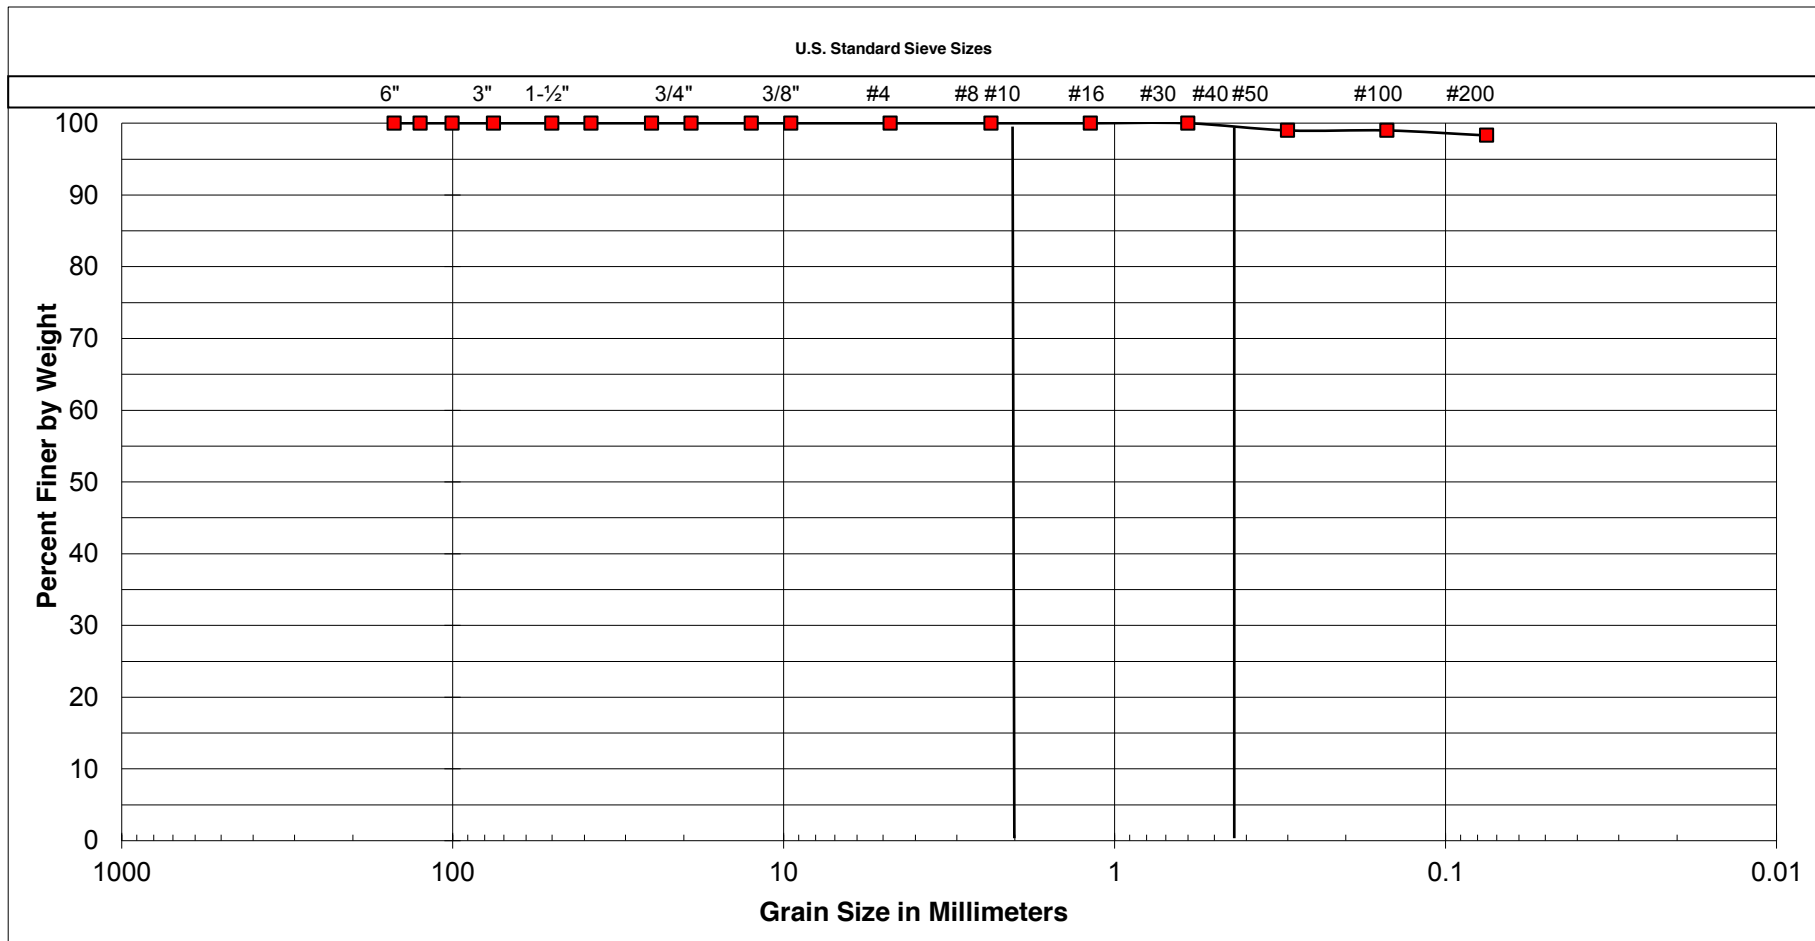
By:	DAS	Date:	2/18/15
Job Number:	140568N	Figure:	II-1

Cobbles	Gravel		Sand			Silt or Clay
	Coarse	Fine	Coarse	Medium	Fine

<b>SAMPLE LOCATION</b>
B6@40.5-41.5

- **CLASSIFICATION:** Field classifications were verified in the laboratory by visual examination. The final soil classifications are in accordance with the Unified Soil Classification System.
- **GRAIN SIZE DISTRIBUTION:** Grain size distributions were determined for 4 samples in accordance with ASTM D 422. The results of these tests are presented on Figures II-1 through II-2.
- **DIRECT SHEAR:** Direct shear tests were performed in accordance with ASTM D 3080. The shear stress was applied at a constant rate of strain of approximately 0.003 inch per minute. The results of these tests are presented on Figures II-3 through II-5.

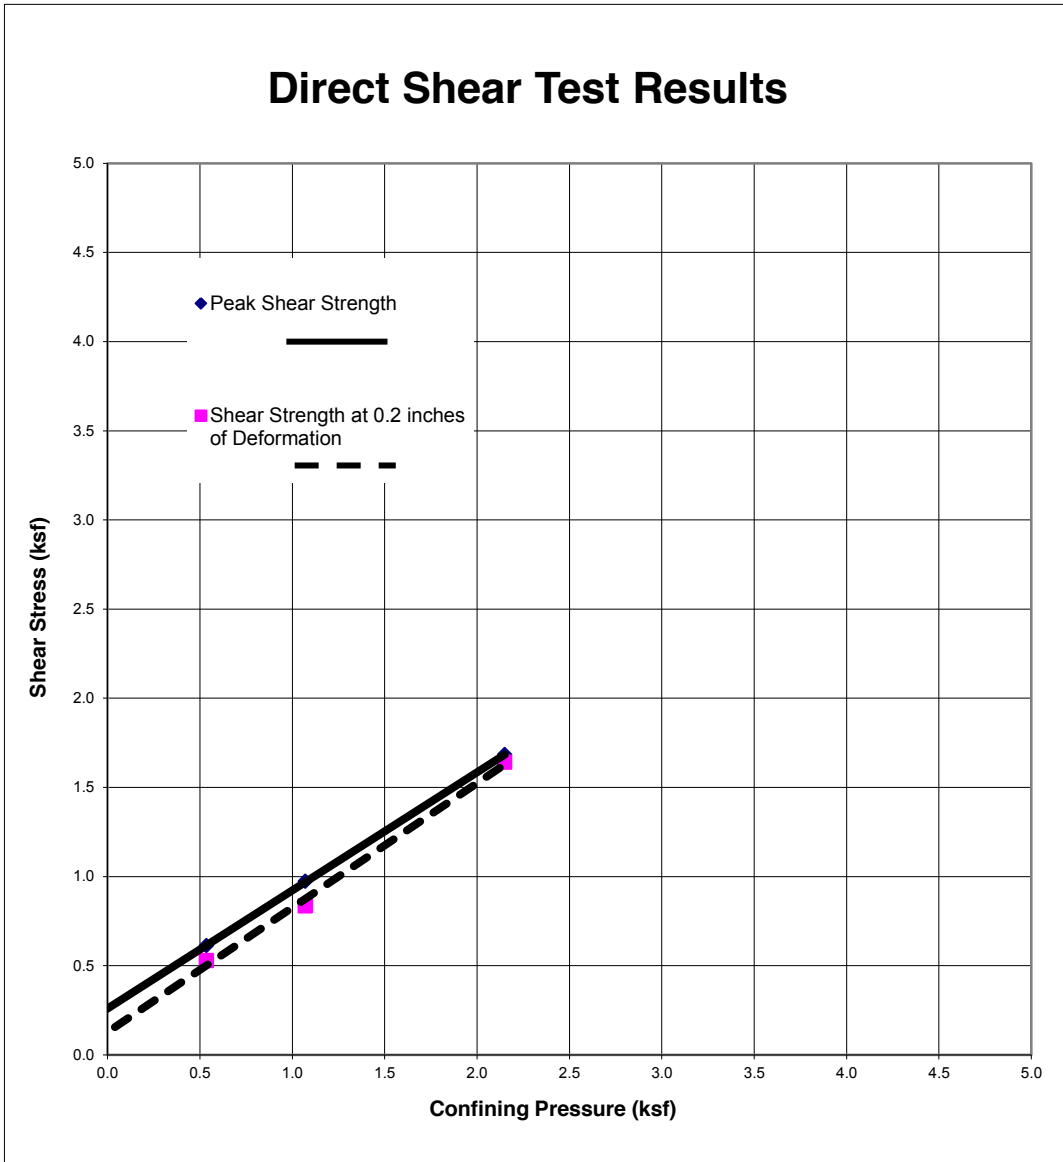
<b>SOUTHERN CALIFORNIA SOIL &amp; TESTING, INC.</b>	5030 COLLEGE AVENUE		
	By:	TBC	Date: 2/18/2015
	Job Number:	140568N	Figure: II-3

## Direct Shear Test Results

SAMPLE	DESCRIPTION	INTERNAL FRICTION ANGLE(DEG.)	COHESION INTERCEPT (PSF)
B4@4	Brown Clayey Sand		
<i>Peak</i>		34	261
<i>Shear Strength at 0.2 inches of Deformation</i>		35	129

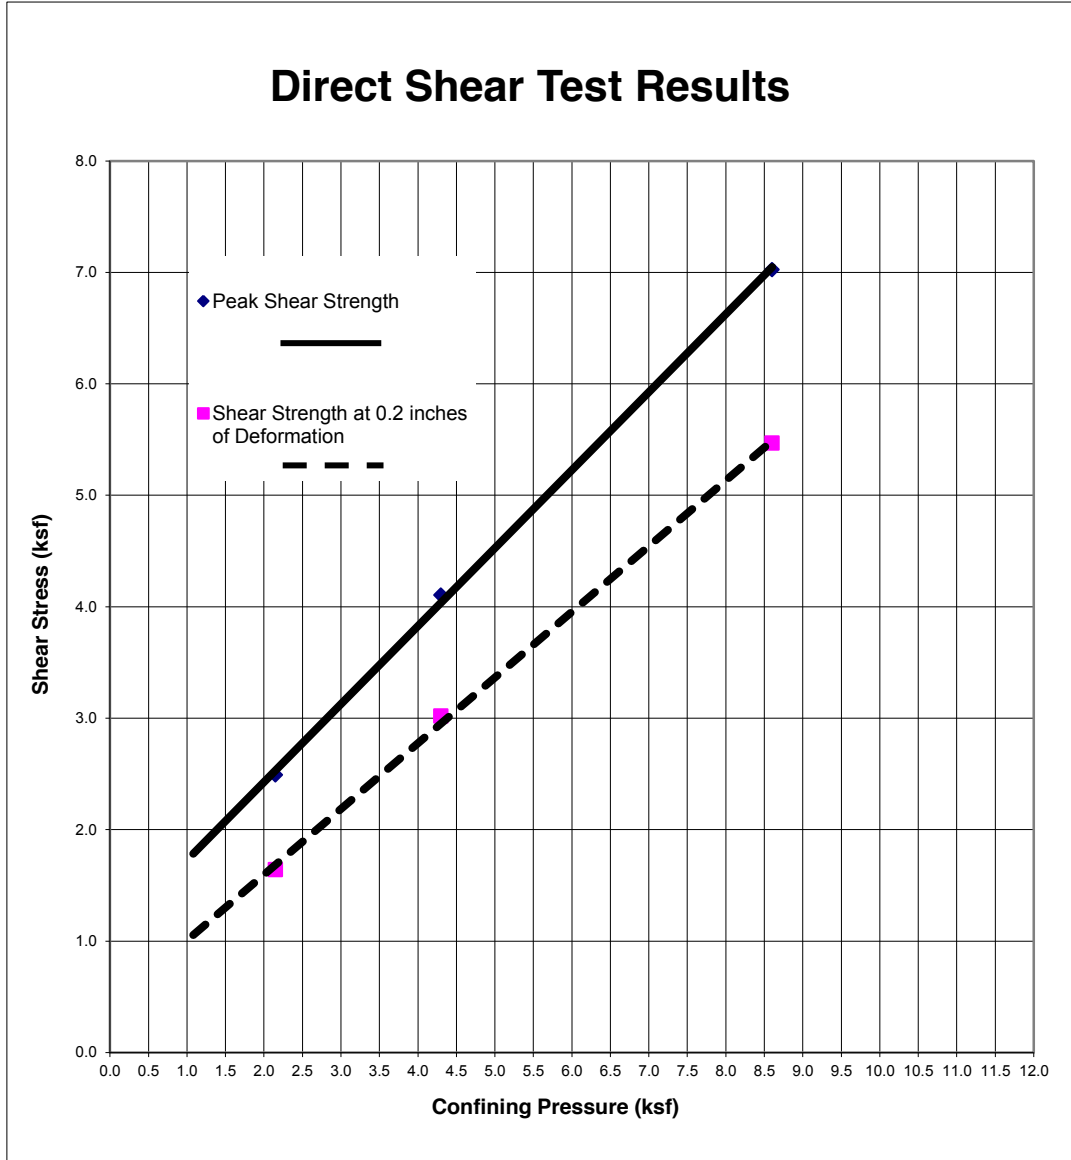
By:	TBC	Date:	2/18/2015
Job Number:	140568N	Figure:	II-5

## Direct Shear Test Results

SAMPLE	DESCRIPTION	INTERNAL FRICTION ANGLE(DEG.)	COHESION INTERCEPT (PSF)
B6@45	SILTY SANDSTONE		
<i>Peak</i>		35	1030
<i>Shear Strength at 0.2 inches of Deformation</i>		31	420
