# PHASE I ENVIRONMENTAL SITE ASSESSMENT

Perry's Cafe 4620 Pacific Highway San Diego, CA 92110

Apex Job No.: 3621-A4002-001

April 20, 2021

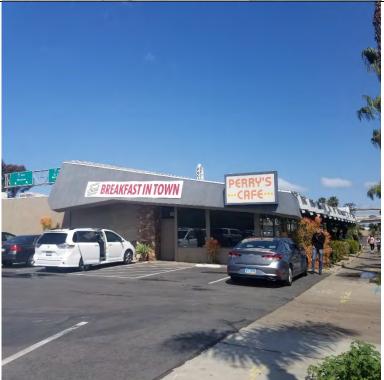
## Photograph 2:

View of the rear entrance of Perry's Café.

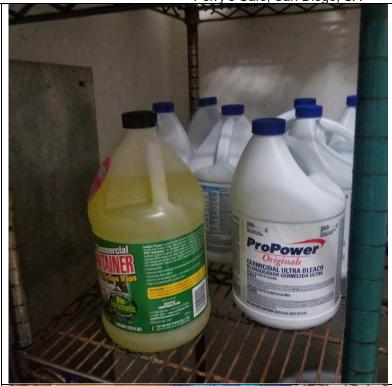
## Photograph 3-4:

Showing typical cleaning supplies that were observed in a storage room inside the restaurant.

Miscellaneous quantities of maintenance and cleaning products were observed in a storage closet inside the restaurant. The storage of these products is not considered a REC.

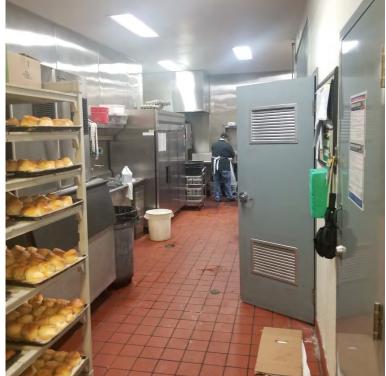
## Photograph 5:

View of the kitchen area. No major issues were observed.

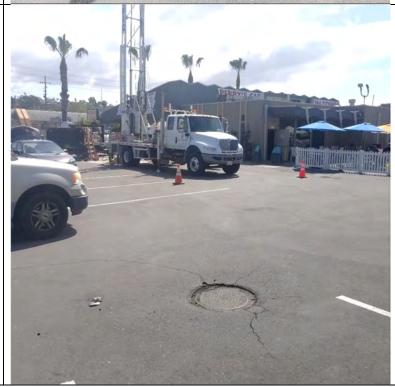
## Photograph 8:

View of a lid that appears to be associated with the sewer system.

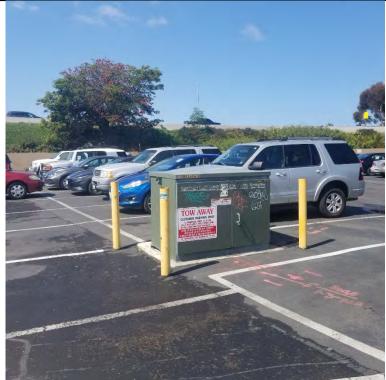
## Photograph 9:

View of the one, pad mounted transformer located south of the restaurant. The transformer was observed in good condition with minimal staining.

Apex observed one pad-mounted electric transformers south of the restaurant building. No evidence of leaks or staining was observed in the vicinity of the transformers. As a result, the transformers are not considered a REC.

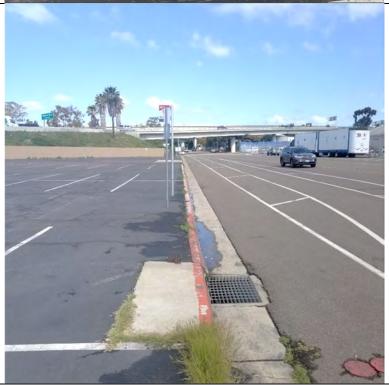
#### Photograph 10:

View of the stormwater drain along Pacific Highway. Stormwater sheet flow enters this inlet from the Site.

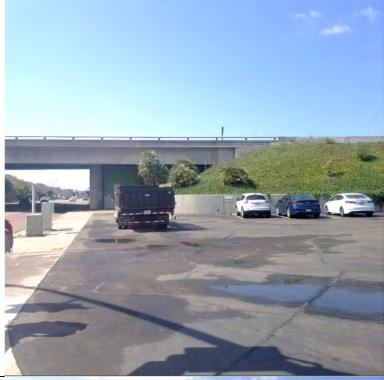
## Photograph 11:

Standing at the southeast corner of the Site, looking west. No major issues observed.

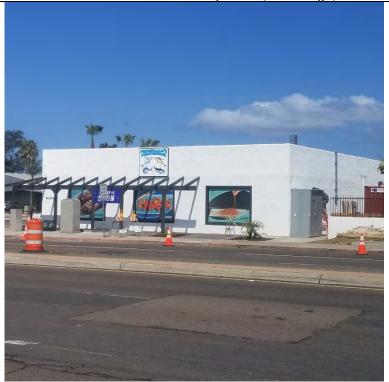
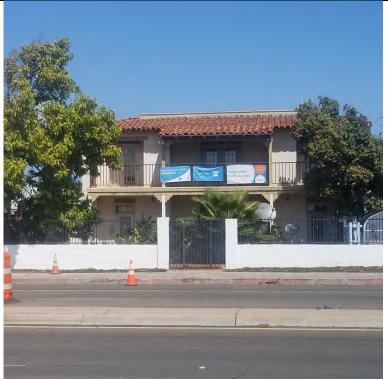
#### Photographs 15-16:

View of the restaurant (top photo) and mixed-use building (bottom photo) located south of the SPAWAR facility. No issues were observed in these areas.
