Survey Results of the 2017 City of San Diego Waterways Maintenance Plan Project Southwestern Willow Flycatcher and Least Bell's Vireo 45-Day Summary Report

CONCEPTUAL SALT MARSH MITIGATION PLAN FOR THE SORRENTO CREEK MAINTENANCE DREDGING PROJECT SAN DIEGO, CALIFORNIA

Attachment B
Revised Tables

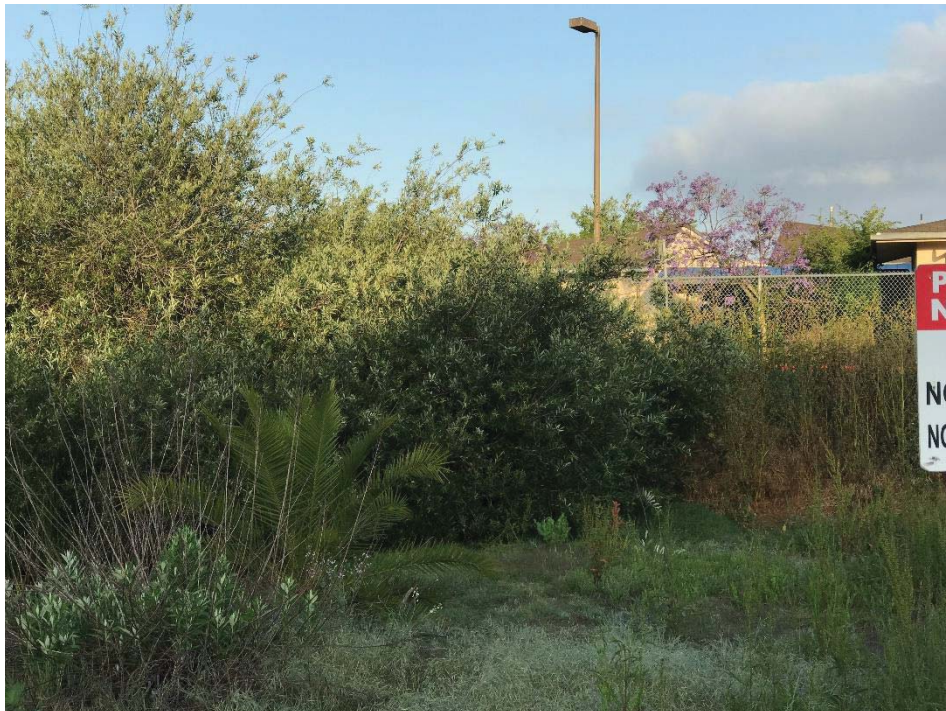
Photo 4: View facing west of habitat along Nestor Creek. Migrant willow flycatchers were observed in this area.

No SWFL were detected during the 2017 WMP protocol surveys. A total of three migrant willow flycatchers (*Empidonax traillii* ssp.) were documented during the surveys: two individuals were observed on the 5/18/17 survey of the Nestor Creek facility, and one individual was observed during the 5/31/17 survey of the Tijuana River facility.

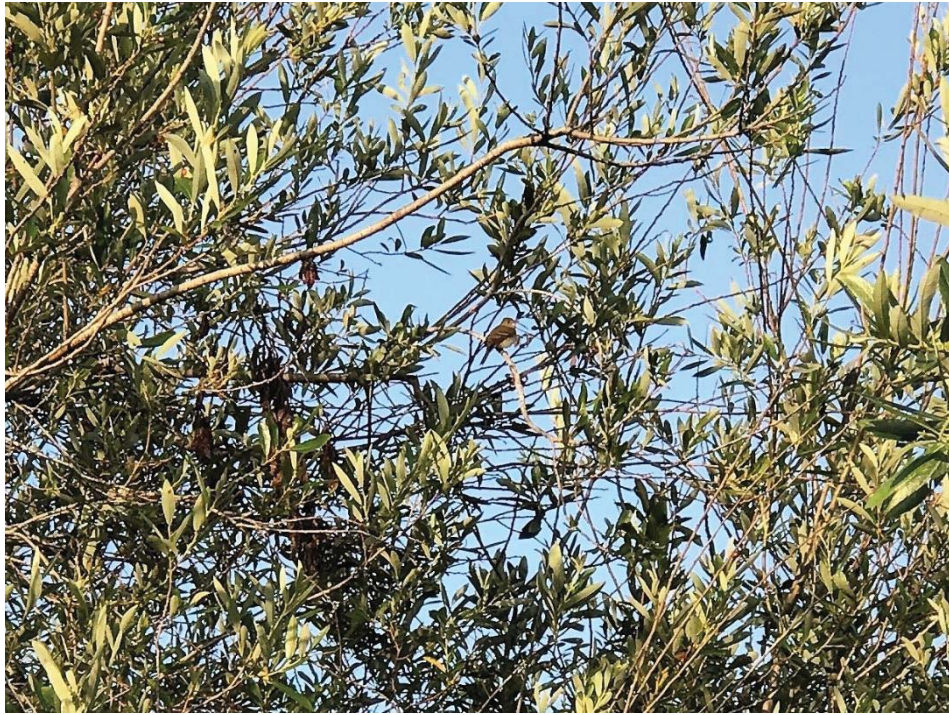
Photo 5: A migrant willow flycatcher (visible at center) detected at Nestor Creek.

The willow flycatchers detected at Nestor Creek and at the Tijuana River/Smuggler's Gulch facilities were only observed once and are determined to be migrants. It is likely these individuals were of the northwestern subspecies (*E.t. brewsteri*) because they were observed during the typical willow flycatcher migration period and because the dialect of their 'fitzbew' call resembled that of the northwestern subspecies. In addition, these individuals were not using habitat typically associated with SWFL breeding colonies. The habitat at Nestor Creek is surrounded by urban area, and supports relatively small, disjointed patches of willows. The Tijuana River/Smuggler's Gulch individual was detected within a large, monotypic patch of dense mulefat (*Baccharis salicifolia*) adjacent to the primary riparian corridor.

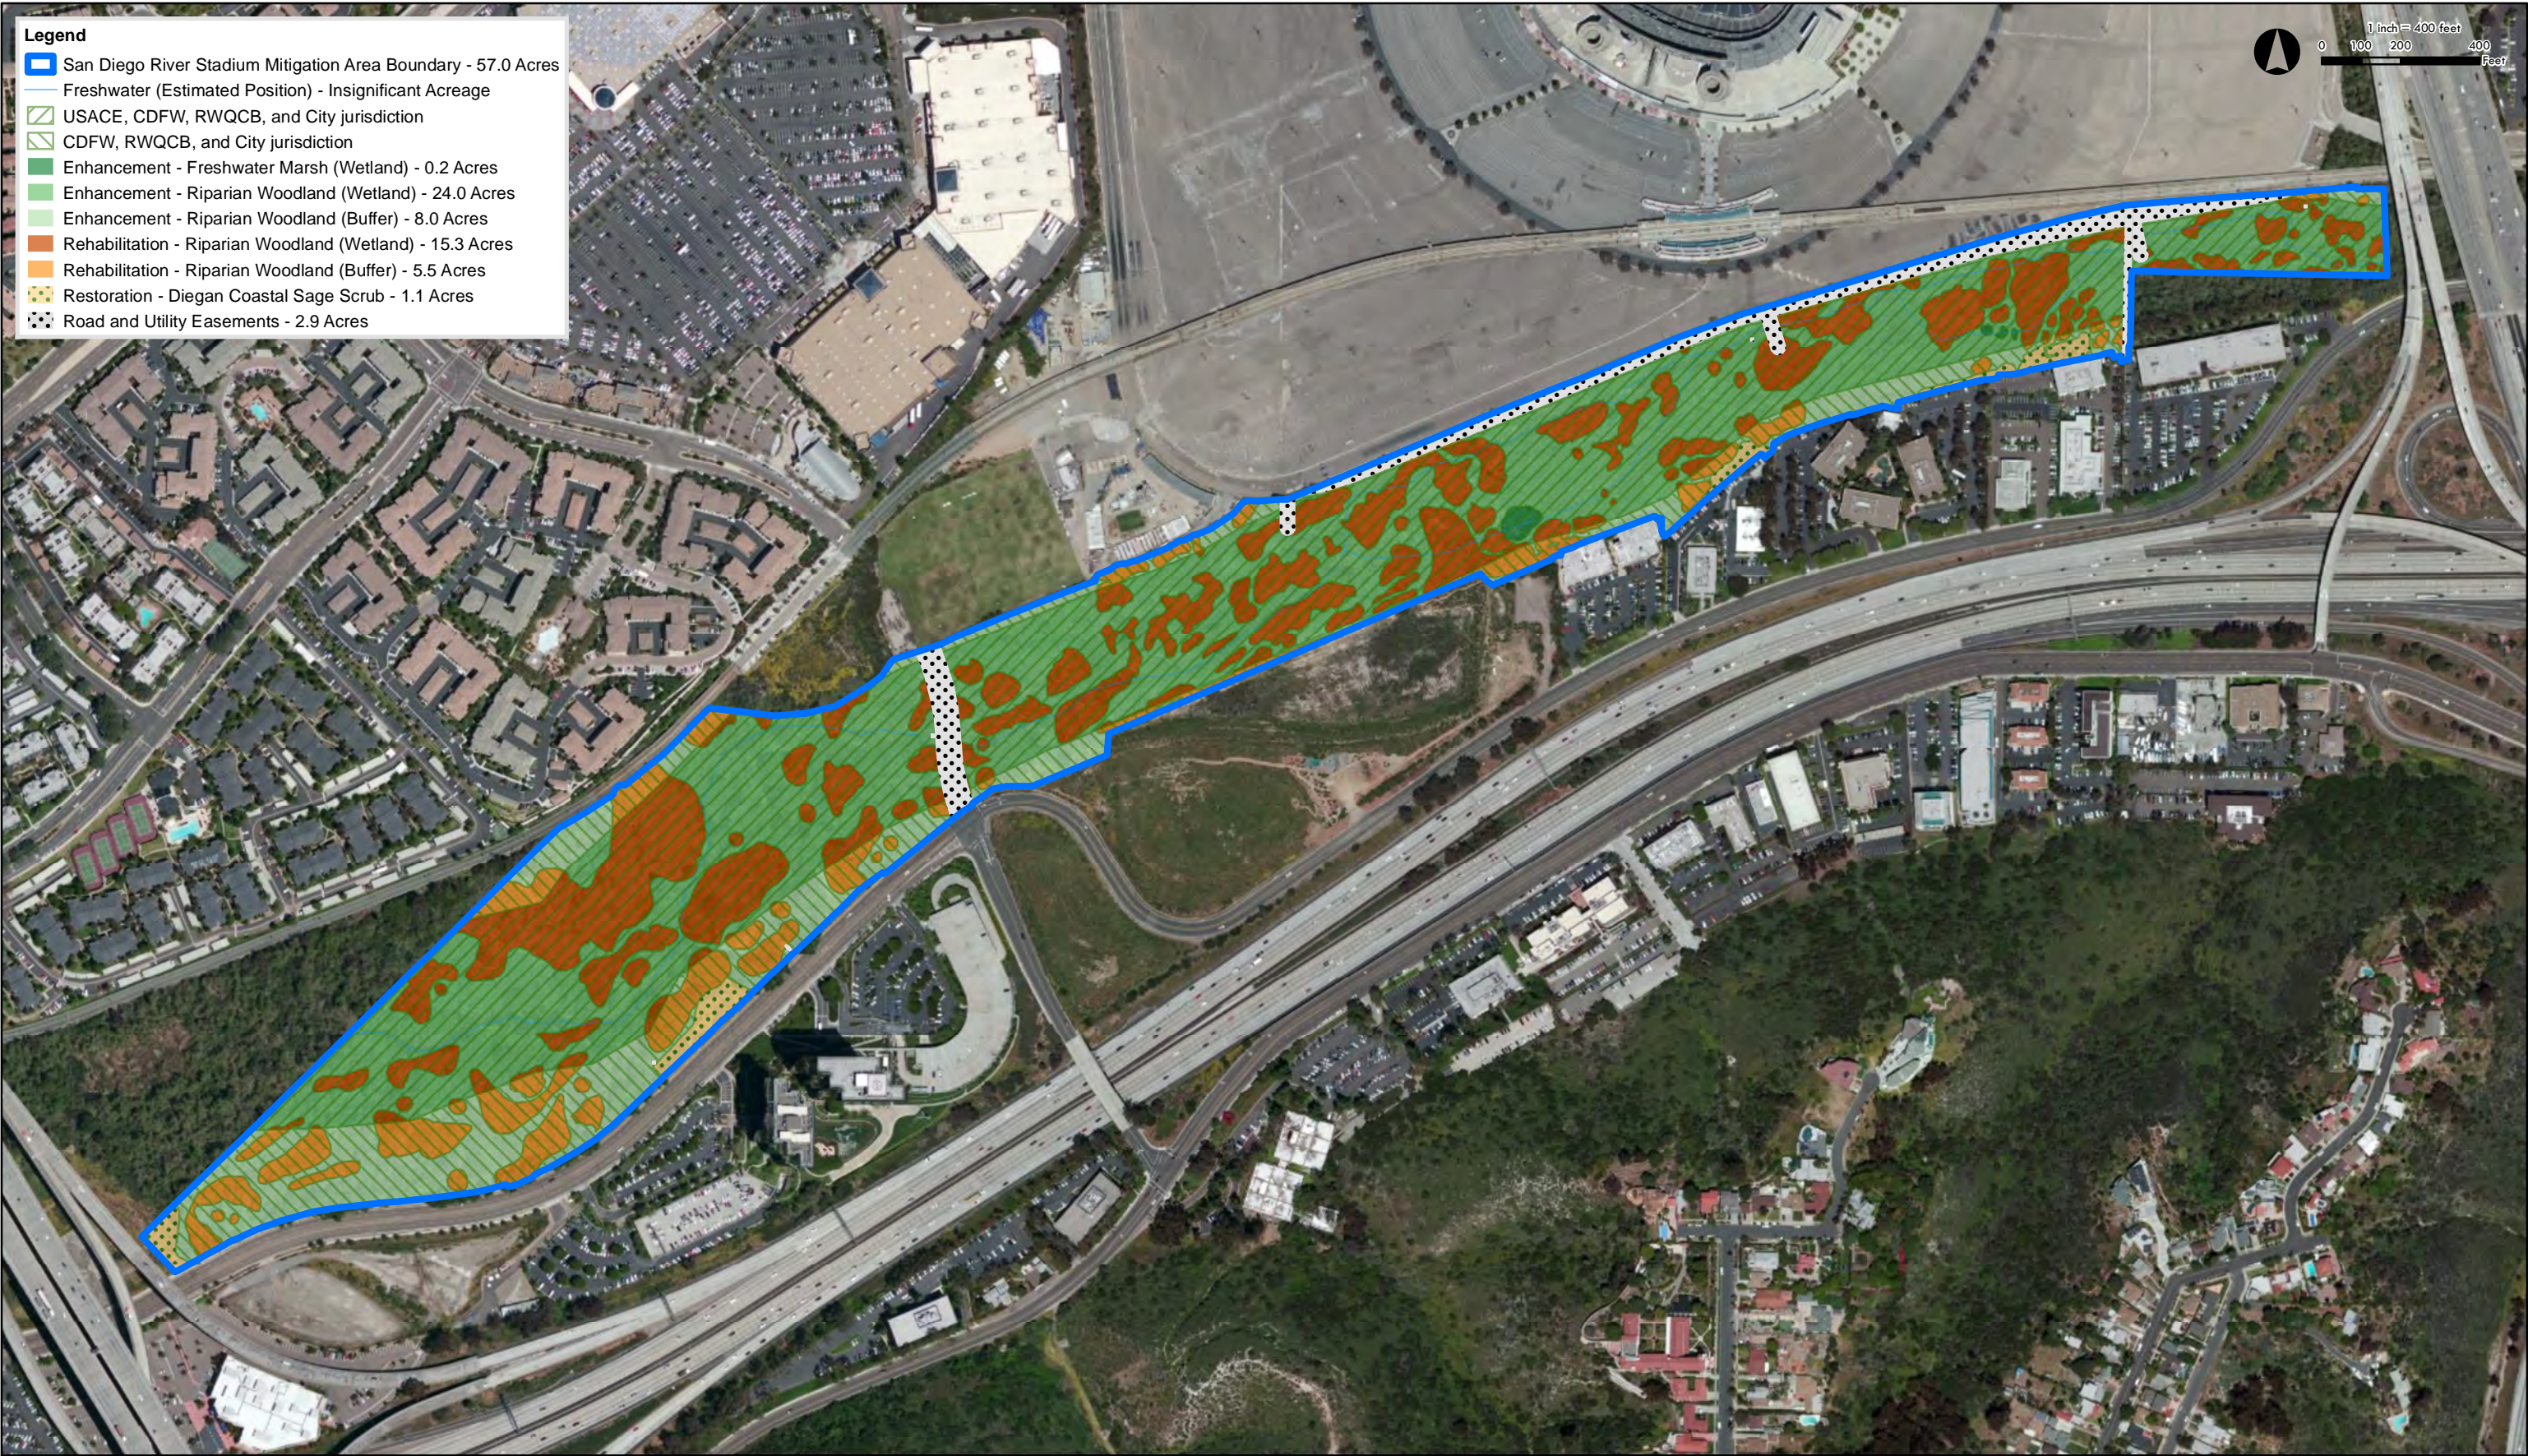
FIGURE 13
Mitigation Credit Areas

** These numbers based on results of time zero report and as-built conditions. Actual acreage for credit will be confirmed at the end of the five year maintenance and monitoring period.

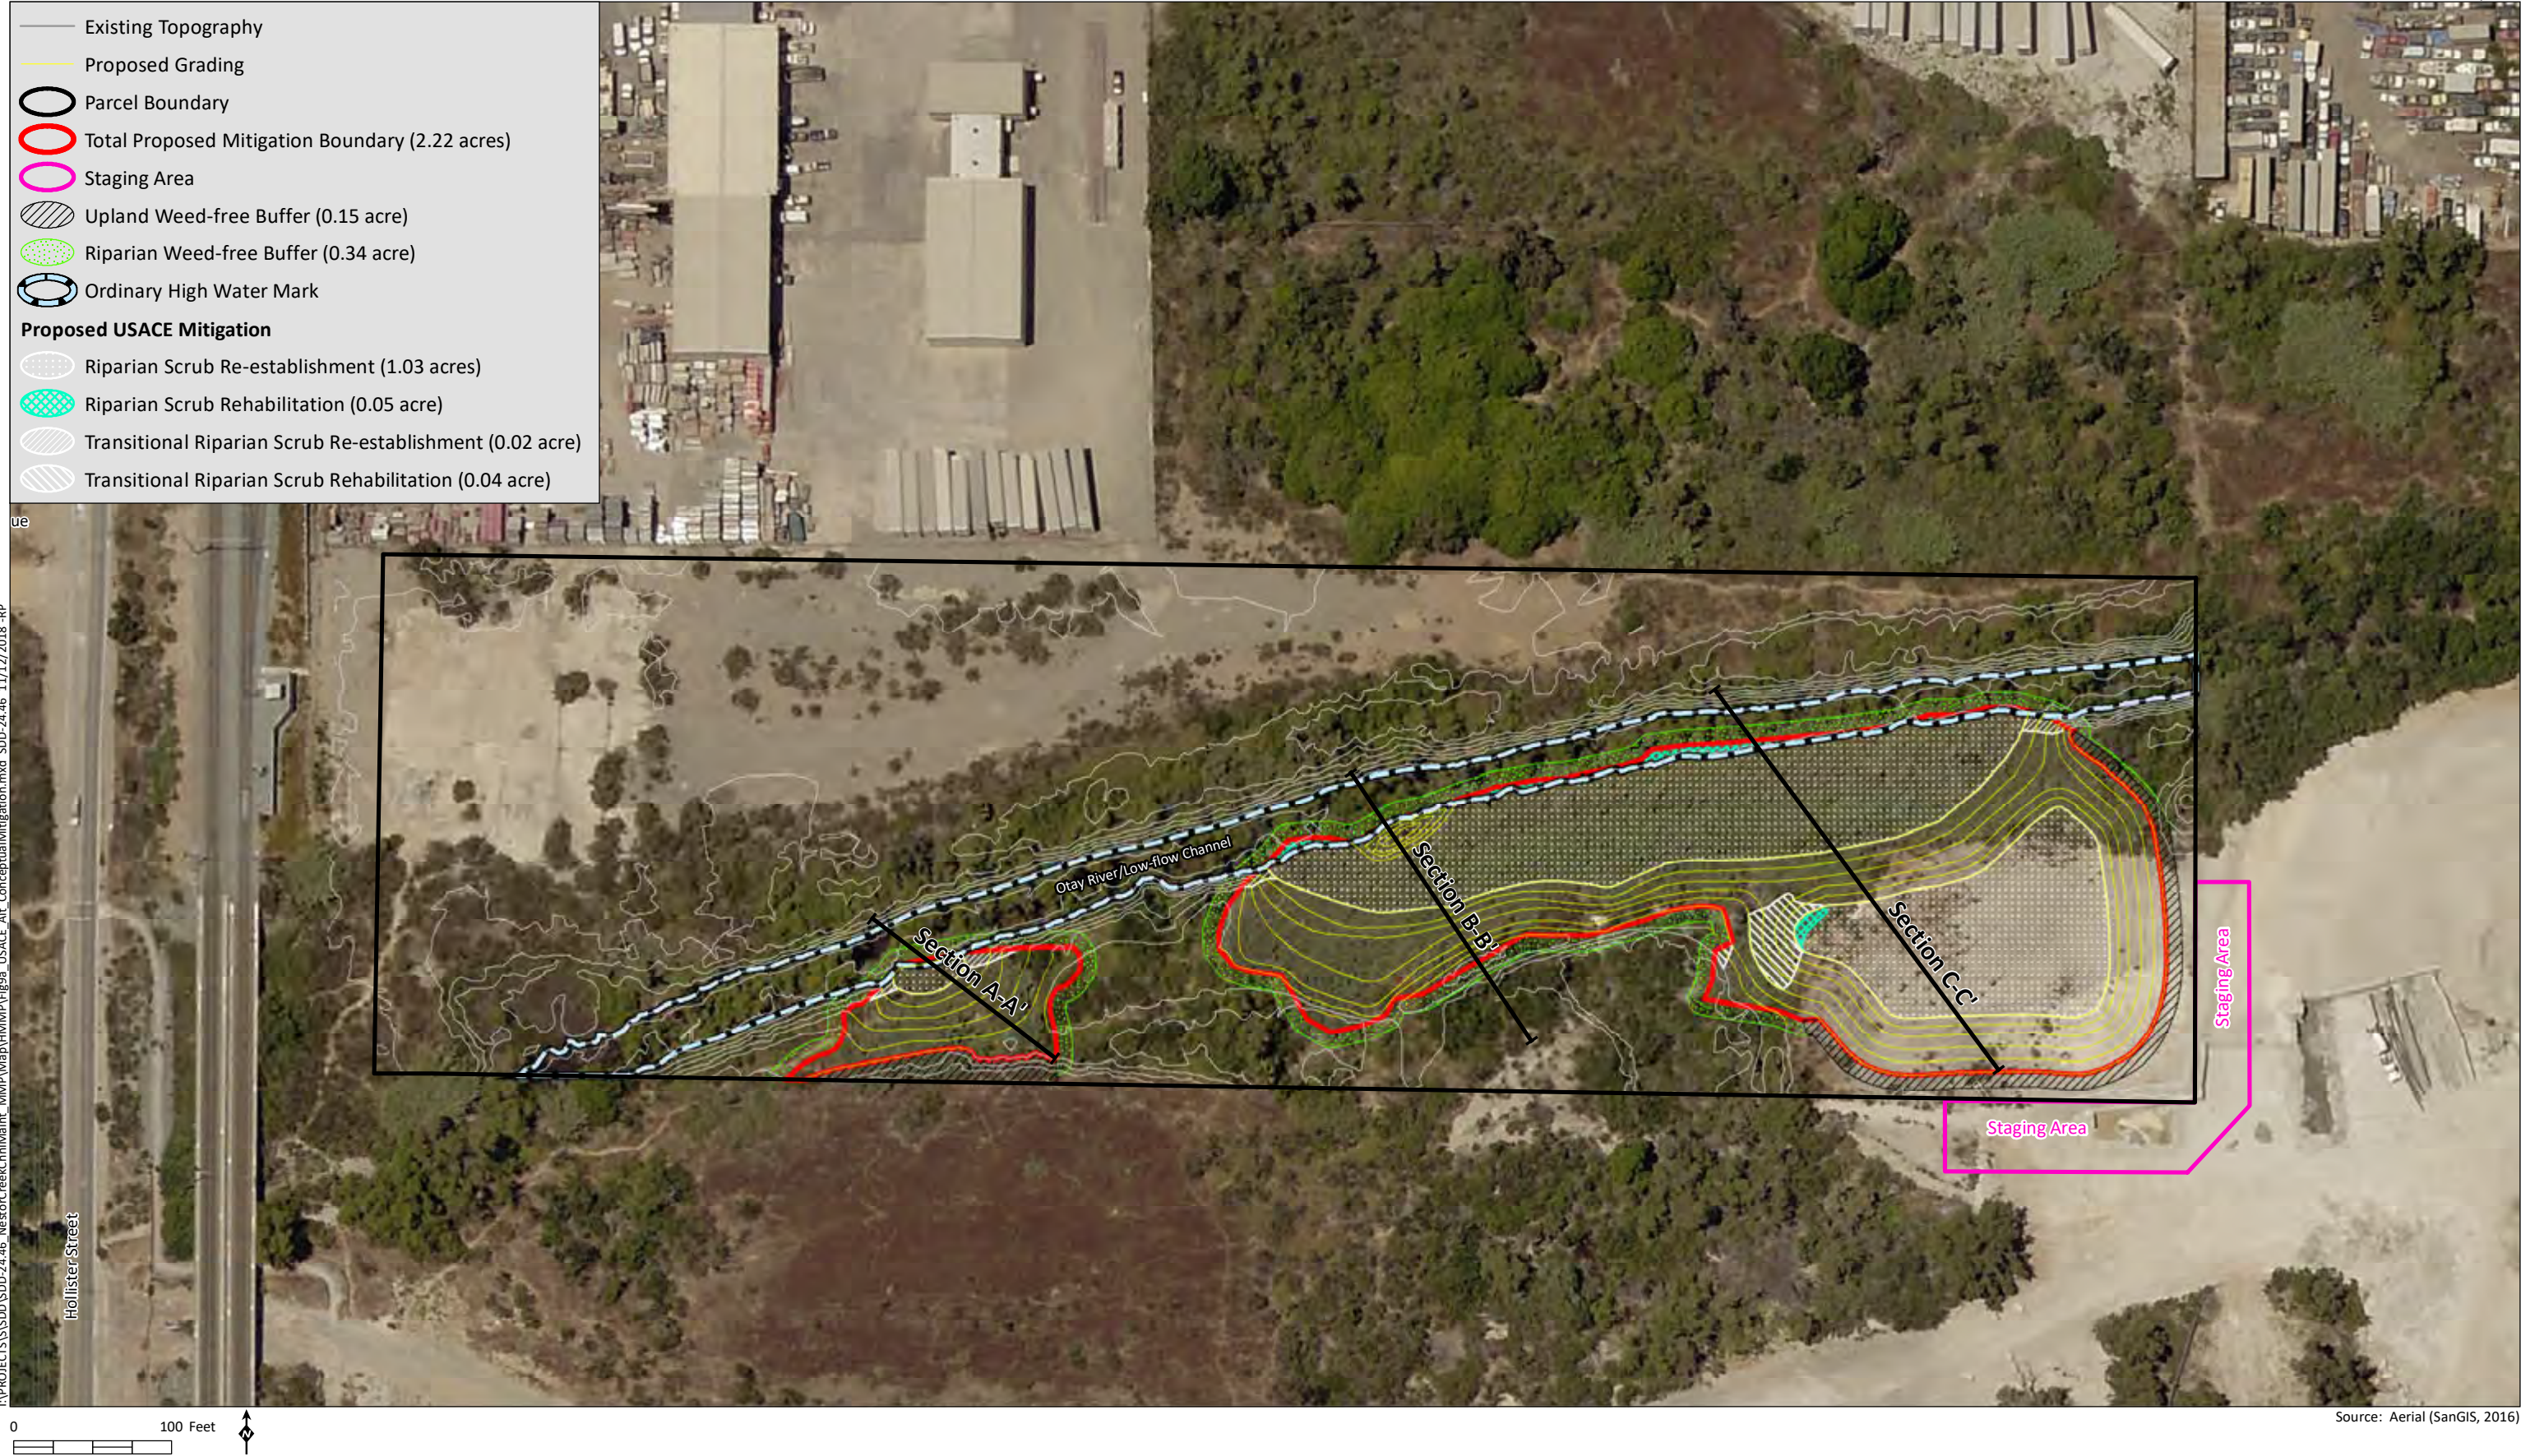
- Existing Topography
- Proposed Grading
- Parcel Boundary
- Total Proposed Mitigation Boundary (2.22 acres)
- Staging Area
- Upland Weed-free Buffer (0.15 acre)
- Riparian Weed-free Buffer (0.34 acre)
- Ordinary High Water Mark
- RWQCB Waters of the State/Active Flood Plain
- Proposed RWQCB Mitigation**
 - Riparian Scrub Re-establishment (0.87 acre)
 - Riparian Scrub Rehabilitation (0.21 acre)
 - Transitional Riparian Scrub Re-establishment (0.77 acre)
 - Transitional Riparian Scrub Rehabilitation (0.05 acre)
