OCEAN BEACH FISHING PIER

Draft Evaluation Report

December 4, 2018

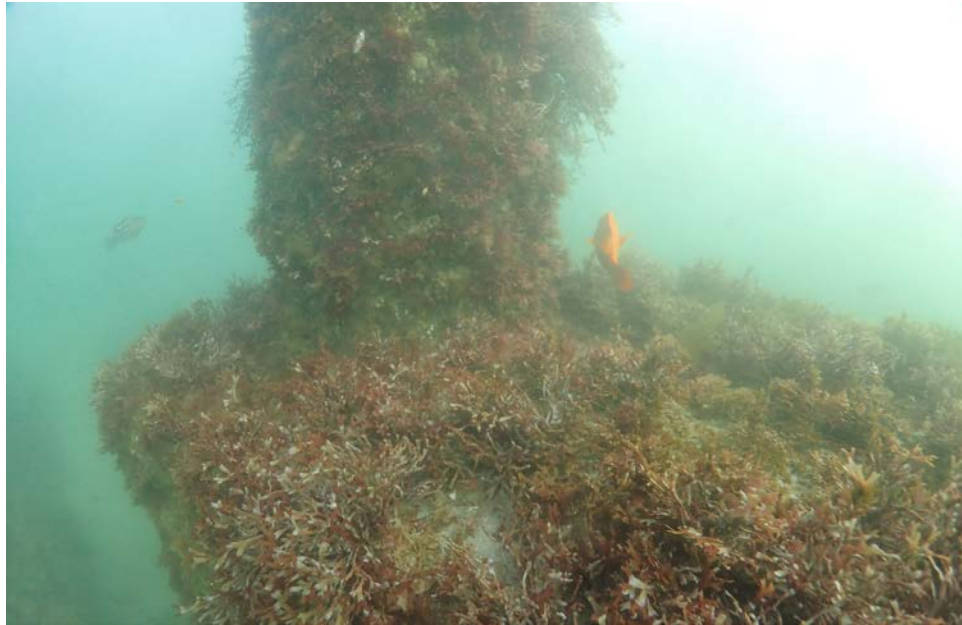
During the 1987 underwater investigation, horizontal cracks were observed in several of the piles. The cracks occurred near the ocean bottom in the piles near the ends of the north and south legs of the Tee at the offshore end of the pier. Grade beams were added connecting the piles at the bottom, reducing the effective height of the piles, see **Figure 3**.

Figure 3 - Grade Beam / Pile interface

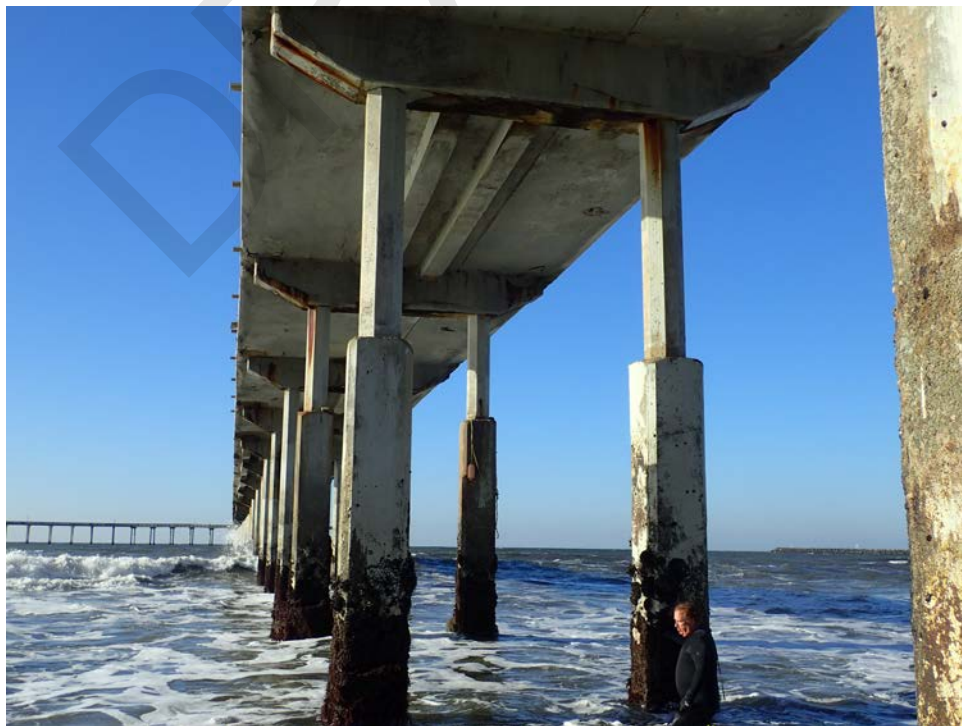
During the repair of vertical cracks in the piles at Bents 6 through 13 it was discovered that significant damage had occurred to the pile prestressing strands. A change was made to the contract during construction to add reinforced concrete encasements, shown in **Figure 4**, to the affected piles.

Figure 4 - Concrete Encasements at Bent 12

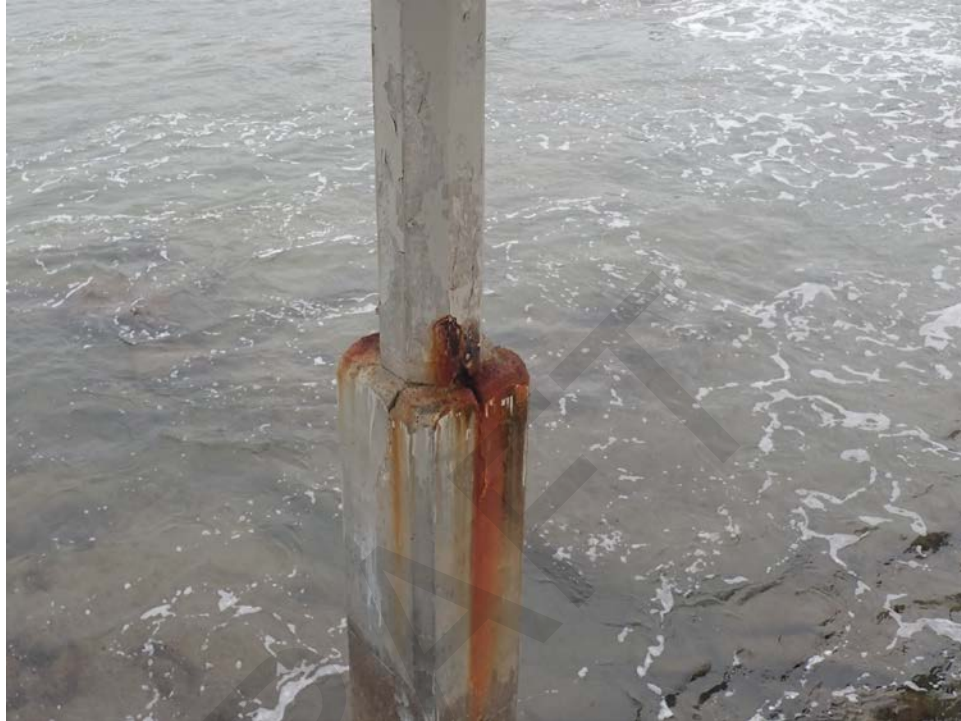
Some spalling was observed near the tops of the pile jackets. It was found that there is an unreinforced cap that was placed on the top of the jackets to prevent water from ponding and this appears to be the area where the spalling occurs.

Figure 9 - Spalling at jacket (Pile 6N)

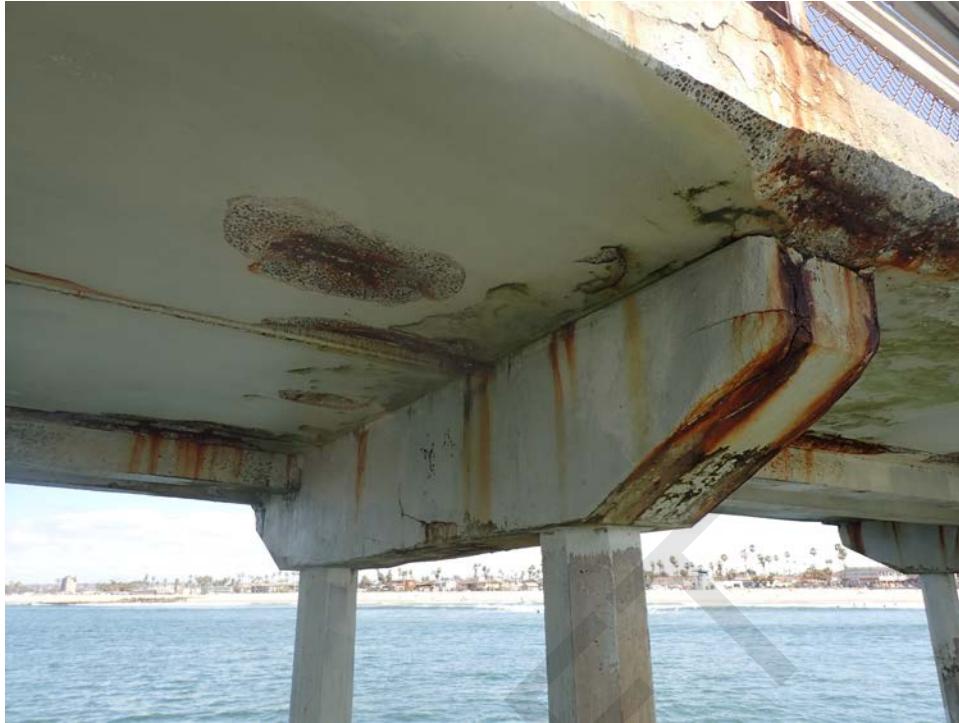
The most severe damage observed during this investigation occurred on the pile caps. This damage occurs throughout the length of the pier with virtually every pile cap affected. As in the case of the vertical cracks in the piles, the pile cap damage appears to be due to corrosion of the reinforcement.

Figure 10 - Typical damage on pile cap

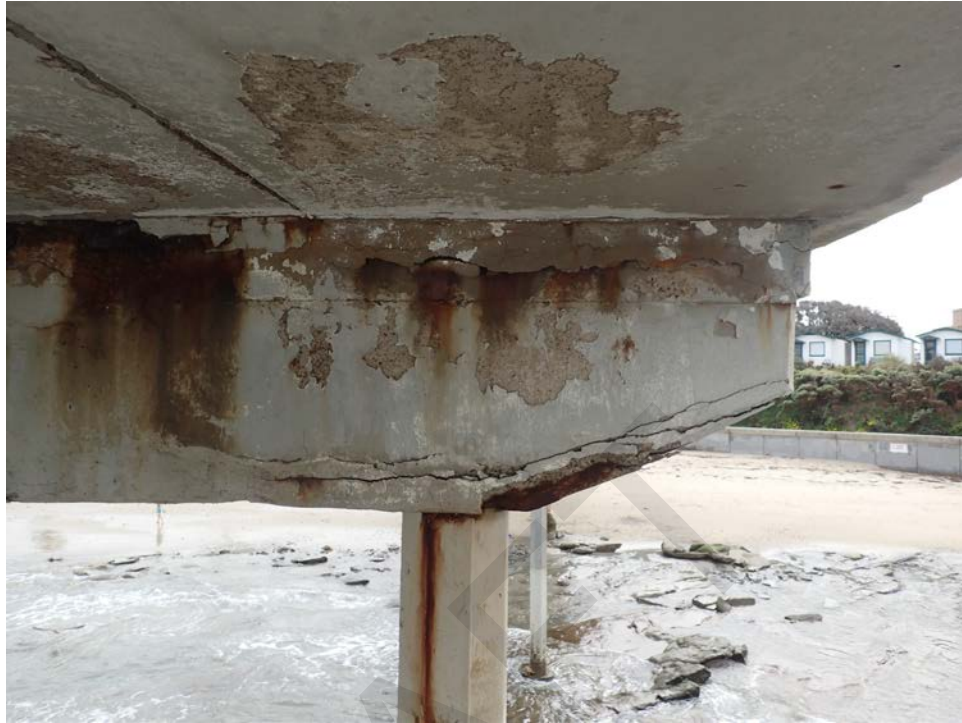
There is also widespread damage to the sloping portions of the caps.

Figure 12 - Concrete spalling in the pile cap

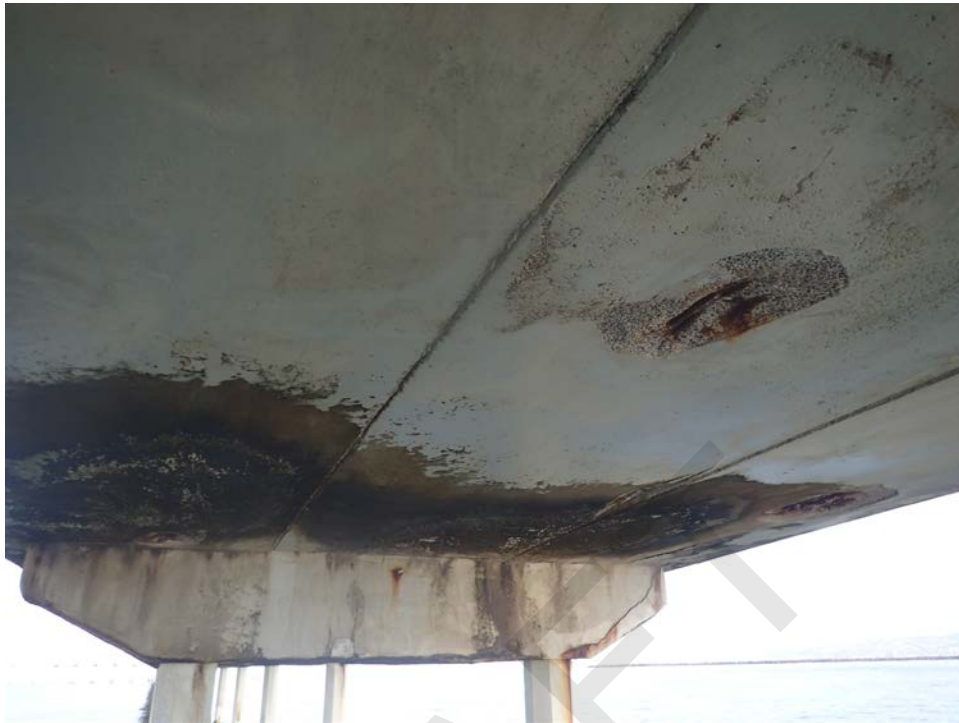
Damage to the slabs is widespread but not as severe as the damage to the caps. Nearly all the spans contain areas of damage. The precast soffit slabs are prestressed lightweight concrete with specified concrete cover of 1.5 in. over the prestressing strands. The topping is four-inch lightweight

Figure 13 - Typical soffit damage

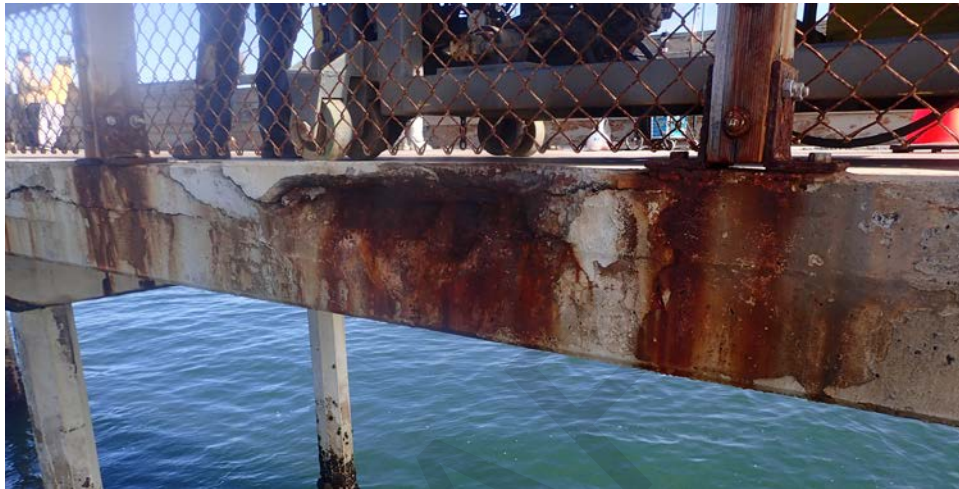
There is extensive cracking on the edge of the pier deck especially on the south side of the deck in the areas where the deck elevation is low, between Bents 15 and 40. From the rust stains and the location and orientation of the cracks, it appears that these cracks have been caused by corrosion of the reinforcement.

Figure 15 - Typical cracking in deck edge

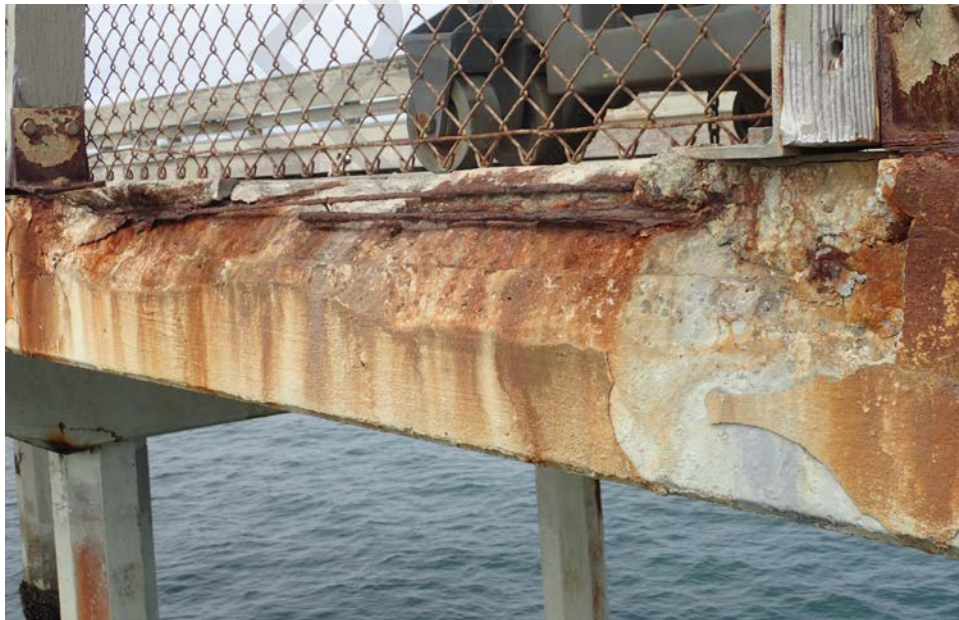
Figure 16 - Severe spalling of deck edge

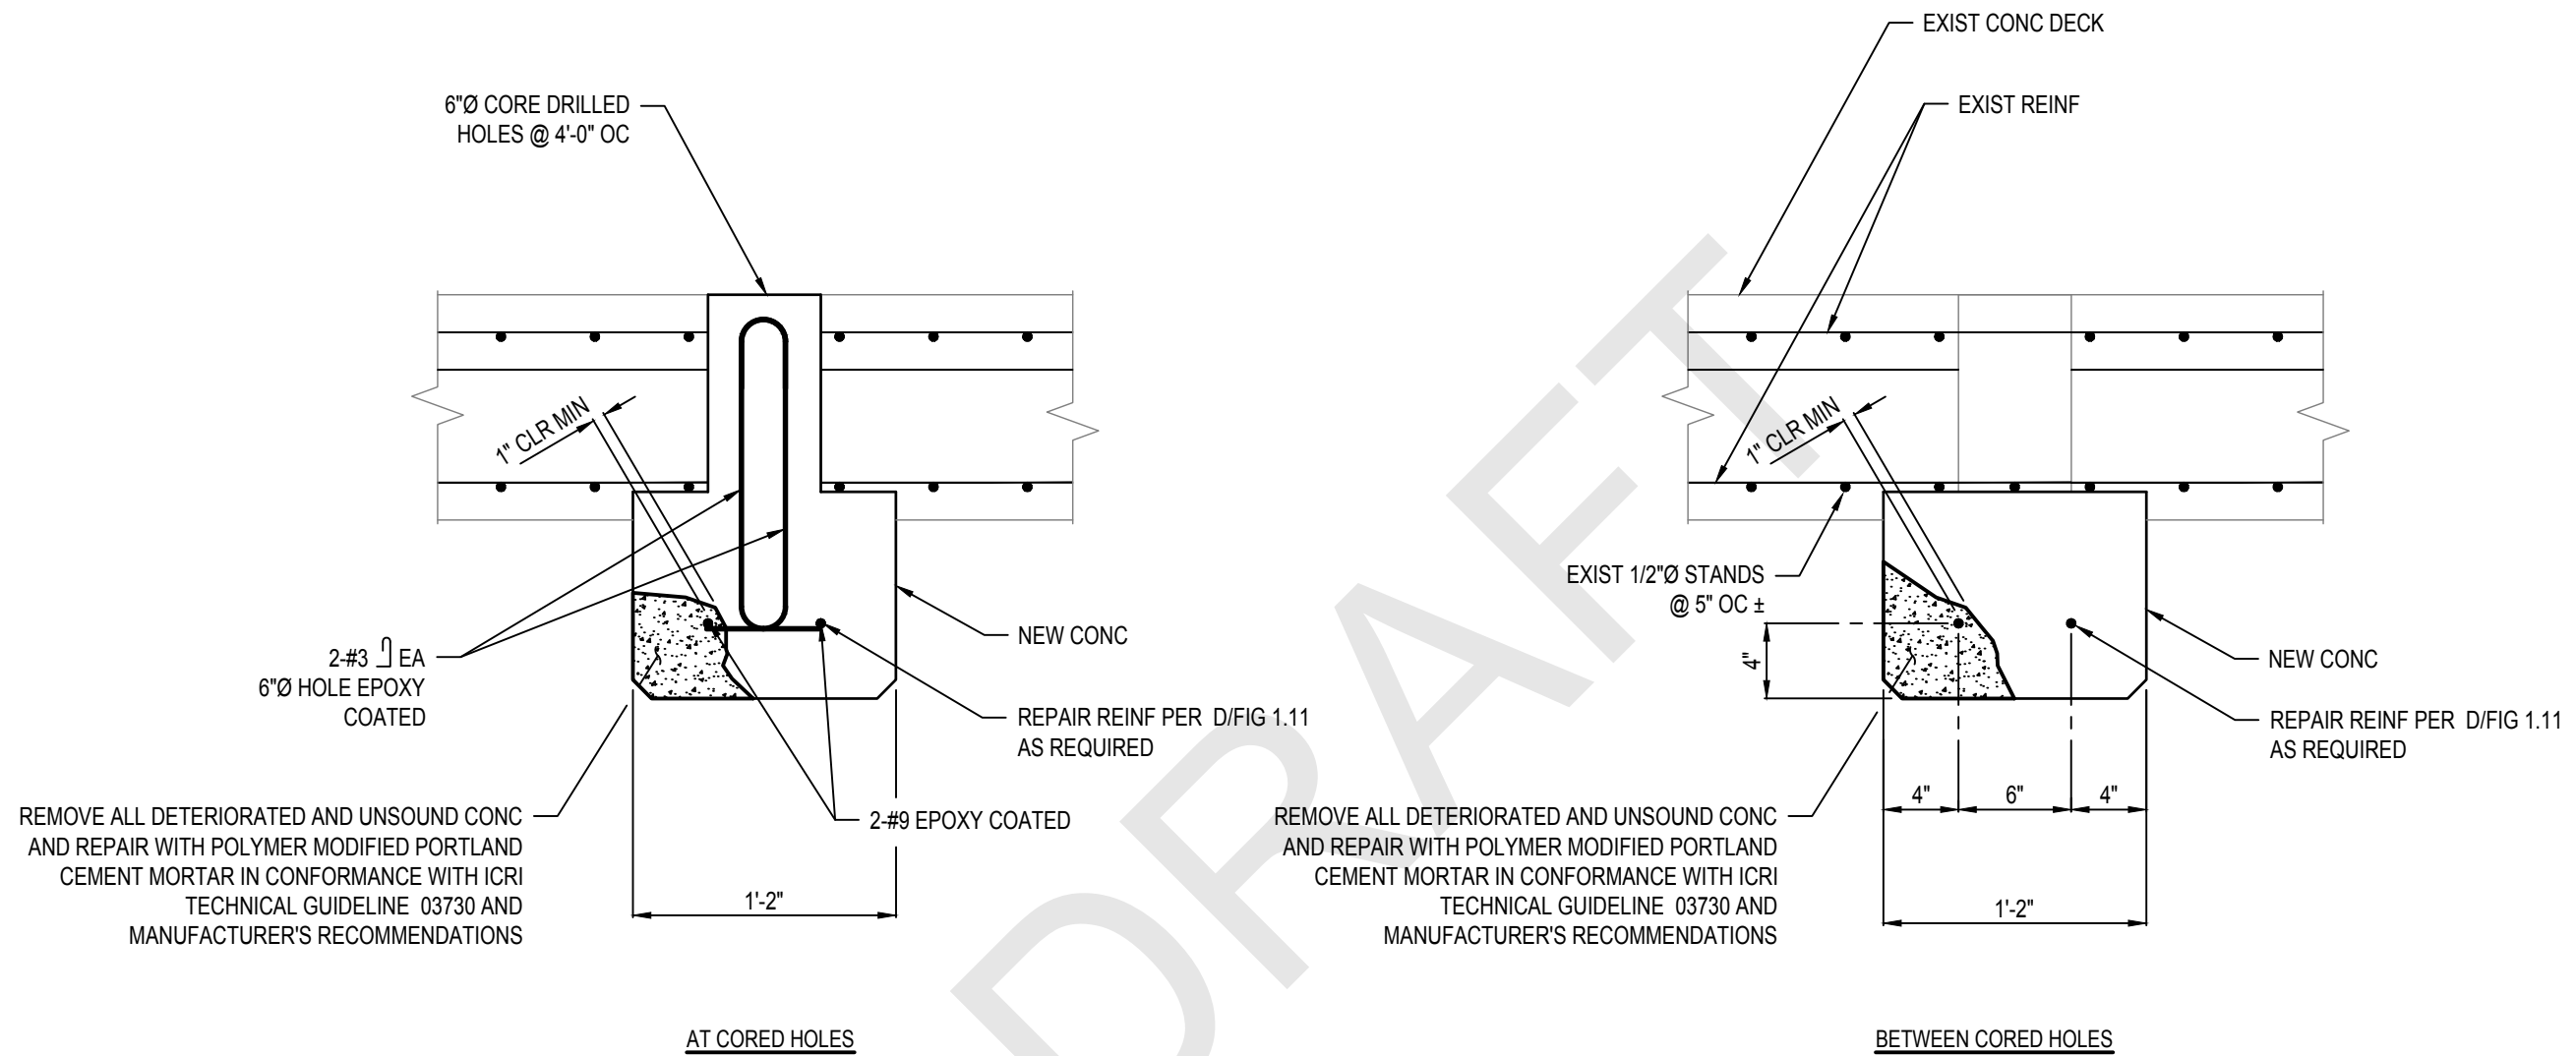
A1 HORIZONTAL CONCRETE BEAMS BETWEEN PILE CAPS
NO SCALE

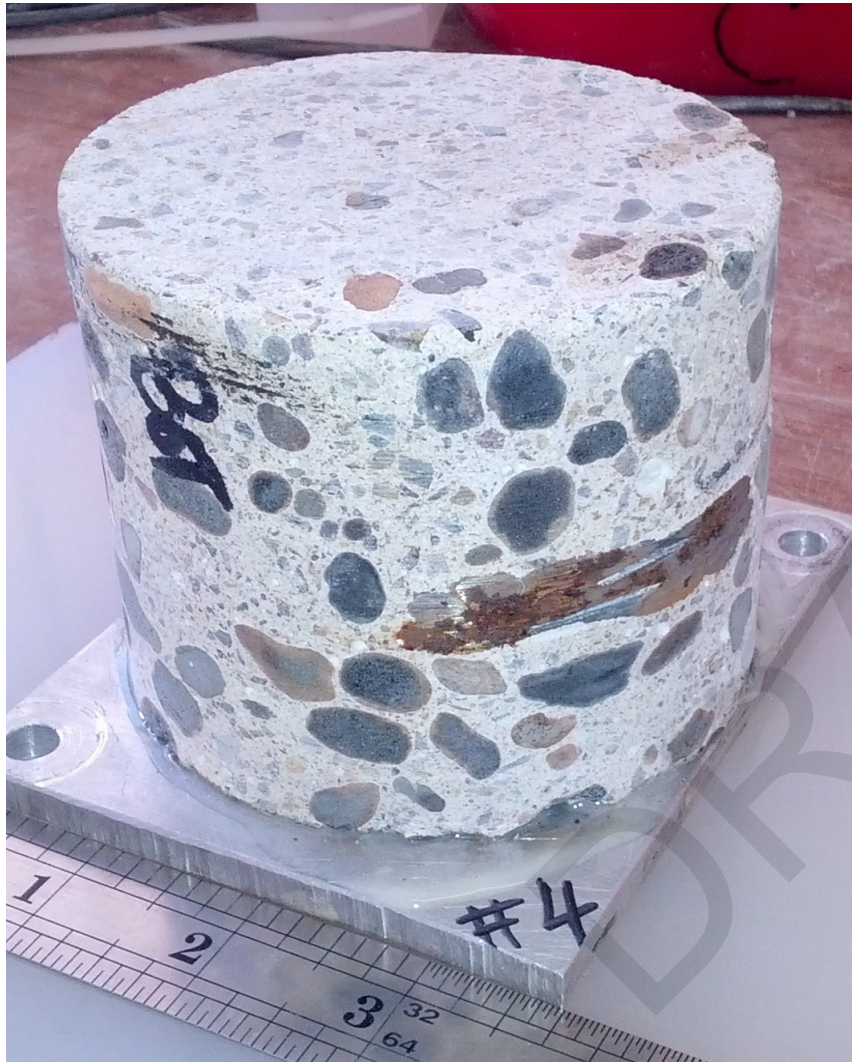
Core #4: Section for chloride analysis was cut at the observed reinforcement level. Reinforcement is located at about 1 5/8" below the exposure surface (bottom)

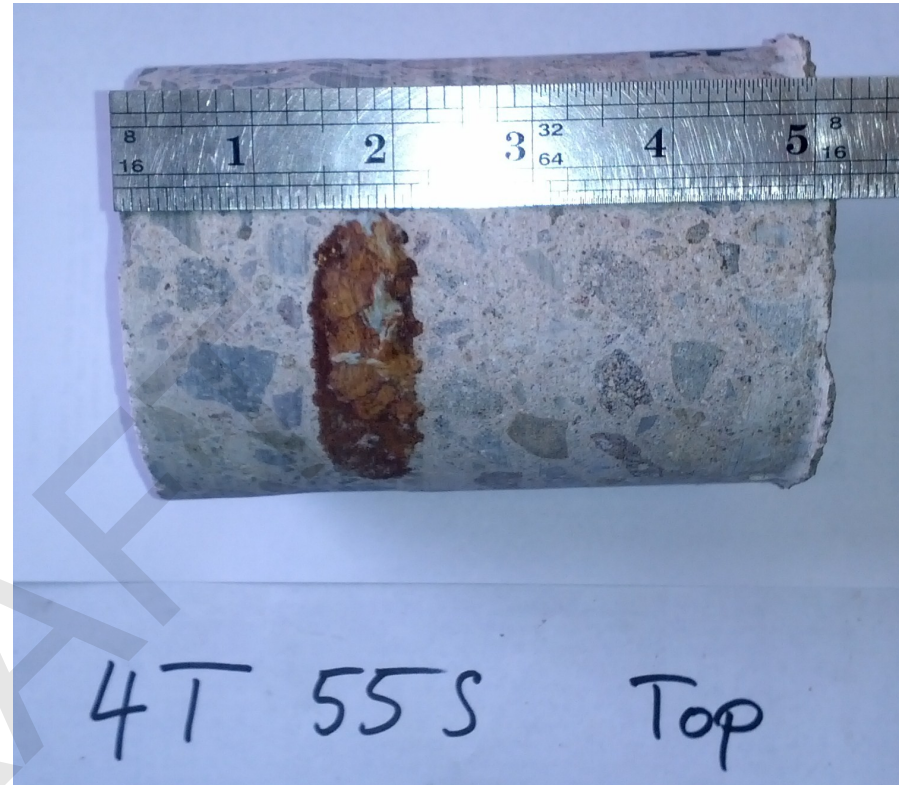
Core #4T: Section for chloride analysis was cut at the observed reinforcement level. Reinforcement is located at about 1 3/4" measured from the bottom surface (left hand side).

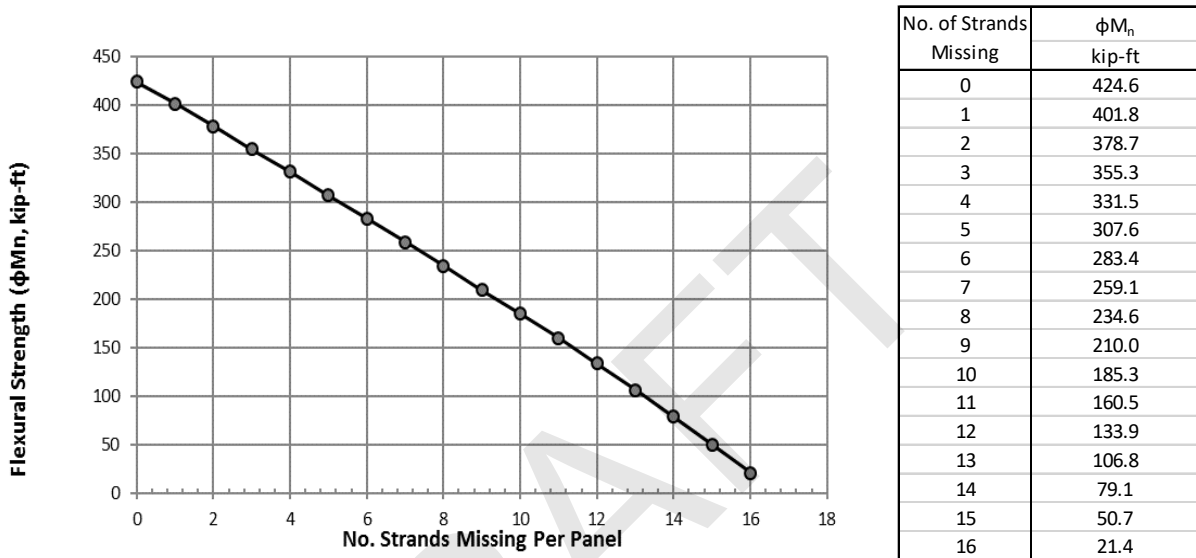
FIGURE 5: Midspan Section – Positive Moment Strength Corresponding to Number of Strands Lost

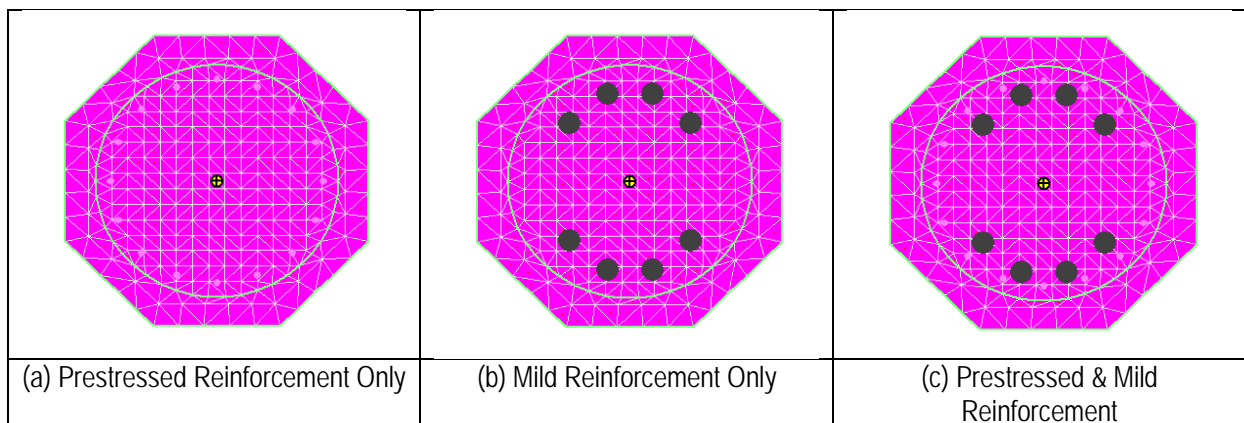
Figure 8 shows the cross sections of the original undamaged 20-in piles.

FIGURE 8: 20" Pile – Undamaged Condition

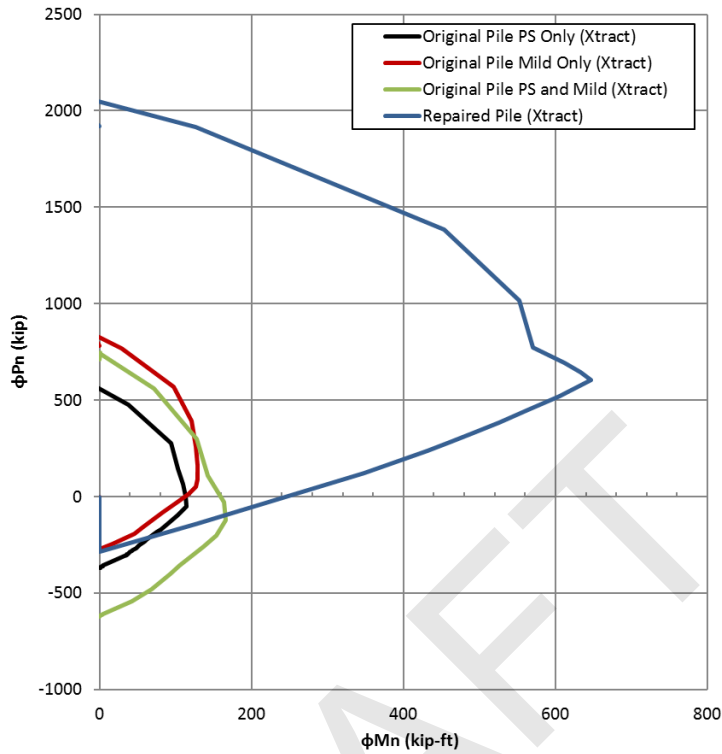
FIGURE 13: Design P-M Interaction Results – 16" Pile
