SHORELINE RESTORATION

Preliminary Engineering Report (PER)

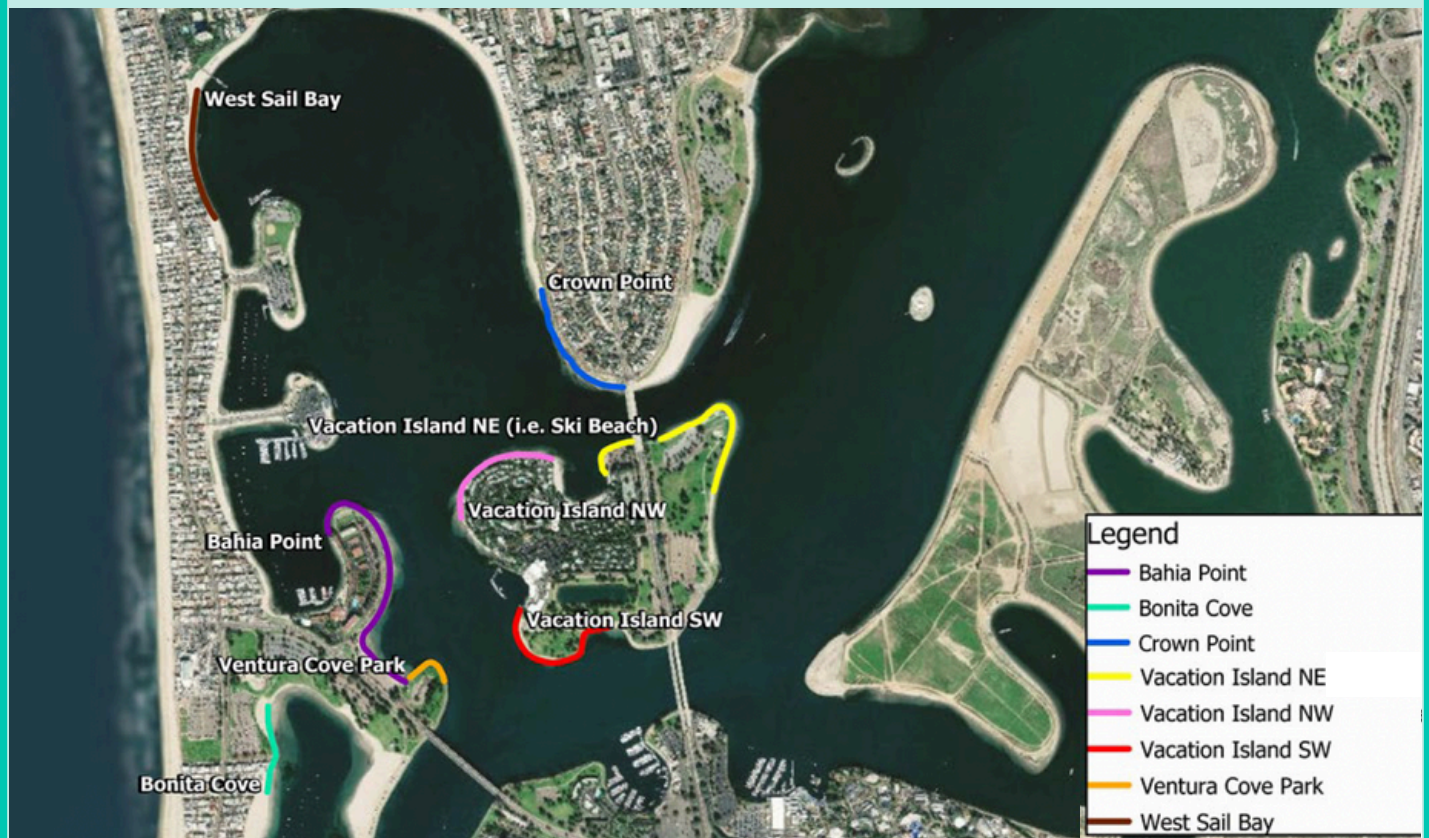
Proposed Improvements

Improvement Area	Recommendations
Bonita Cove	<ul style="list-style-type: none"> • Relocate sidewalk up to 30 ft. inland • Extend beach to 100 ft. wide • Add cobble berm to reduce erosion
Ventura Cove Park	<ul style="list-style-type: none"> • Repair and raise crest height of riprap • Add footpath parallel to riprap • Improve oyster habitat
Vacation Island Southwest	<ul style="list-style-type: none"> • Improve and raise crest height of riprap • Bury riprap within a raised beach area • Add landscaping, benches, and bonfire facilities • Improve oyster habitat
Bahia Point	<ul style="list-style-type: none"> • Widen beach and add paths for maintenance vehicles • Install cobble breakwater and sheet wall groins to reduce erosion • Add stormwater improvements
West Sail Bay	<ul style="list-style-type: none"> • Extend beach to 100 ft. wide
Crown Point	<ul style="list-style-type: none"> • Extend seawall 150 ft. southeast

Vacation Island Northwest	<ul style="list-style-type: none"> • Add two sand retention rock groins with pedestrian access • Widen and elevate the beach
Vacation Island Northeast	<ul style="list-style-type: none"> • Repair and raise crest height of riprap • Add a drainage ditch for runoff flows • Extend Ski Beach to 100 ft. wide with a cobble berm
