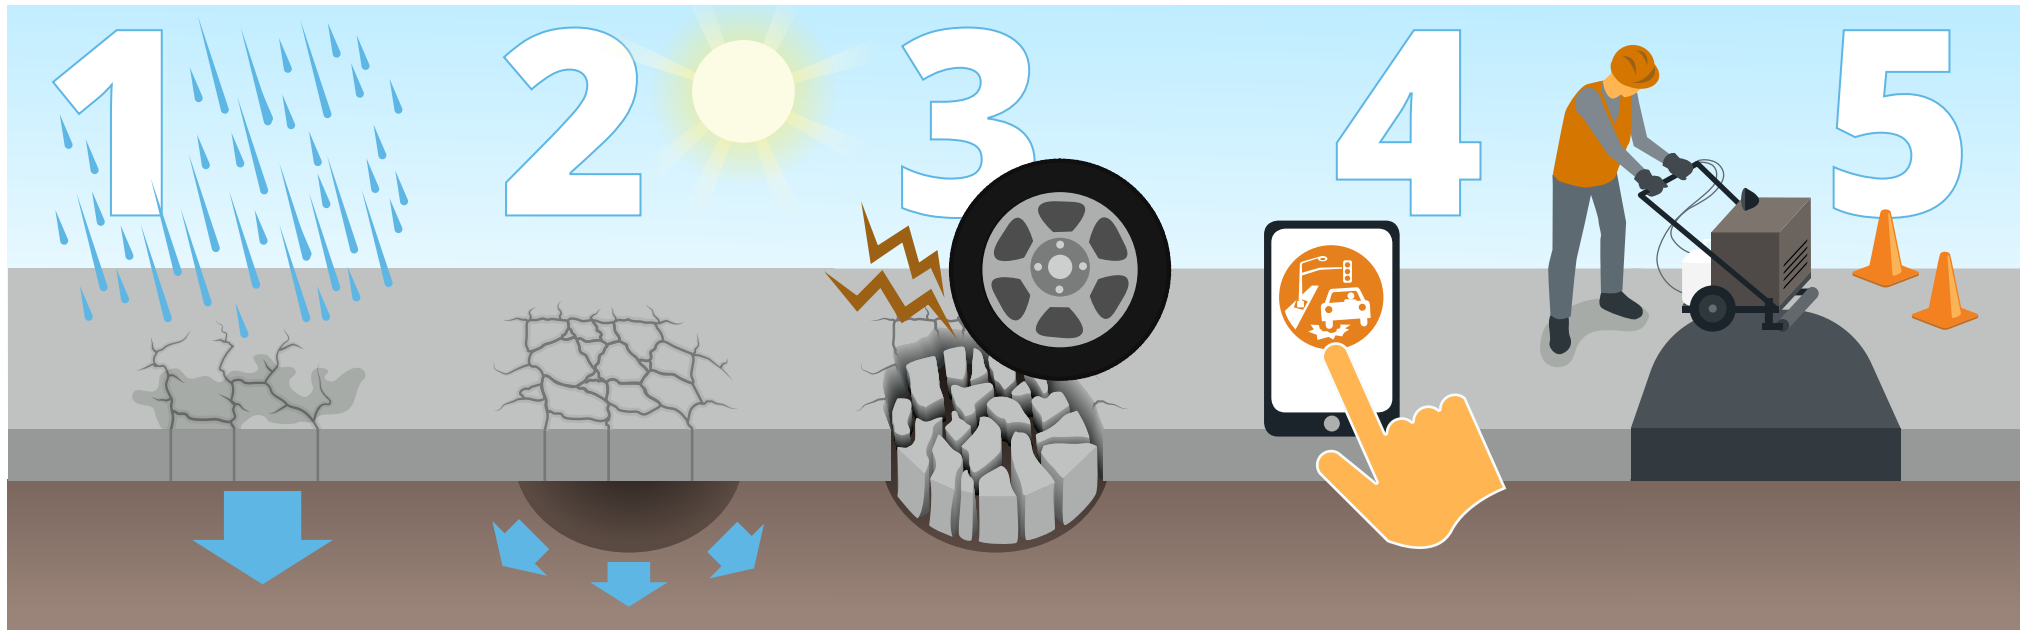
**1.** Cracks caused by traffic and aging allow rainwater to seep through and erode pavement base.

**2.** Traffic and erosion beneath pavement result in additional cracking and a cavity begins to form.

**3.** The pavement surface weakens and collapses into the cavity beneath, creating a pothole.
