## ASBESTOS AND LEAD INSPECTION REPORT

2544 Collier Ave. & 2746 Copley Ave.  
BUILDINGS TO BE RELOCATED

*December 11, 2013*  
*ALMP Project #6937*

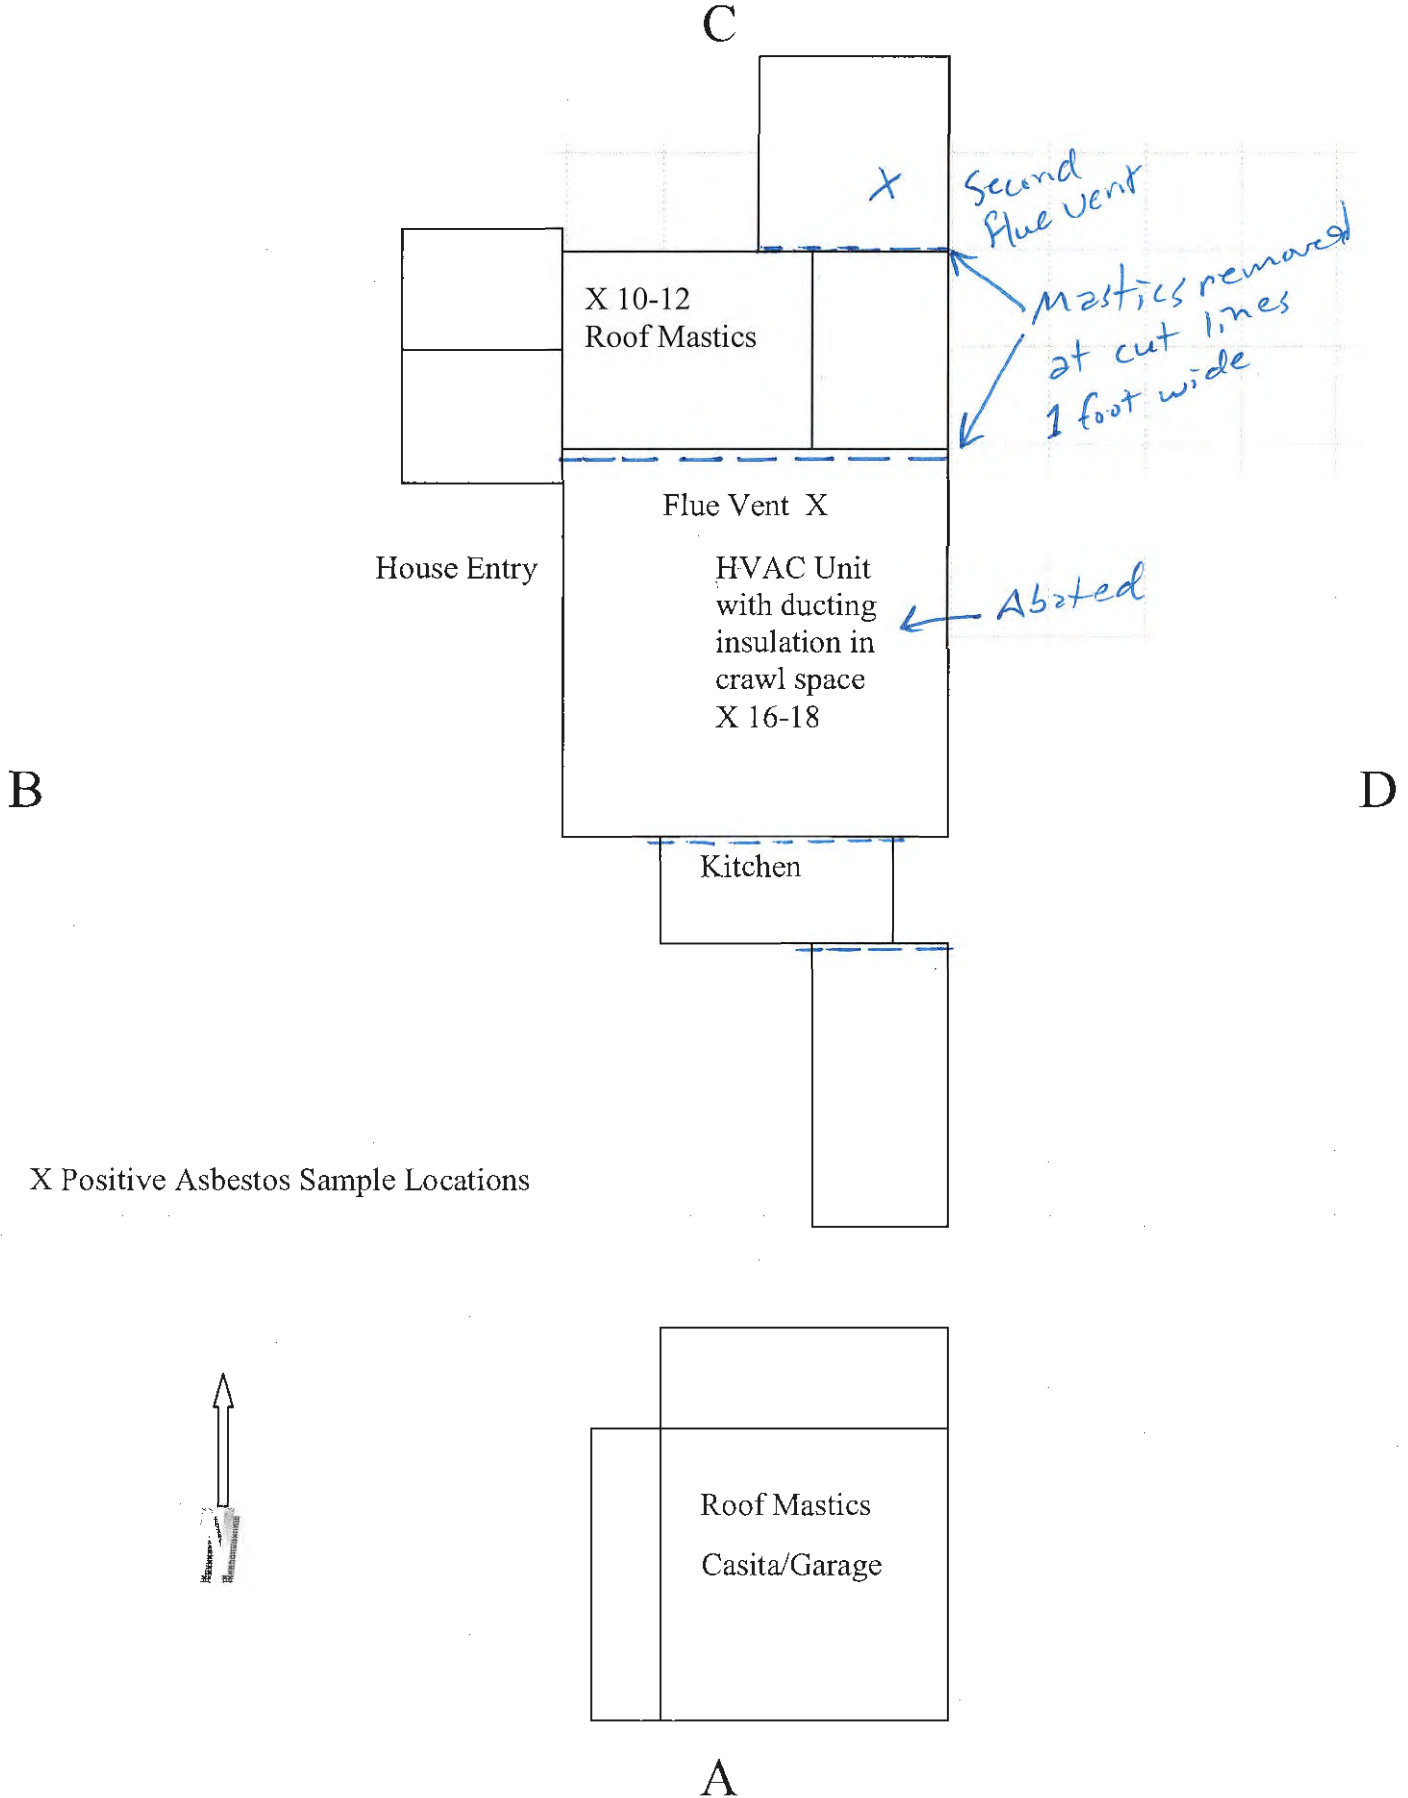
# Sampling Map and Property Sketch

Address: 2544 Collier Ave., San Diego CA Job# 6937a Inspection Date: 10-22-2013

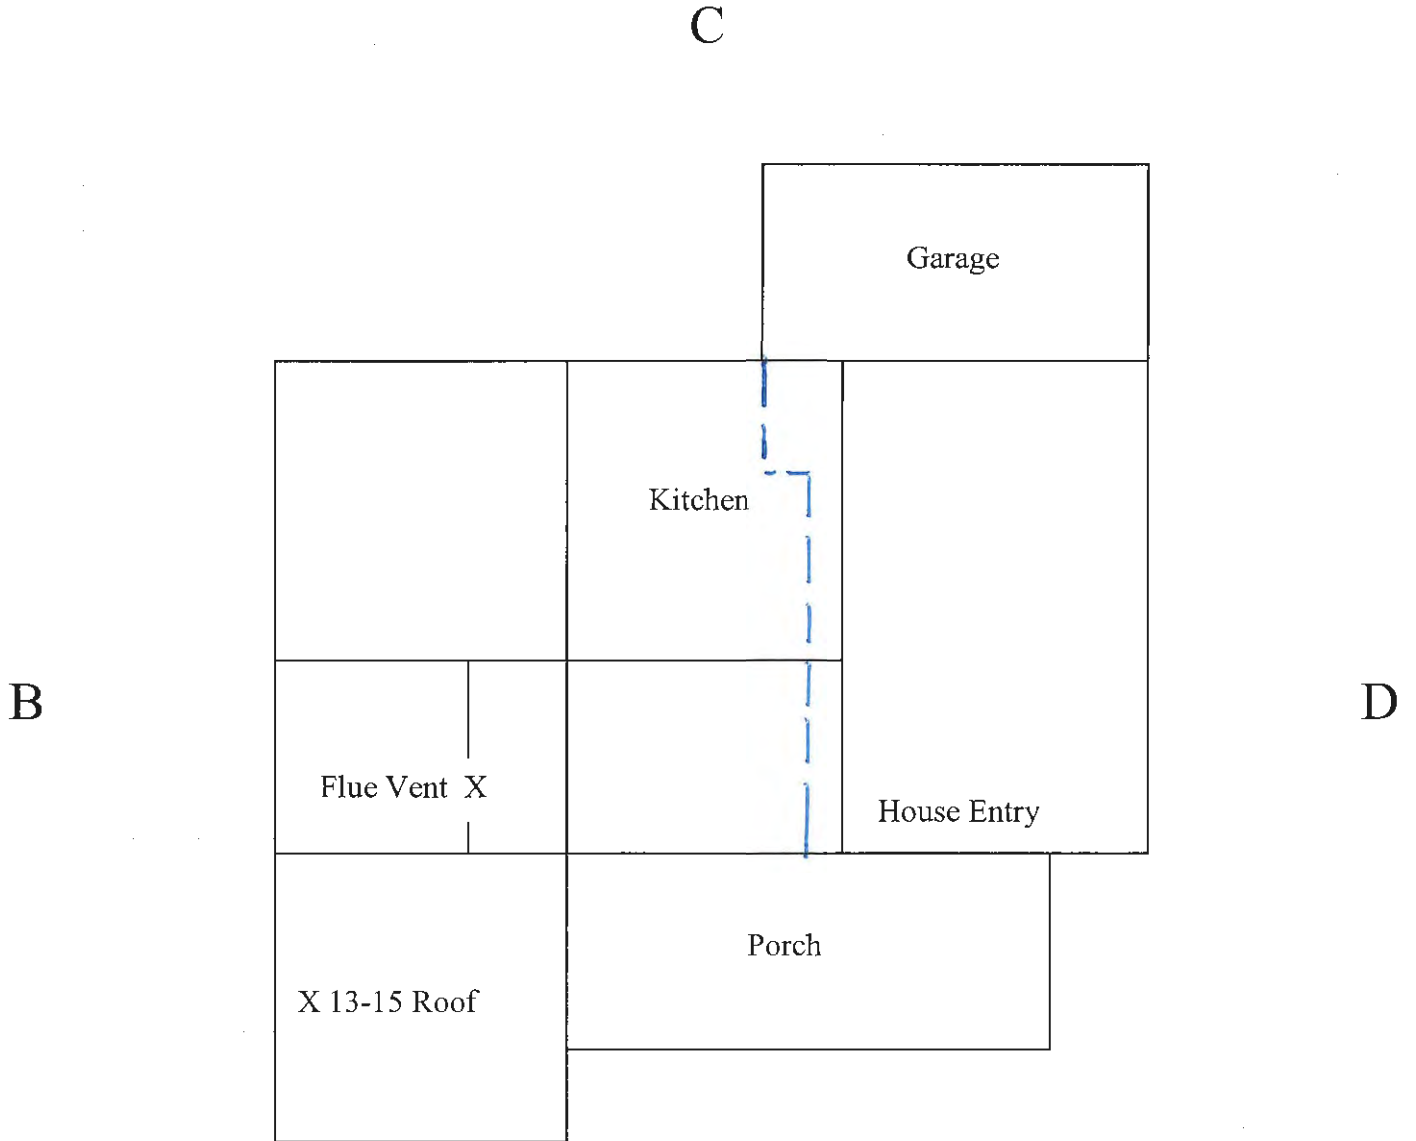
# Sampling Map and Property Sketch

Address: 2764 Copley Ave., San Diego CA Job# 6937b Inspection Date: 11-22-2013

X Positive Asbestos Sample Locations
